ANNUAL INSPECTION REPORT

GREAT RIVER ENERGY – STANTON STATION

Bottom Ash Landfill

January 2016

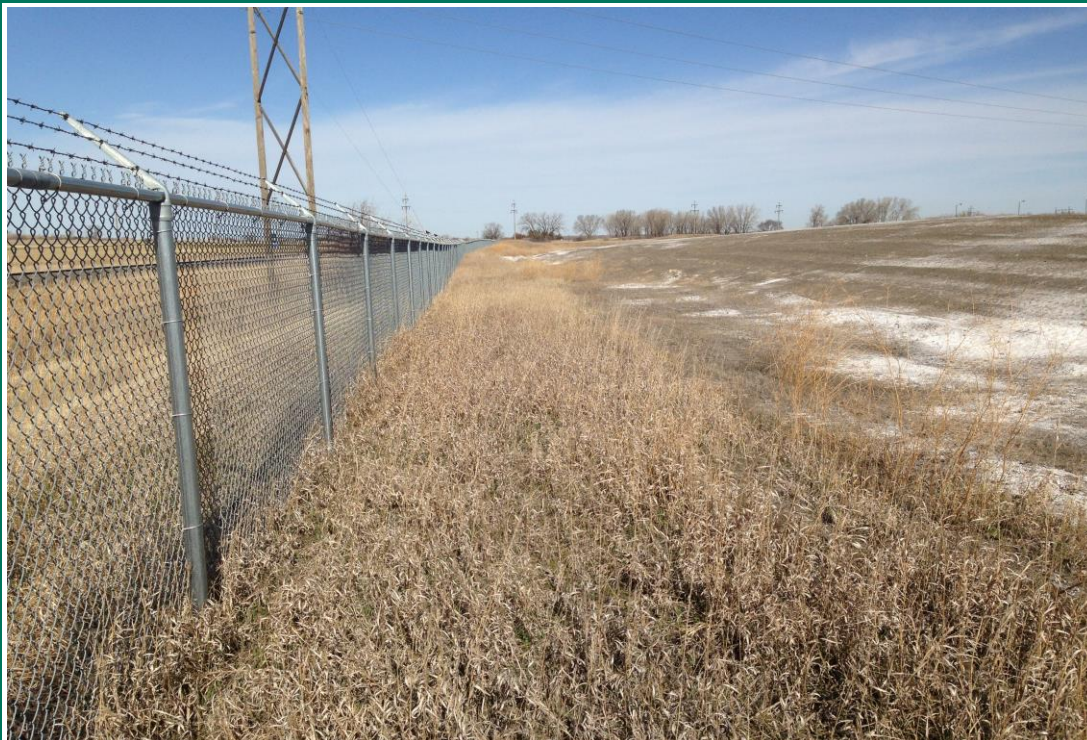
Photograph 4
South crest (contact water channel not well defined) (IMG_3719.JPG)

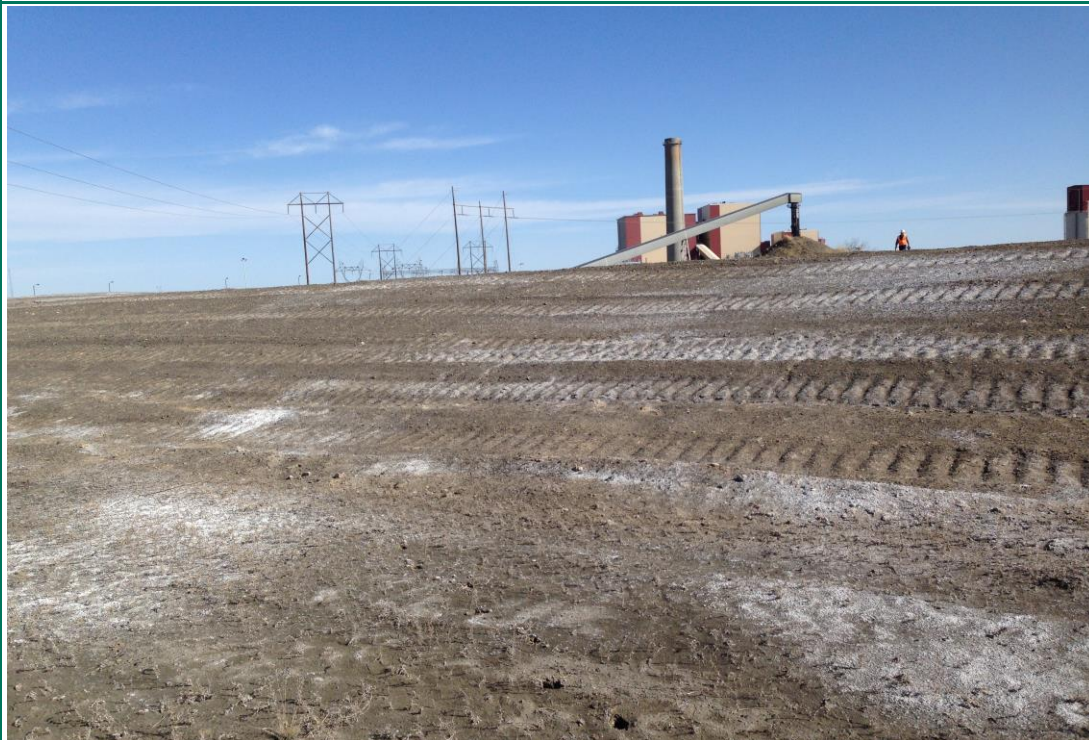
The design and Operations Plan call for bottom ash to be placed at 15% final slopes directing contact water to the edge of active placement. Collected contact water is to be evaporated, used for dust suppression or pumped to the Bottom Ash Surface Impoundment as required. The observed CCR placement slopes appeared to be within the design CCR grades, and contact water was generally directed to the low area on the west end of the landfill. The contact water control berm/channel along the south side of the facility was not well-defined during the inspection. A perimeter berm/channel should be built to direct contact water to the west side of the facility and clean stormwater off of the facility footprint and into perimeter stormwater drainage ditches. The in-place CCRs within the landfill appear to be in fair condition.

Photograph 5
CCR slope on south side (15 and 25% slope, approximately 10' tall) (IMG_3721.JPG)

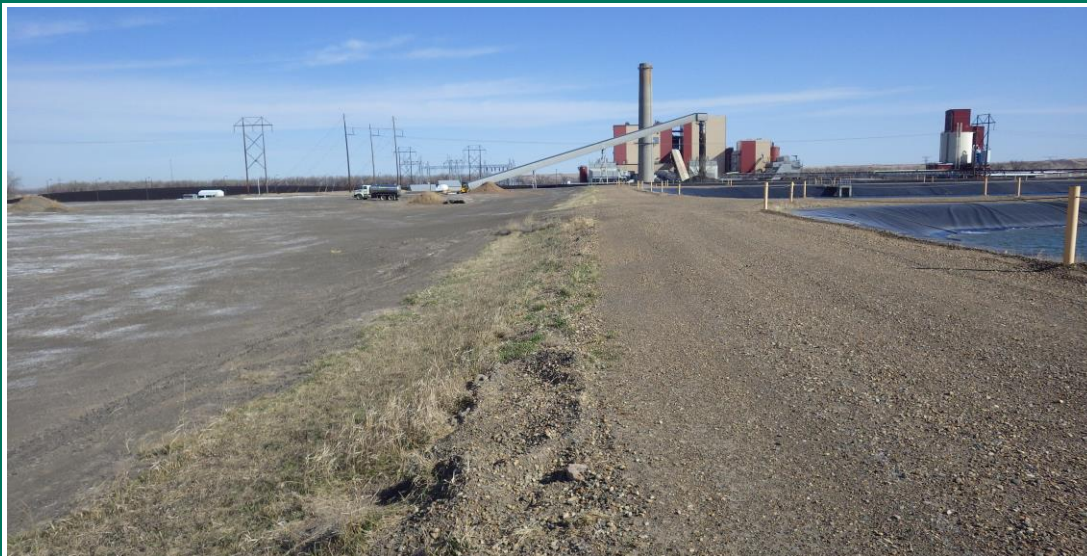
The east berm crest and part of the north berm crest of the Bottom Ash Landfill are surfaced with gravel at elevations between approximately 1715 feet and 1720 feet. These roads are primarily used for light vehicle traffic, but are exposed to heavy construction equipment when the Bottom Ash Surface Impoundment is cleaned out. The west and south perimeter berm crests are vegetated with grass and are not surfaced for vehicle travel. Bottom Ash Landfill berm crests appeared to be in good condition.

Photograph 10
East crest (IMG_P2235.JPG)

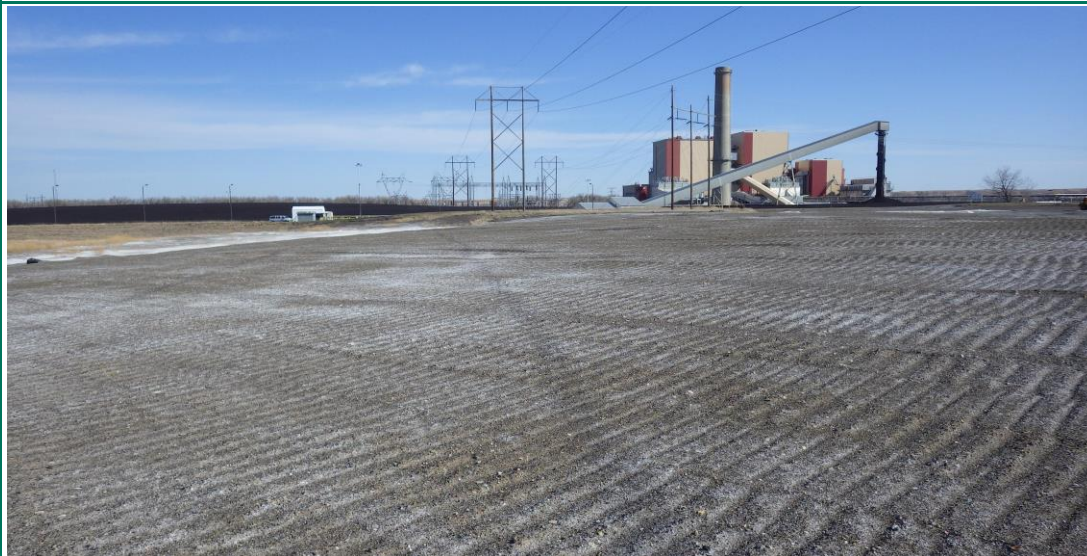
Photograph 11
Recently placed and graded bottom ash (IMGP2237.JPG)

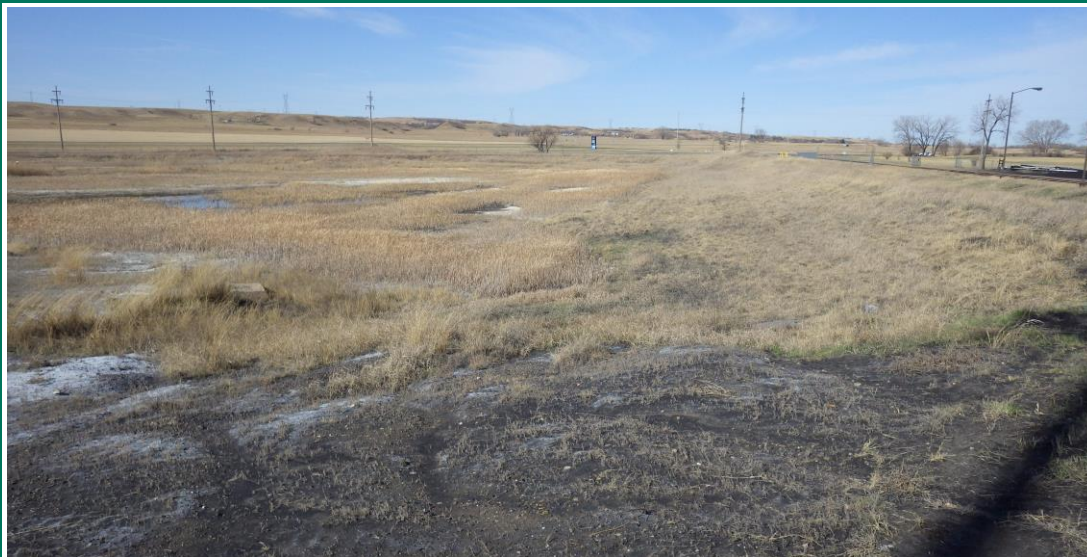
Photograph 12
Northwest corner of active placement area (IMGP2241.JPG)

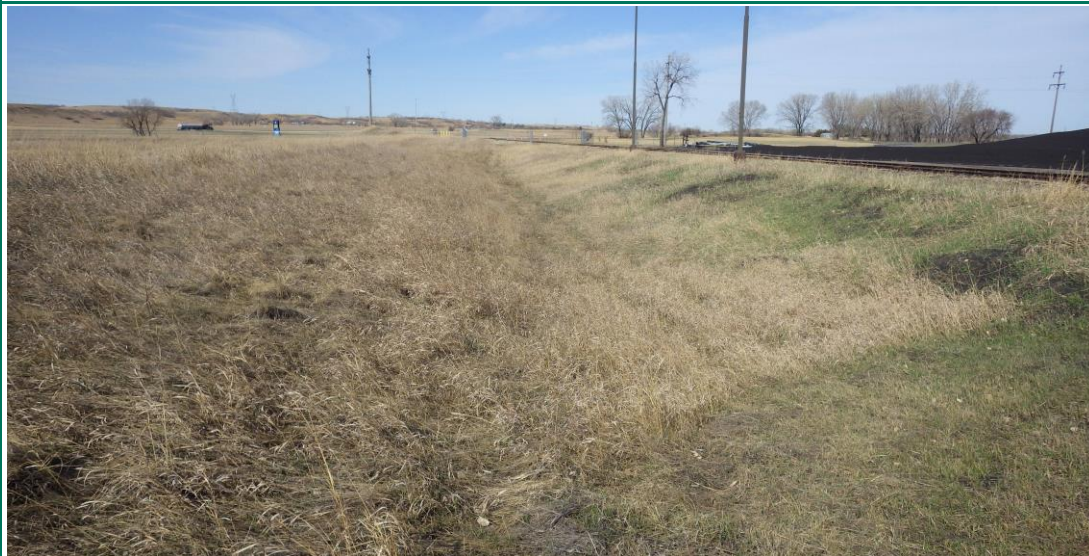
Photograph 13
North exterior slope and perimeter drainage ditch (looking west) (IMGP2243.JPG)

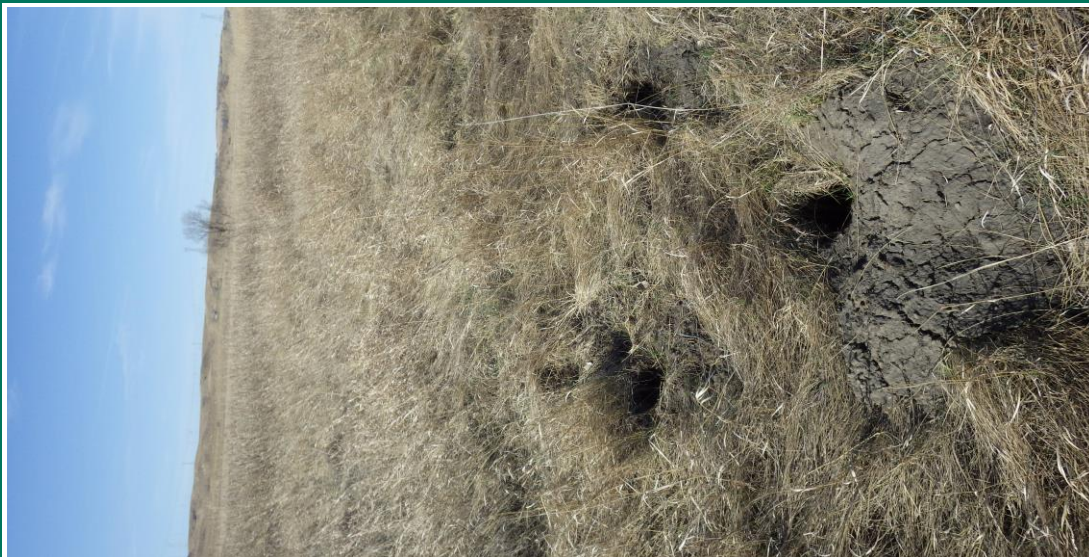
The exterior slopes on the north, west, and south sides are between approximately 5 feet and 10 feet high and have slopes of approximately 3H:1V. Slopes are well vegetated with grass, but do contain numerous, but mostly small, animal burrows. A small tree was observed on the exterior slope on the south side of the

Photograph 14
Animal burrows on northwest exterior slope (IMGP2247.JPG)

Minor maintenance items that may need to be continually addressed include repairing large animal burrows as they appear, repairing stormwater and/or contact water control features to control run-on and runoff, monitoring vegetative success of exterior slopes, and removal of any woody vegetation growing on the exterior slopes.

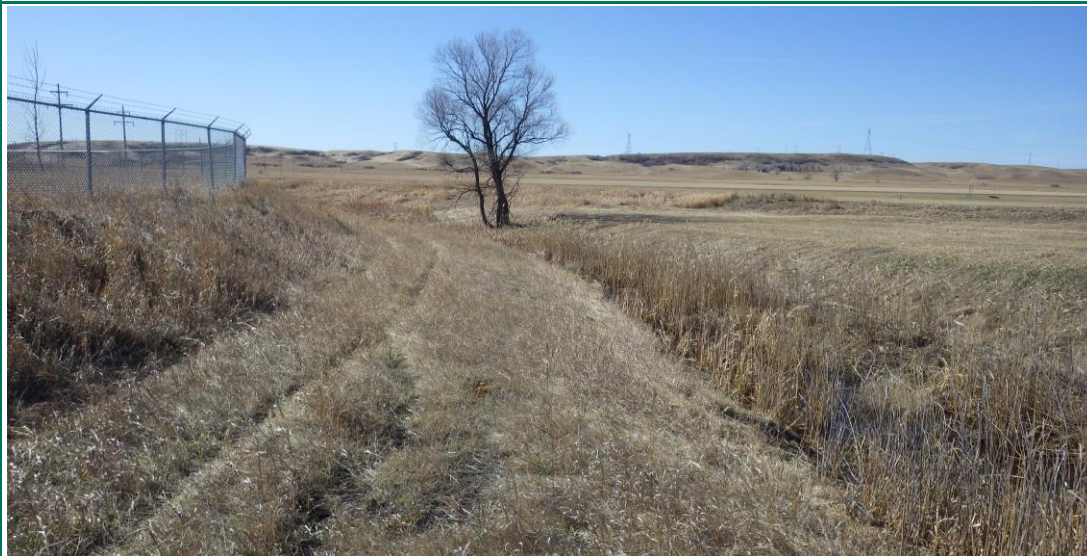
The toe of the west and south perimeter berms is in a surface water drainage ditch that has some marshy vegetation and minor amounts of standing water. Some small animal burrows were noted near the toe of the slope, but there were no observed indications of seepage, settlement, or excessive vegetation at the toe of these slopes.

Photograph 15
West exterior slope and drainage ditch with cat tails (looking south) (IMGP2248.JPG)

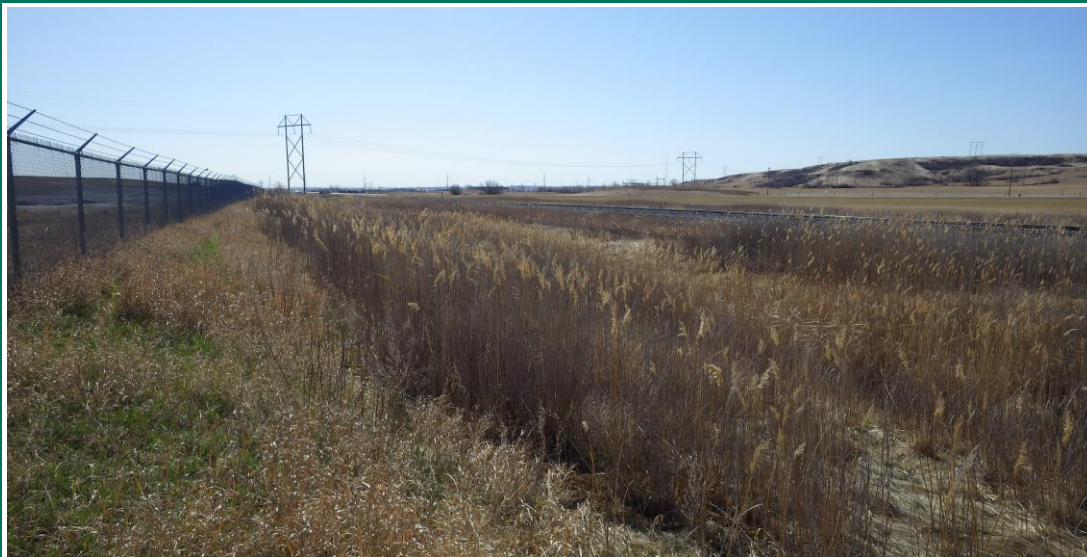
Photograph 16
South exterior slope and drainage ditch (looking southeast) (IMGP2250.JPG)

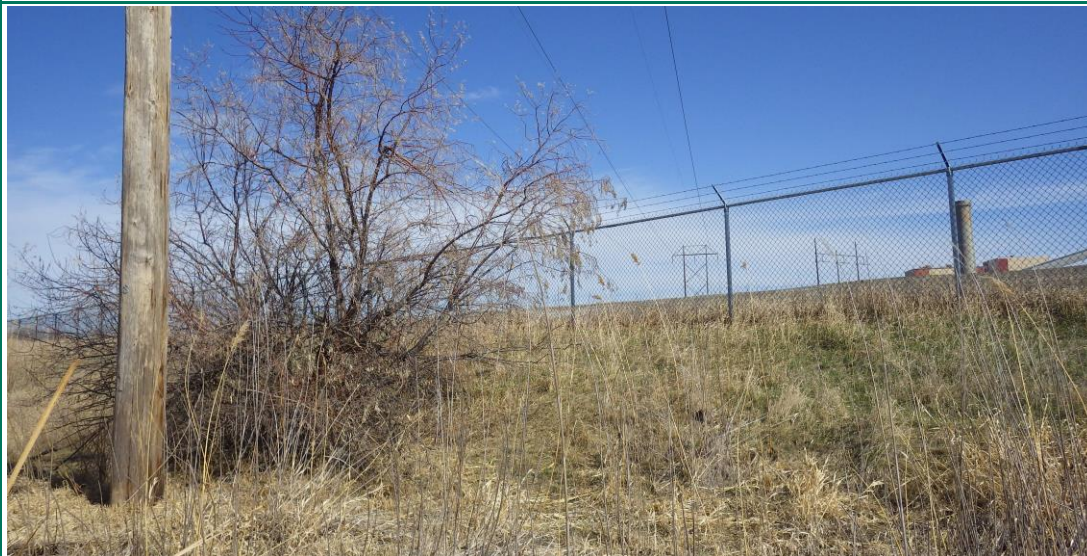
Photograph 17
Tree at toe of south exterior slope (IMGP2252.JPG)

facility. This small tree along with any other woody vegetation should be removed from the landfill. The exterior slopes of the Bottom Ash Landfill appear to be in fair condition.

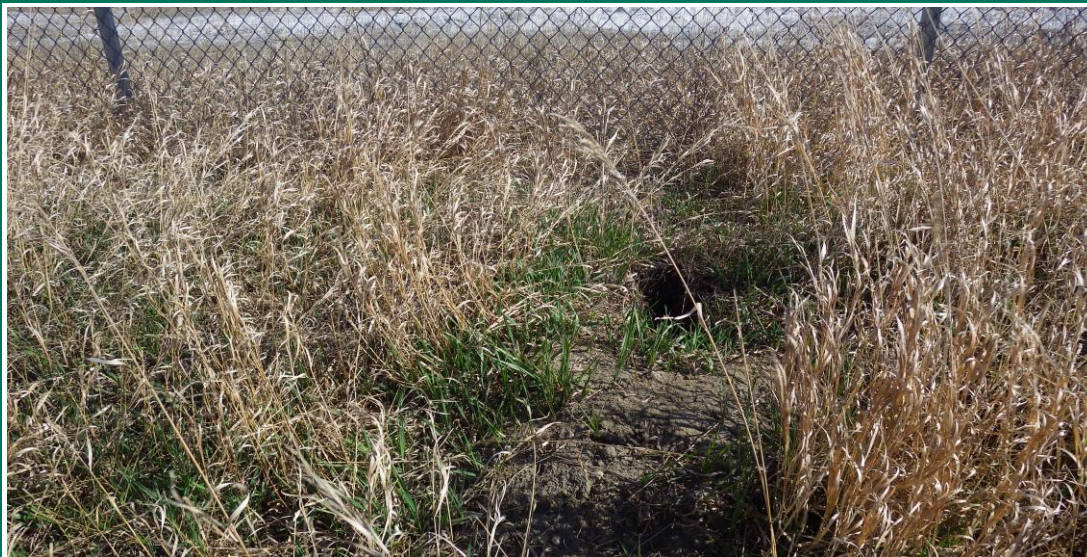
Photograph 18
Grassy vegetation and animal burrows on south exterior slope (IMGP2253.JPG)
