## ANNUAL INSPECTION REPORT

### GREAT RIVER ENERGY – STANTON STATION

#### Bottom Ash Surface Impoundment

**January 2016**

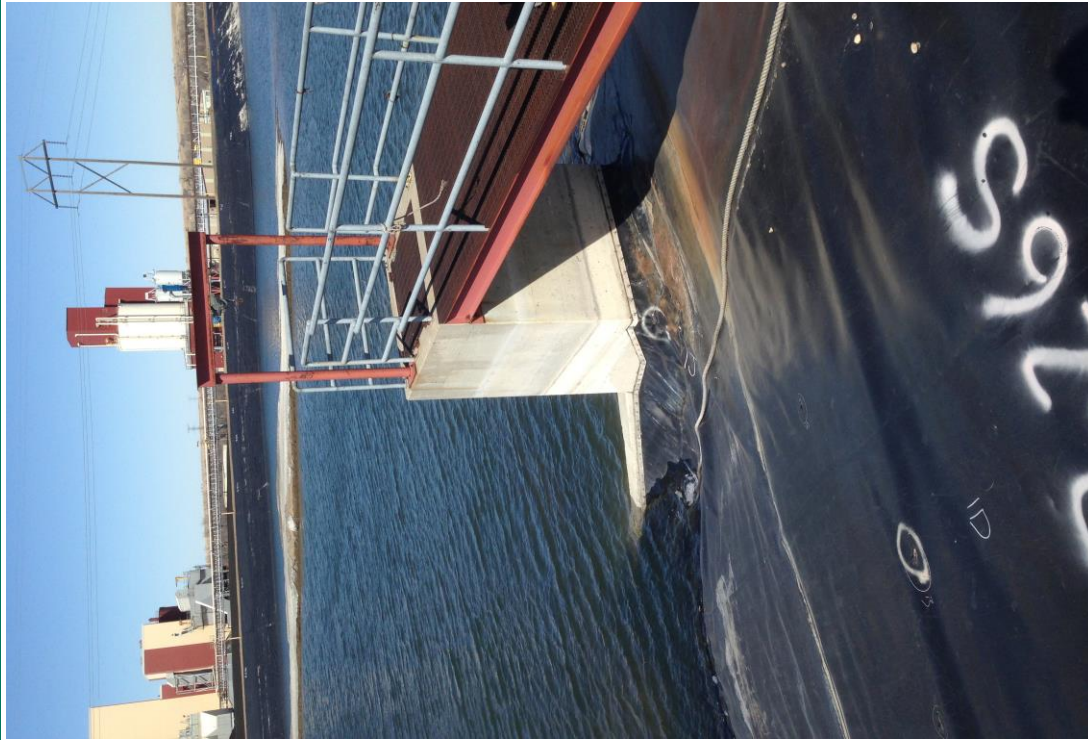
Outflow from the North Cell is through the concrete outflow structure located on the south upstream slope. The structure was in good condition with no signs of blockage, corrosion, erosion or cracking and the geomembrane connection to the structure was recently repaired in 2014. Stop logs were placed in the outfall structure to control the cell water elevation.

**Photograph 1 - North Cell  
Outlet structure on south side (IMG\_3621.JPG)**

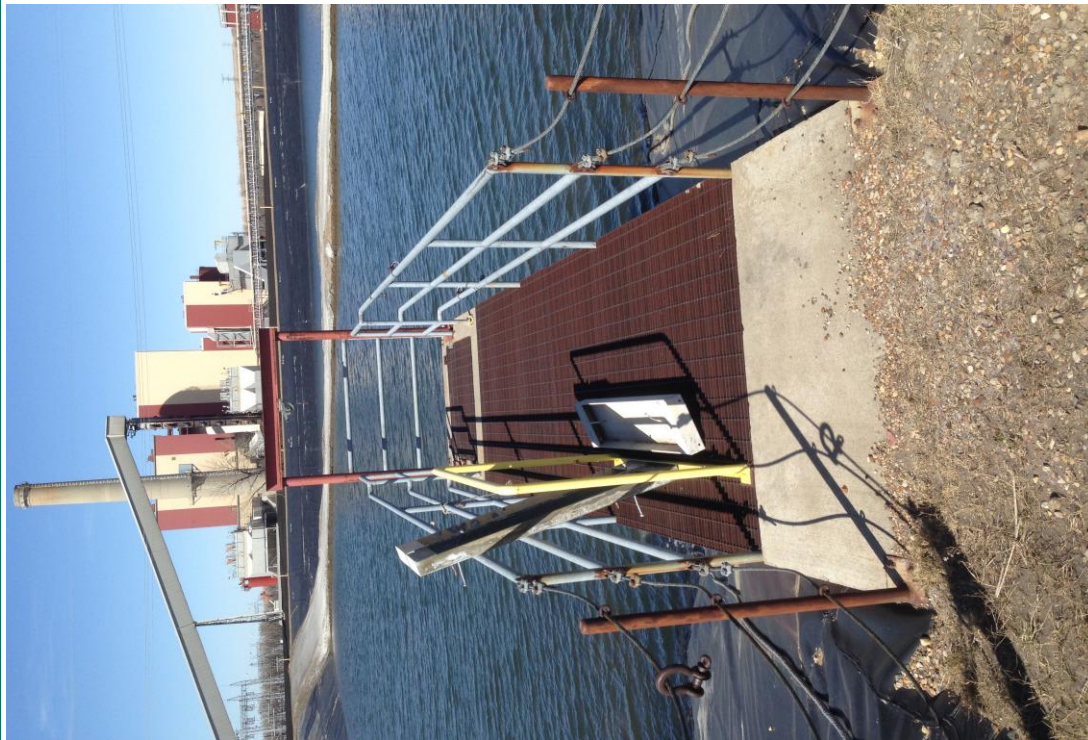
**Photograph 2 - North Cell  
Outlet structure on south side (IMG\_3624.JPG)**

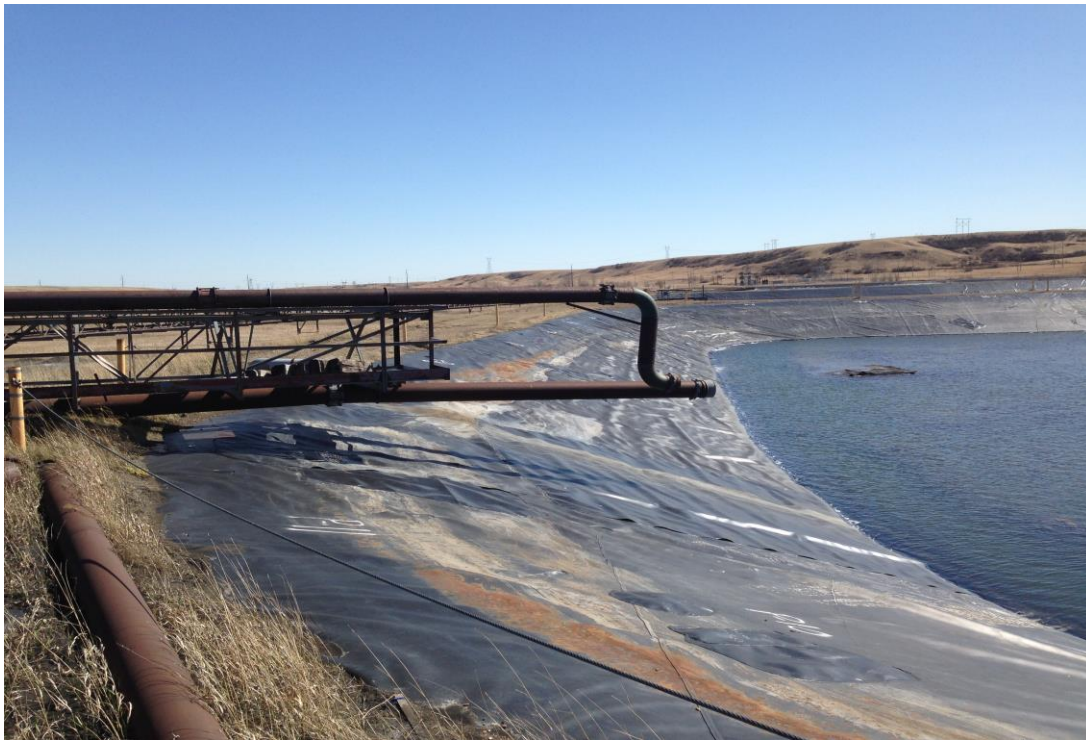
Inflow to the North Cell includes the bottom ash discharge pipes, the retention pond inlet pipe, and the coal pit sump inlet pipe. The bottom ash pipes discharge into the impoundment over previously deposited bottom ash and were in fair condition with minor corrosion and erosion of the pipe. The bottom ash pipes, retention pond inlet, and coal pit sump inlet pipes discharge into the impoundment onto a sacrificial HDPE wear-liner and were in good condition with no indications of wear or penetration of the liner or cracking of the inlet pipes.

**Photograph 6 - North Cell**  
**Bottom ash inlet piping and trestle (IMG\_3633.JPG)**

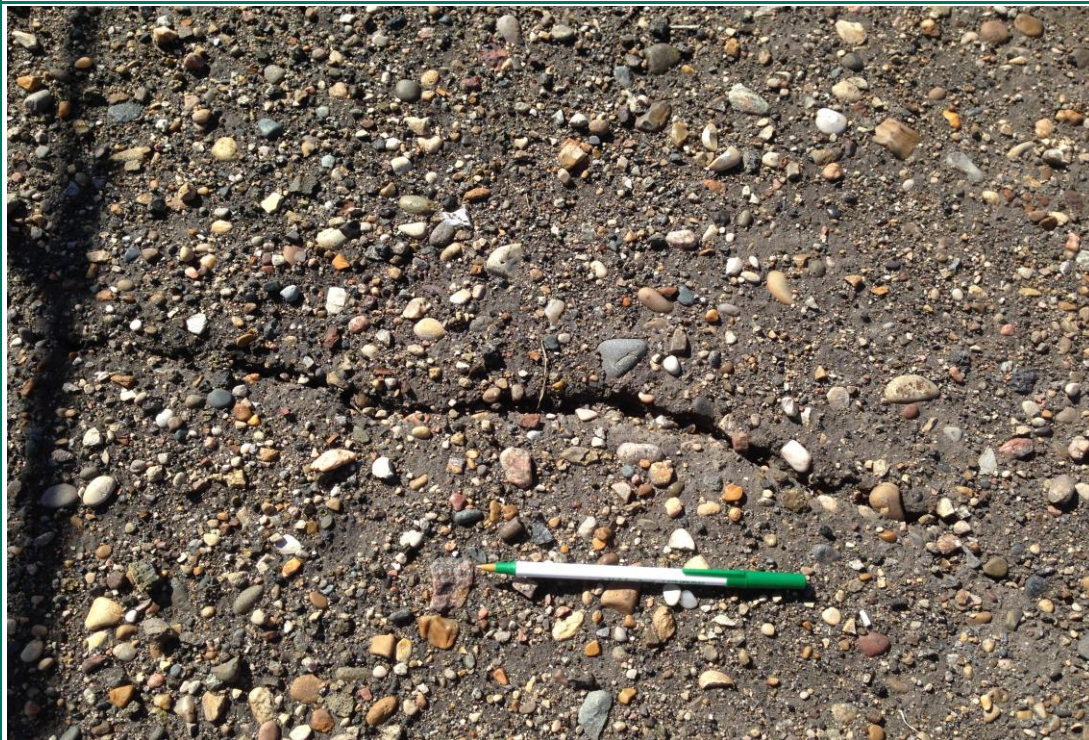
was one minor crack along the crest road near the North Cell, but no movement of upstream or downstream slopes was noted. The crack is small and may be limited to the gravel roadway.

**Photograph 7 - North Cell**  
**Small crack along crest (center of north side) (IMG\_3635.JPG)**

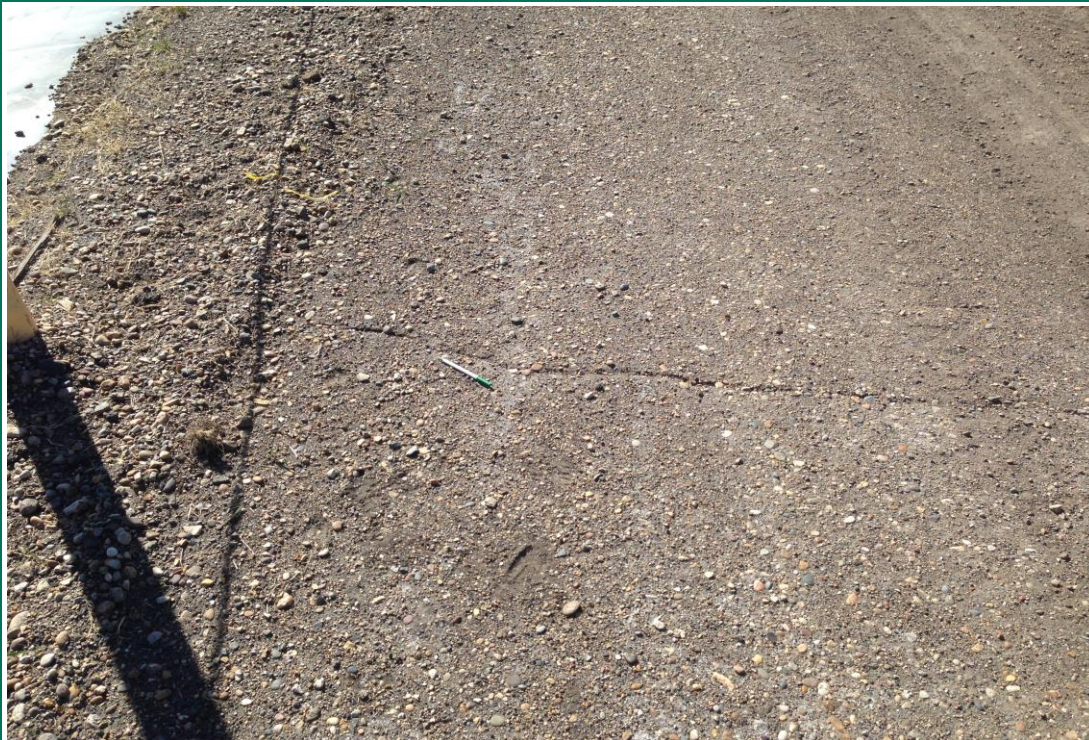
**Photograph 8 - North Cell**  
**Small crack along crest (west end of north side) (IMG\_3637.JPG)**

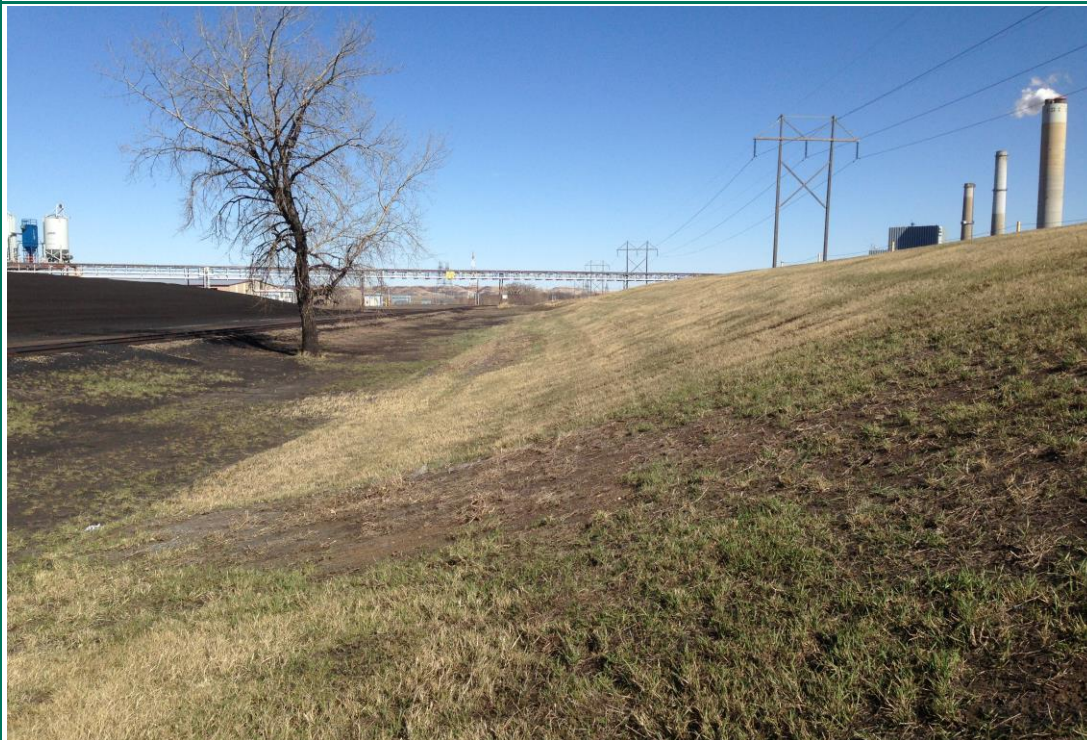
**Photograph 11 - North Cell**  
North downstream slope (area to be reseeded) (IMG\_3646.JPG)

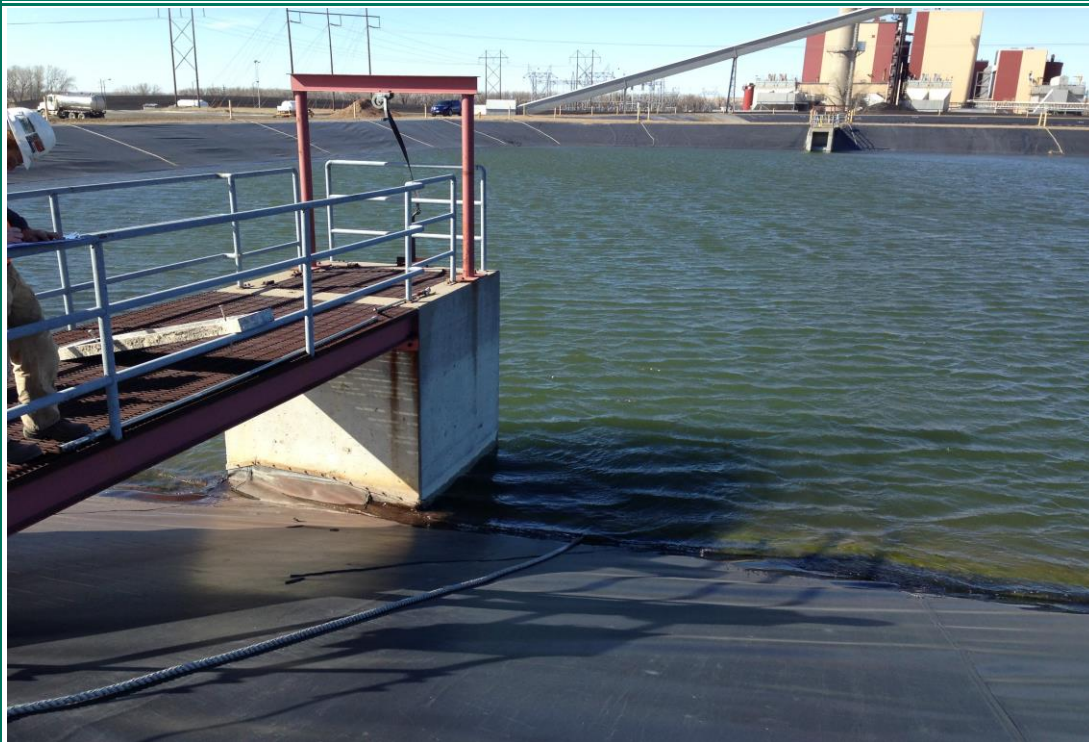
Inflow to the Center Cell is through the outflow structures from the North Cell and The South Cell located on the north and south upstream slopes respectively. These structures were in good condition with no signs of blockage, corrosion, erosion or cracking and the geomembrane connections to the structures was repaired in 2015.

**Photograph 19 - Center Cell  
Inlet structure from South Cell (IMG\_3664.JPG)**

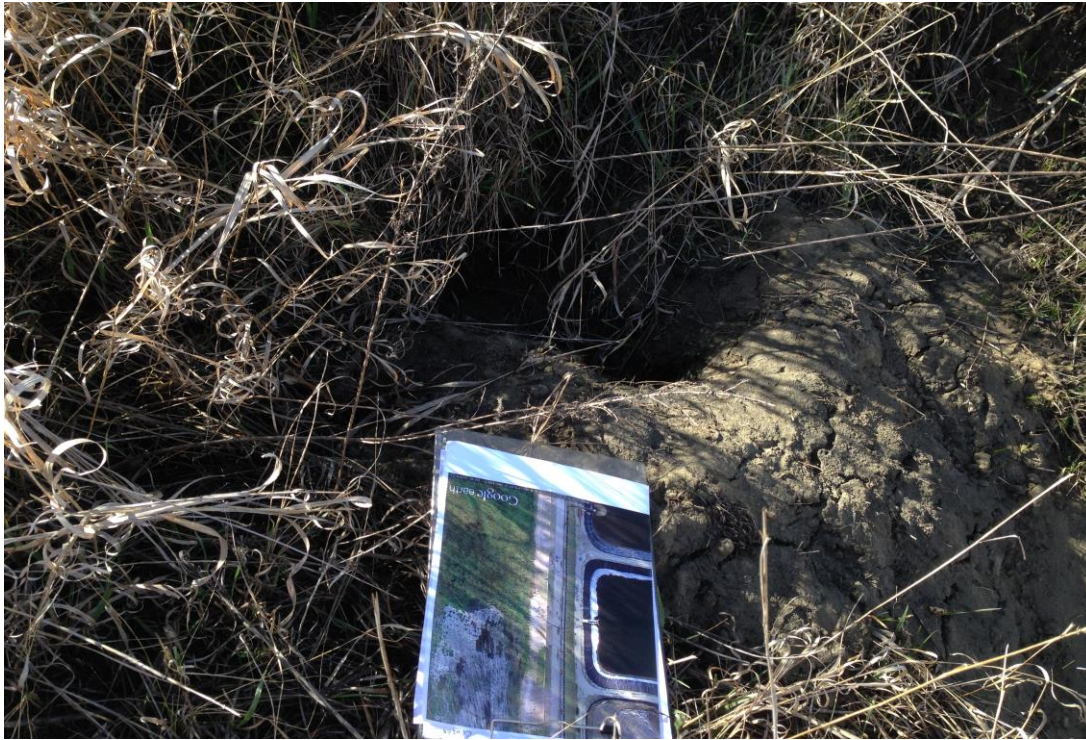
**Photograph 23 - Center Cell**  
**Small animal burrow at the toe of the east downstream slope (IMG\_3675.JPG)**

Minor maintenance items that may need to be continually addressed include repairing large animal burrows as they appear, monitoring vegetative success of downstream slopes, and removal of any woody vegetation growing on the exterior slopes. In addition, the inflow and outflow piping and hydraulic structures should be monitored regularly to ensure proper conveyance of water through the impoundment system.

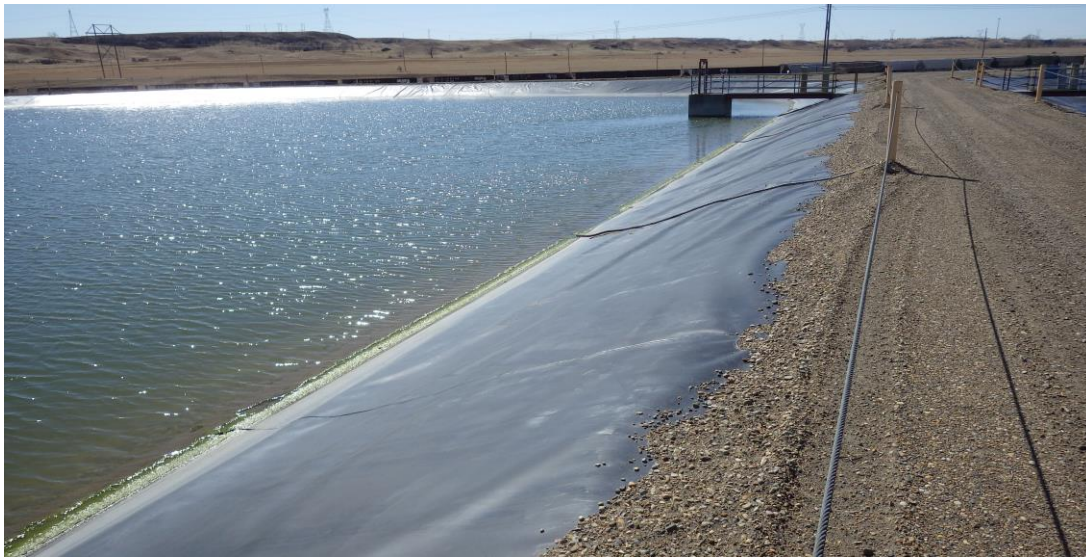
The upstream slopes above the water level and not covered with bottom ash were evaluated. The slopes appeared to match the design slopes of 3:1 with minor sections of slope difference where the slopes curved inward to a steeper concave shape. This displacement of the lower slope is likely due to “pumping” of saturated soils beneath the geomembrane due to wave action and the lack of confining pressure from overlying protective cover layer. Significant geomembrane repairs were performed in 2013. The South Cell upstream slopes appear to be in fair condition.

**Photograph 24 - South Cell**  
**North upstream slope (IMGP2174.JPG)**

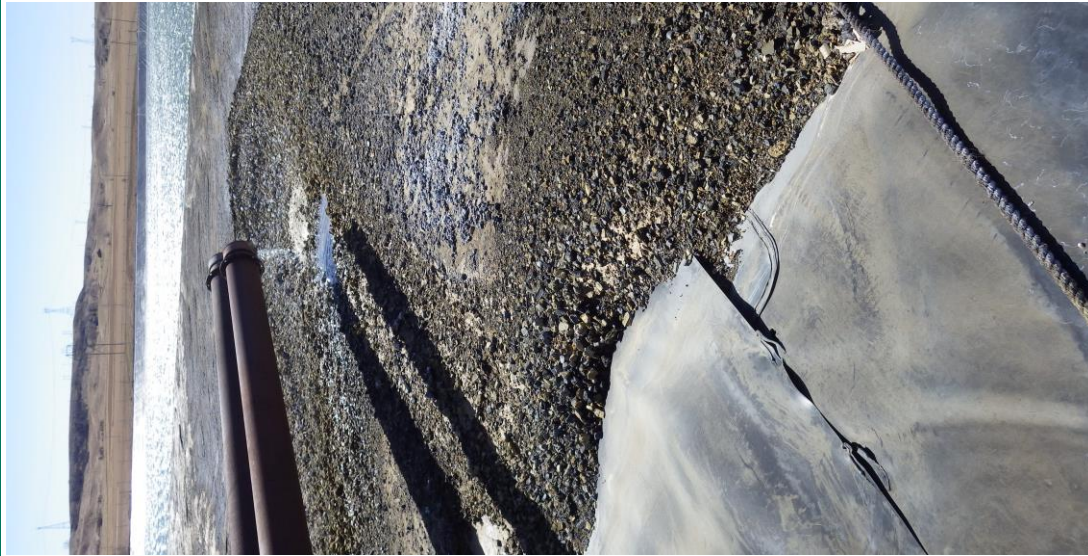
Inflow to the South Cell includes the bottom ash discharge pipes, the retention pond inlet pipe, and the coal pit sump inlet pipe. The bottom ash pipes discharge into the impoundment over previously deposited bottom ash and were in fair condition with minor corrosion and erosion of the pipe. The bottom ash pipes,

**Photograph 25 - South Cell  
Bottom ash deposition pipes (IMG2177.JPG)**

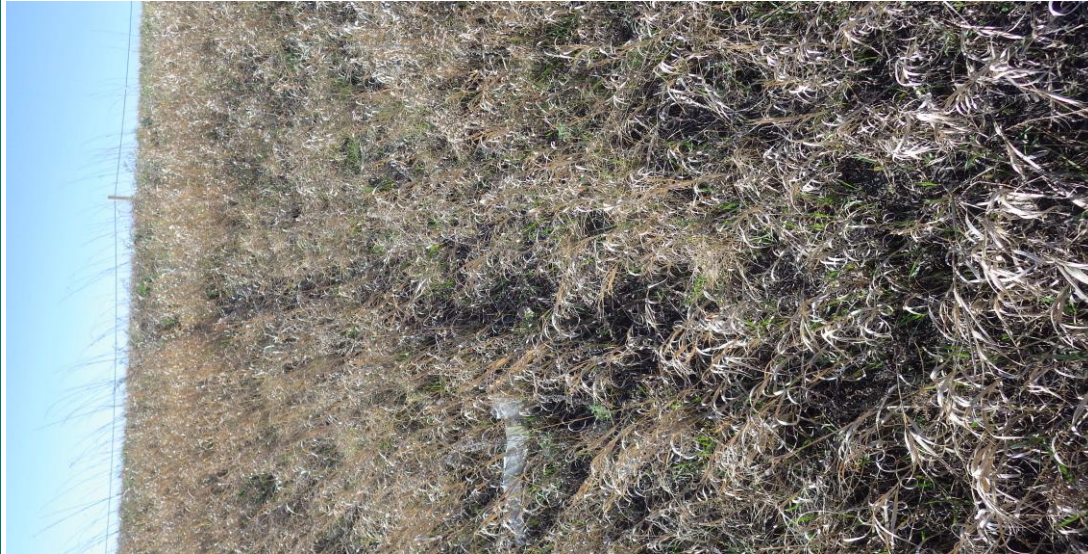
The downstream slope on the east and south side is approximately 20 feet high and the downstream slope on the west side is approximately 5 feet high. The slopes are graded at approximately 3H:1V and are well vegetated with grass, with a few small areas of bare ground along the south side of the South Cell. Small rodent burrows were observed on the east and south downstream slopes. The downstream slopes are generally in fair condition due to the large number of animal burrows noted during the inspection.

**Photograph 26 - South Cell  
Erosion rills on the east downstream slope (IMG2183.JPG)**

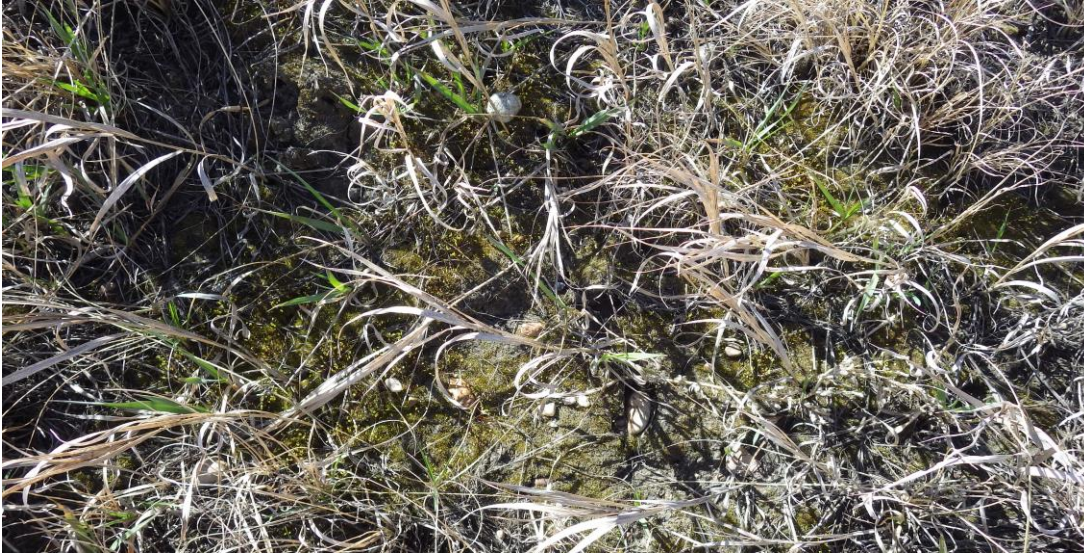
**Photograph 27 - South Cell**  
**Mossy vegetation on the east downstream slope (no seepage observed) (IMGP2184.JPG)**

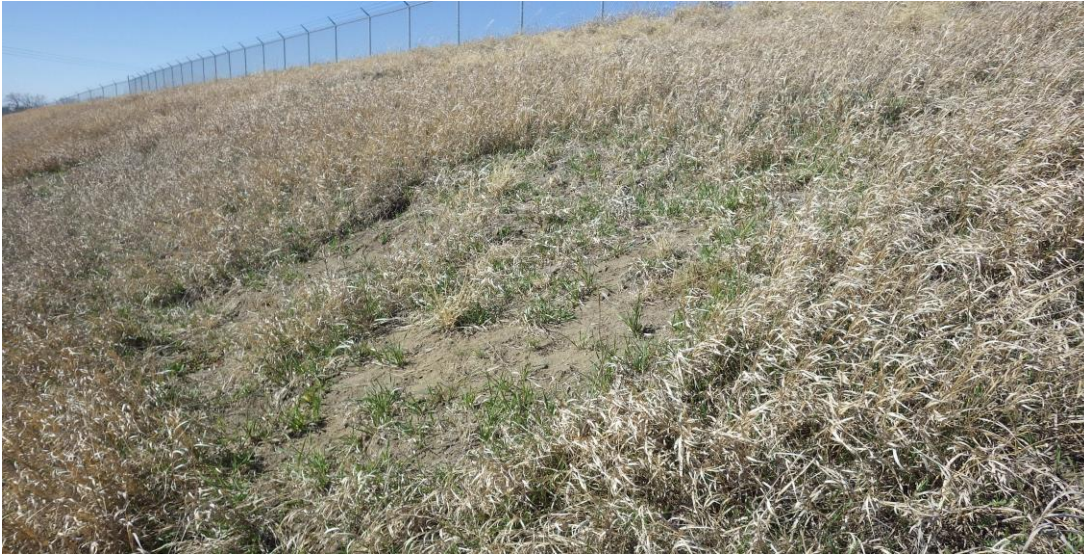
**Photograph 28 - South Cell**  
**Bare spot on south downstream slope (IMGP2191.JPG)**

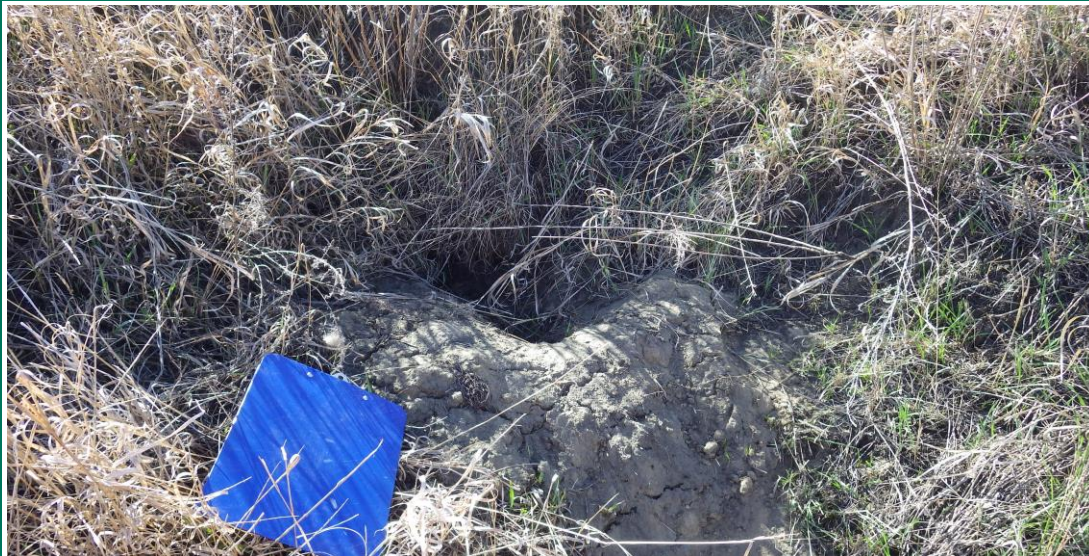
**Photograph 32 - South Cell**  
**Small animal burrow (IMGP2203.JPG)**
