### **ANNUAL INSPECTION REPORT**

# **GREAT RIVER ENERGY – STANTON STATION**

#### **Bottom Ash Landfill**

January 2017 1649580

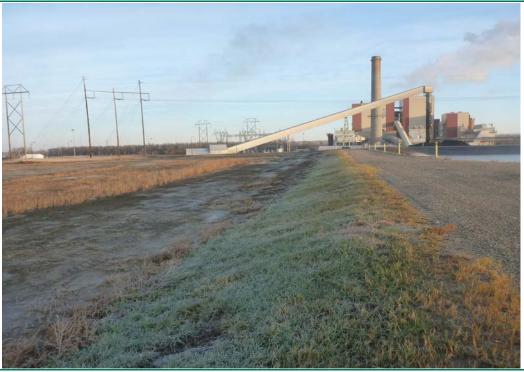
Photograph 1
East interior berm and crest (looking north) (P1030333.JPG)

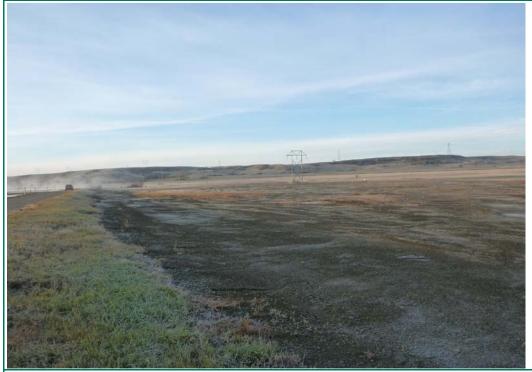
Photograph 2
Panoramic of interior from northeast corner (1 of 3) (P1030338.JPG)

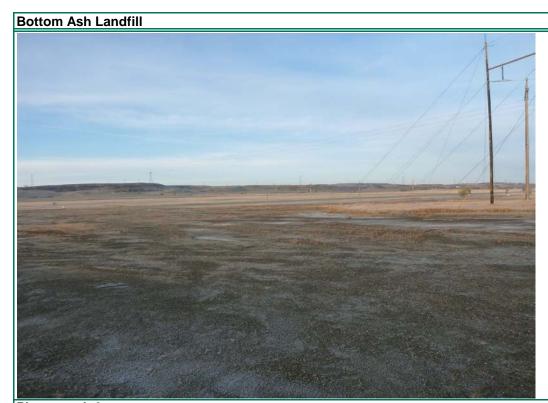
Photograph 3
Panoramic of interior from northeast corner (2 of 3) (P1030339.JPG)

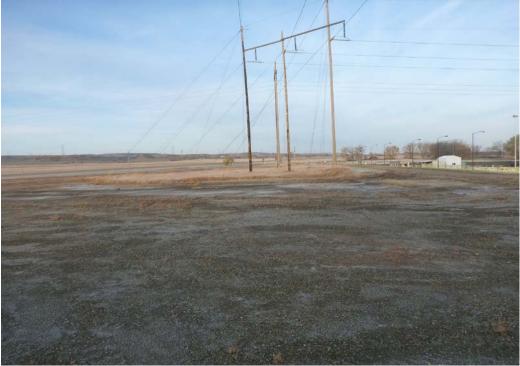
Photograph 4
Panoramic of interior from northeast corner (3 of 3) (P1030340.JPG)

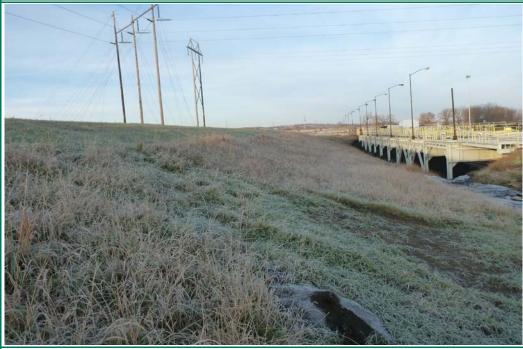
Photograph 5
Grass vegetation on north exterior embankment berm (looking west from northeast corner of landfill) (P1030341.JPG)

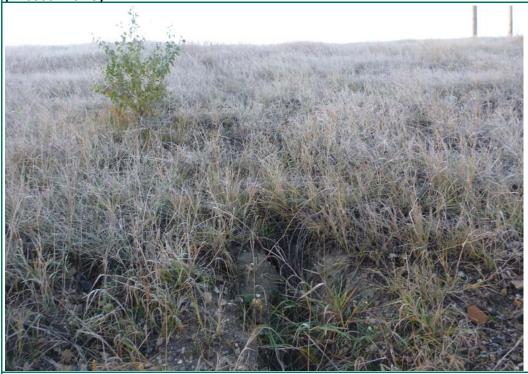
f.	Damage from vehicles/machinery		Х		
6.		vnstream slope		1 80	PA TE	
0.	a.	Erosion	Х			< 6-inch deep erosion rills on north slope to coa pit unloading sump area

b.	Vegetation	Х			Grass – well vegetated; Occasional woody vegetation evident on south and north slopes
	C.	Rodent burrows	X			4-10" diameter burrows on NW and S slopes

Photograph 6
Erosion rills and woody vegeation on north exterior embankment (P1030345.JPG)

exterior slope. This burrow should be excavated and backfilled with compacted soil. A small tree was also observed on the exterior slope on the south side of the facility. This small tree along with any other woody vegetation should be removed from the landfill. The exterior slopes of the Bottom Ash Landfill appear to be in fair condition.

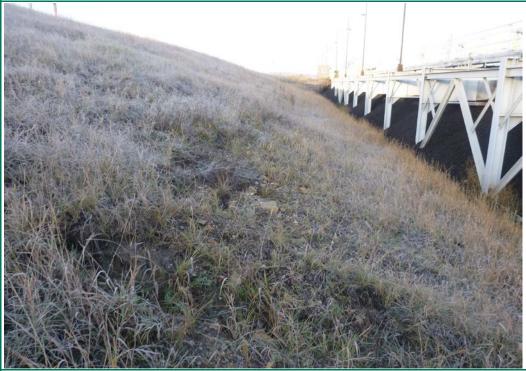
Photograph 7
Erosion rills on north exterior embankment near coal unloading area (looking west) (P1030346.JPG)

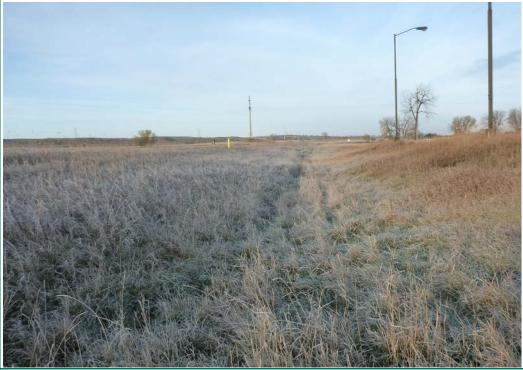
Photograph 8
Grass vegetation on north exterior embankment (looking west) (P1030356.JPG)

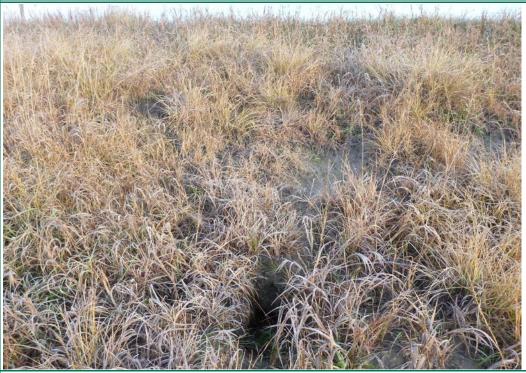
The exterior slopes on the north, west, and south sides are between approximately 5 feet and 10 feet high and have slopes of approximately 3:1. Slopes are well vegetated with grass, but do contain numerous, but mostly small, animal burrows. A larger (10-inch diameter) animal burrow was found on the southern

Photograph 9
Animal burrow on north exterior embankment (P1030358.JPG)

Minor maintenance items that may need to be continually addressed include repairing large animal burrows as they appear, repairing stormwater and/or contact water control features to control run-on and runoff, monitoring vegetative success of exterior slopes, and removal of any woody vegetation growing on the exterior slopes.

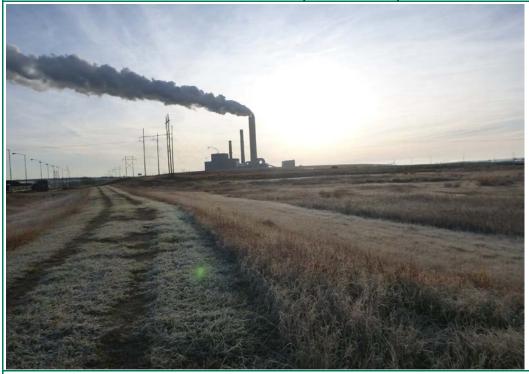
Photograph 10
Panoramic of interior from northwest corner (1 of 3) (P1030359.JPG)

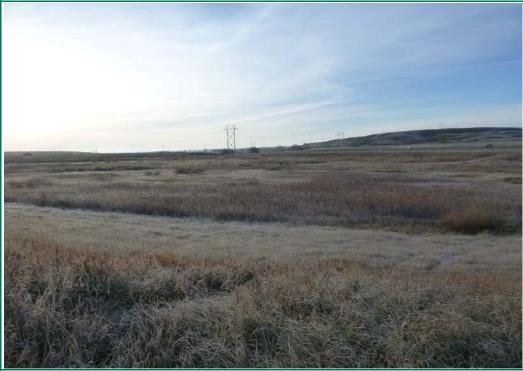
Photograph 11
Panoramic of interior from northwest corner (2 of 3) (P1030360.JPG)

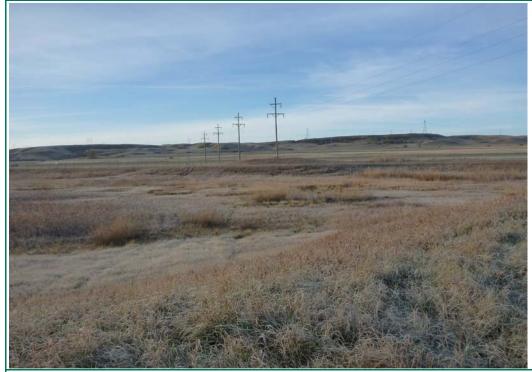
Photograph 12
Panoramic of interior from northwest corner (3 of 3) (P1030361.JPG)

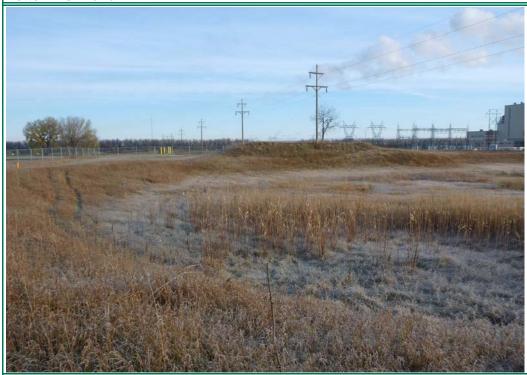
Photograph 13
Interior west side of landfill (looking north) (P1030364.JPG)

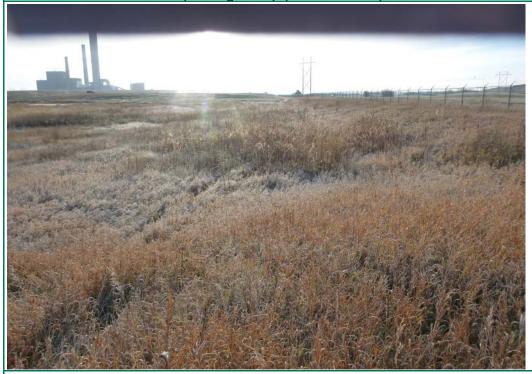
Photograph 14
Grass vegetation on south interior embankment (looking east) (P1030365.JPG)

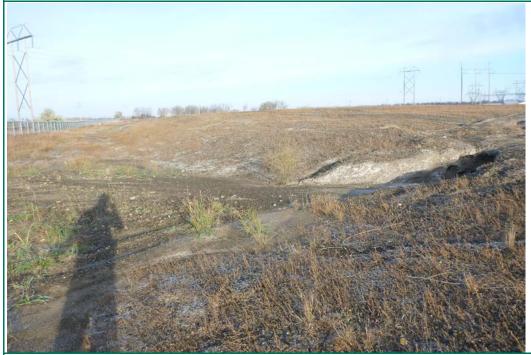
The Operations Plan and design documentation call for bottom ash to be placed at 15% final slopes directing contact water to the edge of active placement. Collected contact water is to be evaporated, used for dust suppression, or pumped to the Bottom Ash Impoundment as required. The observed CCR placement slopes appeared to be within the design CCR grades, and contact water was generally directed to the low area on the west end of the landfill. The contact water control berm/channel along the south side of the facility where active placement is occurring was not well-defined during the inspection. A perimeter berm/channel should be built to direct contact water to the west side of the facility and clean stormwater off of the facility footprint and into perimeter stormwater drainage ditches. The majority of inplace CCRs within the landfill appear to be in fair condition except near the southeast corner of the facility where there are several erosion rills.

Photograph 15
Erosion of placed bottom ash in the southeast corner and lack of well-defined contact water channel/berm (looking northwest) (P1030370.JPG)

C.	Containment controls working		Х		Repair contact water control berm along south side to control potential contact water runoff
	d.	Ponding water outside of				
		contact water control area		X

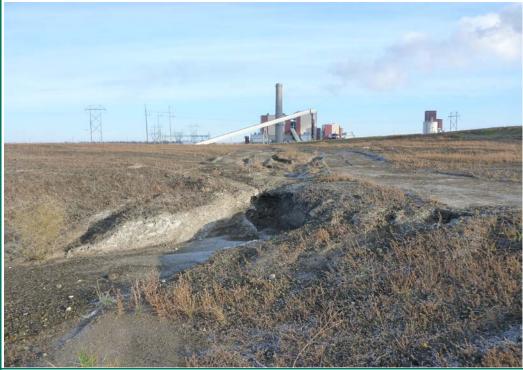
Photograph 16
Erosion of placed bottom ash in the southeast corner (looking north) (P1030371.JPG)

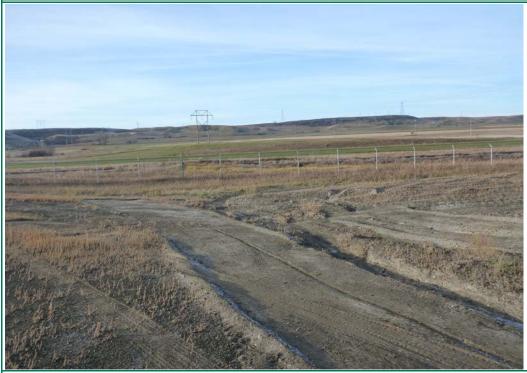
Photograph 17
Bottom ash placement area (looking southwest) (P1030374.JPG)

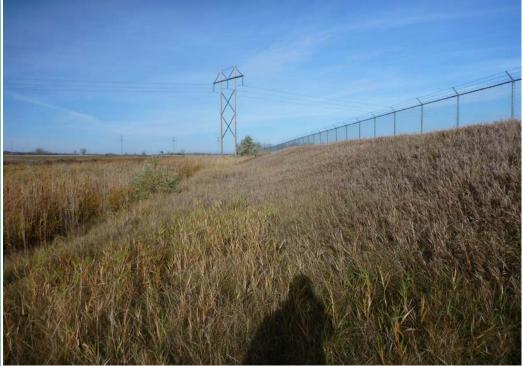
Photograph 18
Grass vegetation of south exterior embankment (looking west) (P1030388.JPG)

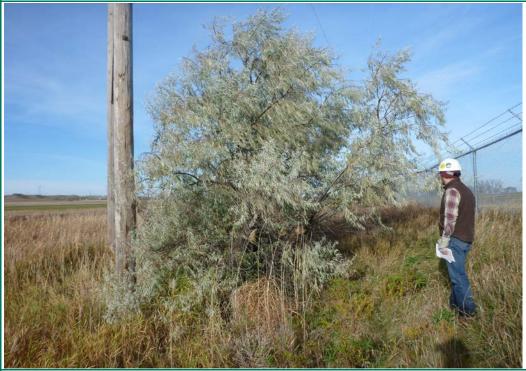
Photograph 19

Small tree near the toe of the south exterior embankment (P1030389.JPG)

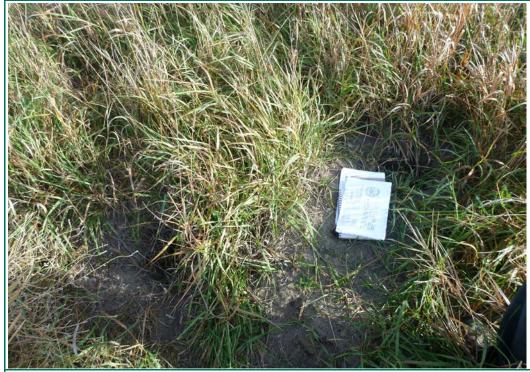
Photograph 20

Animal burrows on south exterior embankment (P1030391.JPG)

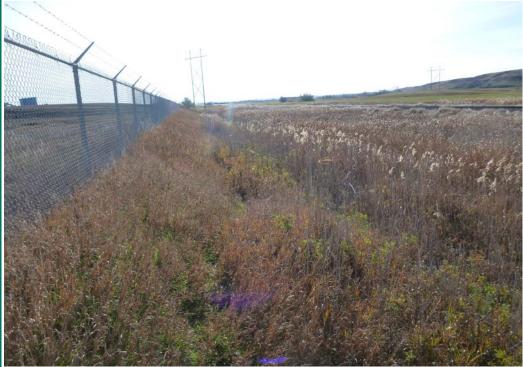
The toe of the west and south perimeter berms is in a surface water drainage ditch that has some marshy vegetation and minor amounts of standing water. Some small animal burrows were noted near the toe of the slope, but there were no observed indications of seepage, settlement, or excessive vegetation at the toe of these slopes.

Photograph 21
Grass vegetation of south exterior embankment and marshy vegetation in the adjacent drainage ditch (looking southeast) (P1030393.JPG)
