ANNUAL INSPECTION REPORT

GREAT RIVER ENERGY – STANTON STATION

Bottom Ash Surface Impoundment

January 2017

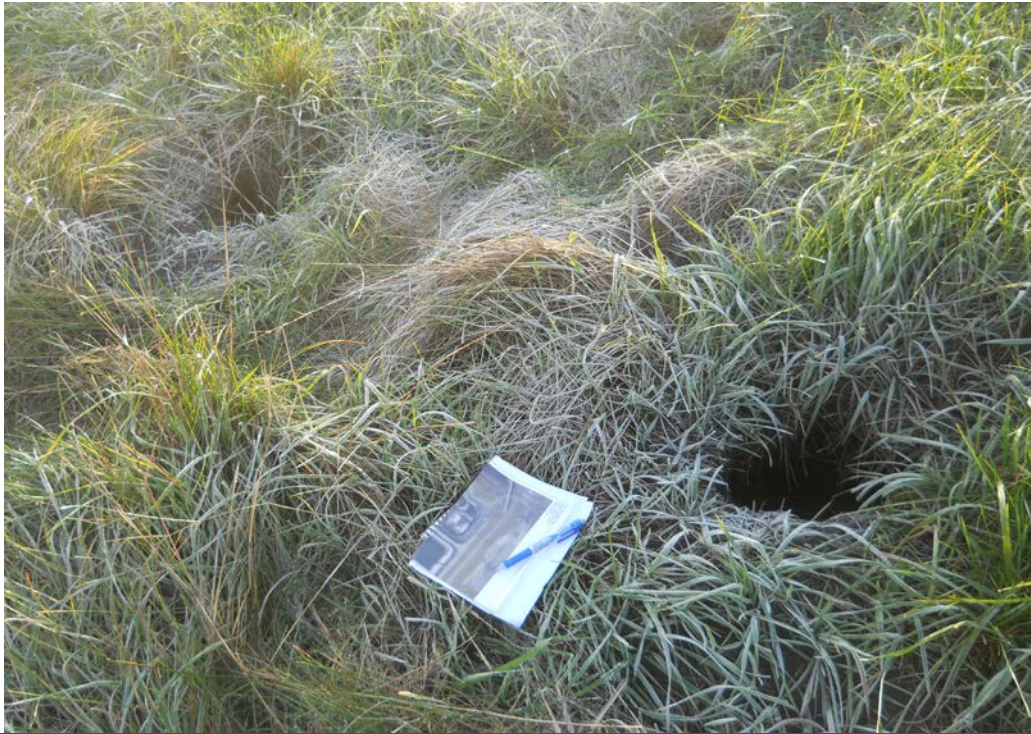
The downstream slopes on the north and east sides are approximately 20 feet high and the downstream slope on the west side is approximately 5 feet high. The slopes are graded at approximately 3:1 and are mostly well vegetated with grass, with a few small areas of bare ground along the east side of the impoundment and the north side of the North Cell that are susceptible to erosion. One small sapling was starting to grow on the east downstream slope and should be removed. Small animal burrows were observed on the downstream slopes. The downstream slopes are generally in good condition.

Photograph 1 (North Cell)
Animal burrows on north downstream slope (DSCN0790.JPG)

Minor maintenance items that may need to be continually addressed include repairing large animal burrows as they appear, monitoring vegetative success of downstream slopes, and removal of any woody vegetation growing on the exterior slopes. In addition, the inflow and outflow piping and hydraulic structures should be monitored regularly to ensure proper conveyance of water through the impoundment system.

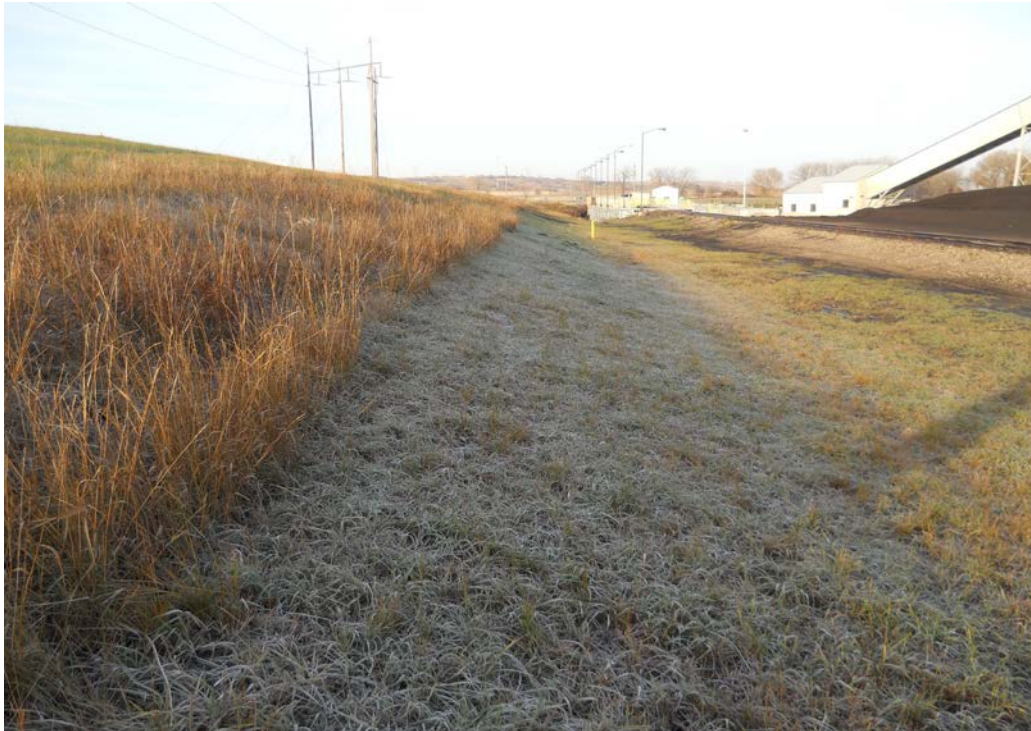
Photograph 2 (North Cell)
Grass vegetation on north downstream slope (DSCN0789.JPG)

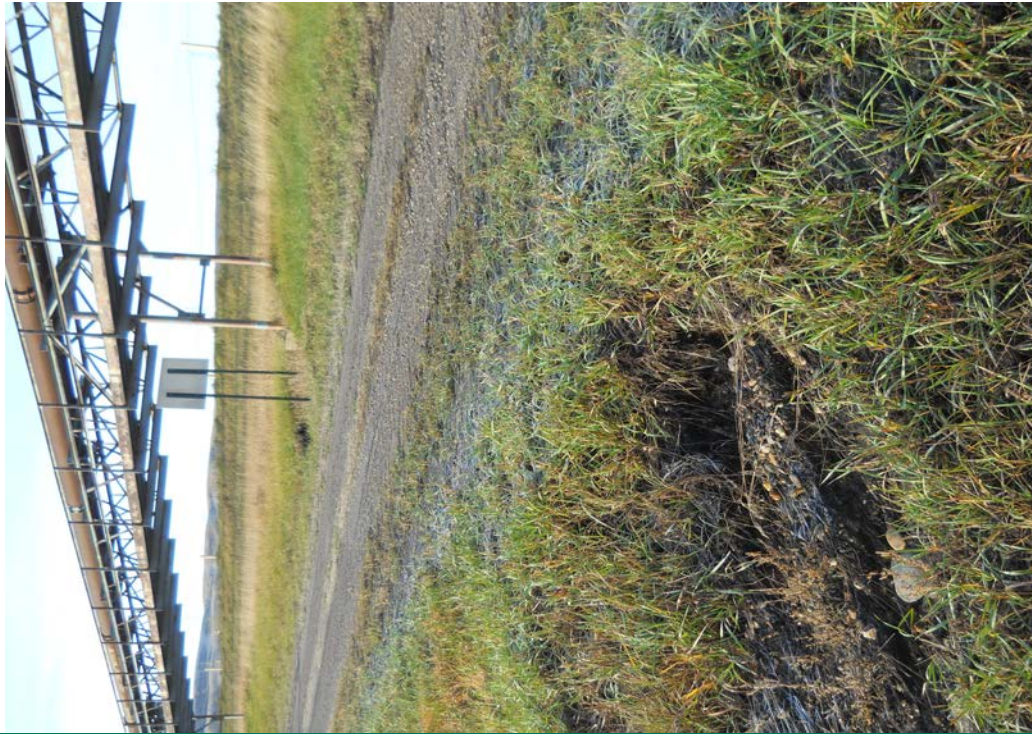
Photograph 3 (North Cell)

Minor erosion on east downstream slope near the intermediate crest roadway (DSCN0788.JPG)

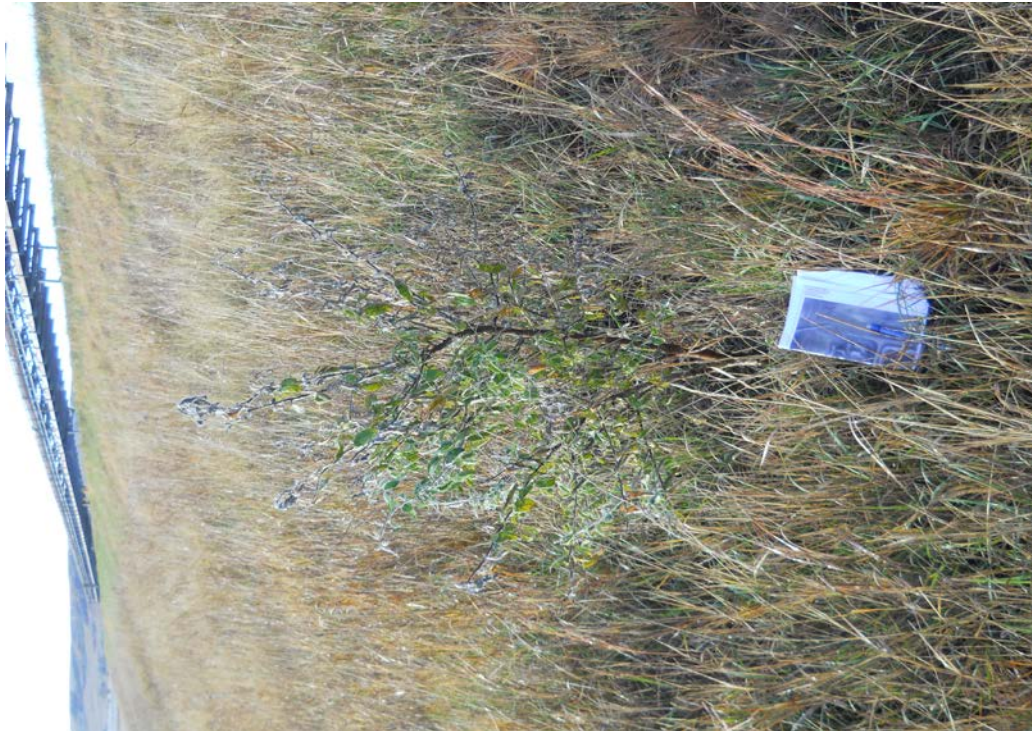
Photograph 4 (North Cell)

Sapling on east downstream slope (DSCN0787.JPG)

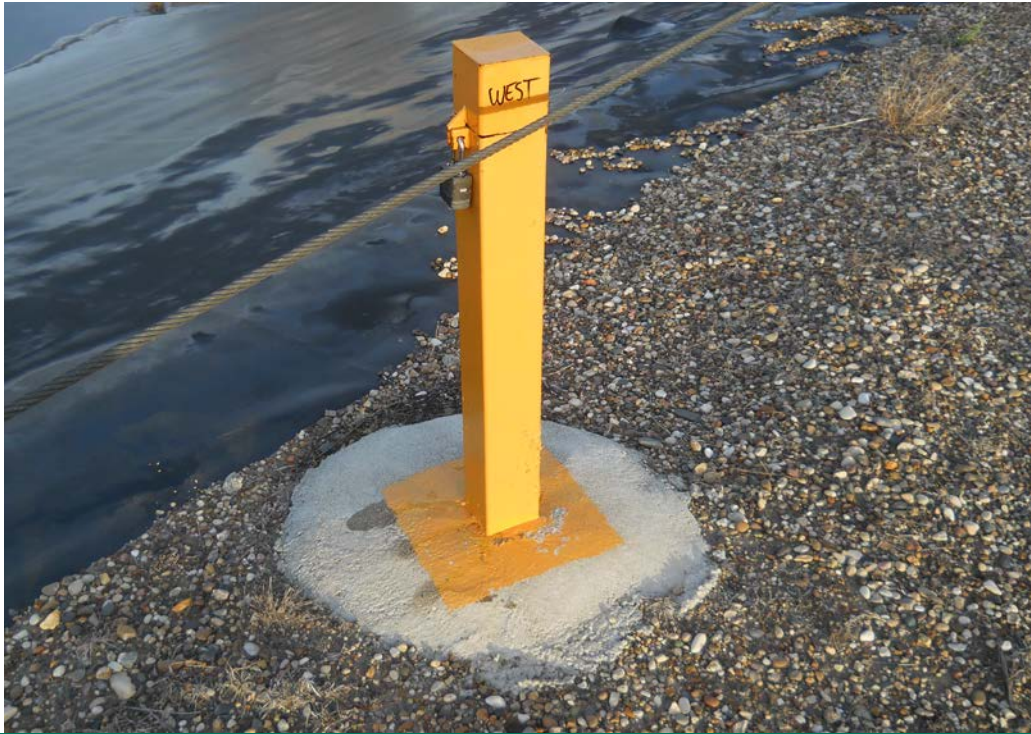
The Bottom Ash Impoundment currently has two piezometers (P-1 and P-2) on the downstream slope on the east side of the Center Cell (Figure 2). Water elevations observed in piezometers P-1 and P-2 were measured monthly between January and November of 2016. Water elevations in both piezometers varied by less than approximately one foot over the course of the year and had average elevations of approximately 1692.7 feet in P-1 and 1692.4 feet in P-2.

Photograph 5 (Center Cell)
Piezometer on the east side of the Center Cell (DSCN0784.JPG)

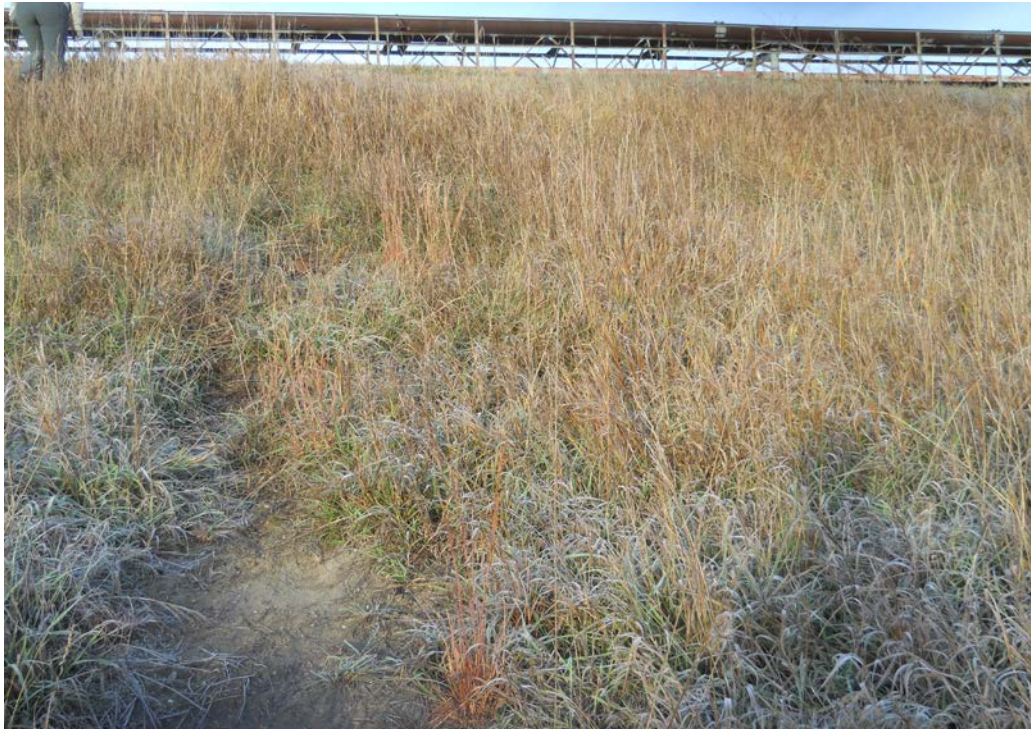
Photograph 6 (South Cell)
Erosion and barren spot on the east downstream slope (DSCN0781.JPG)

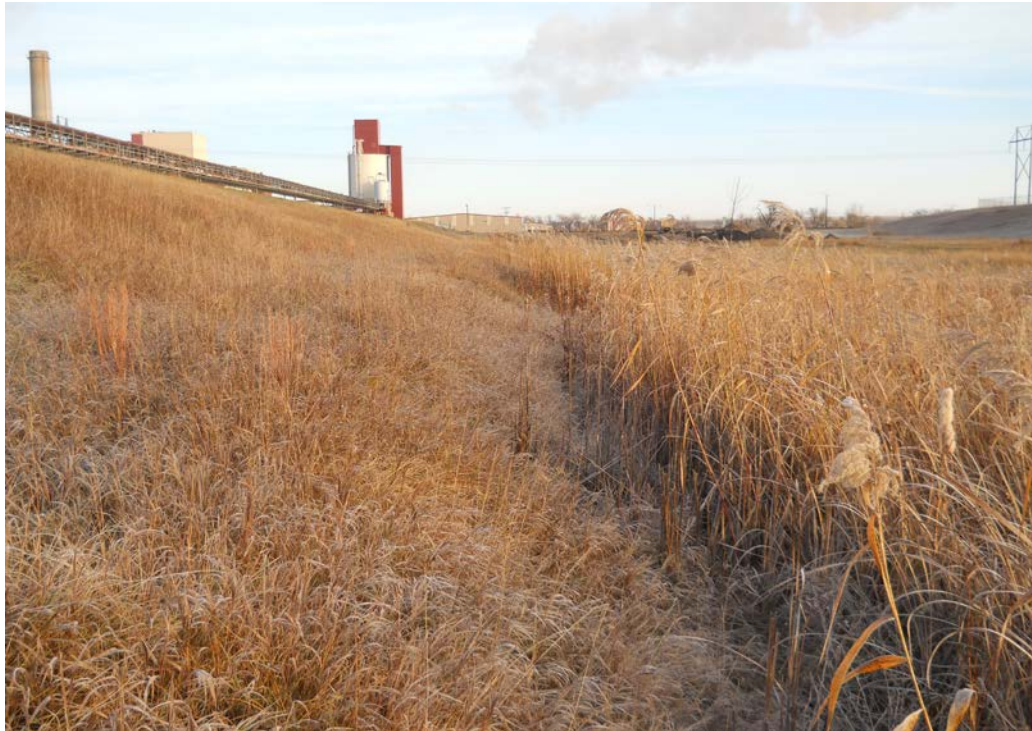
The toe of the west berm is in the bottom ash deposition area and has no observed seepage, standing water, animal burrows, settlement, or excessive vegetation. The toe of the east berm is in a low area that has some marshy vegetation, but no standing water. There were no observed indications of seepage, animal burrows, settlement, or excessive vegetation, but a portion of the slope does support mossy vegetation, likely from receiving minimal sunlight during the afternoon. The toe of the south berm is in a surface water drainage ditch that has some marshy vegetation and minor amounts of standing water. There were no observed indications of seepage, animal burrows, settlement, or excessive vegetation.

Photograph 7 (South Cell)
East toe of slope (DSCN0780.JPG)

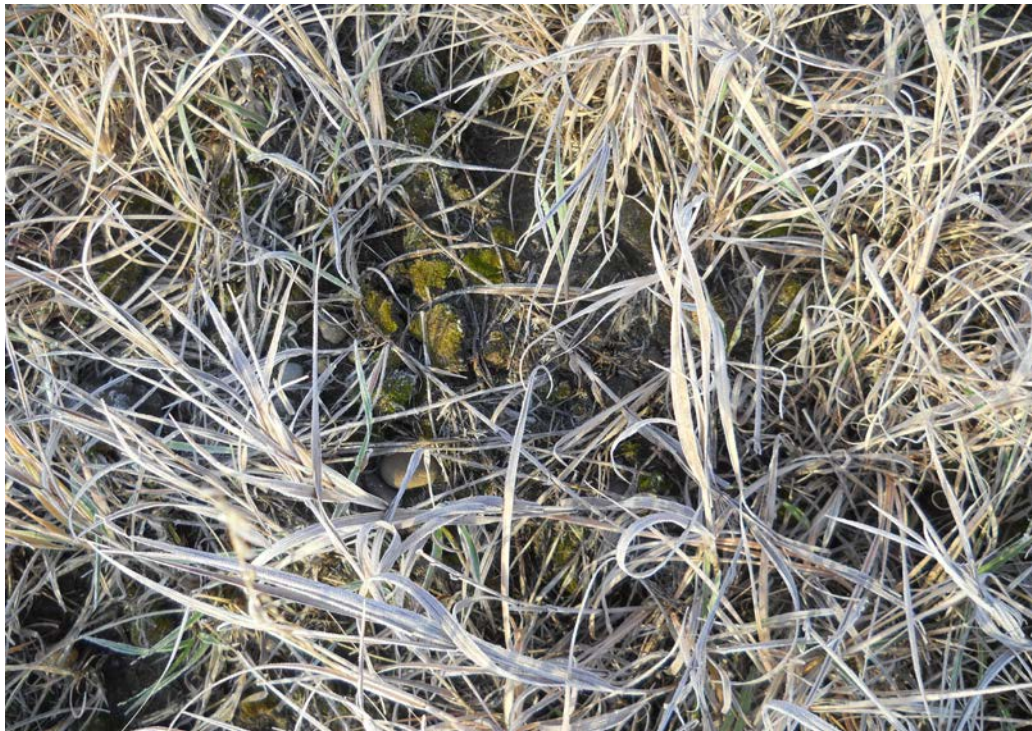
Photograph 8 (South Cell)
Moss on east downstream slope (DSCN0775.JPG)

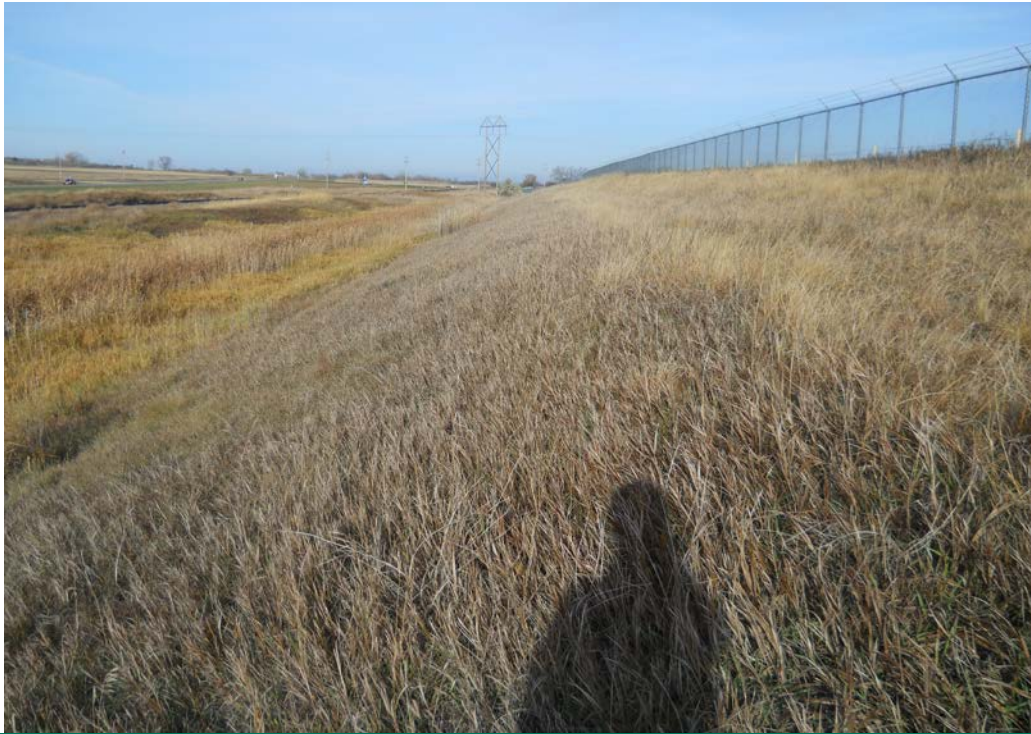
Photograph 9 (South Cell)
Vegetation on downstream slope (DSCN0802.JPG)

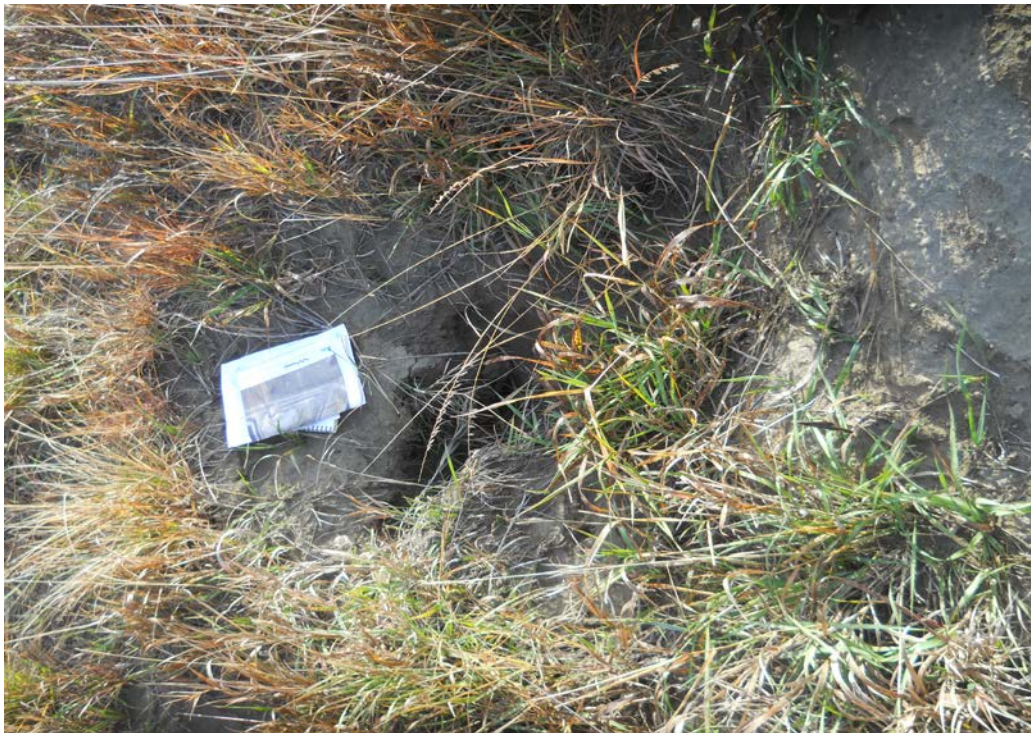
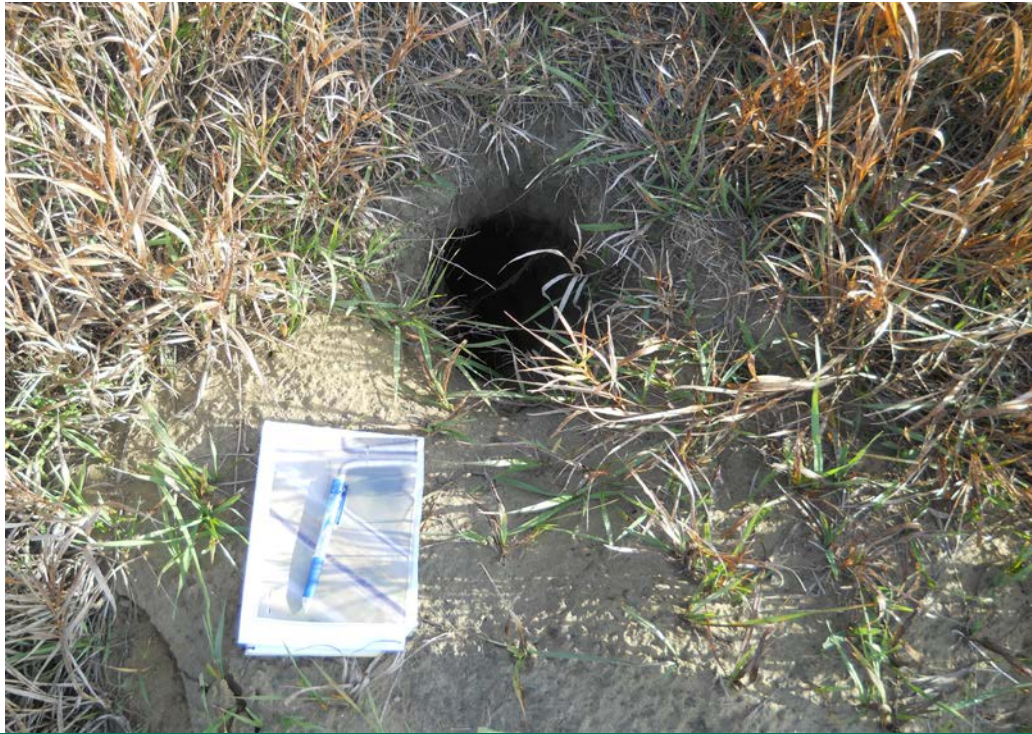
The downstream slope on the east and south side is approximately 20 feet high and the downstream slope on the west side is approximately 5 feet high. The slopes are graded at approximately 3:1 and are well vegetated with grass, with a few small areas of bare ground along the east and south sides of the impoundment that are susceptible to erosion. Several small (2-inch diameter) animal burrows were observed on the east downstream slopes and several large-sized (10-inch diameter) animal burrows were observed on the south downstream slopes. The downstream slopes are generally in fair condition due to the large number and size of animal burrows noted during the inspection.

Photograph 10 (South Cell)
Large animal burrow on south downstream slope (DSCN0803.JPG)

Photograph 11 (South Cell)
Large animal burrow on south downstream slope (DSCN0806.JPG)

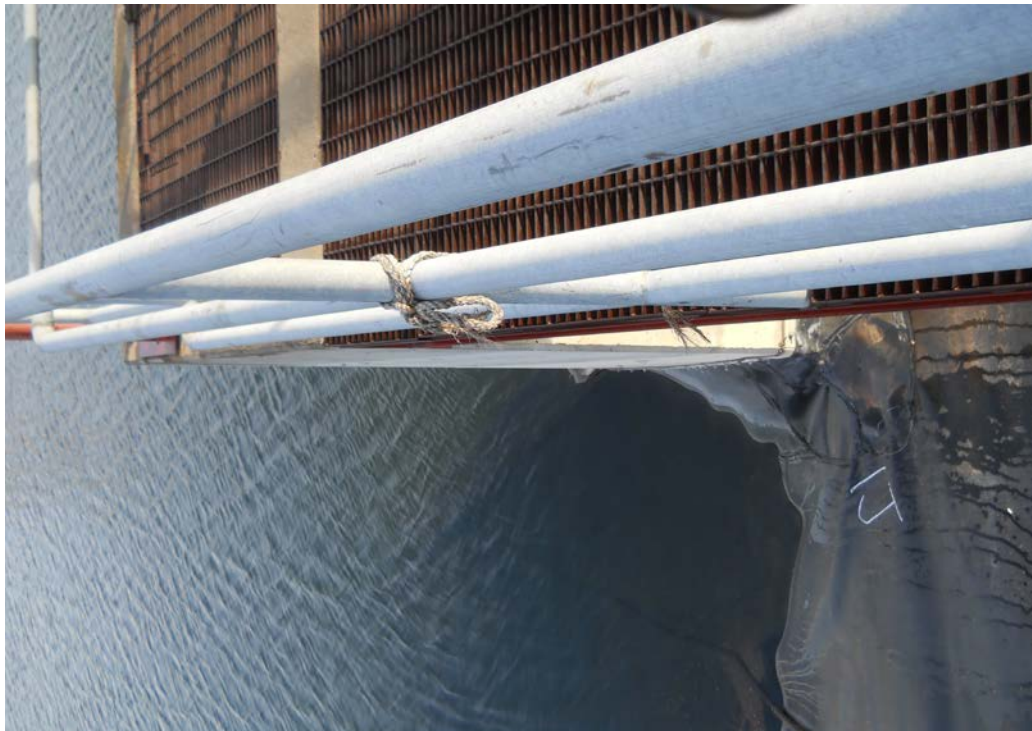
Outflow from the North Cell is through the concrete outflow structure located on the south upstream slope. The structure was in good condition with no signs of blockage, corrosion, erosion, or cracking. Stop logs were placed in the outfall structure to control the cell water elevation.

Photograph 12 (North Cell)
North outlet hydraulic structure and geomembrane attachment to concrete (DSCN0792.JPG)

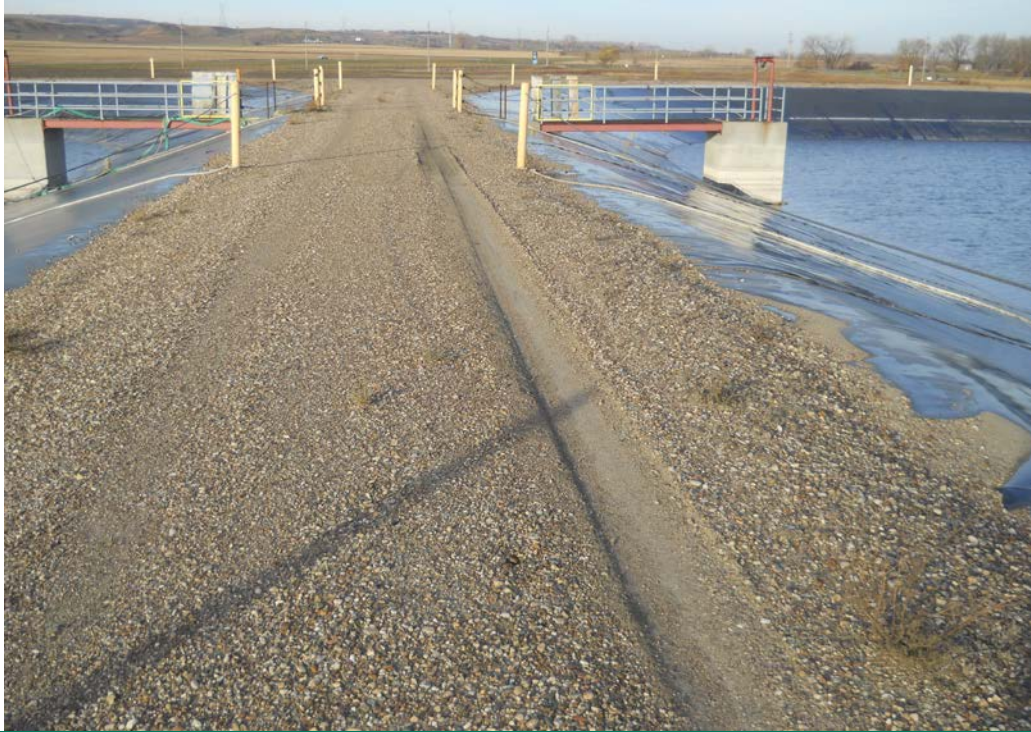
Photograph 13 (North Cell and Center Cell)

The berm crest around the Bottom Ash Impoundment is surfaced with gravel at a constant elevation of 1720 feet. The crest roadway is primarily used for light vehicle traffic, but is exposed to heavy construction equipment when the North and South Cells are cleaned out. The crest appears to be in good condition with no vegetation, animal burrows, or settlement, and appears to be well maintained. There was minor rutting along the crest road between the North and Center cells. The rutting is limited to a small area of the road and most likely caused from light vehicle traffic during wet conditions.

Minor rutting of gravel access road between North Cell and Center Cell (DSCN0794.JPG)

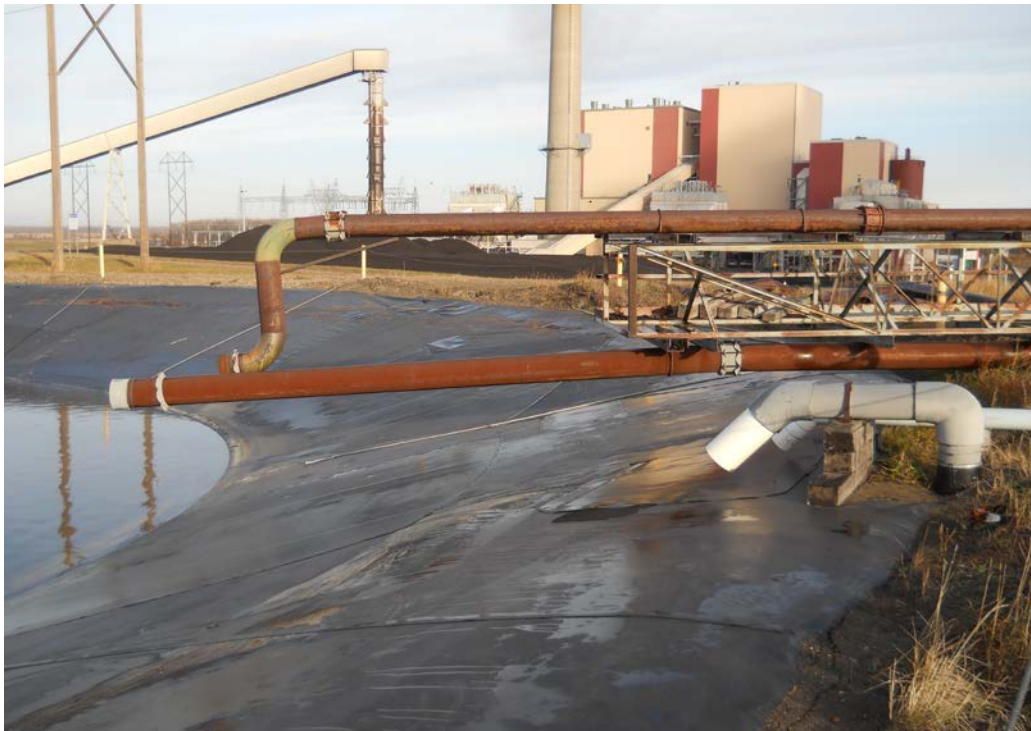
Photograph 14 (North Cell)

Inflow to the North Cell includes the bottom ash discharge pipes, the retention pond inlet pipe, and the coal pit sump inlet pipe. The bottom ash pipes discharge into the impoundment over previously deposited bottom ash and were in fair condition with minor corrosion and wear of the pipe. The bottom ash pipes, retention pond inlet, and coal pit sump inlet pipes discharge into the impoundment onto a sacrificial HDPE wear-liner and were in good condition with no indications of wear or penetration of the liner or cracking of the inlet pipes.

Bottom ash inlet piping and trestle entering North Cell (DSCN0796.JPG)

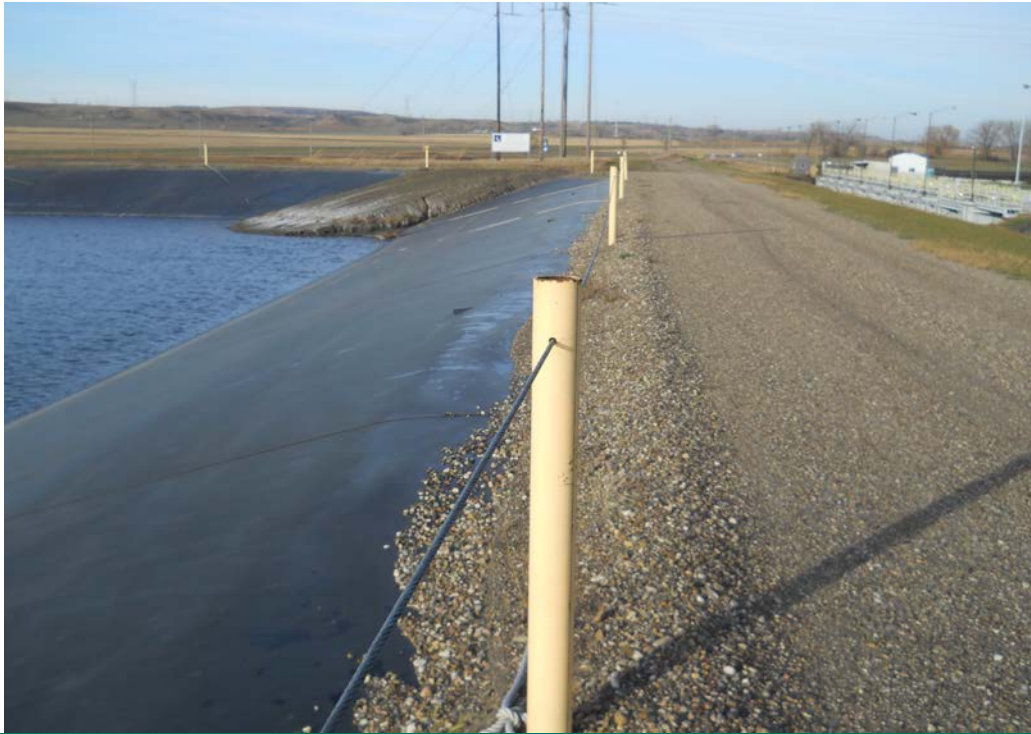
The upstream slopes above the water level were evaluated. The upstream slopes appeared to match the design slopes of 3:1 to about 6 feet down (approximate elevation 1714 feet) with no observed sections of significant slope difference. The geomembrane liner is exposed on the slopes with no protective cover. There were no signs of vegetation or animal burrows on the upstream slopes. The North Cell upstream slopes appear to be in fair condition.

Photograph 15 (North Cell)
Upstream slope of North Cell and gravel access road (DSCN0798.JPG)

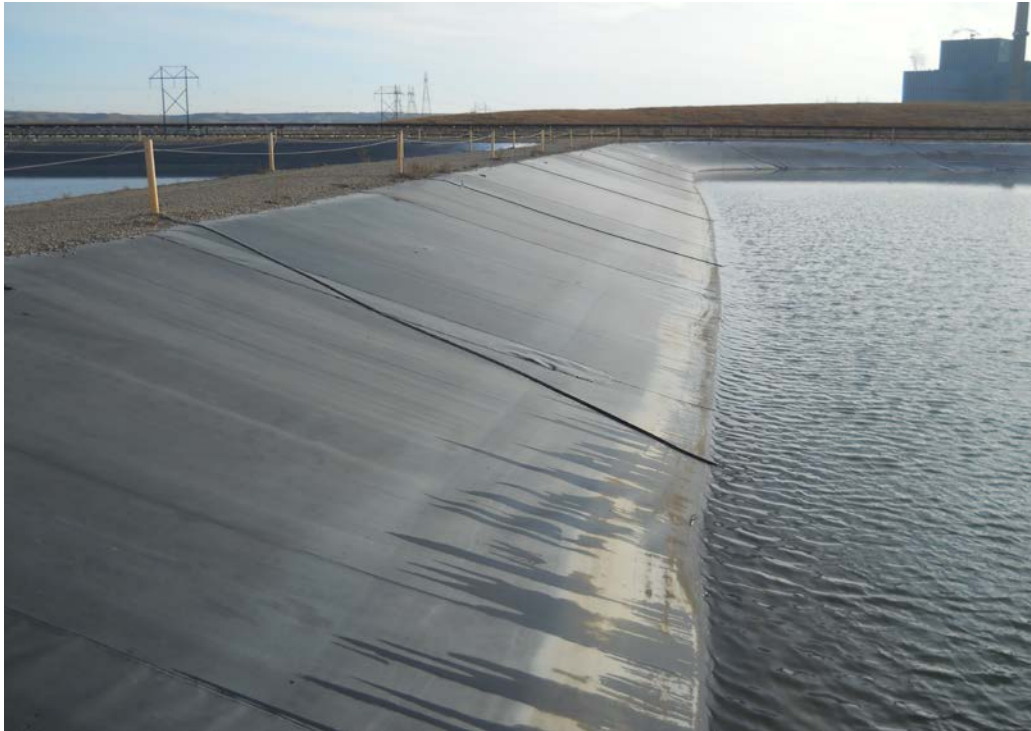
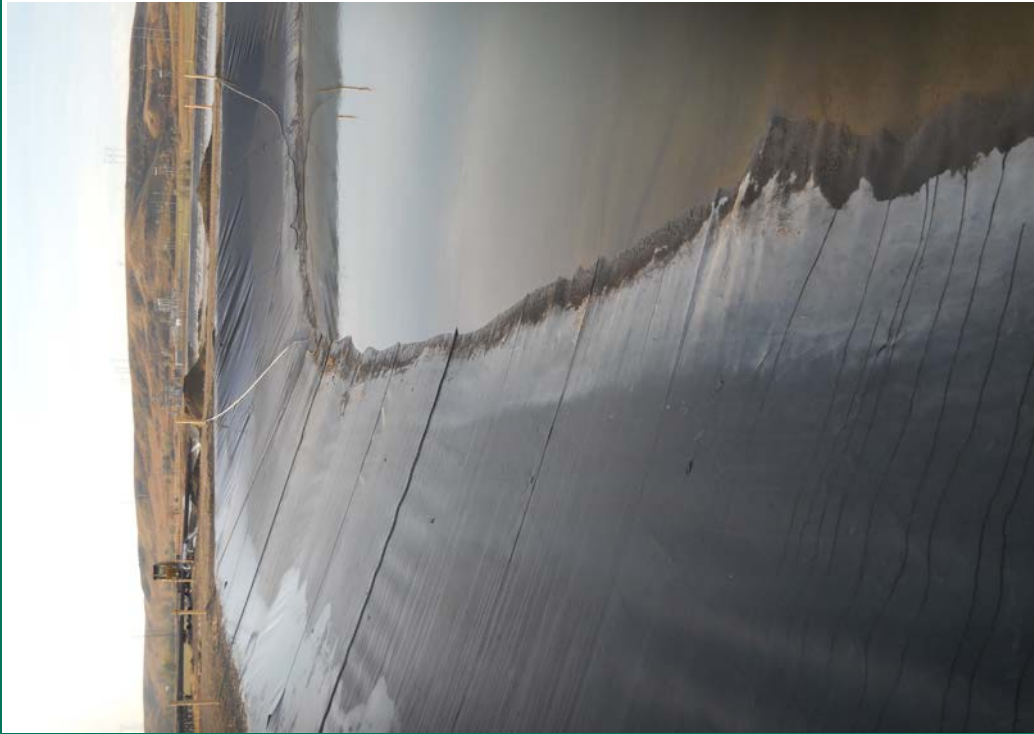
The upstream slopes above the water level were evaluated. The slopes appeared to match the design slopes of 3:1 to about 4 feet down (approximate elevation 1716 feet) at which point the slopes curved inward to a steeper concave shape. This displacement of the lower slope is likely due to “pumping” of saturated soils beneath the geomembrane due to wave action and the lack of confining pressure from overlying protective cover. Geomembrane repairs were performed in the fall of 2015 to patch defects in the geomembrane liner. The Center Cell upstream slopes appear to be in fair condition.

Photograph 16 (Center Cell)
Upstream slope of north side of Center Cell (DSCN0799.JPG)

Photograph 17 (Center Cell)
Upstream slope of east side of Center Cell (DSCN0801.JPG)

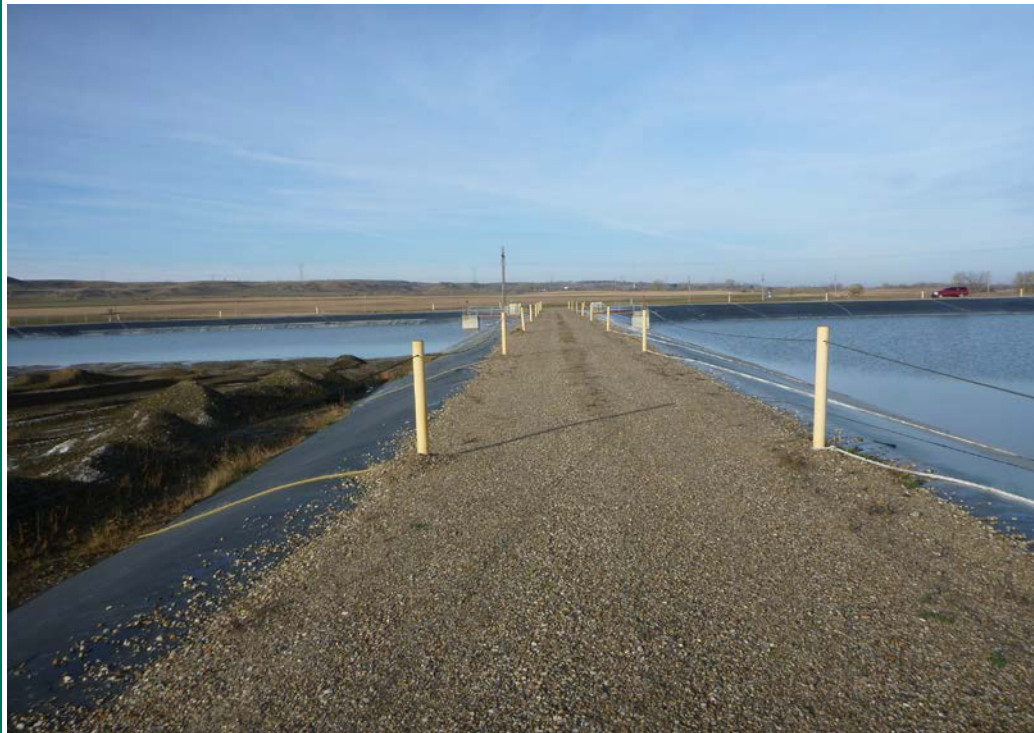
Photograph 18 (South Cell and Center Cell)
Gravel access road between the South Cell and Center Cell (P1030385.JPG)

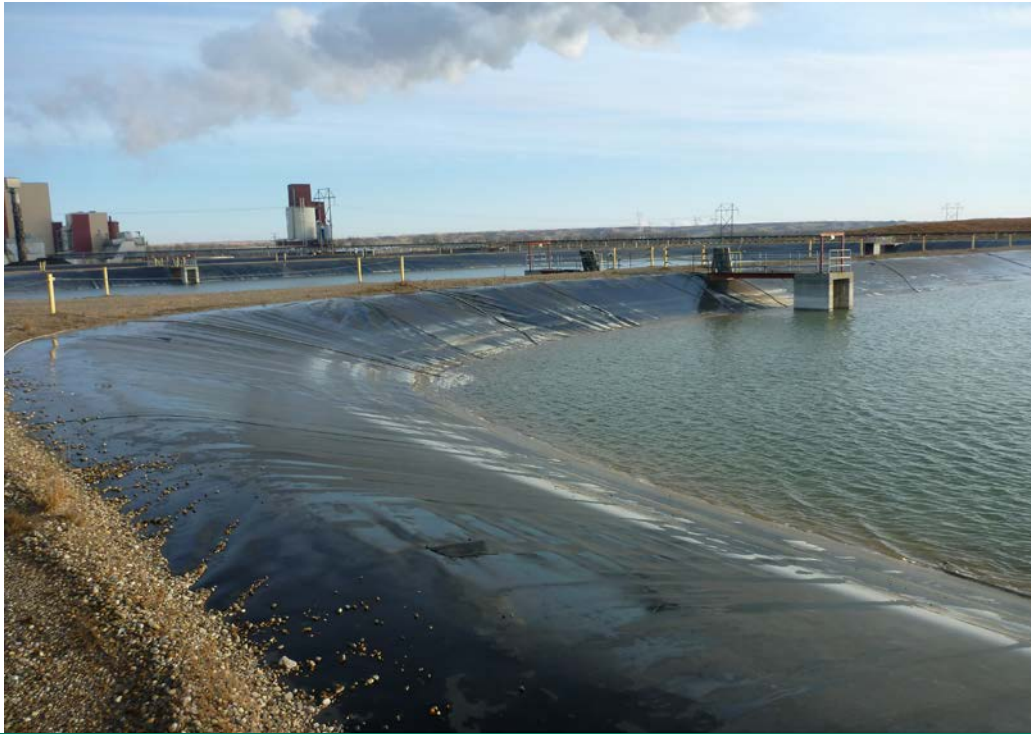
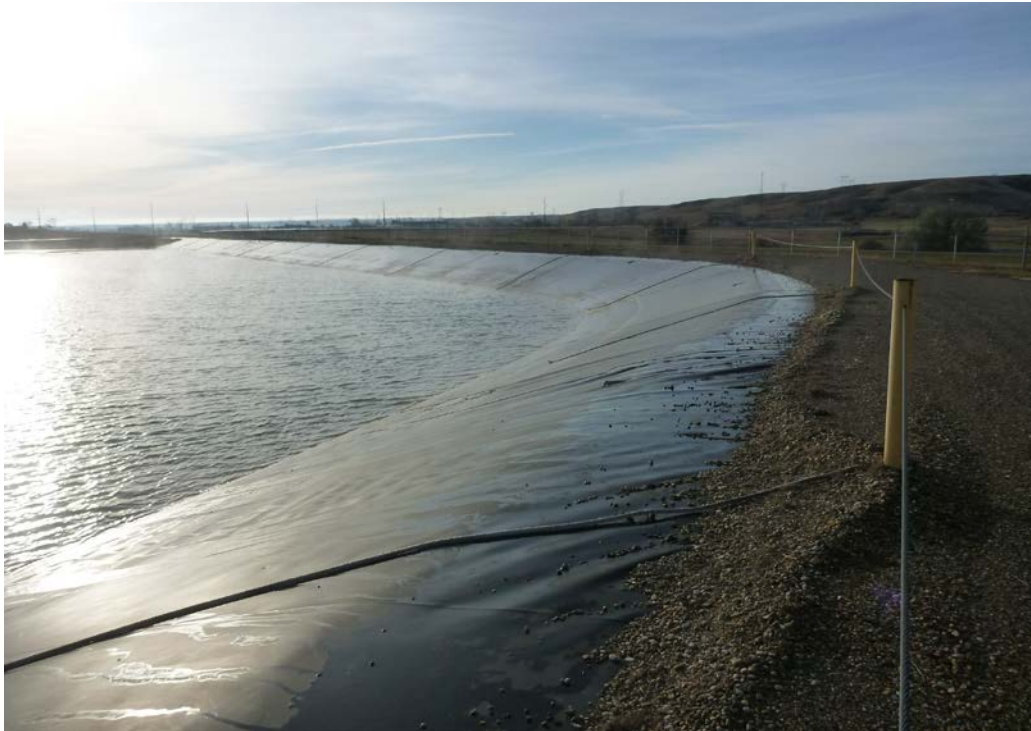
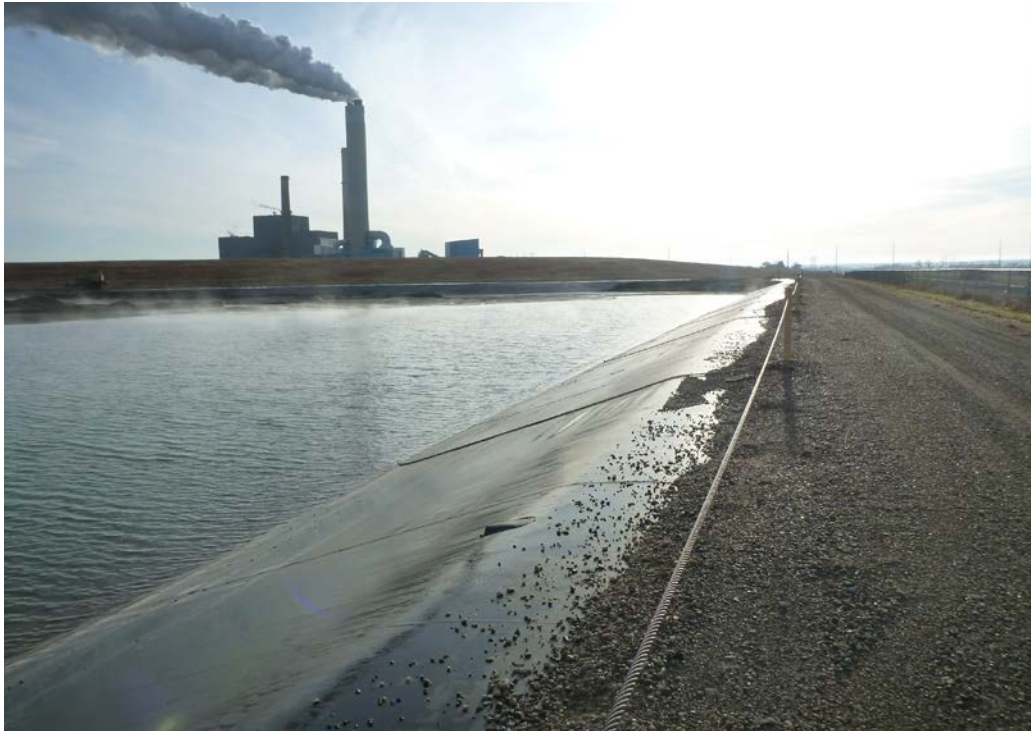
The upstream slopes above the water level and not covered with bottom ash were evaluated. The slopes appeared to match the design slopes of 3:1 with minor sections of slope difference where the slopes curved inward to a steeper concave shape. This displacement of the lower slope is likely due to “pumping” of saturated soils beneath the geomembrane due to wave action and the lack of confining pressure from overlying protective cover layer. The South Cell upstream slopes appear to be in fair condition.

Photograph 19 (South Cell)
Upstream slope of the northwest corner of the South Cell (P1030375.JPG)

Photograph 20 (South Cell)
Upstream slope on the south side of the South Cell (P1030376.JPG)

Photograph 22 (South Cell)
Upstream slope on the south side of the South Cell (P1030381.JPG)

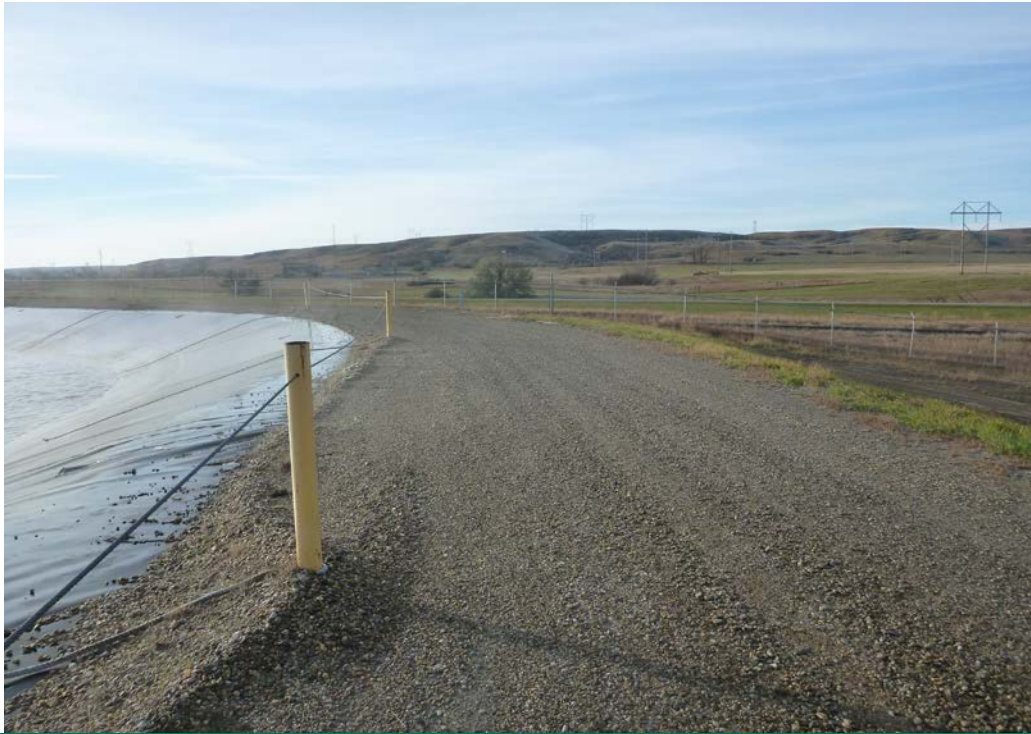
Photograph 21 (South Cell)
Gravel access road on the southeast side of the South Cell (P1030377.JPG)

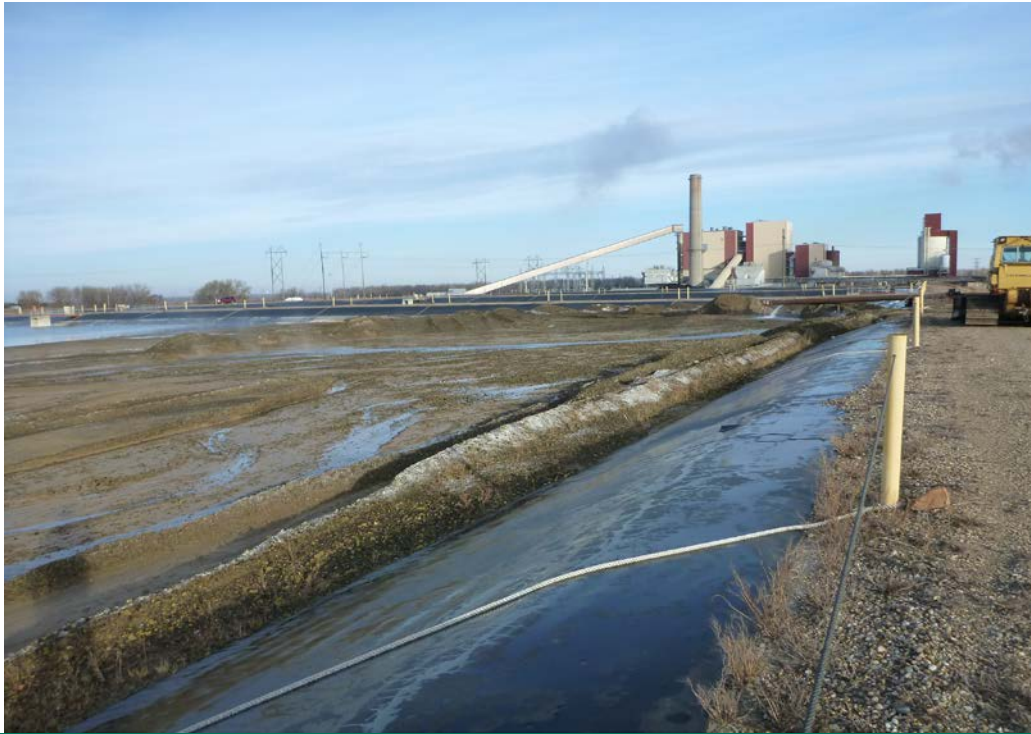
Photograph 23 (South Cell)
Bottom ash deposition on the east side of of the South Cell (P1030383.JPG)

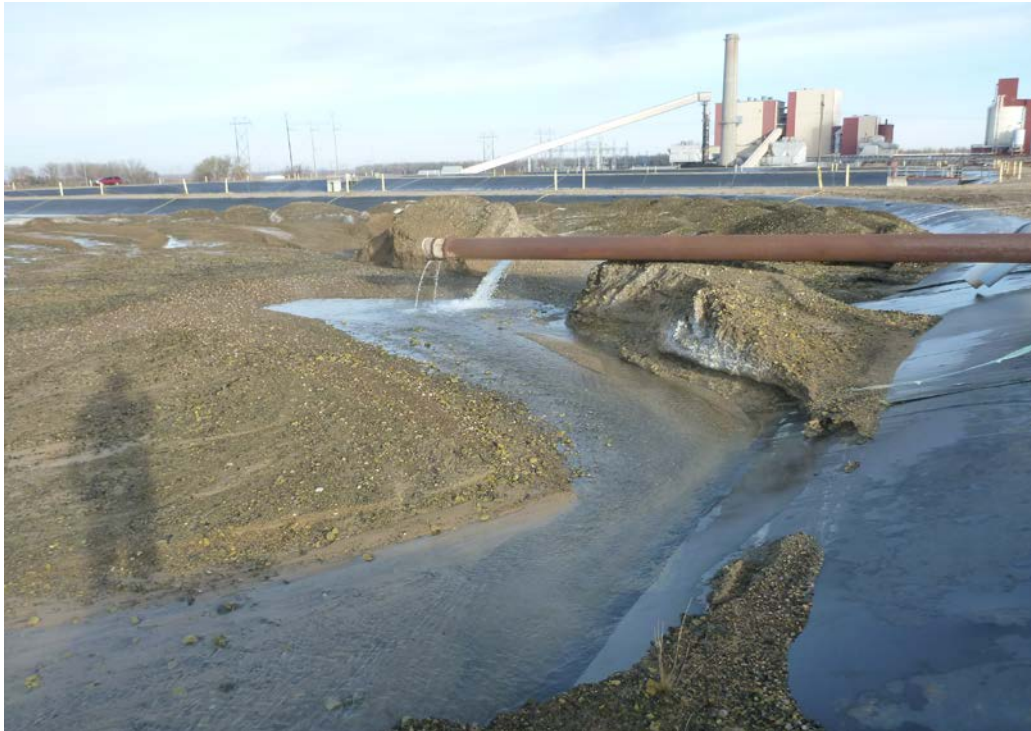
Inflow to the South Cell includes the bottom ash discharge pipes, the retention pond inlet pipe, and the coal pit sump inlet pipe. The bottom ash pipes discharge into the impoundment over previously deposited bottom ash and were in fair condition with minor corrosion and wear of the pipe. The bottom ash pipes, retention pond inlet, and coal pit sump inlet pipes discharge into the impoundment onto a sacrificial HDPE wear-liner. The retention pond inlet and coal pit sump inlet pipes appeared to be in good condition.

Photograph 24 (South Cell)
Bottom ash conveyance water and geomembrane rub sheet on the east side of the South Cell (P1030384.JPG)
