ANNUAL INSPECTION REPORT

GREAT RIVER ENERGY – STANTON STATION

Bottom Ash CCR Landfill

January 2018

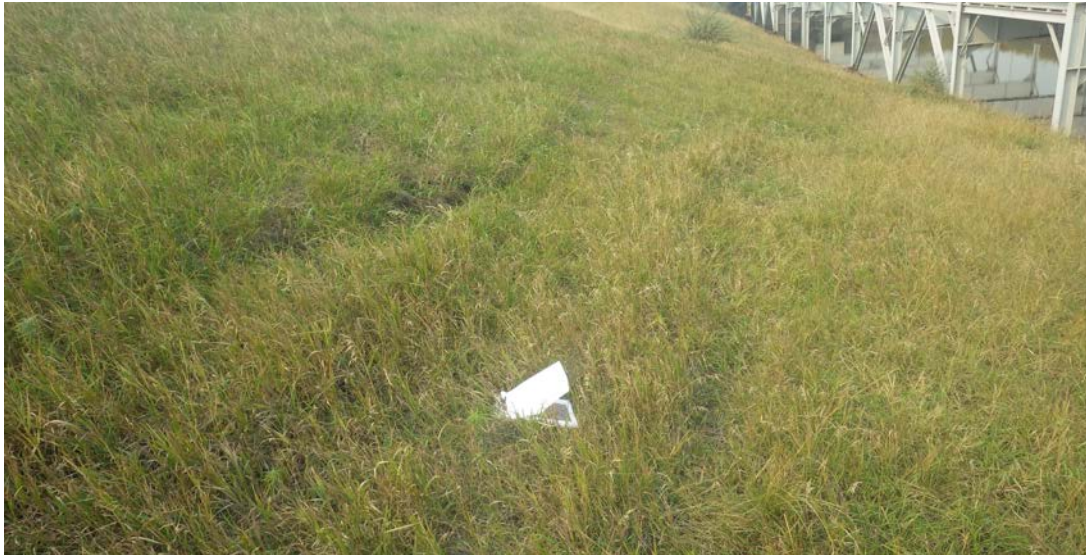
Photograph 4 (North berm downstream slope)
Rutting along the north berm downstream slope (IMGP5404.JPG)

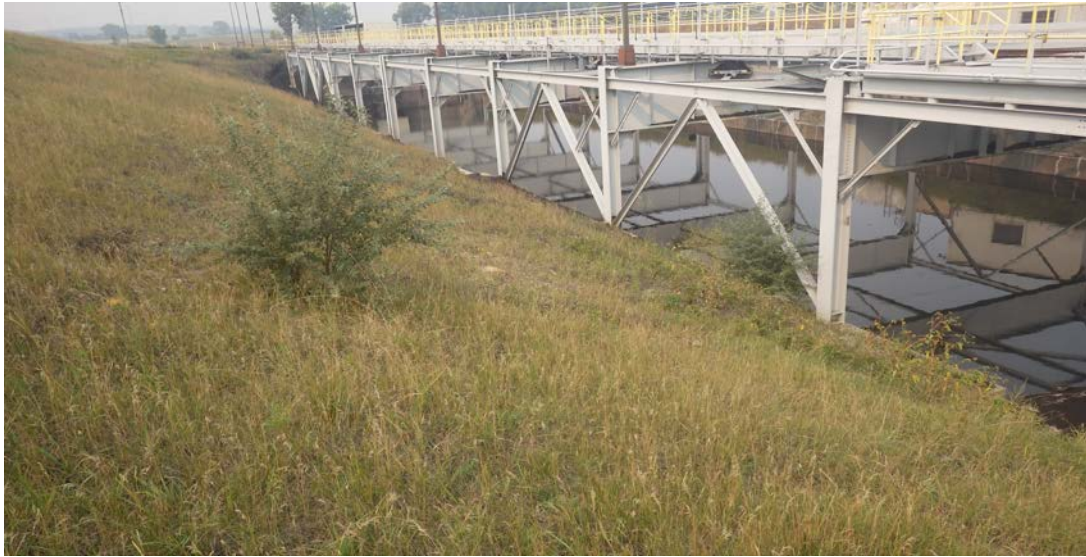
Photograph 5 (North berm downstream slope)

The berm downstream slopes on the north, west, and south sides are between approximately 5 feet and 10 feet high and have slopes of approximately 3:1. Slopes are well vegetated with grass, but do contain numerous, but mostly small, animal burrows. A small tree was also observed on the berm downstream slope on the south side of the facility. This small tree along with any other woody vegetation should be removed from the landfill. The berm downstream slopes of the Bottom Ash Landfill appear to be in fair condition.

Woody vegetation along the north berm downstream slope to be removed (IMGP5407.JPG)

Minor maintenance items that may need to be continually addressed include repairing larger animal burrows as they appear, repairing stormwater and/or contact water control features to control run-on and runoff, monitoring vegetative success of berm downstream slopes, and removal of any woody vegetation growing on the berm downstream slopes.

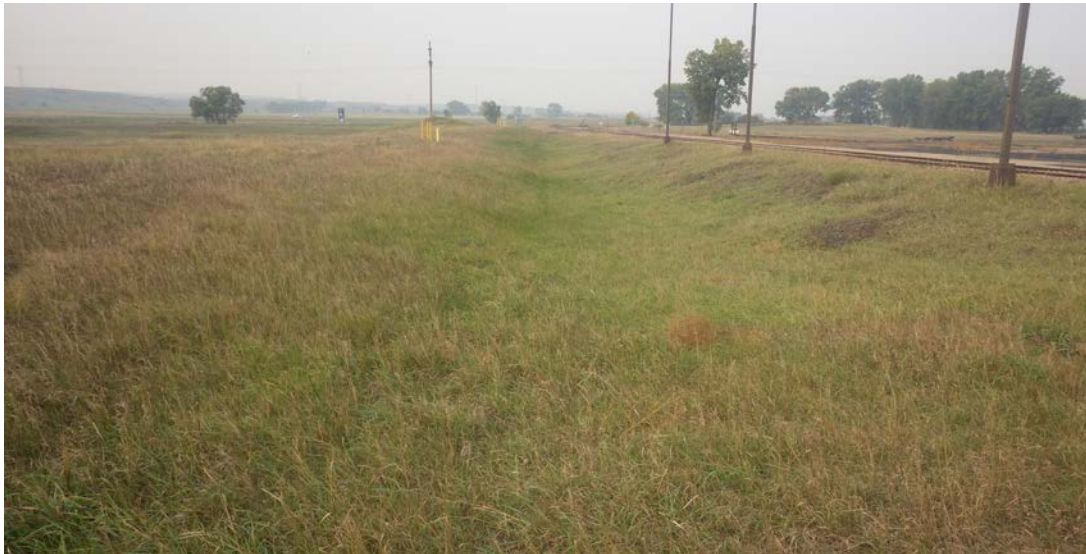
Photograph 6 (North berm downstream slope)

Drainage ditch on the north side of the landfill (IMGP5412.JPG)

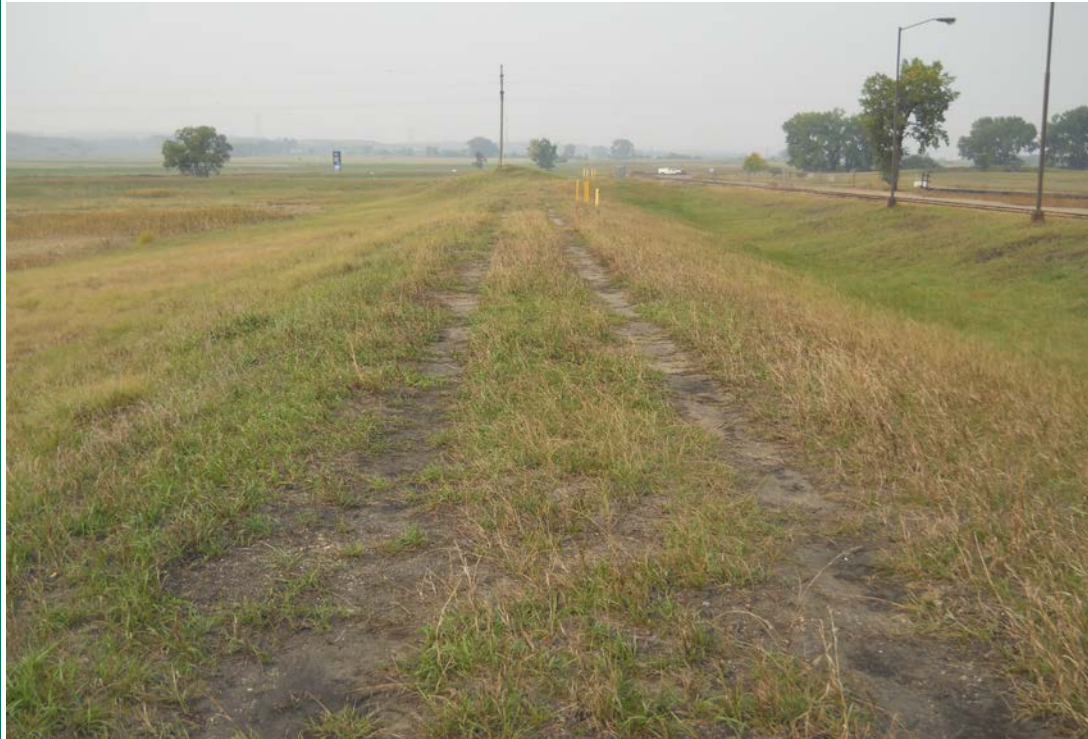
Photograph 7 (North berm crest)
North perimeter berm crest (DSCN1580.JPG)

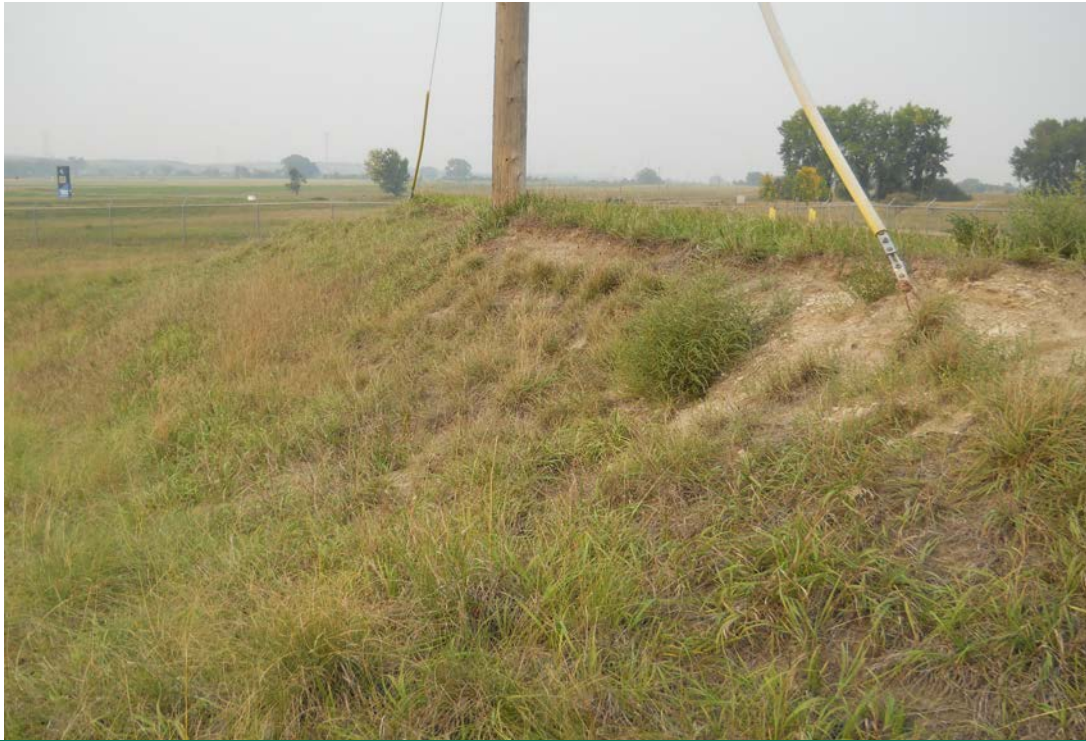
Photograph 9 (North berm upstream slope)
Steep slope/erosion on south side of power pole (DSCN1586.JPG)

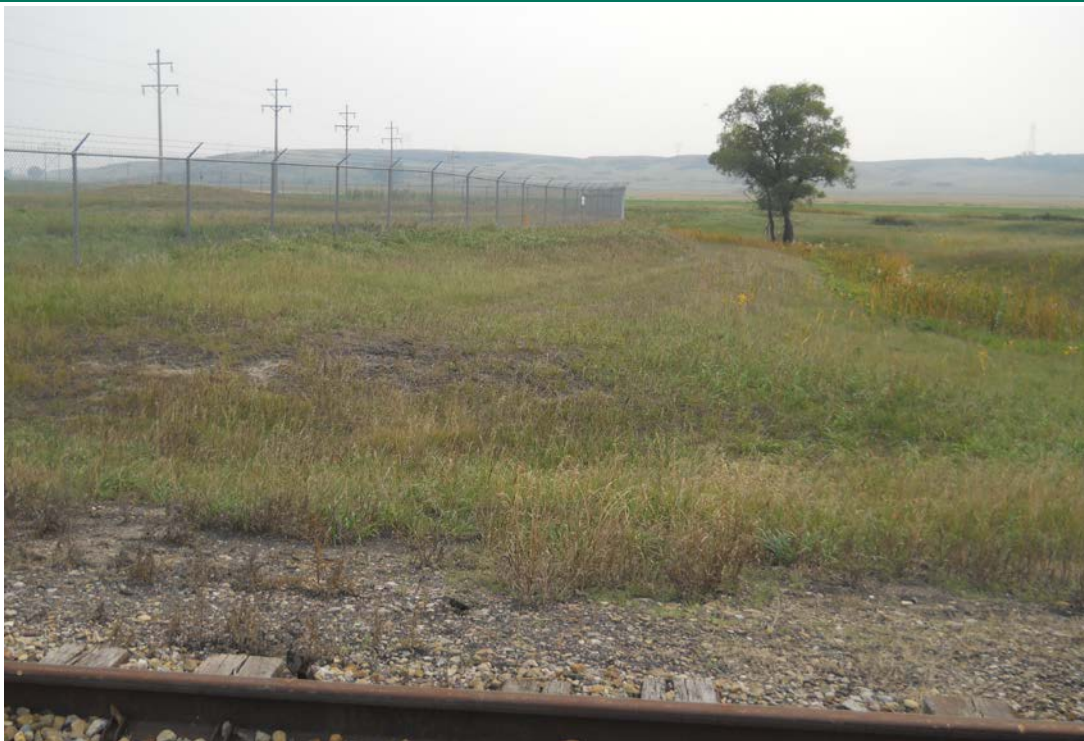
Photograph 14 (West berm downstream slope)
Grass vegetation on west berm downstream slope (DSCN1598.JPG)

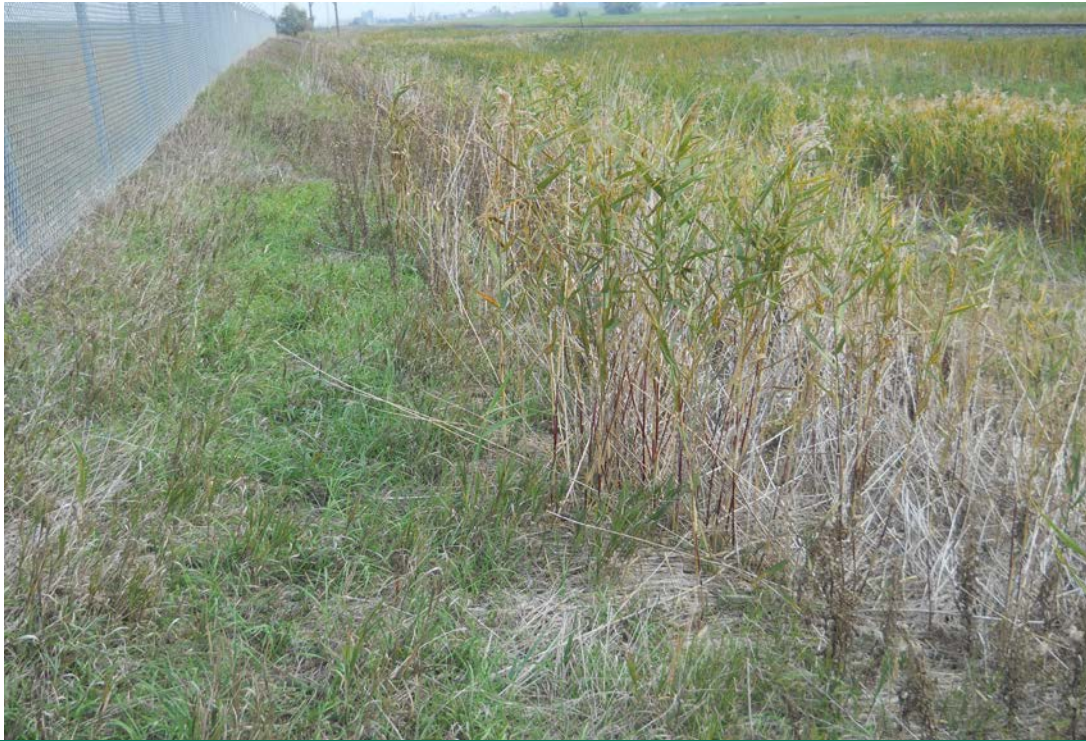
Photograph 15 (South berm downstream slope)
Reedy vegetation on south berm downstream slope (DSCN1597.JPG)

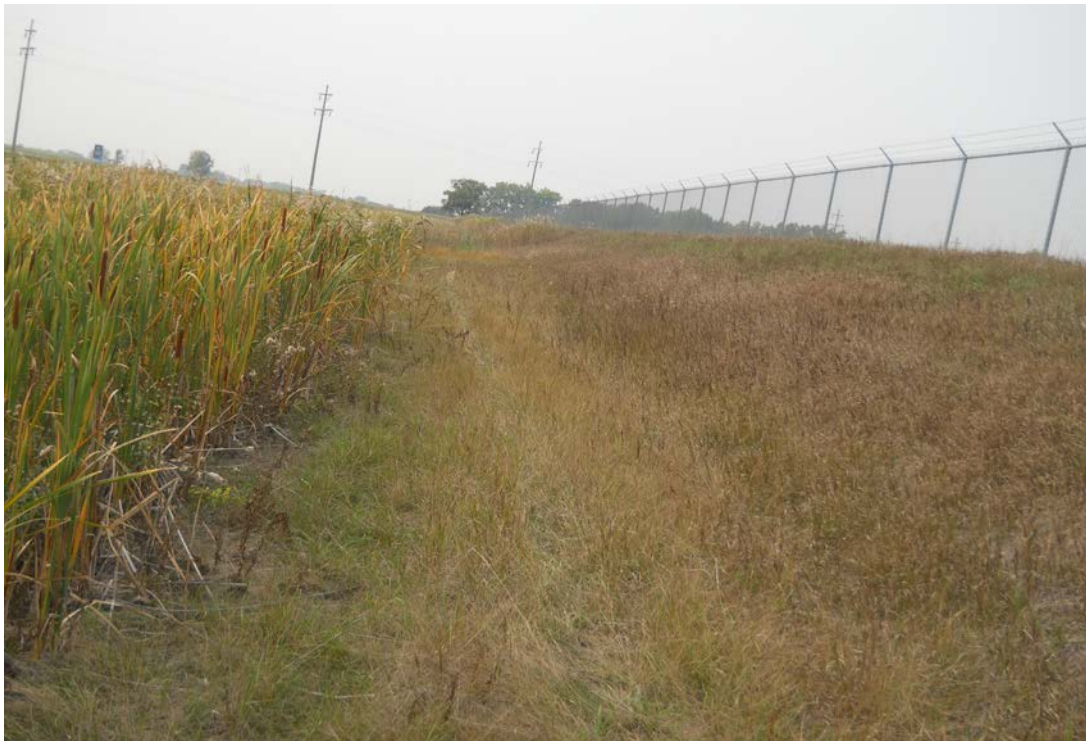
Photograph 16 (South berm downstream slope)
Grass vegetation on south berm downstream slope of the landfill (DSCN1596.JPG)

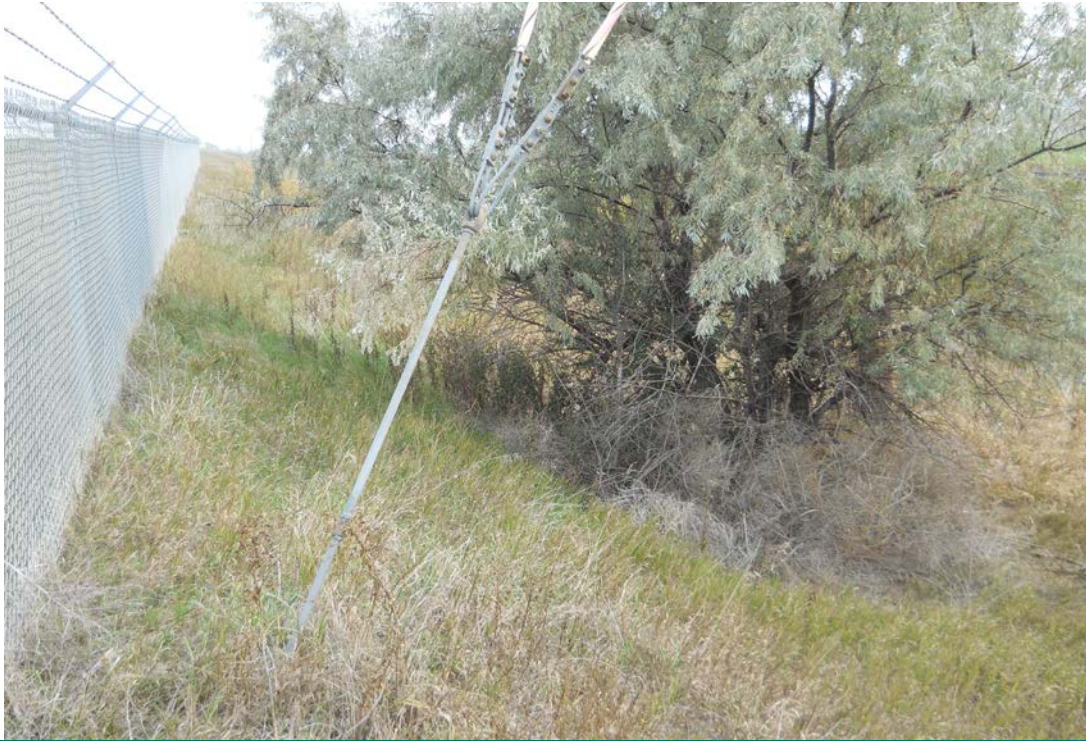
d. Cracks/settlement/scarps		X		
e. Seepage		X		
7. Toe				
a. Vegetation	X			Grass – small tree on south side
b. Rodent burrows	X			South side
c. Settlement		X

Photograph 17 (South toe)
Tree along south downstream berm slope toe (DSCN1594.JPG)

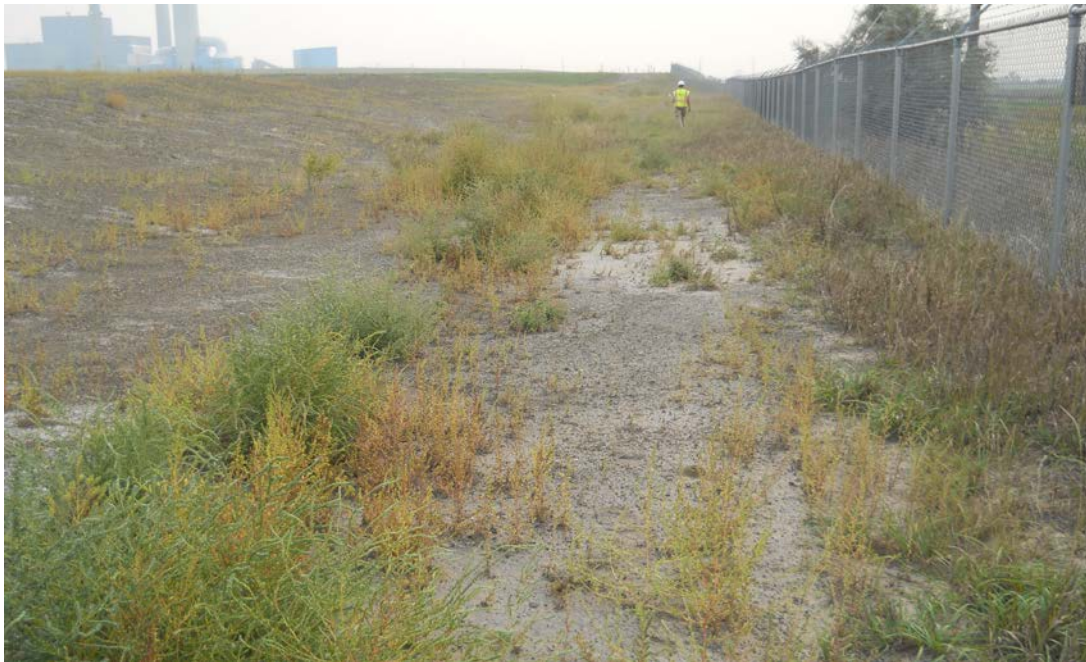
placement slopes appeared to be within the design CCR grades, and contact water was generally directed to the low area on the west end of the landfill. The contact water control berm/channel along the south side of the facility where recent placement has occurred was not well-defined during the inspection. A perimeter berm/channel should be built to direct contact water to the west side of the facility and clean stormwater off of the facility footprint and into perimeter stormwater drainage ditches. The majority of in-place CCRs within the landfill appear to be in fair condition except near the southeast corner of the facility where there are several erosion rills. No cracks, settlement, or seepage was observed on the CCR slopes.

Photograph 18 (South berm crest)
South perimeter berm crest with lack of well-defined contact water channel/berm (looking east)
(DSCN1588.JPG)

2. Contact Water Controls				
a. Water level in contact water control area	X			Depth: <1 foot
b. Sump & pump in good condition			X	
c. Containment controls working		X		Repair contact water control berm along south side to control potential contact water runoff

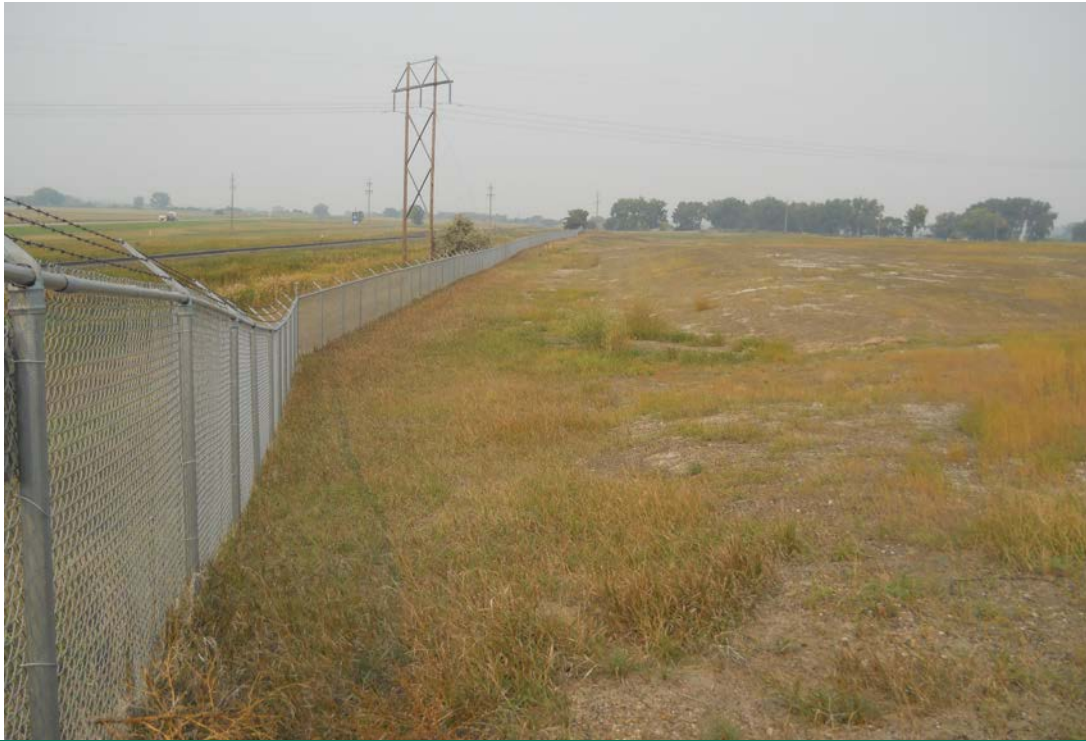
Photograph 19 (South berm crest)

South side of landfill from the southeast berm crest corner looking west (DSCN1559.JPG)

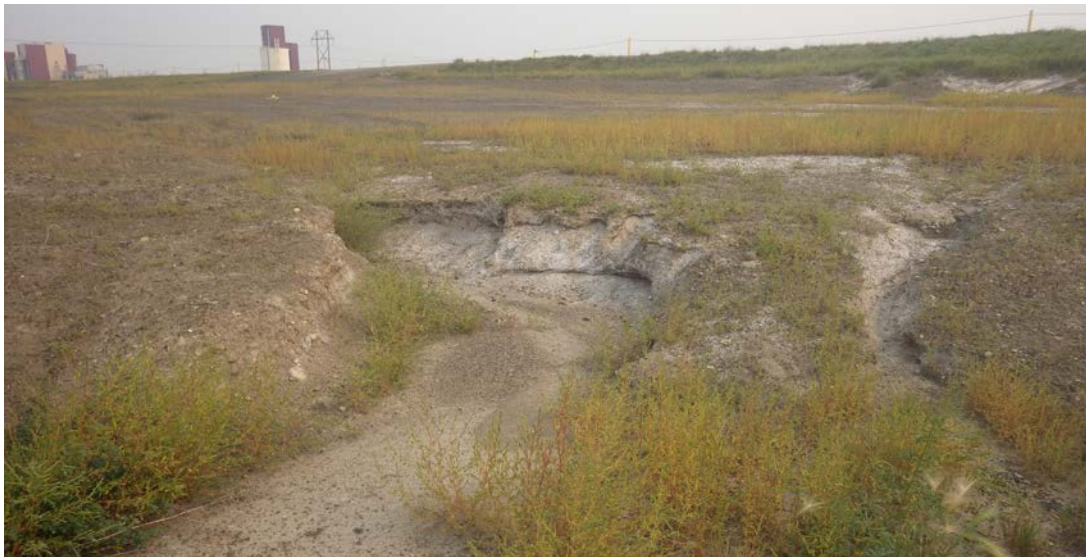
Photograph 20 (CCR Placement)

Southeast landfill corner looking north, erosion of CCR material (IMG5418.JPG)
