ANNUAL INSPECTION REPORT

GREAT RIVER ENERGY – STANTON STATION

Bottom Ash CCR Surface Impoundment

January 2018

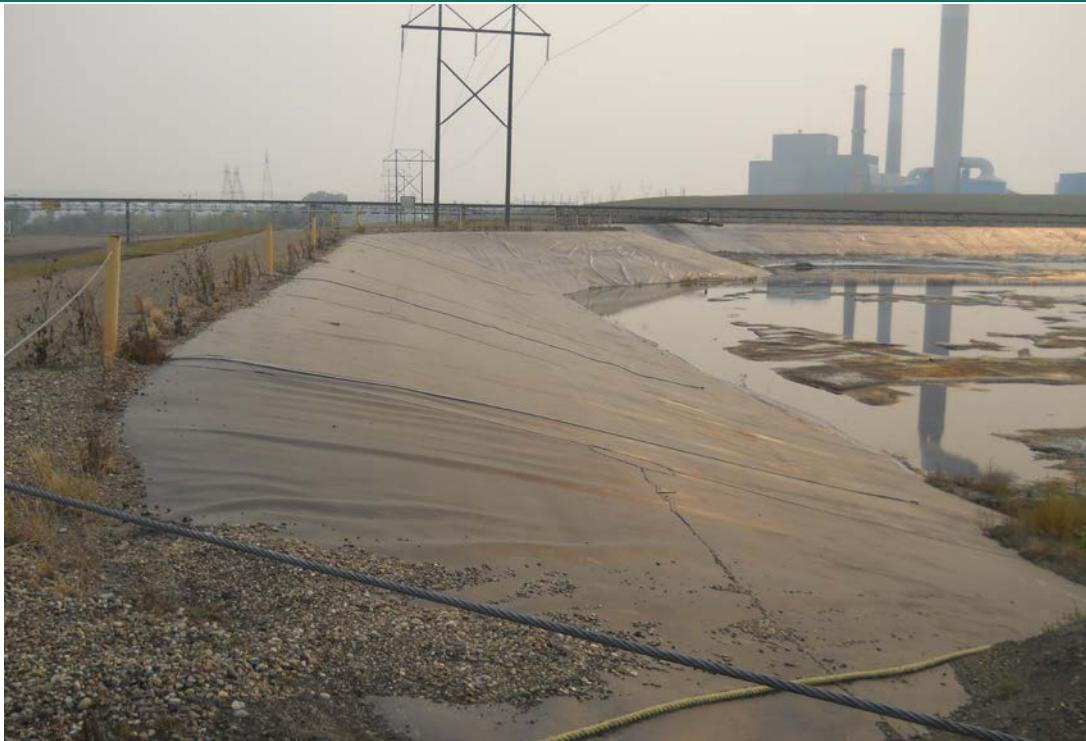
Photograph 1 (North cell berm upstream slope)
Panoramic of north cell interior (1 of 3). (DSCN1533.JPG)

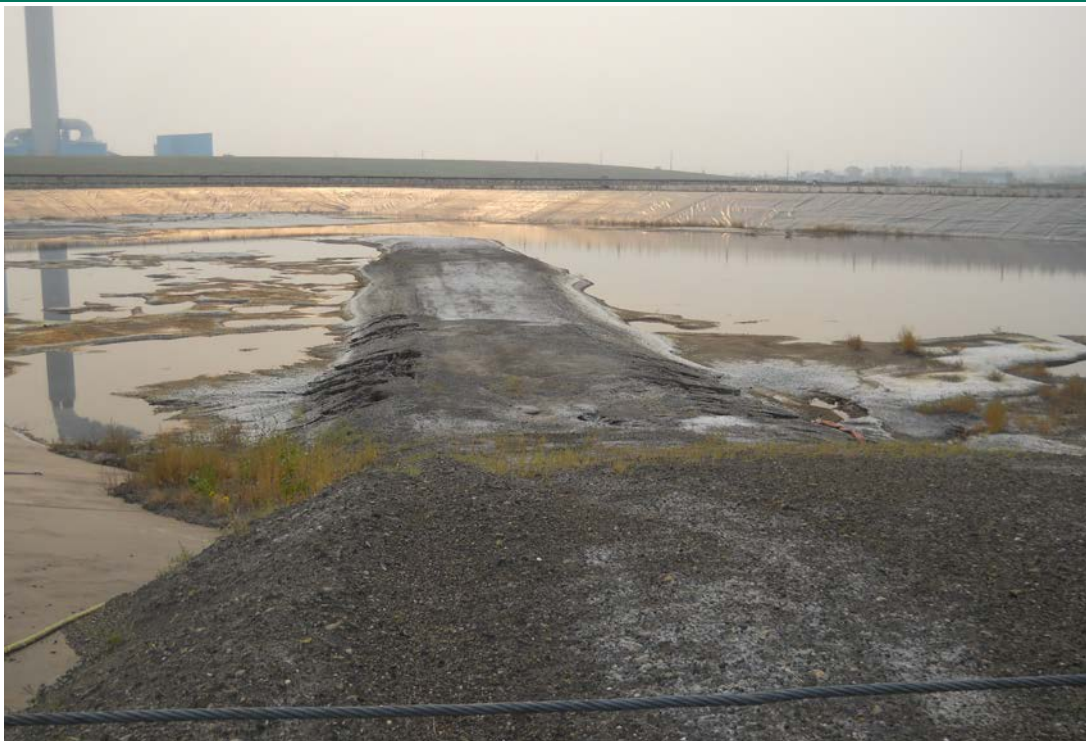
Photograph 2 (North cell berm upstream slope)
Panoramic of north cell interior (2 of 3). (DSCN1534.JPG)

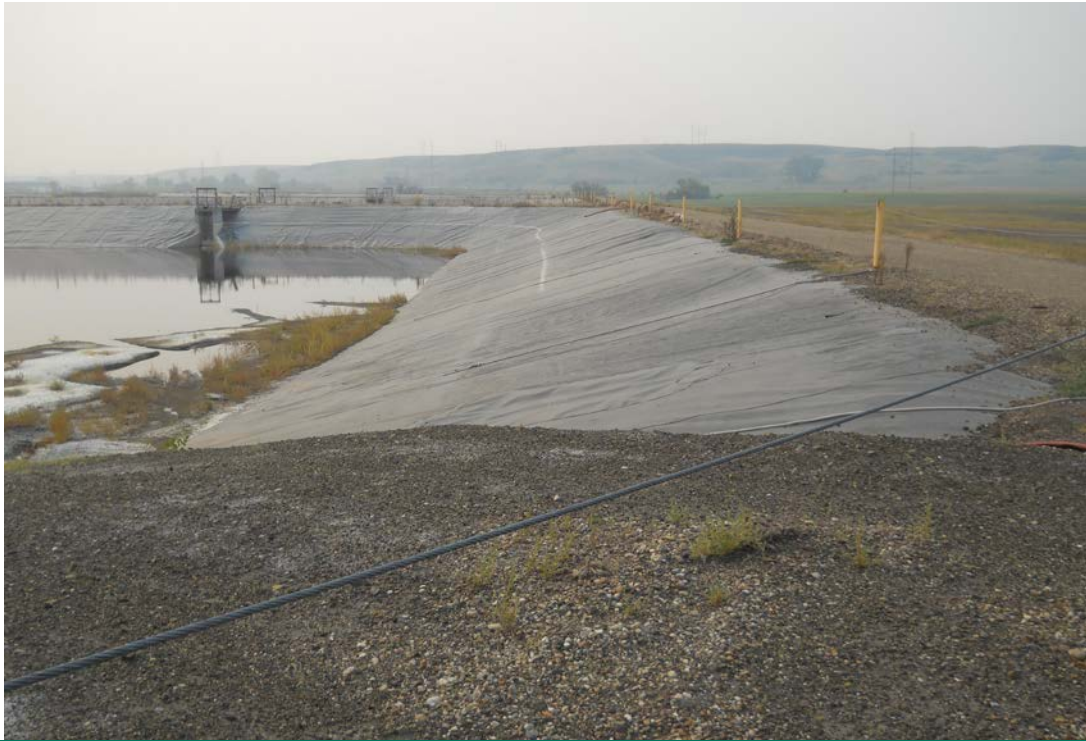
Photograph 3 (North cell berm upstream slope)
Panoramic of north cell interior (3 of 3). (DSCN1535.JPG)

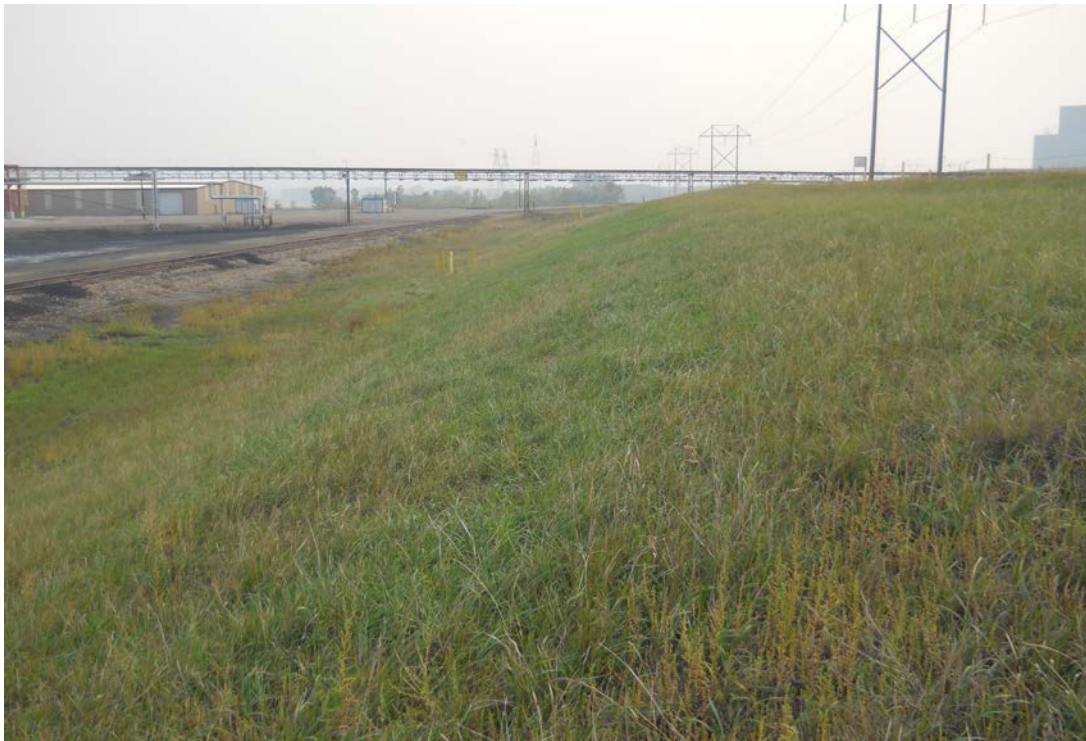
Photograph 4 (North berm downstream slope)
Grass vegetation on north berm downstream slope of the north cell. (DSCN1536.JPG)

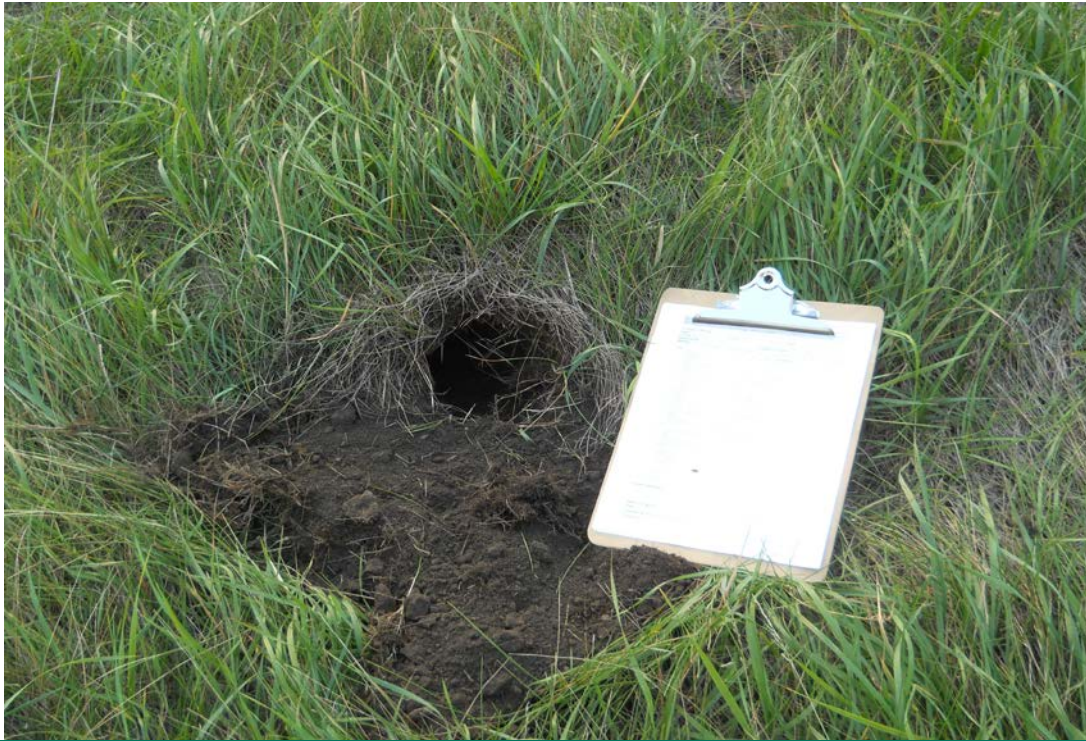
Photograph 5 (North berm downstream slope)
Animal burrow on north berm downstream slope of the north cell. (DSCN1537.JPG)

Minor maintenance items that may need to be continually addressed include repairing larger animal burrows as they appear, monitoring vegetative success of berm downstream slopes, removal of any woody vegetation growing on the berm downstream slopes, and repair of the perimeter security fence. In addition, the inflow and outflow piping and hydraulic structures should be monitored regularly to ensure proper conveyance of water through the impoundment system.

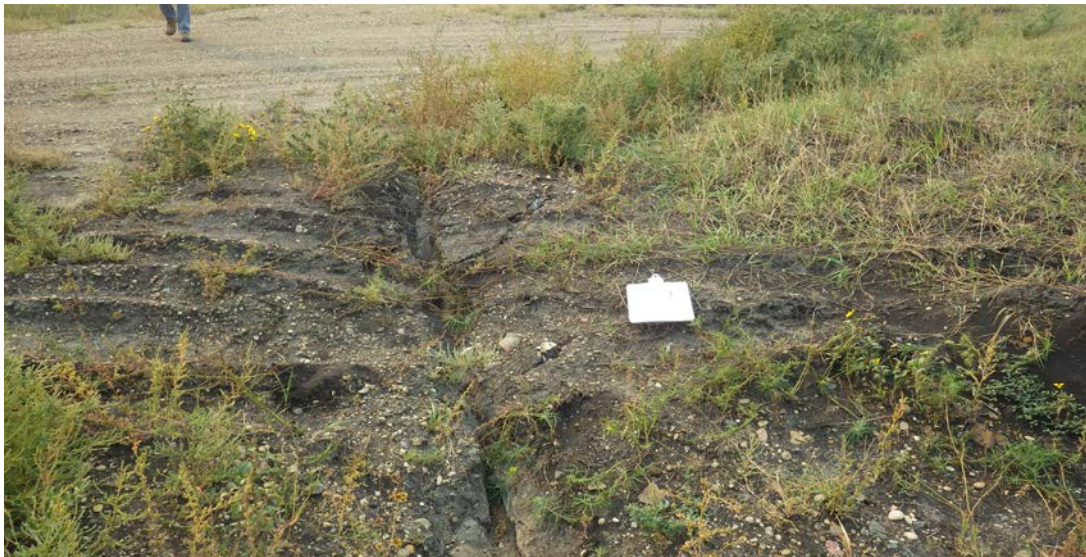
Photograph 6 (North berm downstream slope)
Erosion rill on the north side of the north berm crest gravel road. (IMGP5390.JPG)

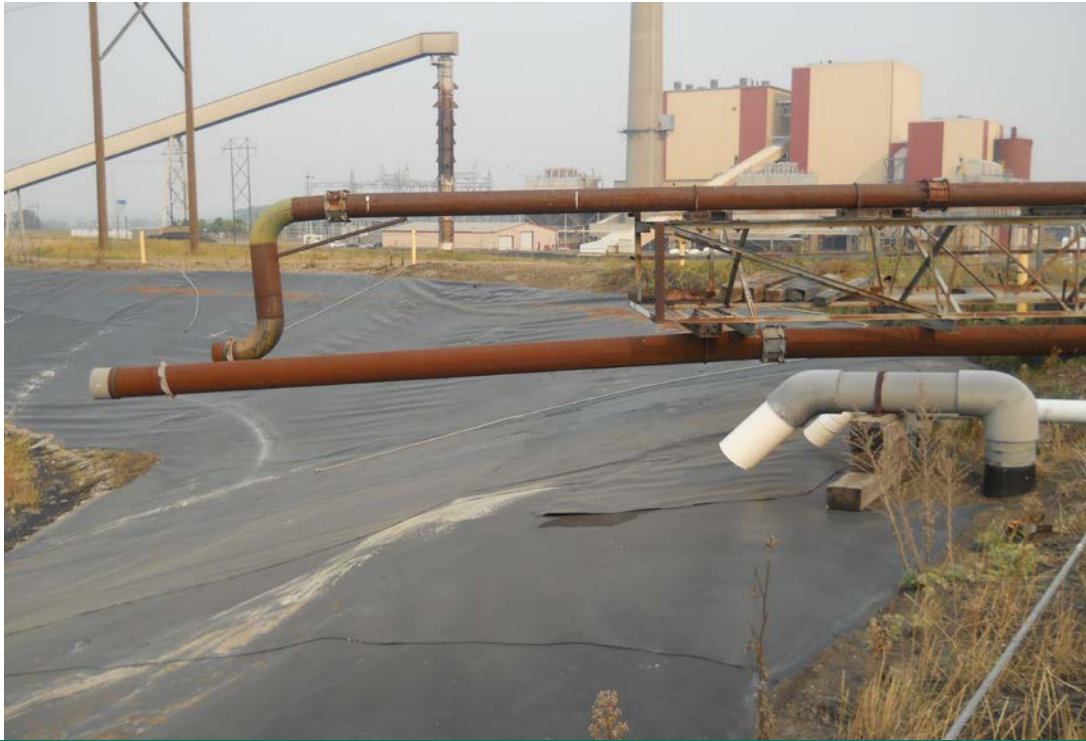
Photograph 7 (North cell berm upstream slope)
Bottom ash inlet piping and trestle entering north cell. (DSCN1540.JPG)

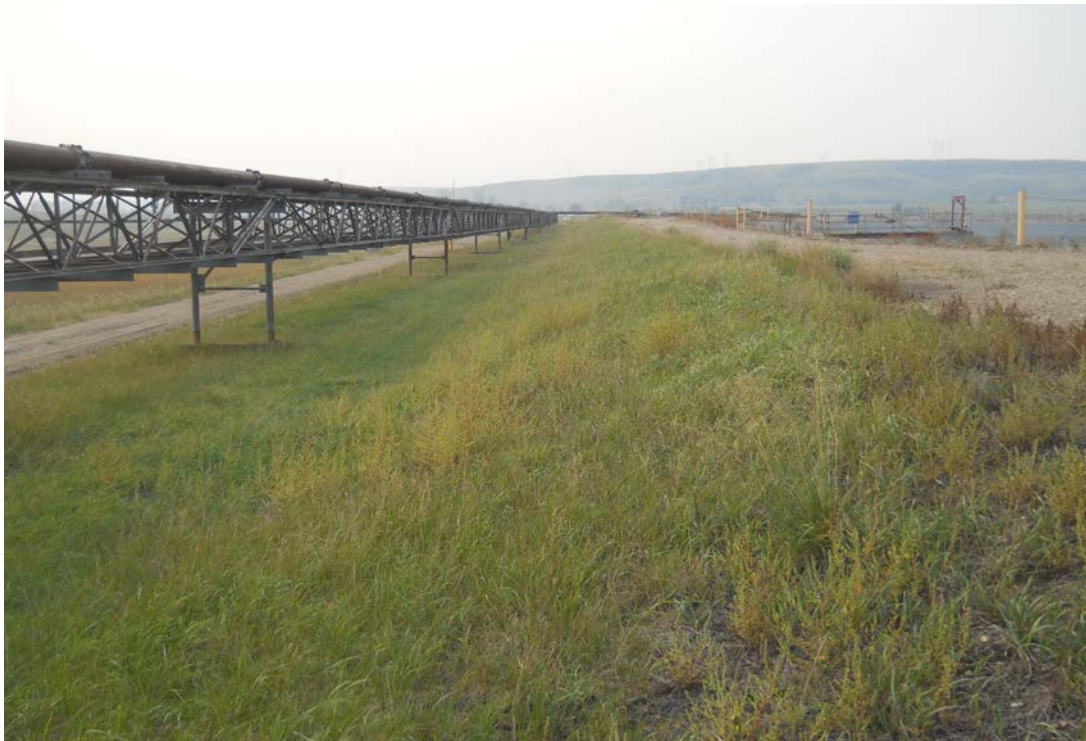
Photograph 8 (East berm downstream slope)
Grass vegetation on upper east berm downstream slope (DSCN1541.JPG)

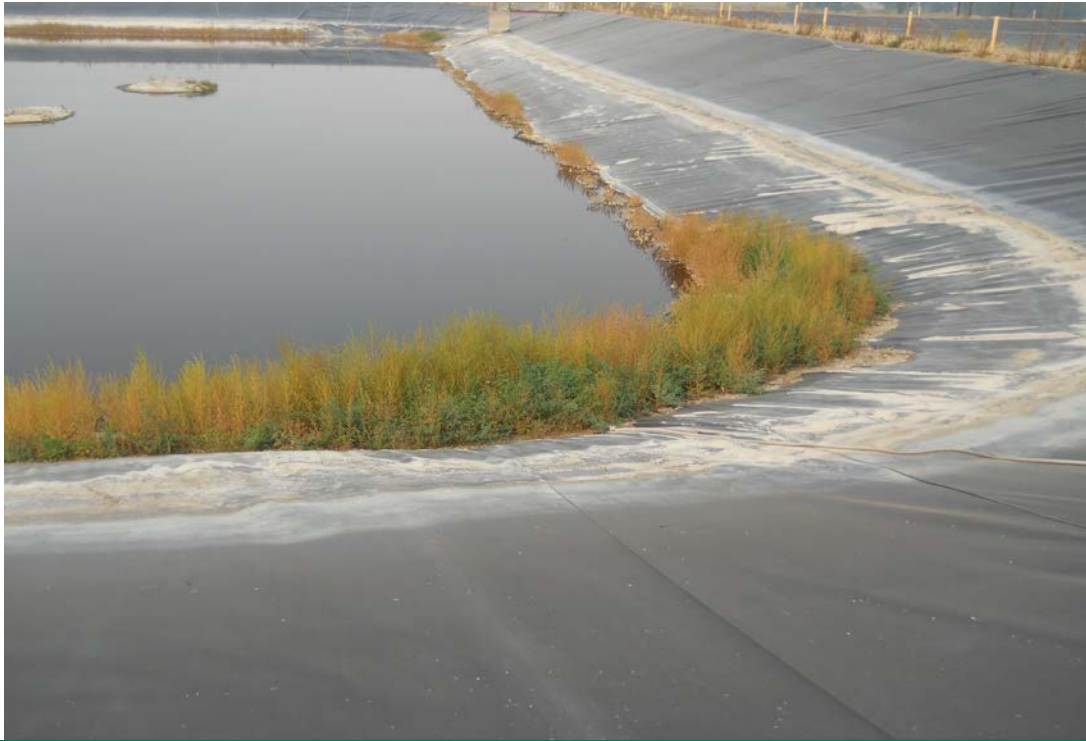
Photograph 9 (Center cell berm upstream slope)

Vegetation along the NE corner berm upstream slope of the center cell. (DSCN1543.JPG)

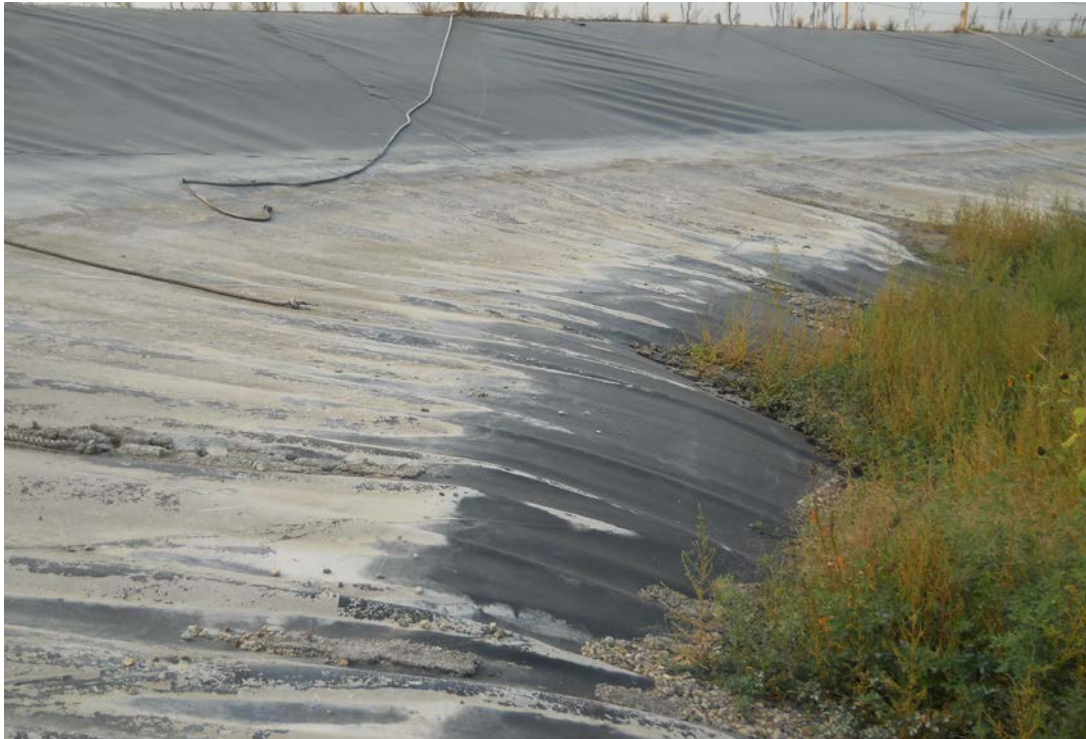
Photograph 10 (Center cell berm upstream slope)

Berm upstream slope of center cell. (DSCN1544.JPG)

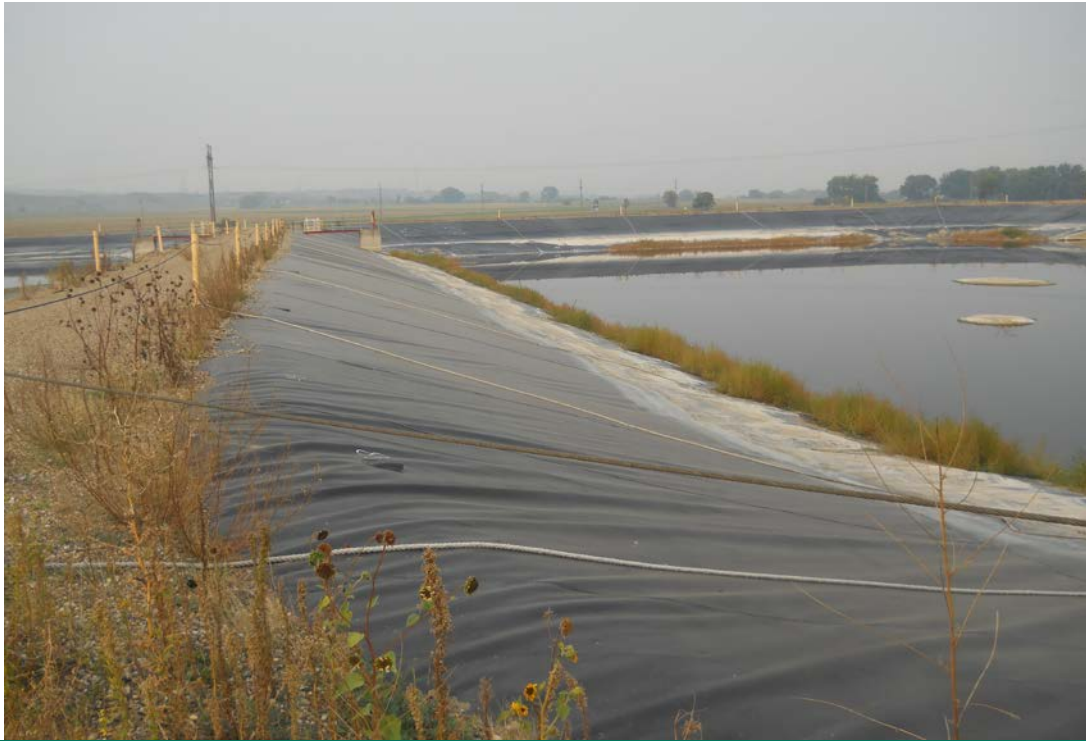
Photograph 11 (Center cell berm upstream slope)
Panoramic of center cell from SE corner (1 of 3). (DSCN1545.JPG)

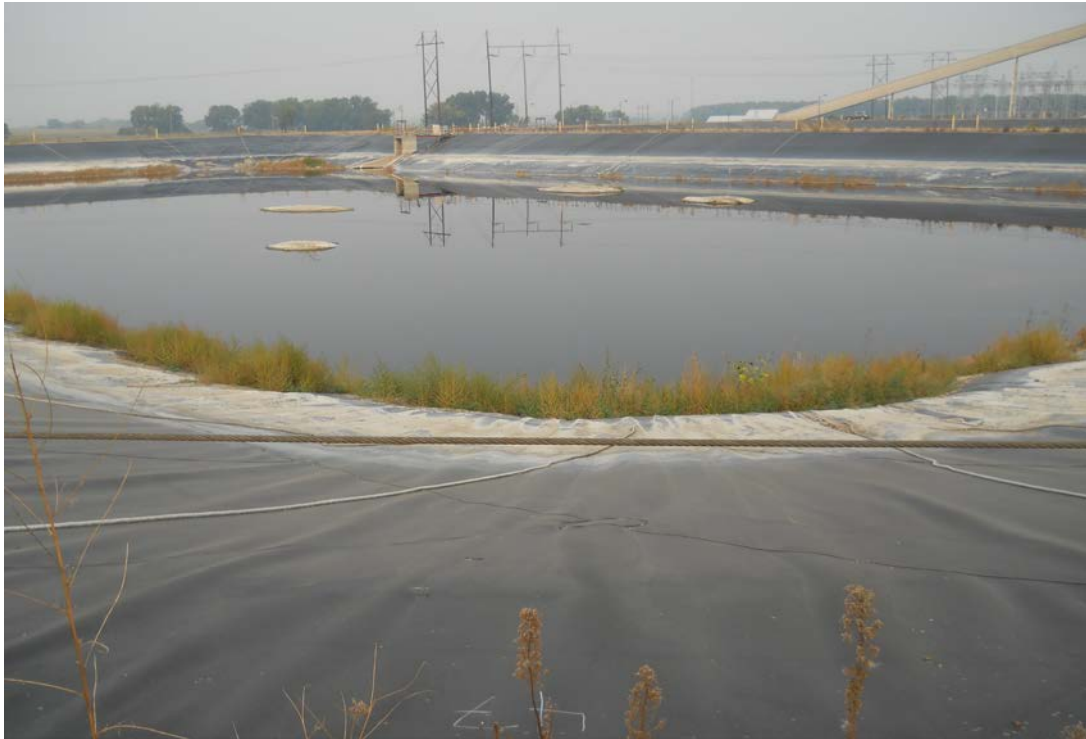
Photograph 12 (Center cell berm upstream slope)
Panoramic of center cell from SE corner (2 of 3). (DSCN1546.JPG)

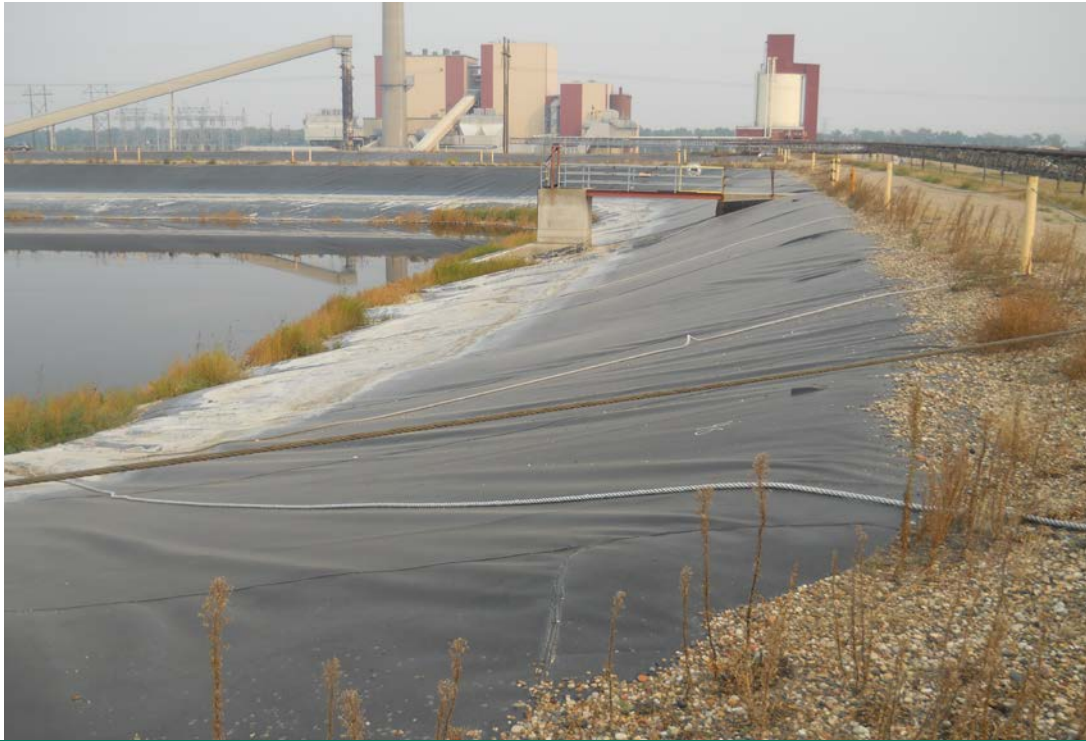
Photograph 13 (Center cell berm upstream slope)
Panoramic of center cell from SE corner (3 of 3). (DSCN1547.JPG)

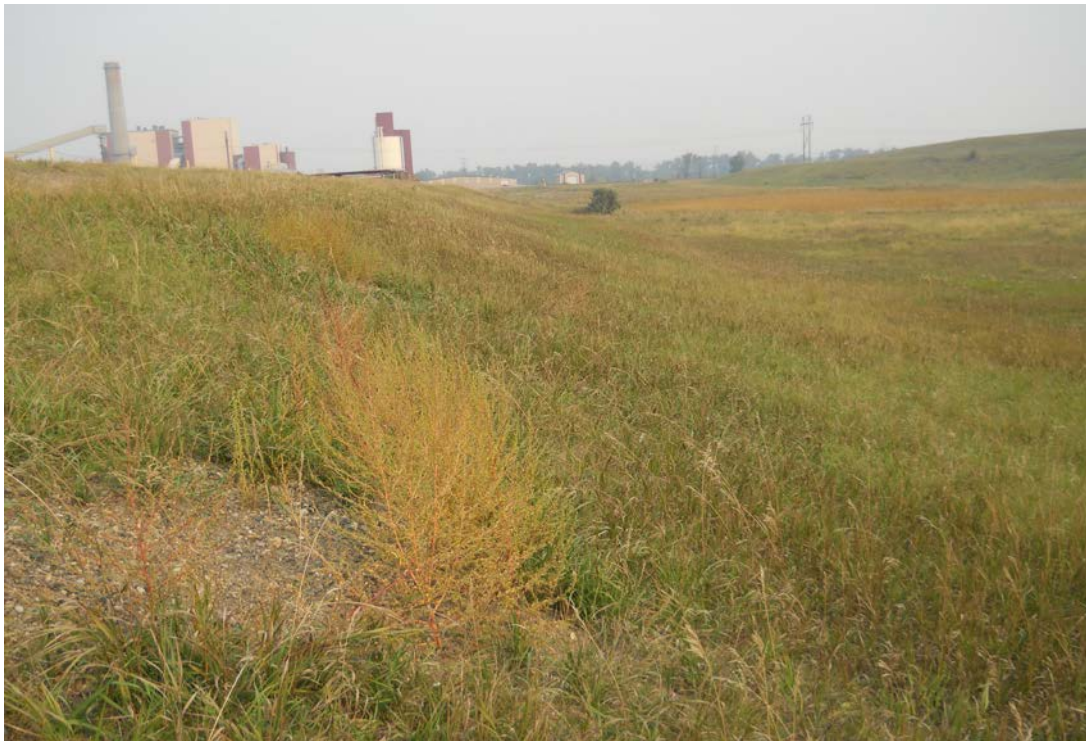
Photograph 14 (East berm downstream slope)
Grass vegetation on lower east berm downstream slope. (DSCN1554.JPG)

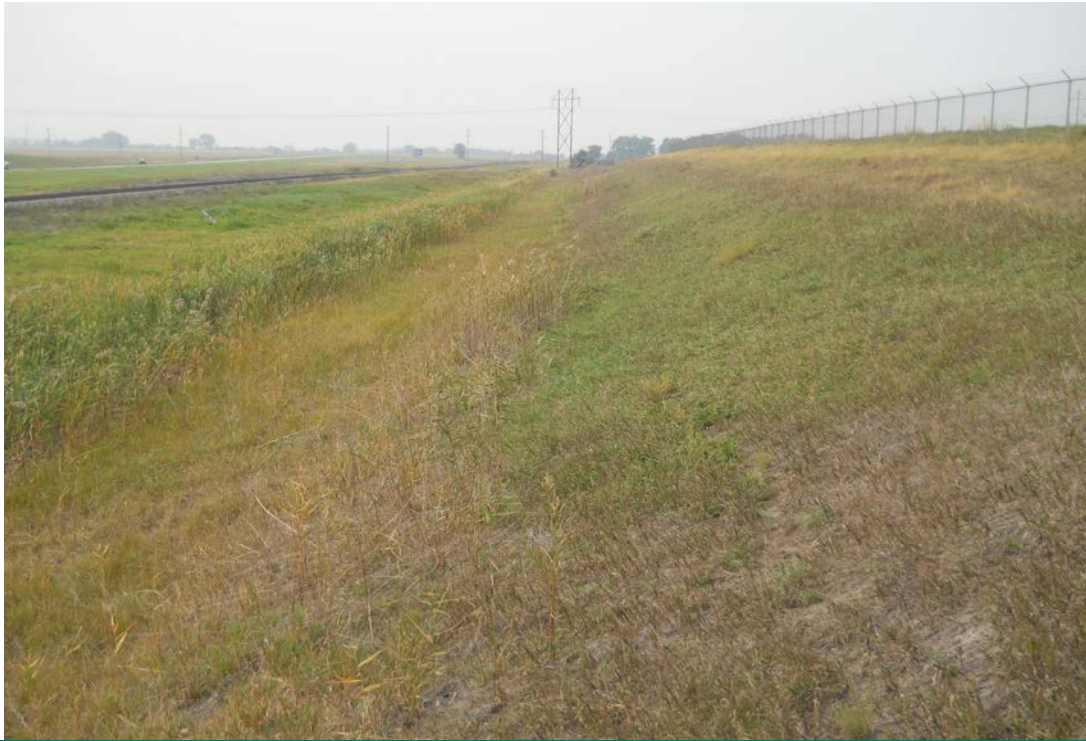
Photograph 15 (South berm downstream slope)
Vegetation on south berm downstream slope of the south cell. (DSCN1591.JPG)

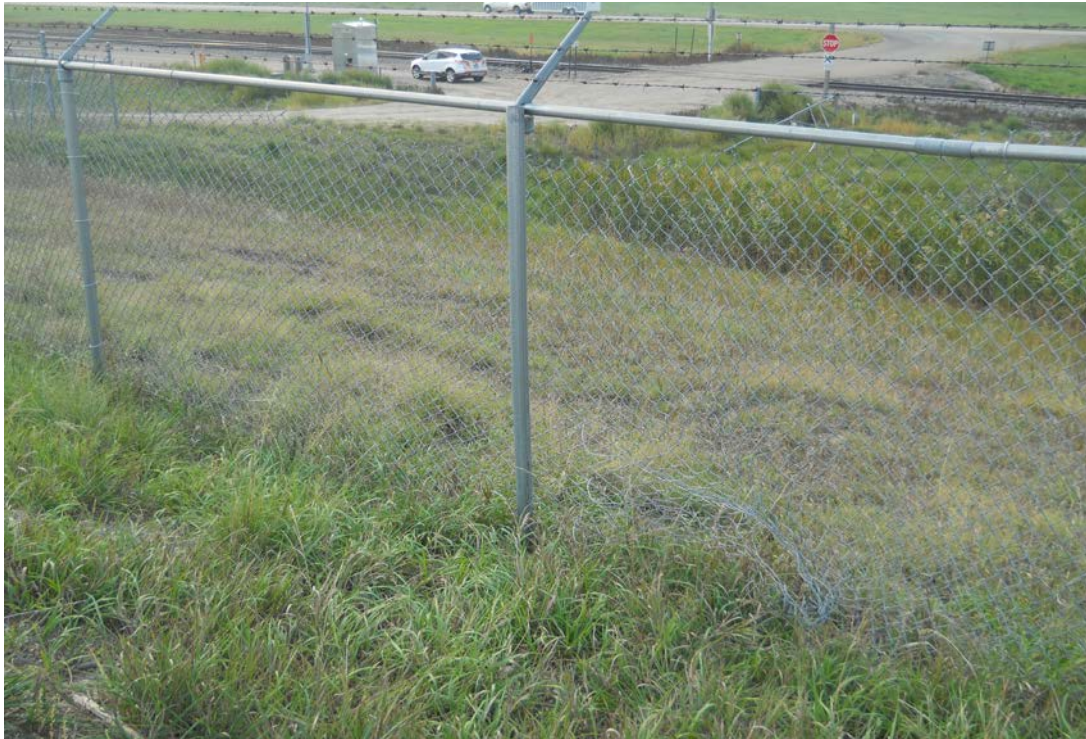
Photograph 16 (South berm downstream slope)
Fence damage on the south berm downstream slope of the south cell. (DSCN1553.JPG)

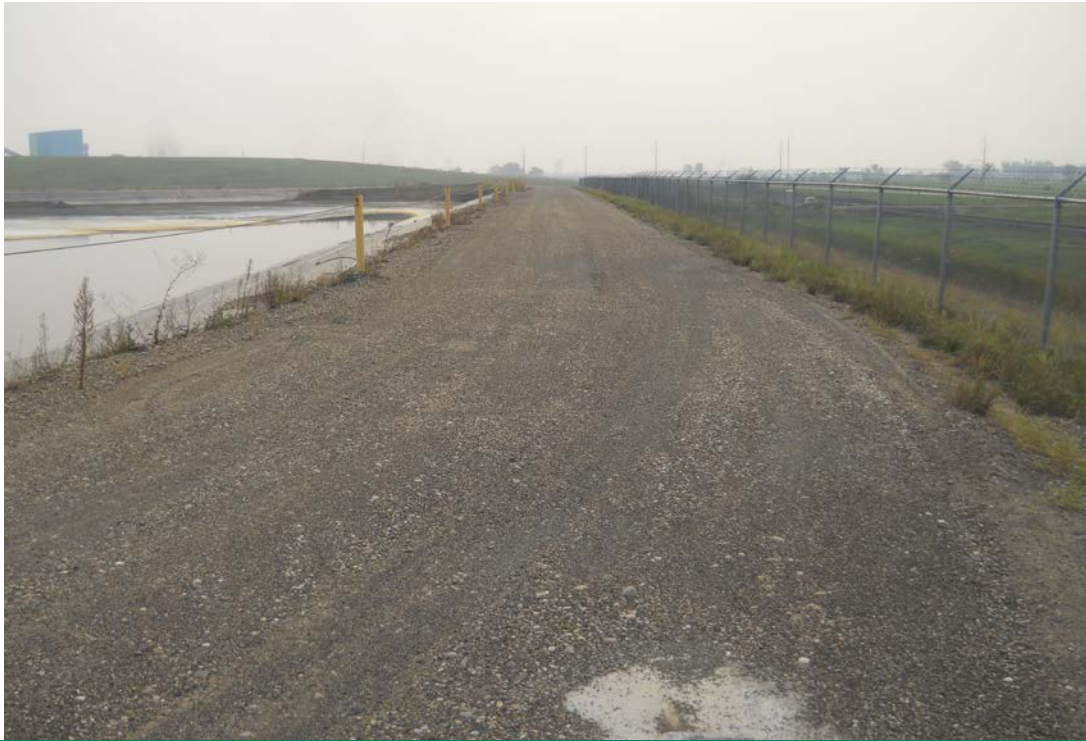
Photograph 17 (South berm crest)
South berm crest. (DSCN1557.JPG)

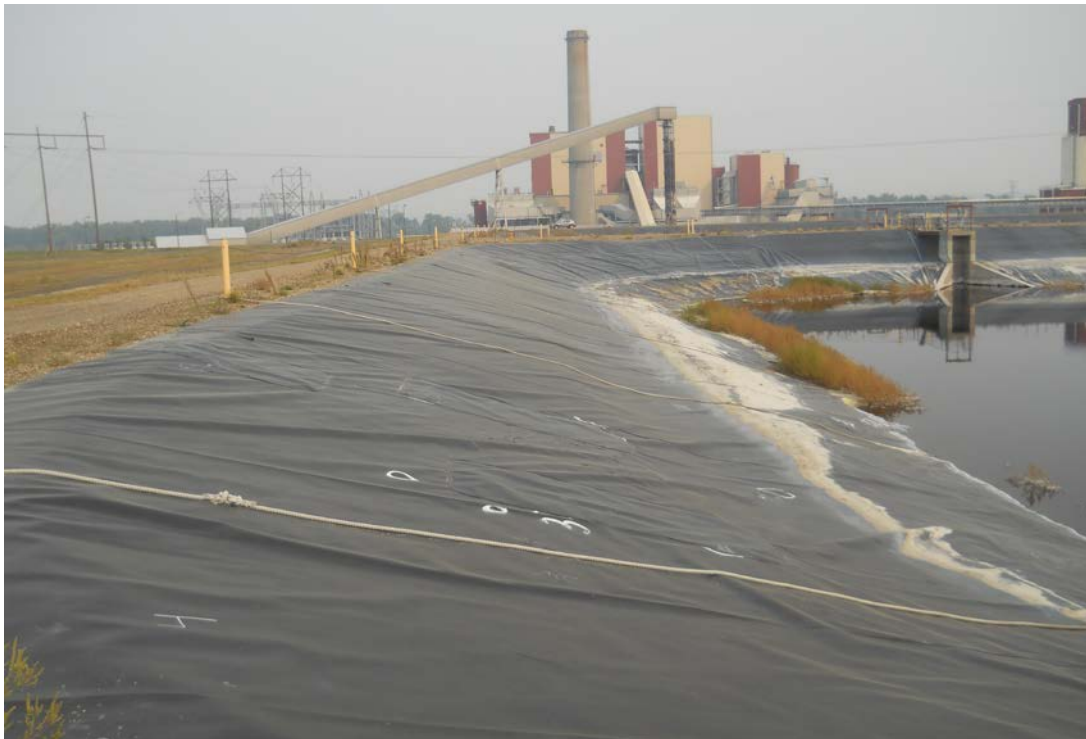
Photograph 18 (Center cell berm upstream slope)
Berm upstream slope on west side of center cell. (DSCN1563.JPG)

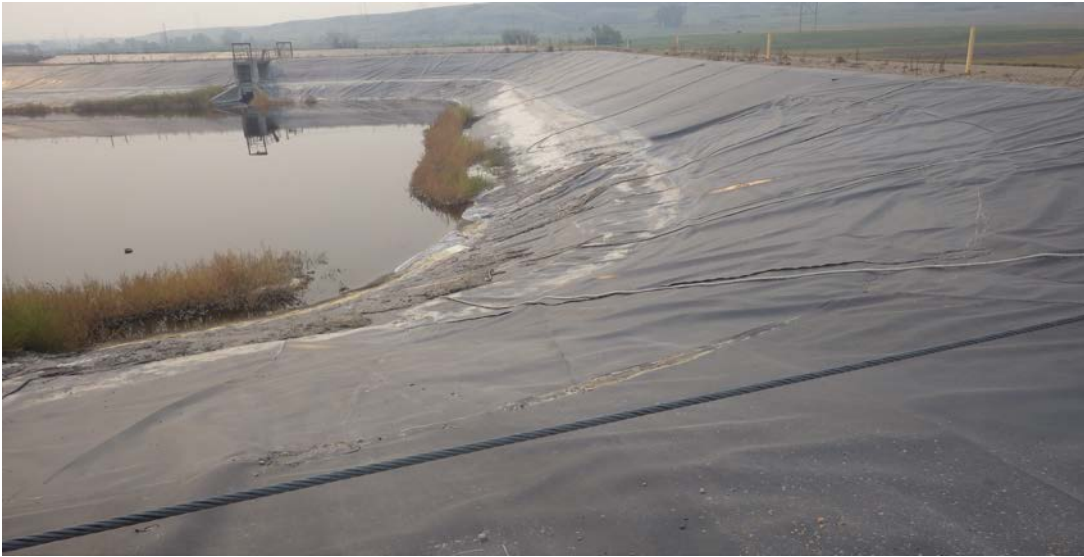
Photograph 19 (Center cell berm upstream slope)
West berm upstream slope of center cell. (IMGP5400.JPG)

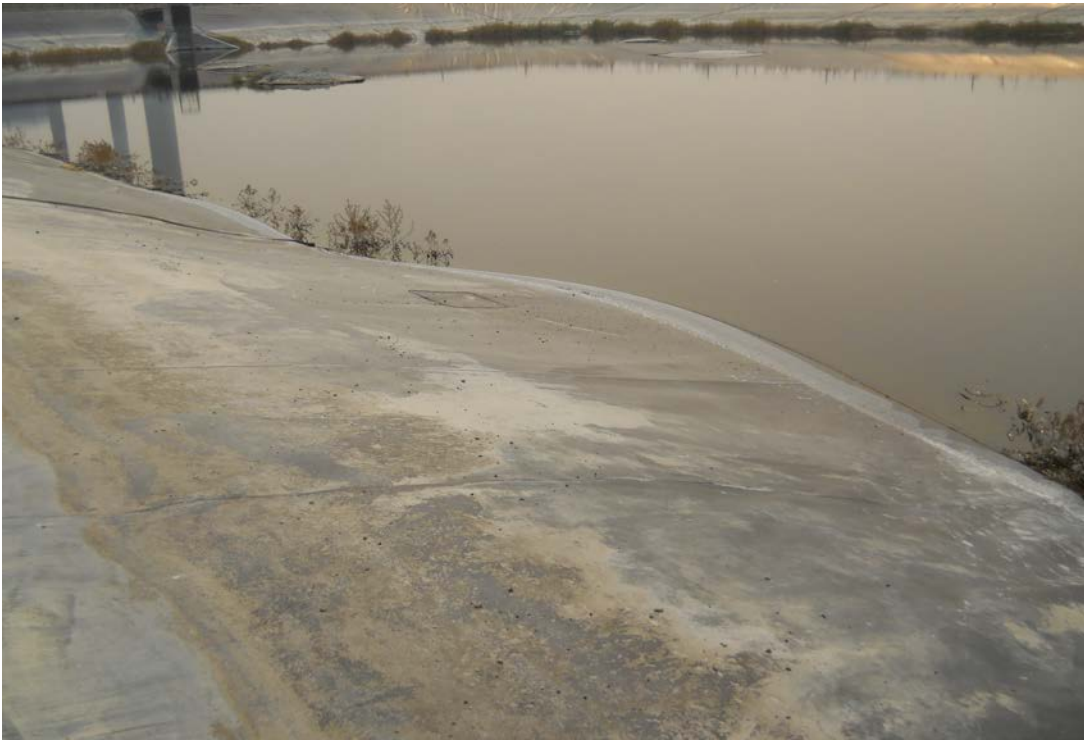
Water found between clay and geomembrane near toe of cells.

Photograph 20 (Center cell berm upstream slope)
Water trapped under geomembrane liner along north berm upstream toe of the center cell. (DSCN1568.JPG)
