ANNUAL INSPECTION REPORT

GREAT RIVER ENERGY – COAL CREEK STATION

Drains Pond System CCR Surface Impoundment

January 2018

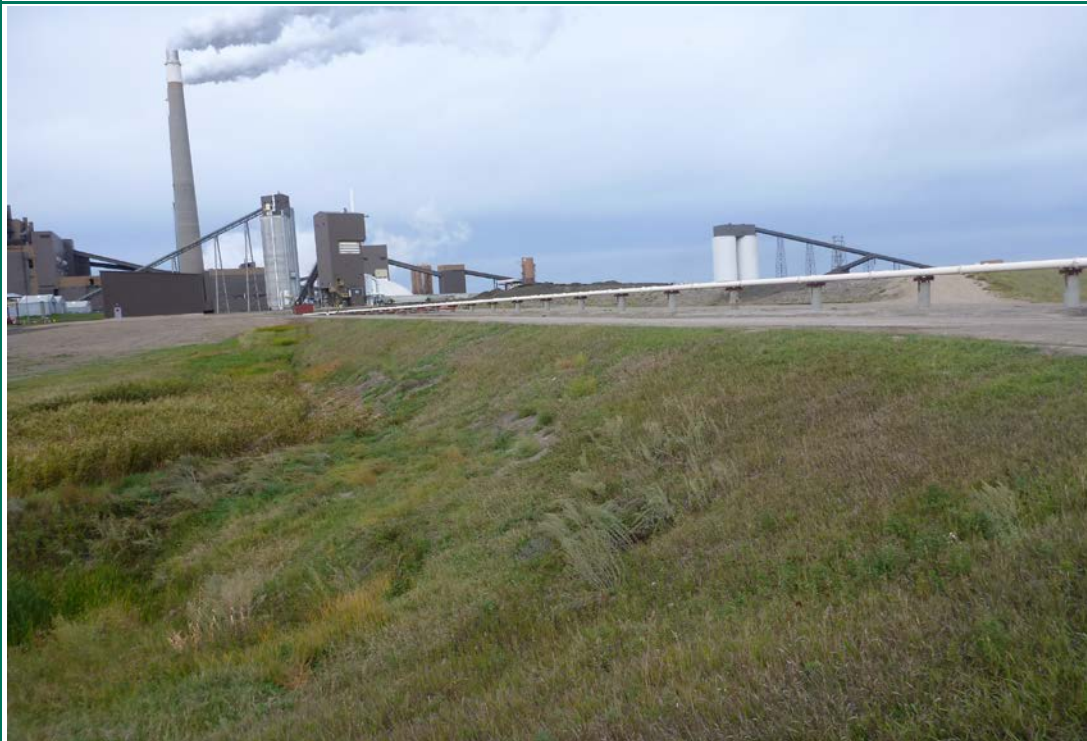
Photograph 1 (South toe)
South toe, no seeps or burrows noted (P1040189.JPG)

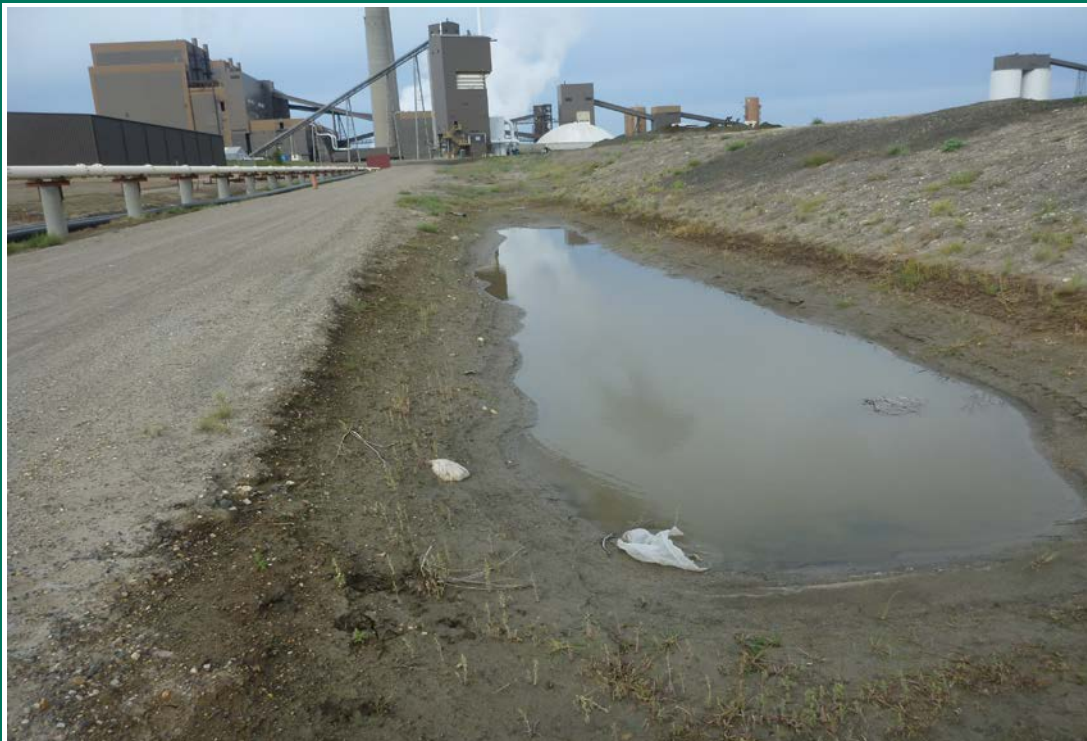
Photograph 2 (South berm downstream slope)
Water ponded at low point along the south berm downstream slope (P1040193.JPG)

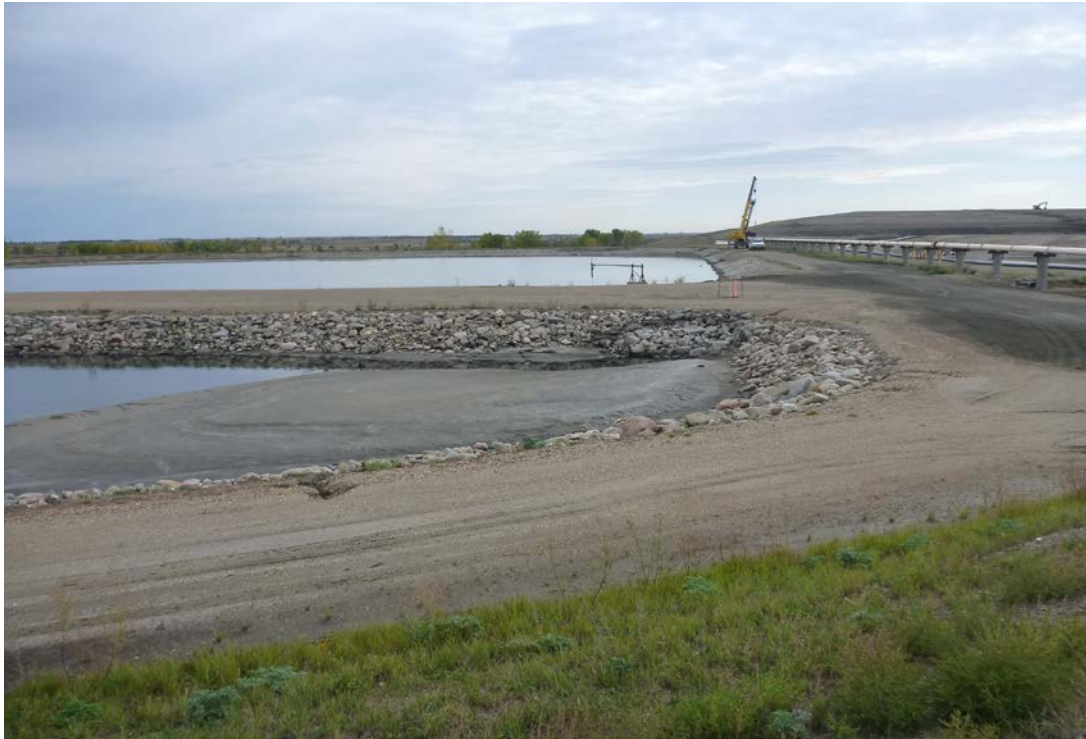
The center cell does not directly receive CCR materials. The plant drains contribute a small inflow of solids from the plant. At the time of inspection, approximately 6,000 cy of plant drains solids (sediment) were present (mostly in the southeast corner and northwest corner of the center cell). This sediment will be cleaned out as required to promote flow and allow for uninterrupted cell operations.

Photograph 3 (Center cell berm upstream slope)
Center cell riprap and sediment accumulation from plant drains (P1040195.JPG)

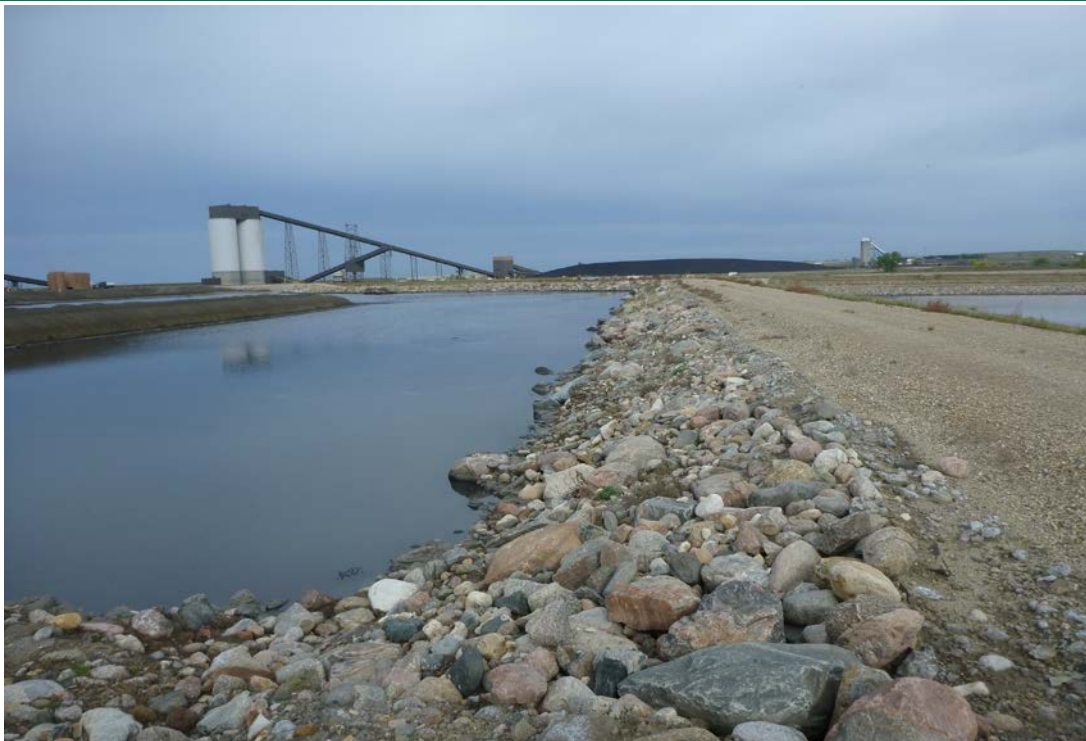
Photograph 4 (West cell berm upstream slope)
West cell berm upstream slope (P1040196.JPG)

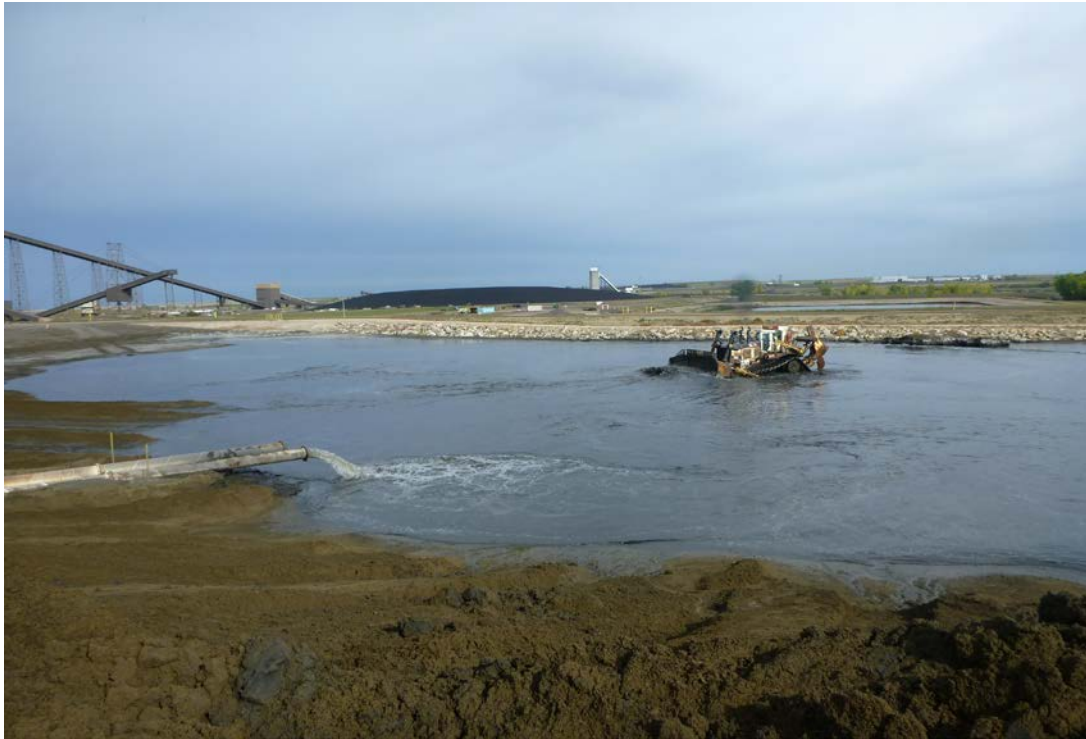
**Photograph 5 (West cell berm upstream slope)
Operations within west cell (P1040205.JPG)**

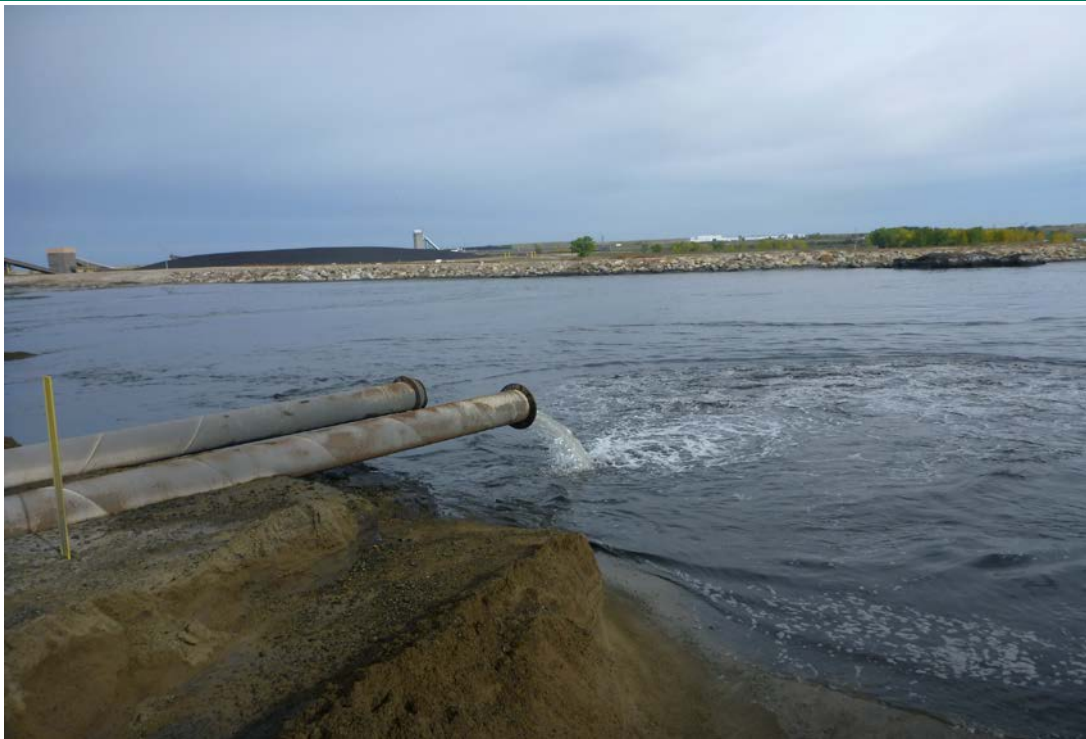
**Photograph 6 (West cell berm upstream slope)
CCR discharge pipes (P1040209.JPG)**

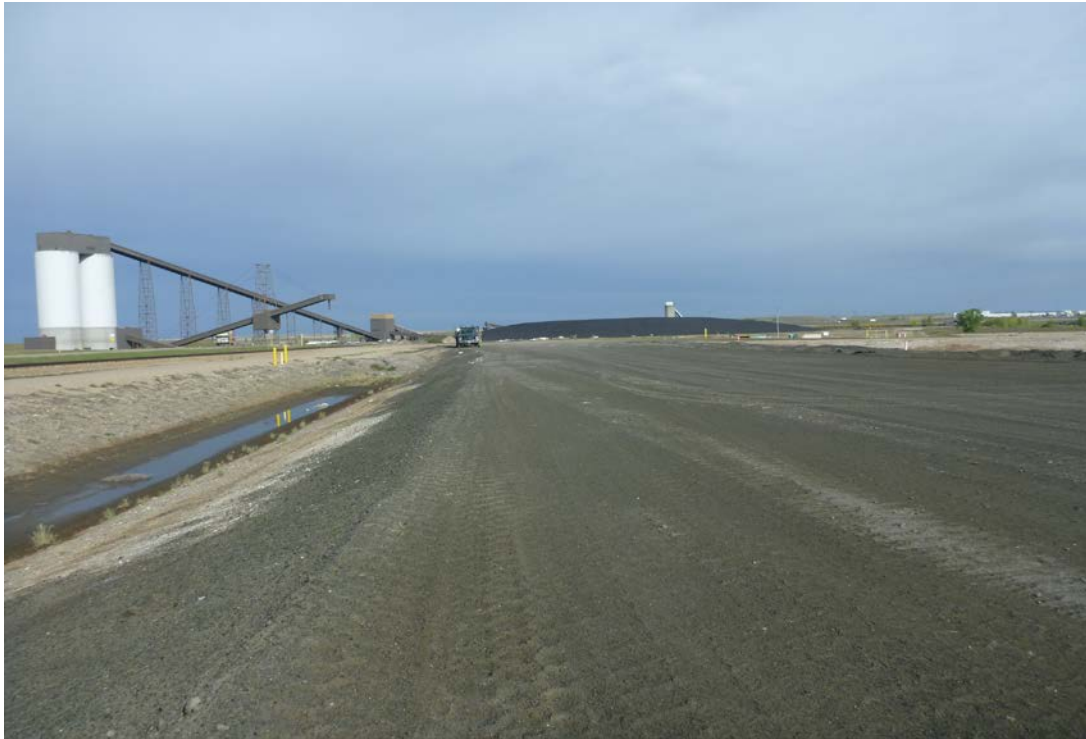
**Photograph 7 (West berm crest)
West berm crest haul road (P1040214.JPG)**

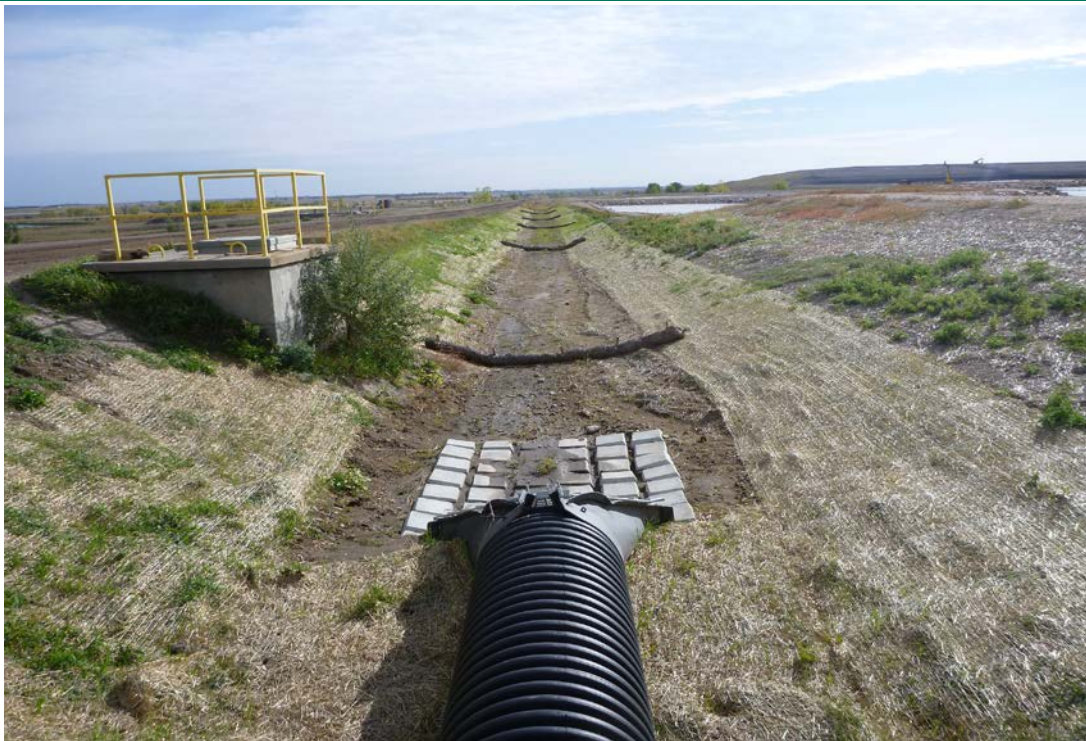
**Photograph 8 (North surface water channel)
Culvert and channel, limited vegetation due to recent reseeding (P1040218.JPG)**

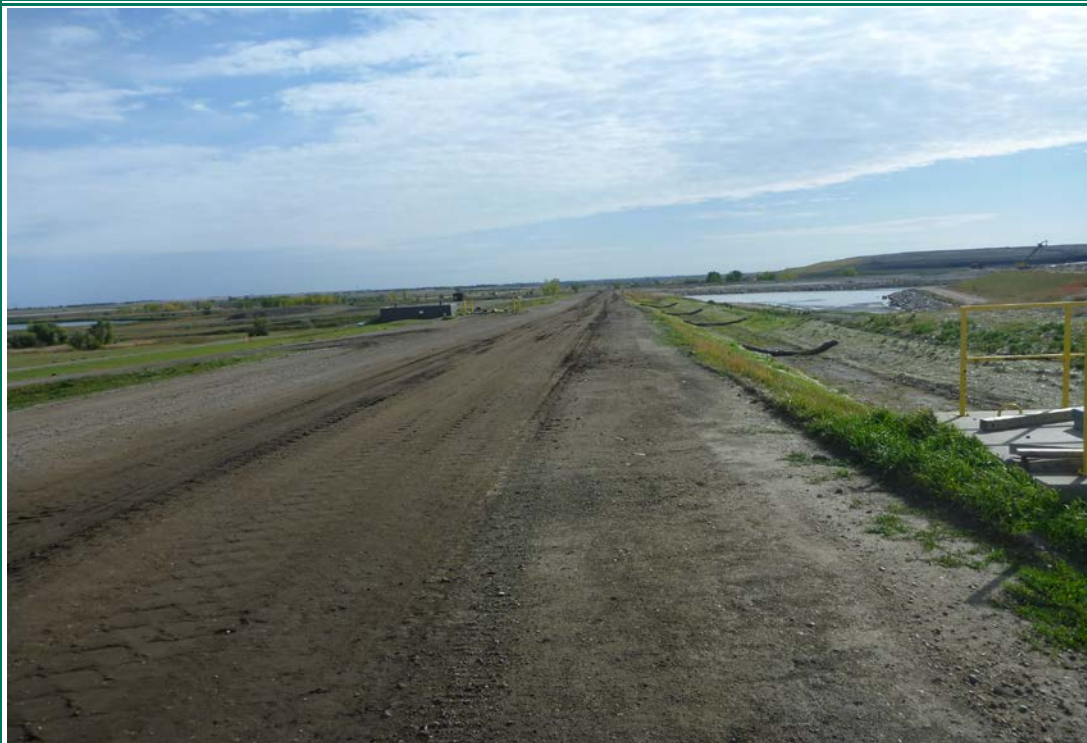
The crest of the perimeter berm on the north side is a gravel surfaced roadway supporting both light passenger vehicles and heavy construction equipment, such as Caterpillar 777 haul trucks. The berm crest on the south and west sides is an engineered haul road constructed with beneficially re-used CCRs (fly ash and bottom ash) supporting both light passenger vehicles and heavy construction equipment, such as Caterpillar 777 haul trucks. The berm crest on the east side experiences little heavy traffic and is mostly exposed to light vehicle traffic (cars, pickups, etc.). The roads surrounding the Drains Pond System appear to be in good condition, with no noticeable cracking or settlement, and appear to be well maintained. When wet, gravel road surfaces can become rutted and slippery. Ruts that develop on the road surface should be repaired as soon as possible to maintain access.

Photograph 9 (North berm crest)
North perimeter berm crest haul road. (P1040219.JPG)

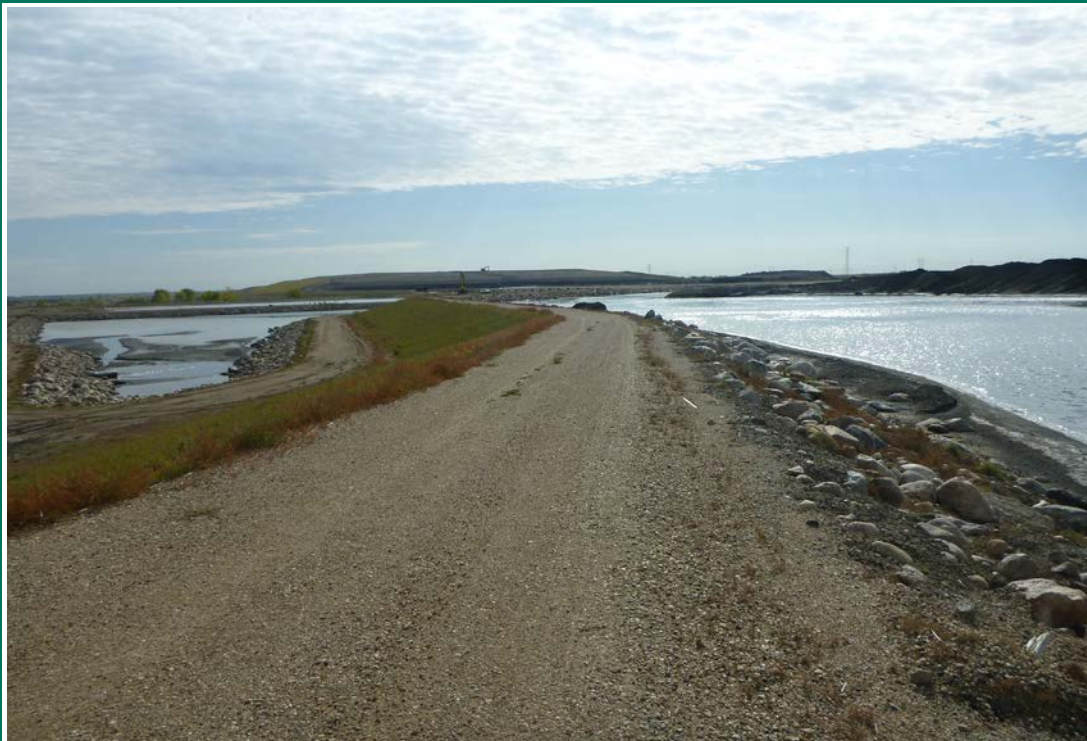
Photograph 10 (West cell berm crest)
Center cell and west cell intercell-berm crest and gravel road (P1040222.JPG)

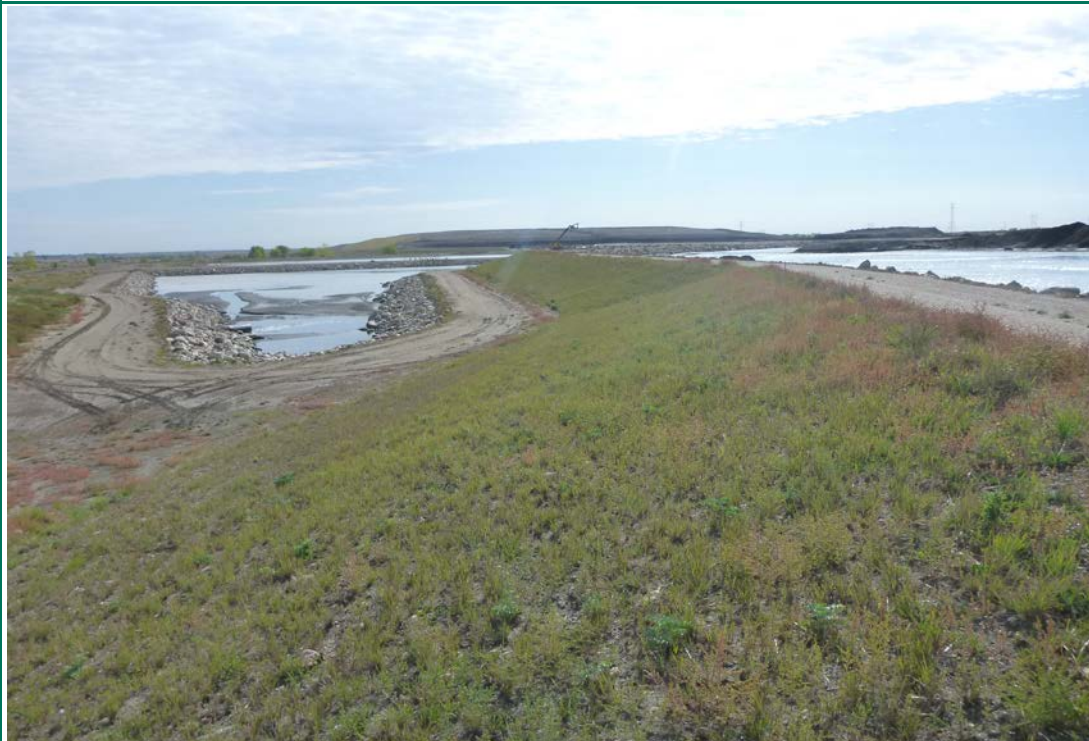
Photograph 11 (West cell/center cell intercell berm)
West cell/center cell intercell berm (minor erosion) (P1040223.JPG)

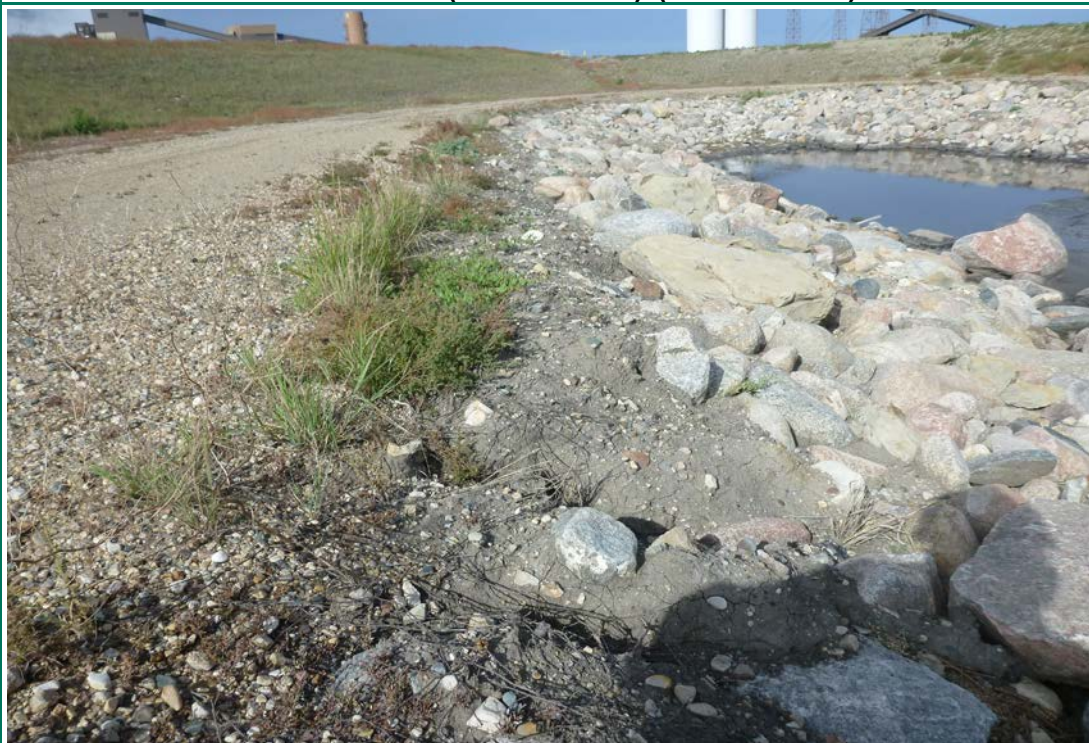
Photograph 12 (Center cell berm upstream slope)
Center cell gravel road, some minor erosion into the riprap (P1040229.JPG)

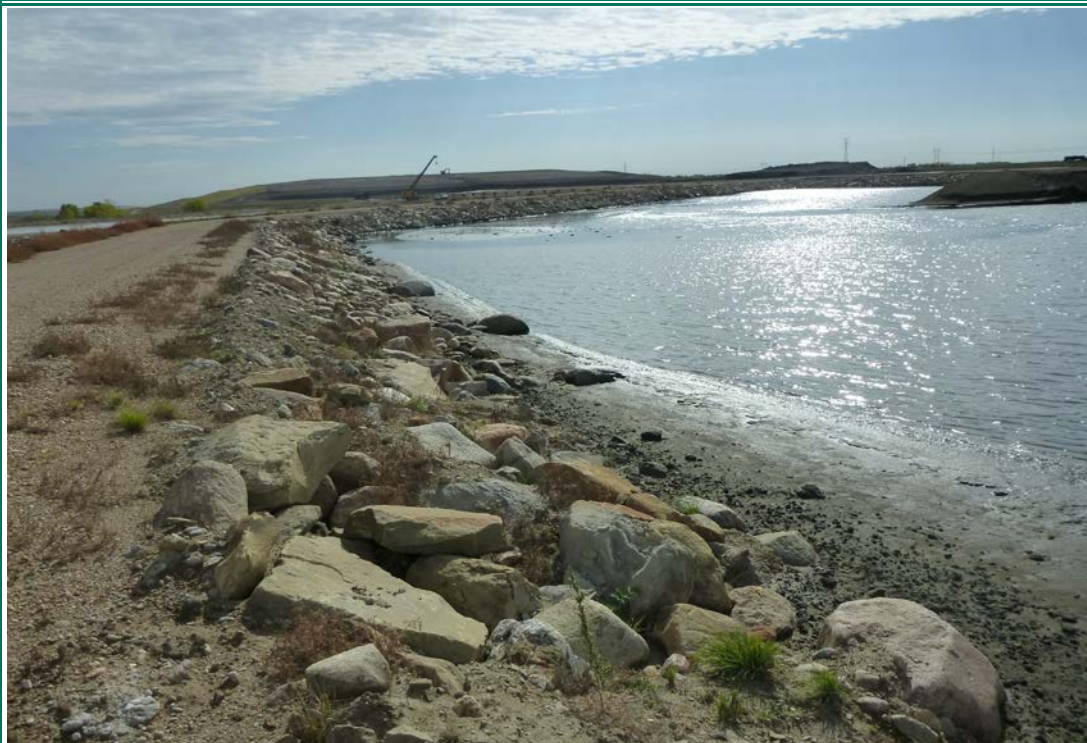
Photograph 13 (West cell berm upstream slope)
Berm upstream slope with riprap (P1040230.JPG)

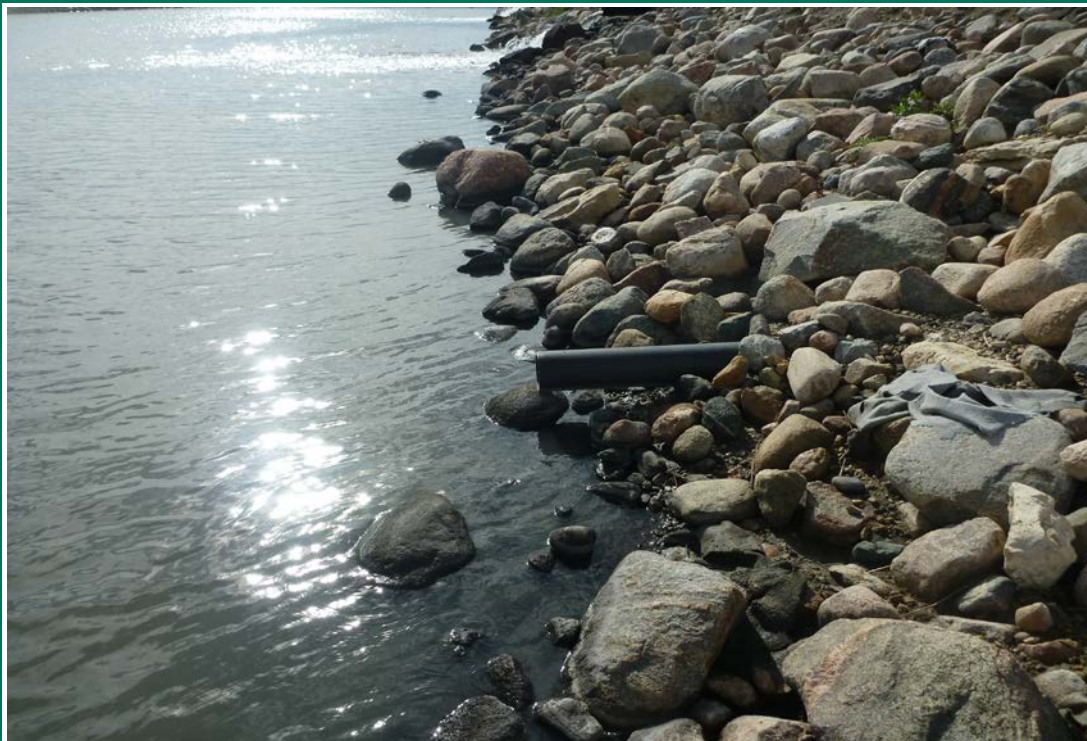
Photograph 14 (Center cell berm upstream slope)
Passive drainage sump outlet pipe approximately 6 inches above water level (P1040231.JPG)

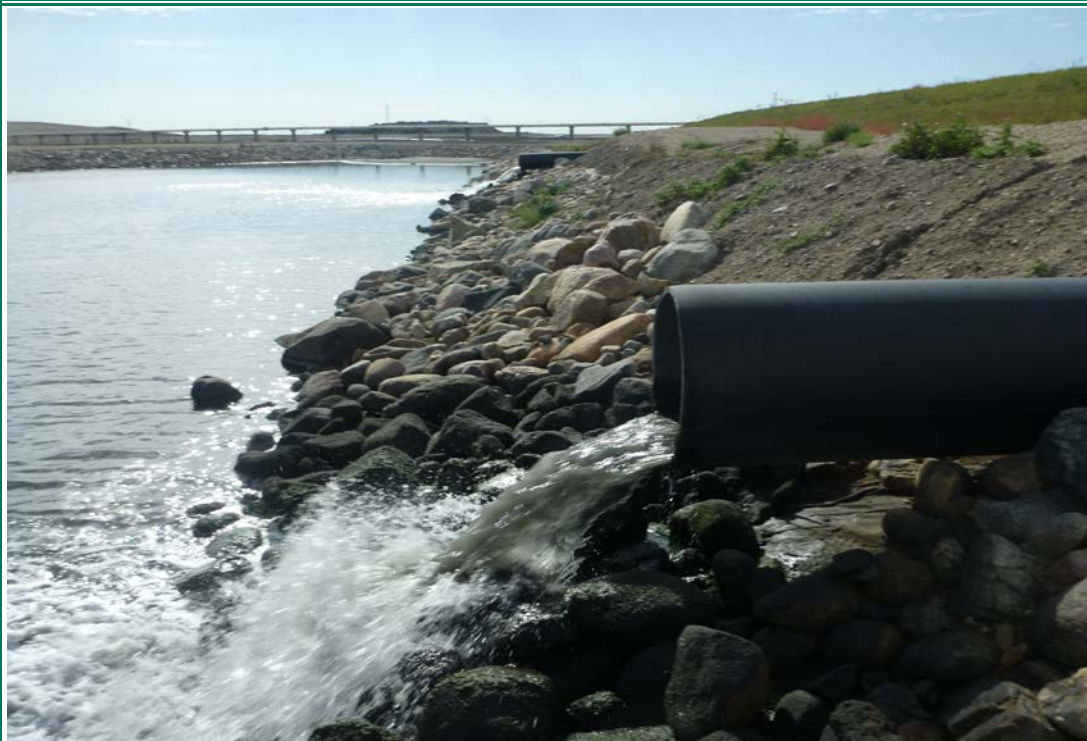
**Photograph 15 (Center cell berm upstream slope)
North decant outlet between the west cell and center cell (P1040232.JPG)**

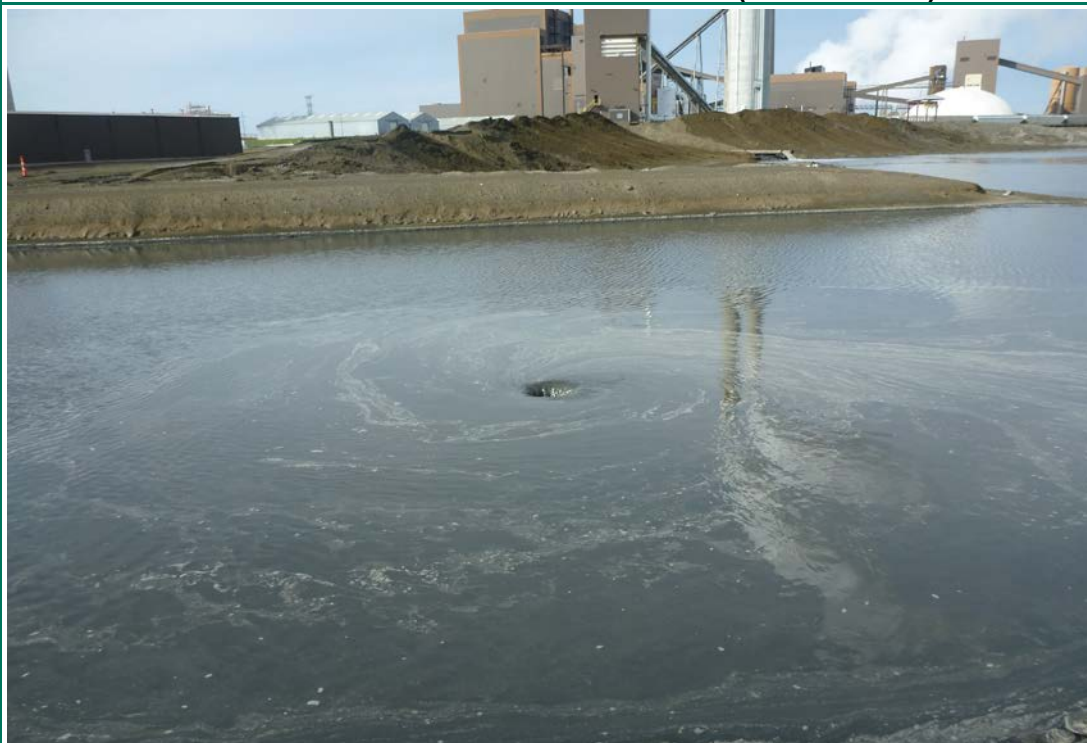
**Photograph 16 (West cell)
Decant pipe inlet from west cell to center cell (P1040233.JPG)**

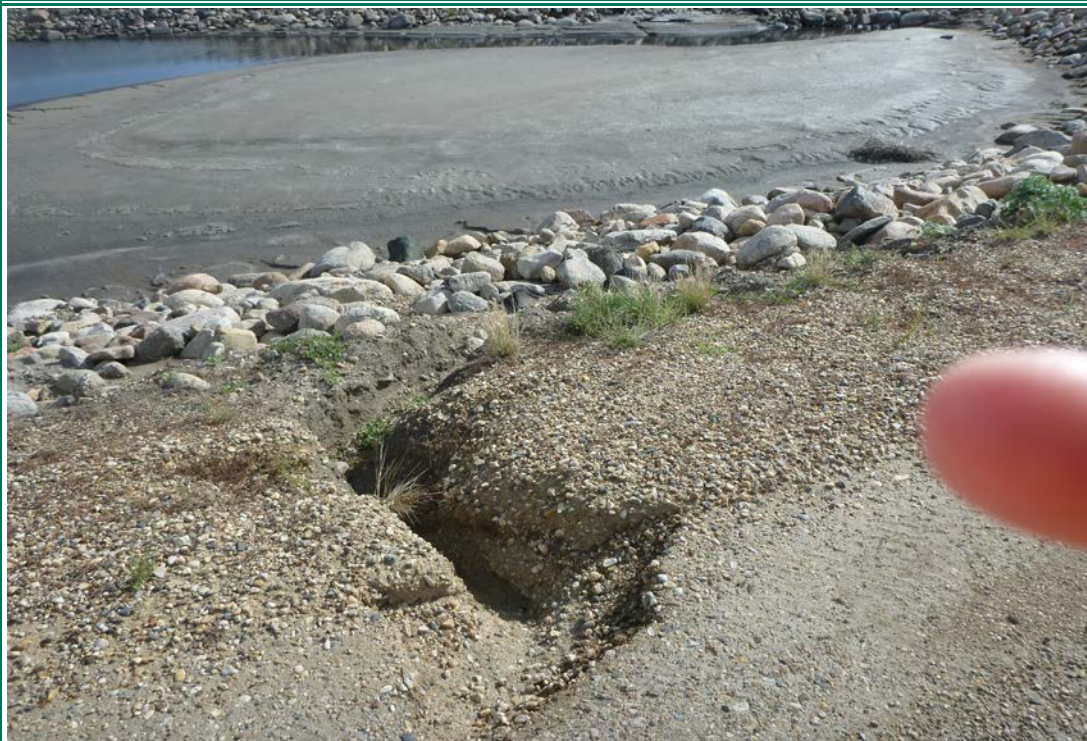
Photograph 17 (Center cell berm upstream slope)
Erosion of intercell gravel road between west cell and center cell (P1040235.JPG)

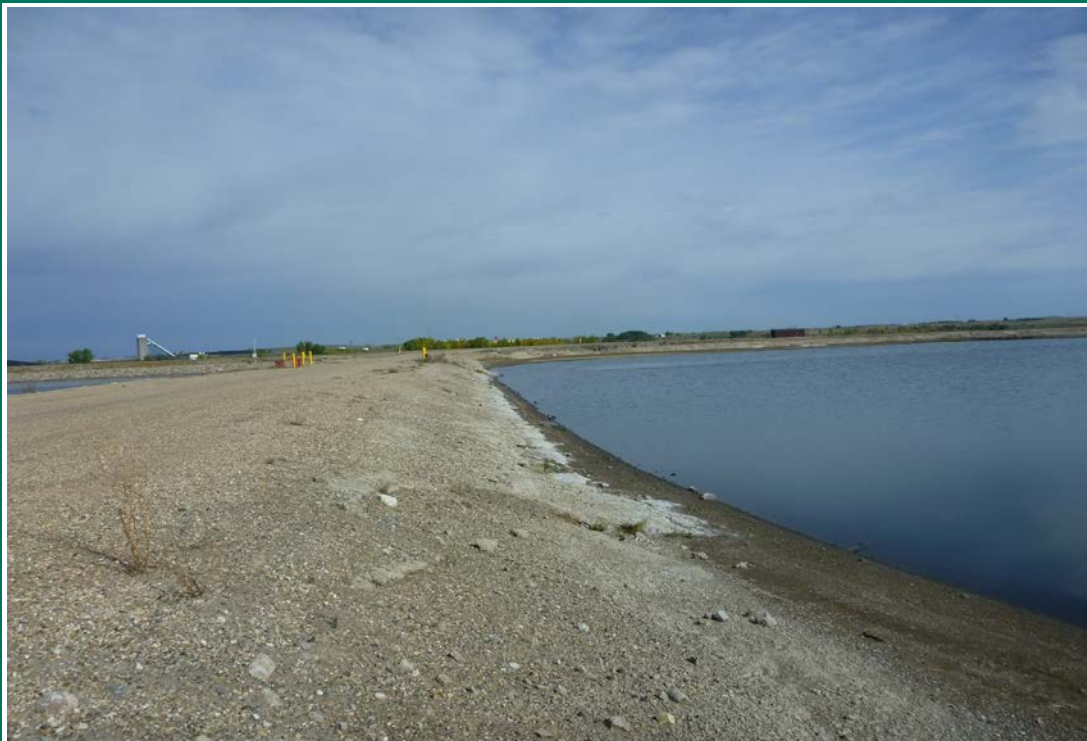
Photograph 18 (East cell berm upstream slope)
East cell berm upstream slope fly ash protective cover (P1040238.JPG)

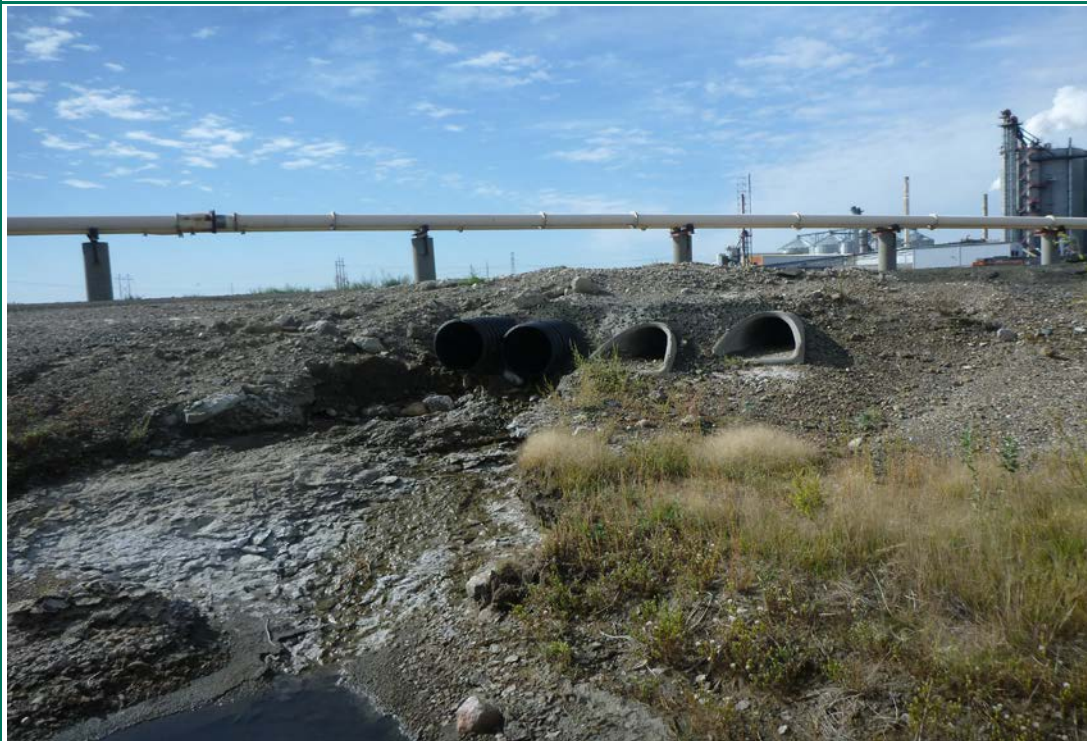
**Photograph 19 (East cell berm upstream slope)
Culvert outlet from ash pipelines ditch to the east cell (P1040239.JPG)**

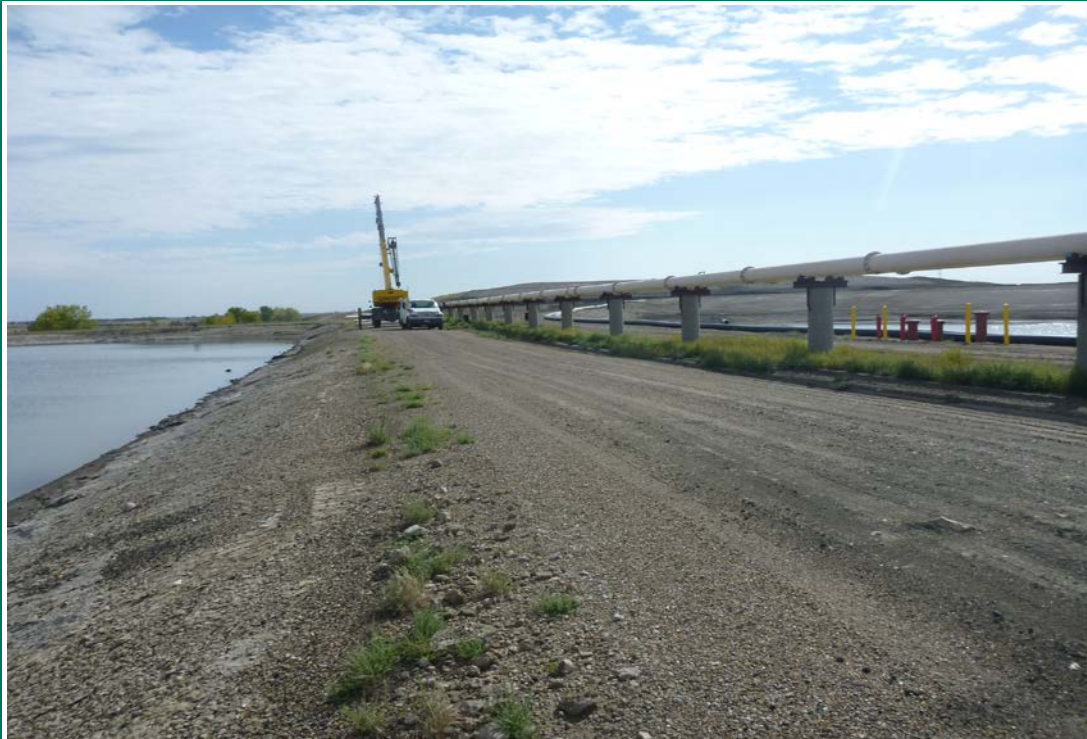
**Photograph 20 (East cell berm crest)
South perimeter berm crest gravel road (P1040242.JPG)**

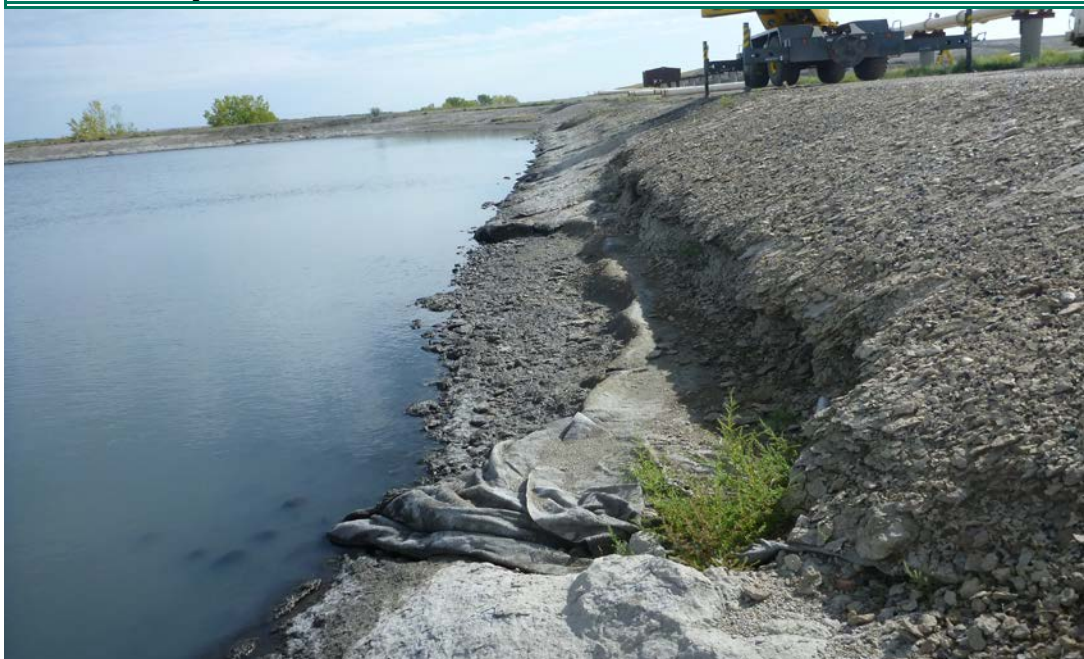
East cell slopes are being protected from erosion with a cemented fly ash layer from the floor up to the embankment crest. This cemented fly ash layer overlies a geotextile and a 1-foot protective sand layer and appeared to be competent. The water level is typically managed between elevation 1916 feet amsl and 1918 feet amsl (4 to 6 feet freeboard). At the time of observations, the water level was approximately at elevation 1916 feet amsl. The berm upstream slopes of the east cell appear to be in good condition; however, the south side had an area of erosion where geotextile was exposed.

Photograph 21 (East cell berm upstream slope)
Oversteepened fly ash protective cover on the south upstream slope of the east cell and exposed geotextile (P1040243.JPG)

Minor maintenance items that may need to be continually addressed include repairing ruts that develop within the crest roads, repairing eroded areas of the berm upstream slope fly ash and riprap protection layers, monitoring berm downstream slopes for large animal burrows or erosion that may affect operations and reseeding as required, and removing sediment that accumulates within the facilities that negatively impacts operations. In addition, the inflow and outflow piping should be monitored regularly to ensure proper conveyance of water to and from the facility.

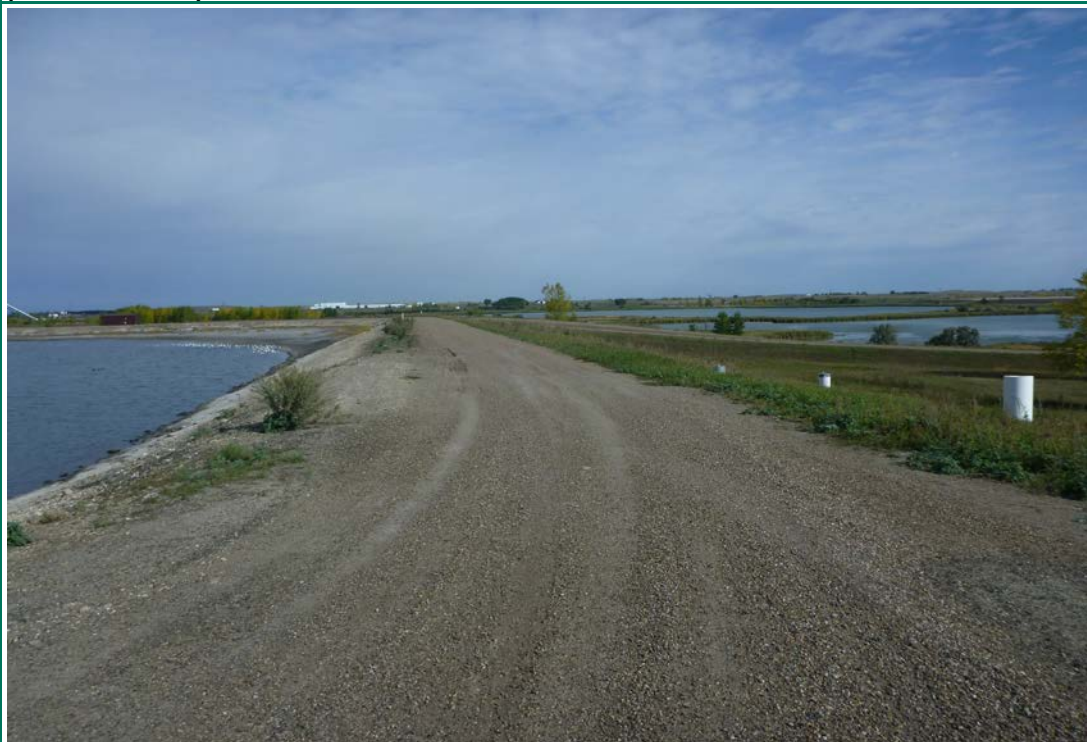
Photograph 22 (East cell berm crest)
East perimeter berm crest gravel road, minor vegetation growing on berm upstream slope (P1040245.JPG)

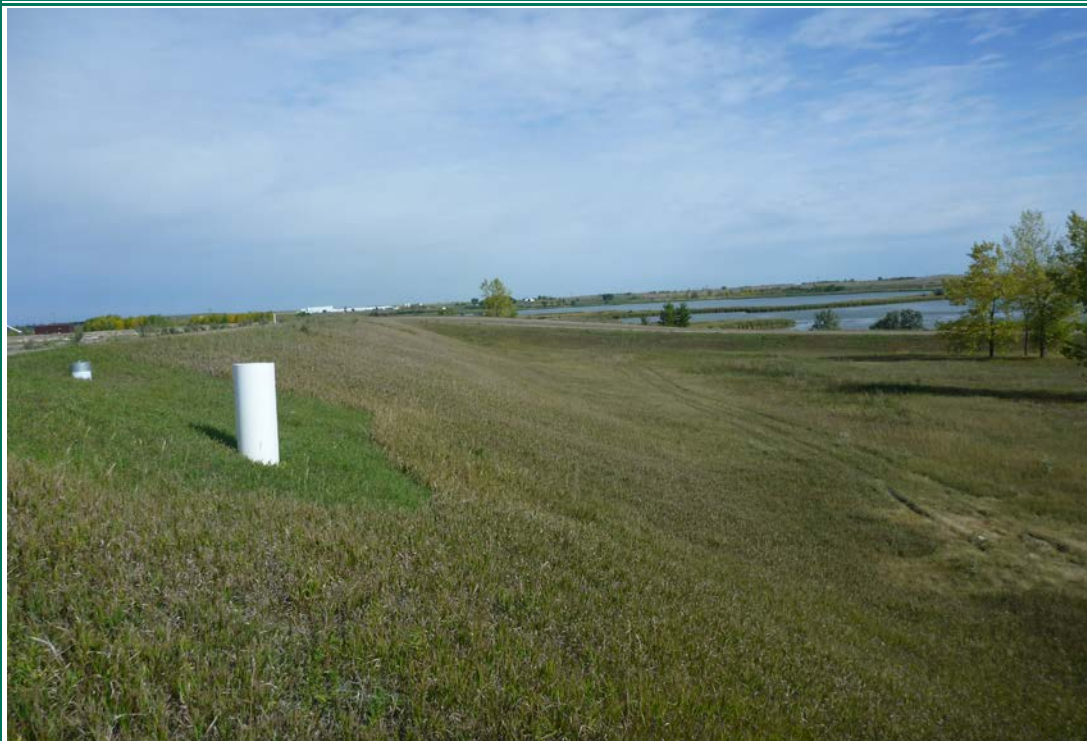
Photograph 23 (East cell berm downstream slope)

East cell berm downstream slope well-vegetated, no woody vegetation (P1040246.JPG)

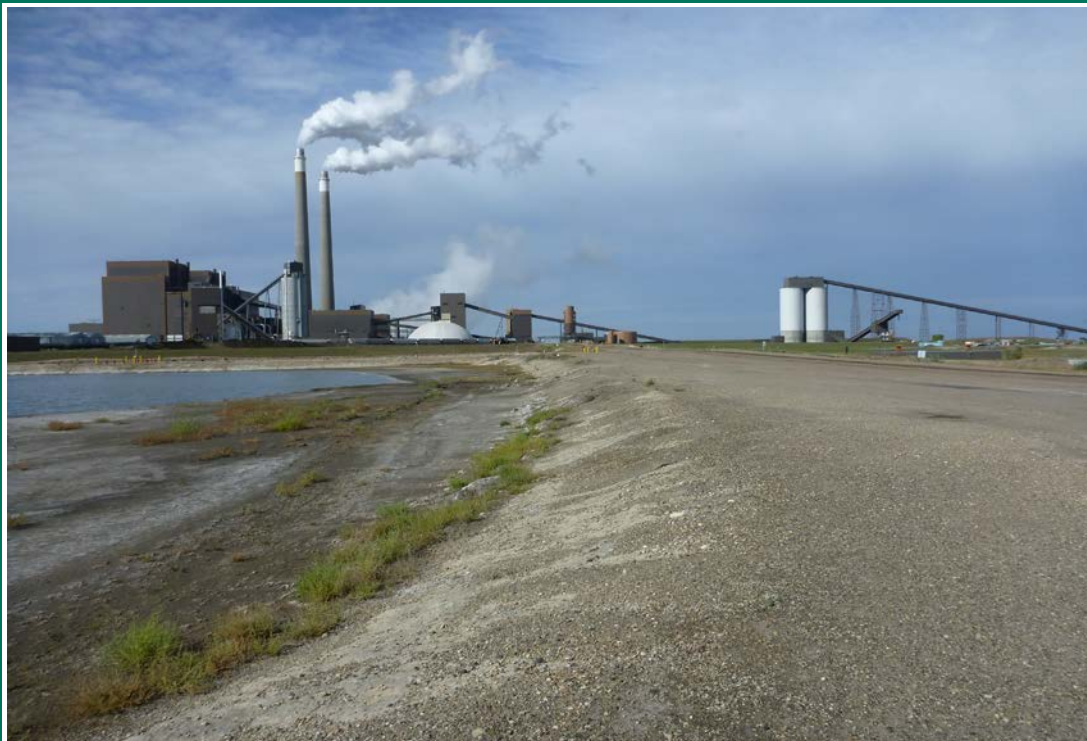
Photograph 24 (East cell berm upstream slope)

Berm upstream fly ash slope on north side of east cell (P1040250.JPG)

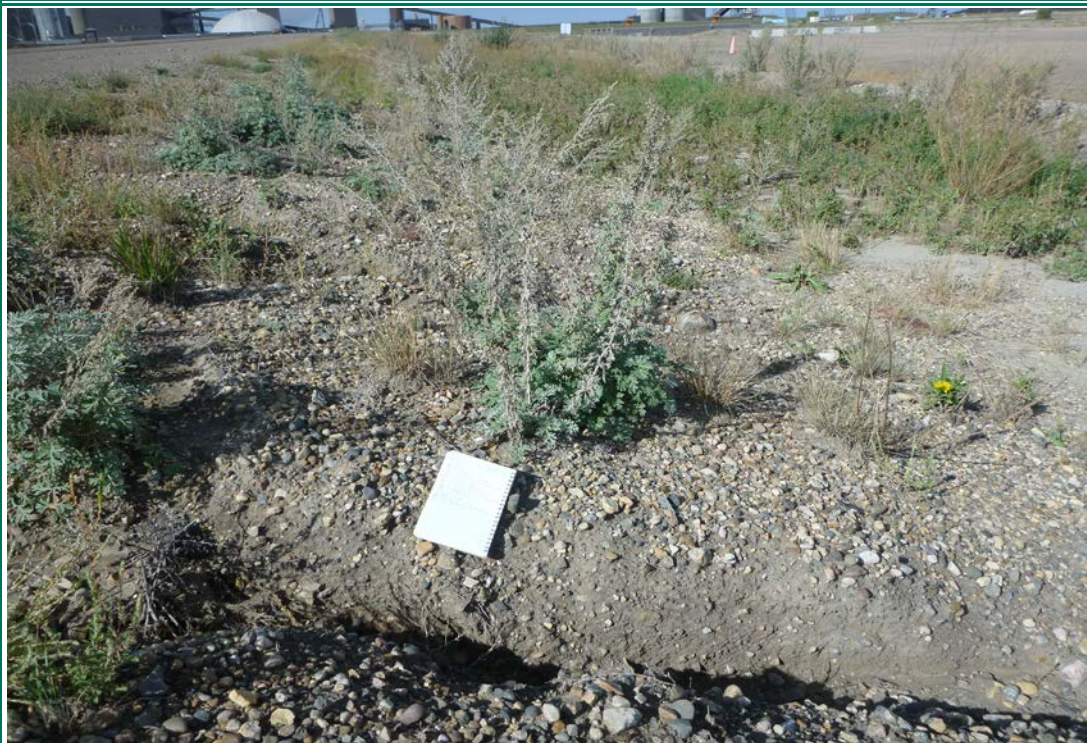
Photograph 25 (North berm downstream slope)
East cell north berm downstream slope erosion rills (6-12 inches deep) (P1040253.JPG)

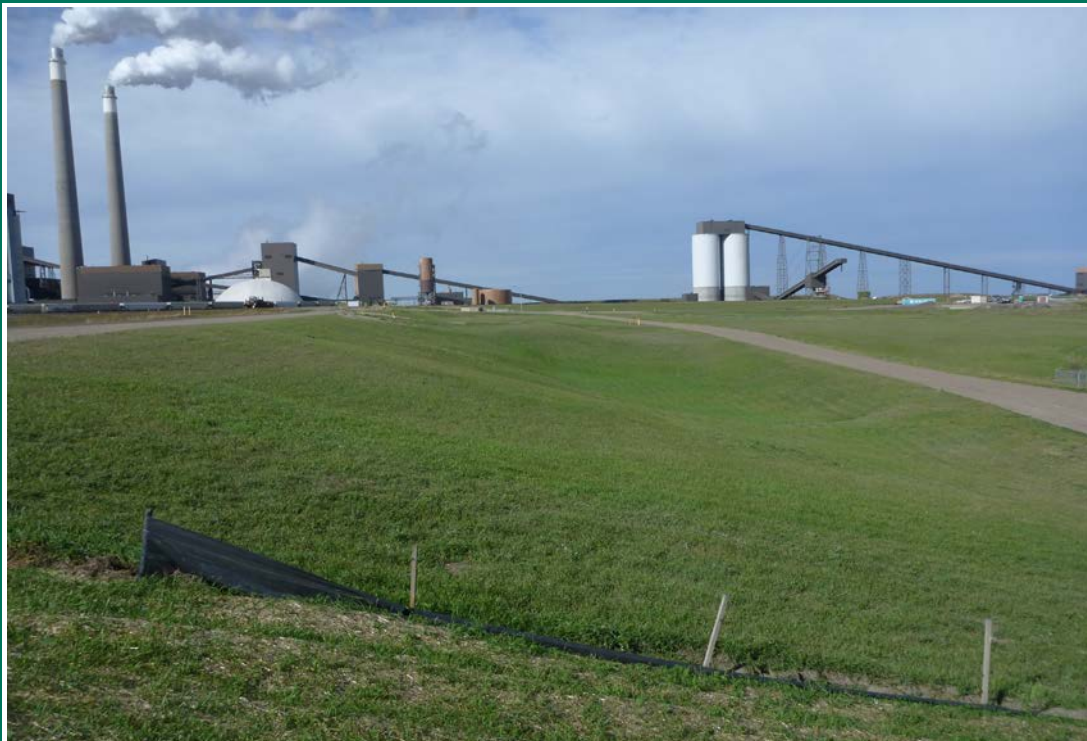
Photograph 26 (North berm downstream slope)
North center cell and west cell berm downstream slope (P1040254.JPG)

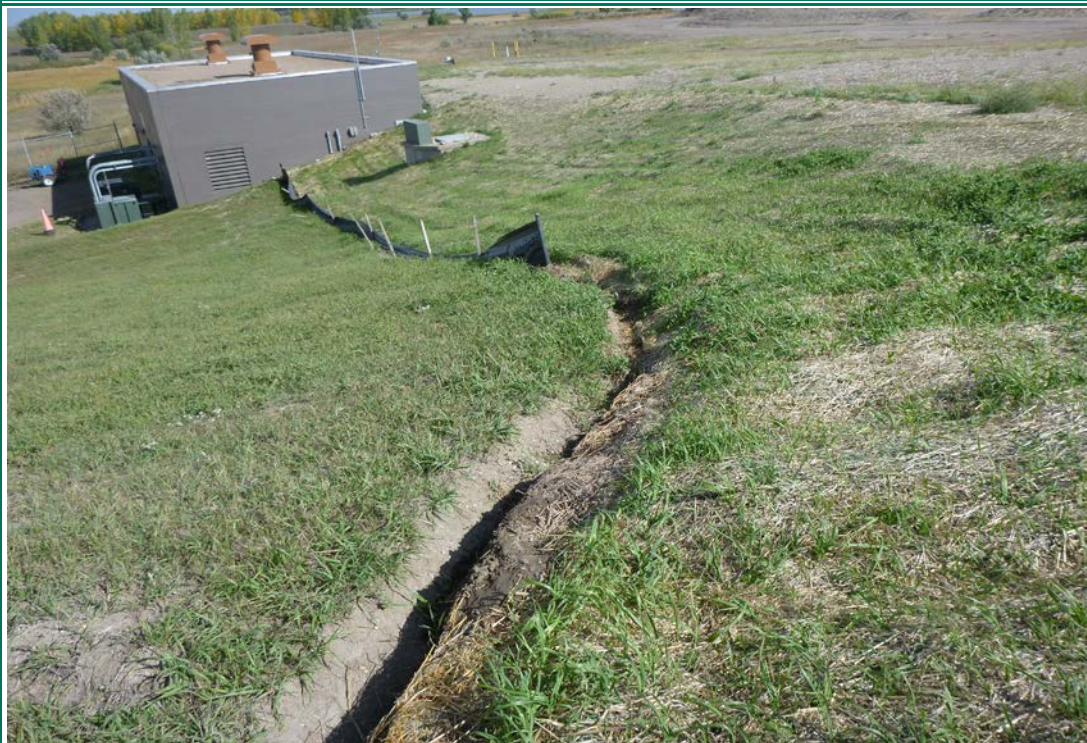
Photograph 27 (North berm downstream slope)
Silt fence trench to be filled in (P1040255.JPG)
