ANNUAL INSPECTION REPORT

GREAT RIVER ENERGY – COAL CREEK STATION

Drains Pond System CCR Surface Impoundment

January 2018

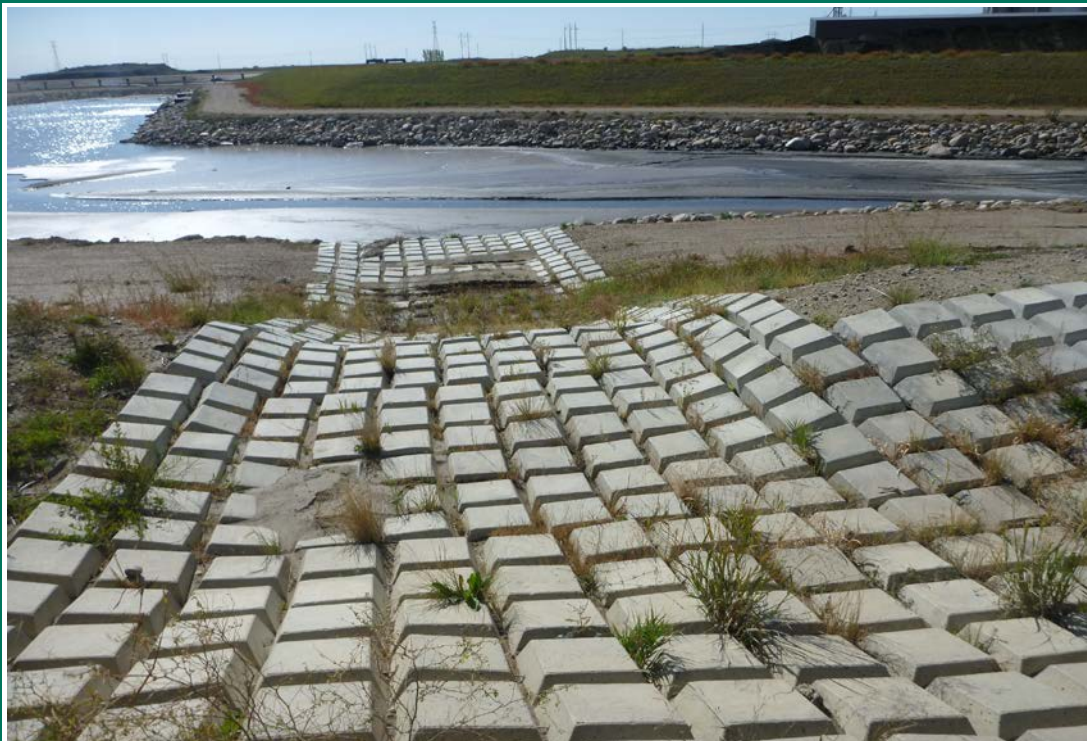
Photograph 28 (North surface water channel inlet to Center Cell)
Articulated Concrete Block (ACB) armoring (P1040257.JPG)

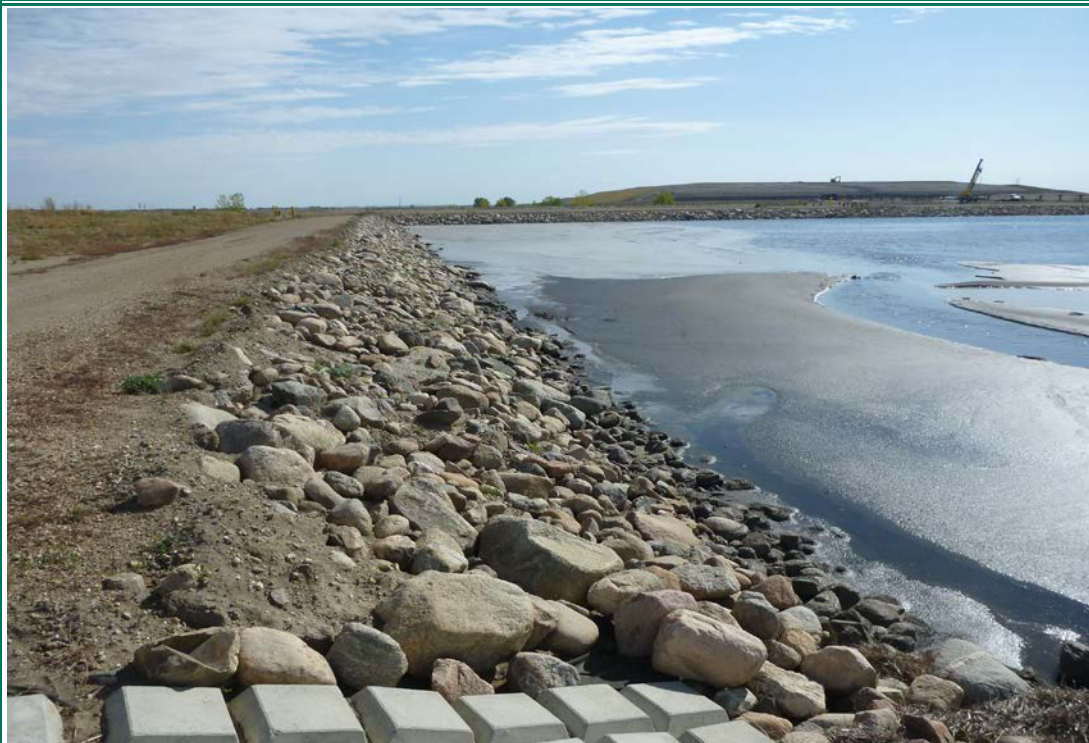
**Photograph 29 (Center cell berm upstream slope)
Center cell berm upstream slope riprap (P1040258.JPG)**

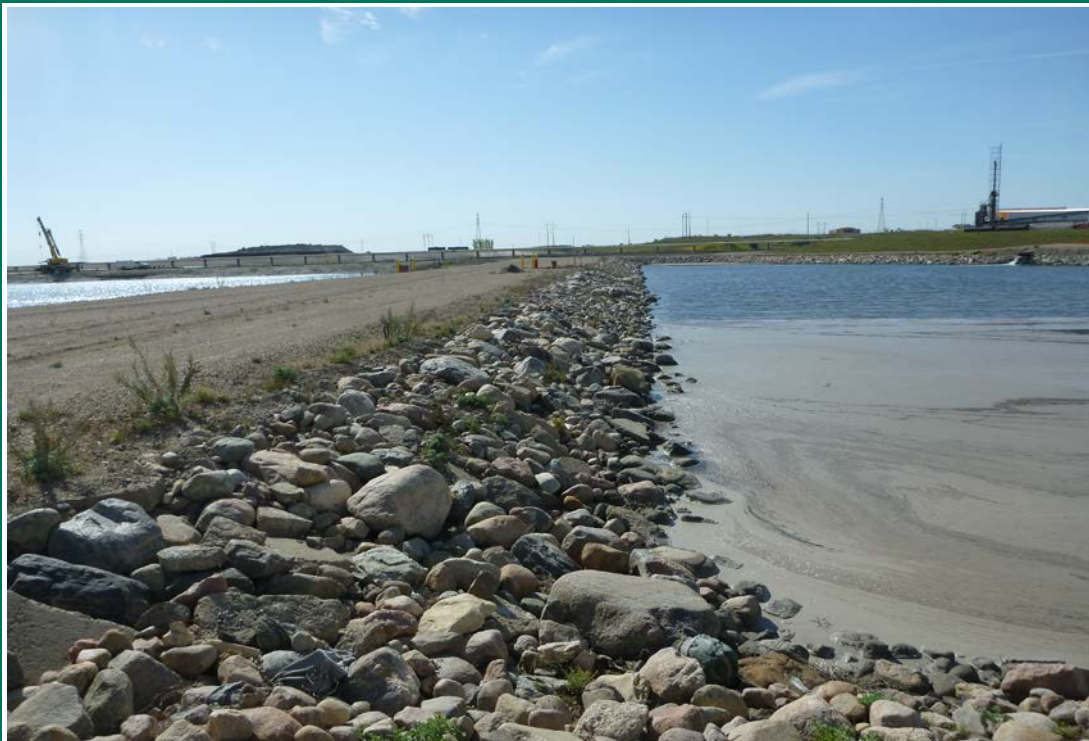
**Photograph 30 (Center cell berm upstream slope)
East side of center cell berm upstream slope riprap (P1040260.JPG)**
