ANNUAL INSPECTION REPORT

GREAT RIVER ENERGY – COAL CREEK STATION

Southeast Section 16 CCR Landfill

January 2018

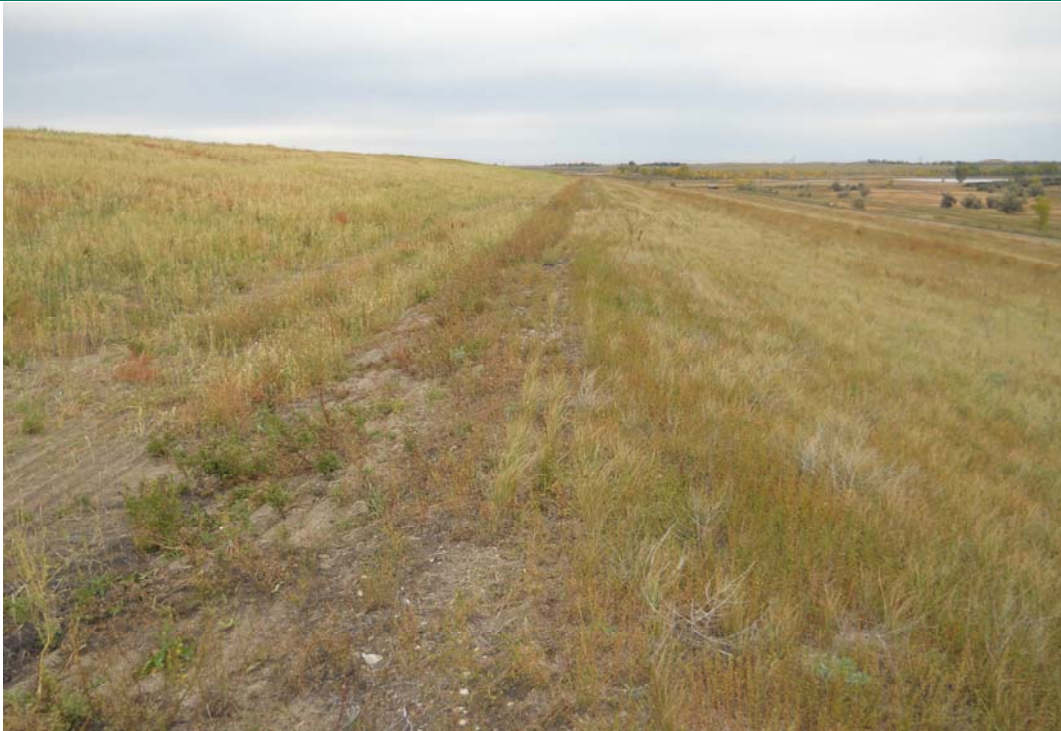
Photograph 1 (East CCR downstream slope)
Boundary between CCR downstream slope with temporary cover (upslope) and CCR downstream slope with final cover (downslope) (DSCN1660.JPG)

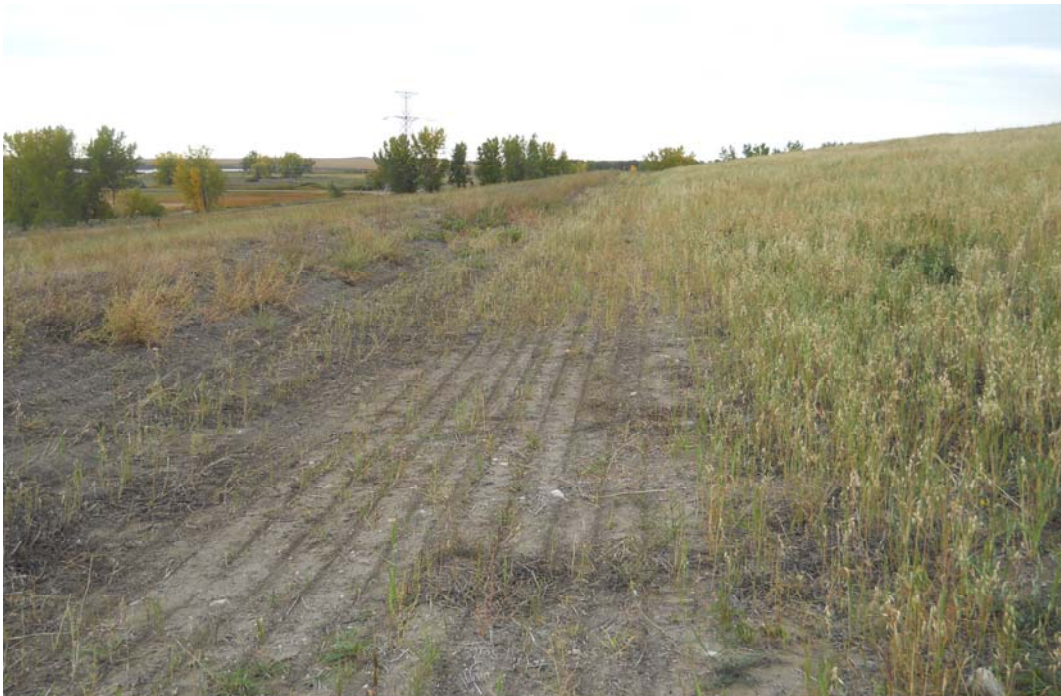
Photograph 2 (East CCR downstream slope)
Contact water control channel (dry) (DSCN1673.JPG)

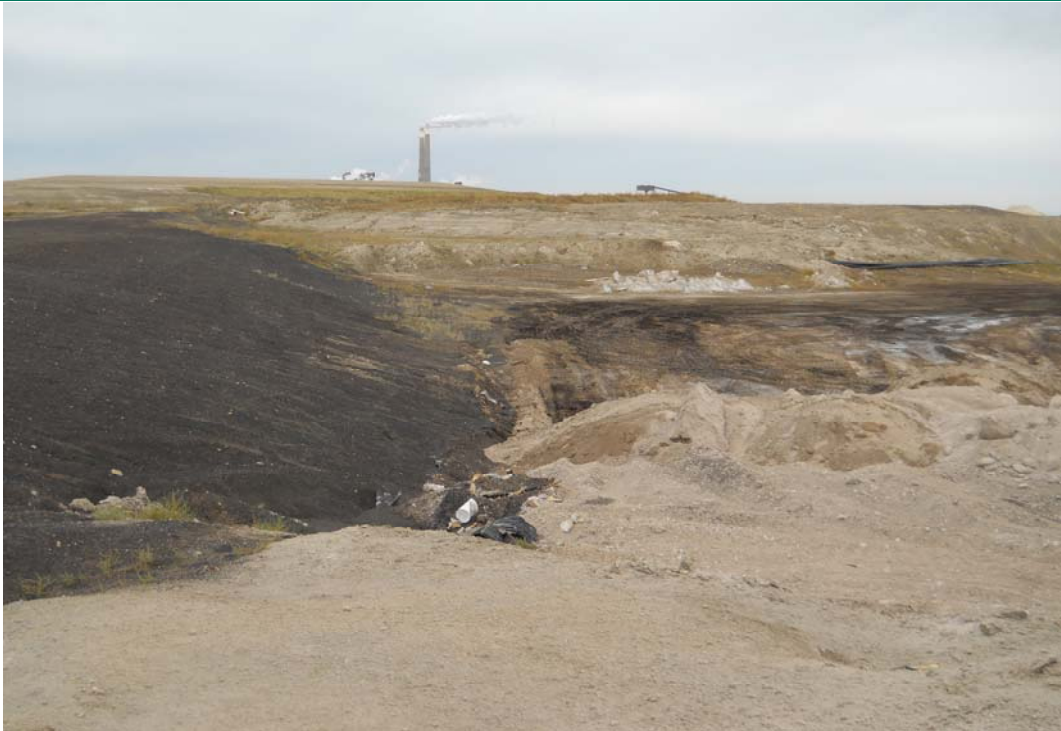
Photograph 3 (Interior)
Interior deposition area of Southeast 16 (DSCN1674.JPG)

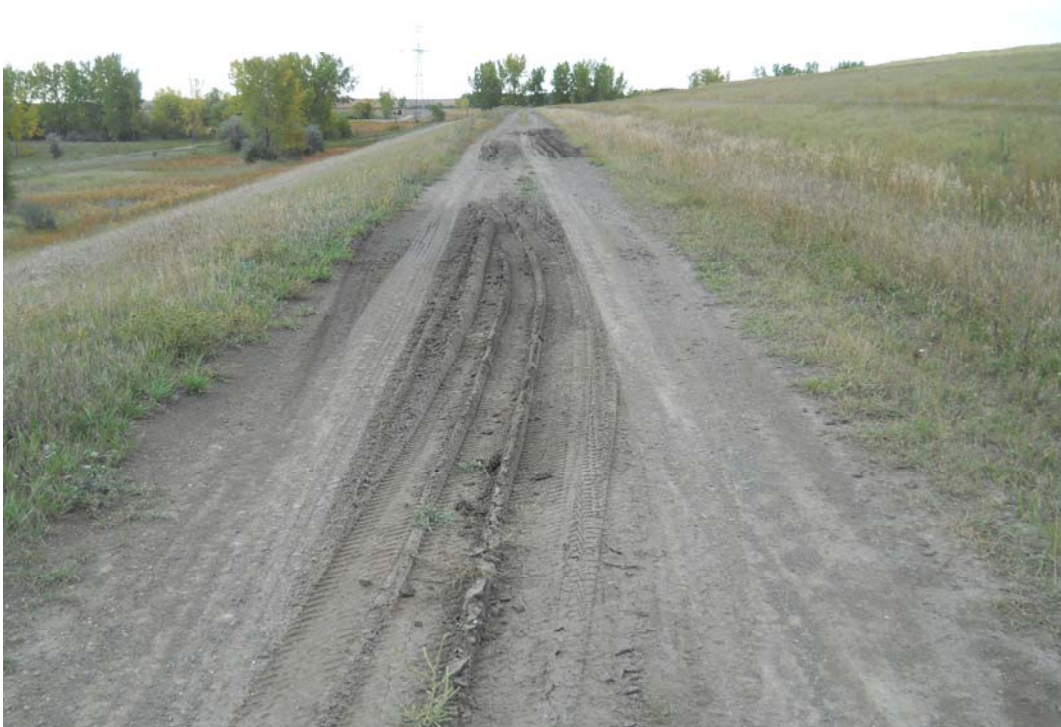
The berm crest around the east and south sides of Southeast 16 is surfaced with gravel and used for light vehicle traffic. The berm crest along the north side is narrow and rarely used for light vehicle traffic. Heavy haul traffic bringing CCR to the site use an internal road constructed over previously placed CCR. The road on the berm crest of Southeast 16 appears to be in good condition, with no noticeable cracking or settlement, and appears to be well maintained. When wet, the road surface can become rutted and slippery. During the inspection, minor rutting was noticed on the south and east crests due to recent rain events. Ruts that develop on the road surface should be repaired as soon as practical to maintain access.

Photograph 4 (East berm crest)
Rutting of berm crest perimeter access road (DSCN1678.JPG)

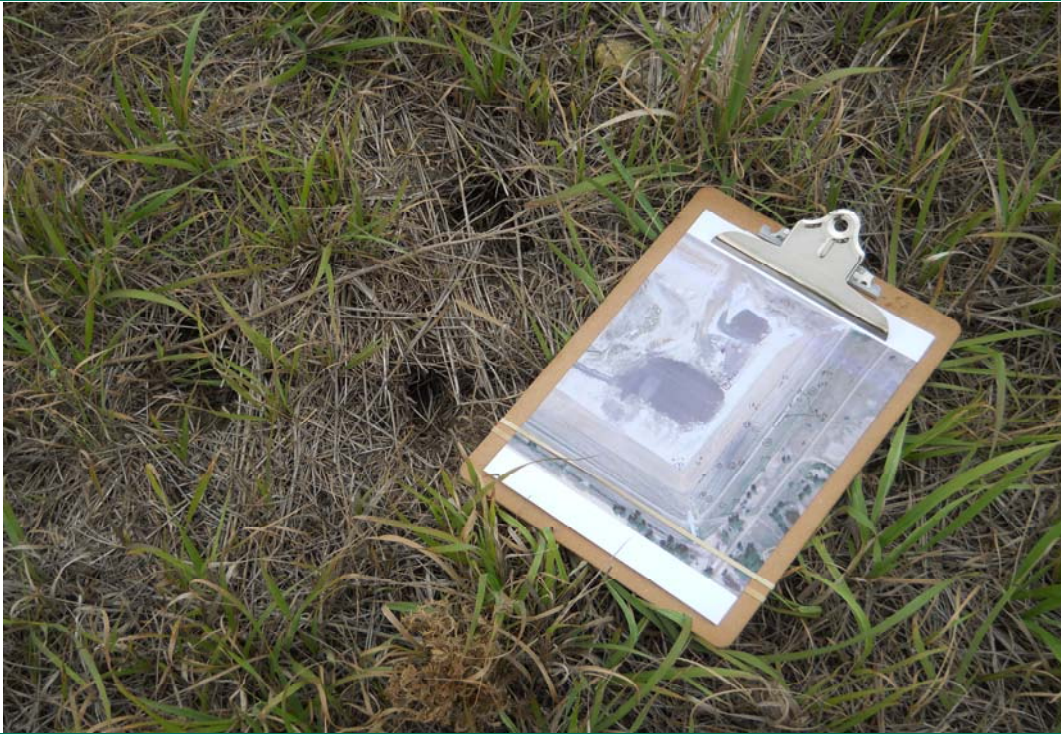
Photograph 5 (East berm downstream slope)
Small animal burrows (DSCN1683.JPG)

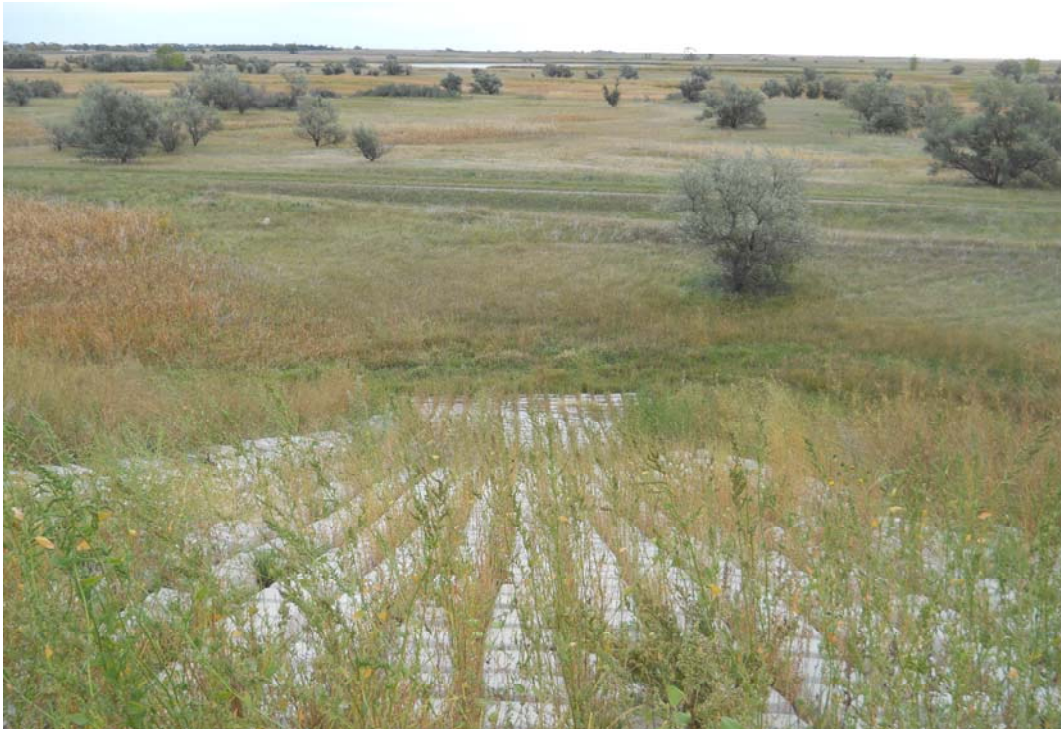
Photograph 6 (Northeast berm downstream slope)
Downchute channel below berm crest perimeter access road (DSCN1688.JPG)

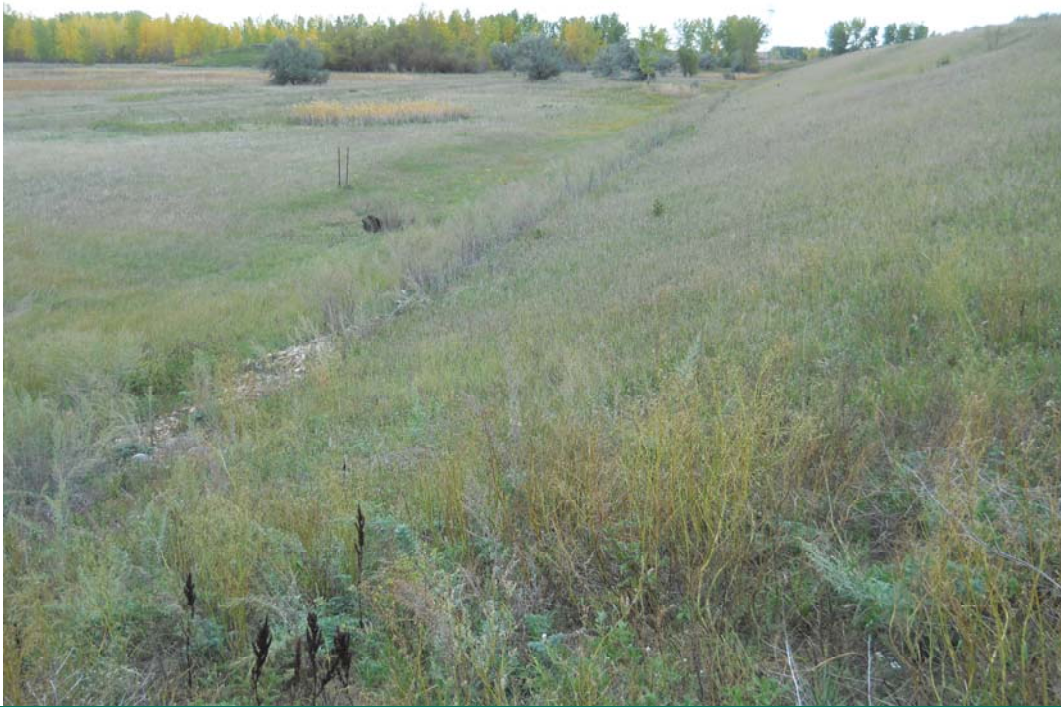
Photograph 7 (Northeast toe)
Toe of slope at northeast corner (DSCN1689.JPG)

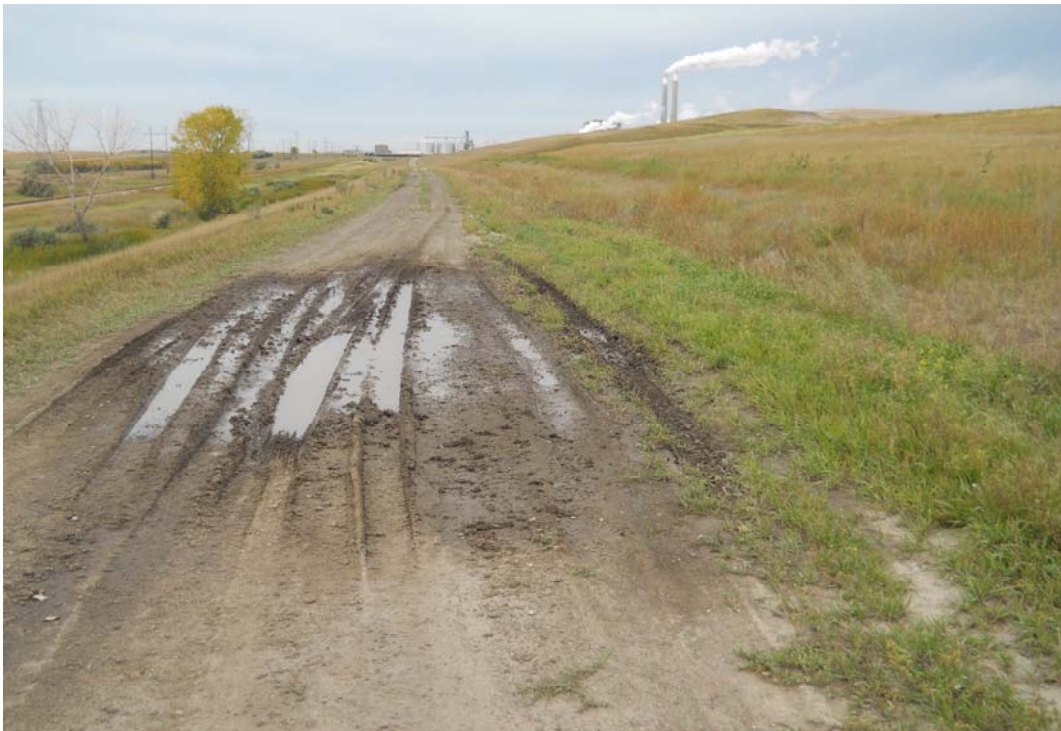
Photograph 8 (South berm crest)
Rutting of berm crest perimeter access road (DSCN1693.JPG)

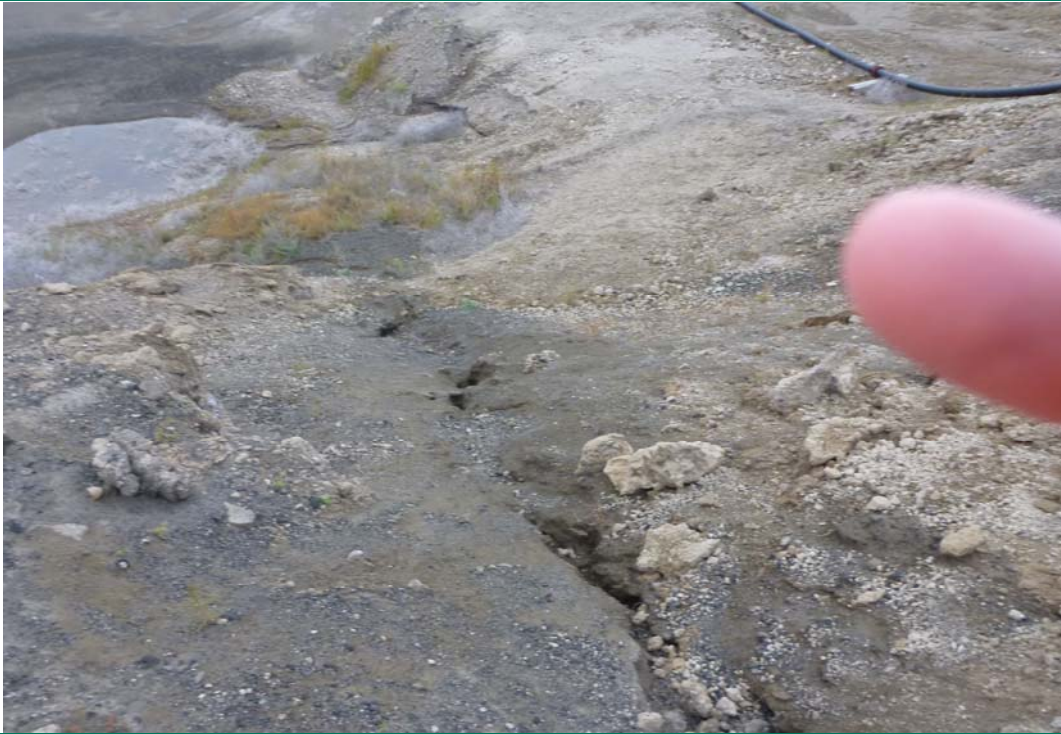
Uncovered CCR downstream slopes appeared to be in fair condition with no noticeable cracks, settlement, sloughing, seepage, or other signs of structural distress. The uncovered CCR downstream slopes appeared to match the design slopes with only minor erosion noted, particularly of fly ash along the north CCR downstream slope.

Photograph 9 (North CCR slope)
Erosion of placed CCR materials (P1040150.JPG)

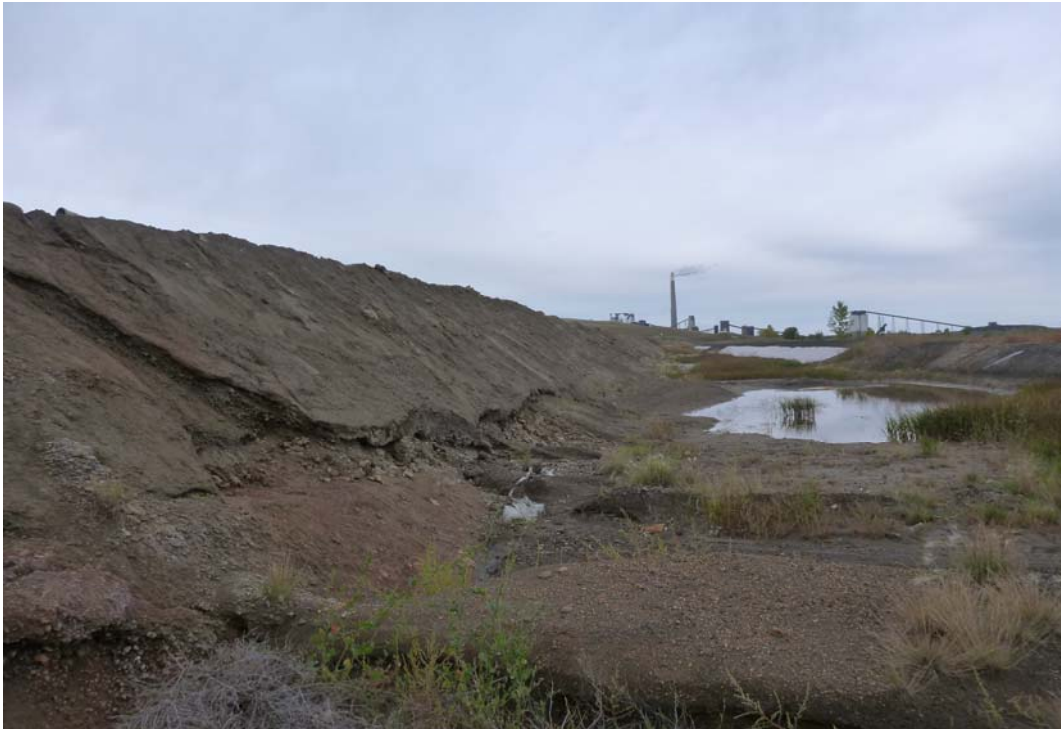
Photograph 10 (North CCR slope)
North interior CCR placement slope (P1040155.JPG)

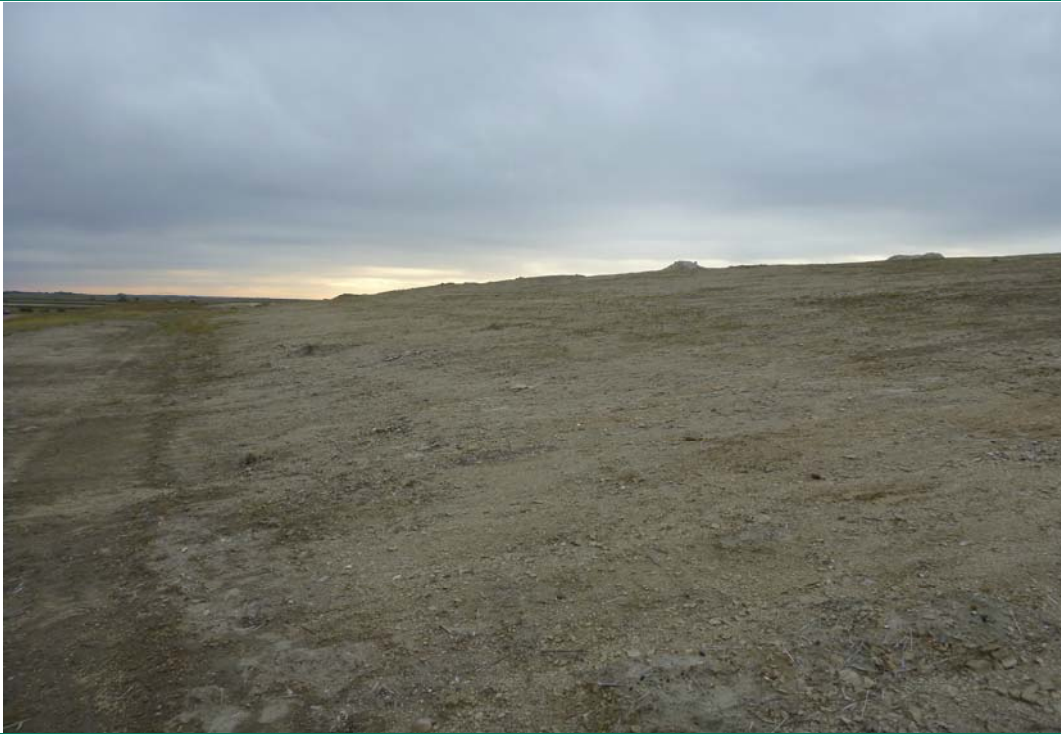
Photograph 11 (North CCR slope)
North fly ash slope (P1040158.JPG)

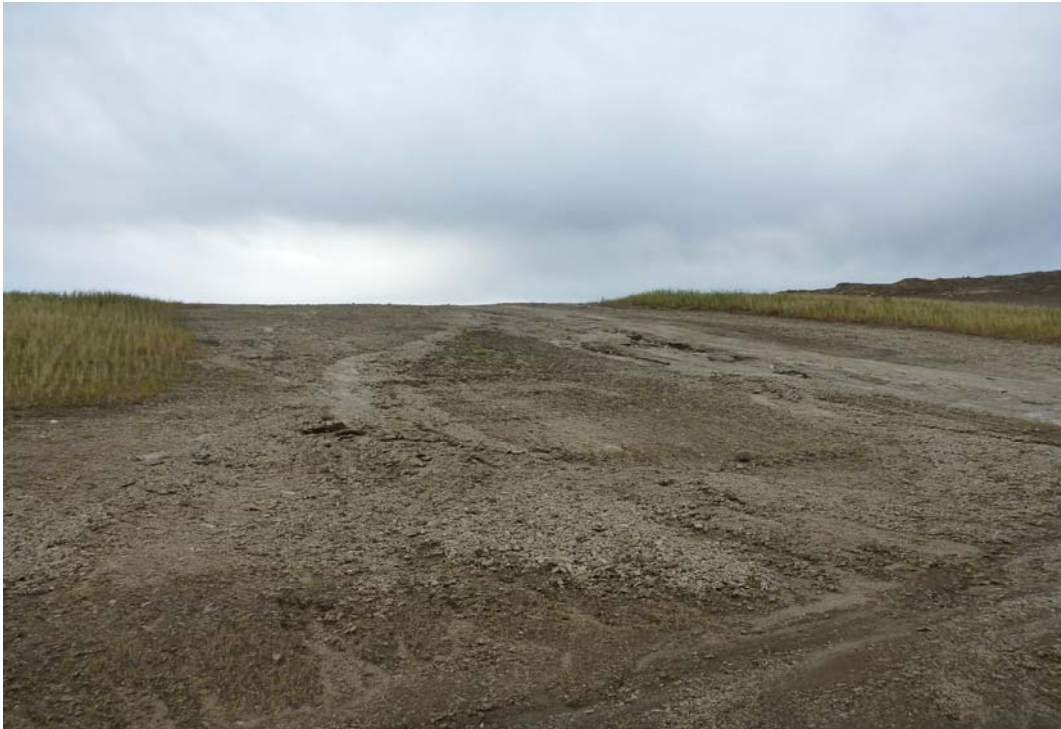
Photograph 12 (North CCR slope)
Minor erosion of fly ash slope due to channelized water flow (P1040162.JPG)

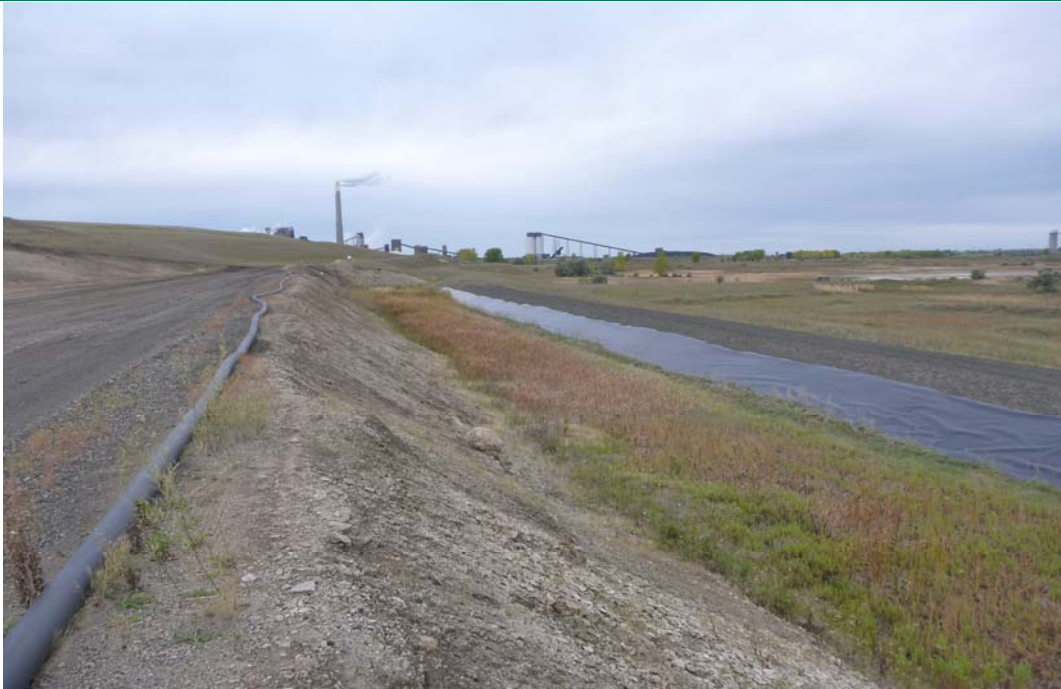
Photograph 13 (North CCR slope)
Haul road within Southeast 16 footprint and contact water area (P1040163.JPG)

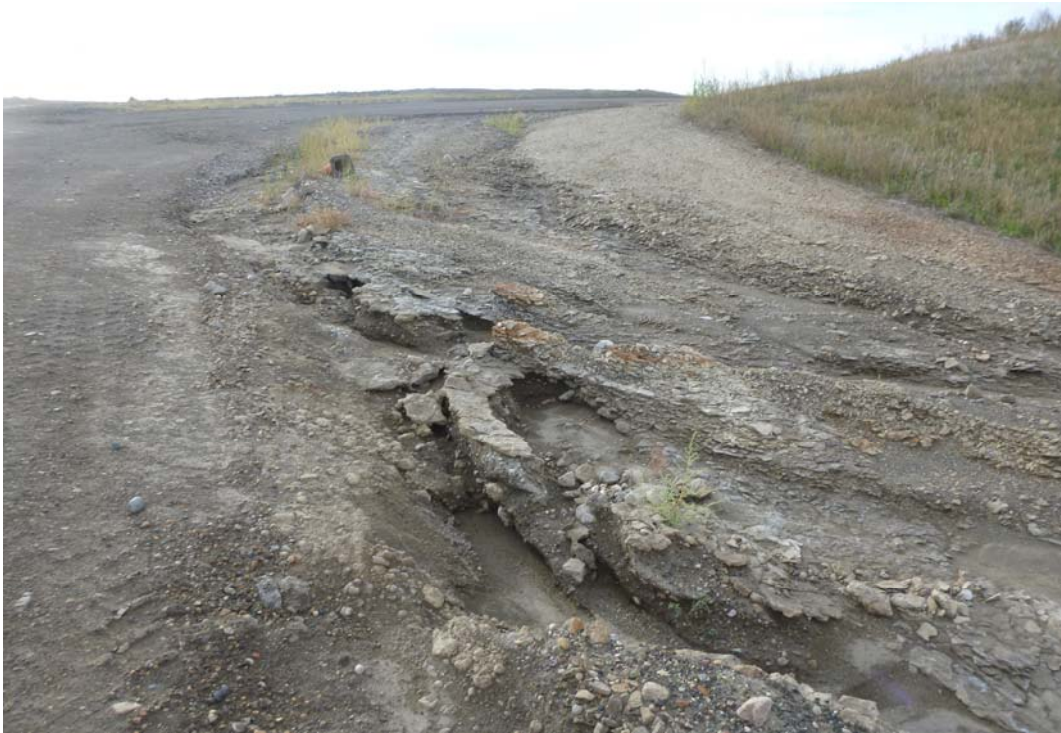
Photograph 14 (Northwest CCR slope)
Minor erosion of fly ash at interface between Upstream Raise 92 and Southeast 16 (P1040166.JPG)

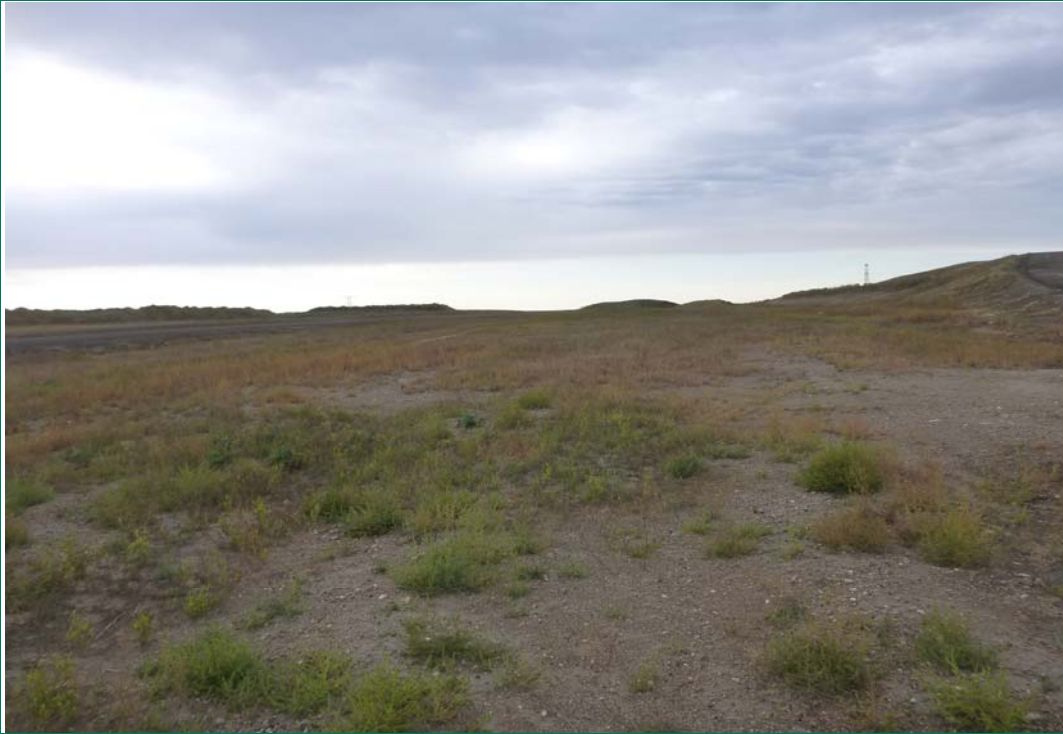
**Photograph 15 (West CCR slope)
Southeast 16 interior (P1040167.JPG)**

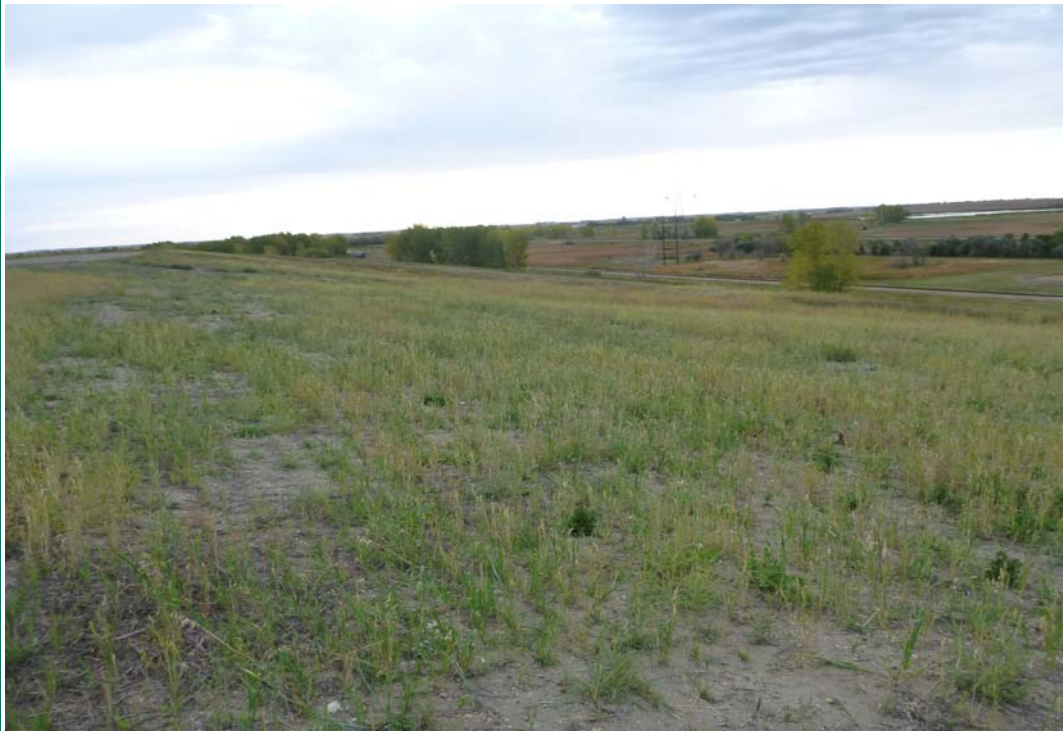
Portions of CCR downstream slopes on the north, east and south sides of Southeast 16 have temporary cover installed as of late 2016. These areas had some vegetation beginning to grow in 2017 (a combination of grassy vegetation and weeds) and minor erosion on the soil surface below. However, these CCR downstream slopes with temporary cover appeared to be in generally good condition to aid in controlling erosion of the outer fly ash “shell” and limit wind-blown fugitive dust.

**Photograph 16 (South downstream CCR slope with temporary cover)
Temporary cover (P1040170.JPG)**

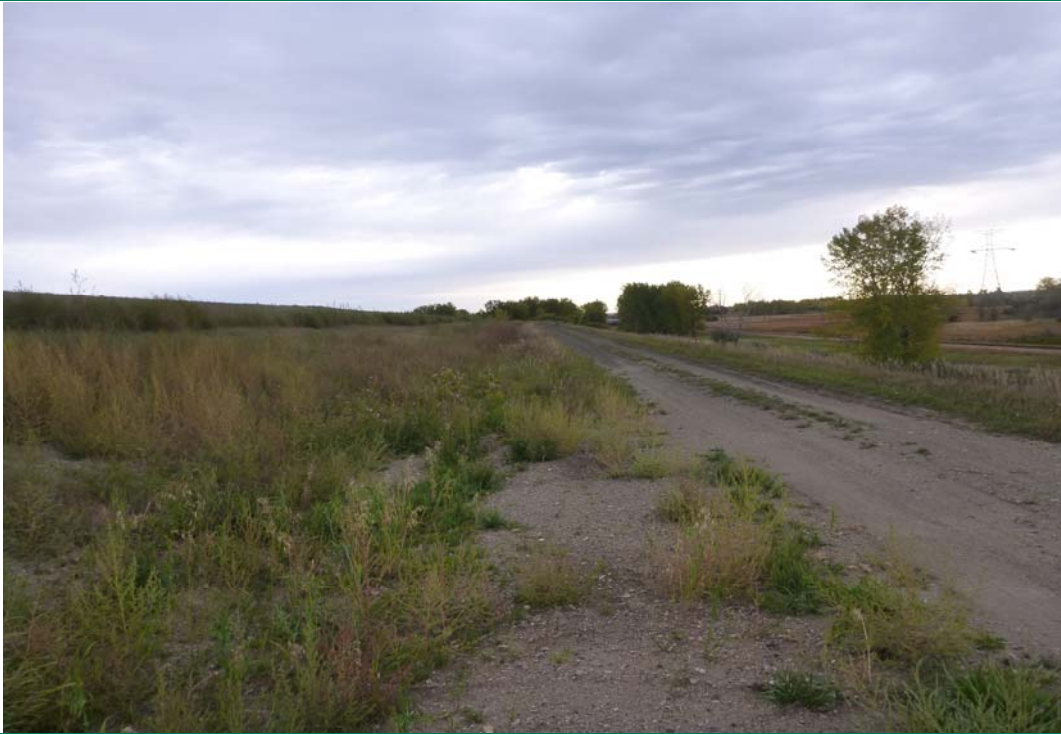
**Photograph 17 (South berm crest)
Perimeter berm crest access road (P1040173.JPG)**

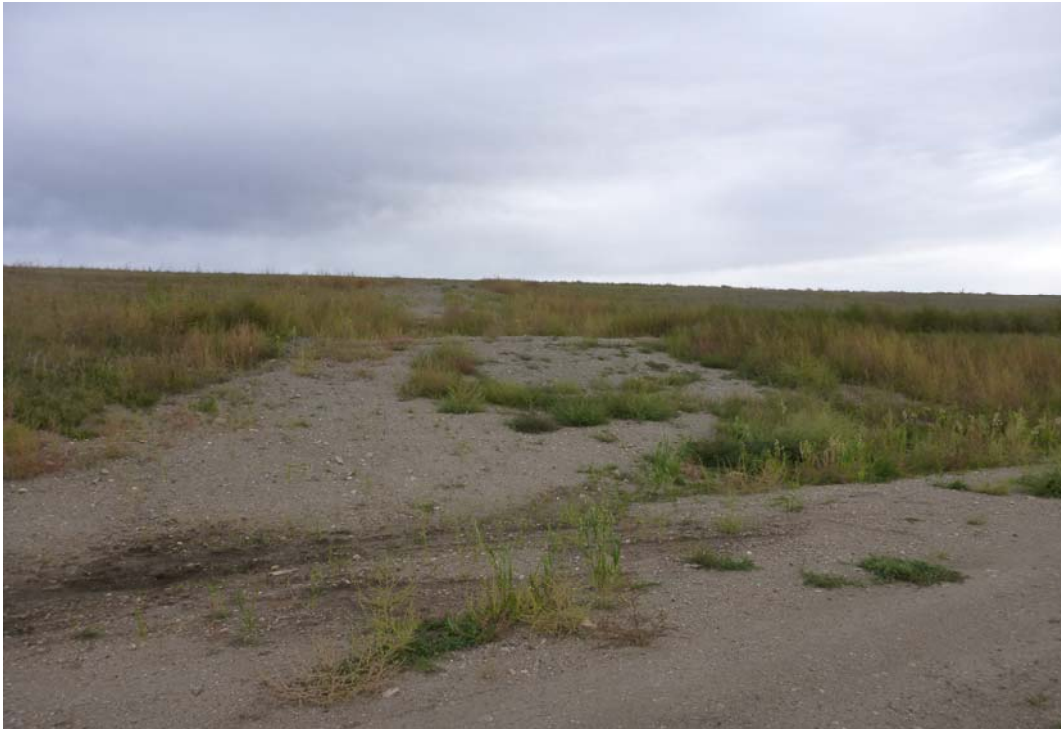
**Photograph 18 (Southwest CCR downstream slope)
Prior access ramp area (P1040174.JPG)**

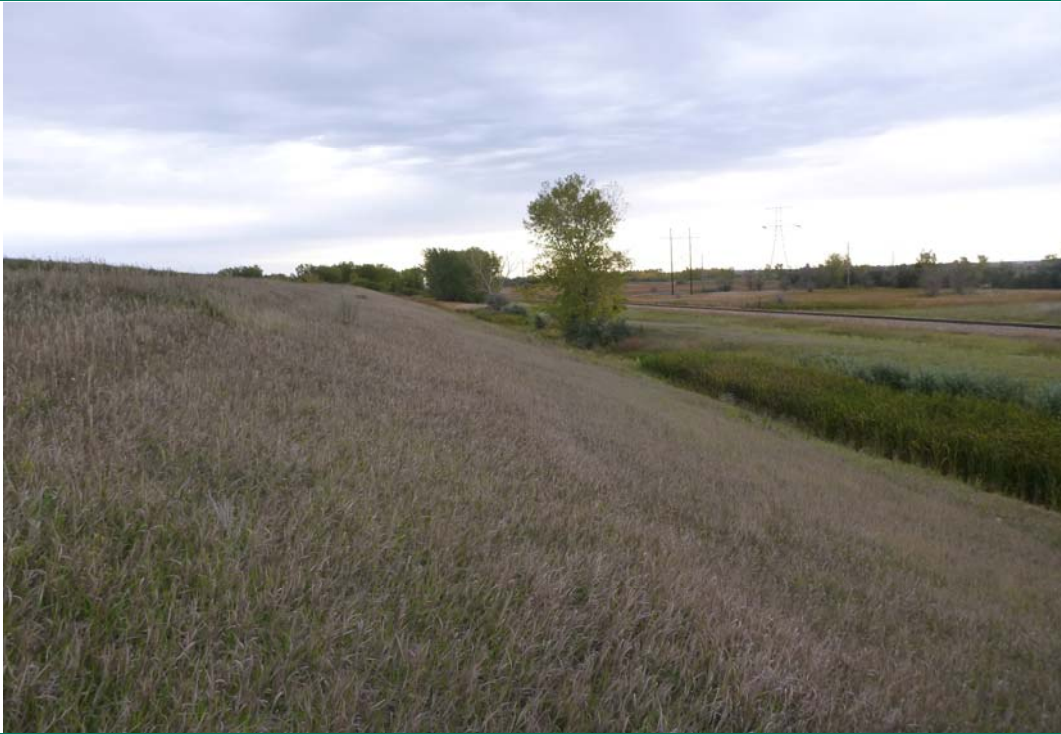
Photograph 19 (South berm downstream slope)
Grass vegetated slope below berm crest perimeter access road (P1040175.JPG)

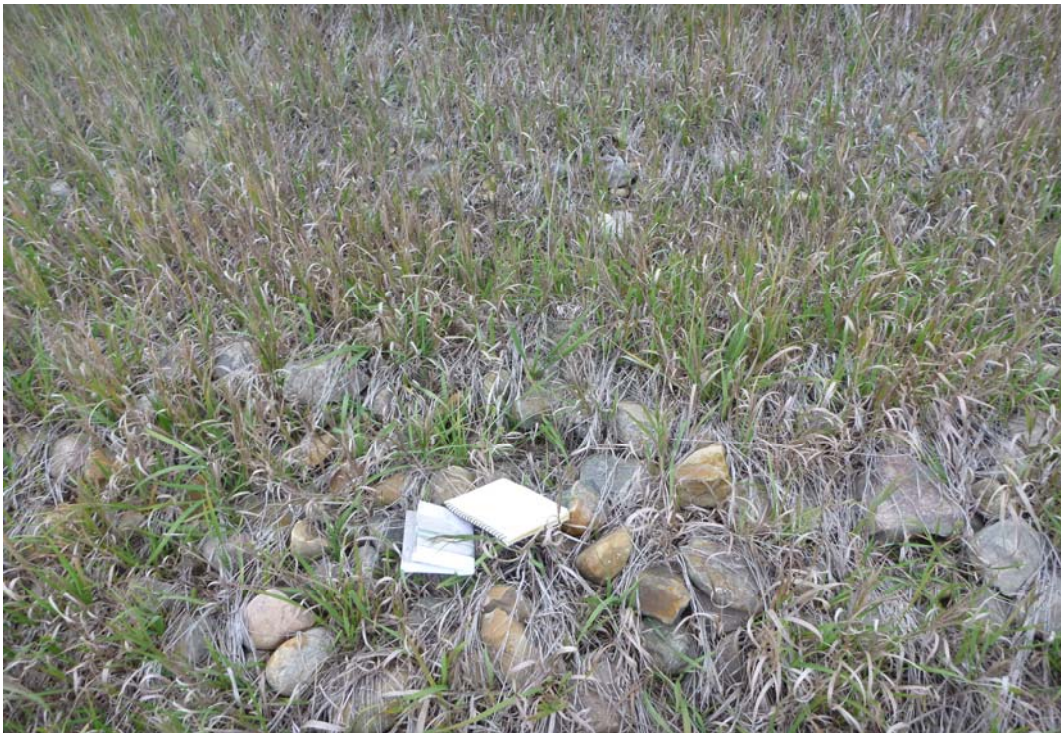
Photograph 20 (South toe)
Original toe drain and grass vegetated toe of slope (P1040176.JPG)

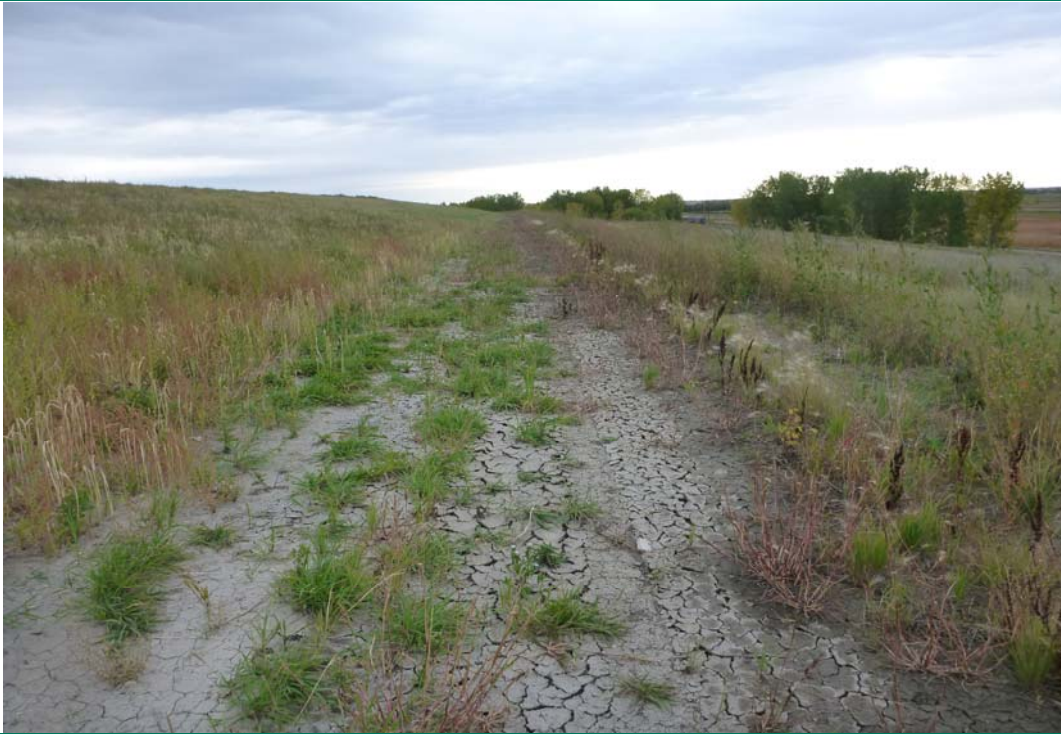
**Photograph 21 (South CCR downstream slope with temporary cover)
Contact water control channel (P1040180.JPG)**

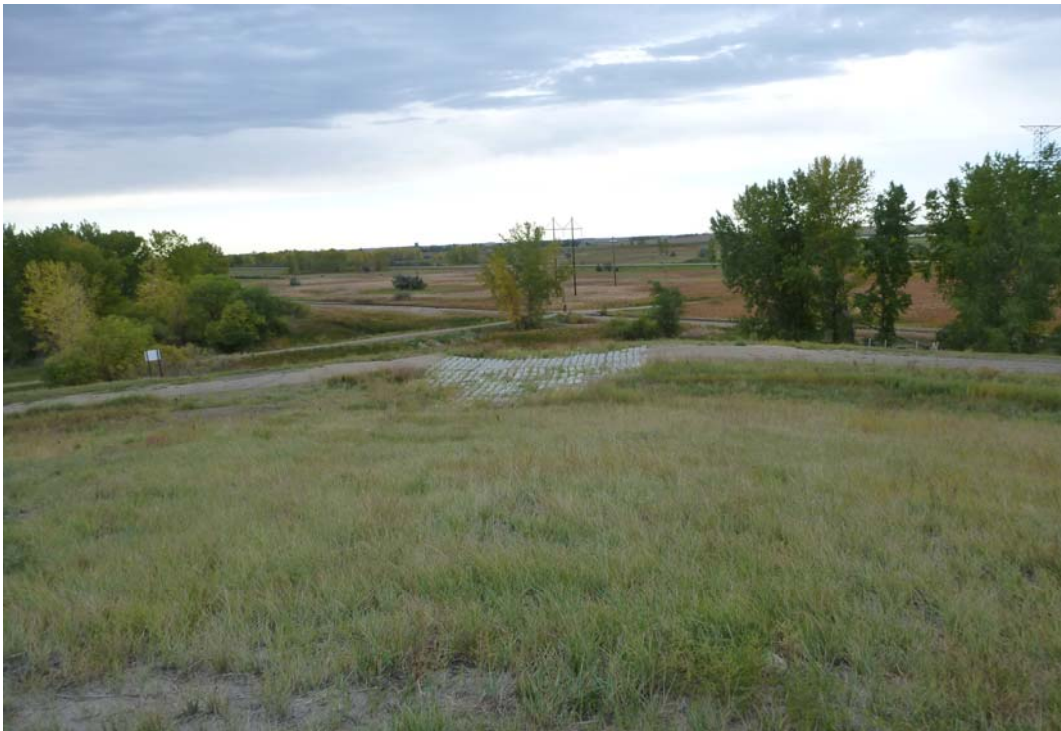
**Photograph 22 (Southeast CCR downstream slope)
Articulated Concrete Block (ACB) downchute (P1040184.JPG)**

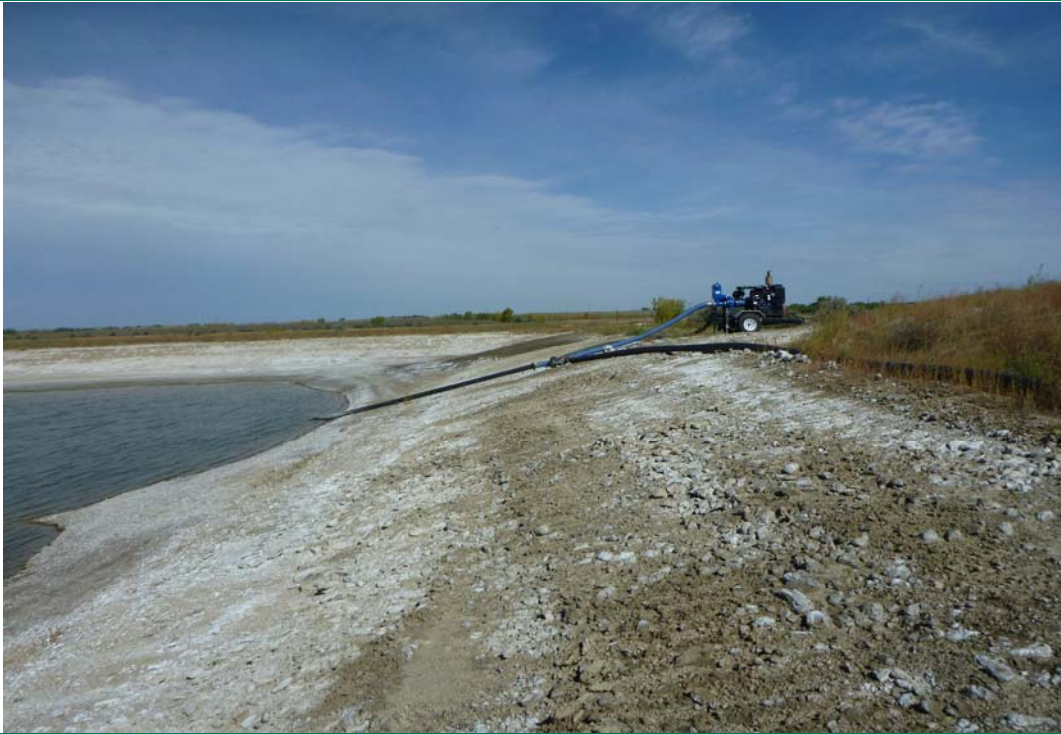
**Photograph 23 (Contact water collection area)
Pump pad and intake (P1040262.JPG)**

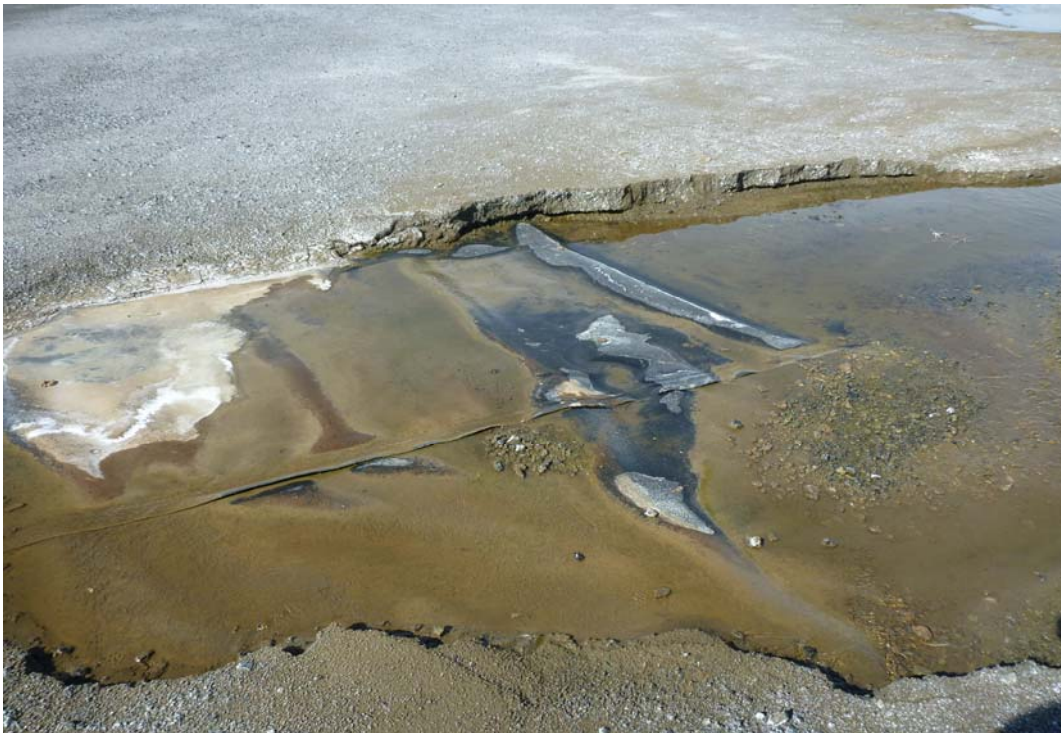
**Photograph 24 (Contact water collection area)
Top of geomembrane liner in contact water collection area (P1040263.JPG)**

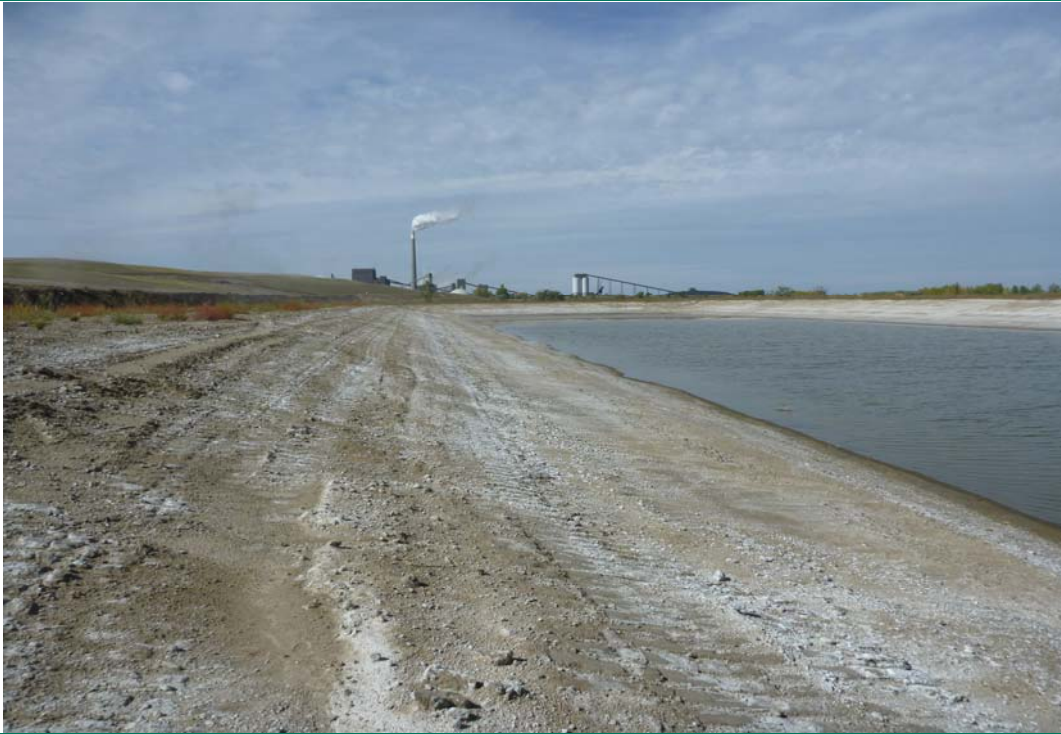
Photograph 25 (Contact water collection area)
Fly ash protective cover in contact water collection area (P1040264.JPG)

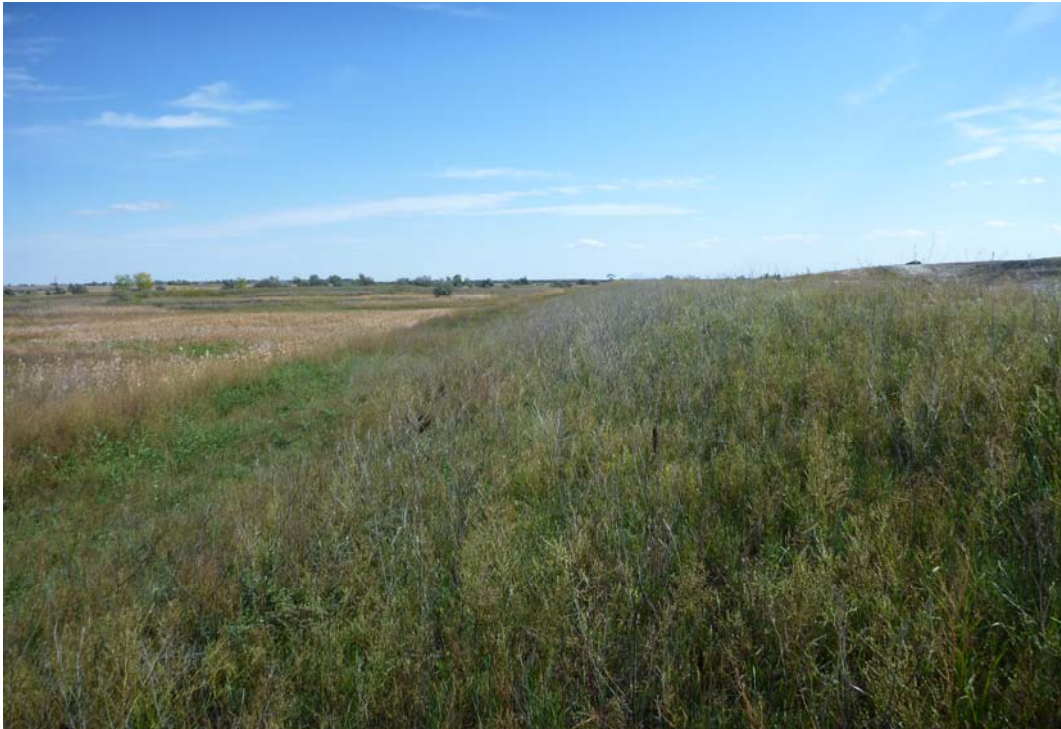
Photograph 26 (Contact water collection area)
North berm downstream slope and toe (P1040273.JPG)

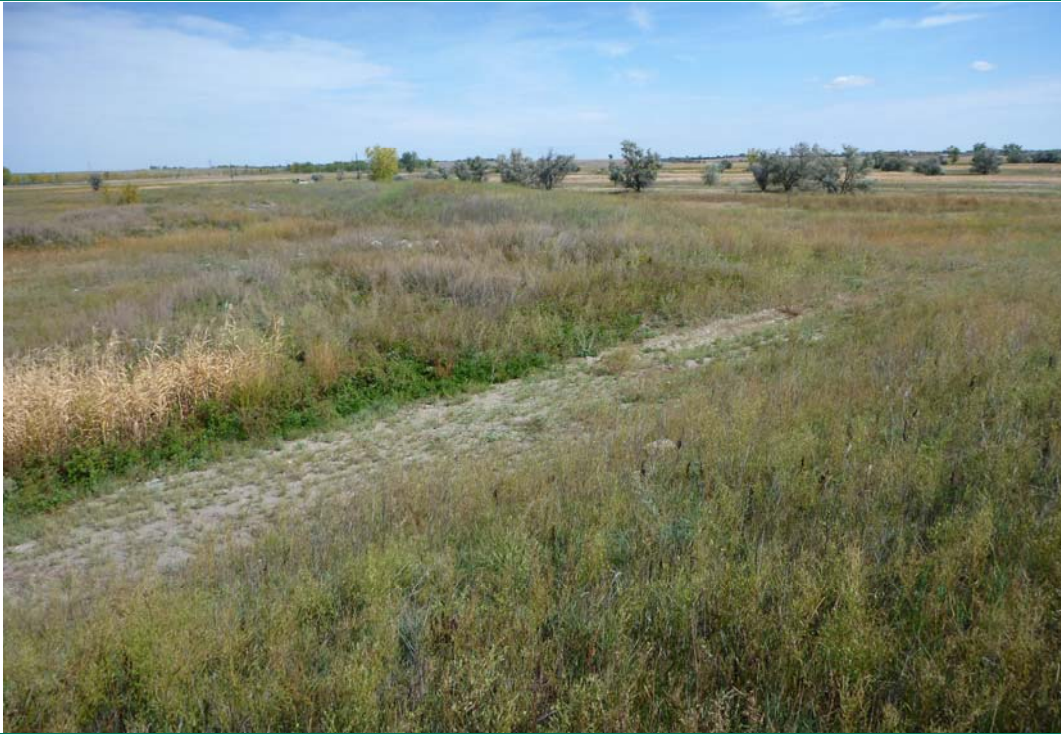
**Photograph 27 (Contact water collection area)
Northeast toe of slope (P1040276.JPG)**
