ANNUAL INSPECTION REPORT

GREAT RIVER ENERGY – COAL CREEK STATION

Upstream Raise 91

January 2018

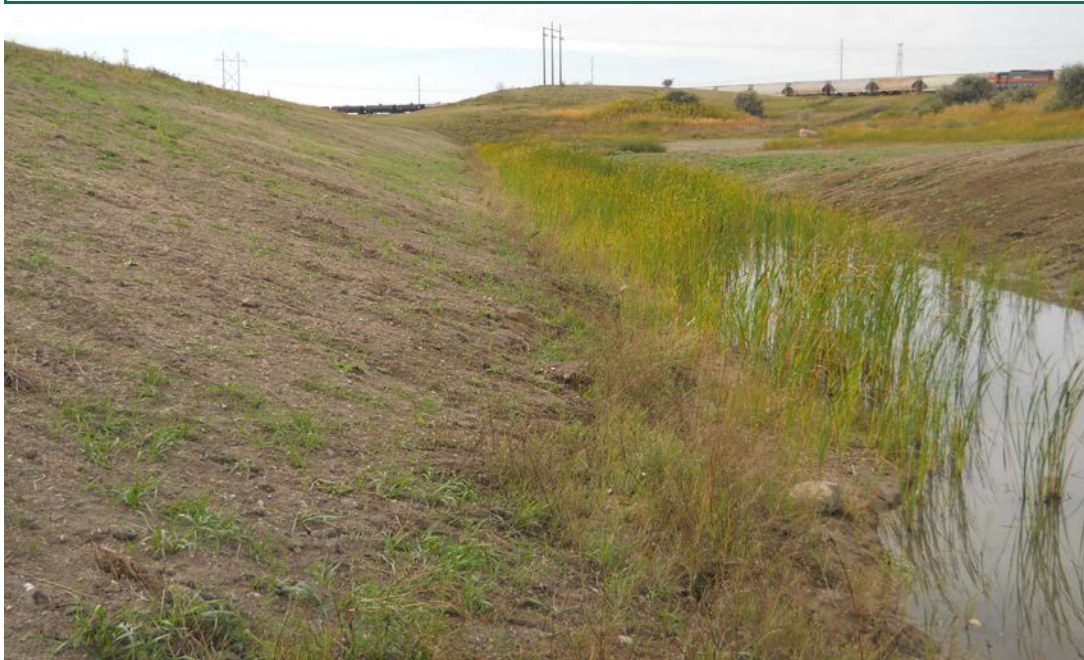
Photograph 1 (West berm downstream slope)

Recently vegetated west berm downstream slope of Upstream Raise 91 and toe, 1-2 feet of water in the ditch (DSCN1697.JPG)

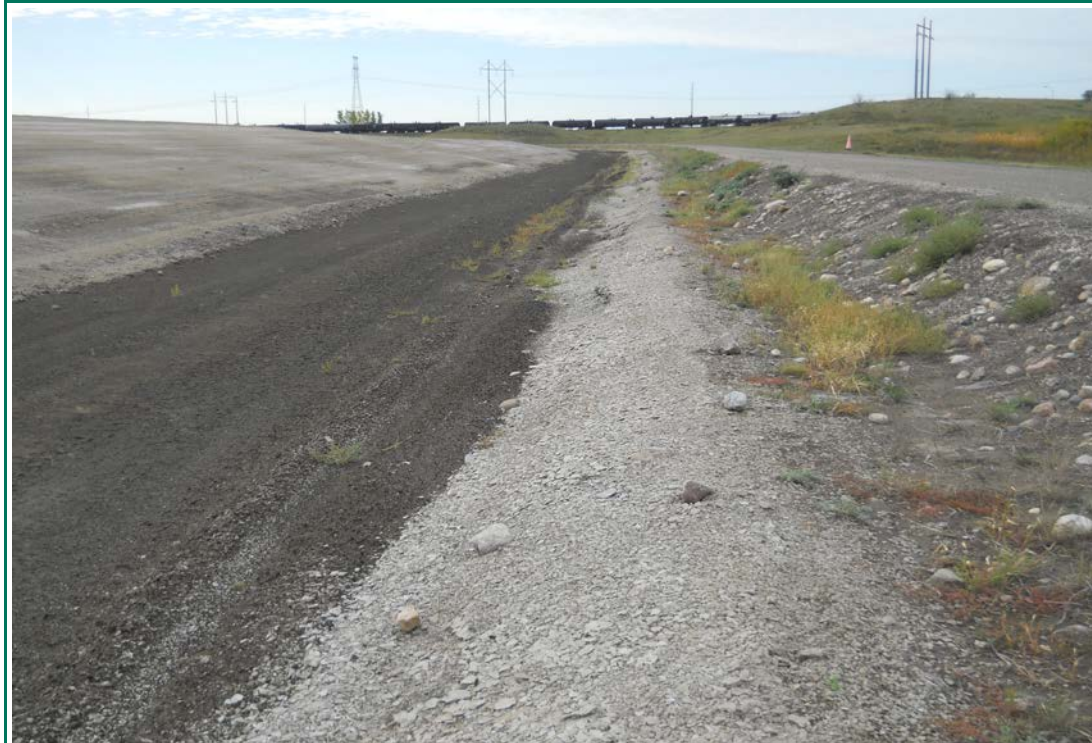
Photograph 2 (West berm upstream slope)

Berm upstream slope of Upstream Raise 91 and contact water control channel (DSCN1698.JPG)

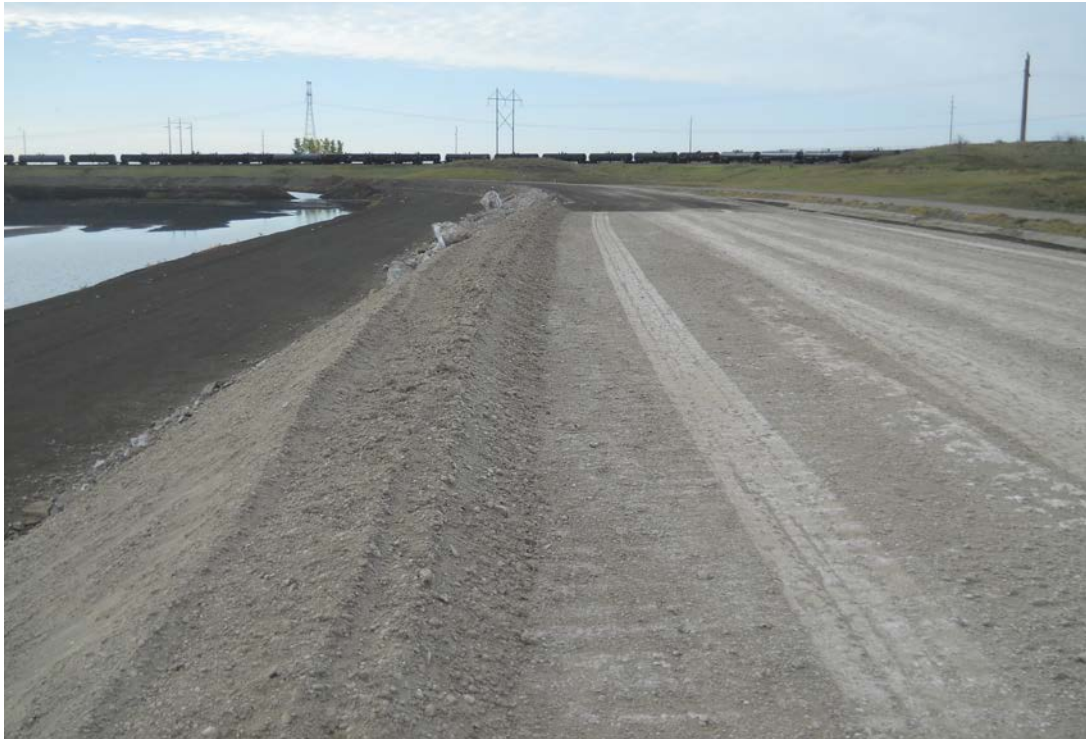
Photograph 3 (West CCR crest)
CCR material placement (DSCN1699.JPG)

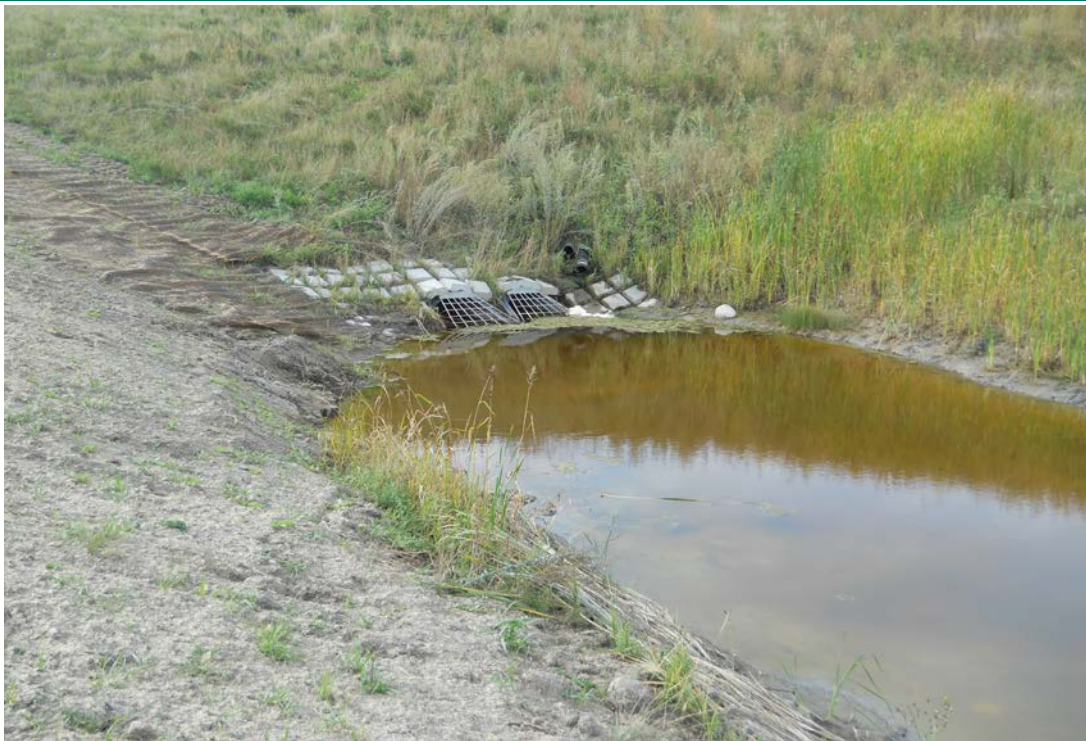
Photograph 4 (West toe)
Inlet of north surface water culvert (DSCN1704.JPG)

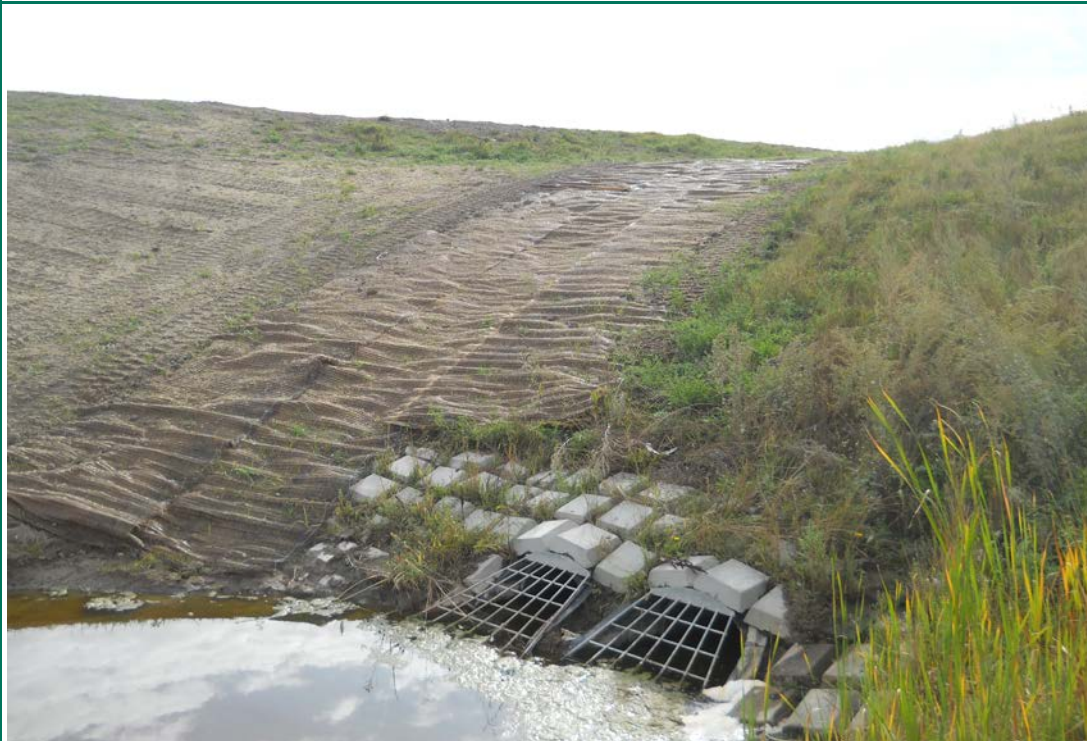
Photograph 5 (West berm downstream slope)
Erosion control blanket on west berm downstream slope of Upstream Raise 91 (DSCN1705.JPG)

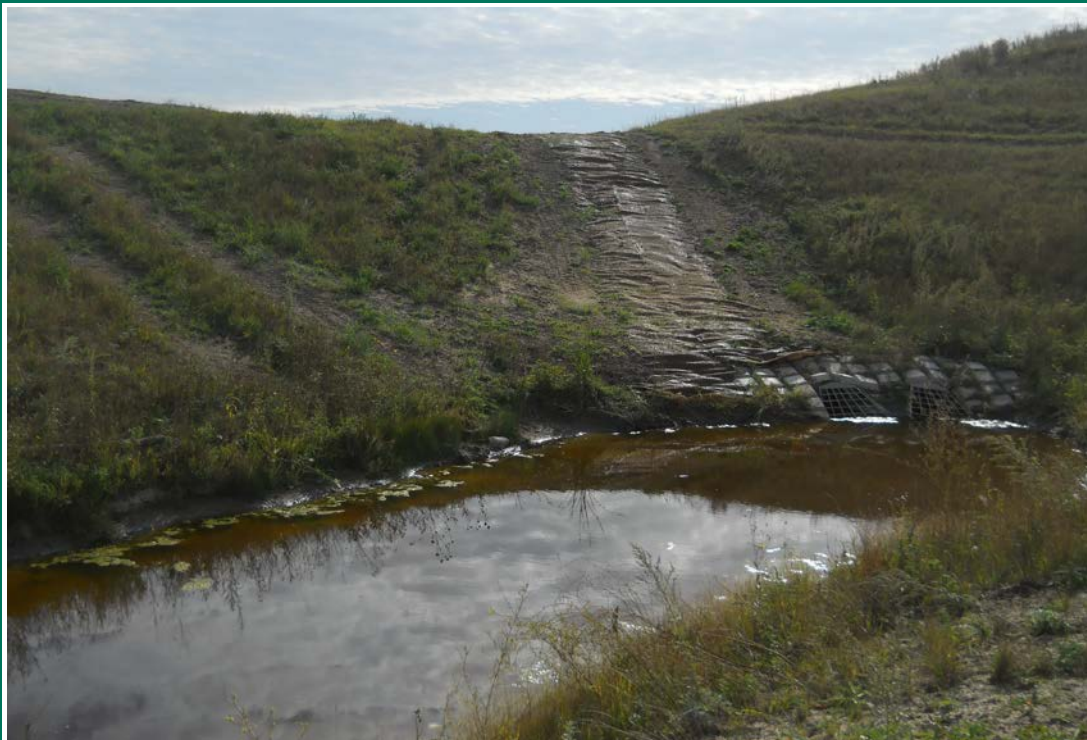
Photograph 10 (Southwest berm downstream slope)
Southwest surface water ditch and southwest culvert inlets, 1 foot of water in ditch (DSCN1715.JPG)

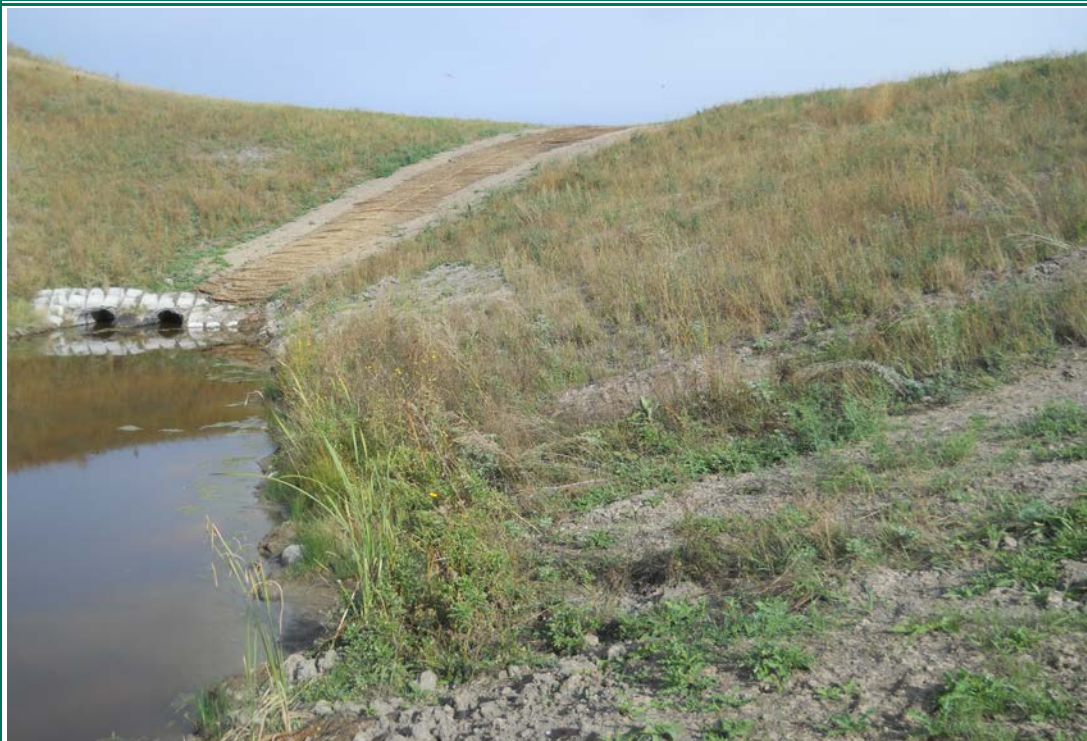
Photograph 11 (Southwest berm downstream slope)
Southwest surface water ditch and berm downstream slope of Upstream Raise 91 (DSCN1717.JPG)

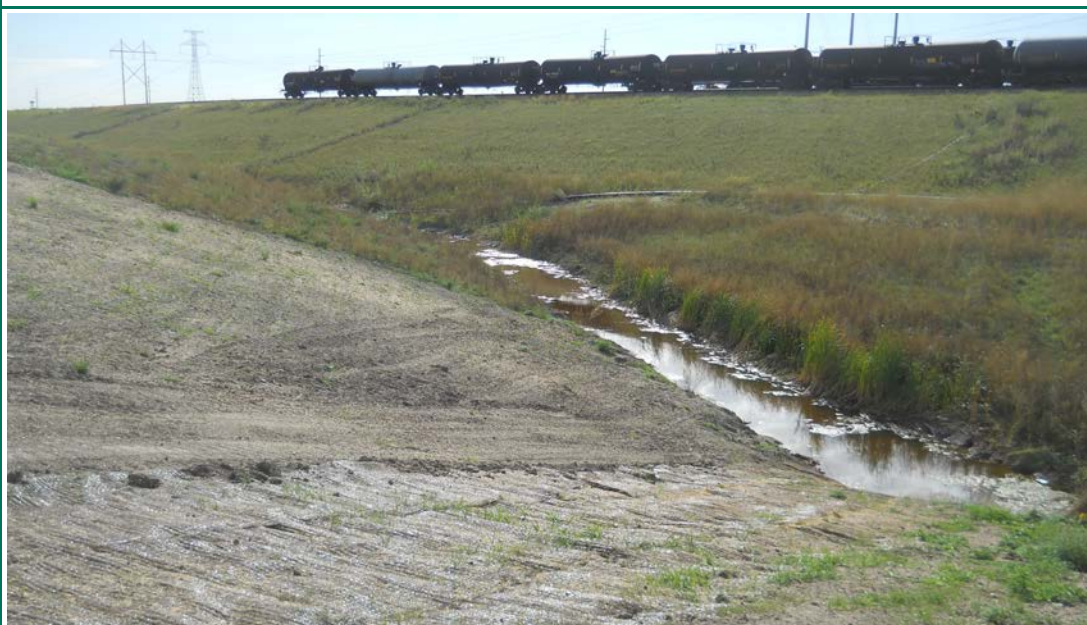
Photograph 12 (South berm downstream slope)
Outlet of southwest culverts and erosion control blankets installed on south berm downstream slope (DSCN1719.JPG)

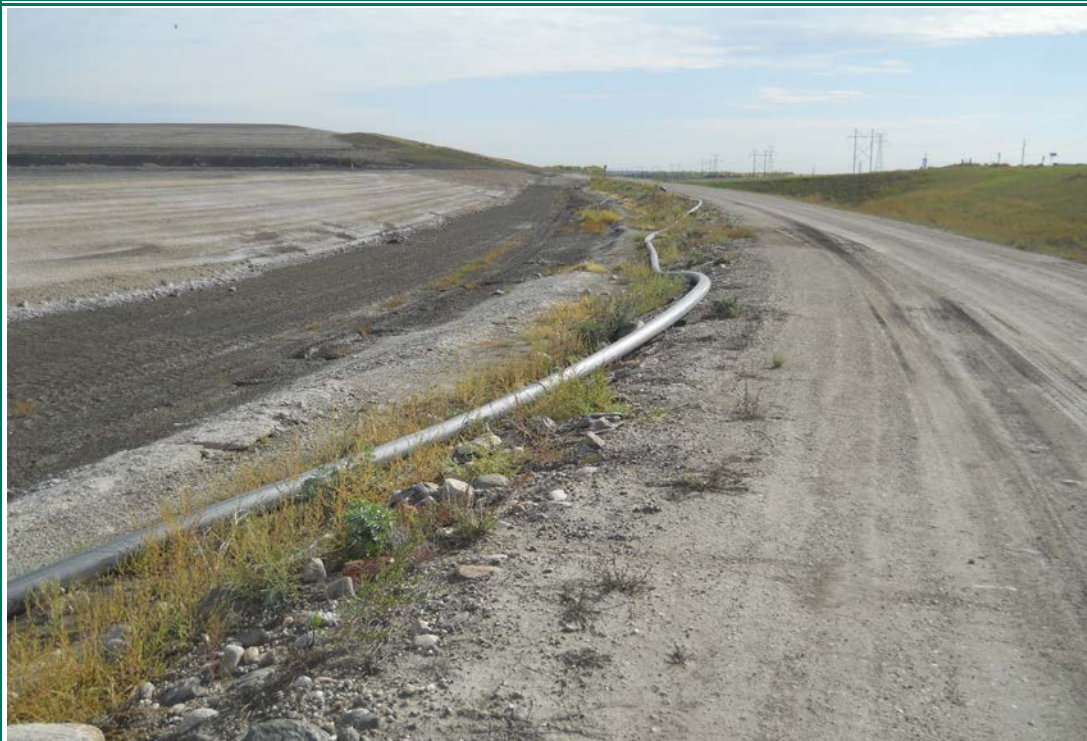
Photograph 13 (South berm upstream slope)
Berm upstream slope of Upstream Raise 91 and contact water control channel (DSCN1723.JPG)

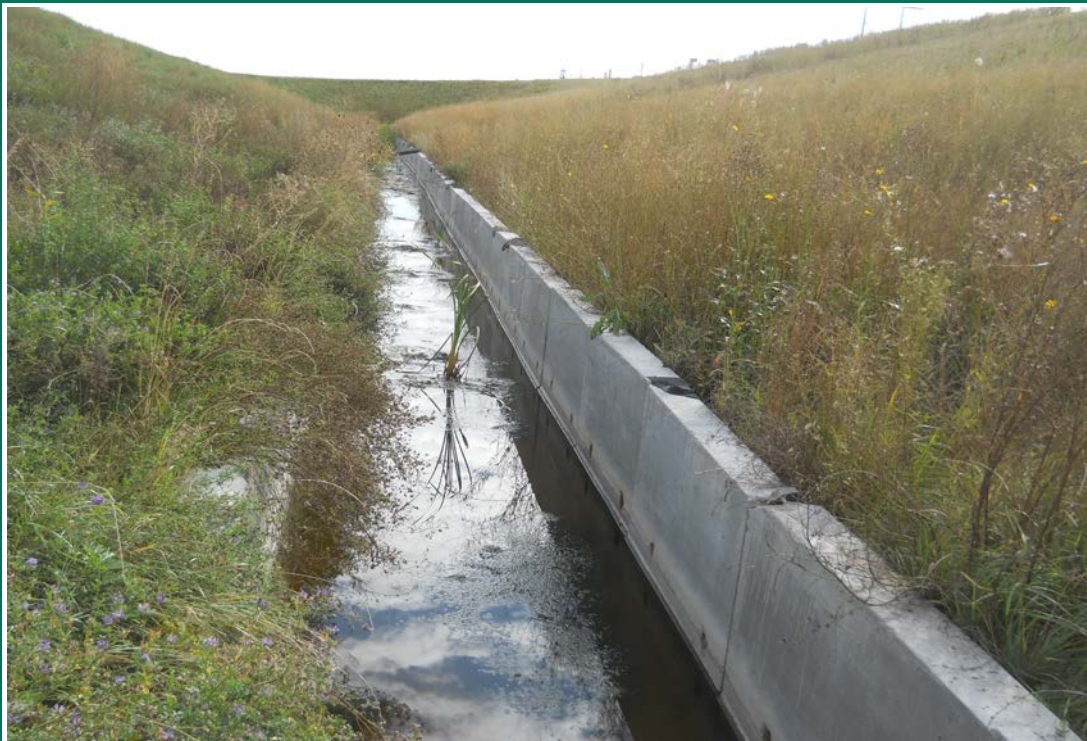
Photograph 14 (South toe)
Approximately 1 foot of water in concrete surface water channel (DSCN1726.JPG)

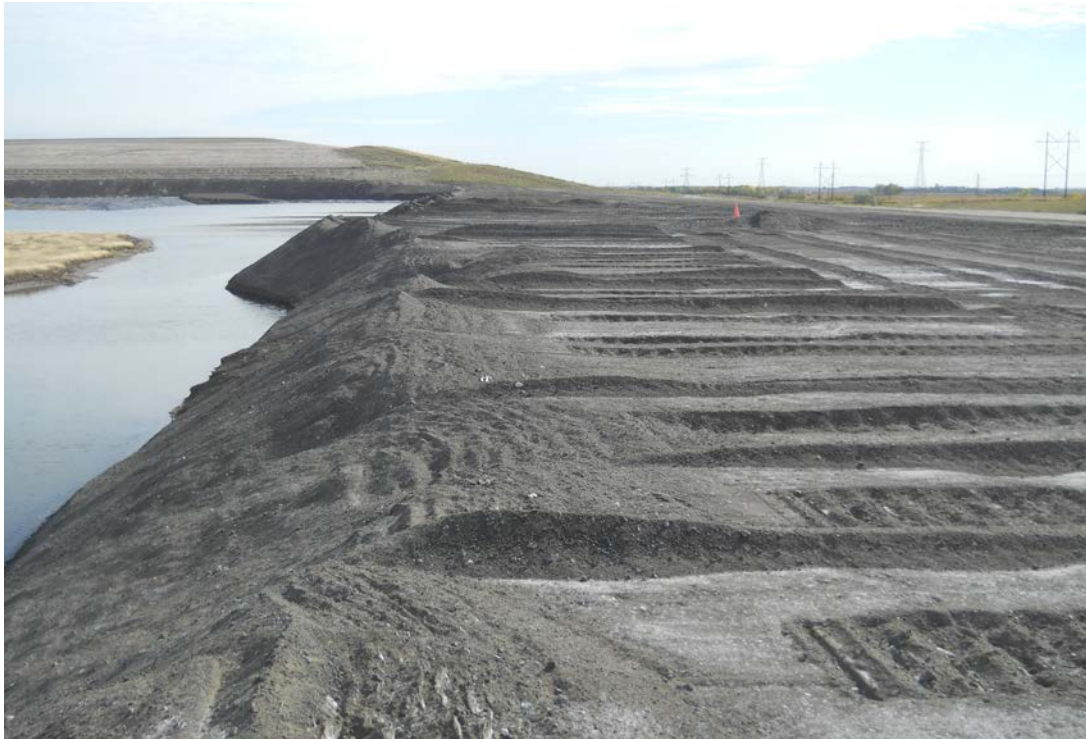
**Photograph 15 (South CCR upstream slope)
CCR placement in Upstream Raise 91 (DSCN1727.JPG)**

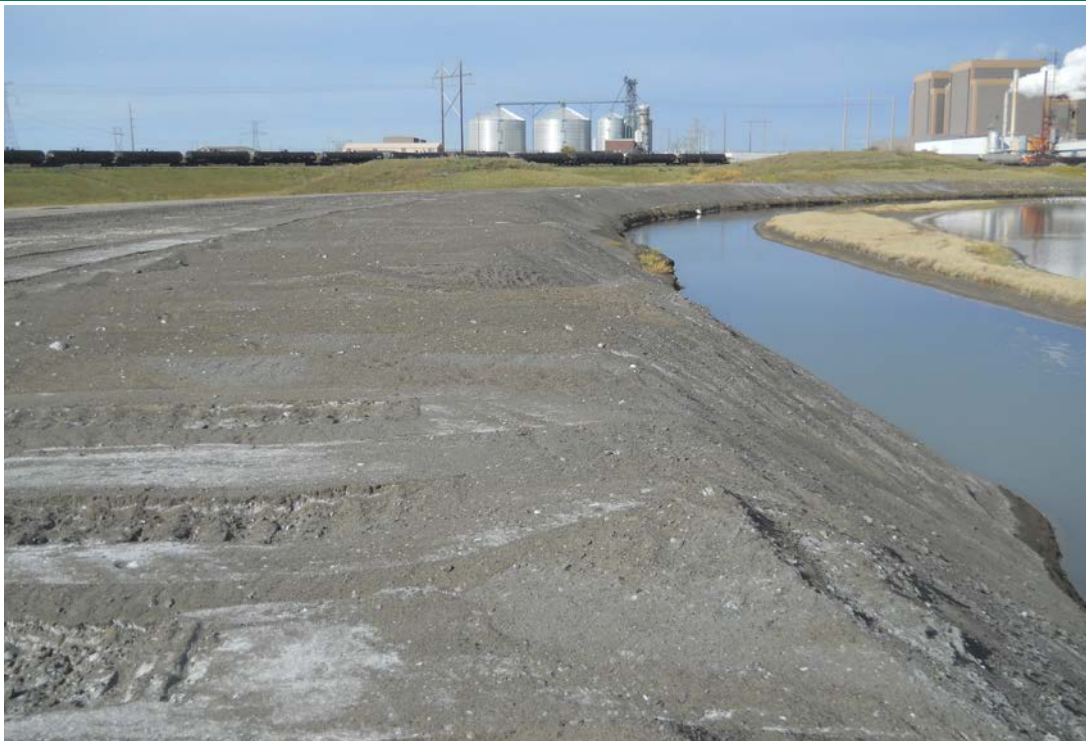
**Photograph 16 (South CCR upstream slope)
CCR placement in Upstream Raise 91 (DSCN1728.JPG)**

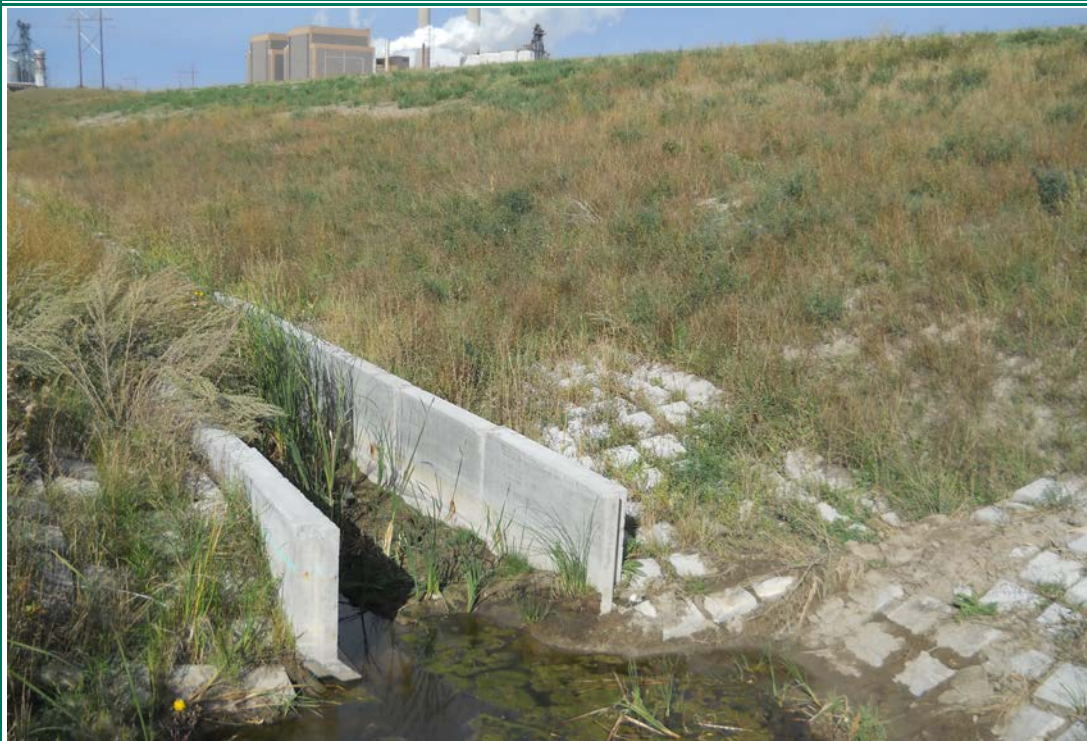
Photograph 17 (South berm downstream slope)
South berm downstream slope and concrete surface water channel (DSCN1731.JPG)

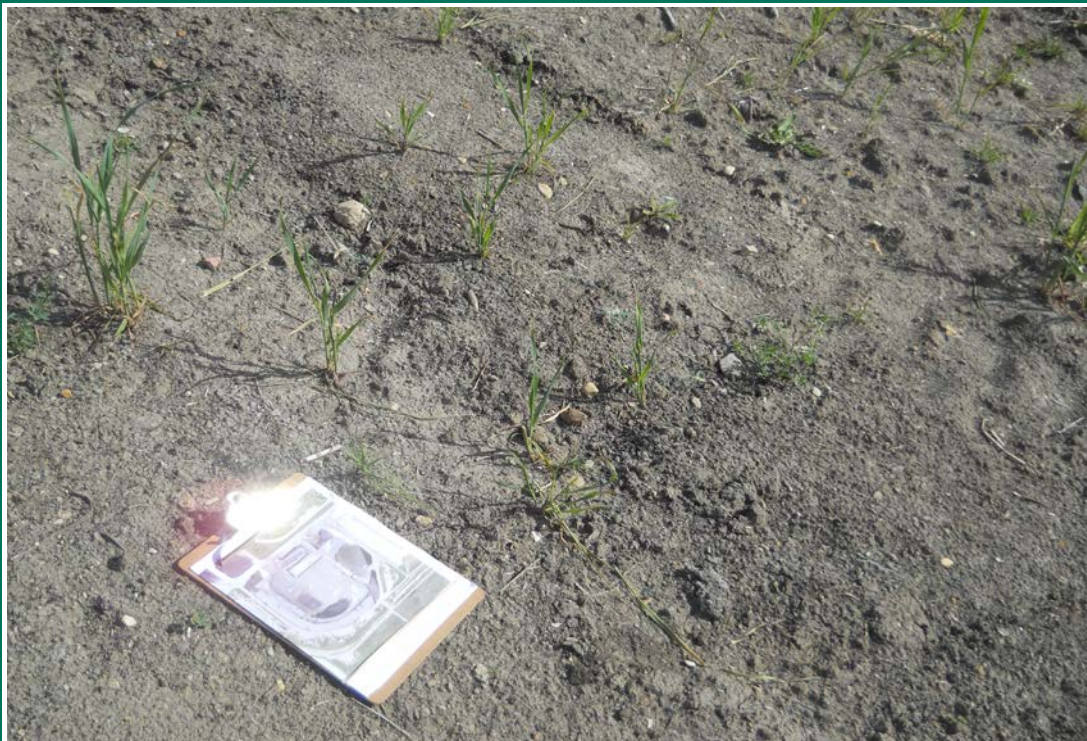
Photograph 18 (South berm downstream slope)
Scarce vegetation on south berm downstream slope (recently repaired) (DSCN1734.JPG)

General Remarks: The impoundment is in good condition (no significant stability concerns). Downstream slopes were repaired and reseeded, and erosion controls were installed. Areas on the south downstream slope may need to be reseeded again to limit future erosion.

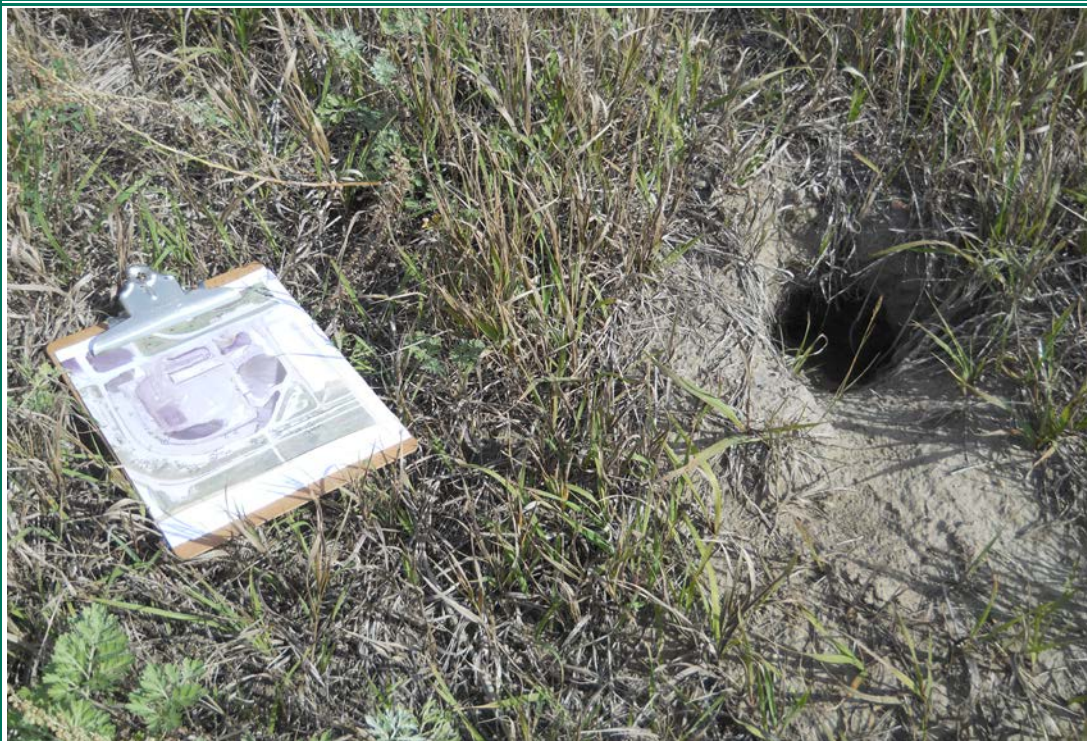
Photograph 19 (South berm downstream slope)
Animal burrow (DSCN1738.JPG)

Minor maintenance items that may need to be continually addressed include repairing large animal burrows as they appear, monitoring erosion and vegetative success of the re-configured surface water channel along the west and south toe of the facility, clean-out of collected material in the contact water perimeter channels and maintaining gravity and culvert piping, repairing and re-seeding eroded areas on or adjacent to berm downstream slopes, and removal of any woody vegetation growing on the berm downstream slopes. In addition, the inflow and outflow piping should be monitored regularly and cleared of debris as required to ensure proper conveyance of water to and from the facility.

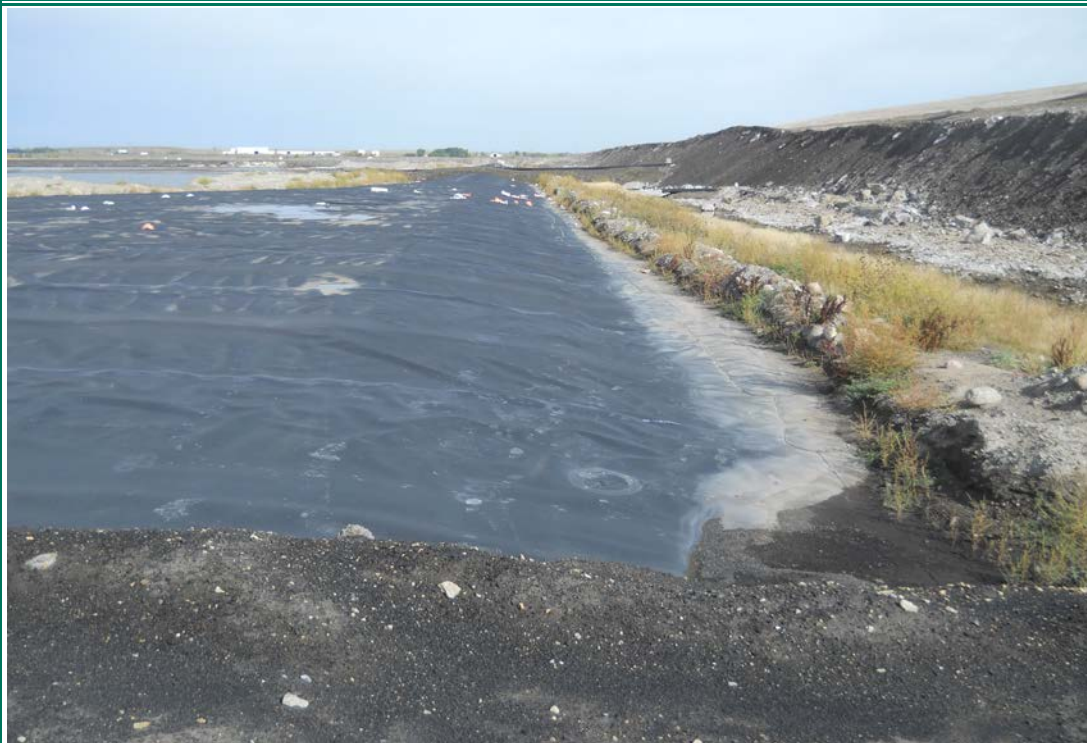
Photograph 21 (East berm crest)

Upstream Raise 91/Upstream Raise 92 liner connection (DSCN1741.JPG)

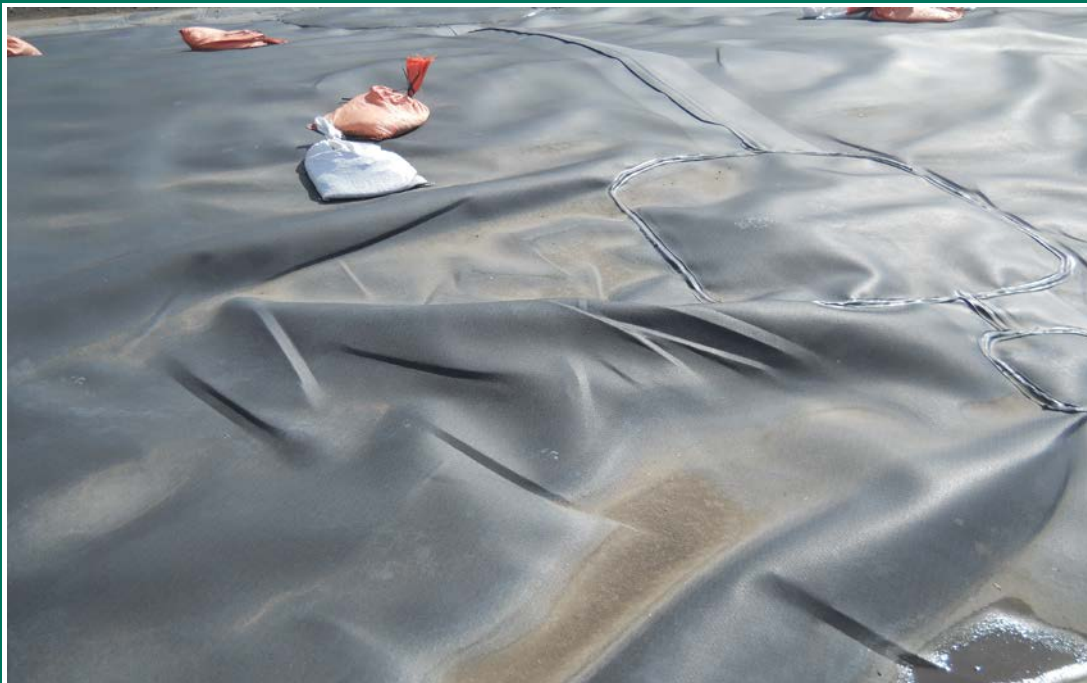
Photograph 22 (East berm crest)

Upstream Raise 91 was lined in September 2016 to connect the liner system of Upstream Raise 91 with the liner system of Upstream Raise 92. The exposed liner on the east berm crest appears to be in good condition with minor wrinkles noted of the geomembrane portion of the liner system. The berm crest roads on the west and south sides experience little heavy traffic and are mostly exposed to light vehicle traffic (cars, pickups, etc.). The berm crest road on the north side experiences frequent heavy traffic from large haul trucks. The road on the berm crest of Upstream Raise 91 appears to be in good condition, with no noticeable cracking or settlement, and appears to be well maintained. When wet, the road surface can become rutted and slippery. Ruts that develop on the road surface should be repaired as soon as possible to maintain access.

Geomembrane wrinkles in Upstream Raise 91/Upstream Raise 92 liner connection (DSCN1742.JPG)

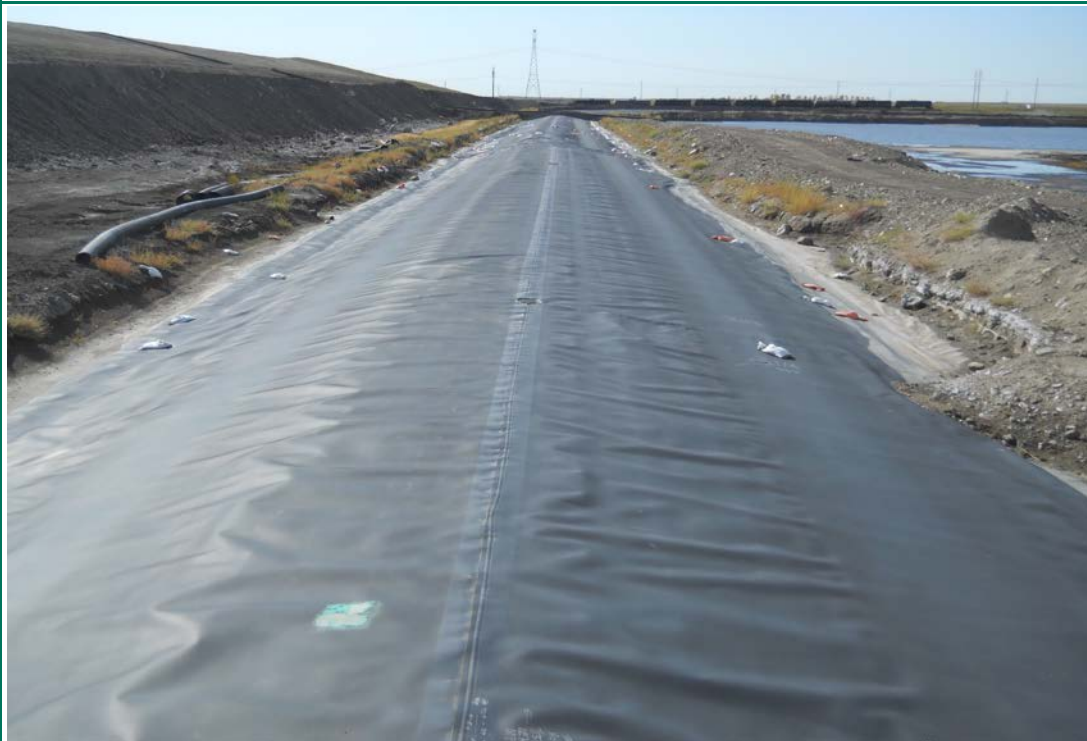
Photograph 23 (East berm crest)

Upstream Raise 91/Upstream Raise 92 liner connection (DSCN1747.JPG)

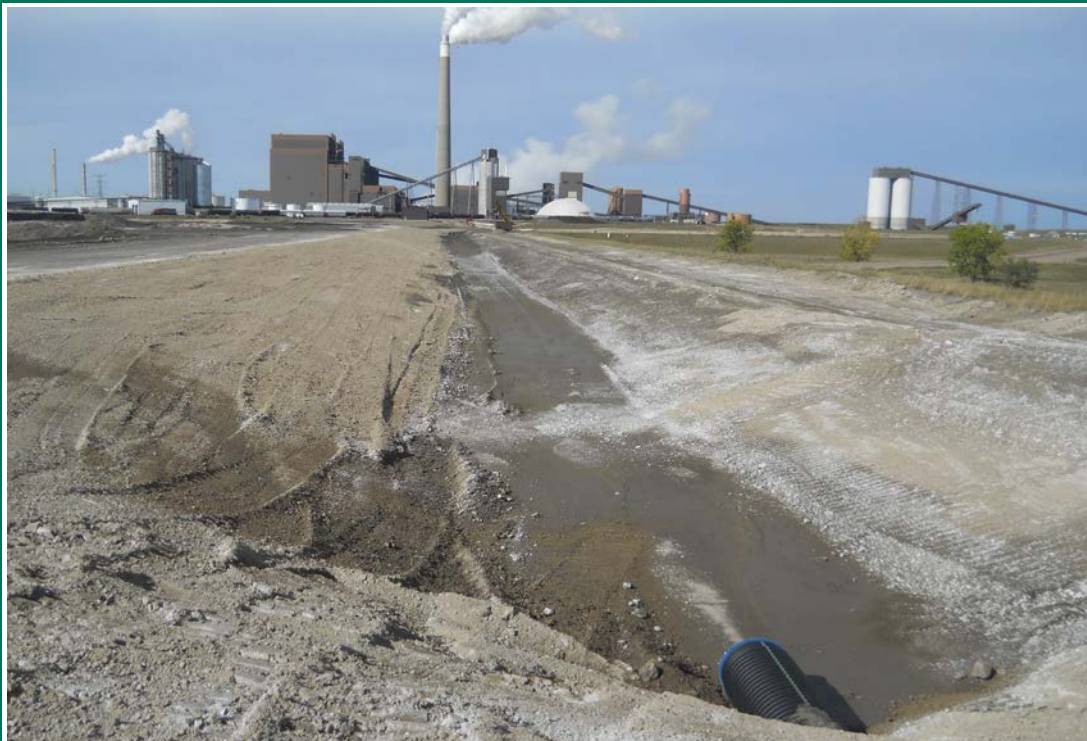
Photograph 24 (Northeast berm crest)

Culvert outlet from Upstream Raise 92 and contact water control channel (DSCN1748.JPG)

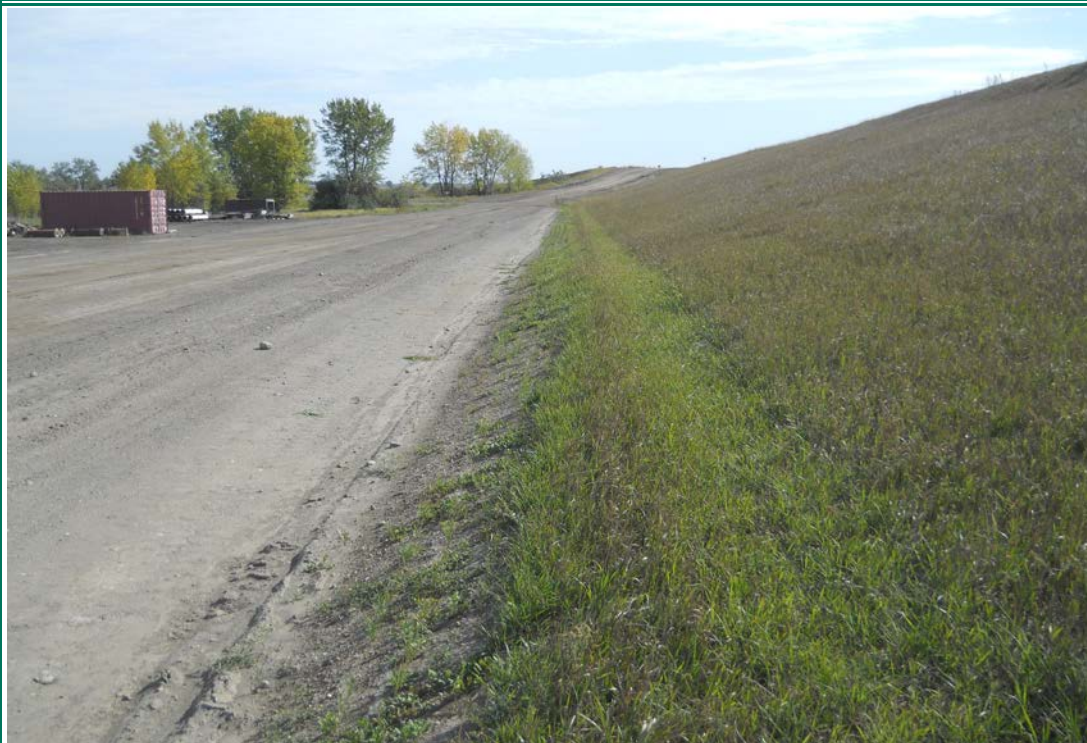
Photograph 25 (North toe)
North toe in good condition (DSCN1752.JPG)

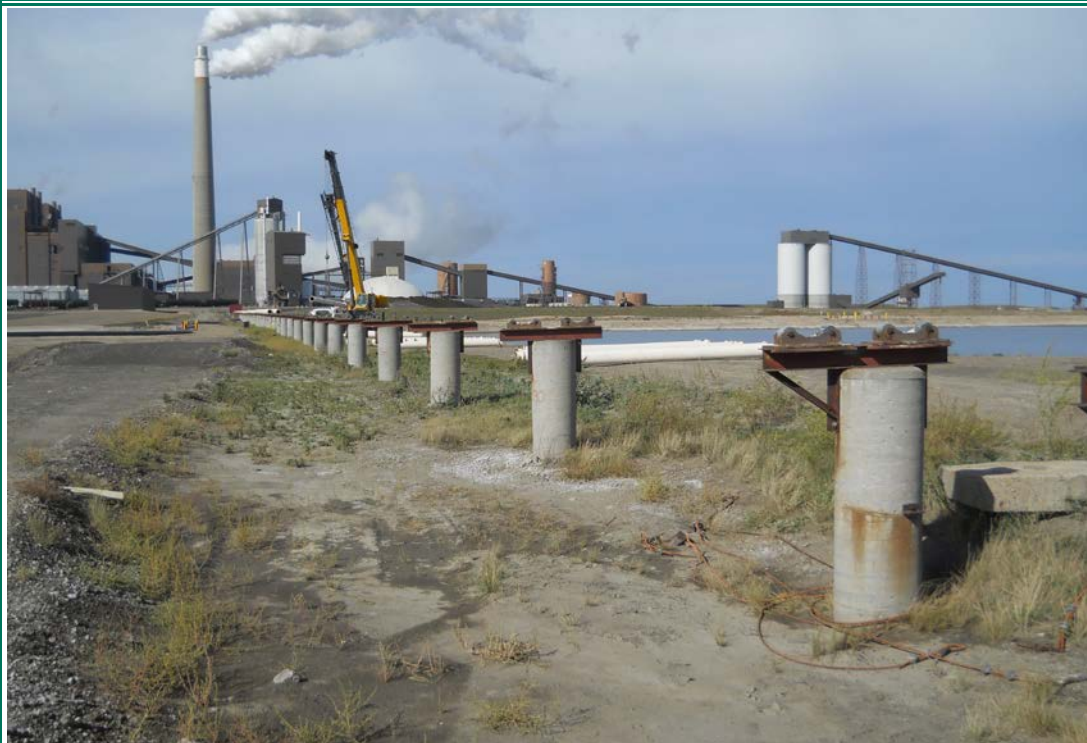
Photograph 31 (North Berm crest)
Ash pipeline ditch (DSCN1763.JPG)

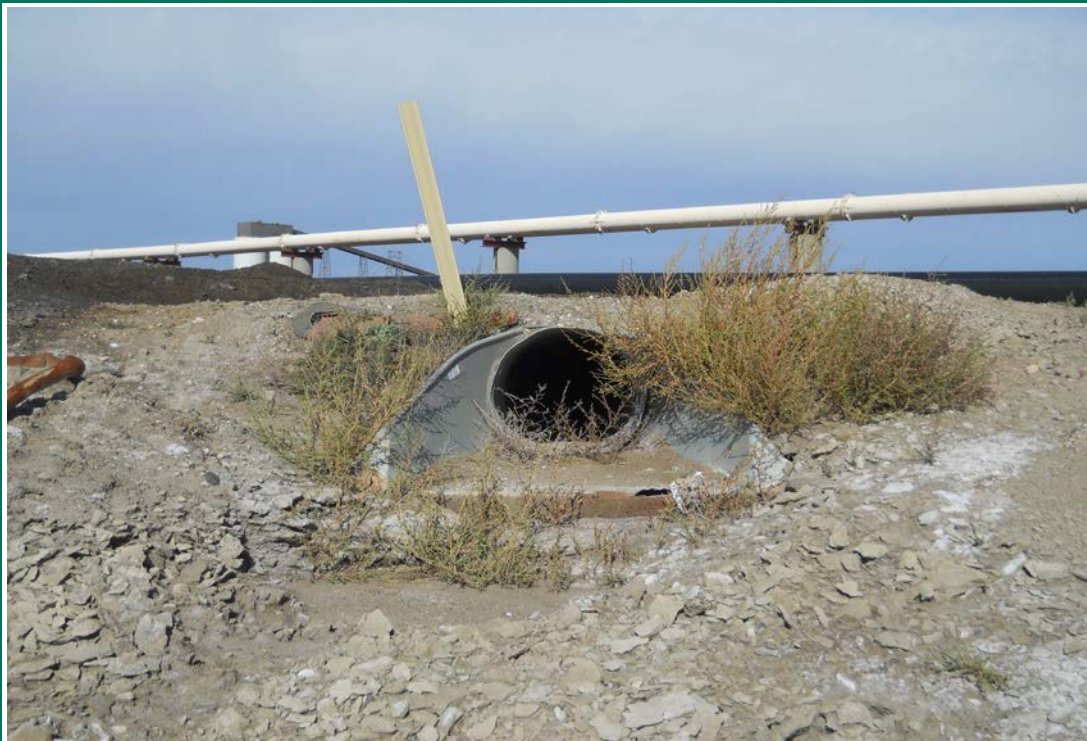
Photograph 32 (North berm upstream slope)
Ash pipelines ditch culvert to Upstream Raise 91 (DSCN1770.JPG)

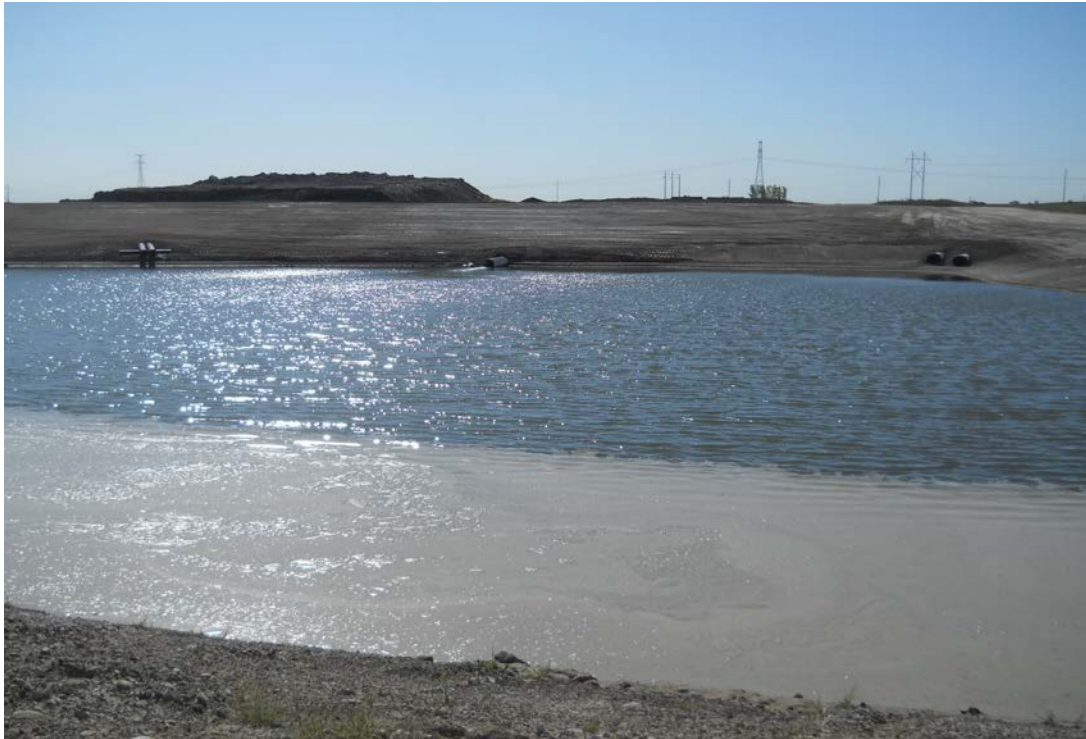
Photograph 33 (North berm upstream slope)

Gravity drainage pipelines (left side of photograph) and contact water management culverts (right side of photograph) (DSCN1769.JPG)
