ANNUAL INSPECTION REPORT

GREAT RIVER ENERGY – COAL CREEK STATION

Upstream Raise 92 CCR Surface Impoundment

January 2018 1772255

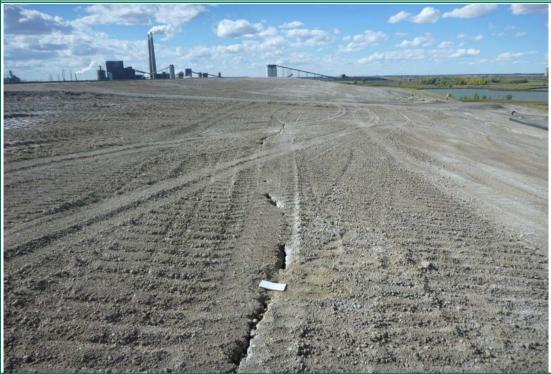
Photograph 1 (North CCR downstream slope)
Minor (<6 inches) crack approximately 50 feet long (P1040090.JPG)

Minor maintenance items that may need to be continually addressed include monitoring the size and shape of cracks in CCR downstream slope and CCR crest of the facility, repairing large animal burrows as they appear, monitoring erosion and vegetative success of the re-configured surface water channel along the south toe of the facility (including construction to complete downchute channels and hydraulic jump basins prior to final cover of the entirety of Upstream Raise 92), clean-out of collected material in the perimeter channels and maintaining gravity and culvert piping between Upstream Raise 91 and Upstream Raise 92, re-seeding of CCR downstream slopes with final cover, and removal of any woody vegetation growing on the berm downstream slopes. In addition, the inflow and outflow piping should be monitored regularly to ensure proper conveyance of water to and from the facility.

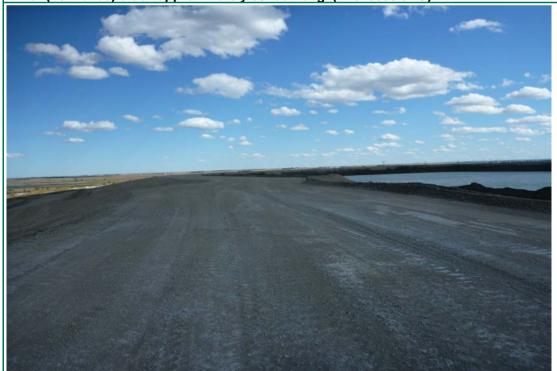
Photograph 2 (North CCR crest)
Fly ash/bottom ash CCR crest (P1040093.JPG)

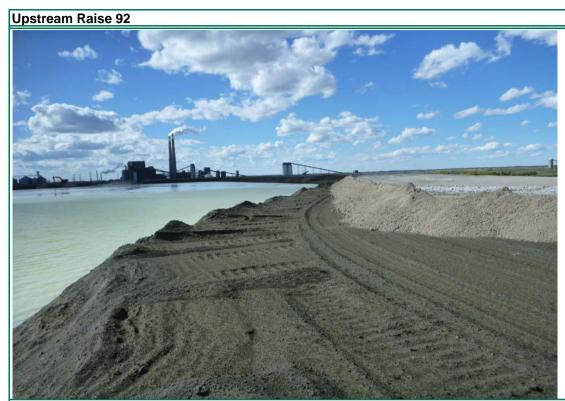
Photograph 3 (North CCR upstream slope)
CCR upstream slope bottom ash (P1040095.JPG)

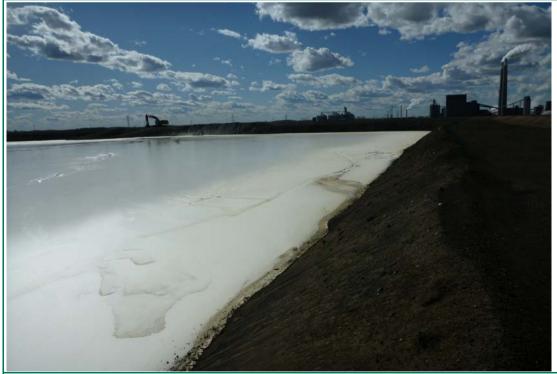
Photograph 4 (North CCR upstream slope)
CCR upstream slope bottom ash (P1040098.JPG)

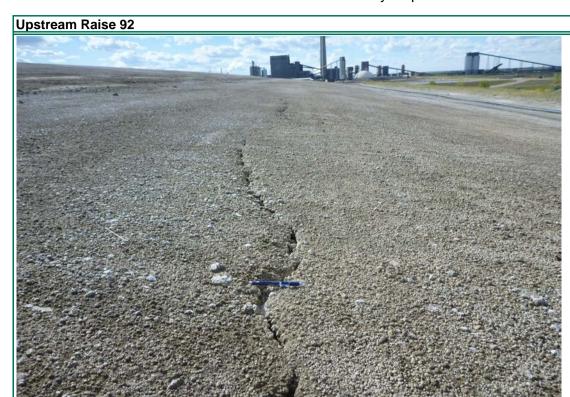
Photograph 5 (North CCR downstream slope)
Minor crack in fly ash (<4 inches) (P1040099.JPG)

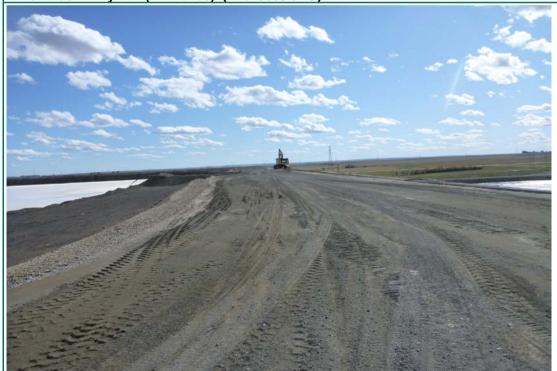
Photograph 6 (West CCR crest)
Fly ash/bottom ash CCR crest (P1040101.JPG)

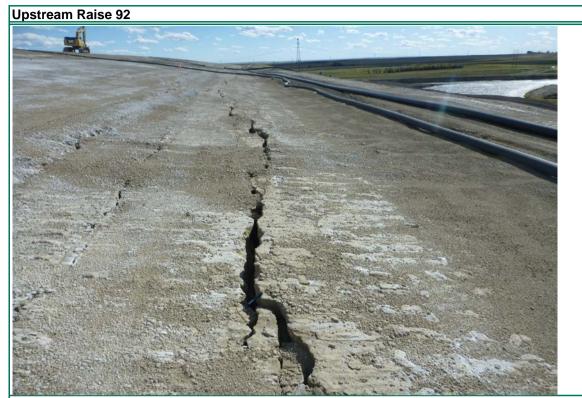
Photograph 7 (West CCR downstream slope)
Crack in fly ash CCR downstream slope (approximately 8 inches wide) (P1040103.JPG)

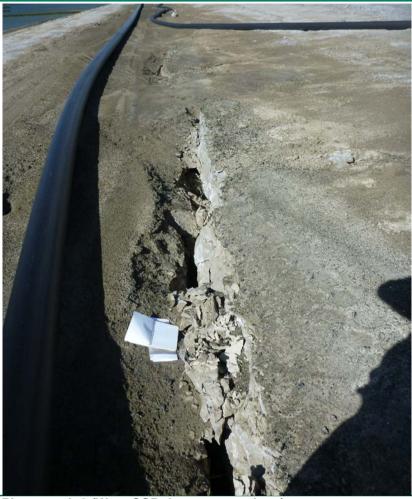
Photograph 8 (West CCR downstream slope)
Crack on fly ash CCR downstream slope (approximately 18 inches) (P1040105.JPG)

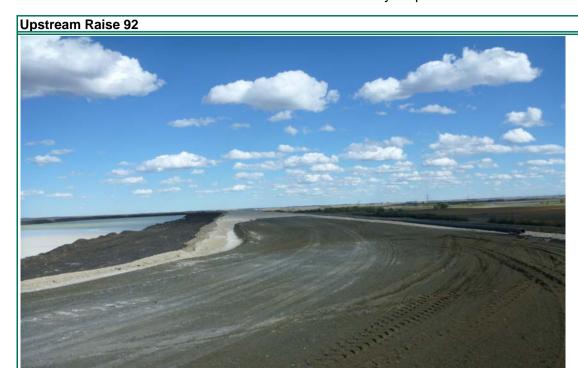
Photograph 9 (South CCR crest)
Fly ash/bottom ash CCR crest (P1040109.JPG)

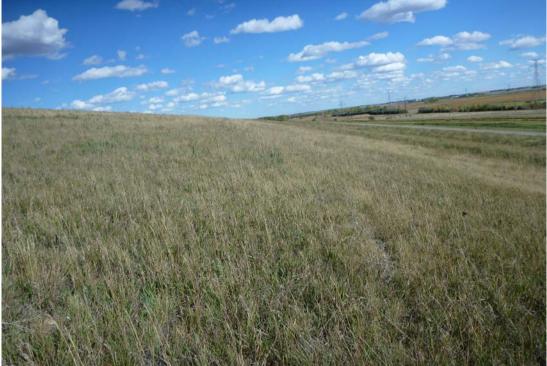
Photograph 10 (South CCR downstream slope with final cover) Final cover on CCR downstream slope (P1040112.JPG)

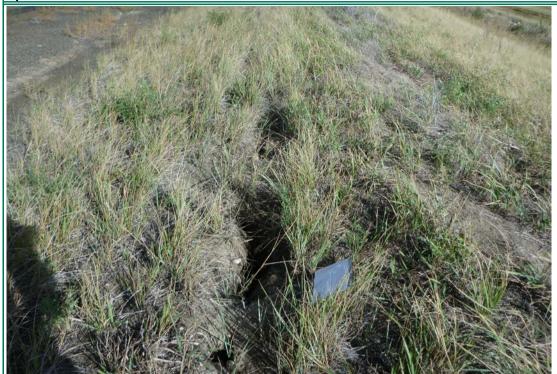
Photograph 11 (South CCR downstream slope with final cover) Crack on final cover slope near 1974 ft. bench (P1040117.JPG)

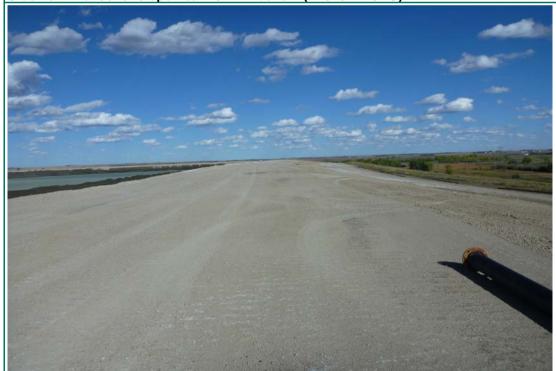
Photograph 12 (South CCR crest)
Fly ash CCR crest (P1040120.JPG)

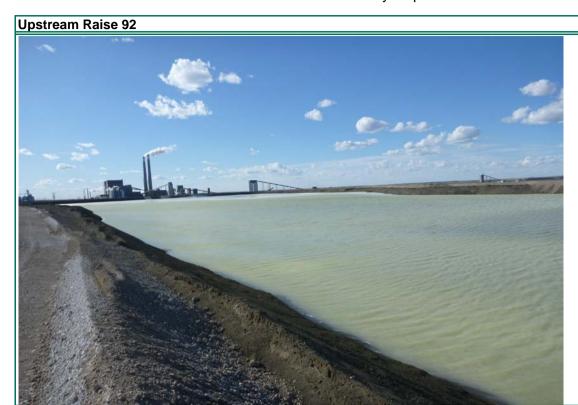
Photograph 13 (South CCR upstream slope)
Bottom ash CCR upstream slope (P1040123.JPG)

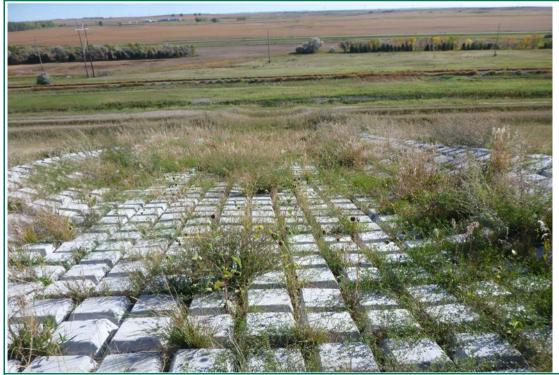
Photograph 14 (South CCR downstream slope with final cover)
Articulated Concrete Block (ACB) downchute channel (P1040124.JPG)

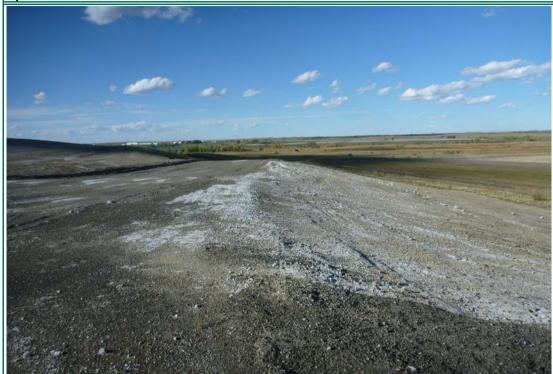
Photograph 15 (East CCR downstream slope)
Fly ash haul road on east side (P1040129.JPG)

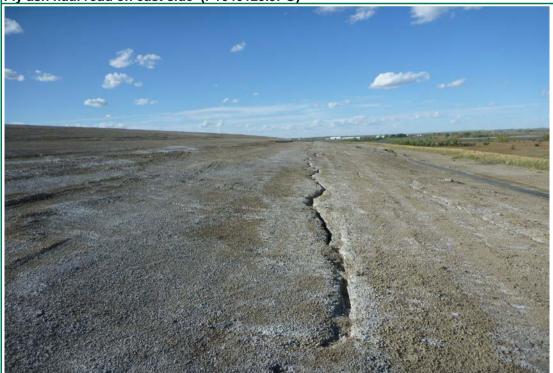
Photograph 16 (East CCR downstream slope)
Crack in fly ash (approximately 6 inches wide) (P1040131.JPG)

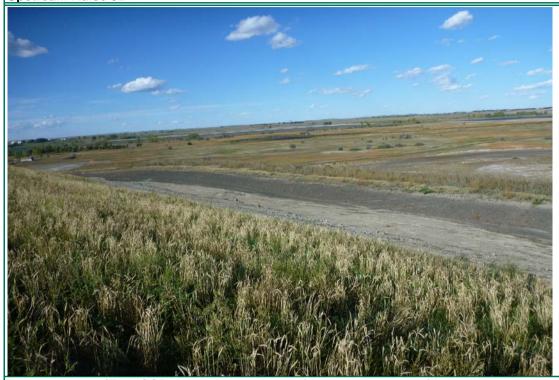
Photograph 17 (East CCR downstream slope with temporary cover)
CCR downstream slope temporary cover and 1950 ft. bench (P1040136.JPG)

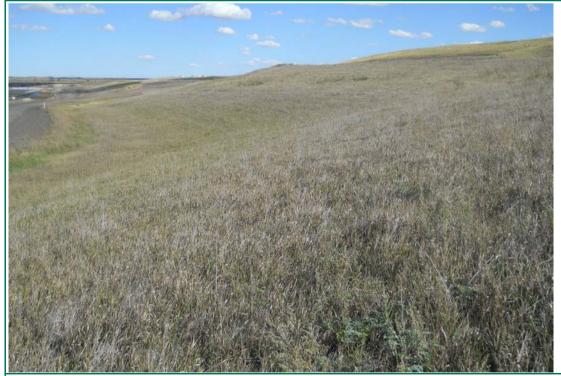
Photograph 18 (North CCR downstream slope with temporary cover) Well vegetated slope below 1950 ft. elevation (DSCN1600.JPG)

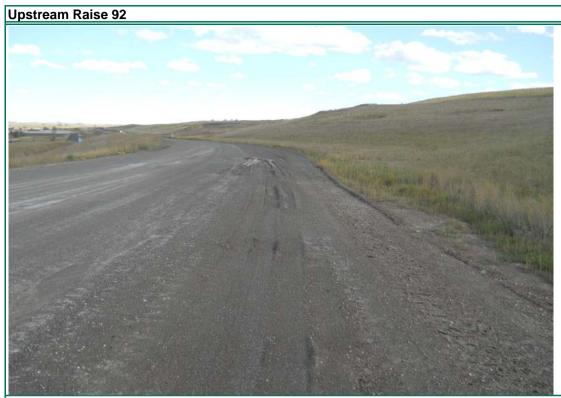
Photograph 19 (North berm crest) North haul road (DSCN1602.JPG)

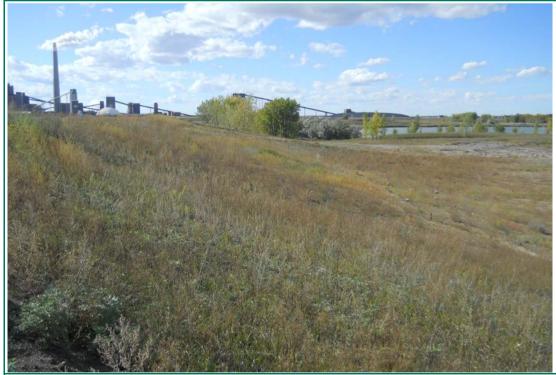
Photograph 20 (North berm downstream slope)
Berm downstream slope below 1920 ft. road (DSCN1605.JPG)

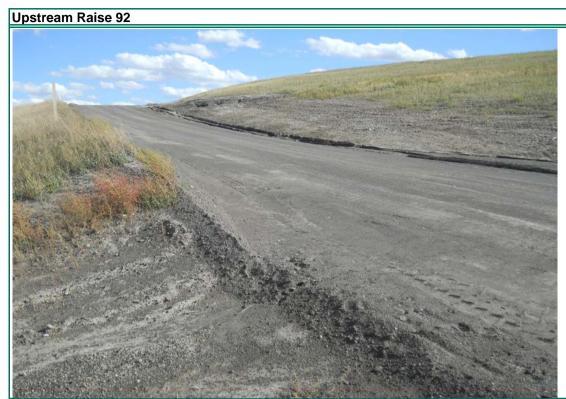
Photograph 21 (North CCR downstream slope with temporary cover)
North haul road ramp and CCR downstream slope temporary cover (DSCN1607.JPG)

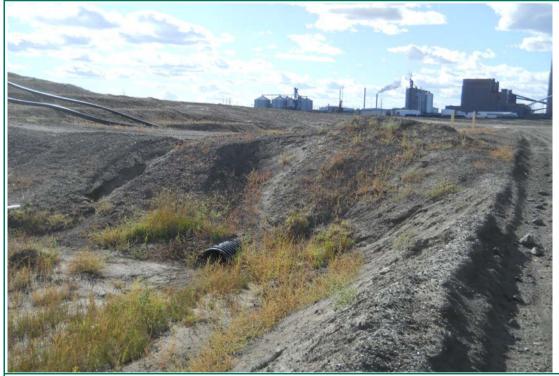
Photograph 22 (Northwest berm upstream slope)
Contact water culvert to Upstream Raise 91 (DSCN1616.JPG)

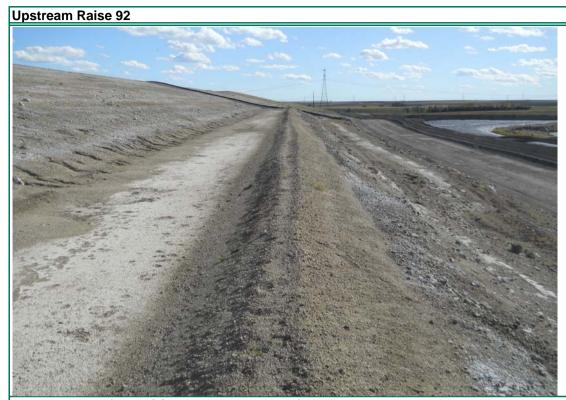
Photograph 23 (West CCR downstream slope)
Minor erosion rills in fly ash at 1950 ft. bench (DSCN1619.JPG)

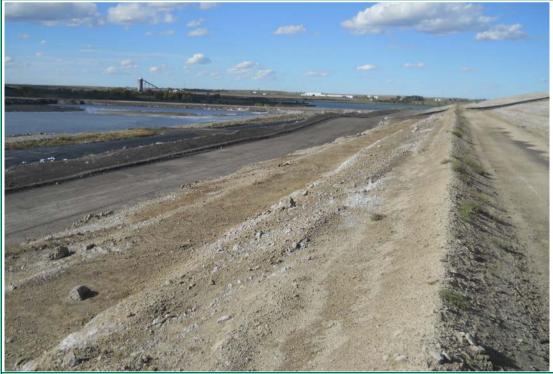
Photograph 24 (West CCR downstream slope)
West CCR downstream slope and 1950 ft. bench (DSCN1622.JPG)

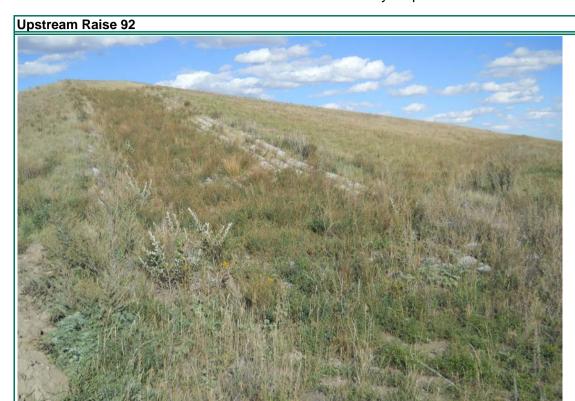
Photograph 25 (Southwest CCR downstream slope with final cover) Southwest downchute channel (DSCN1623.JPG)

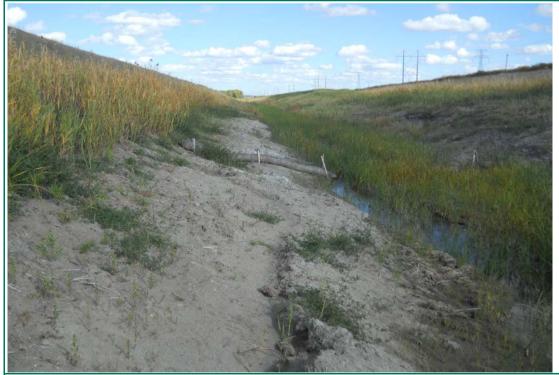
Photograph 26 (South berm downstream slope and toe) South surface water drainage ditch (DSCN1625.JPG)

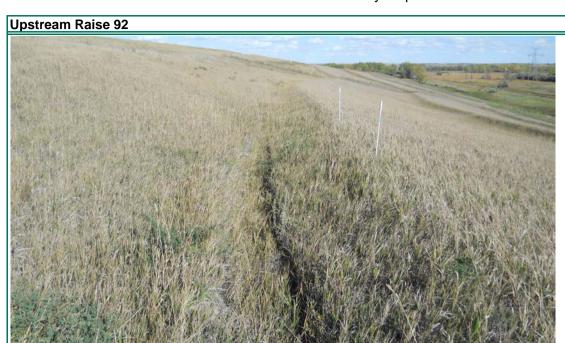
Photograph 27 (South CCR downstream slope with final cover)
Terrace channel rutting (approximately 12 inches deep) (DSCN1635.JPG)

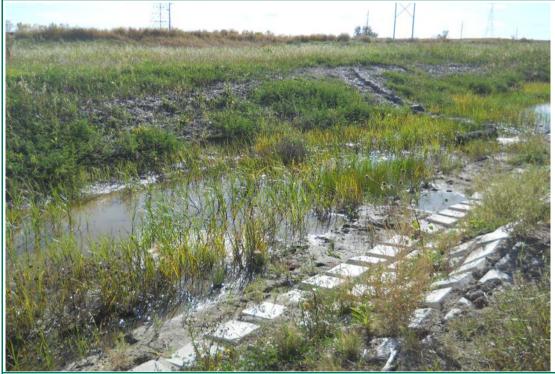
The surface water drainage at the toe of the slope on the south side of Upstream Raise 92 had some marshy vegetation and standing water. The surface water drainage ditch in this area was recently modified to promote flow toward site surface water drainages and therefore portions of this ditch were not yet well-vegetated. The presence of some standing water in this surface water drainage ditch was still noted due to the low average slope of this ditch and the fact that it is near groundwater levels. Side slopes of this drainage ditch are also relatively steep near the toe, but did not show signs of movement. The toe may need to be regraded and reseeded in the future to limit erosion. In addition, the downchute channels should be extended and hydraulic jump basins constructed on the south side of the facility to limit erosion when final cover is constructed over the entirety of Upstream Raise 92.

Photograph 28 (South berm downstream slope and toe)
Standing water in south surface water drainage ditch and toe of downchute channel (DSCN1638.JPG)

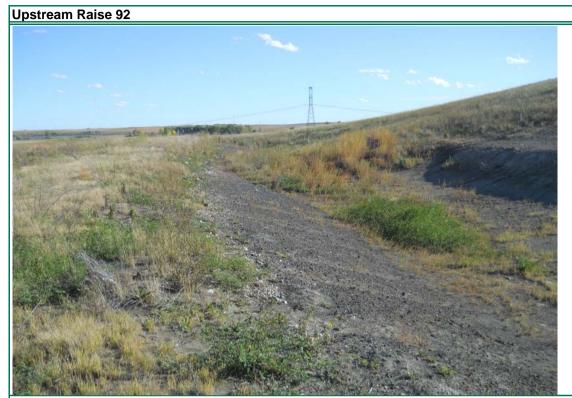
Photograph 29 (East CCR downstream slope)
East CCR downstream slope and connection with Southeast 16 (DSCN1644.JPG)

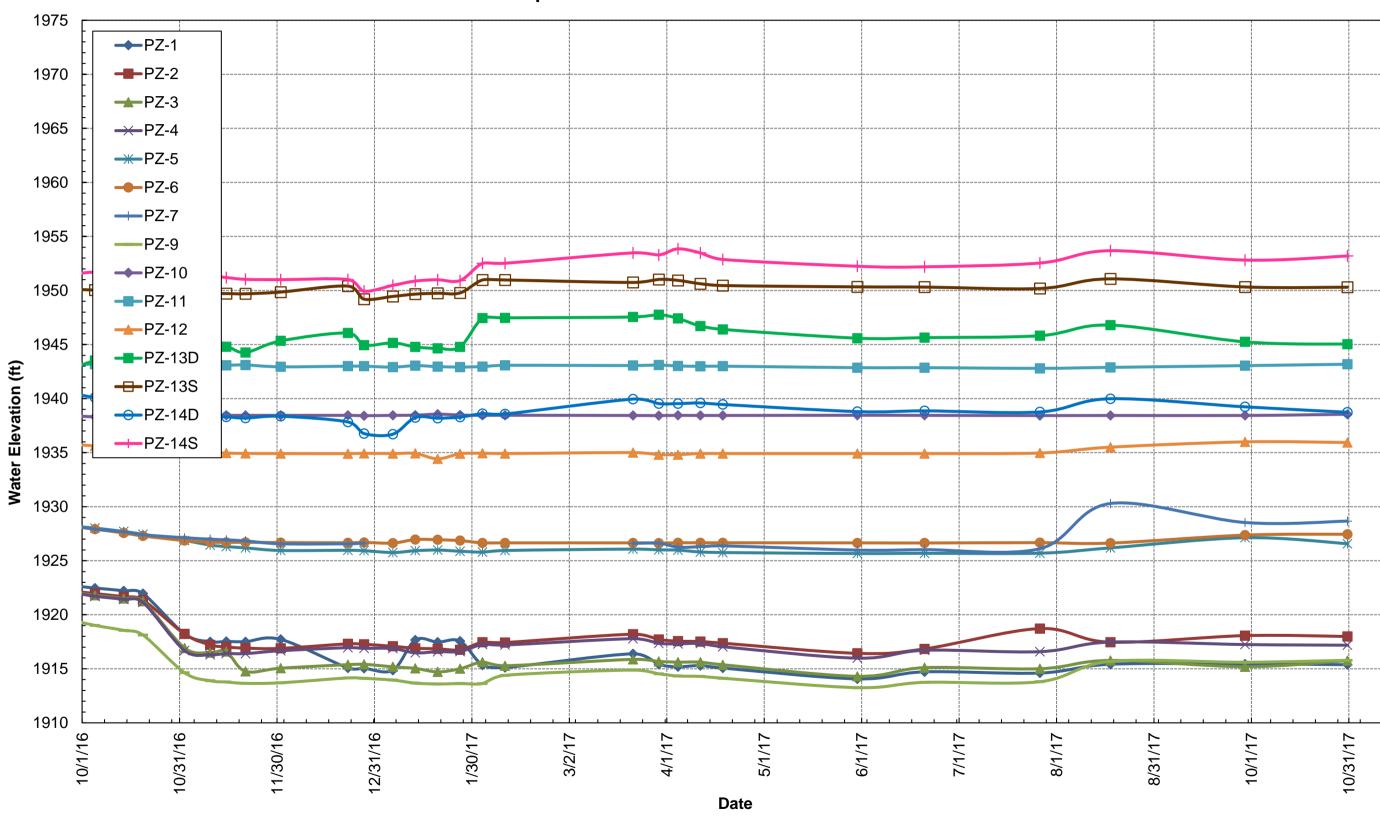
Upstream Raise 92 Piezometer Elevations

Piezometer measurements for the past year are included in Appendix D-1. Piezometers PZ-1 through PZ-12 were constructed near the perimeter bottom ash seepage piping and have historically fluctuated by less than approximately 3 feet as the facility height has increased. Piezometers PZ-13 (D and S) and PZ-14 (D and S) were constructed along the side slopes of the facility and show greater variability since installation as they are nearer to the FGD material pool in the center of the facility.

In 2016, piezometer PZ-13D rose approximately 15 feet, and has equilibrated at this new higher level. Preliminary evaluation of Piezometer PZ-13D suggests that the casing may be damaged and connecting the water within the piezometer to a different zone than the screened portion of the piezometer. This piezometer will continue to be monitored, but may be removed from future monitoring if deemed to be damaged.
