REPORT

Annual Inspection

Stanton Station - Bottom Ash CCR Landfill

January 2019

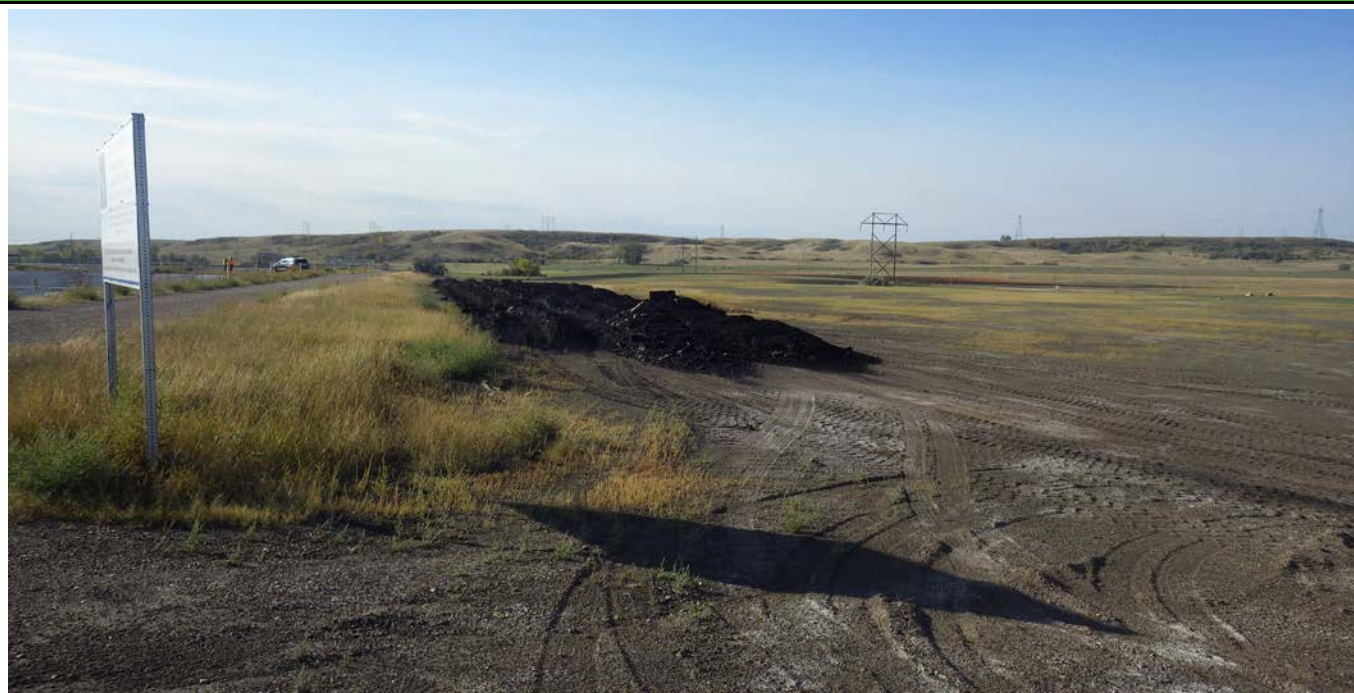
Photograph 1 (NE corner)
Bottom Ash Landfill panoramic from northeast corner (1 or 3) (IMG6257.JPG)

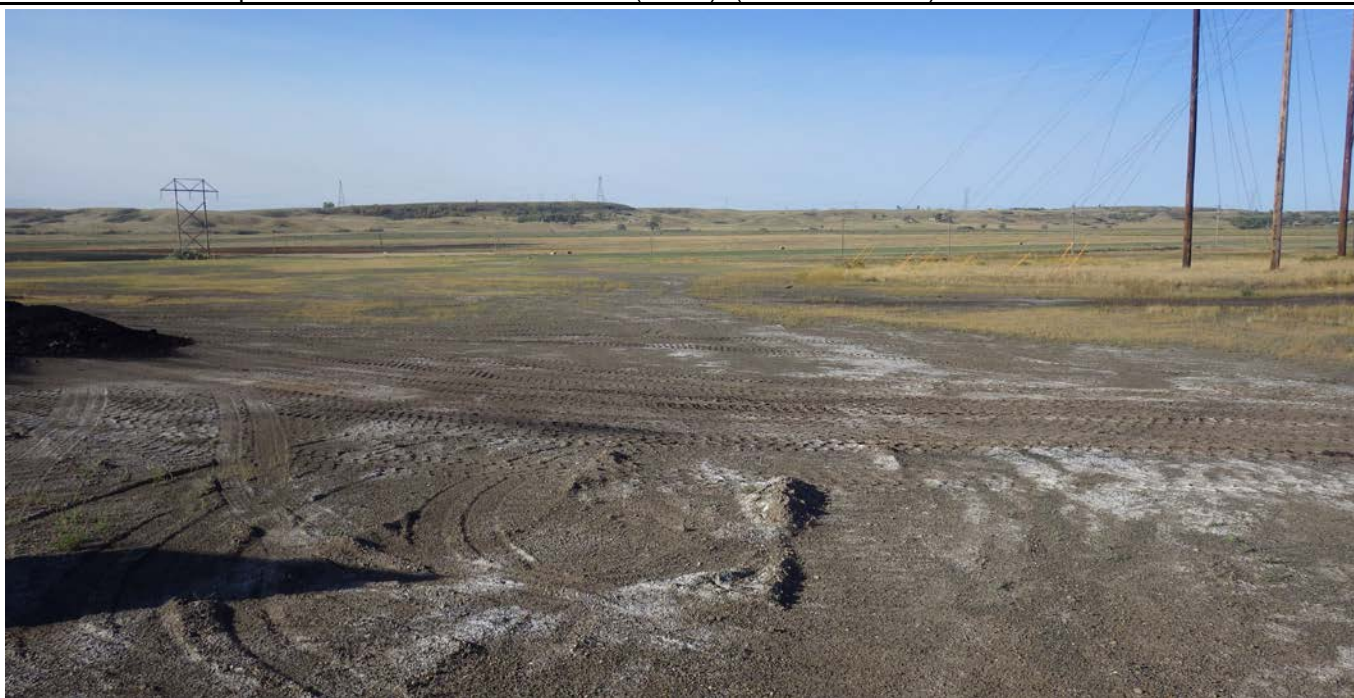
Photograph 2 (NE corner)
Bottom Ash Landfill panoramic from northeast corner (2 or 3) (IMG6258.JPG)

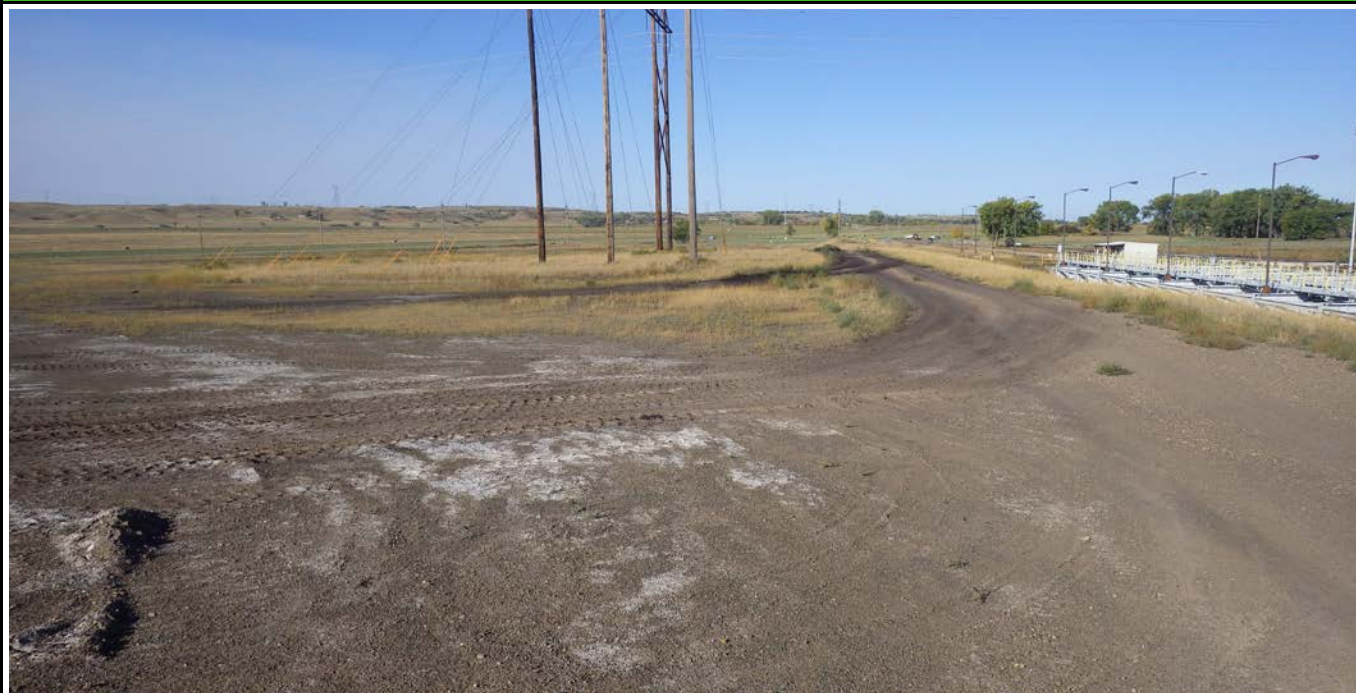
Photograph 3 (NE corner)
Bottom Ash Landfill panoramic from northeast corner (3 or 3) (IMGP6259.JPG)

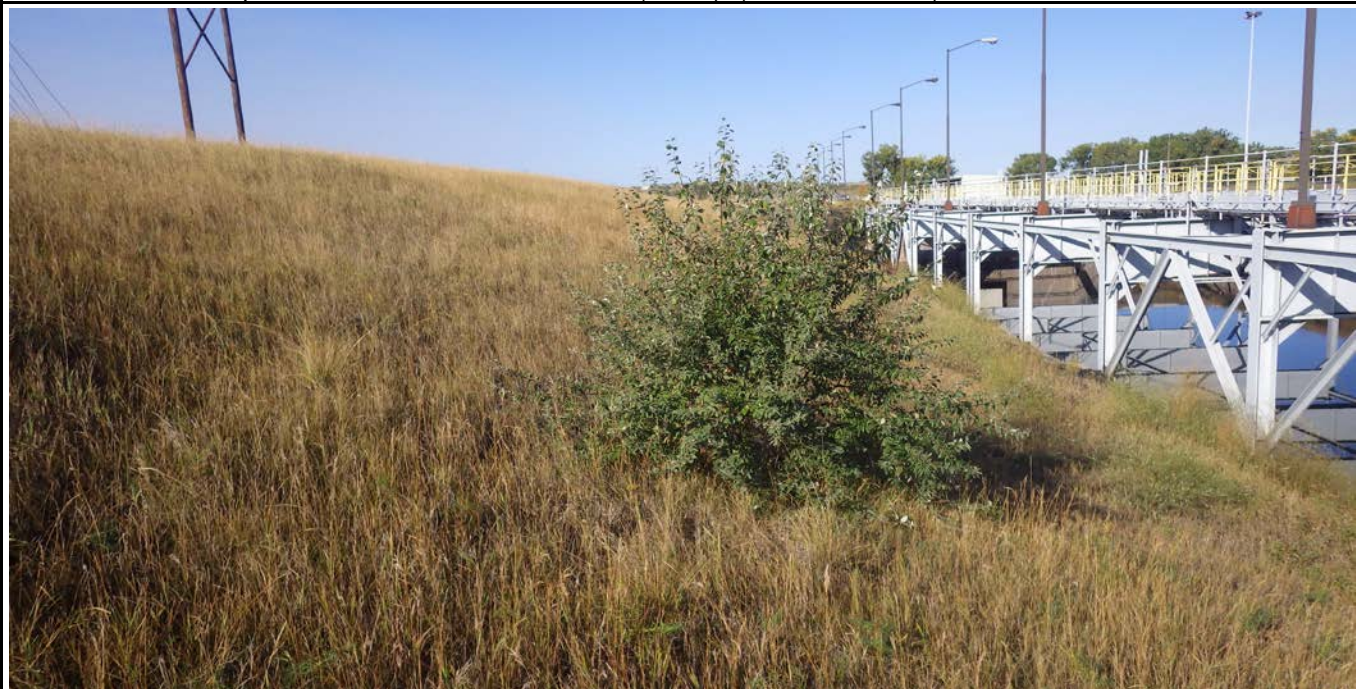
The berm downstream slopes on the north, west, and south sides are between approximately 5 feet and 10 feet high and have slopes of approximately 3:1. Slopes are well vegetated with grass, but do contain numerous, but mostly small, animal burrows. A small tree was also observed on the berm downstream slope on the south side of the facility. This small tree along with any other woody vegetation should be removed from the landfill. The berm downstream slopes of the Bottom Ash Landfill appear to be in fair condition.

Photograph 4 (North downstream slope)
Woody vegetation on downstream slope (IMGP6260.JPG)

Minor maintenance items that may need to be continually addressed include repairing larger animal burrows as they appear, repairing stormwater and/or contact water control features to control run-on and runoff, monitoring vegetative success of berm downstream slopes, and removal of any woody vegetation growing on the berm downstream slopes.

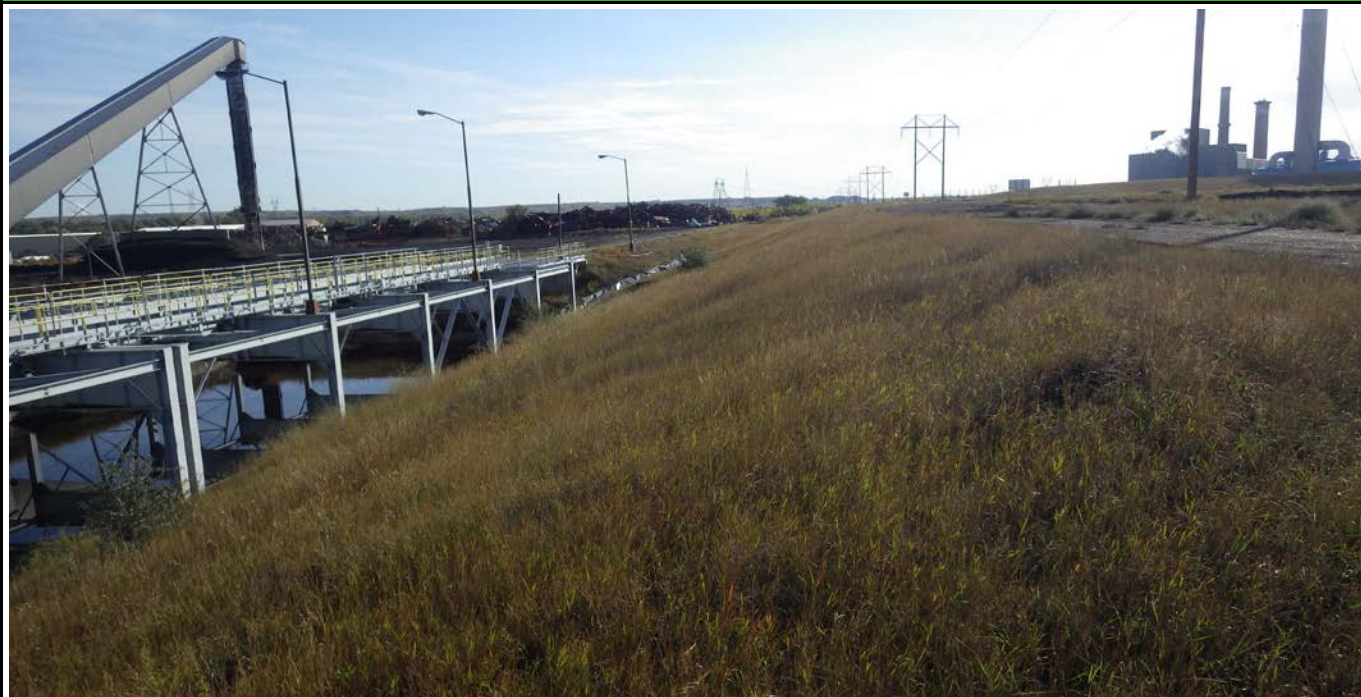
Photograph 5 (North downstream slope)
Grass vegetation on downstream slope (IMG6262.JPG)

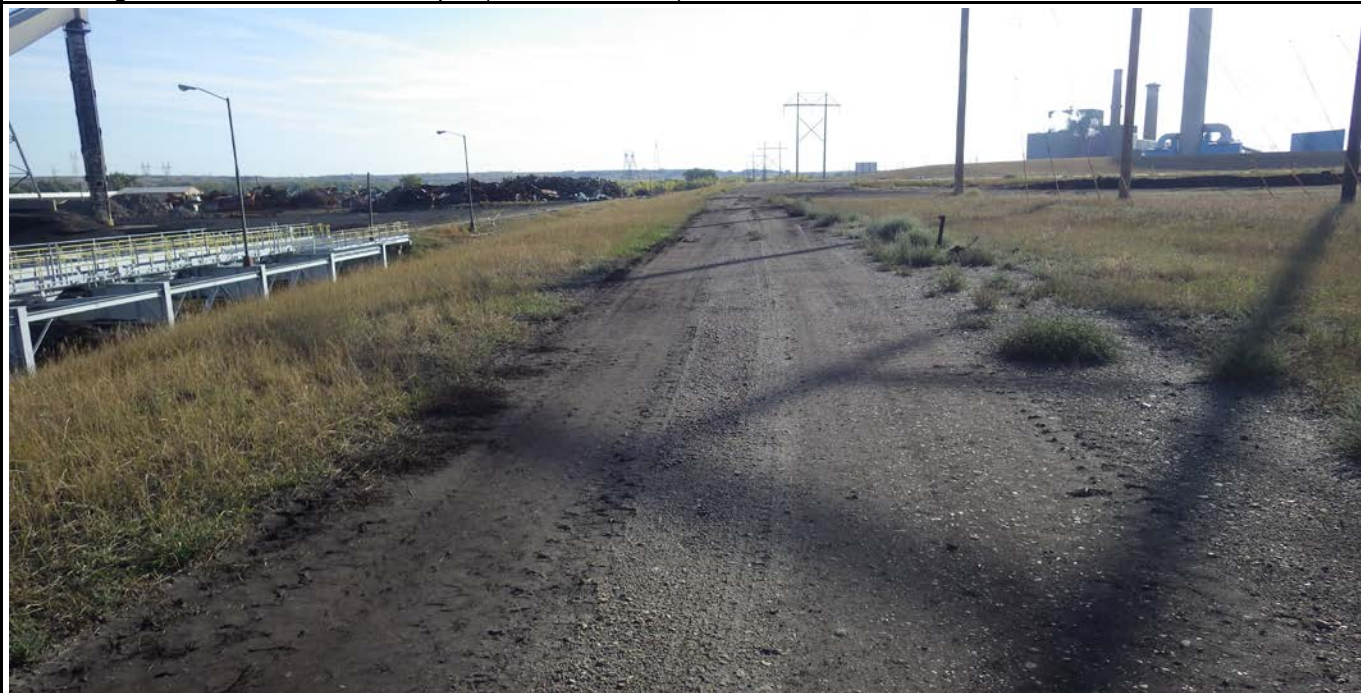
The east berm crest and part of the north berm crest of the Bottom Ash Landfill are surfaced with gravel at elevations between approximately 1715 feet amsl and 1720 feet amsl. These roads are primarily used for light vehicle traffic. The west and south perimeter berm crests are vegetated with grass and are not surfaced for vehicle travel. Bottom Ash Landfill berm crests appeared to be in good condition.

Photograph 6 (North crest)
North berm crest with road surface gravel (IMG6261.JPG)

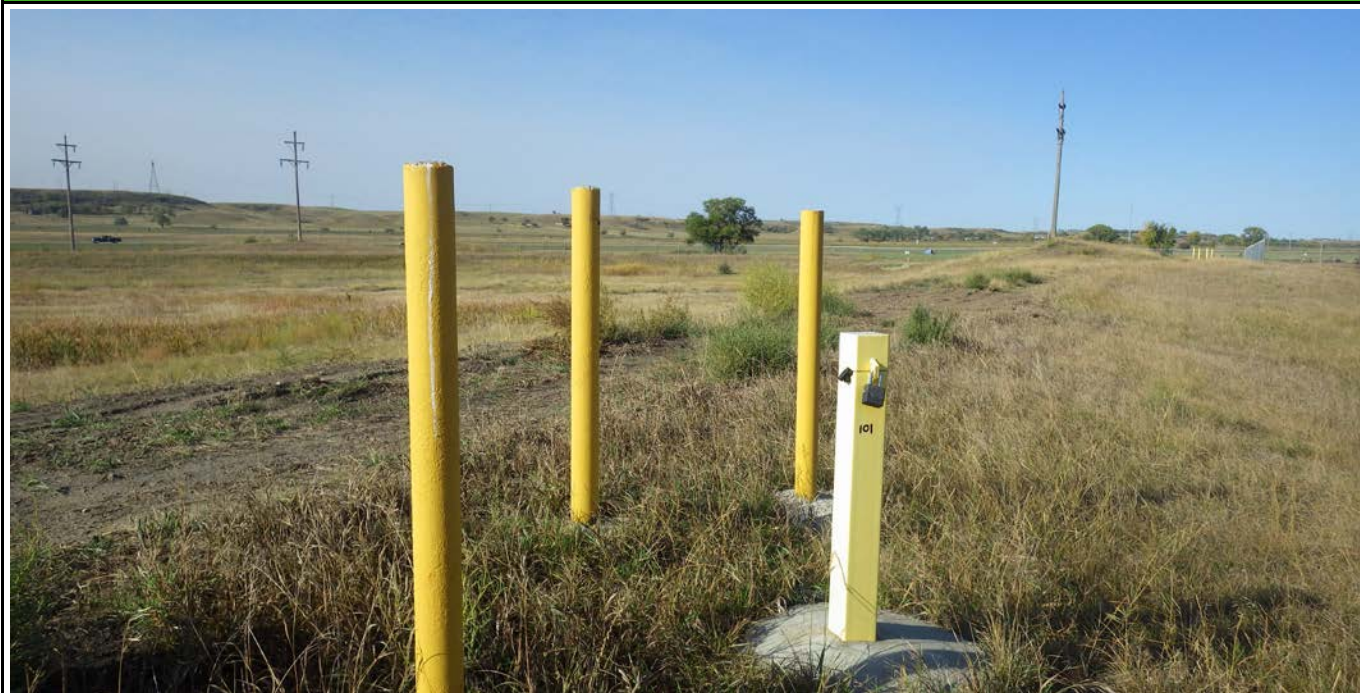
Photograph 7 (North downstream slope)
Monitoring well on north side of Bottom Ash Landfill (IMGP6267.JPG)

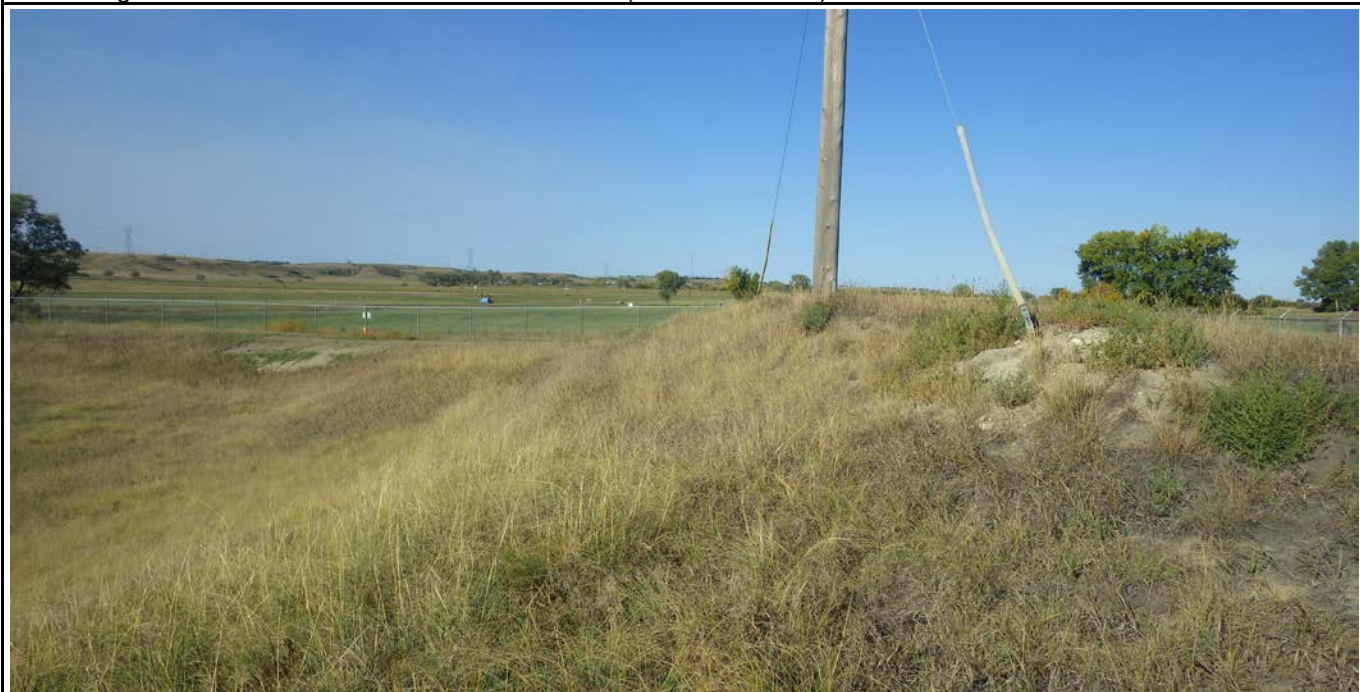
Photograph 8 (NW corner)
North berm crest and power pole (IMGP6269.JPG)

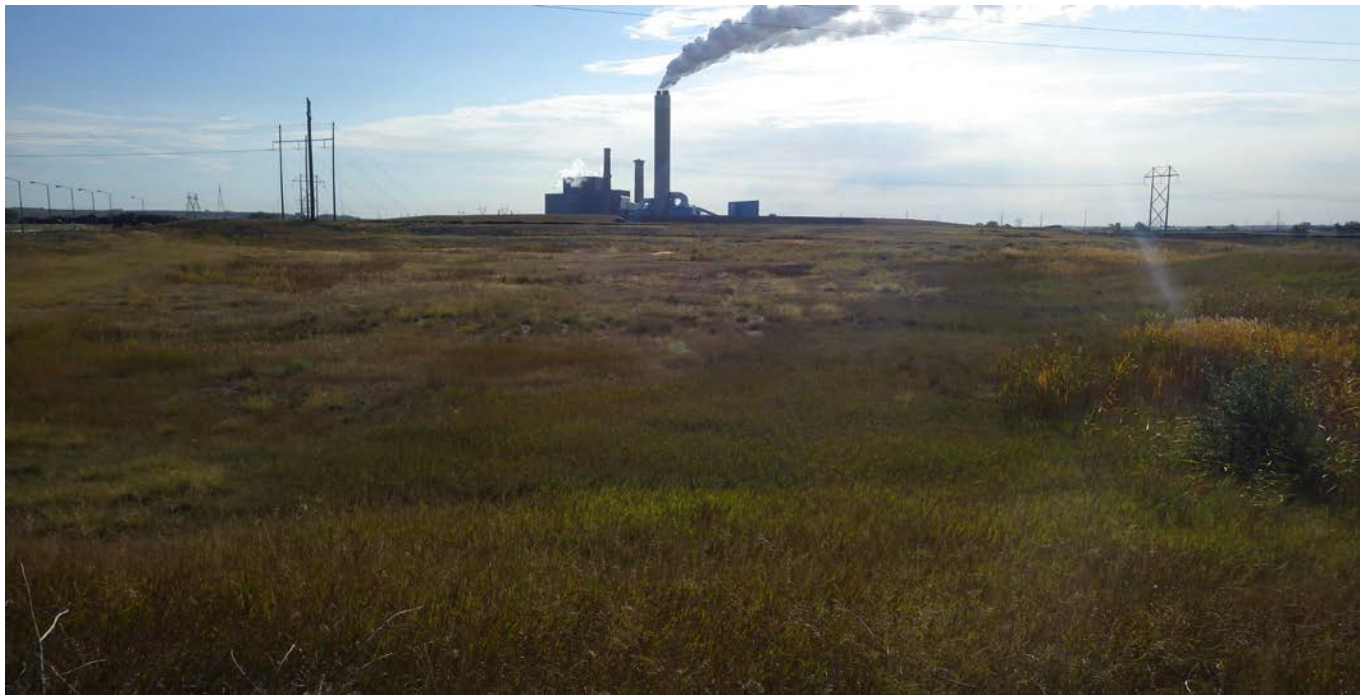
Photograph 9 (West side)
West side of landfill interior (IMGP6272.JPG)

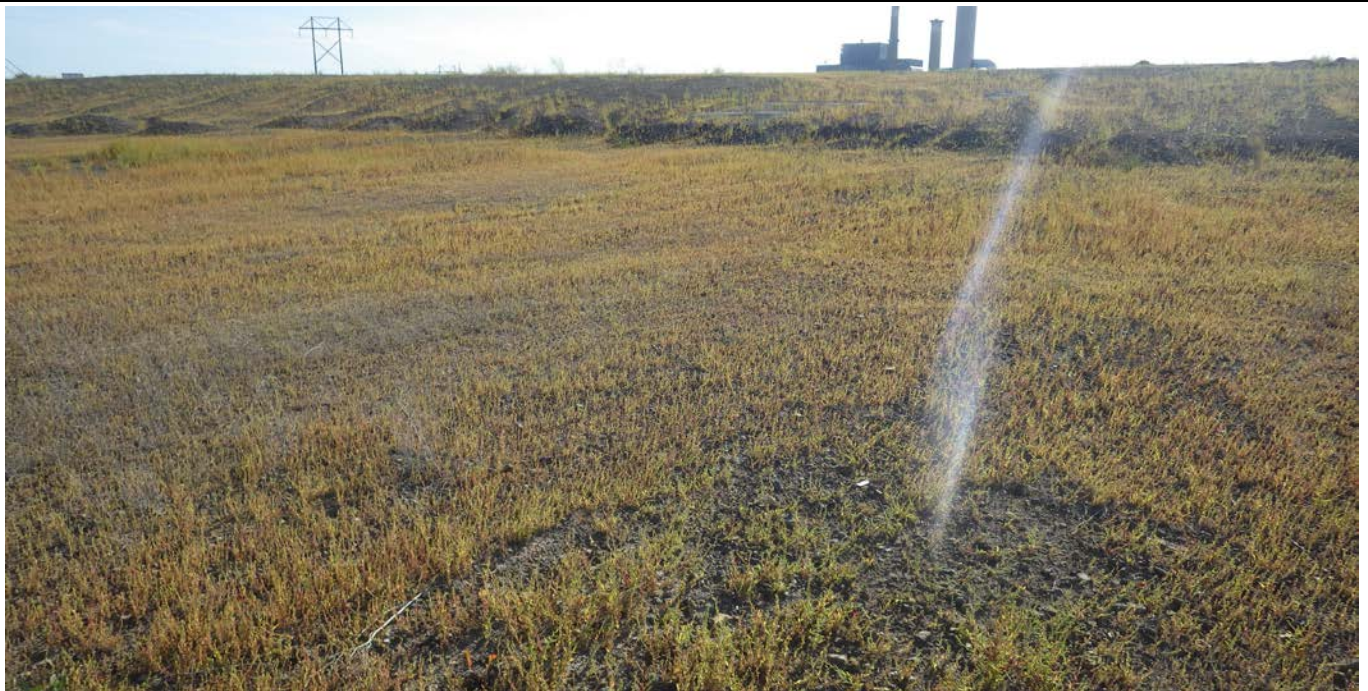
Photograph 10 (West end of placed bottom ash)
West extent of CCR material placement (IMGP6275.JPG)

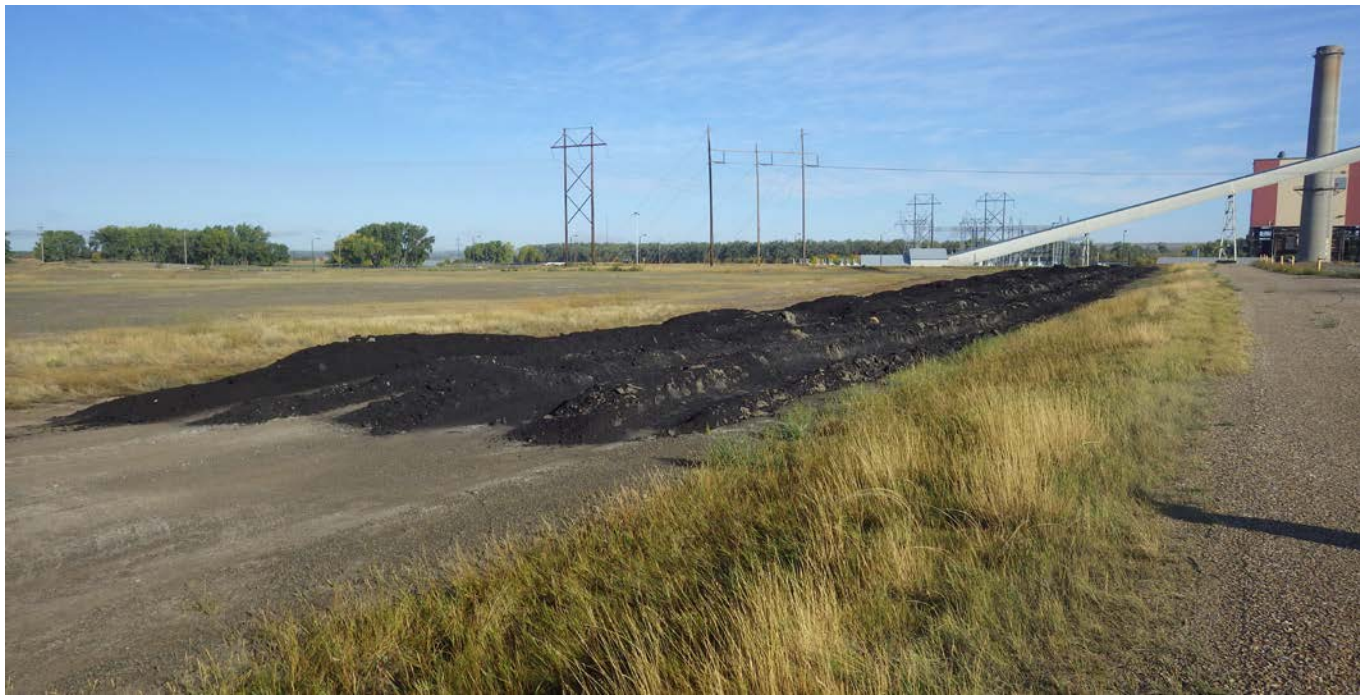
Photograph 11 (East edge)
East side of landfill interior, looking north (IMGP6256.JPG)

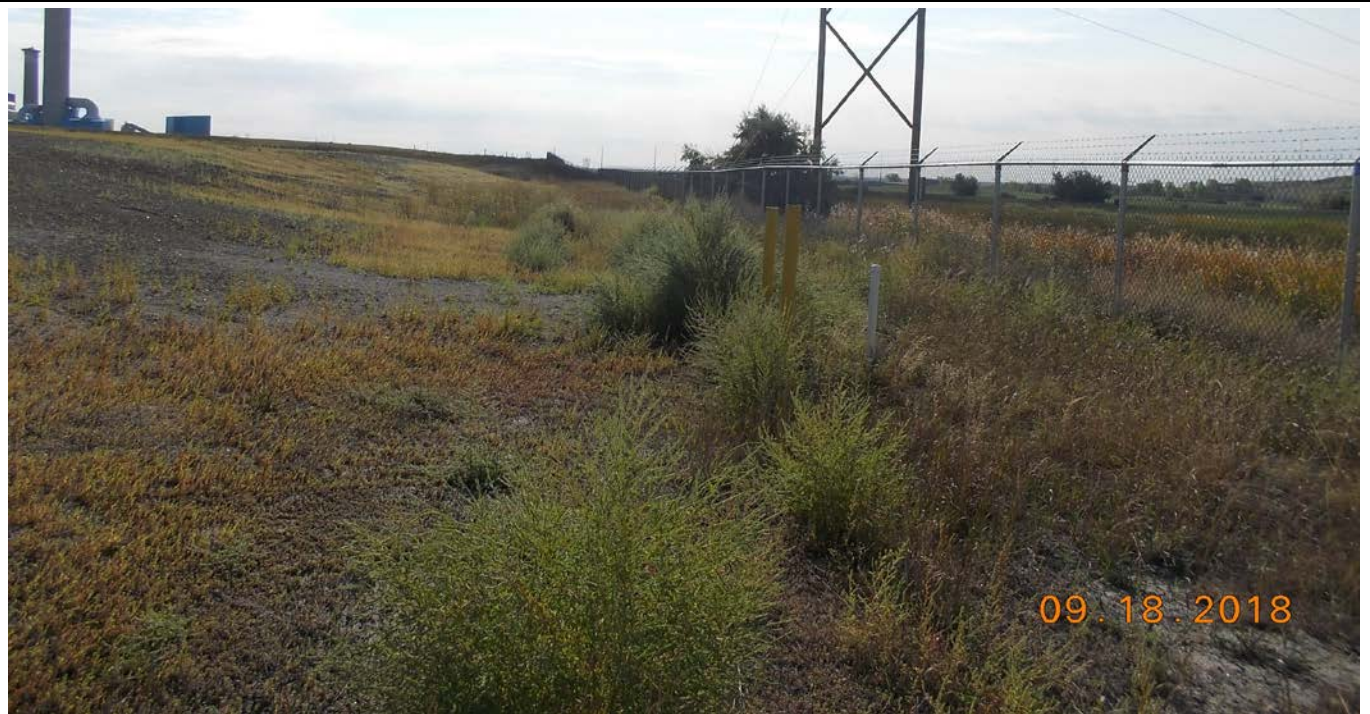
Photograph 12 (South berm)
Low spot in contact water channel, south perimeter berm crest with lack of well-defined contact water channel/berm (SS PDS (1).JPG)

ITEM	Y	N	N/A	REMARKS
1. Contact Water Controls				
a. Water level in contact water control area			X	No water noted
b. Sump & pump in good condition			X	
c. Containment controls working		X		Repair contact water control berm along south side to control potential contact water runoff

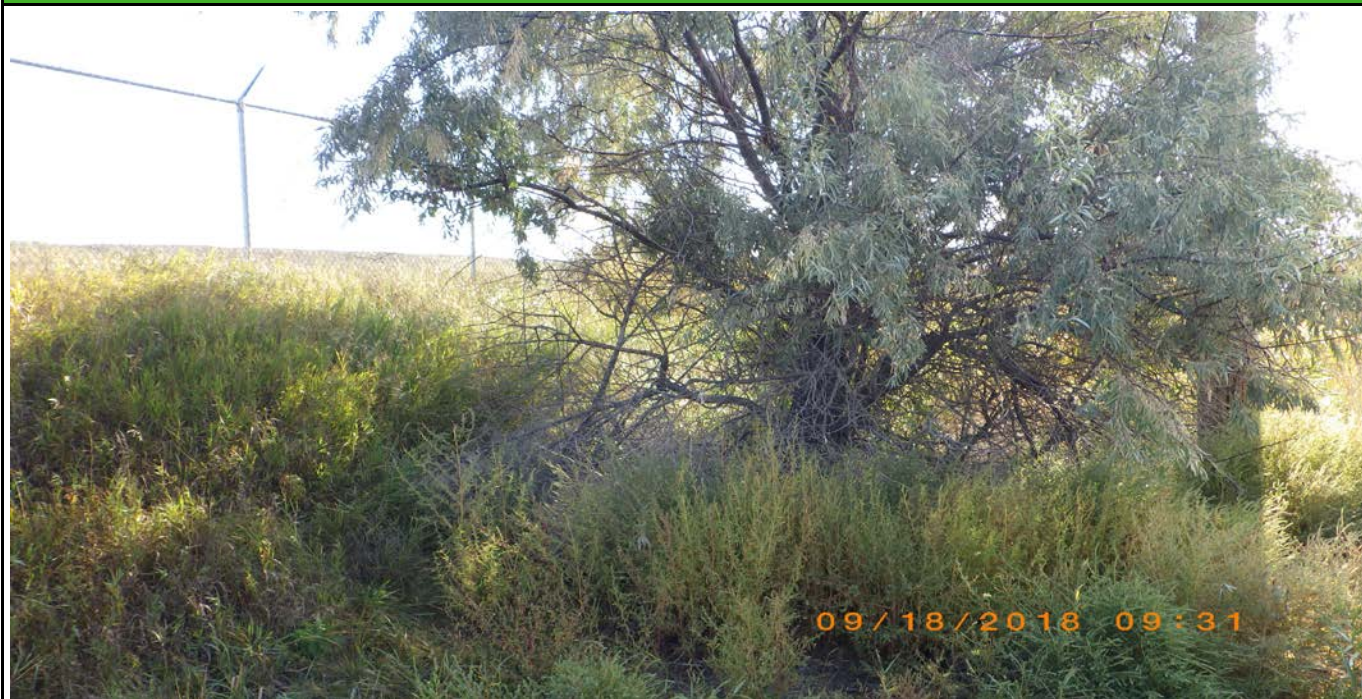
Photograph 13 (South berm)
Tree along south downstream berm slope toe (34ccs.JPG)

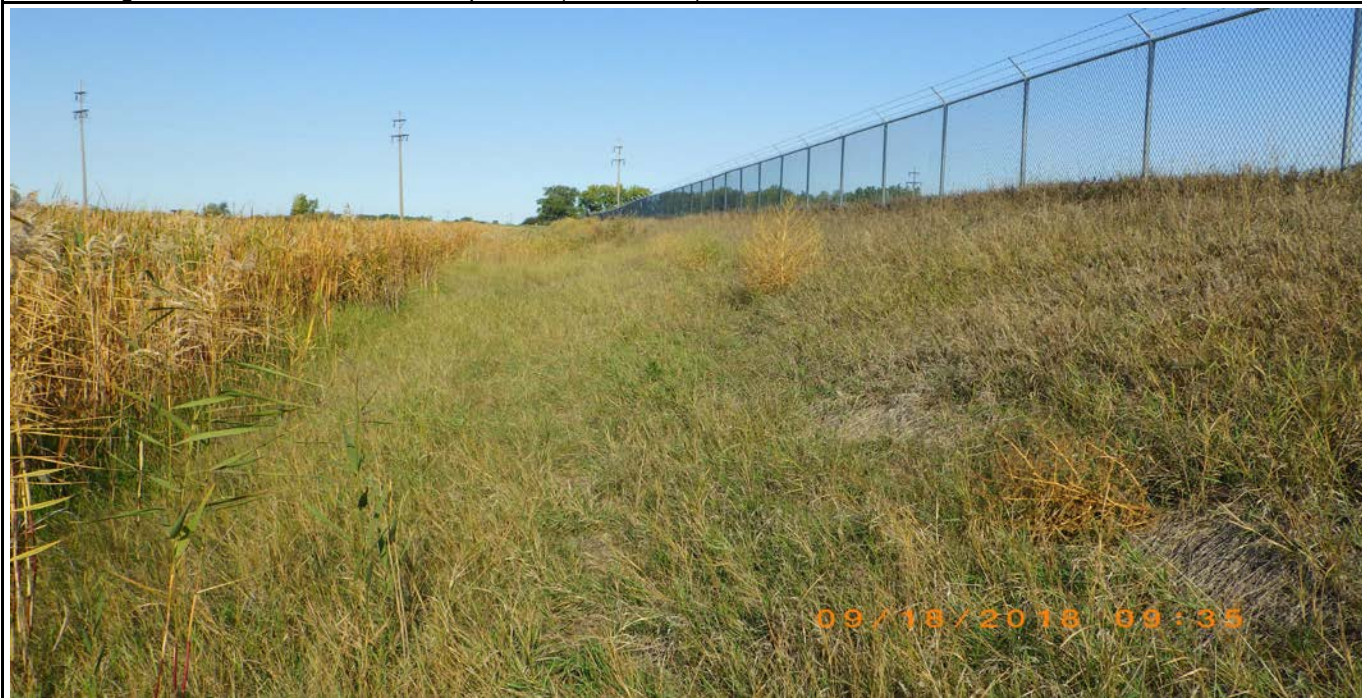
Photograph 14 (South berm)
Grass vegetation on south downstream slope (35ccs.JPG)

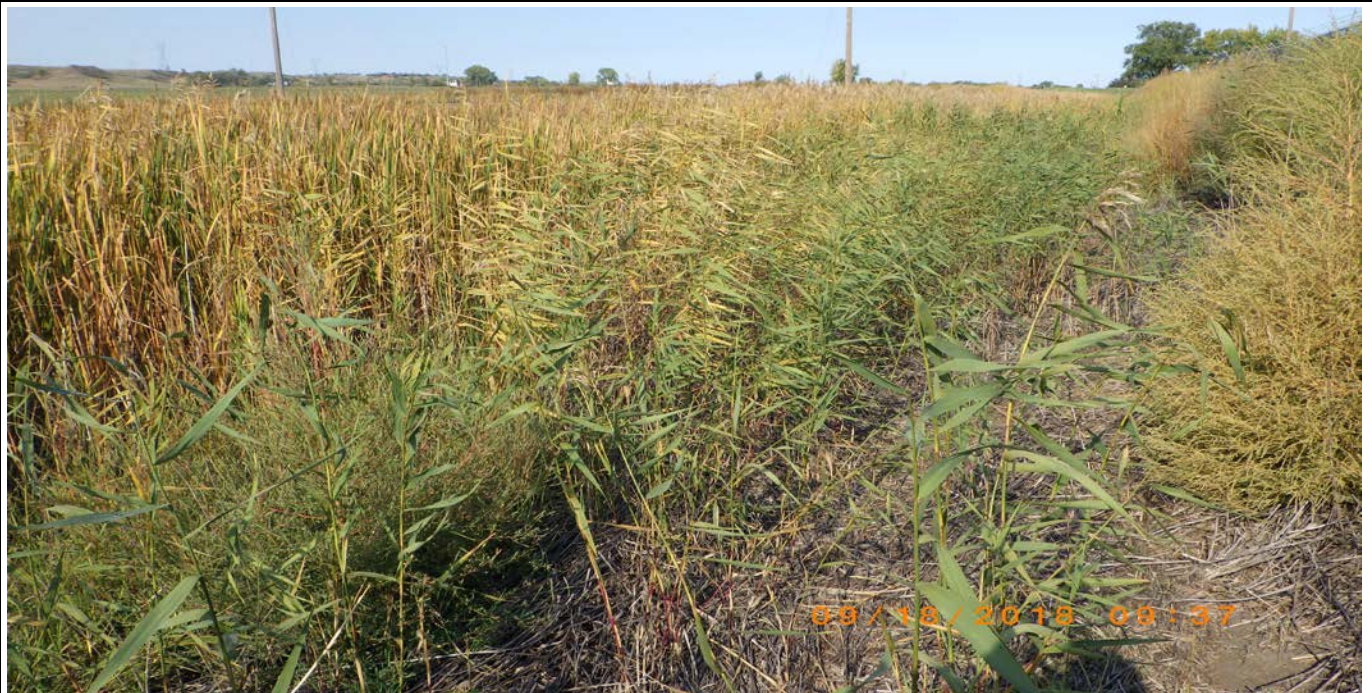
The toe of the west and south perimeter berms is in a surface water drainage ditch that has some marshy vegetation and standing water. Some small animal burrows were noted near the toe of the slope, but there were no observed indications of seepage, settlement, or excessive vegetation at the toe of these slopes.

Photograph 15 (South berm)
Reed vegetation at the bottom of the south downstream slope (36ccs.JPG)

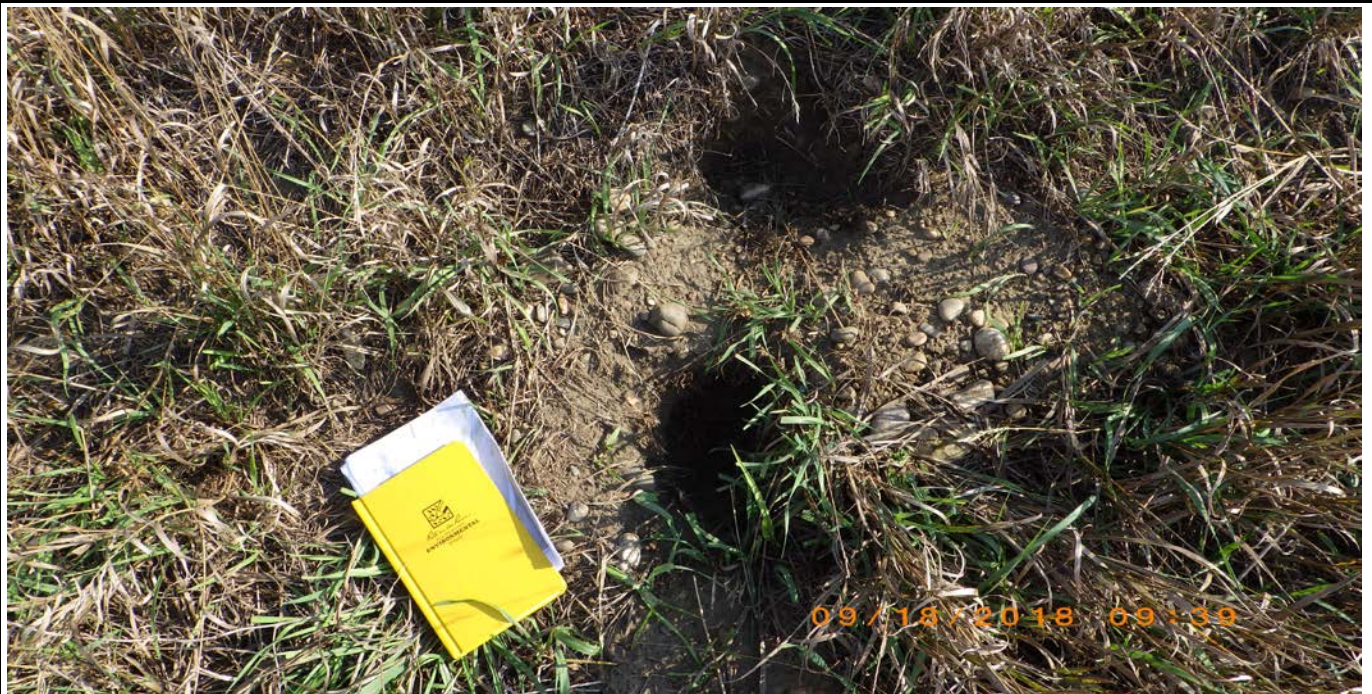
Photograph 16 (South berm)
Animal burrows on south downstream slope (37ccs.JPG)

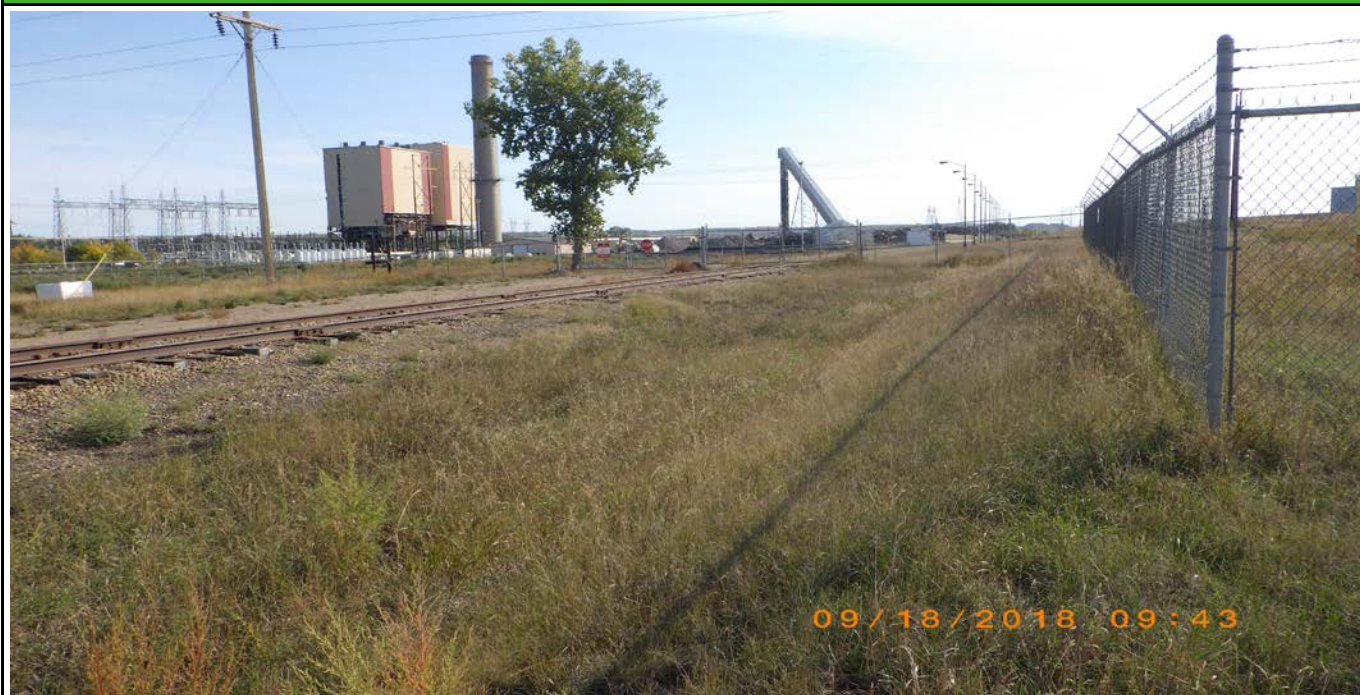
Photograph 17 (Northwest corner)
Grass vegetation on north downstream slope (40ccs.JPG)

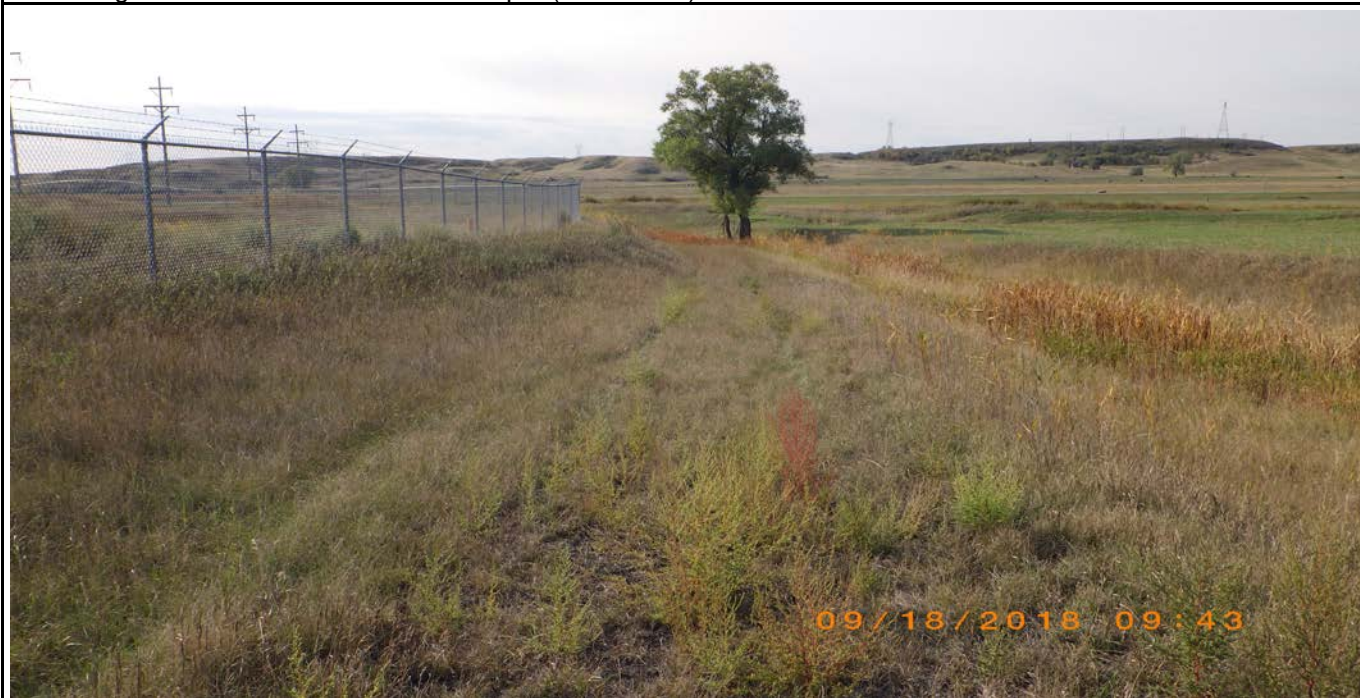
Photograph 18 (Northwest corner)
Grass vegetation on west downstream slope (41ccs.JPG)

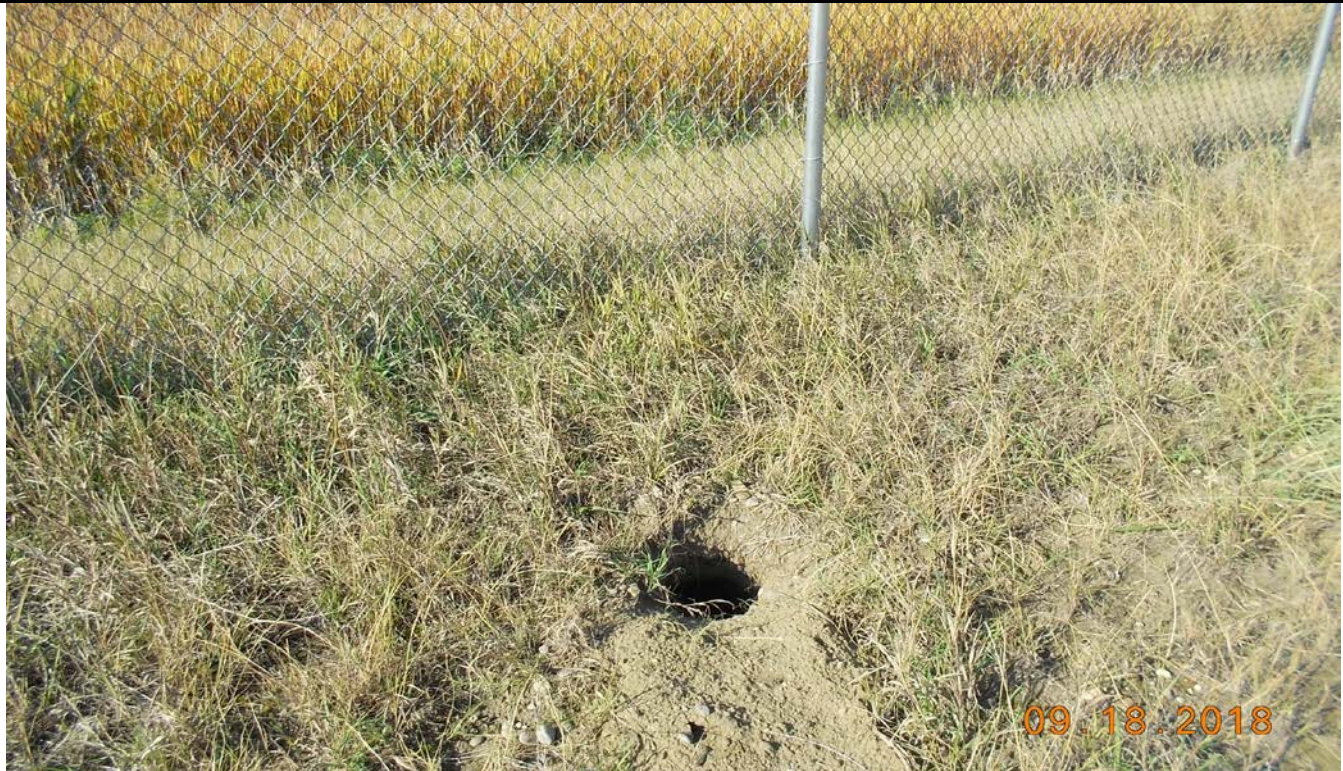
Photograph 19 (South berm)
Animal burrows on south berm crest (SS PDS (2).JPG)

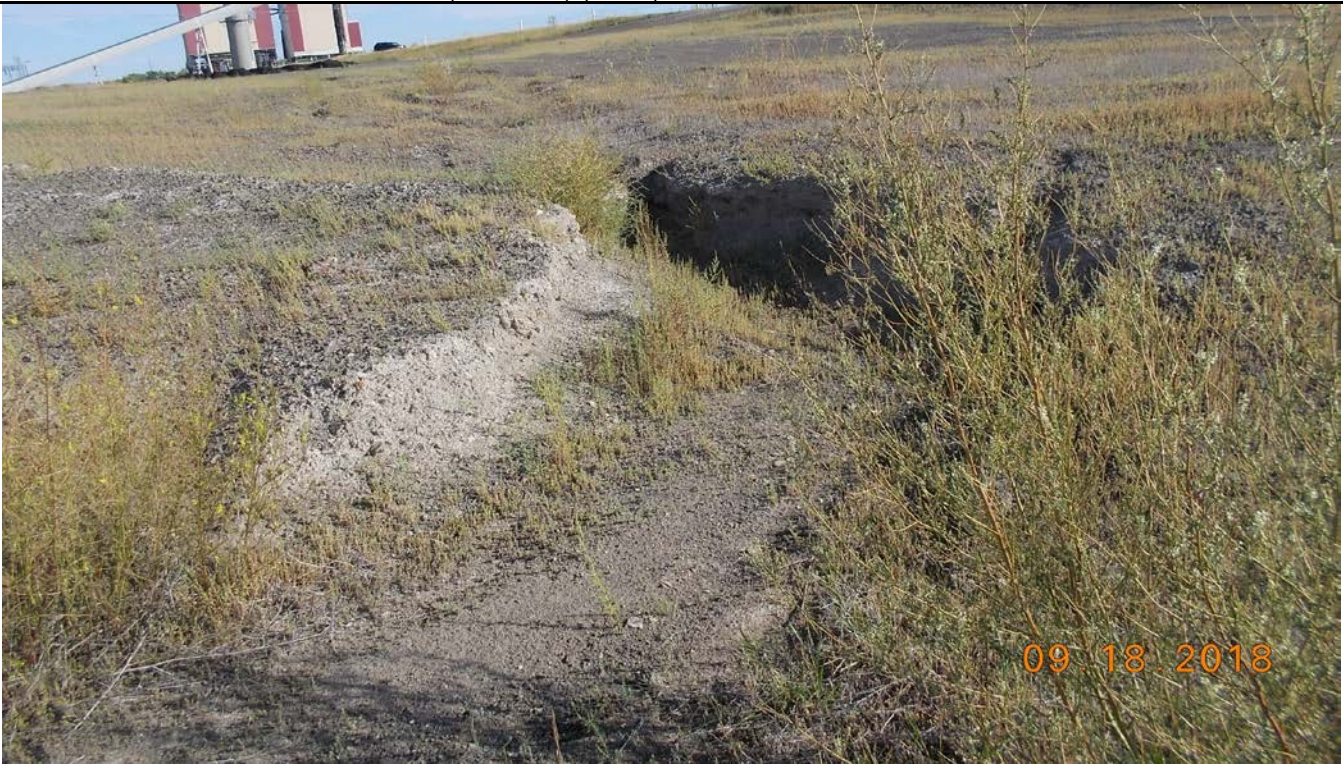
establish a crown on the facility of between 3% and 5% grades. Until closure is complete, contact water is to be evaporated, used for dust suppression, or pumped to the Bottom Ash Impoundment as required. The observed CCR placement slopes appeared to be within the design CCR grades, and contact water was generally directed to the low area on the west end of the landfill. The contact water control berm/channel along the south side of the facility was not well-defined during the inspection; however, this area is expected to be re-graded in 2019 or 2020 as part of the facility closure and is not anticipated to require re-grading prior to that time. The majority of in-place CCRs within the landfill appear to be in fair condition except near the southeast corner of the facility where there are several erosion rills. No cracks, settlement, or seepage was observed on the CCR slopes.

Photograph 20 (South berm)
Erosion of placed CCR material on the south side (SS PDS (37).JPG)
