# Annual Inspection

## *Stanton Station - Bottom Ash CCR Surface Impoundment*

**Great River Energy**

January 2019

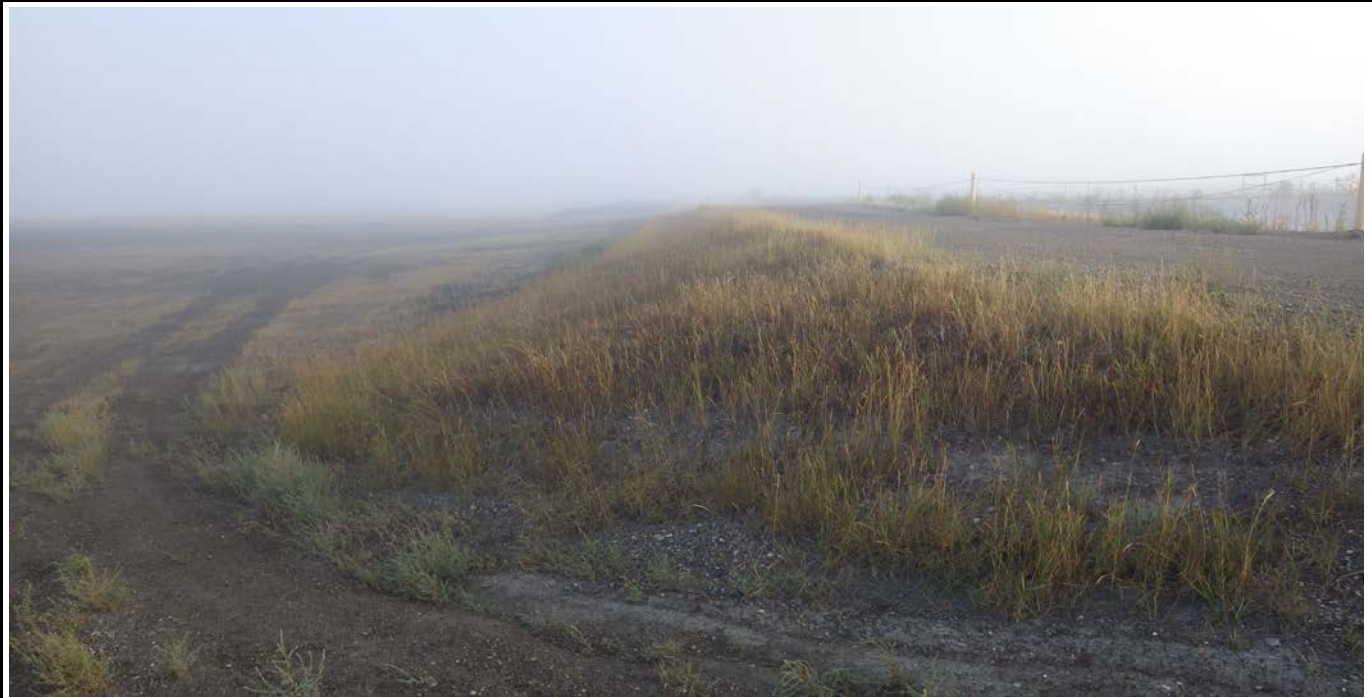
Photograph 1 (West downstream slope)  
Grass vegetation (IMGP6232.JPG)

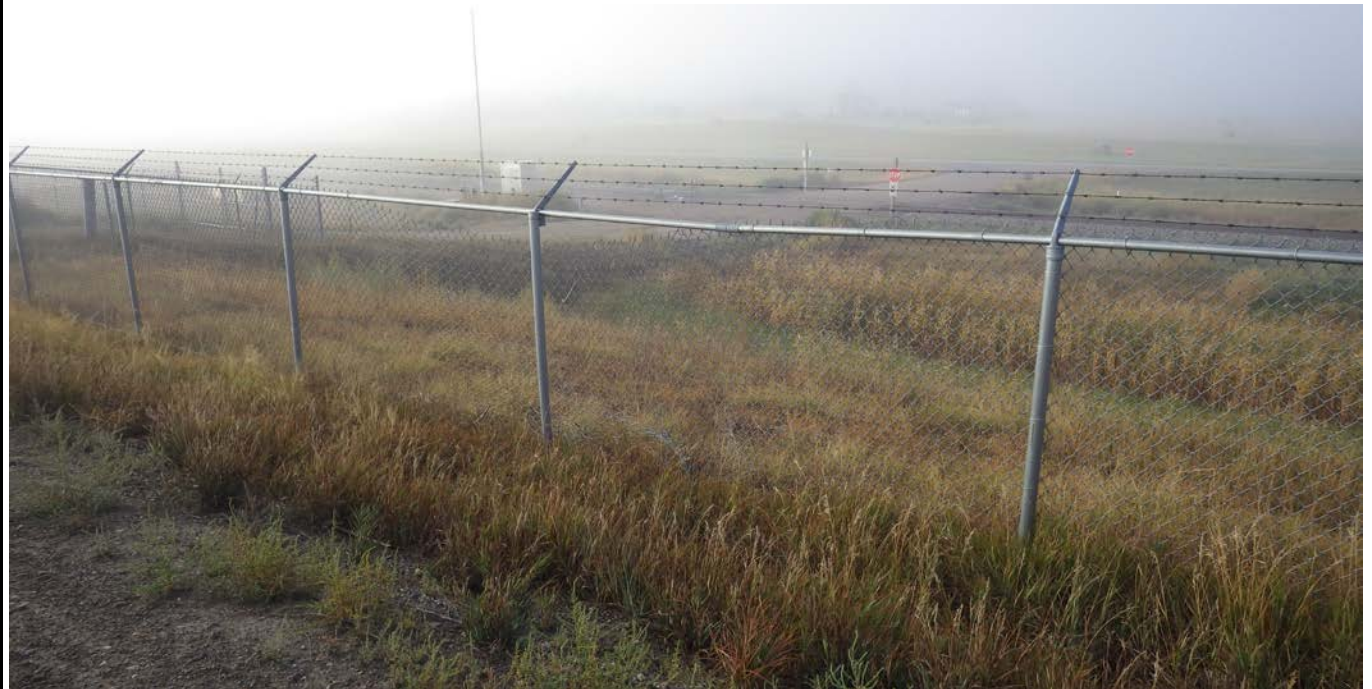
Photograph 2 (SE corner)  
Fence around perimeter of Bottom Ash Impoundment, partially damaged (separated from fence post)  
(IMGP6235.JPG)

Minor maintenance items that may need to be continually addressed include repairing larger animal burrows as they appear, monitoring vegetative success of berm downstream slopes, removal of any woody vegetation growing on the berm downstream slopes, and repair of the perimeter security fence.

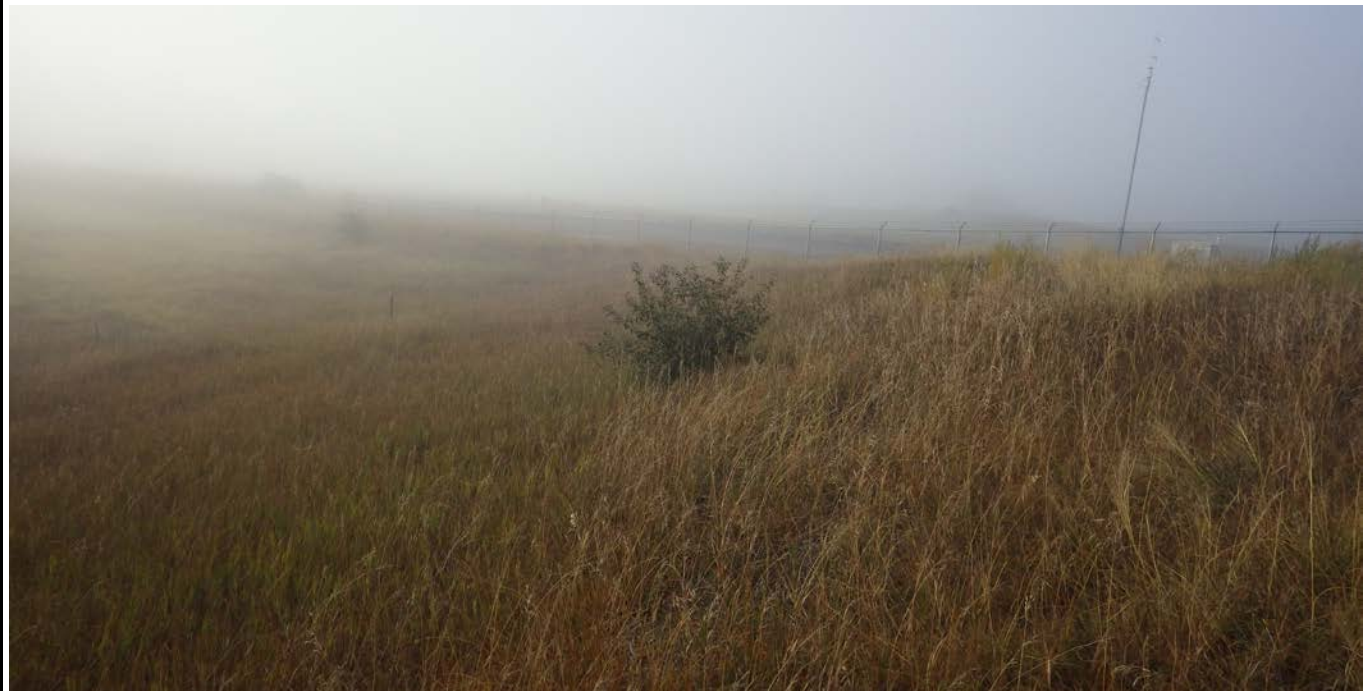
Photograph 3 (East side)  
Woody vegetation on slope (IMGP6238.JPG)

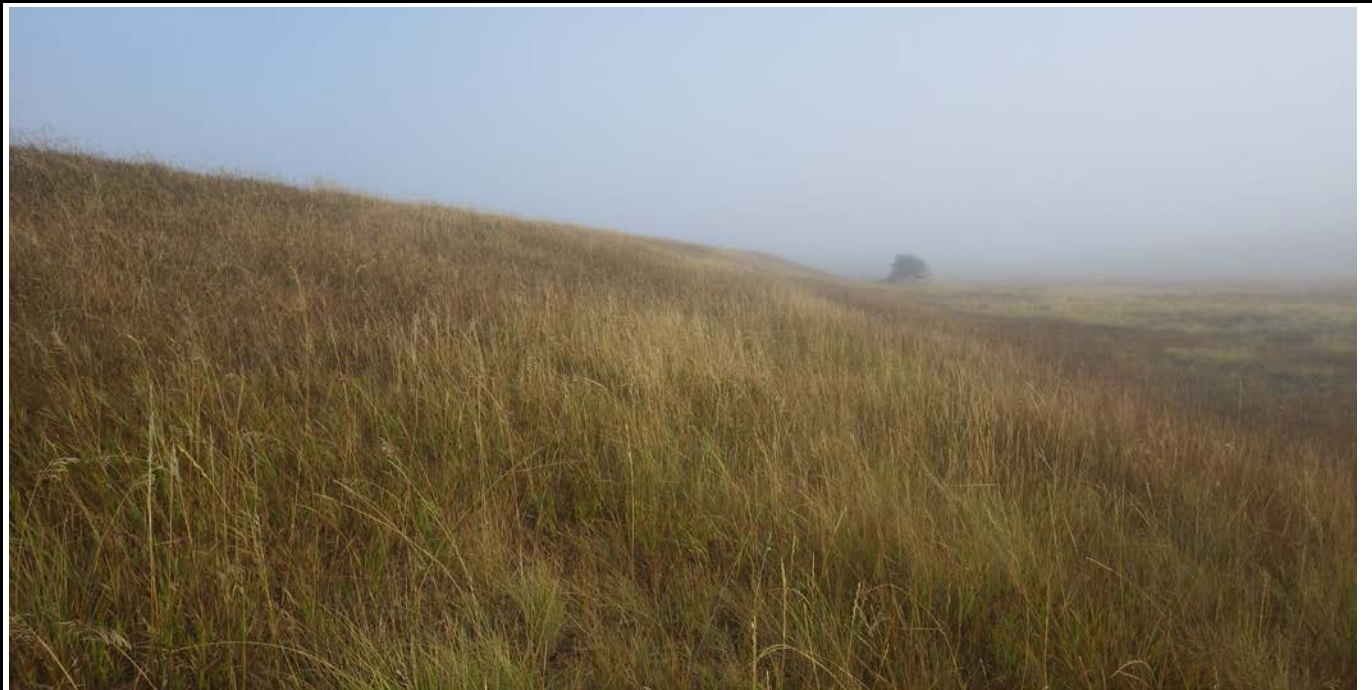
Photograph 4 (East downstream slope)  
Grass vegetation on east berm downstream slope (IMGP6239.JPG)

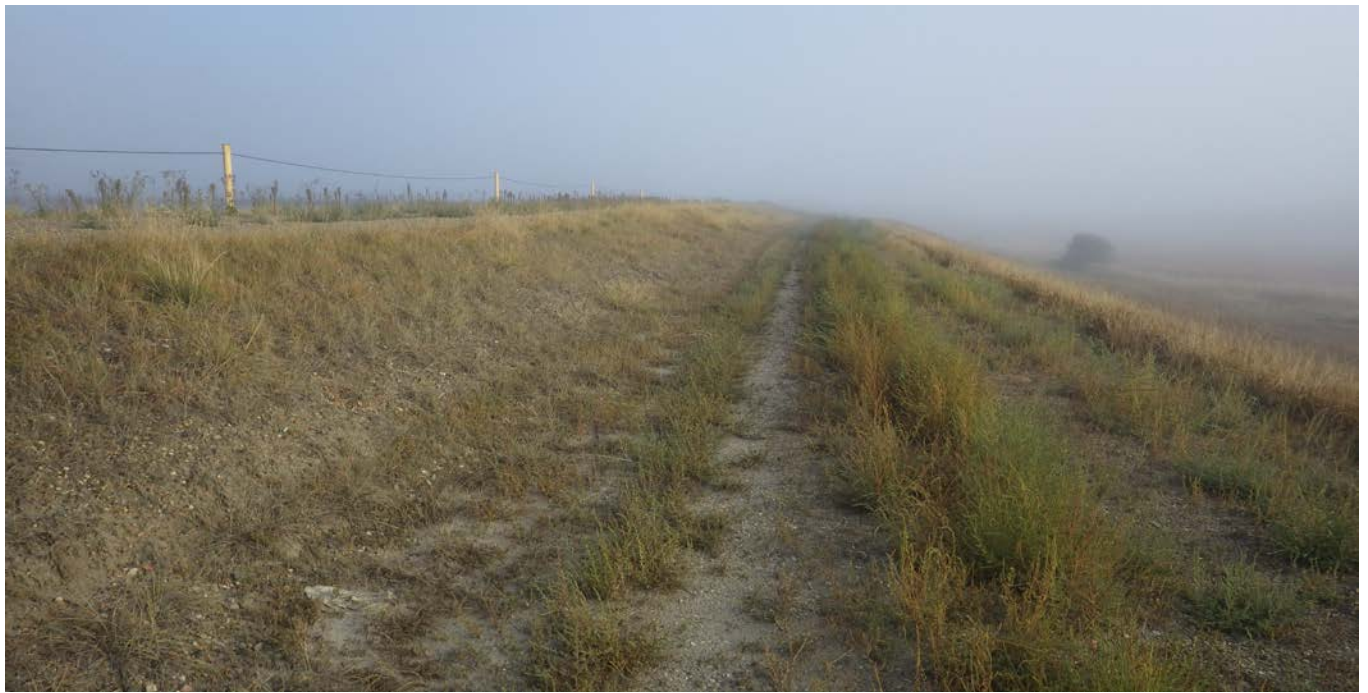
Photograph 5 (East side)  
Mid-slope road and upper east downstream slope (IMGP6240.JPG)

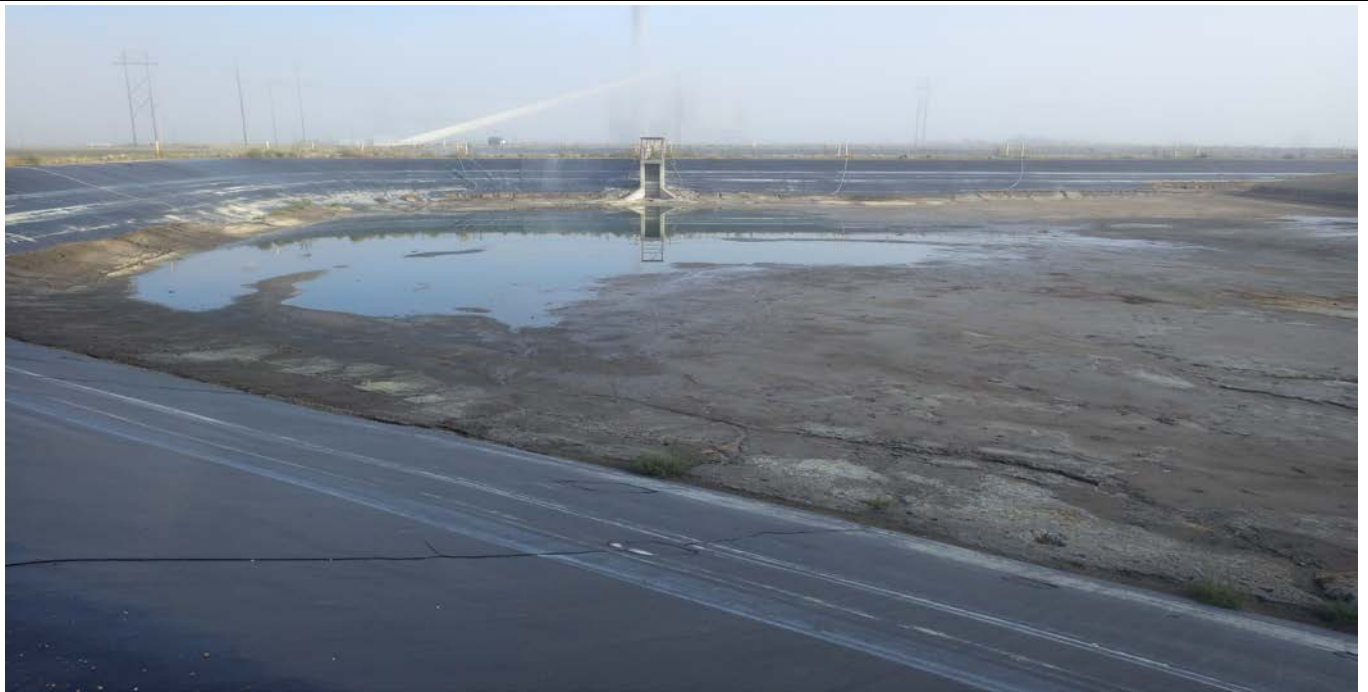
The berm upstream slopes above the water level and not covered with bottom ash were evaluated. Berm upstream slopes appeared to match the design slopes of 3:1 with minor sections of slope difference where the slopes curved inward to a steeper concave shape. This displacement of the lower slope is likely due to “pumping” of saturated soils beneath the geomembrane due to wave action and the lack of confining pressure from overlying protective cover layer. The south cell berm upstream slopes appear to be in fair condition.

Photograph 6 (South Cell berm crest)  
Upstream slope and interior of South Cell (IMGP6253.JPG)

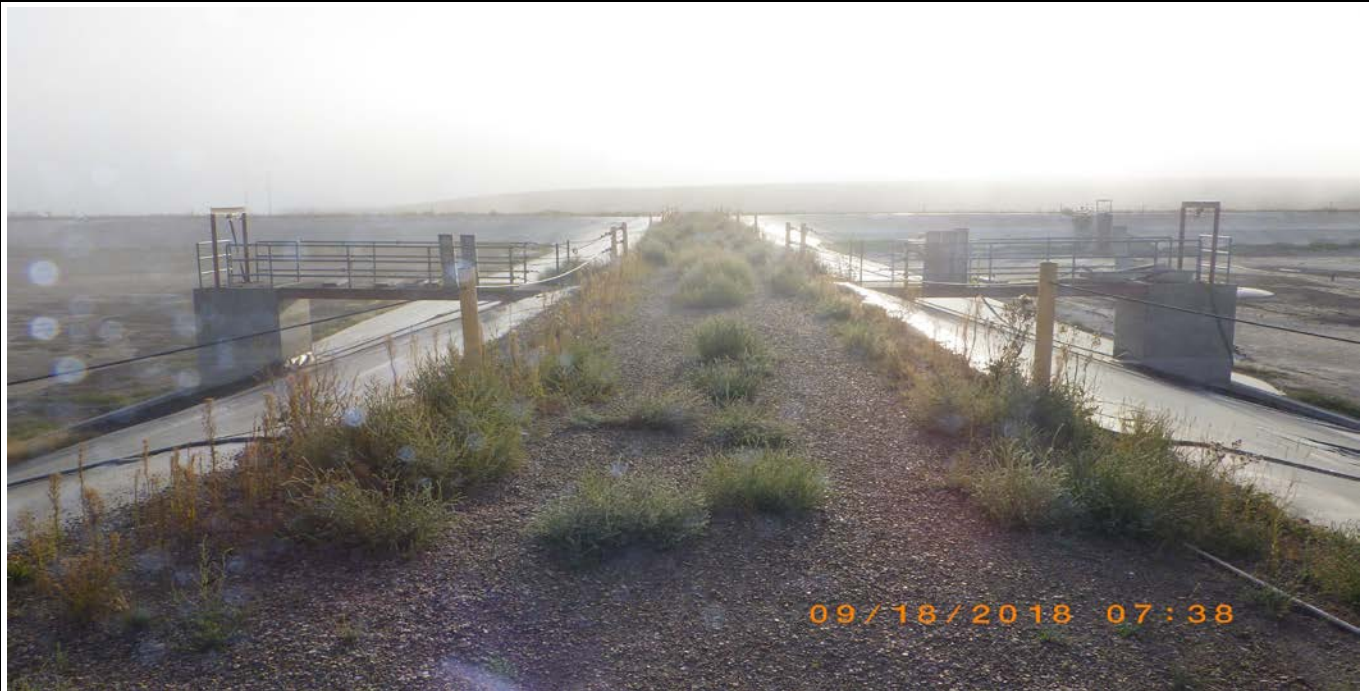
Photograph 7 (North/Center Cell berm crest)  
Center/North Cell crest with gravel road surface (1ccs.JPG)

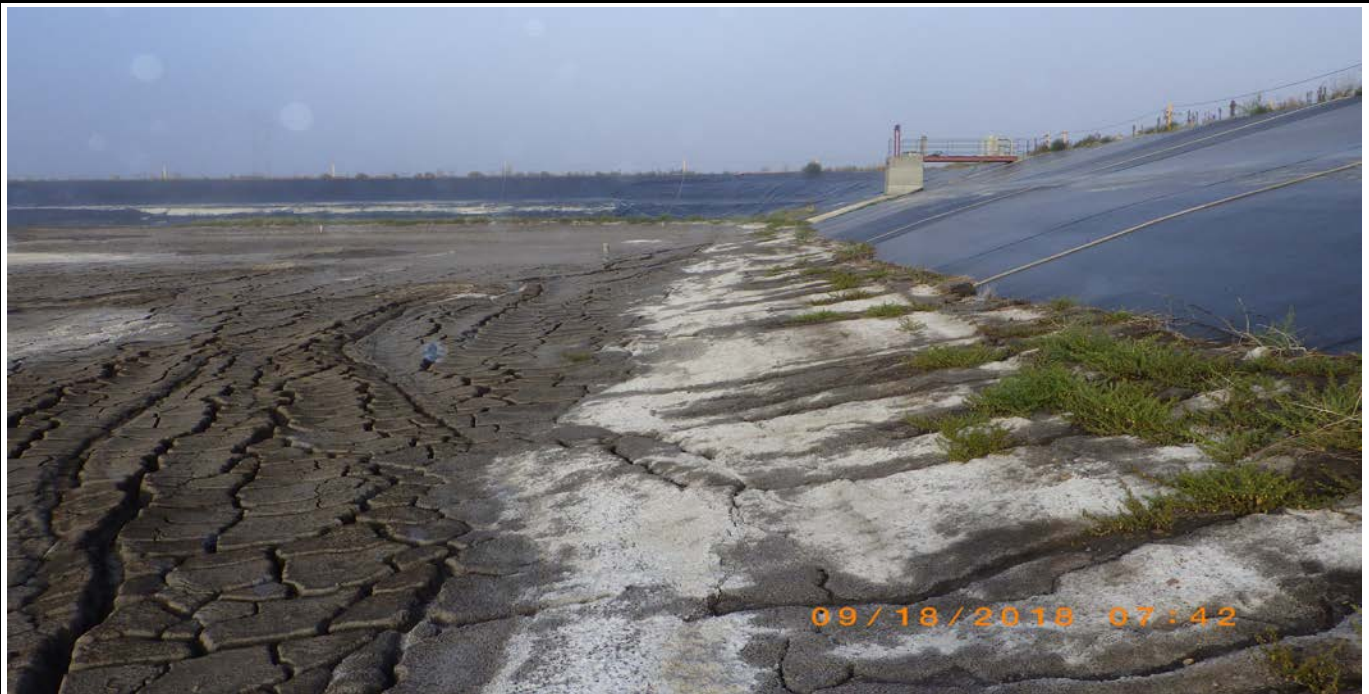
Berm upstream slopes appeared to match the design slopes of 3:1 to about 4 feet below the crest elevation (approximate elevation 1716 feet amsl) at which point the slopes curved inward to a steeper concave shape. This displacement of the lower slope is likely due to “pumping” of saturated soils beneath the geomembrane due to wave action and the lack of confining pressure from overlying protective cover. Water was observed between the geomembrane liner and compacted clay liner along the toe of the berm upstream slope and along the floor of the facility that was able to be evaluated; however, no signs of geomembrane defects were noted. The center cell berm upstream slopes appear to be in fair condition.

Photograph 8 (Center Cell upstream slope)  
Upstream slope and toe of Center Cell (3ccs.JPG)

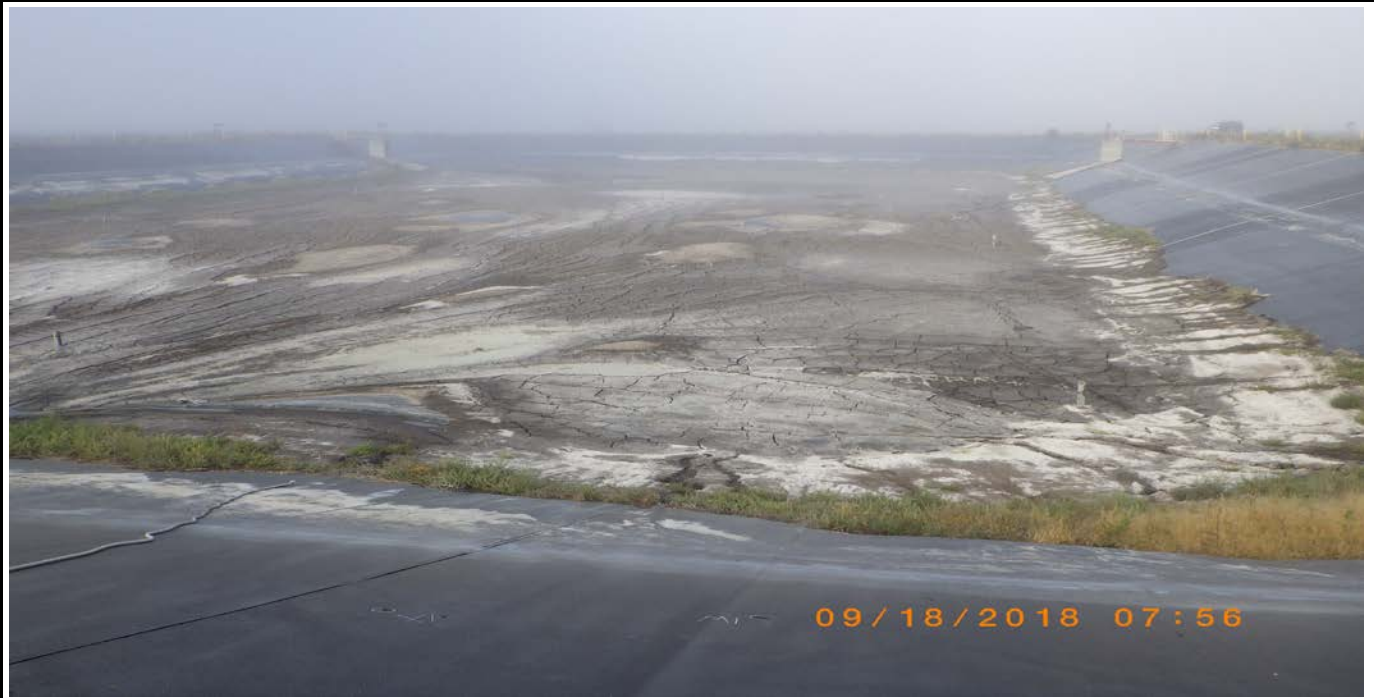
Photograph 9 (East berm crest)  
Upstream slope and interior of Center Cell (8ccs.JPG)

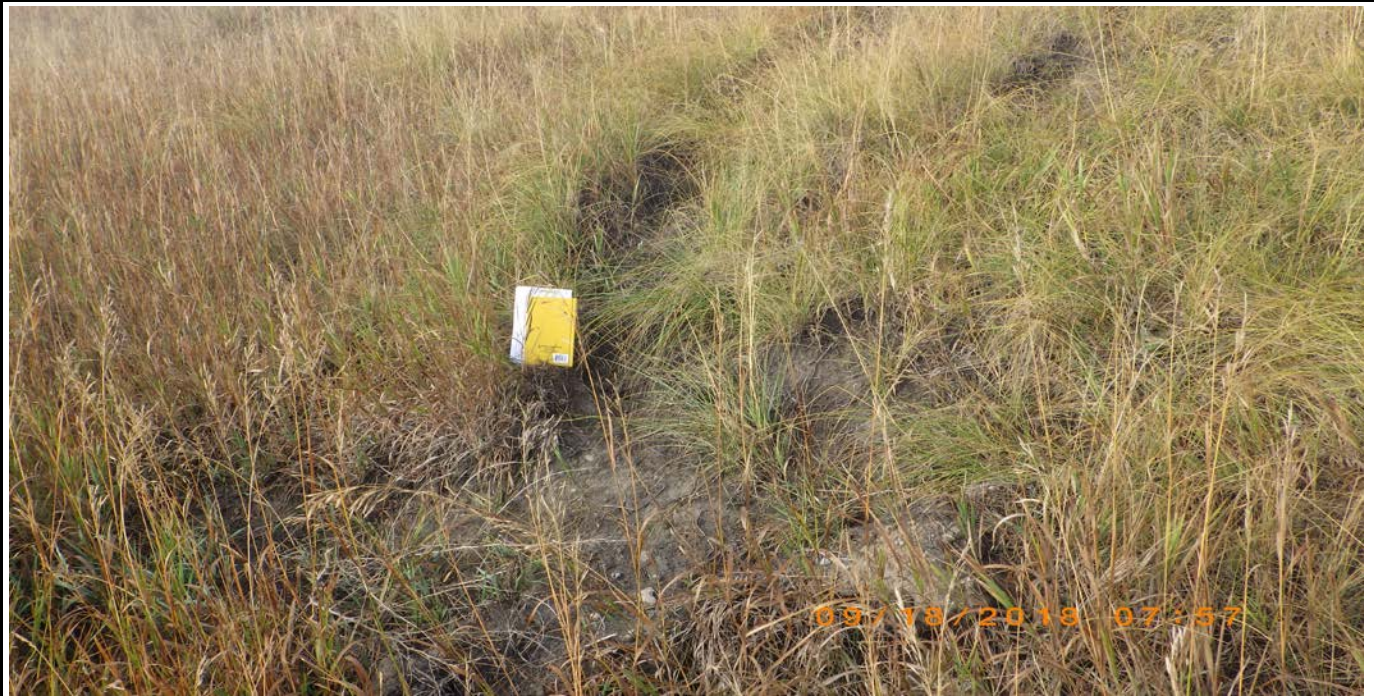
Photograph 10 (East downstream slope)  
Erosion and rutting on downstream slope near the toe (9ccs.JPG)

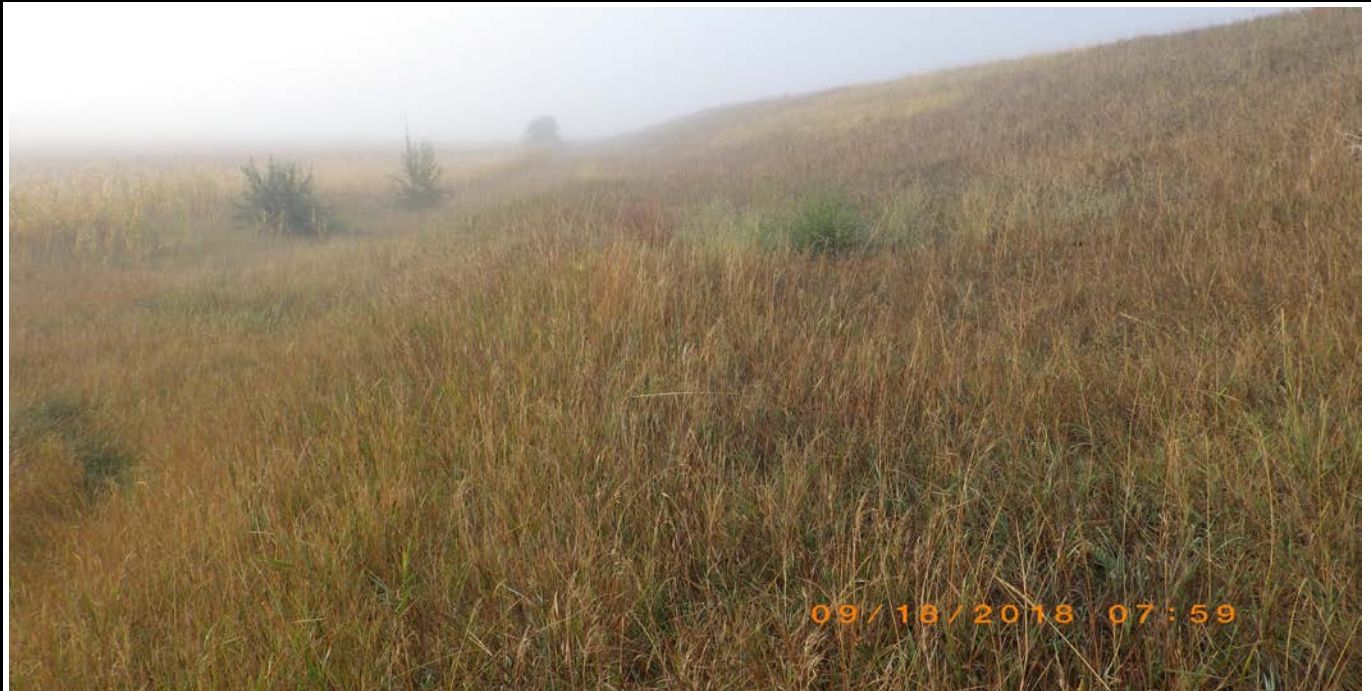
Photograph 11 (East toe)  
Grass vegetation at the toe of the slope (10ccs.JPG)

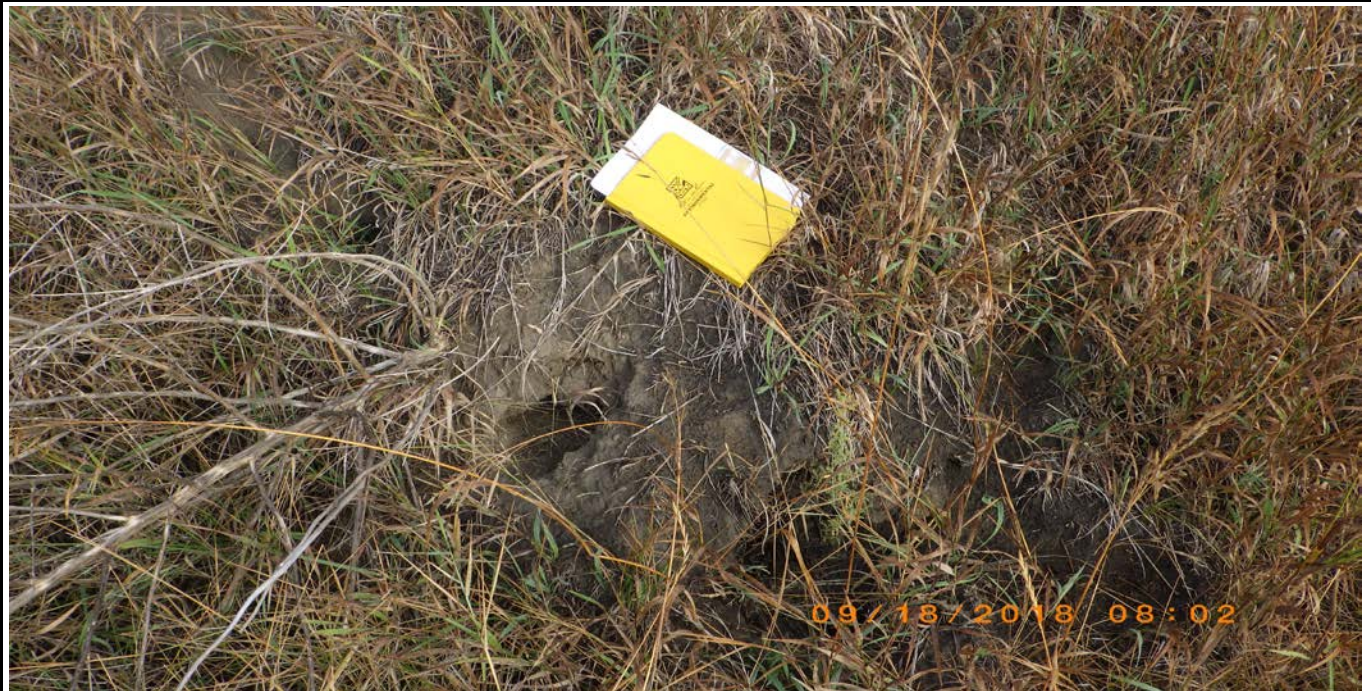
Photograph 12 (East toe)  
Animal burrows at the toe of the slope (12ccs.JPG)

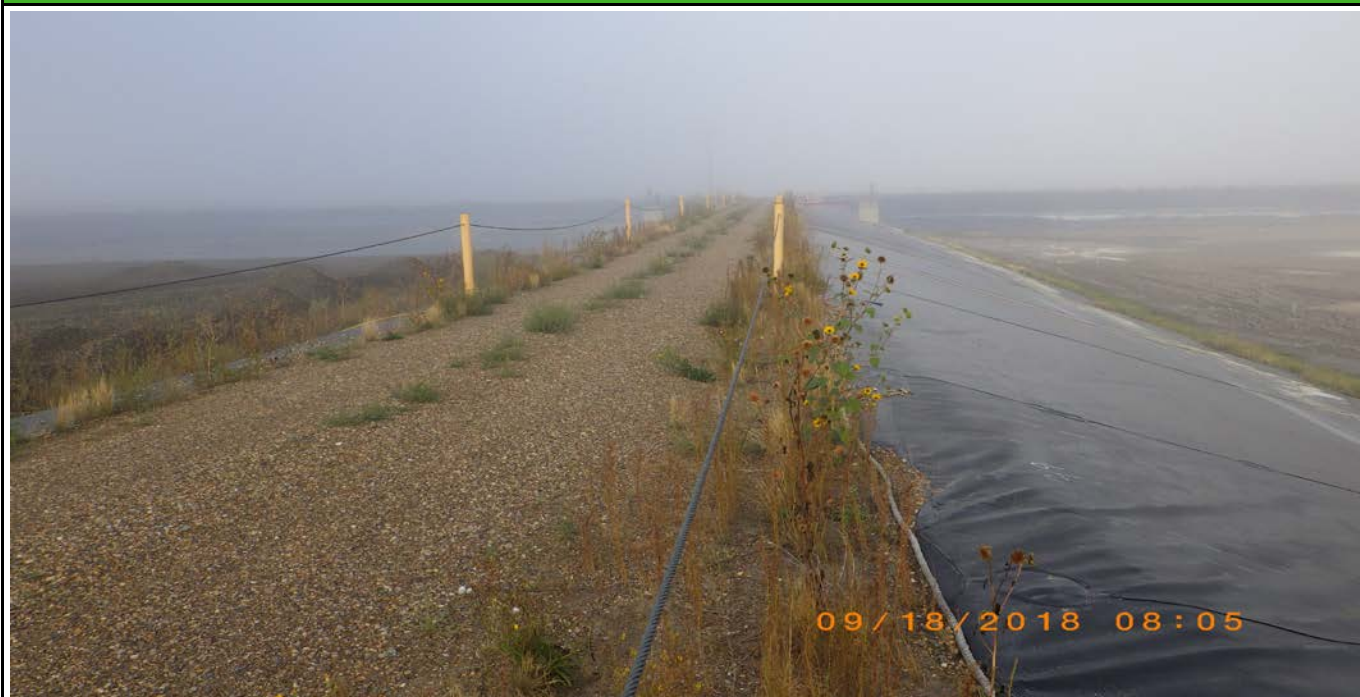
Photograph 13 (Center/South Cell berm crest)  
Center/South Cell crest with gravel road surface (15ccs.JPG)

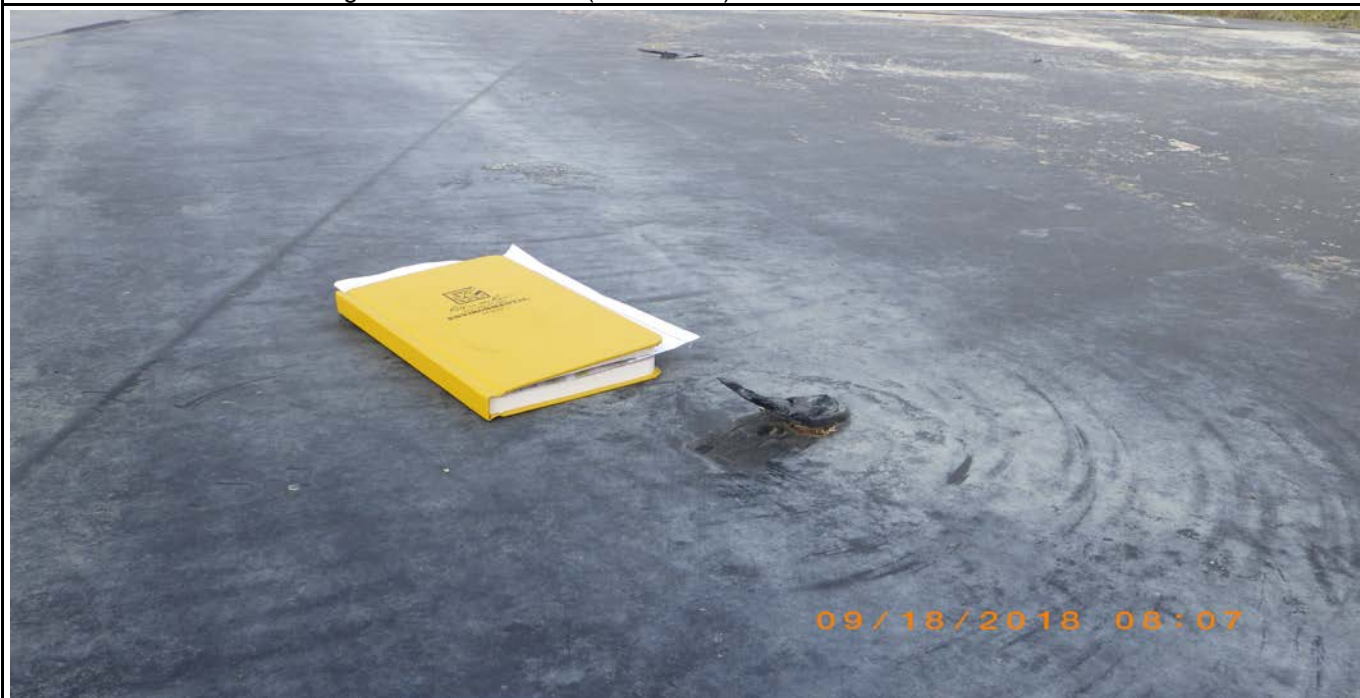
Photograph 14 (Center Cell east upstream slope)  
Failed geomembrane extrusion bead repair (16ccs.JPG)

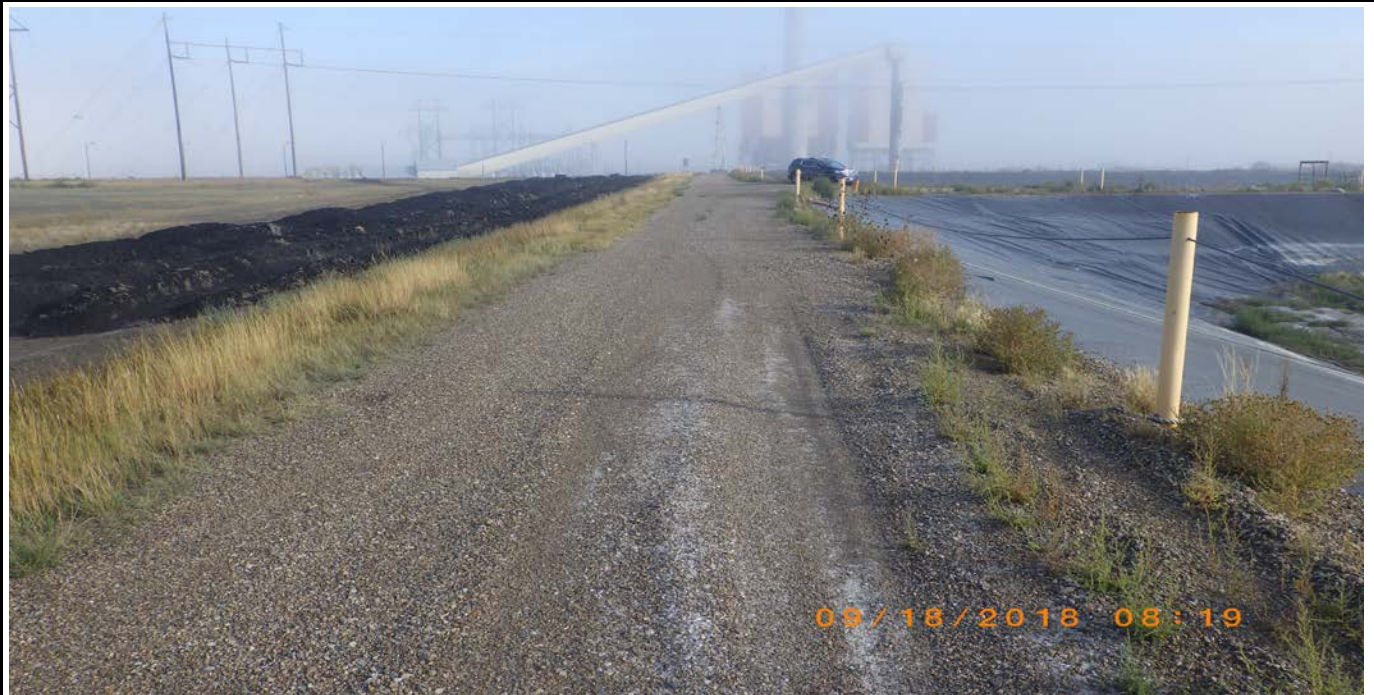
Photograph 15 (West berm crest)  
West crest with gravel road surface (21ccs.JPG)

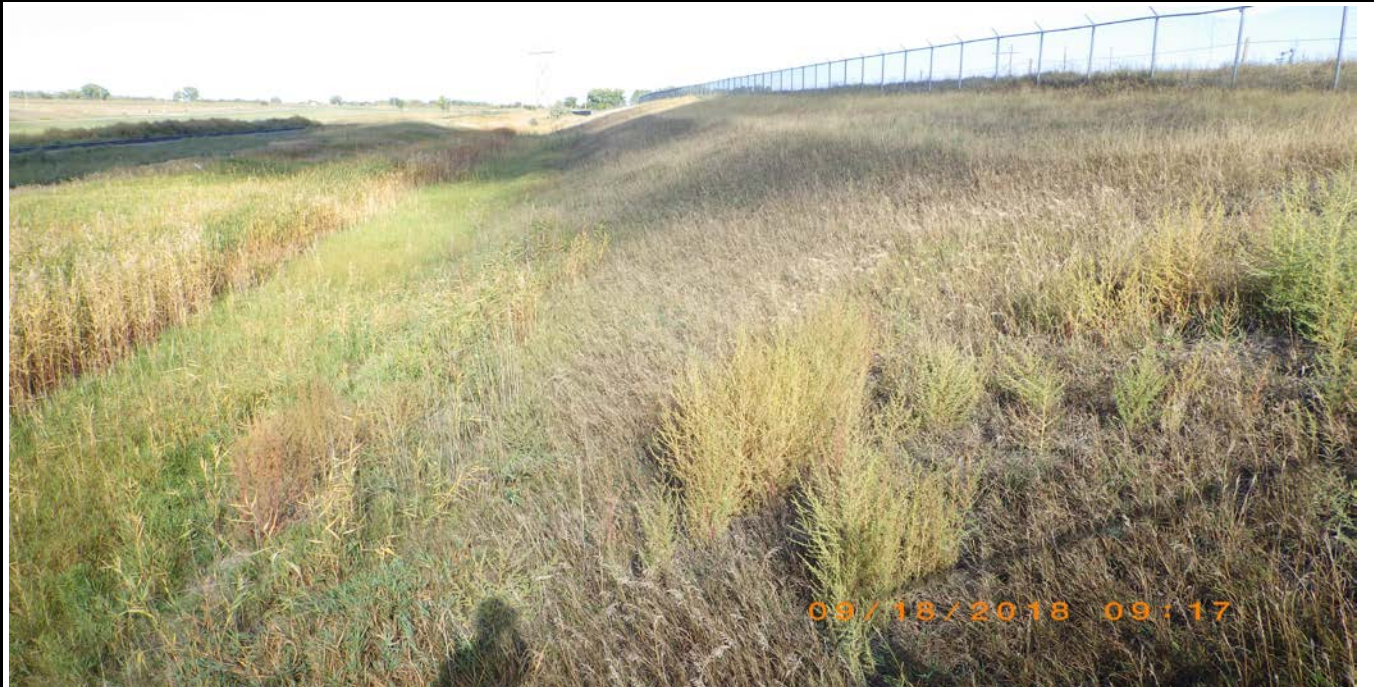
Photograph 16 (South downstream slope)  
Grass vegetation on the south slope (25ccs.JPG)

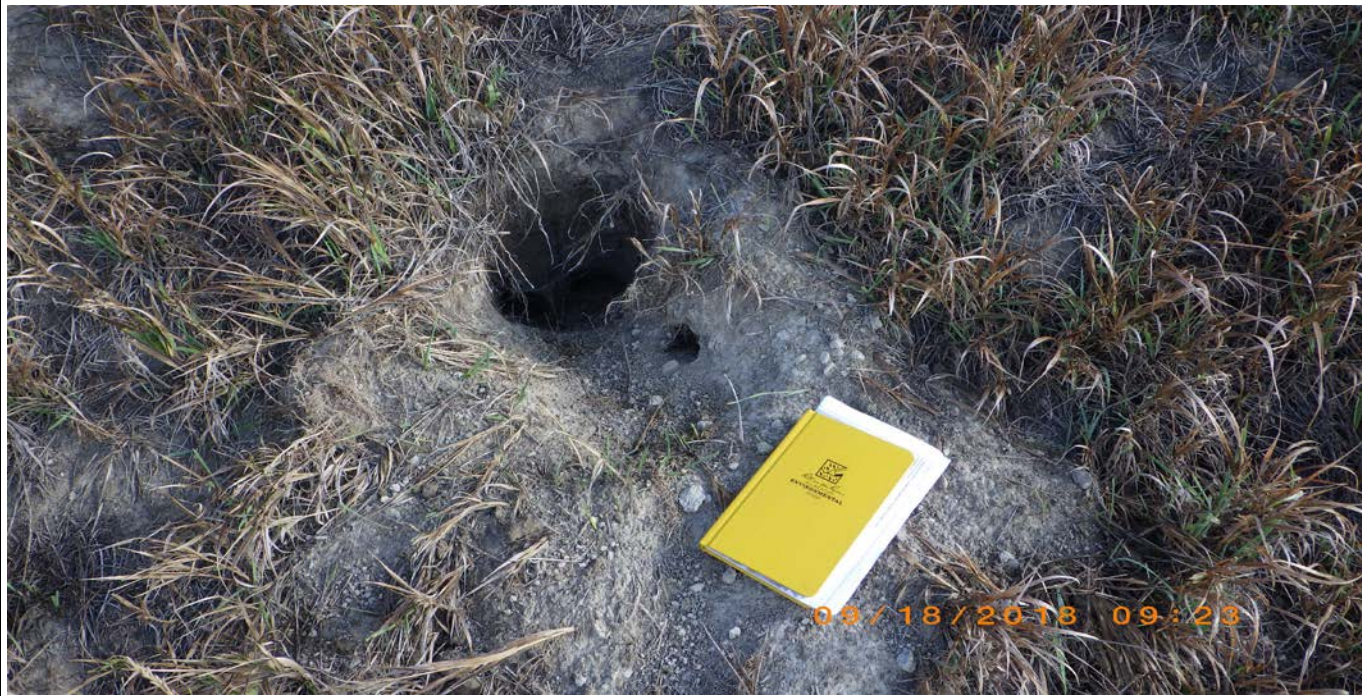
The berm downstream slope on the east and south side is approximately 20 feet high and the berm downstream slope on the west side is approximately 5 feet high. The slopes are graded at approximately 3:1 and are well vegetated with grass, with a few small areas of bare ground along the east and south sides of the impoundment that are susceptible to erosion. Several small (2-inch diameter) animal burrows were observed on the east berm downstream slopes and several large-sized (6 to 10-inch diameter) animal burrows were observed on the south berm downstream slopes. The perimeter security fence on the south berm downstream slope near the southeast corner was also damaged. Berm downstream slopes are generally in fair condition due to the large number and size of animal burrows noted during the inspection.

Photograph 17 (South downstream slope)  
Animal burrow on south downstream slope (29ccs.JPG)

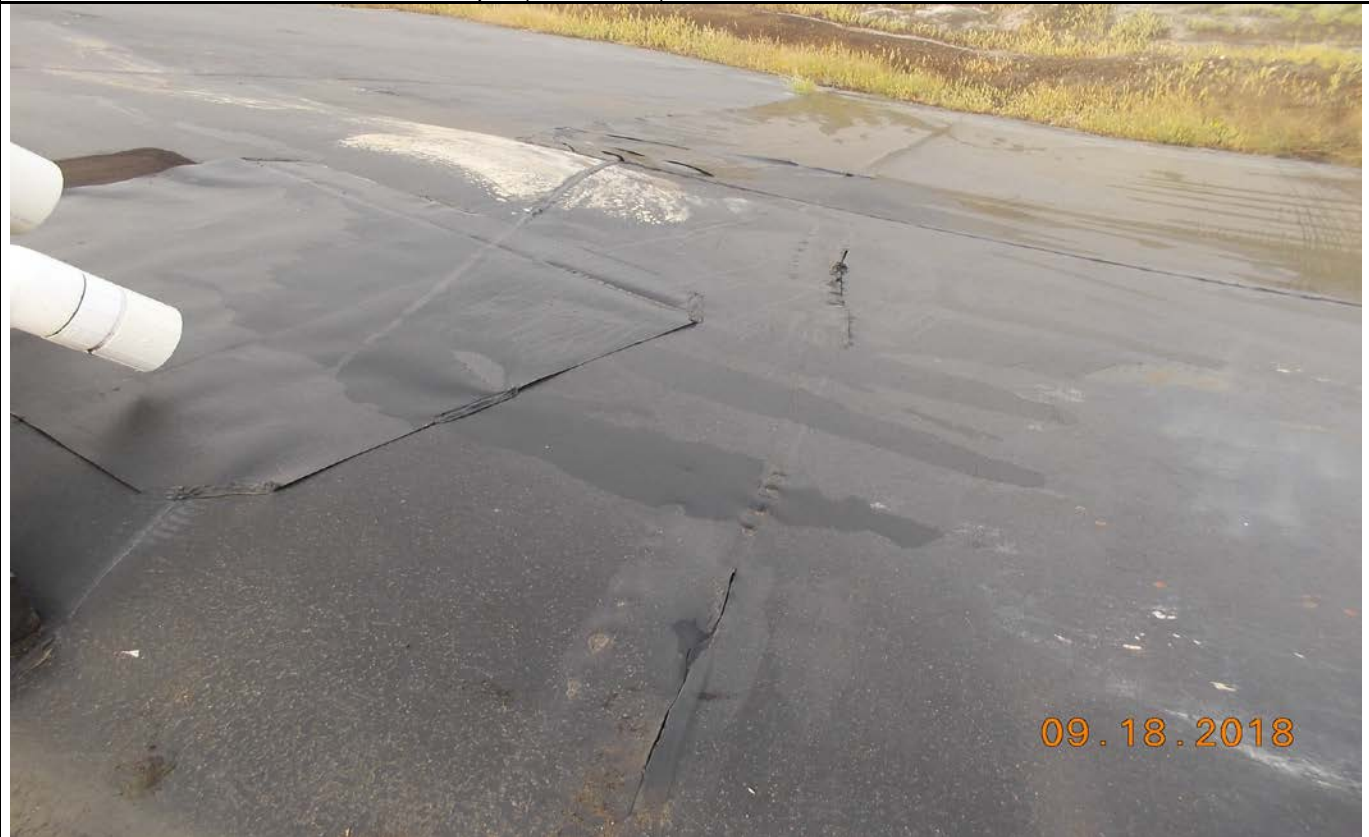
and compacted clay liner along the toe of the berm upstream slope in a couple of locations. Several geomembrane defects were observed on the upper portion of the geomembrane on the upstream slopes; however, the defect locations were observed well above the water elevation within the north cell observed over the course of 2018. The north cell berm upstream slopes appear to be in fair condition.

Photograph 18 (North Cell east upstream slope)  
Minor geomembrane damage on upstream slope and retention pond/coal pit sump inlet piping (SS PDS (6).JPG)

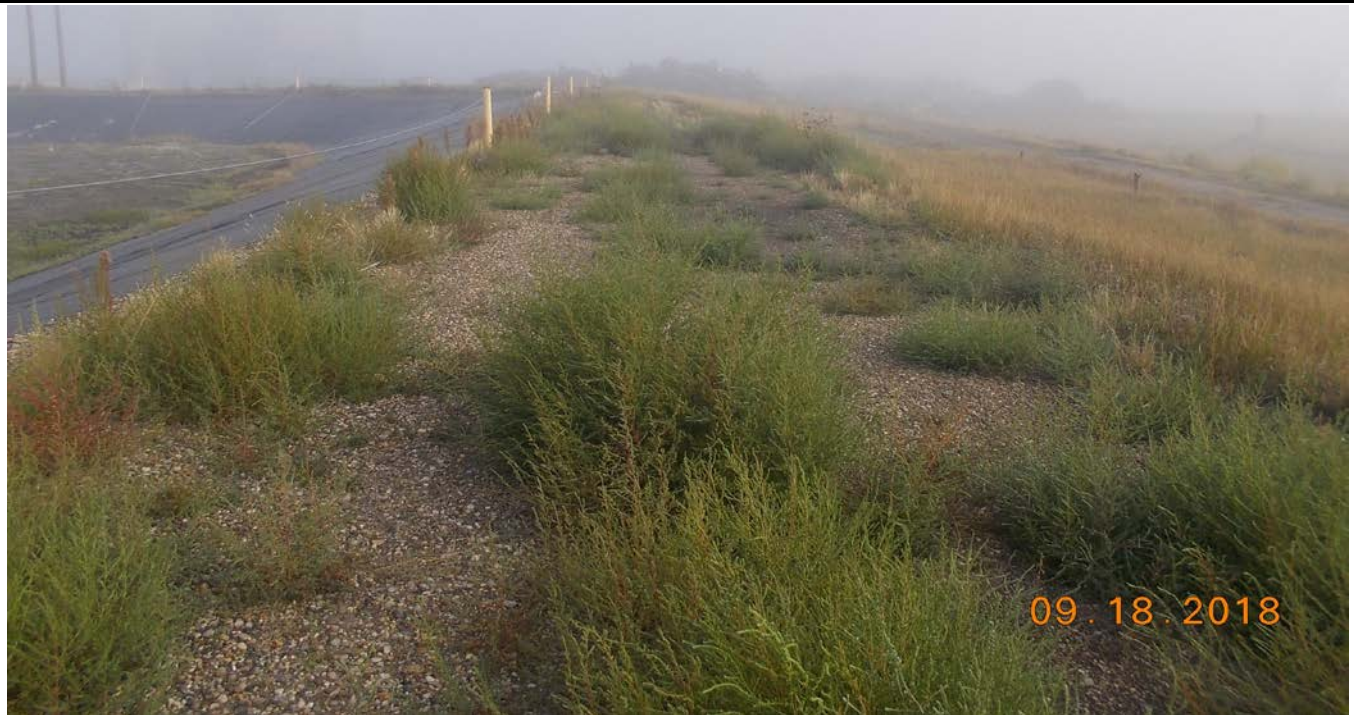
Photograph 19 (East berm crest)  
East berm crest with gravel road surface (SS PDS (8)).JPG)

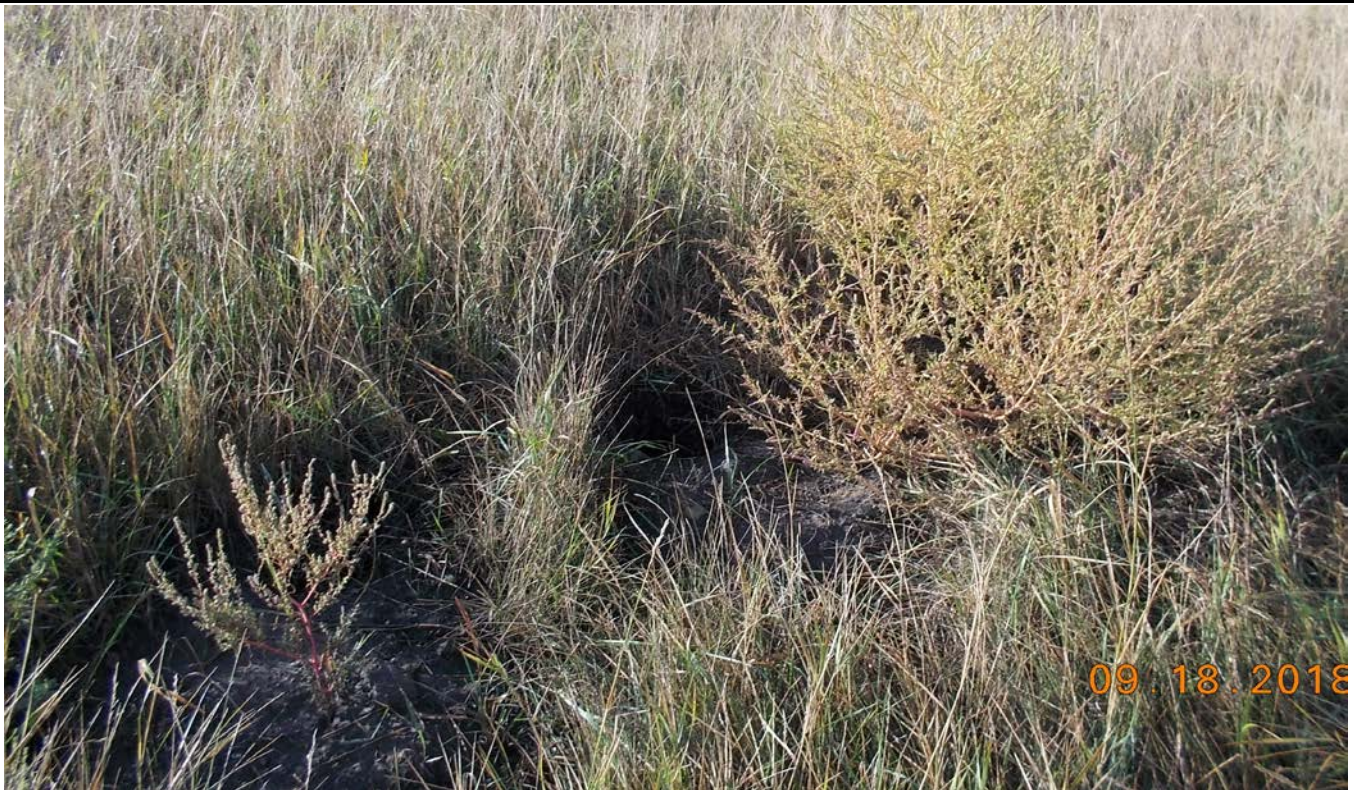
Photograph 20 (North downstream slope)  
Grass vegetation and animal burrows on the north downstream slope (SS PDS (29)).JPG)
