# Annual Inspection

## *Coal Creek Station - Drains Pond System CCR Surface Impoundment*

### **Great River Energy**

January 2019

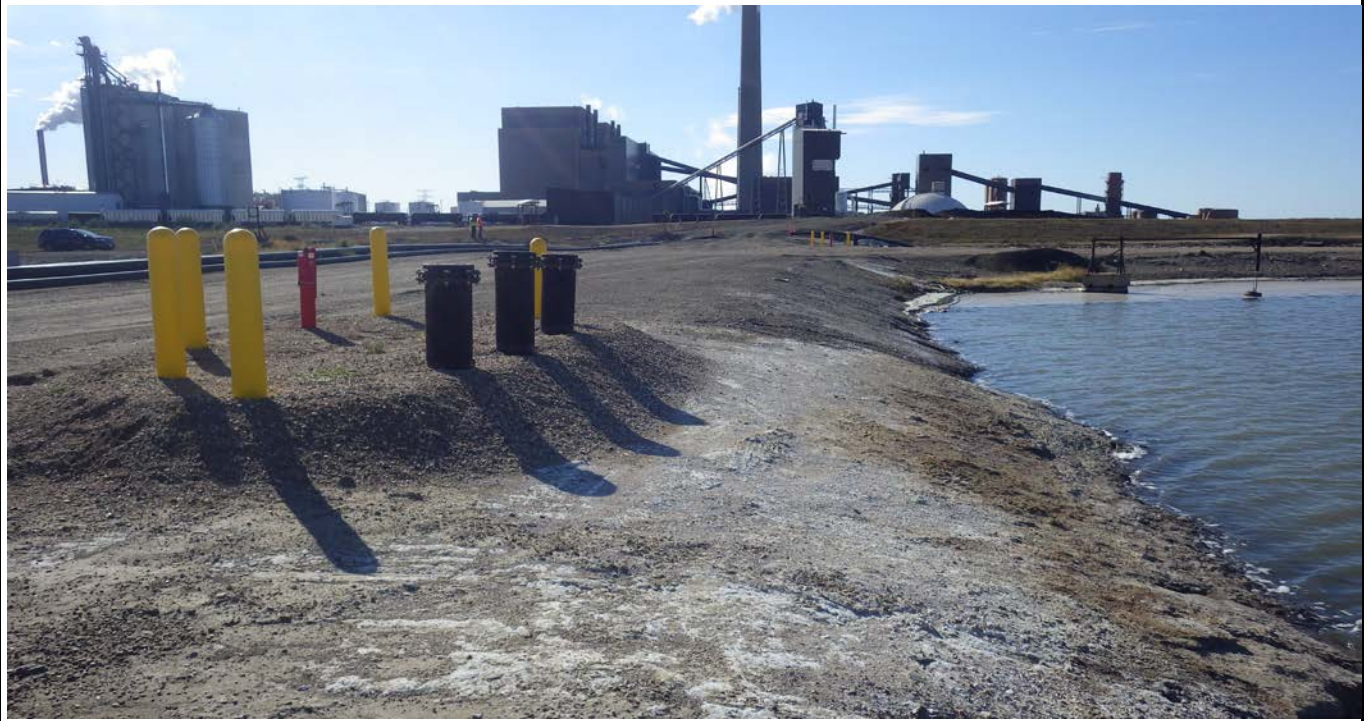
Photograph 1 (South berm crest)  
Cleanout and valve control for Upstream Raise 91 and east cell cross-over pipes (IMGP6327.JPG)

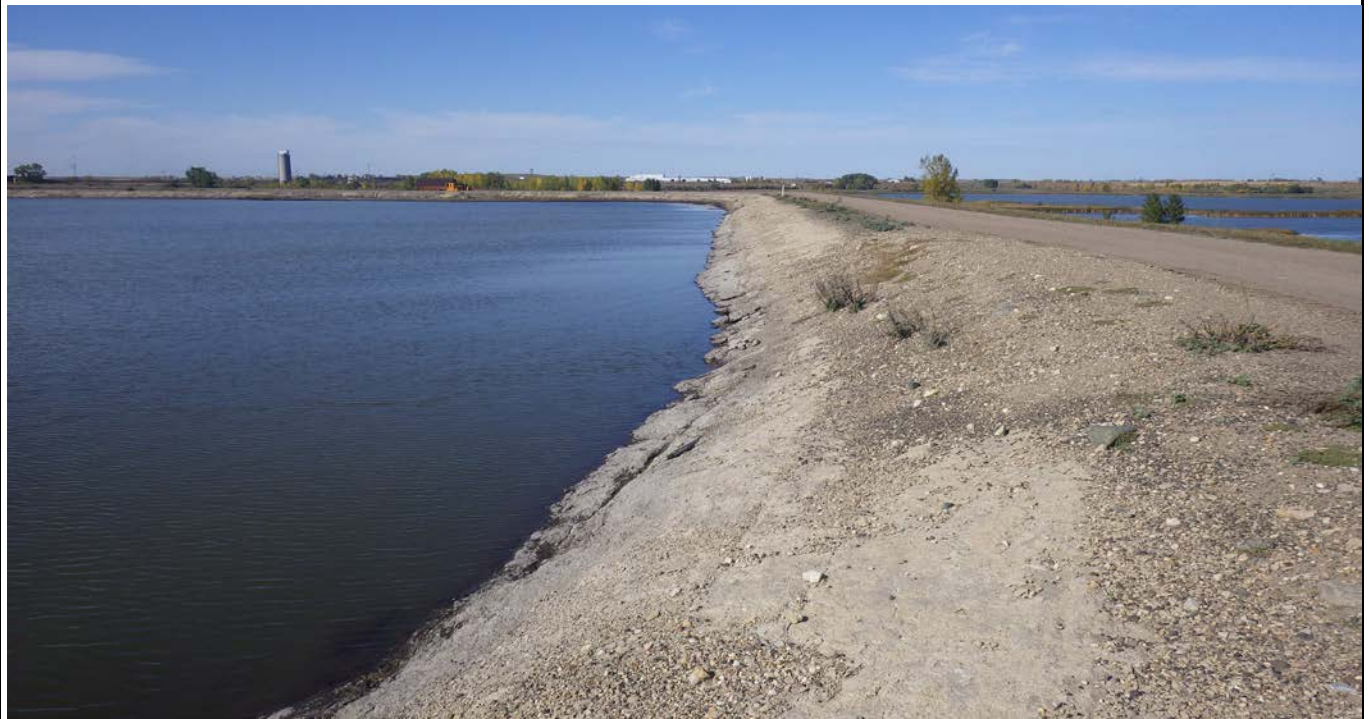
East cell slopes are being protected from erosion with a cemented fly ash layer from the floor up to the embankment crest. This cemented fly ash layer overlies a geotextile and a 1-foot protective sand layer and appeared to be competent. The water level is typically managed between elevation 1,916 feet amsl and 1,918 feet amsl (4 to 6 feet freeboard). At the time of observations, the water level was approximately at elevation 1,917.5 feet amsl. The berm upstream slopes of the east cell appear to be in good condition.

Photograph 2 (East berm upstream slope)  
Upstream slope fly ash protective cover (IMGP6328.JPG)

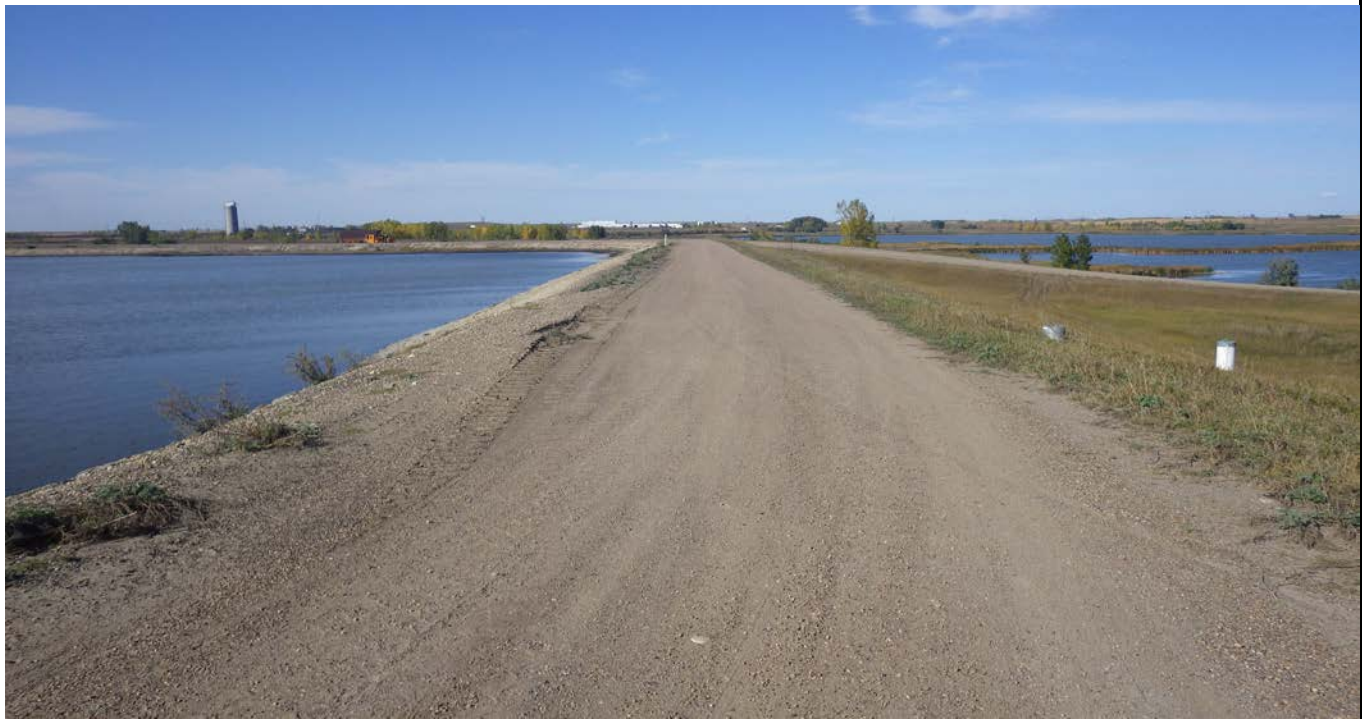
Photograph 3 (East berm crest)  
East berm crest and gravel road surface (IMGP6329.JPG)

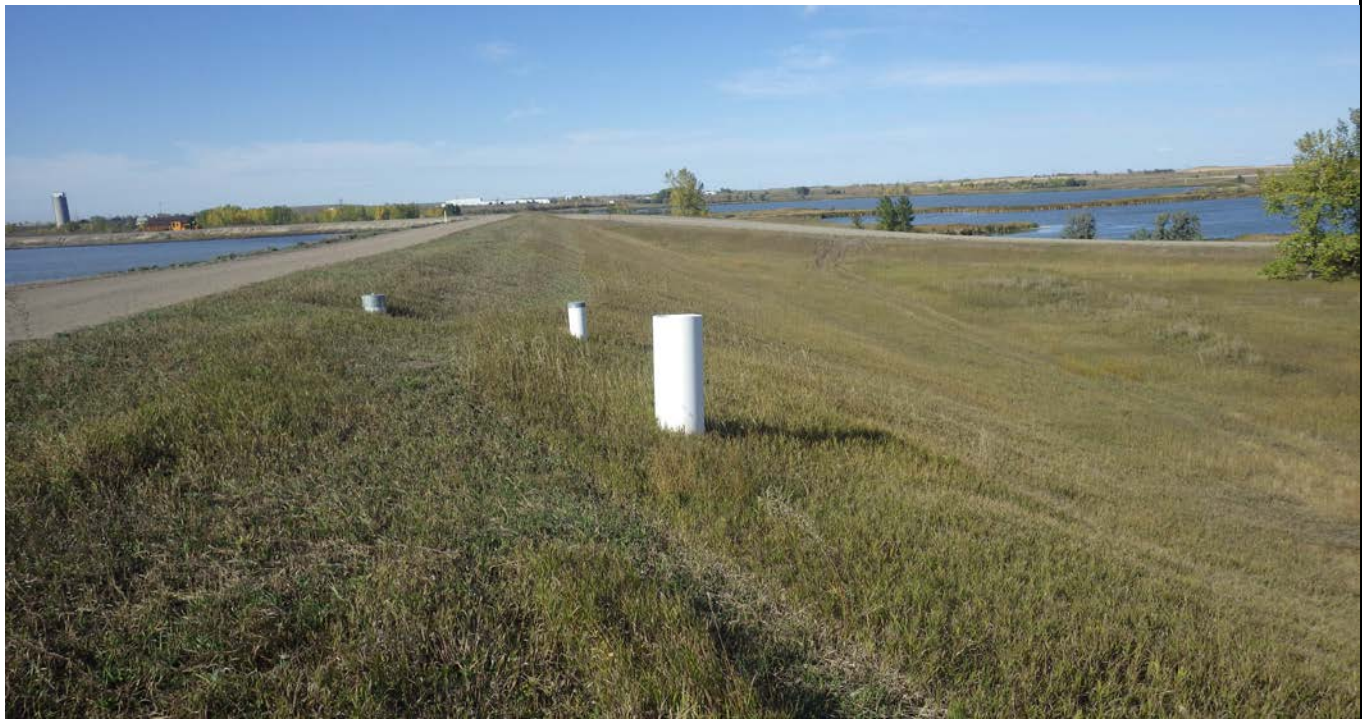
Photograph 4 (East berm downstream slope)  
Grass vegetation on east downstream slope (IMGP6330.JPG)

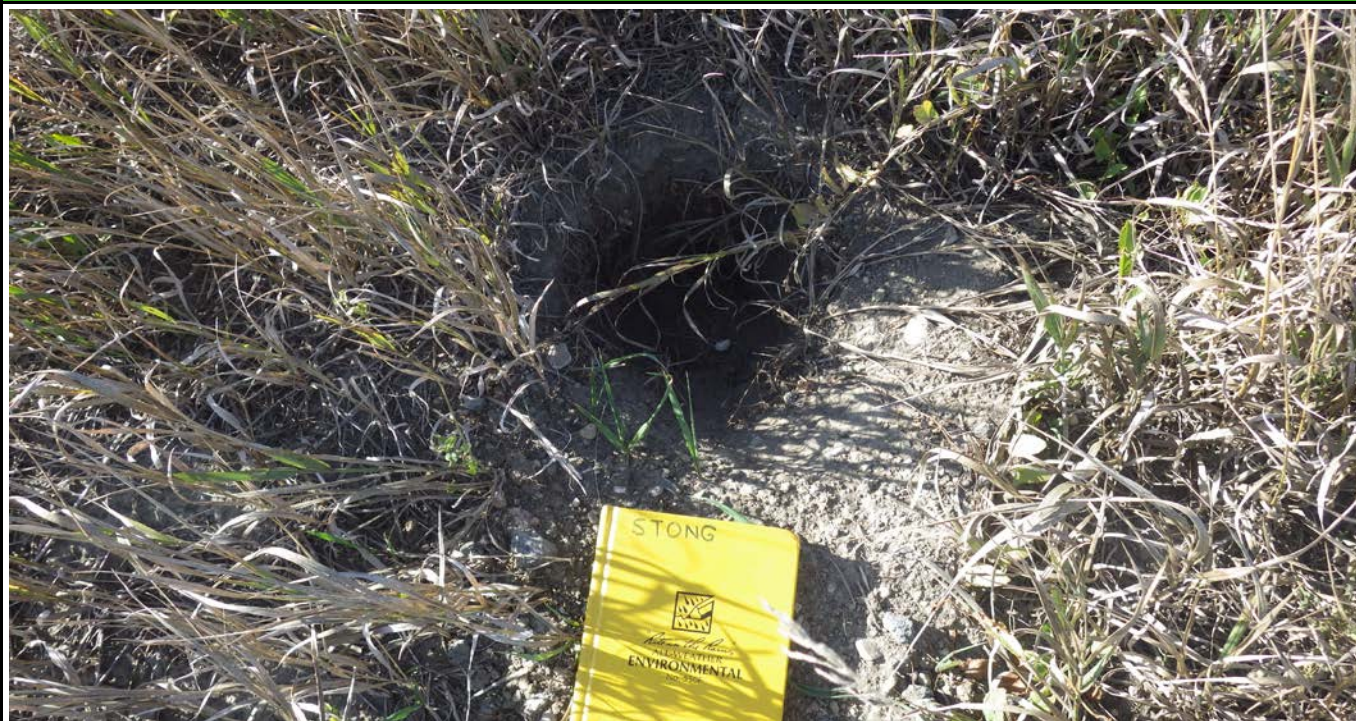
The toe of the north, east, and south slopes of the Drains Pond System were covered with tall grass and reeds (south toe of slope) with no indications of seepage, sloughing, cracking, significant erosion, settlement, or abnormally thriving vegetation. Some minor rutting was observed near a monitoring well near the toe on the south end of the east berm and minor animal burrows were noted. The toe appeared to be in good condition.

Photograph 5 (East berm downstream toe)  
Animal burrow at the downstream toe (IMGP6335.JPG)

Minor maintenance items that may need to be continually addressed include repairing ruts that develop within the crest roads, repairing eroded areas of the berm upstream slope fly ash and riprap protection layers, monitoring berm downstream slopes for large animal burrows or erosion that may affect operations and reseeding as required, and removing sediment that accumulates within the facilities that negatively impacts operations. In addition, the inflow and outflow piping should be monitored regularly to ensure proper conveyance of water to and from the facility.

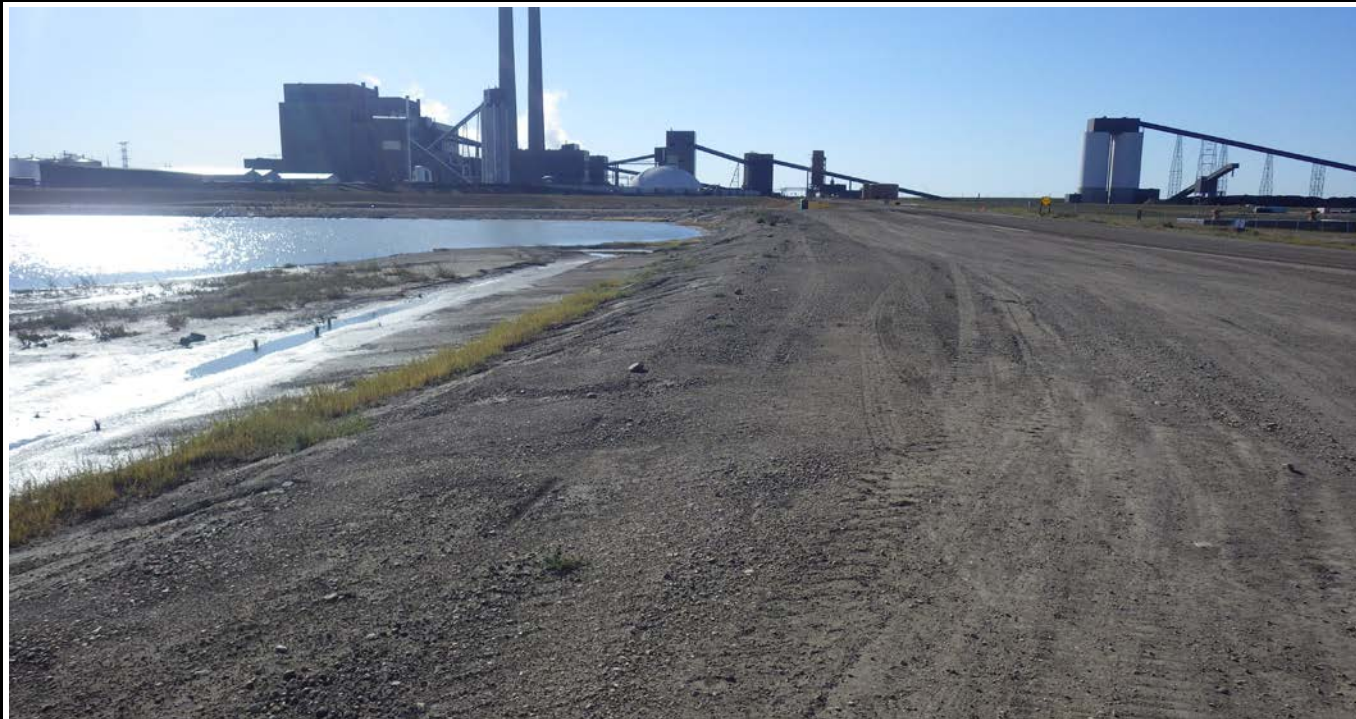
Photograph 6 (North berm crest)  
North berm crest and gravel road surface (IMGP6337.JPG)

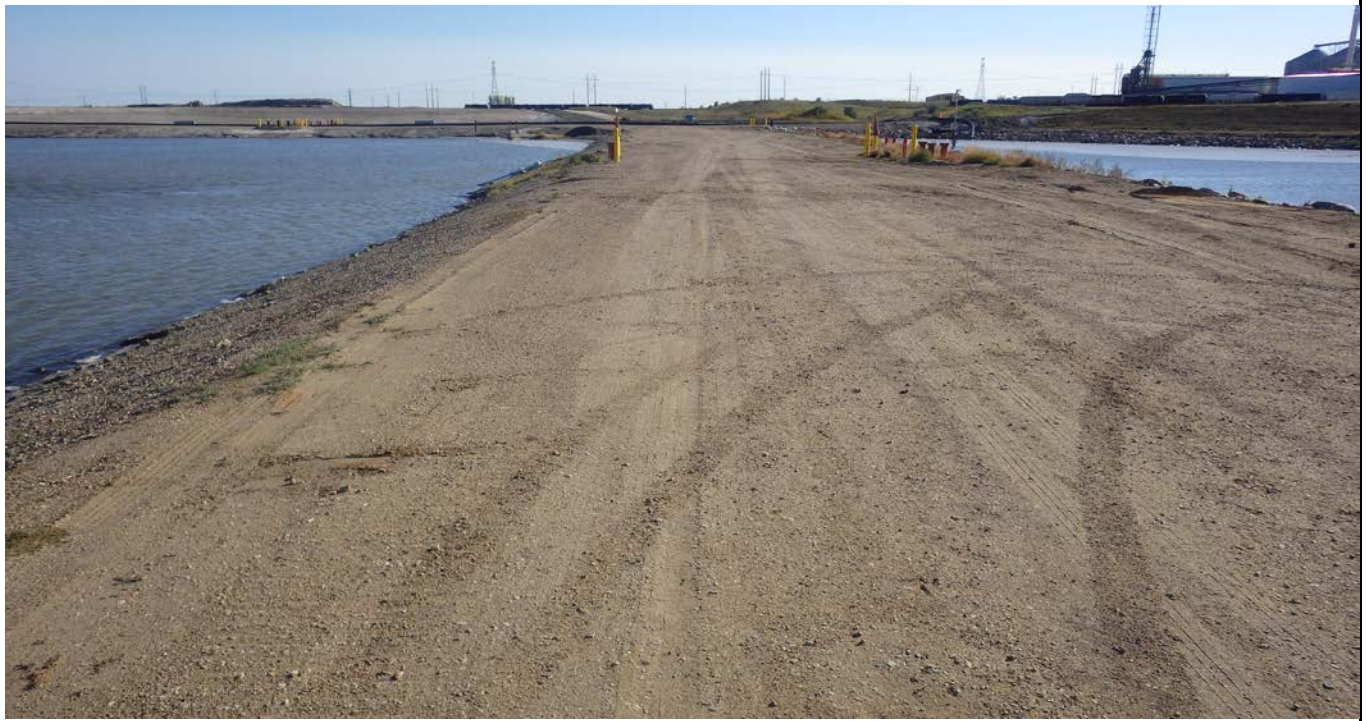
Photograph 7 (East/Center Cell berm crest)  
Center/east cell berm crest and gravel road surface (IMGP6345.JPG)

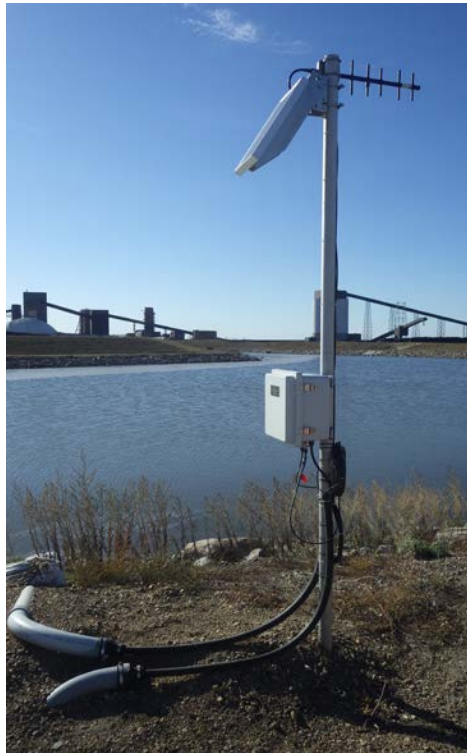
Photograph 8 (East/Center Cell berm crest)  
Pond level instrumentation panel (IMGP6347.JPG)

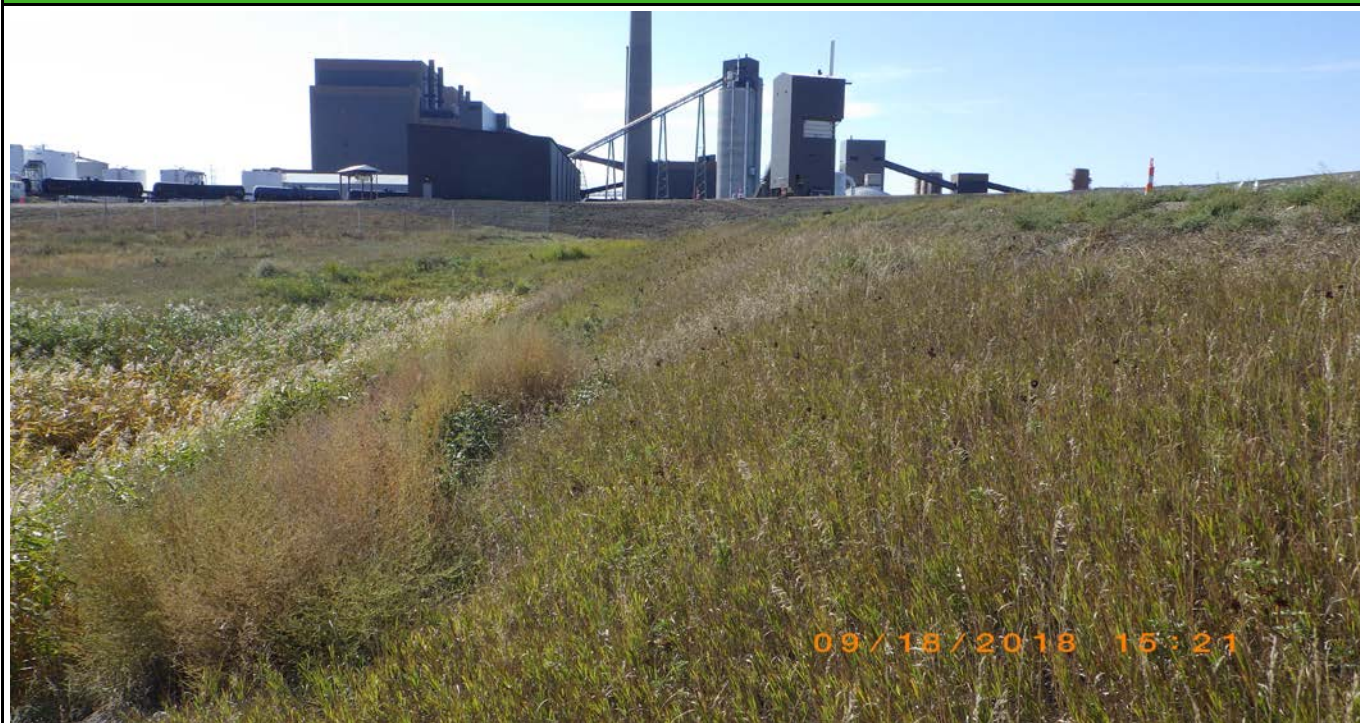
Photograph 9 (South downstream slope)  
Grass vegetation on south downstream slope (1ccs.JPG)

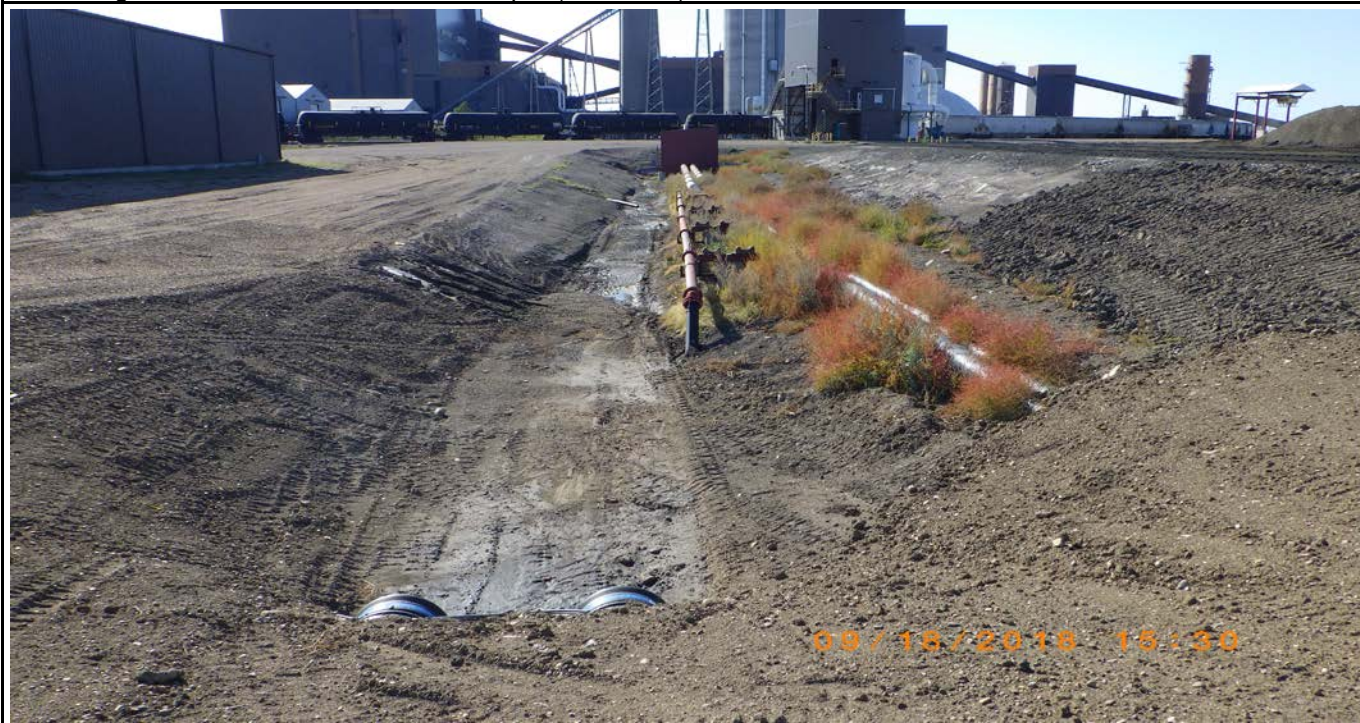
Photograph 10 (South berm downstream slope)  
Channel on south side of west cell (7ccs.JPG)

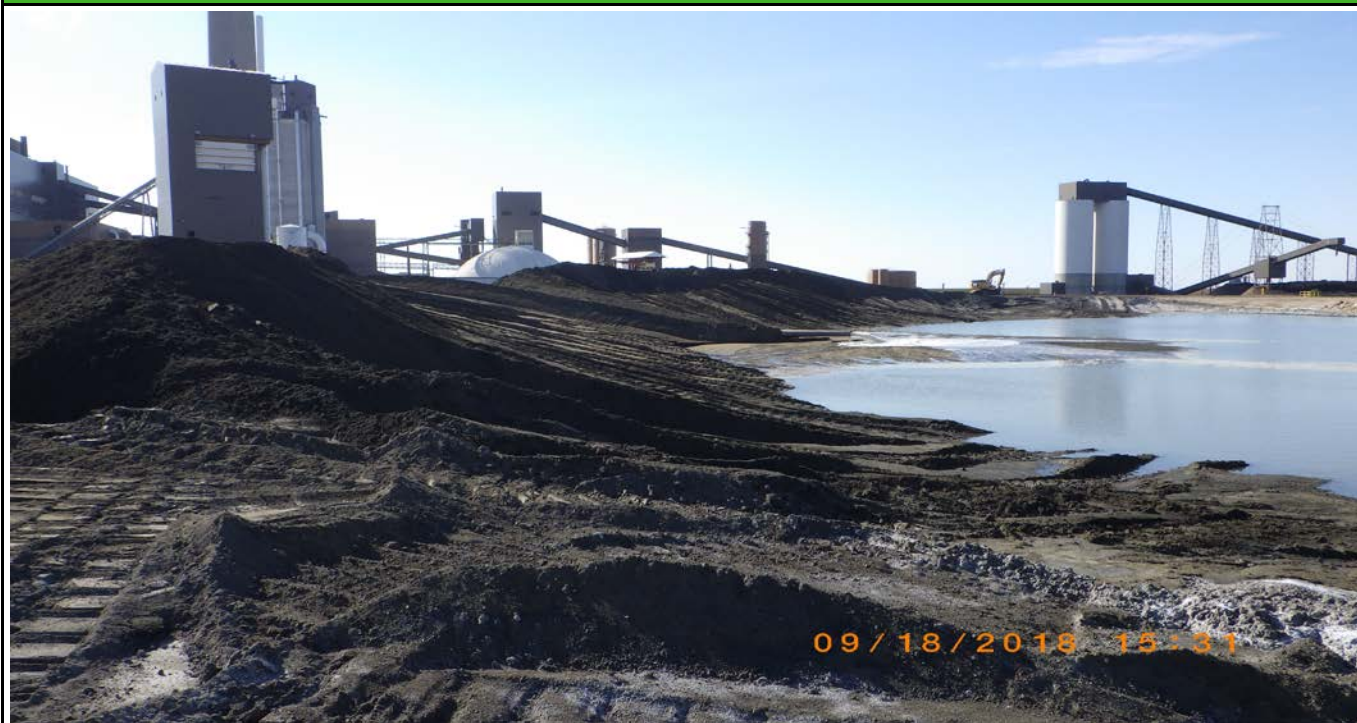
Photograph 11 (South berm upstream slope)  
Bottom ash discharge pipes and bottom ash dewatering stockpiles (8ccs.JPG)

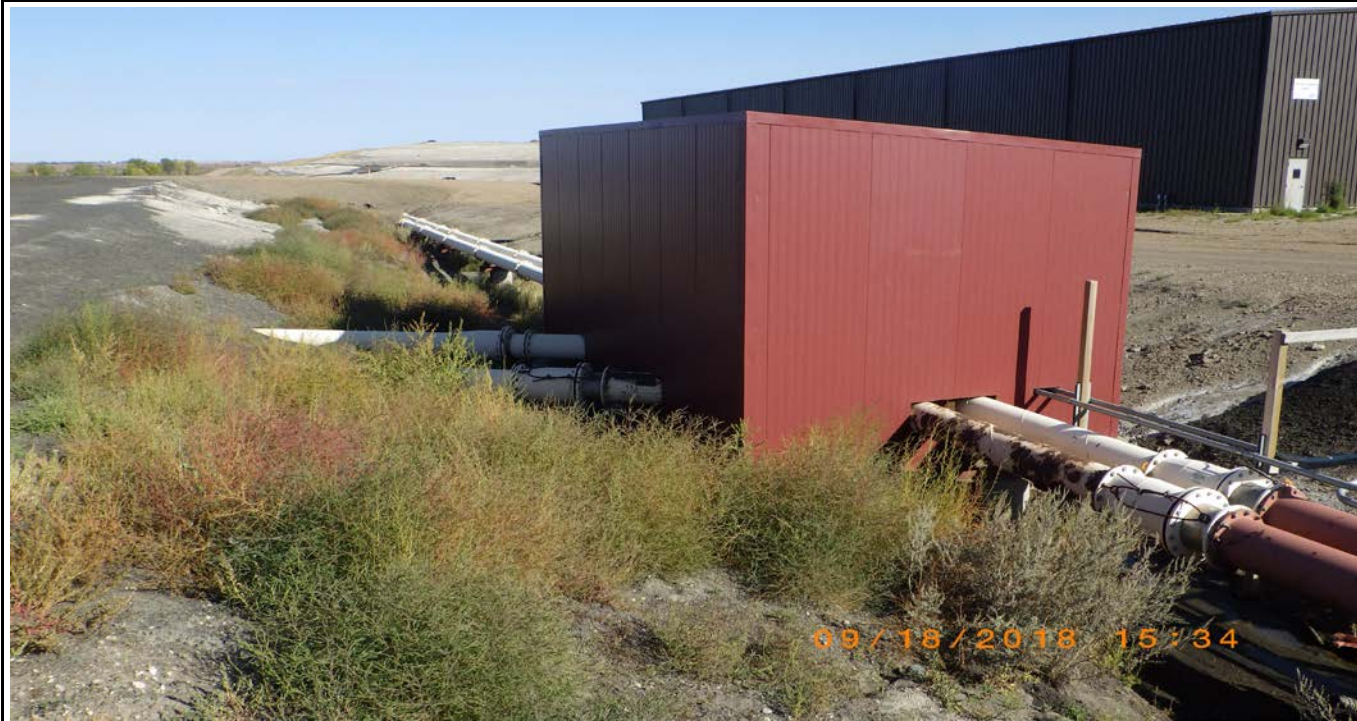
Photograph 12 (SW corner)  
Switch valve house (10ccs.JPG)

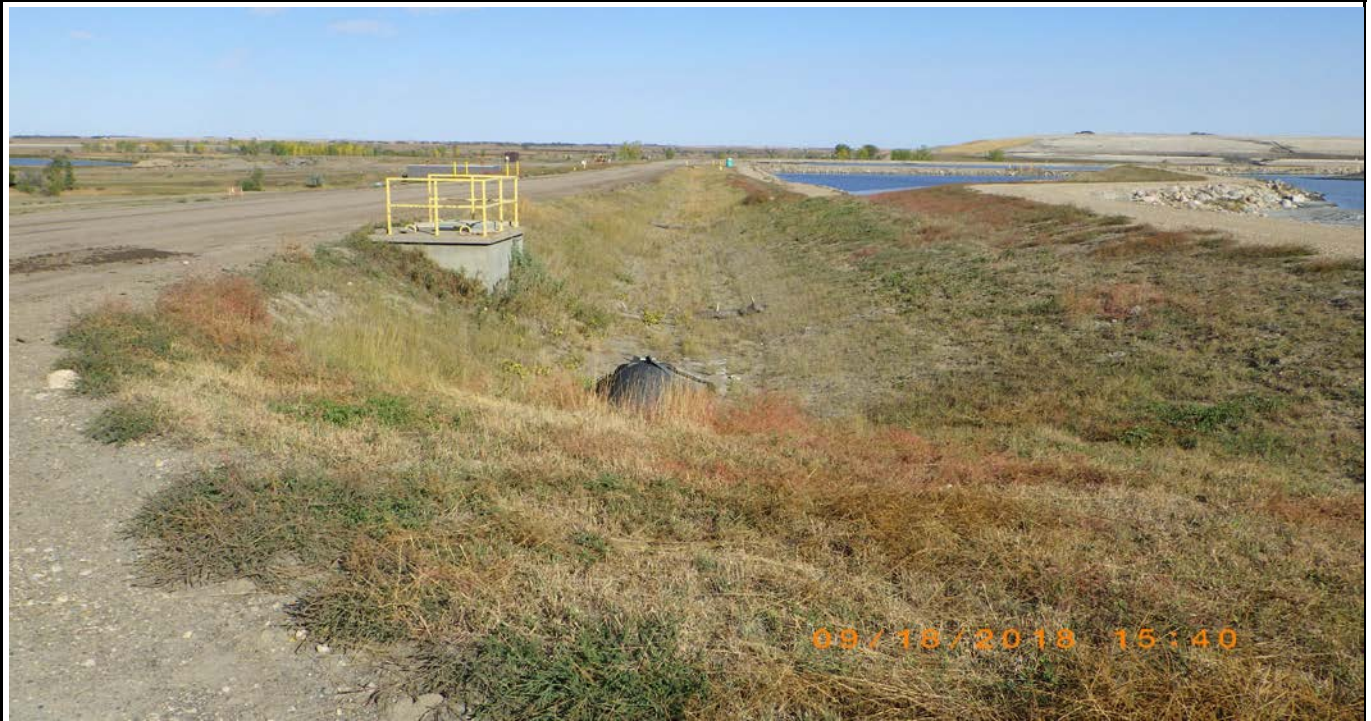
Photograph 13 (North drainage ditch)  
Culvert and channel with recently established vegetation (15ccs.JPG)

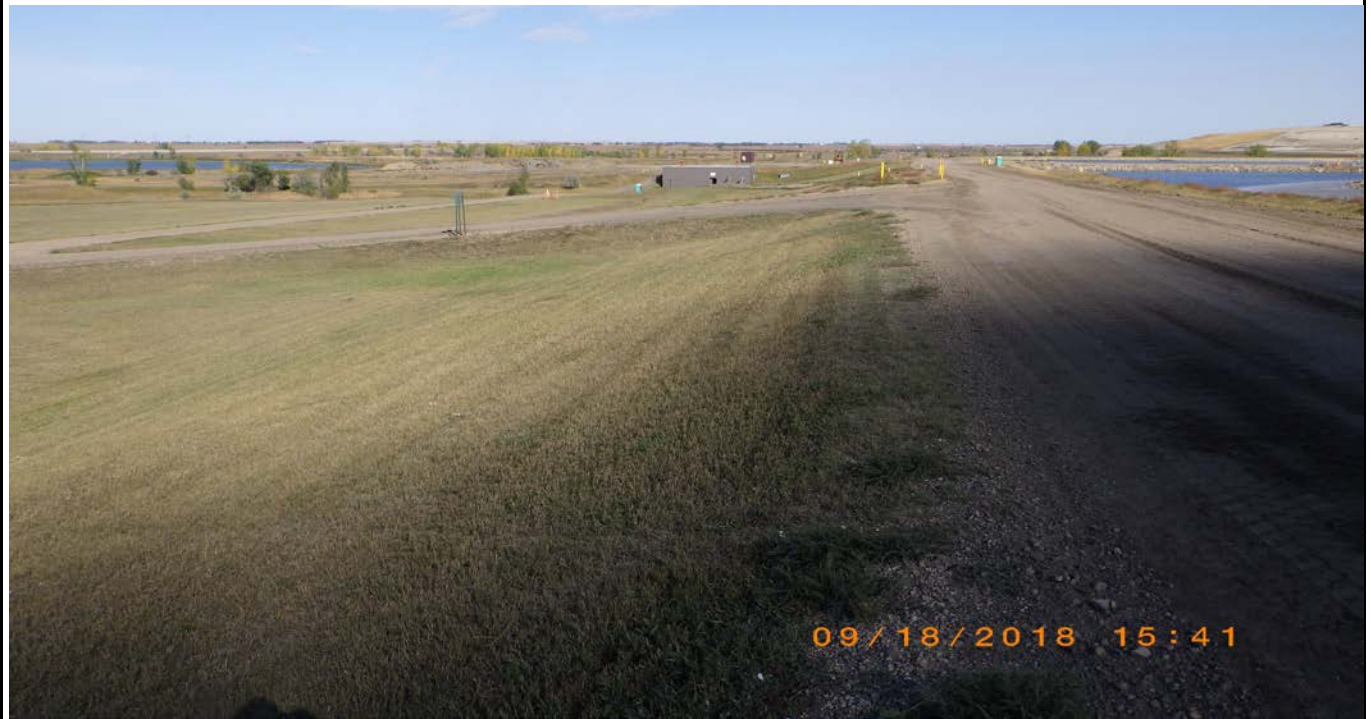
Photograph 14 (North downstream slope)  
Grass vegetation on downstream slope (16ccs.JPG)

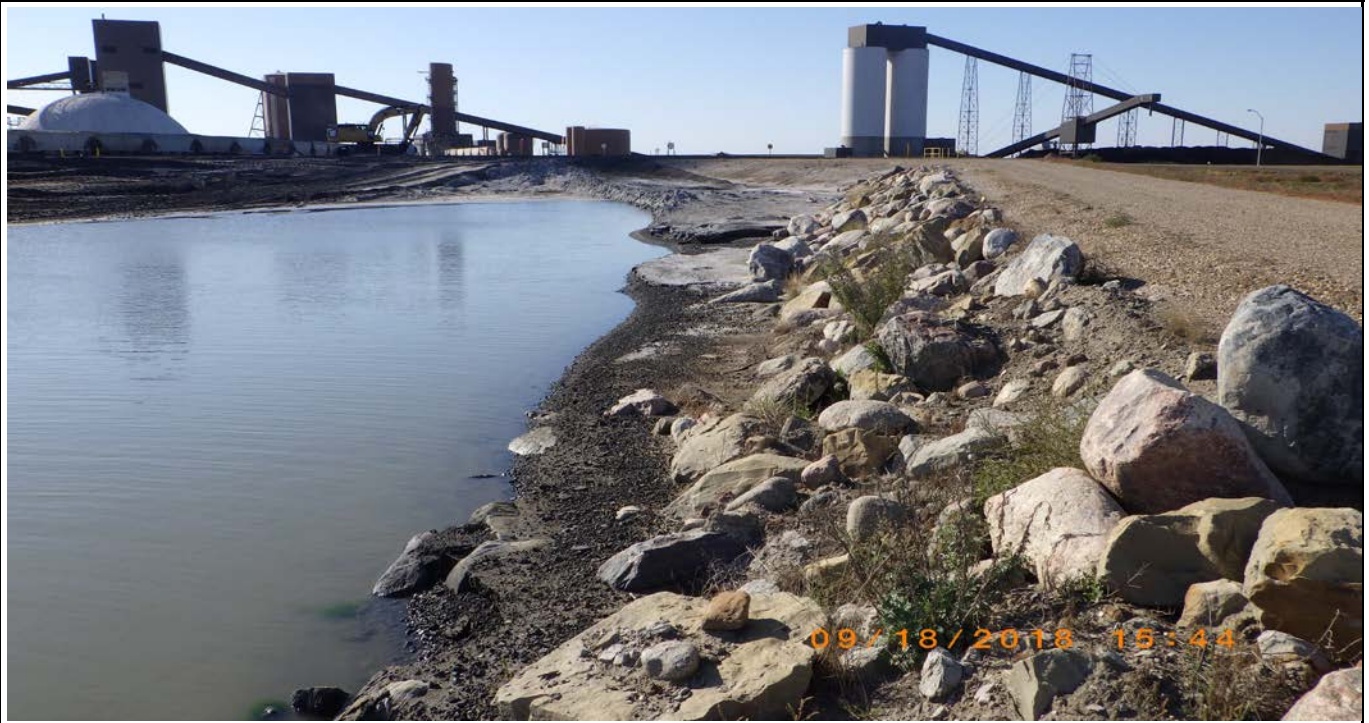
Photograph 15 (North berm upstream slope)  
West cell riprap on upstream slope (18ccs.JPG)

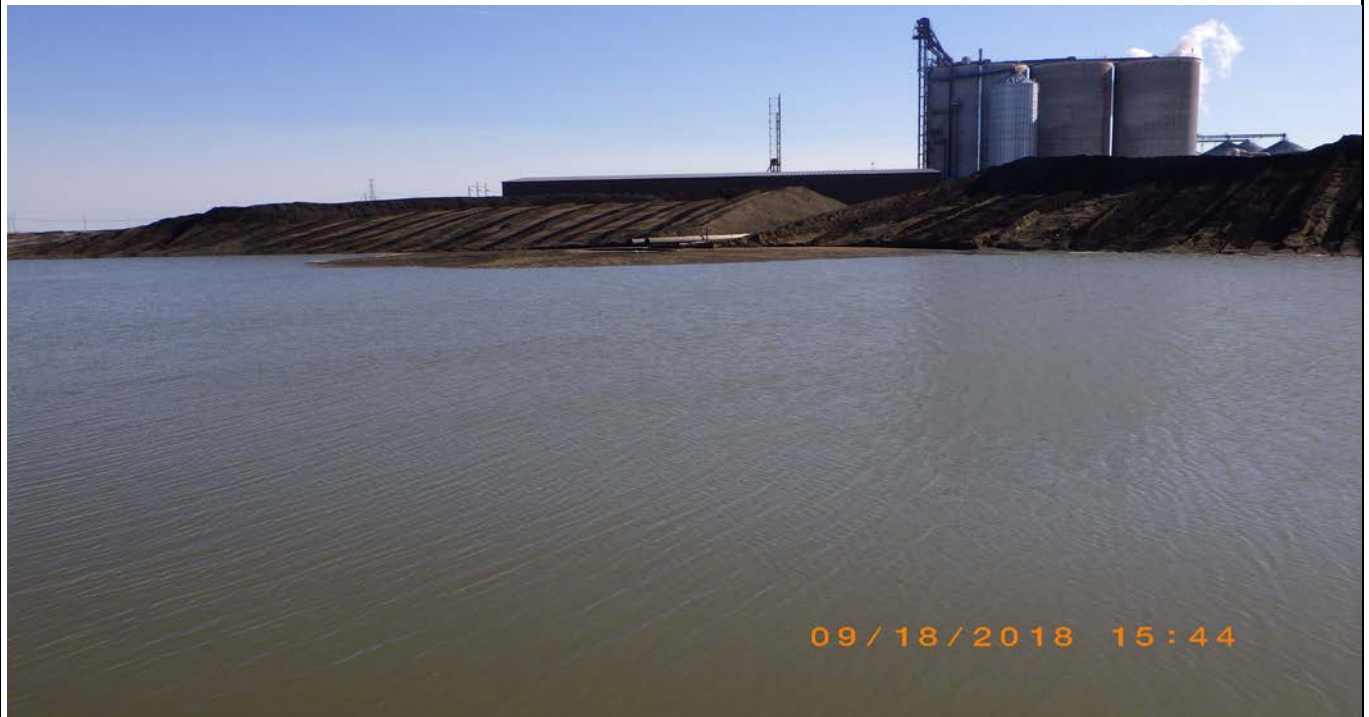
Photograph 16 (North berm upstream slope)  
Bottom ash discharge pipes, dewatering stockpiles, and interior of west cell (19ccs.JPG)

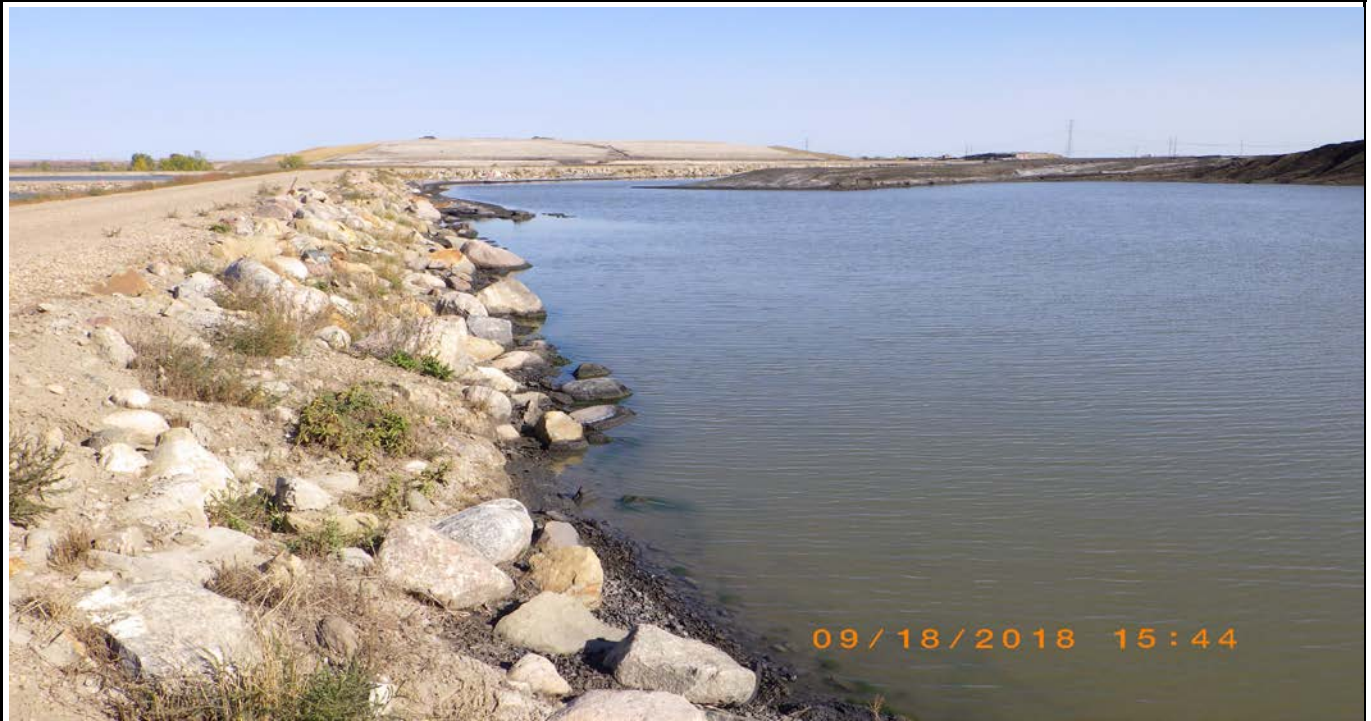
Photograph 17 (North berm upstream slope)  
West cell riprap on upstream slope (20ccs.JPG)

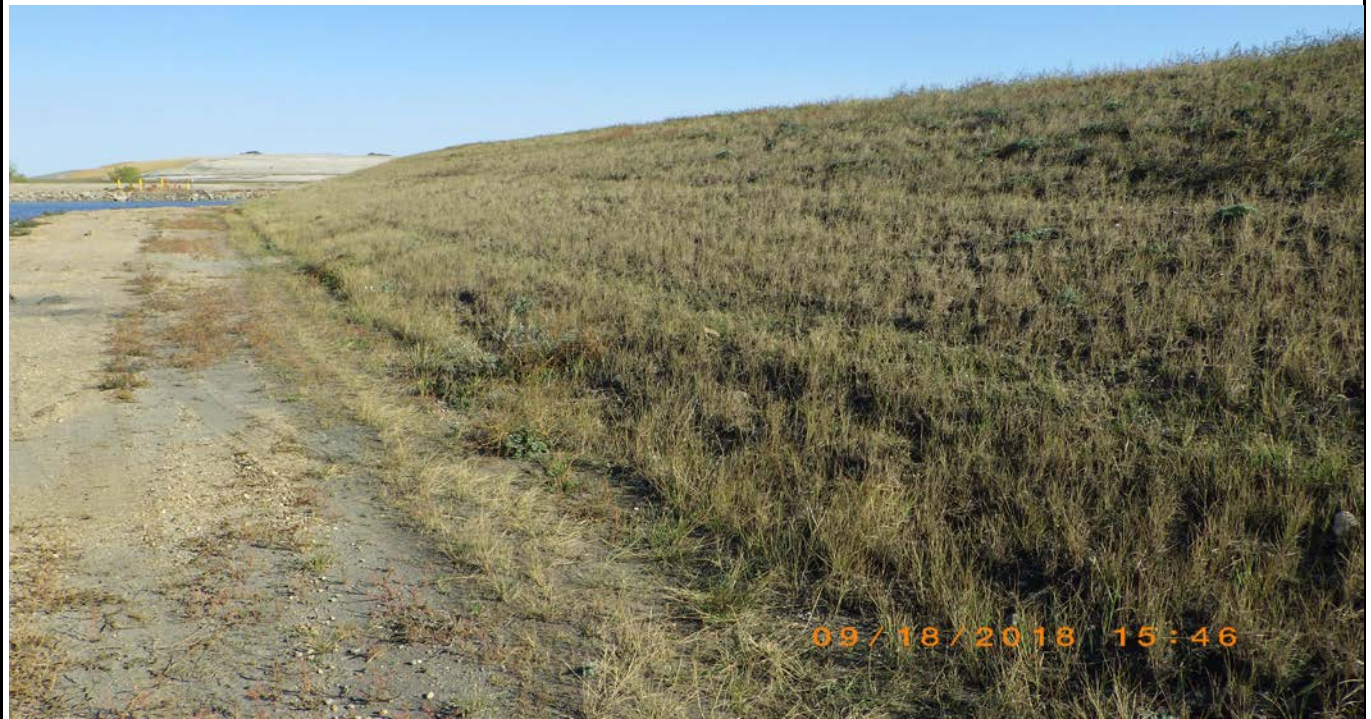
Photograph 18 (West/Center cell downstream slope)  
Grass maintained on West/Center Cell intercell-berm (21ccs.JPG)

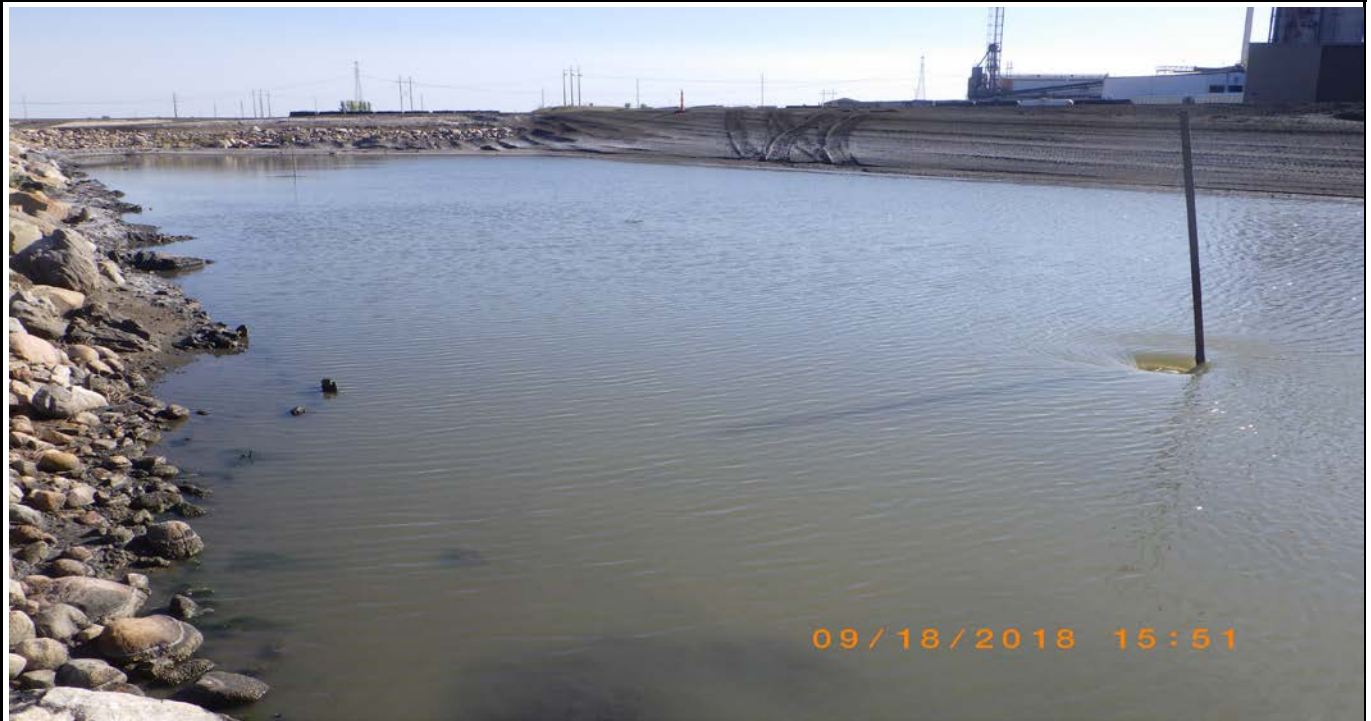
Photograph 19 (West Cell interior)  
Decant pipe inlet from west cell to center cell (24ccs.JPG)

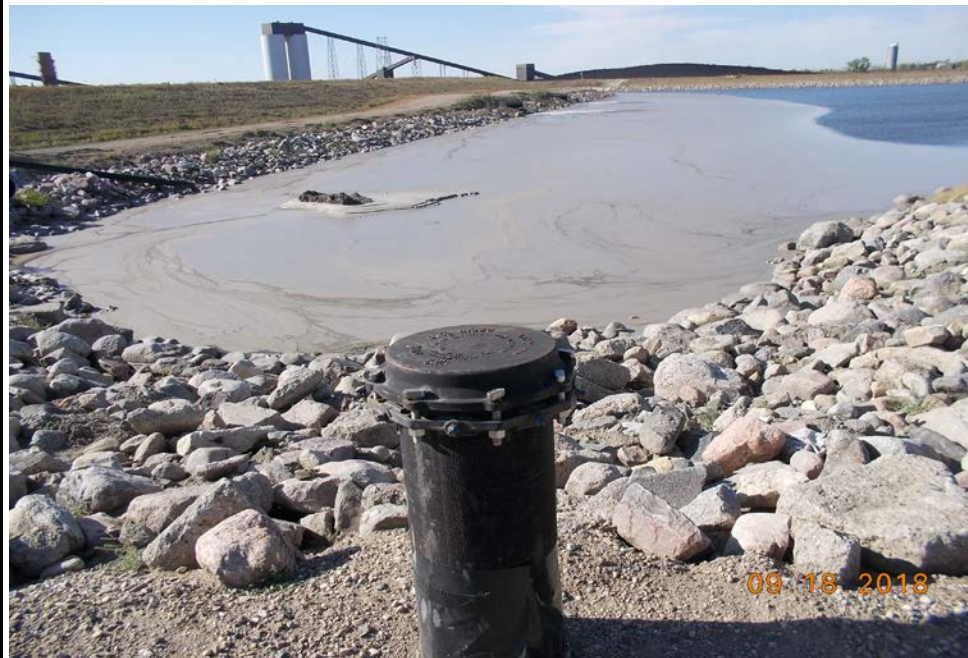
Photograph 20 (Center Cell upstream slope)  
Cross-over pipe riser and upstream slope riprap (1PDS.JPG)

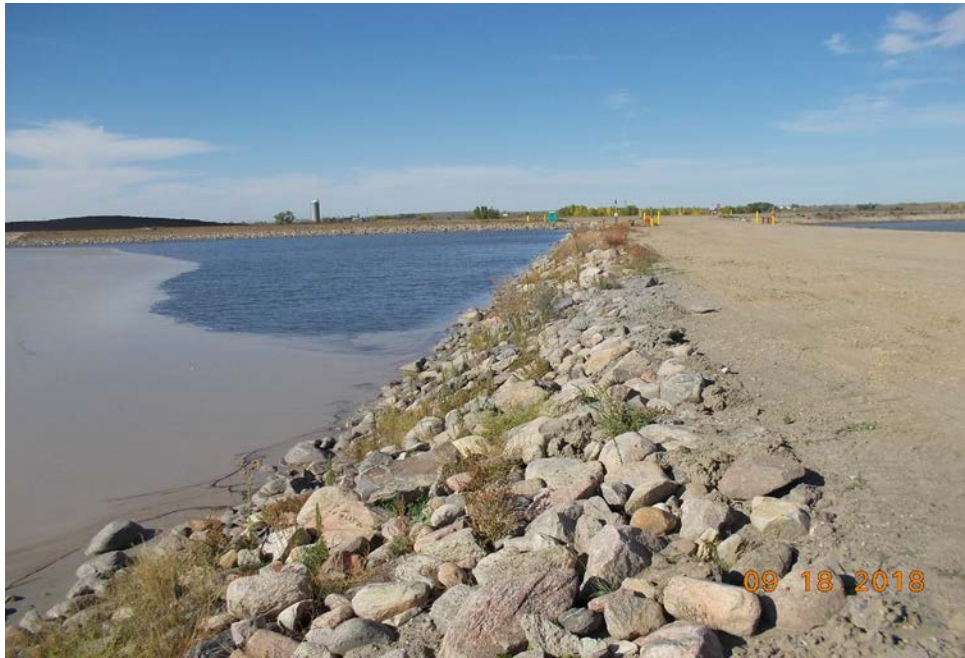
The observable berm upstream slopes appeared to match the design slopes of 3:1 with no observed sections of significant slope movement. The berm upstream slope along the south and west sides of the west cell were below temporarily stacked bottom ash materials and were not visible during the inspection. Center cell slopes and the east berm upstream slopes of the west cell are protected from erosion with a 1-foot thick fly ash layer from the floor to the embankment crest as well as riprap within the normal operating levels of the cells. At the time of inspection, the riprap and fly ash appeared to be in good condition. Minor erosion in the riprap was observed, especially on the west berm upstream slope of the center cell.

Photograph 21 (Center Cell upstream slope)  
Center cell upstream slope riprap (2PDS.JPG)

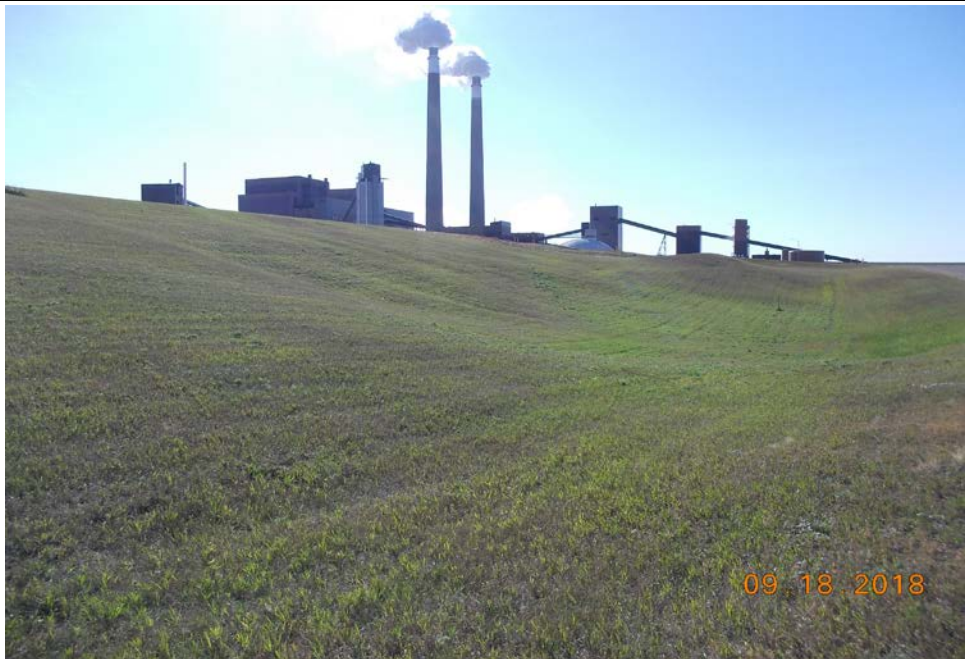
Photograph 22 (North downstream slope)  
Grass vegetation on north downstream slope (7PDS.JPG)

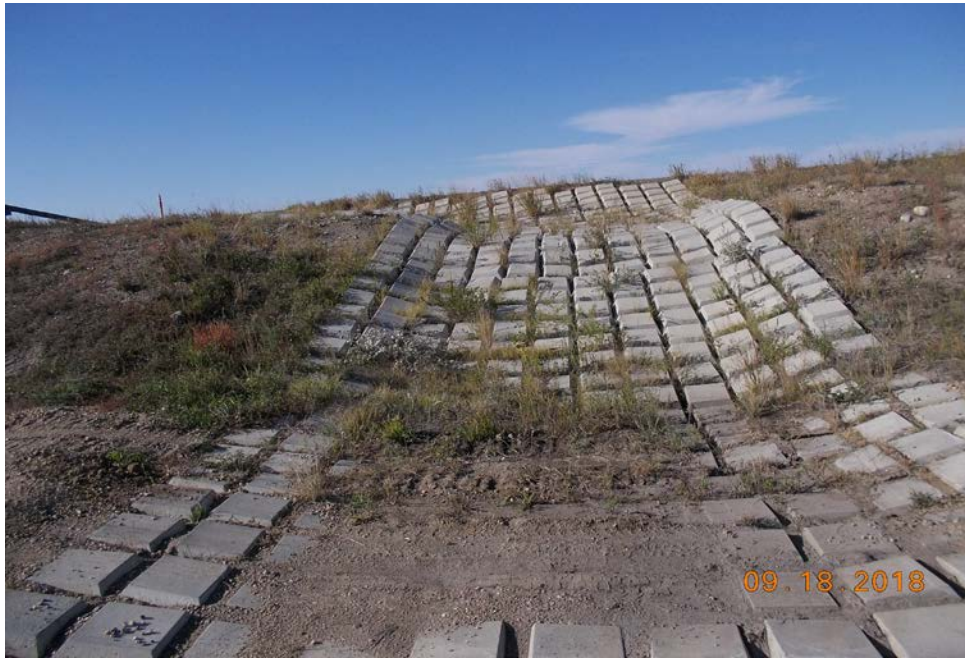
Photograph 23 (North upstream slope)  
Articulated Concrete Block (ACB) armored downchute channel (11PDS.JPG)

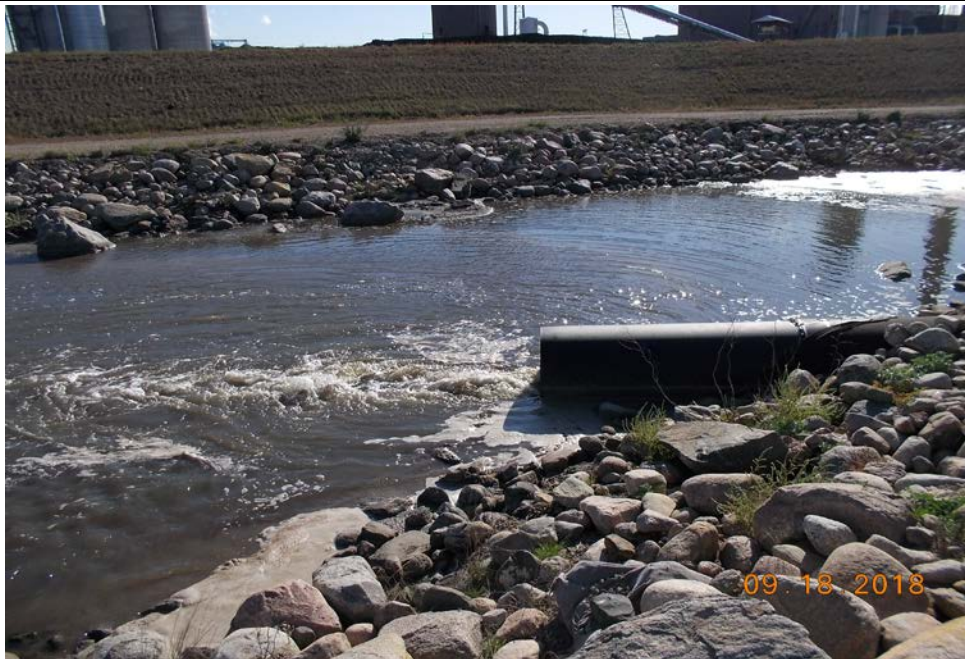
Photograph 24 (Center Cell upstream slope)  
Center cell upstream slope riprap and plant drains inflow pipe (14PDS.JPG)

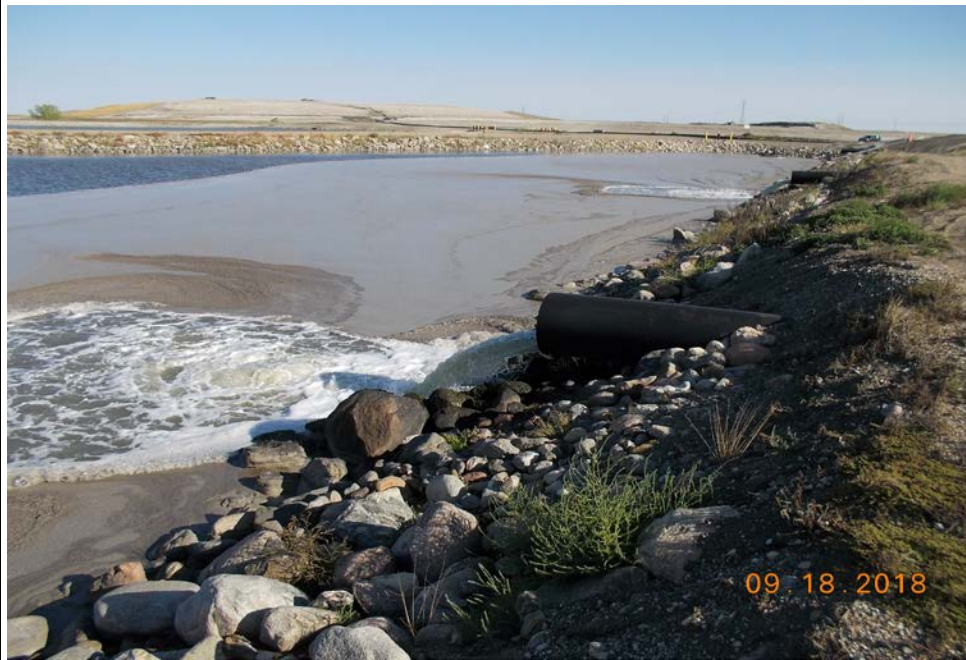
Photograph 25 (Center Cell upstream slope)  
Center cell upstream slope riprap and west cell decant piping outlet to the center cell (17PDS.JPG)
