# Annual Inspection

## *Coal Creek Station - Drains Pond System CCR Surface Impoundment*

### **Great River Energy**

January 2019

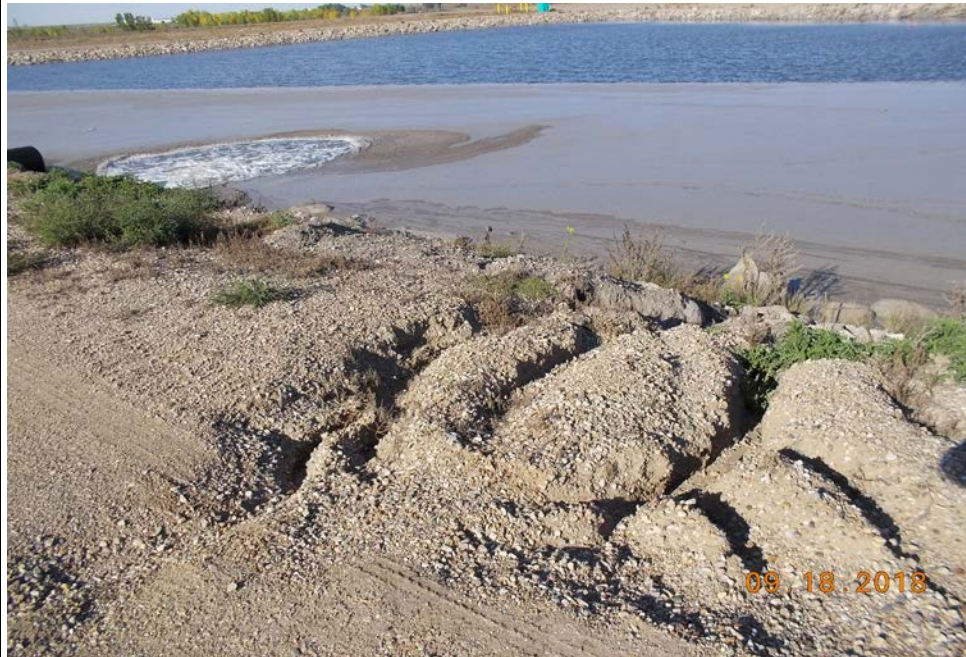
Photograph 26 (West/Center Cell crest road)  
Erosion of gravel surface on intercell-crest road between the west cell and the center cell (18PDS.JPG)

Minor maintenance items that may need to be continually addressed include repairing ruts that develop within the crest roads, repairing eroded areas of the berm upstream slope fly ash and riprap protection layers, monitoring berm downstream slopes for large animal burrows or erosion that may affect operations and reseeding as required, and removing sediment that accumulates within the facilities that negatively impacts operations. In addition, the inflow and outflow piping should be monitored regularly to ensure proper conveyance of water to and from the facility.
