REPORT

Annual Inspection

Coal Creek Station - Southeast Section 16 CCR Landfill

Great River Energy

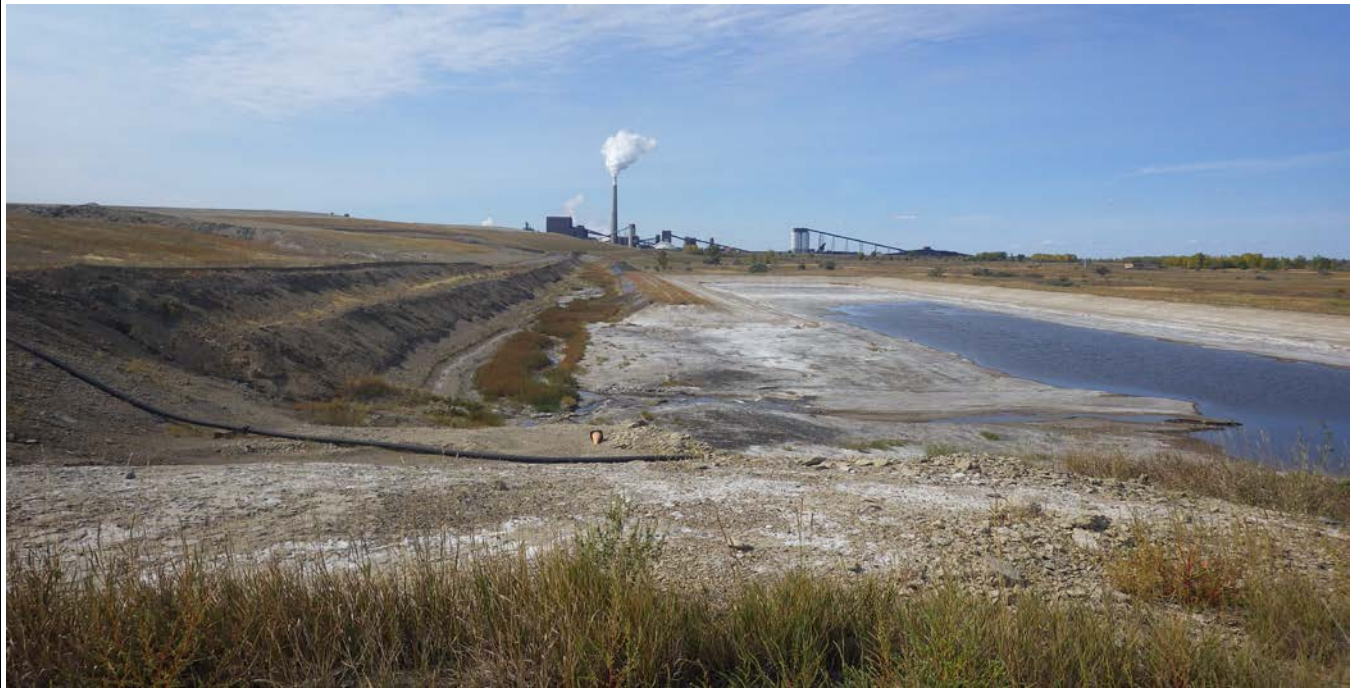
Photograph 1 (SE corner of contact water area (CWA))
Contact water collection area and seepage channel (IMGP6292.JPG)

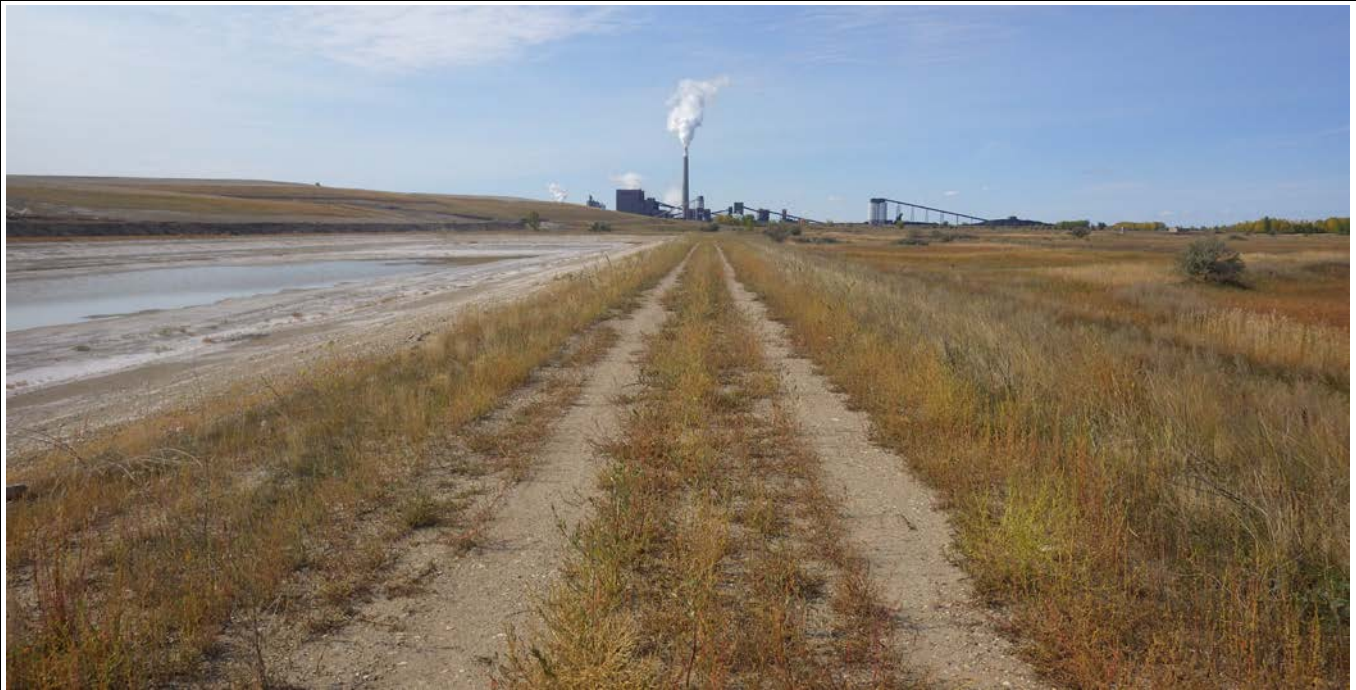
Photograph 2 (CWA north crest)
Contact water collection area berm crest (IMGP6294.JPG)

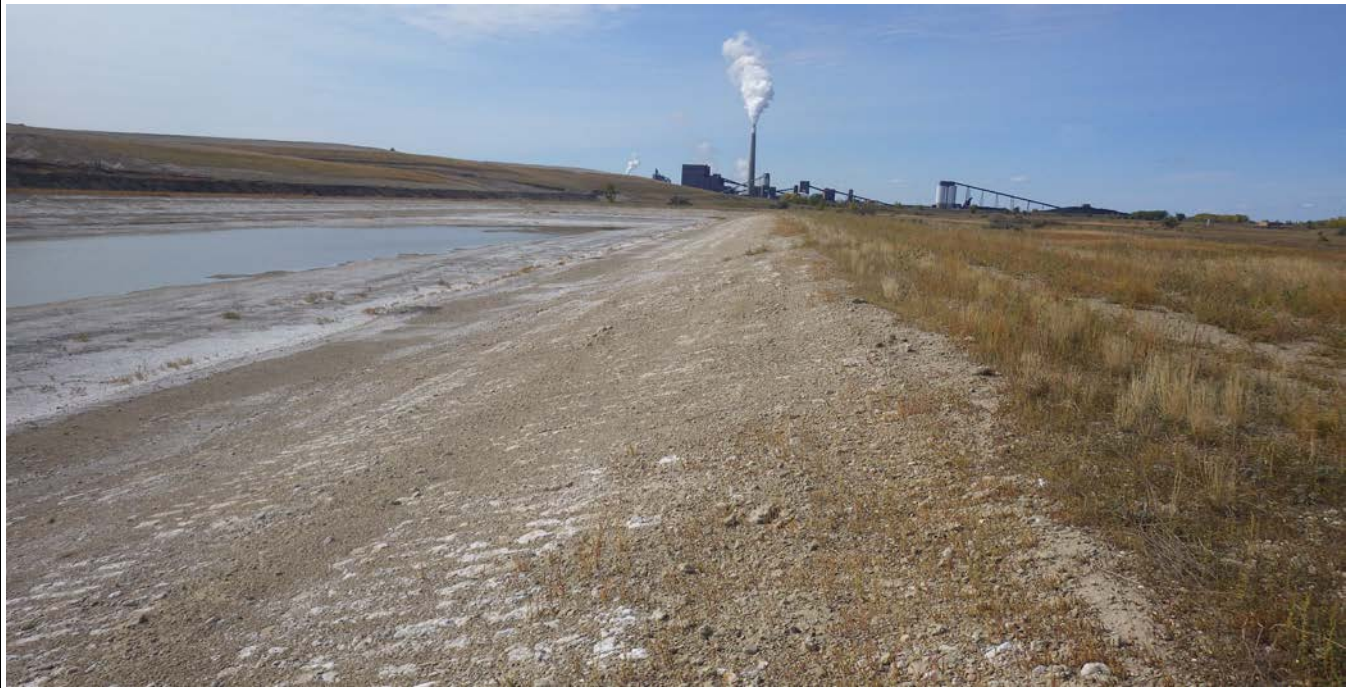
Photograph 3 (CWA north upstream slope)
Fly ash protective cover on contact water collection area upstream slope (IMGP6295.JPG)

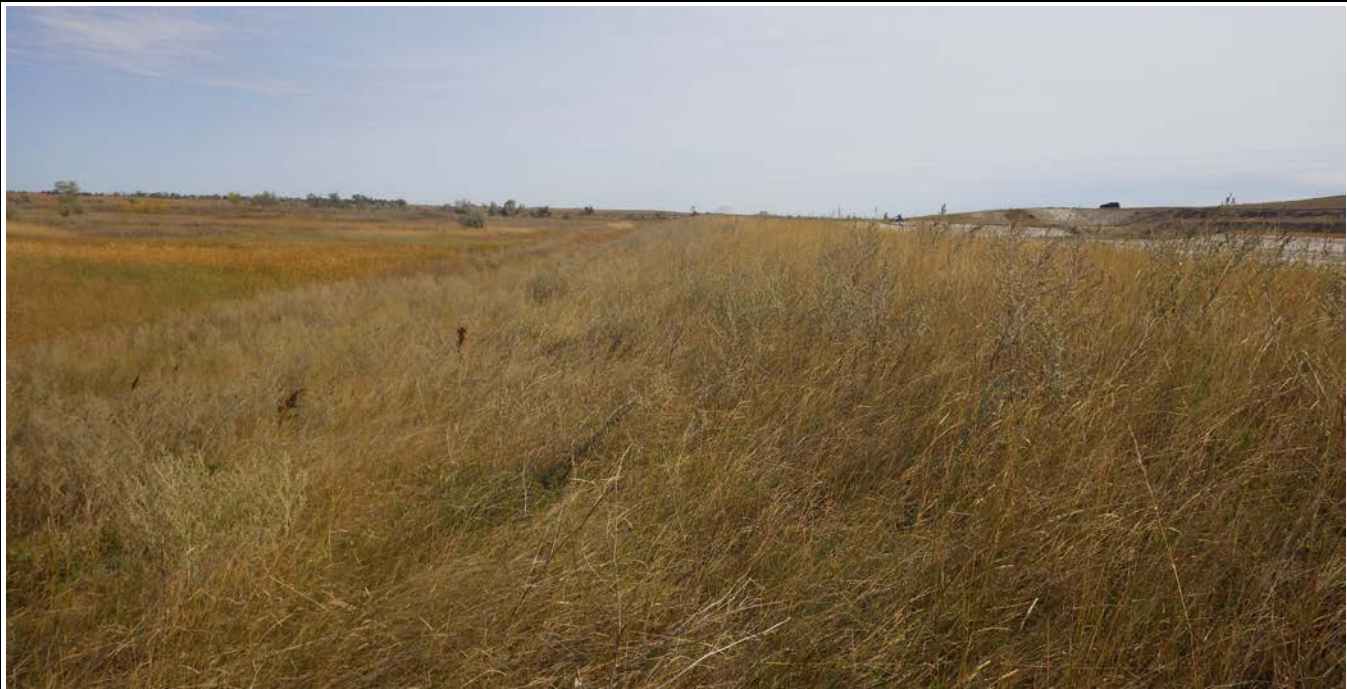
Photograph 4 (CWA north downstream slope)
North berm downstream slope and toe (IMGP6296.JPG)

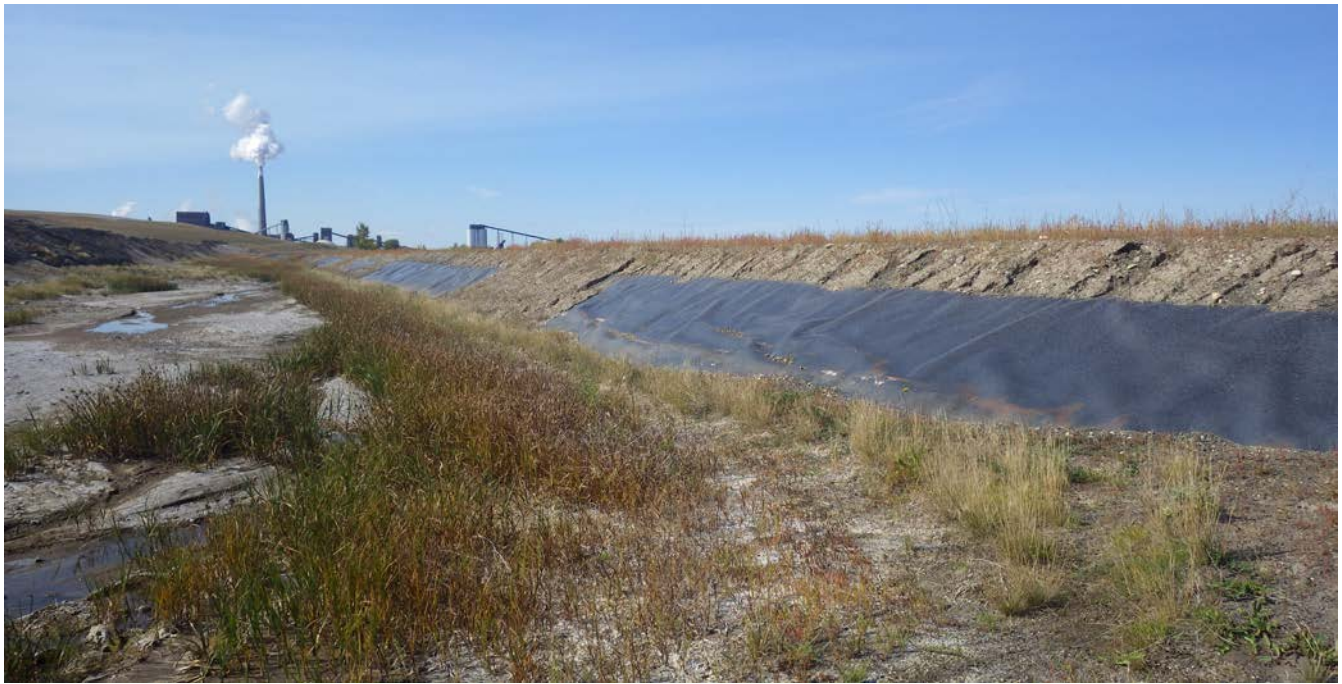
c. Rodent burrows	X			Small burrows
d. Seepage/sloughing/cracking/settlement		X		
4. Perimeter Berm - Upstream slope				
a. Erosion (exposed liner)	X			Exposed liner on north berm, minor damage to geomembrane higher on slope

Photograph 5 (CWA ditch)
Exposed geomembrane on upstream slope (IMGP6303.JPG)

Minor maintenance items that may need to be continually addressed include repairing large animal burrows as they appear, monitoring erosion along CCR slopes, repairing rutted perimeter roads to maintain access, re-seeding poorly vegetated CCR downstream slopes where final cover has been placed, removing woody vegetation growing on the berm downstream slopes and toes, and placing CCR over exposed geomembrane liner.

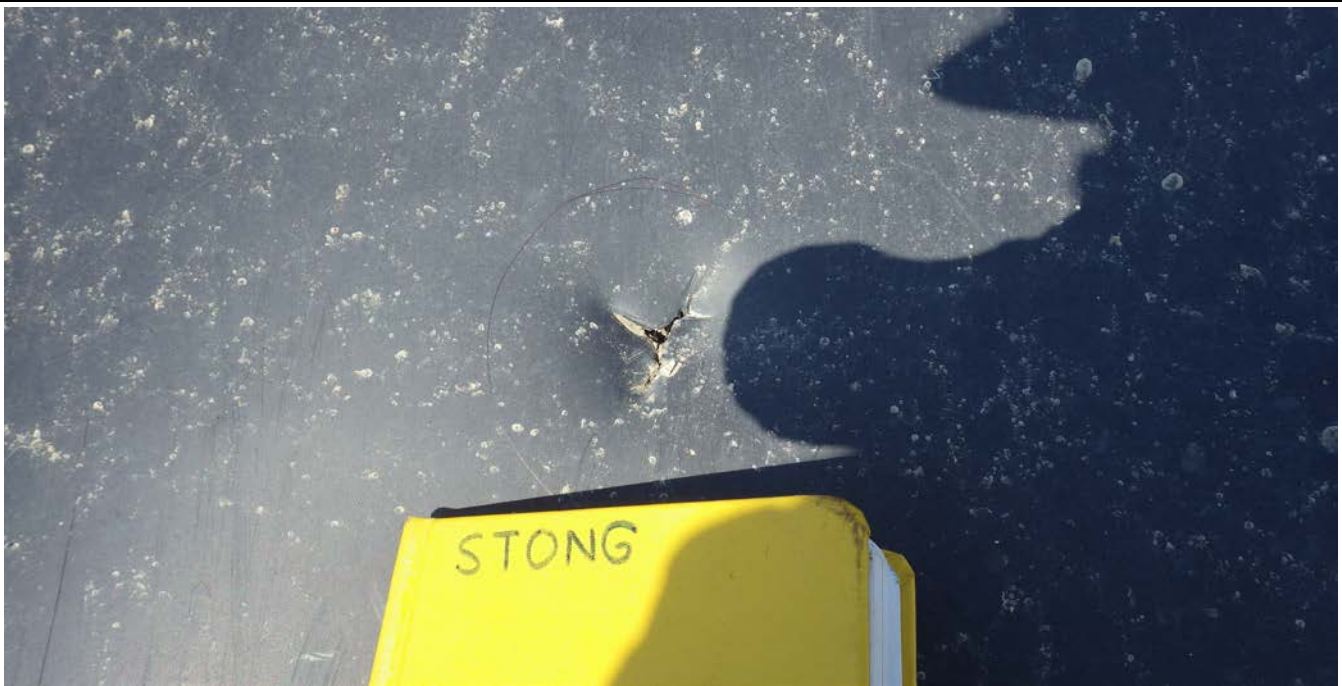
Photograph 6 (CWA ditch)
Damage to exposed geomembrane on upstream slope (not in-contact with water) (IMGP6305.JPG)

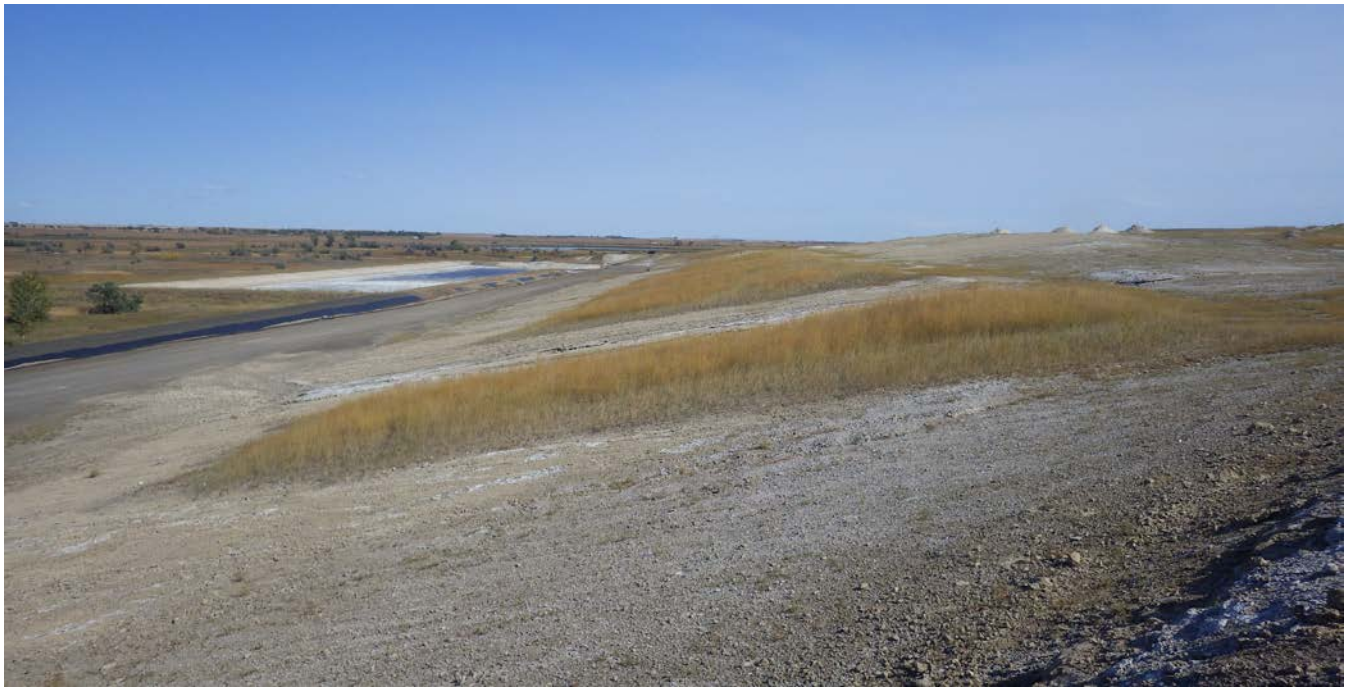
Photograph 7 (North CCR slope)
Temporary cover on north fly ash slope (IMGP6317.JPG)

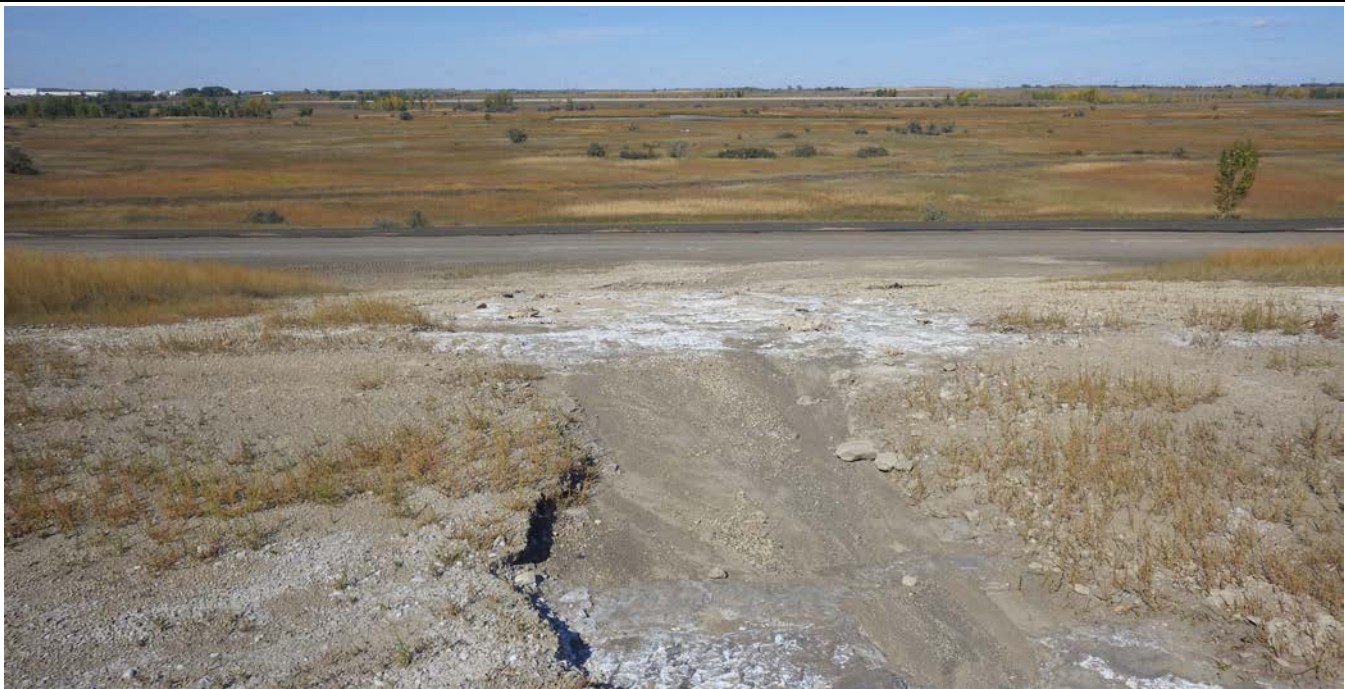
Uncovered CCR downstream slopes appeared to be in fair condition with no noticeable cracks, settlement, sloughing, seepage, or other signs of structural distress. The uncovered CCR downstream slopes appeared to match the design slopes with only minor erosion noted, particularly of fly ash along the north CCR downstream slope.

2. CCR Placement – Downstream Slope (no cover)				
a. Significant Erosion		X		Some erosion on north downstream slope in area of contact water routing
b. Cracks/settlement		X

Photograph 8 (North CCR slope)
Eroded fly ash slope due to channelized water flow (IMGP6318.JPG)

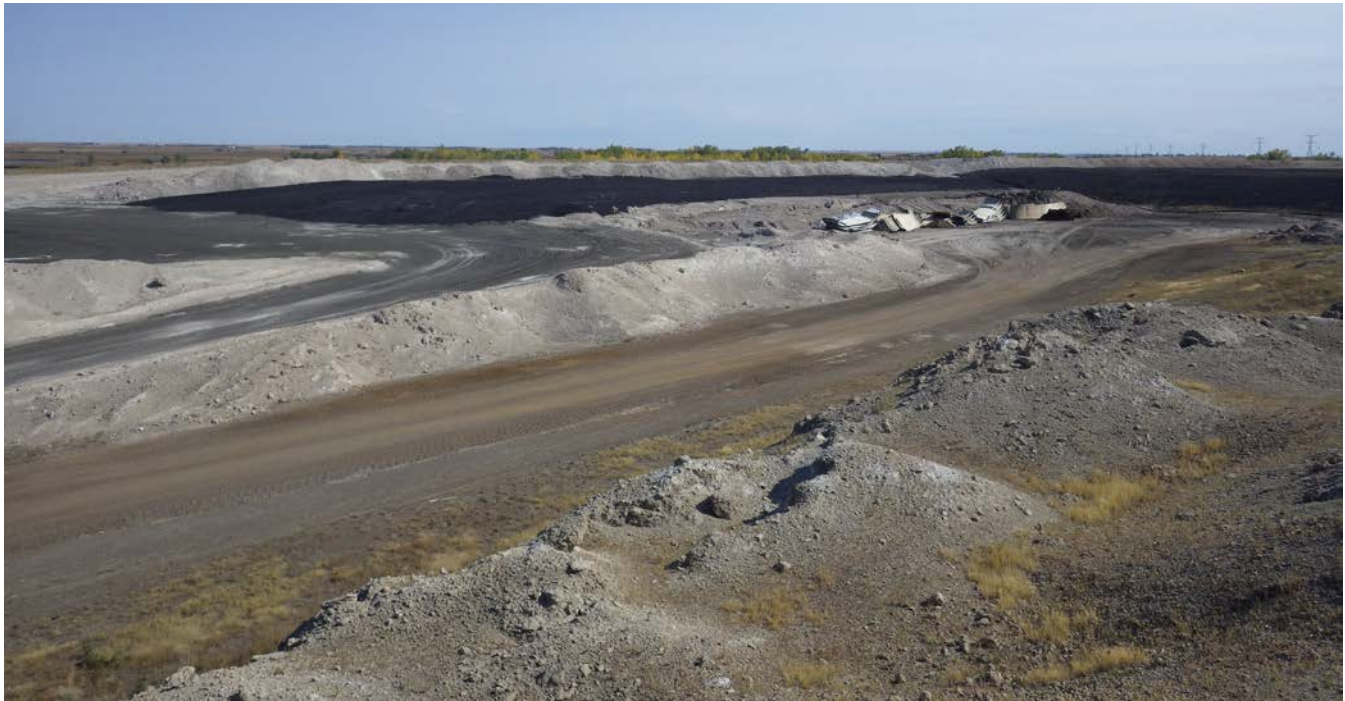
Photograph 9 (C&D Area)
Haul road to construction and demolition deposition area of Southeast 16 (IMGP6320.JPG)

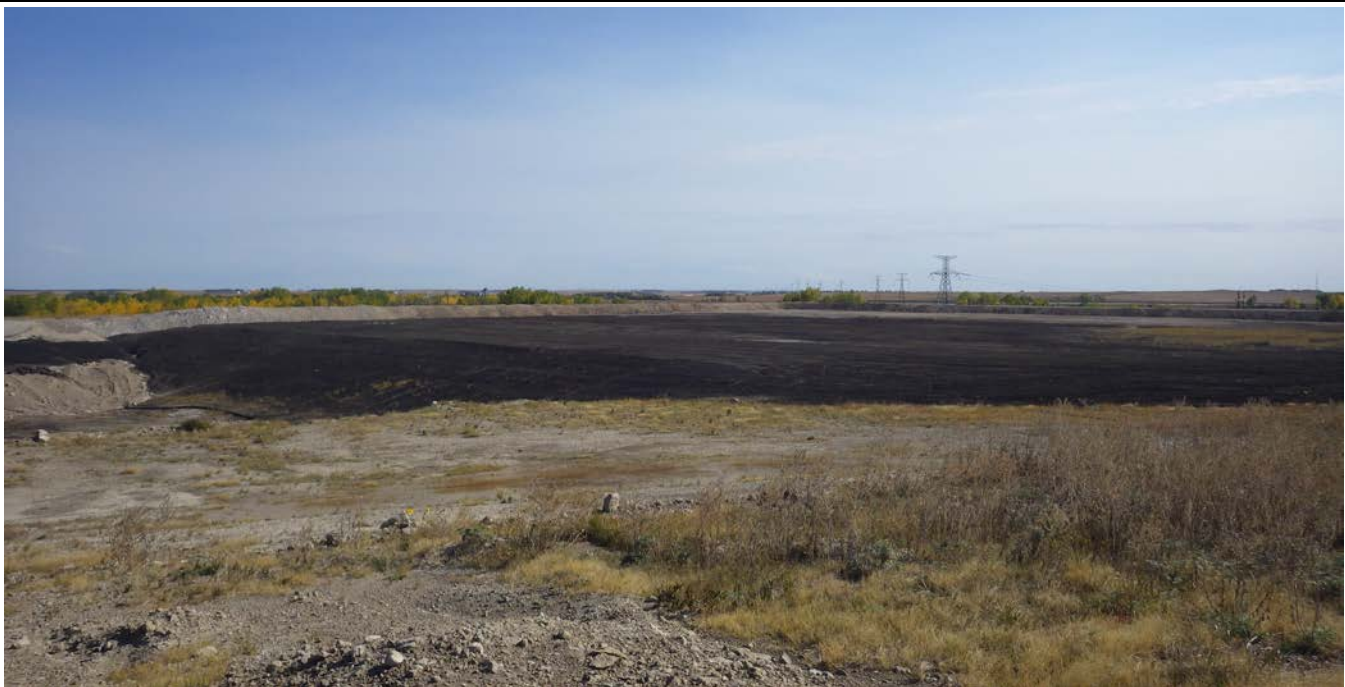
Photograph 10 (CCR placement)
Interior deposition of reject materials (IMGP6322.JPG)

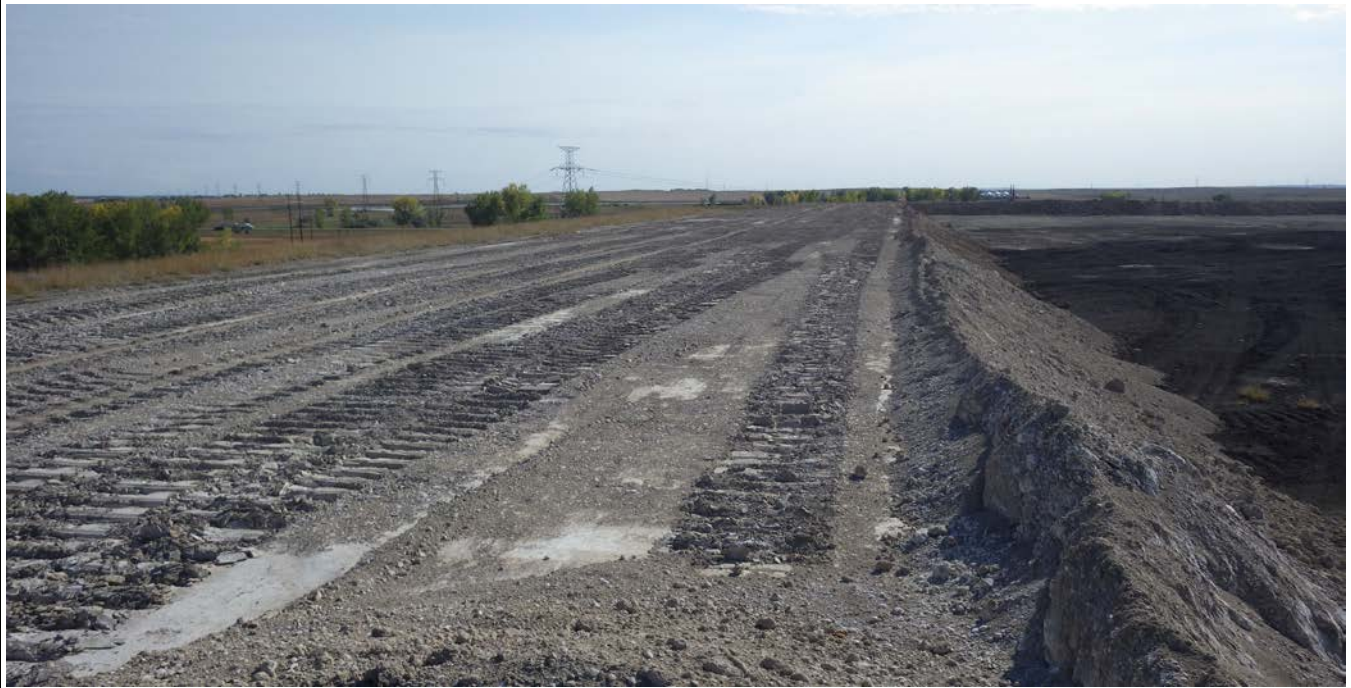
Photograph 11 (CCR placement)
Fly ash berm around rejects placement (approximately 35-40 feet wide) (IMGP6325.JPG)

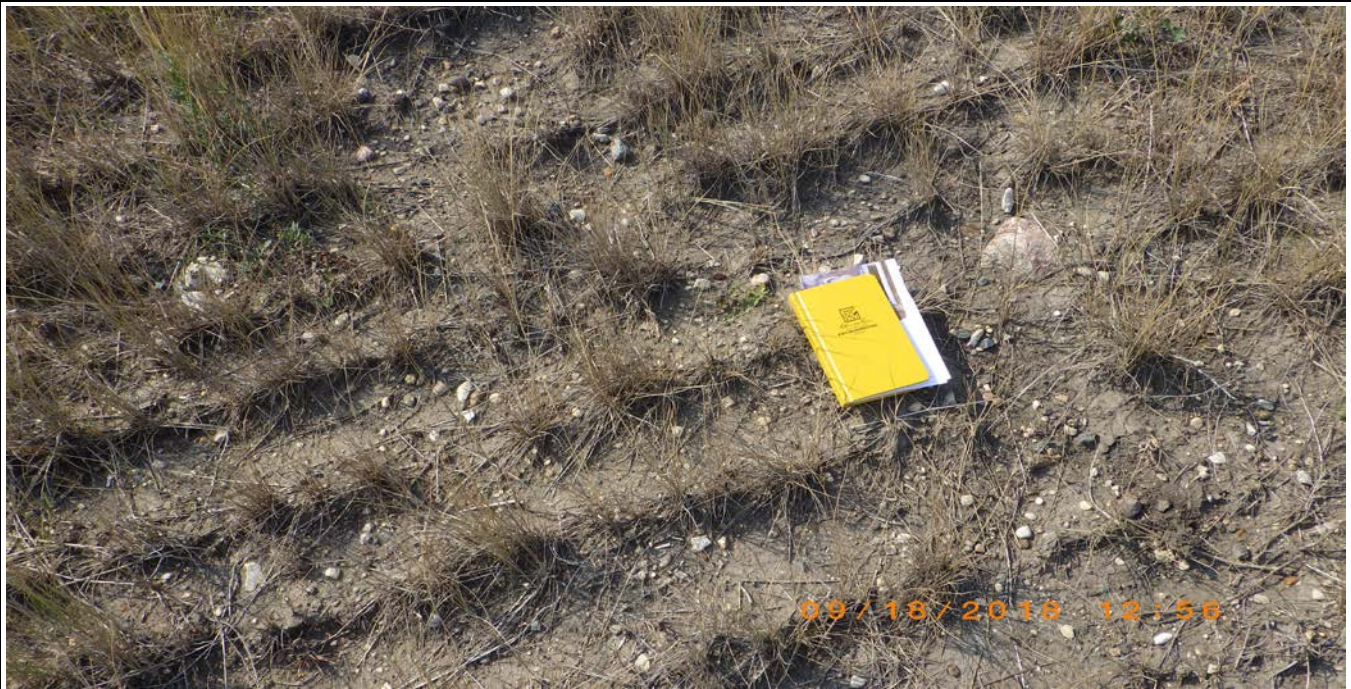
The east and south CCR downstream slopes of Southeast 16 has final cover to an elevation of 1925 feet amsl with terrace channels and downchute drainage channels along the side slopes. This final cover was installed in 2015 and had fair to poor native grass vegetative growth. Golder recommends that topsoil be replaced in portions of this covered area and that it be re-seeded.

Photograph 12 (Northeast downstream slope)
Sparse vegetation on east downstream slope of final cover (2ccs.JPG)

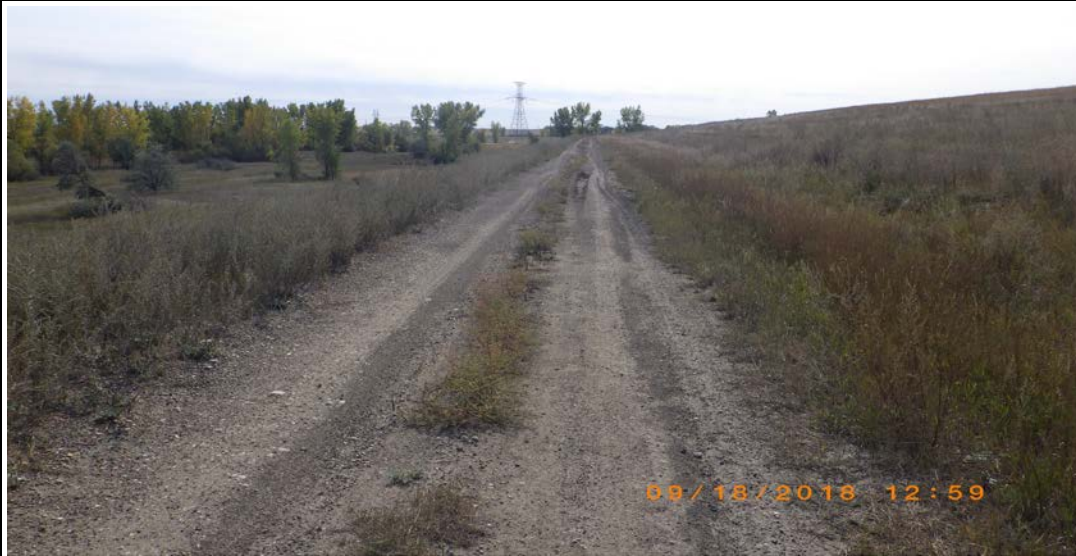
b. Comparable to design width	X			
c. Vegetation		X		
d. Rodent burrows		X		
e. Exposed to heavy traffic		X		
f. Damage from vehicles/machinery	X			Minor rutting along south and east sides

Photograph 13 (East downstream slope access road)
Minor rutting of berm crest perimeter access road (4ccs.JPG)

The berm crest around the east and south sides of Southeast 16 is surfaced with gravel and used for light vehicle traffic. The berm crest along the north side is narrow and rarely used for light vehicle traffic. Heavy haul traffic bringing CCR to the site use an internal road constructed over previously placed CCR. The road on the berm crest of Southeast 16 appears to be in good condition, with no noticeable cracking or settlement, and appears to be well maintained. When wet, the road surface can become rutted and slippery. During the inspection, minor rutting was noticed on the south and east crests. Ruts that develop on the road surface should be repaired as soon as practical to maintain access.

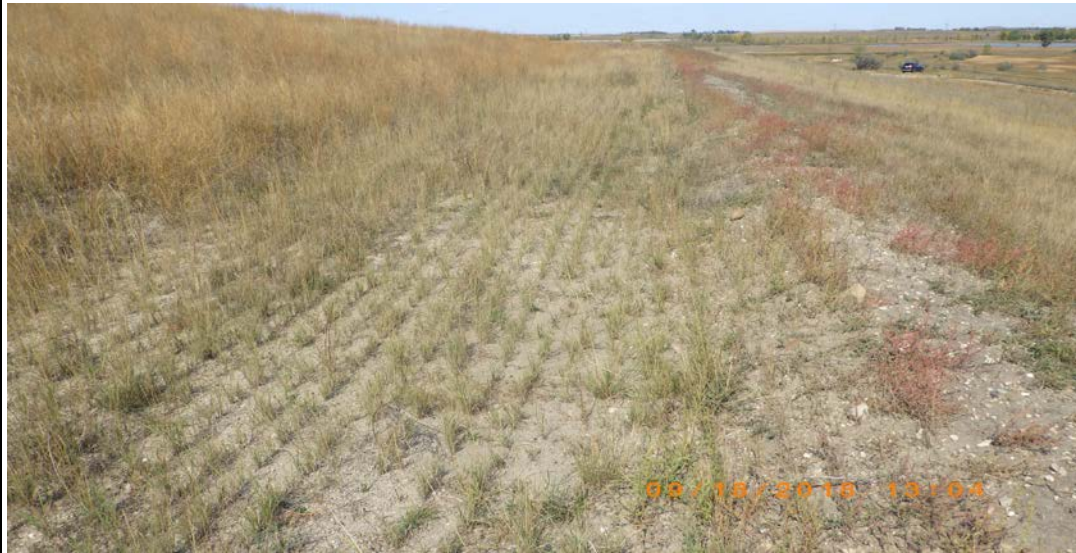
Photograph 14 (East downstream slope separation berm)
Contact water separation berm on downstream slope (6ccs.JPG)

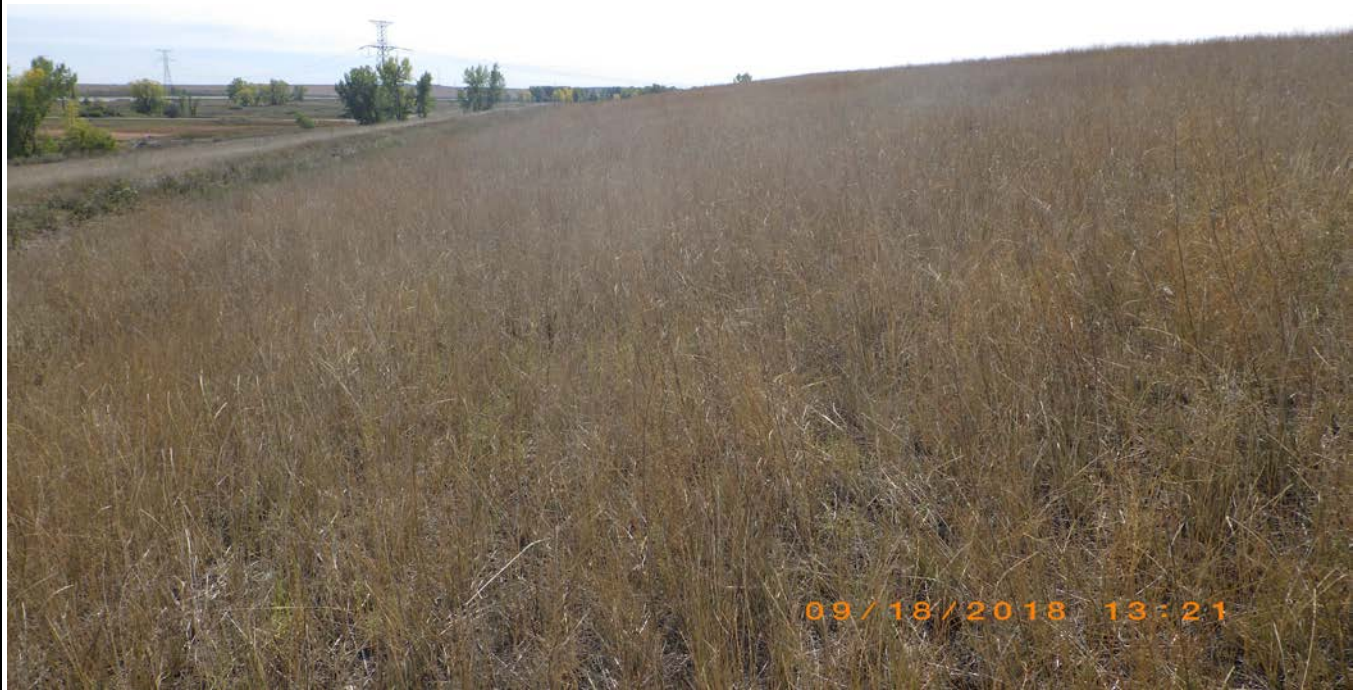
Photograph 15 (East downstream slope)
Temporary cover (approximately 2 feet tall grass) (8ccs.JPG)

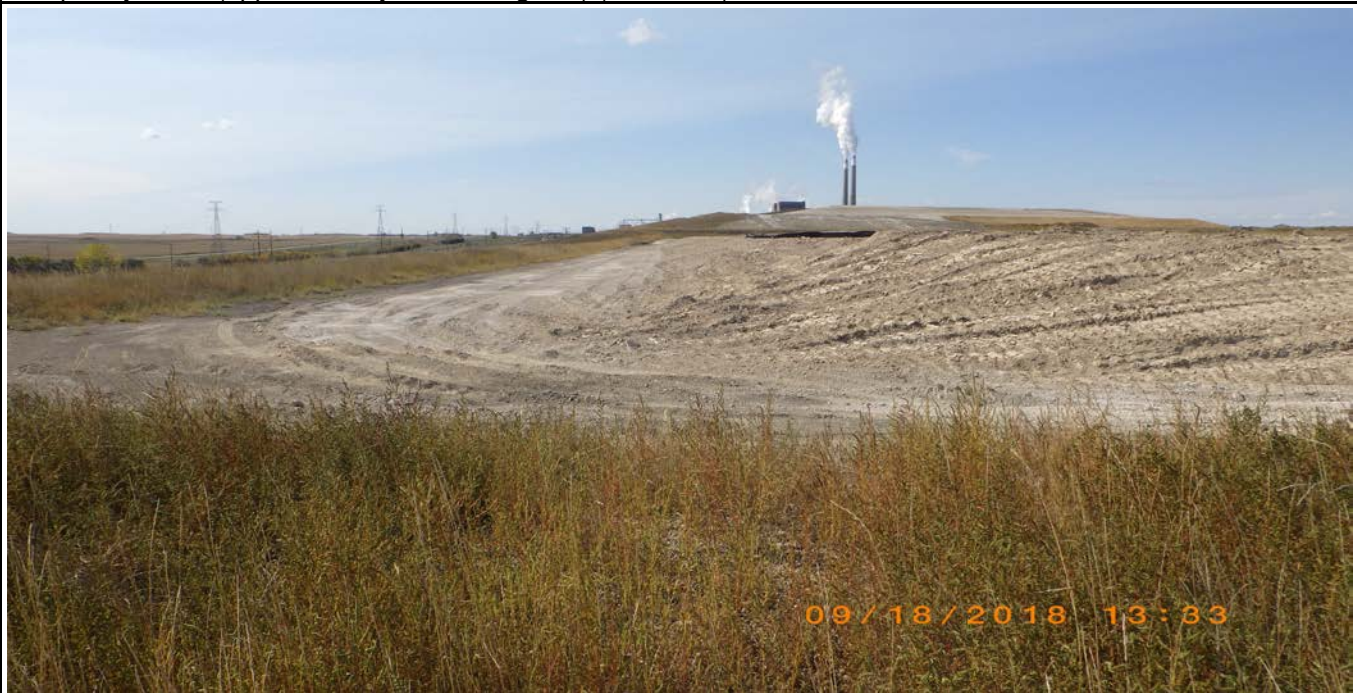
Photograph 16 (Southeast CCR crest)
Southwest Section 16 fly ash slope and contact water ditch at top of temporary cover (16ccs.JPG)

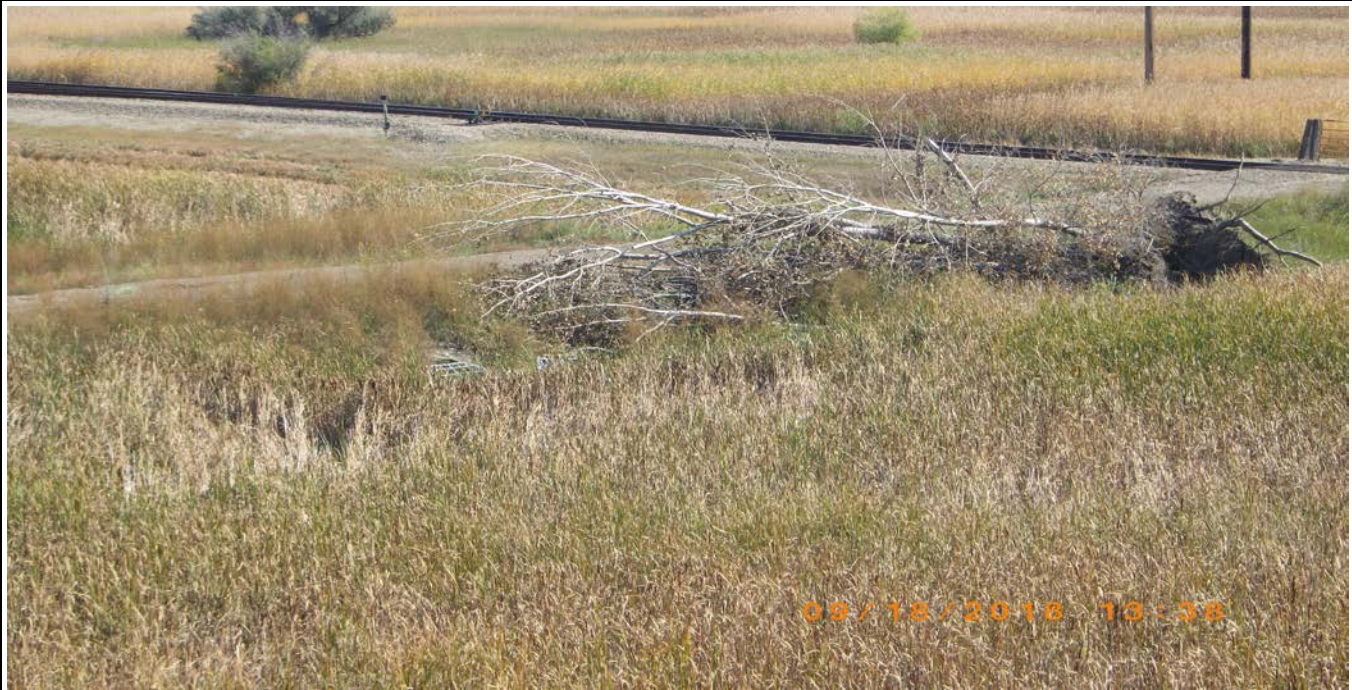
Photograph 17 (Southeast corner)
Culverts partially obstructed by downed tree (19ccs.JPG)

The environment at the toe of the berm slope varies surrounding Southeast 16. A poorly draining area exists at the toe along the north side and surface water drainages exist along the toe on the south and east sides. Golder did not observe indications of sloughing, cracking, significant erosion, excessive settlement, or vegetation that seemed to be thriving abnormally along the toe. No signs of seepage were noted. The toe appeared to be in good condition. There were a few small trees and bushes near the toe along the east and south sides. Although these trees and bushes were not on the berm downstream slopes, Golder recommends that they be removed to keep all woody vegetation clearly off the berm downstream slopes and toe. A few larger trees downed from recent storms were identified in the surface water drainage on the south side of the facility. It is recommended that these downed trees be removed so as not to block flow through the drainage.

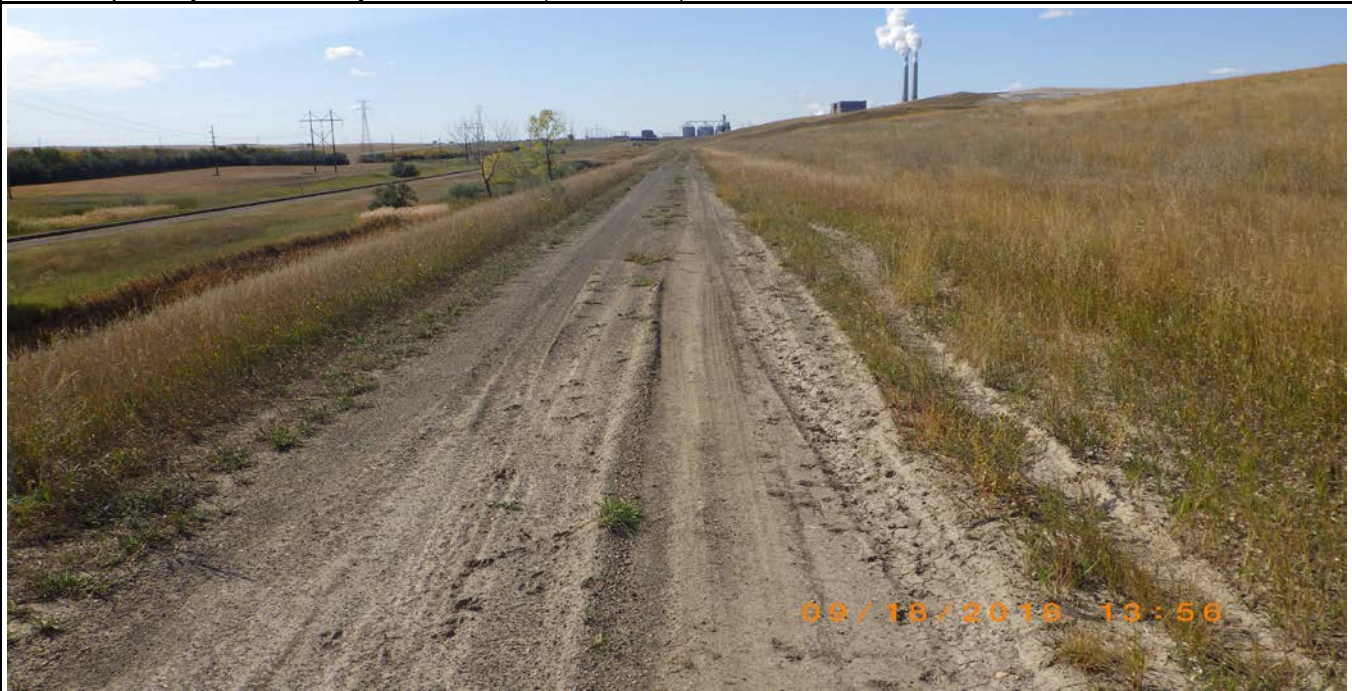
Photograph 18 (South downstream access road)
Minor rutting of berm crest perimeter access road (25ccs.JPG)

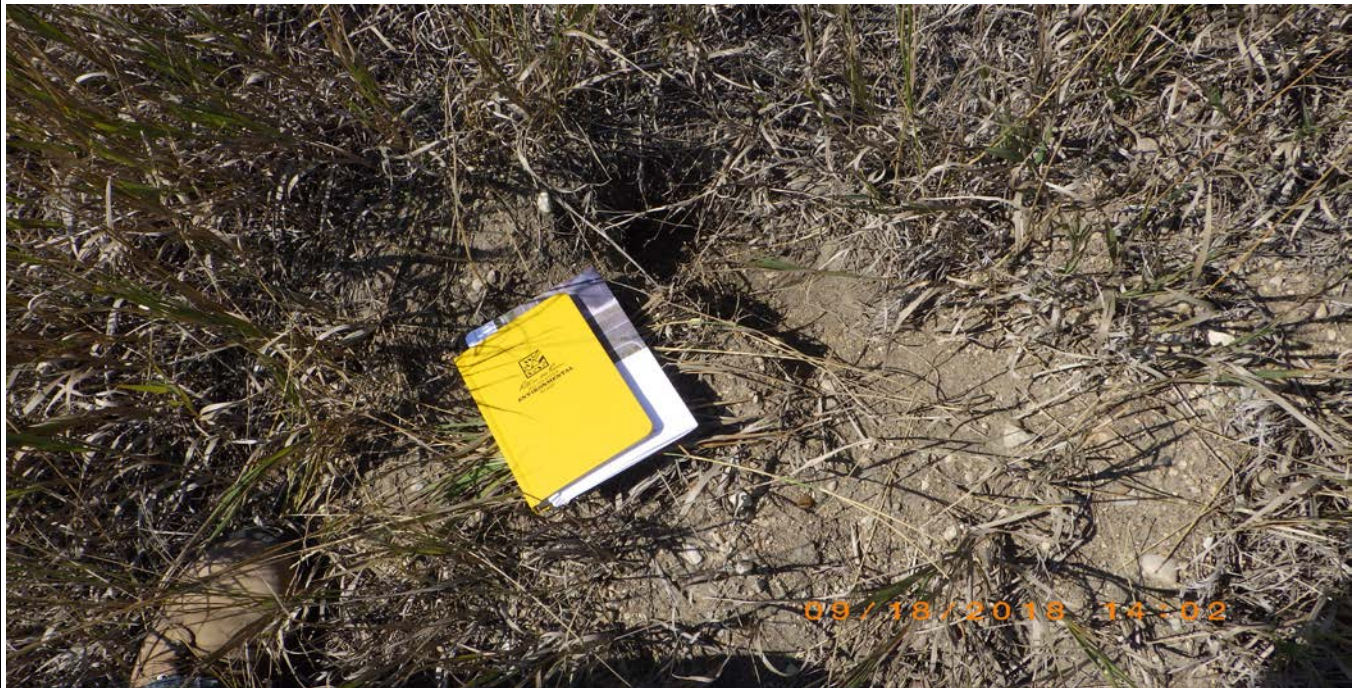
6. Perimeter Berm - Downstream slope				
a. Erosion		X		
b. Vegetation	X			Good native grass
c. Rodent burrows	X			Small burrows
d. Seepage/sloughing/cracking/settlement		X

Photograph 19 (South downstream slope)
Animal burrow on downstream slope (29ccs.JPG)

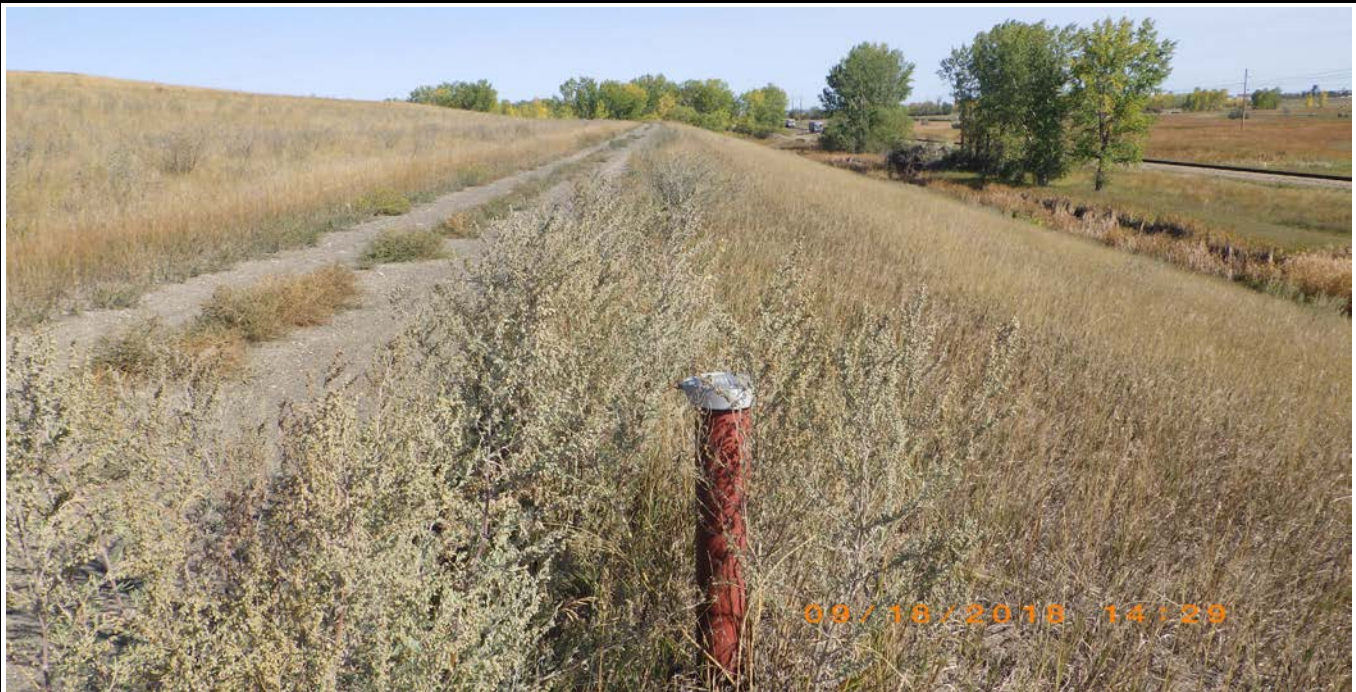
Photograph 20 (South downstream slope)
Piezometer near berm crest perimeter access road and downstream slope vegetation (31ccs.JPG)

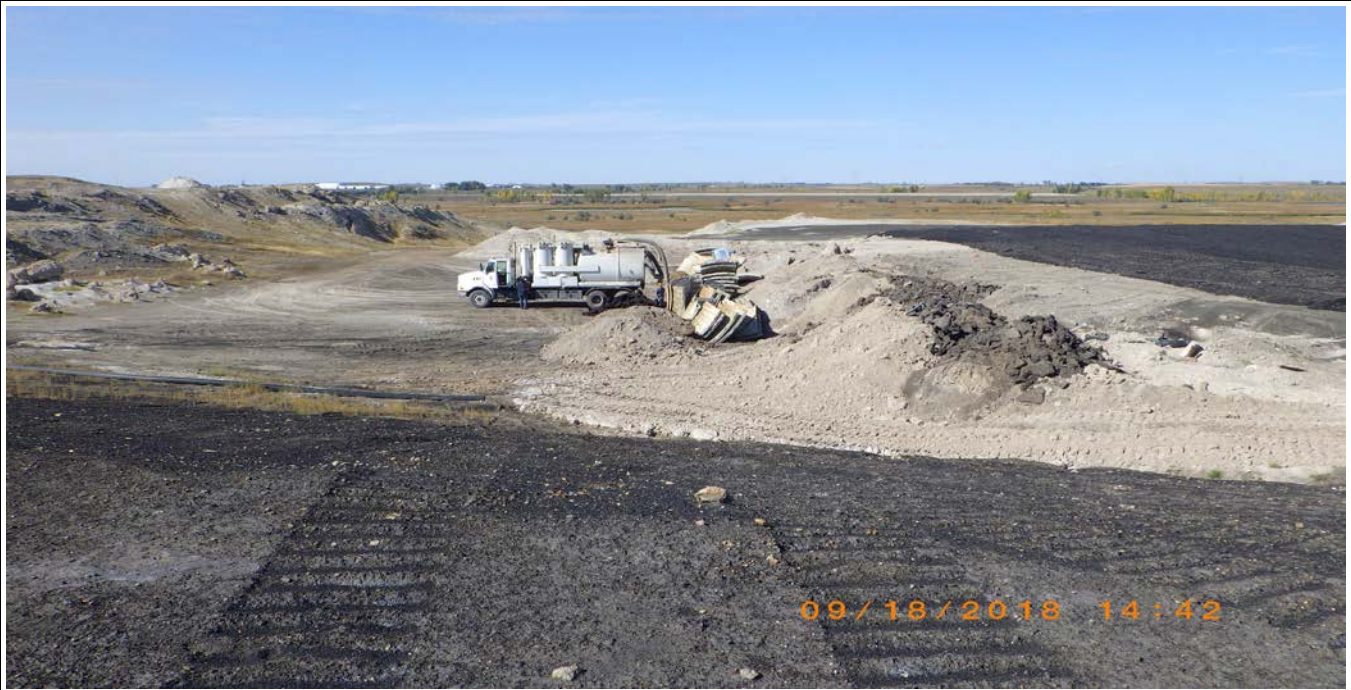
Photograph 21 (C&D Area)
Construction and demolition (C&D) deposition area (37ccs.JPG)

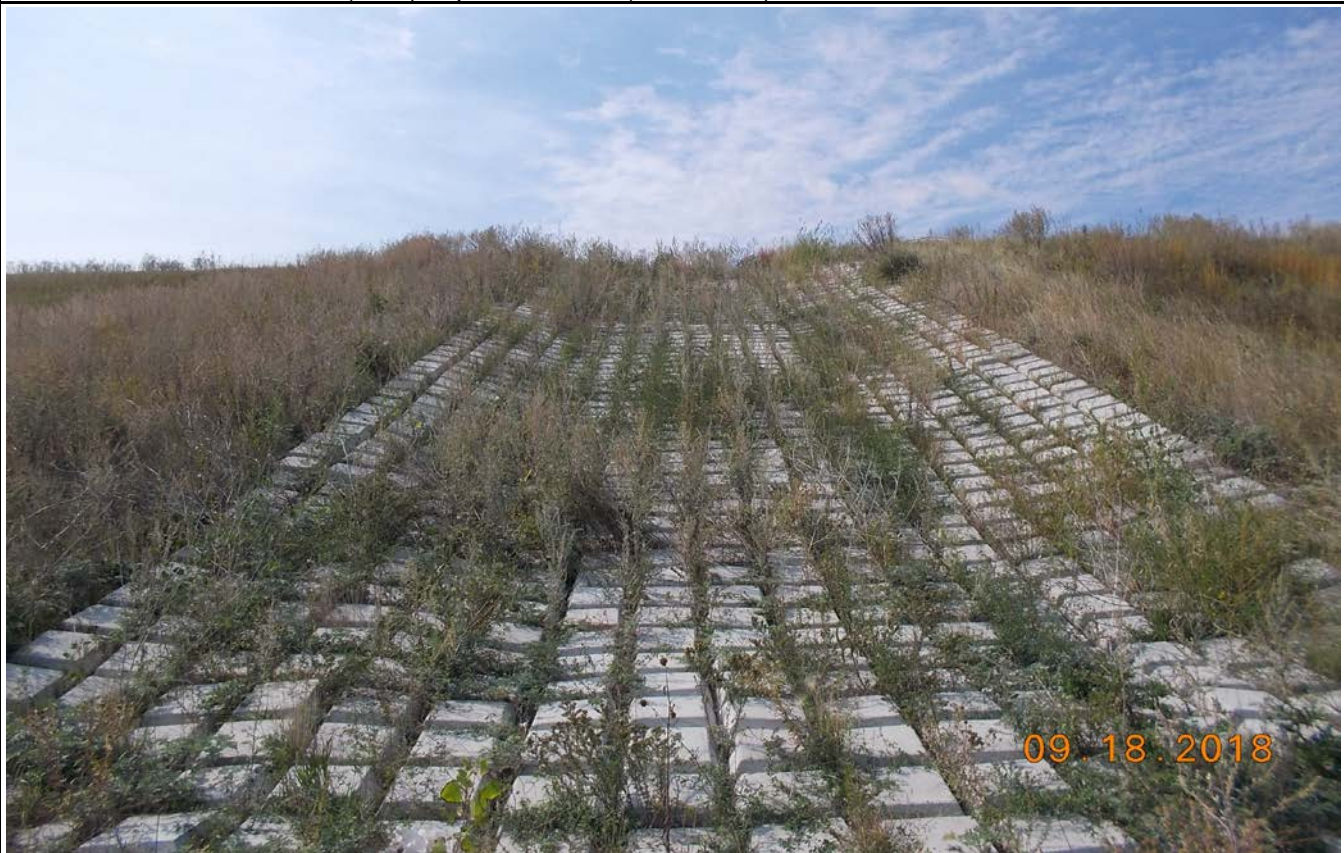
Photograph 22 (Northeast corner)
Articulated Concrete Block (ACB) on northeast downstream slope (PDS 1 CCS SE16.JPG)

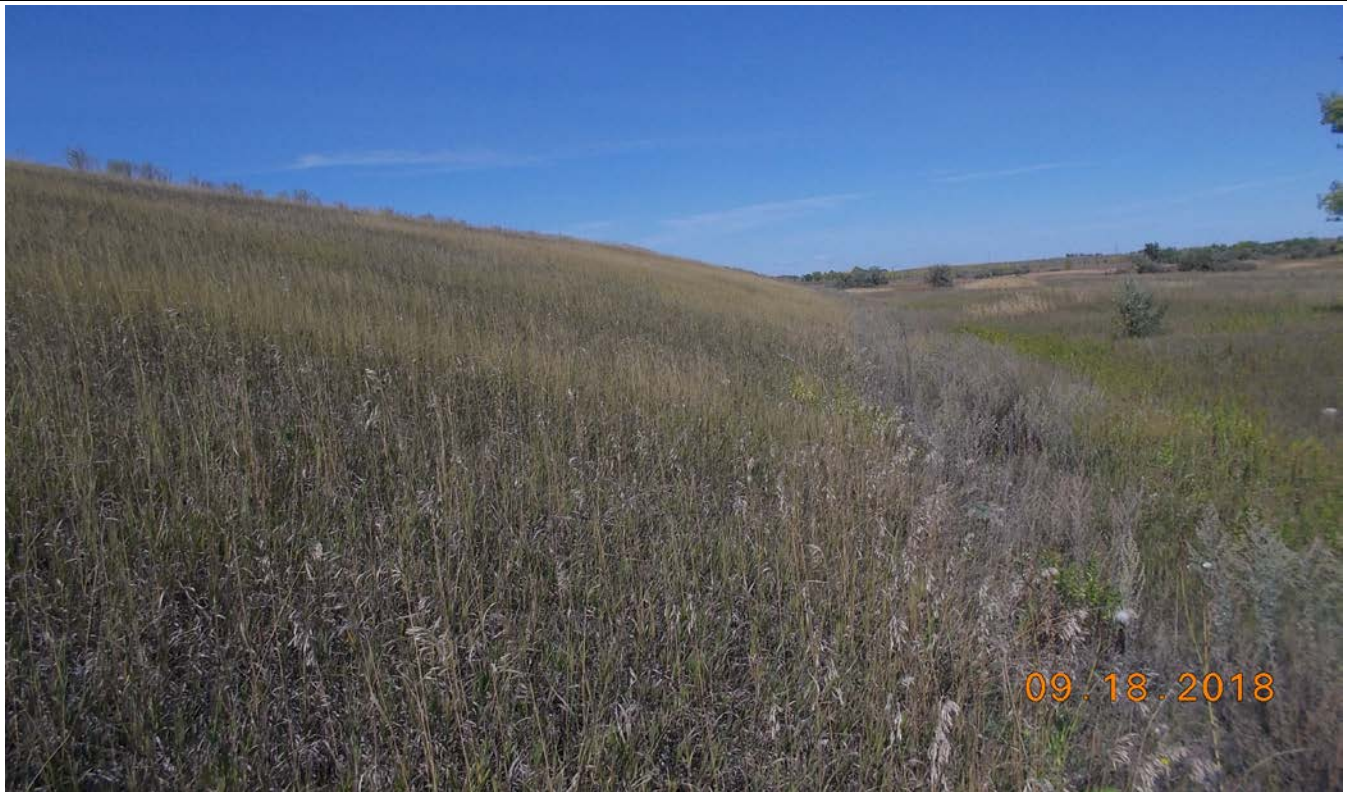
Photograph 23 (East downstream slope)
Grass vegetation on downstream slope (PDS 7 CCS SE16.JPG)
