REPORT

Annual Inspection

Coal Creek Station - Southeast Section 16 CCR Landfill

Great River Energy

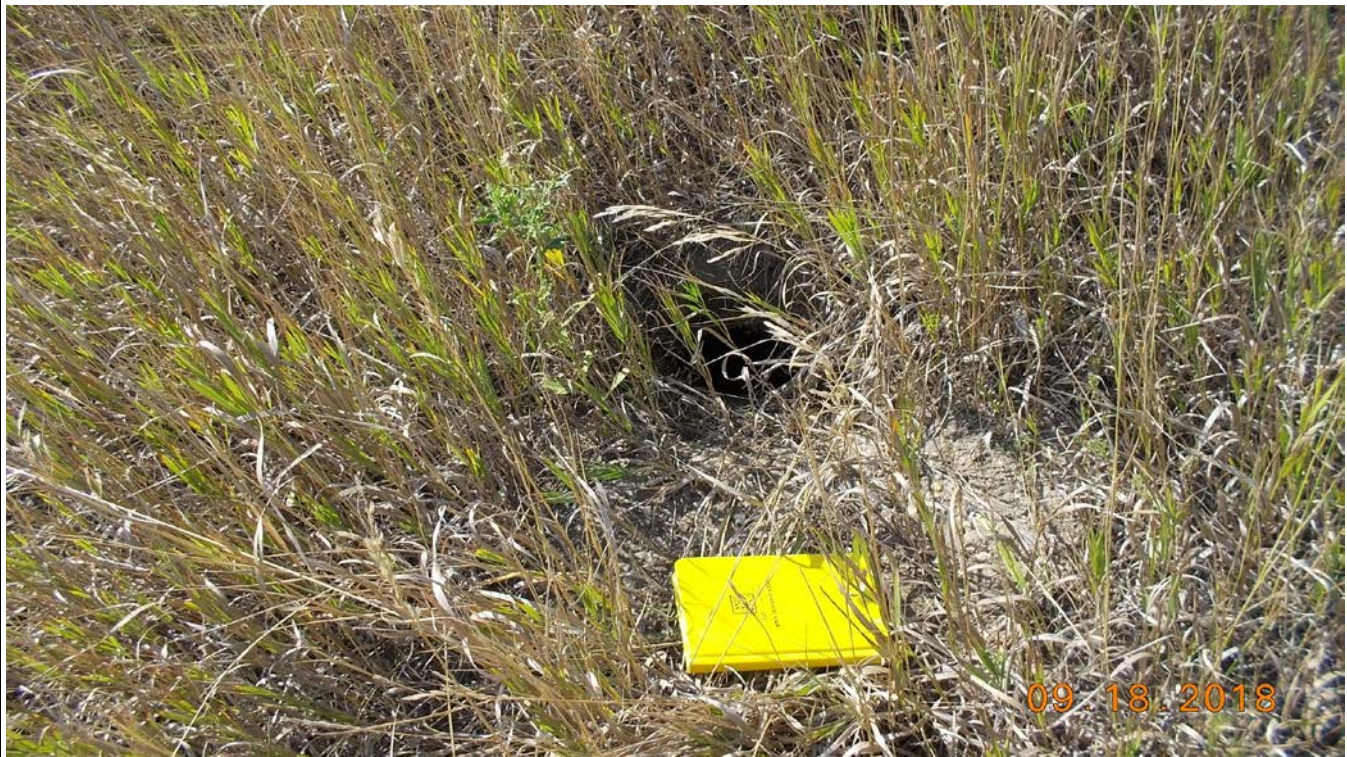
Photograph 24 (East downstream toe)
Animal burrow near downstream toe (PDS 10 CCS SE16.JPG)

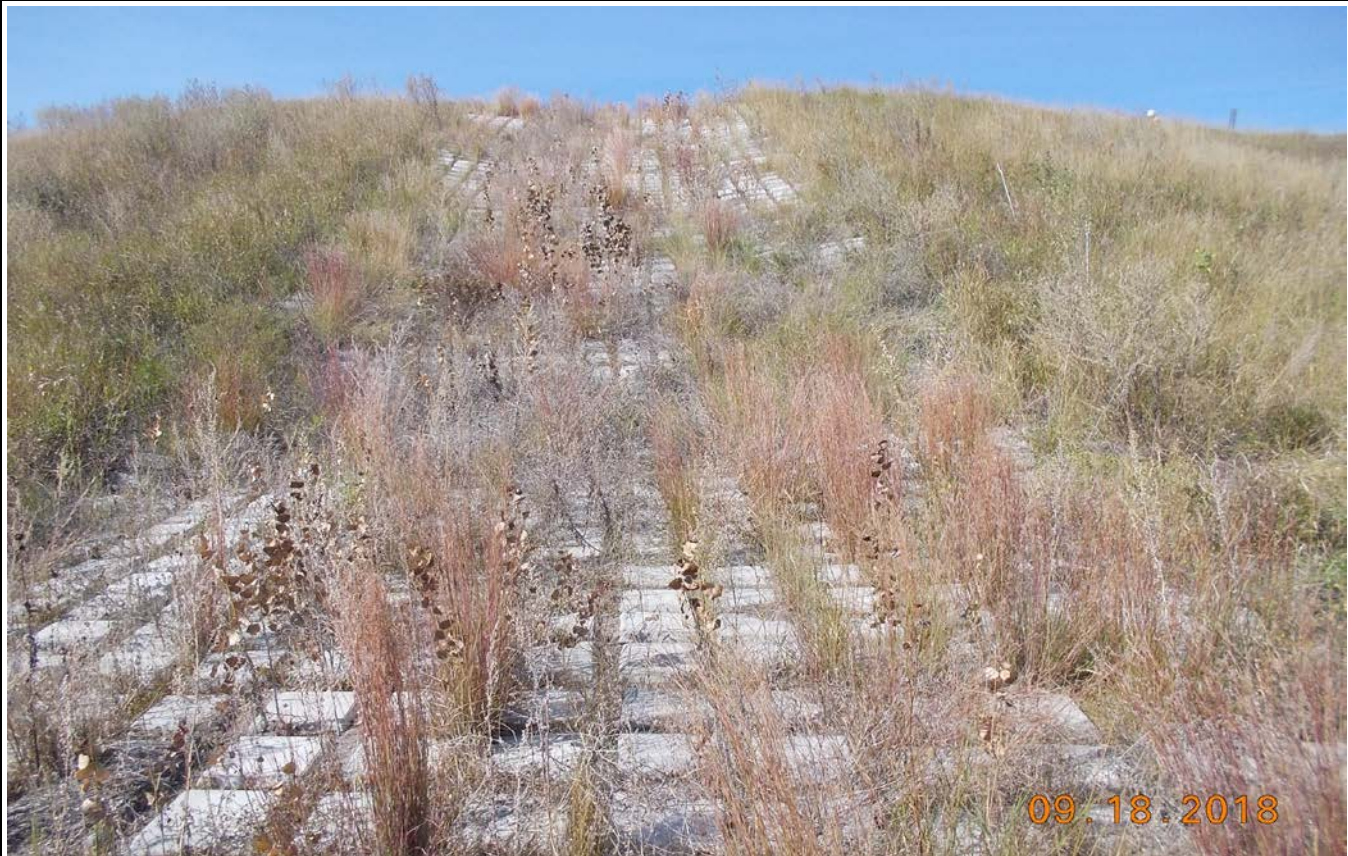
Photograph 25 (Southeast toe)
Articulated Concrete Block (ACB) on southeast downstream slope (PDS 13 CCS SE16.JPG)

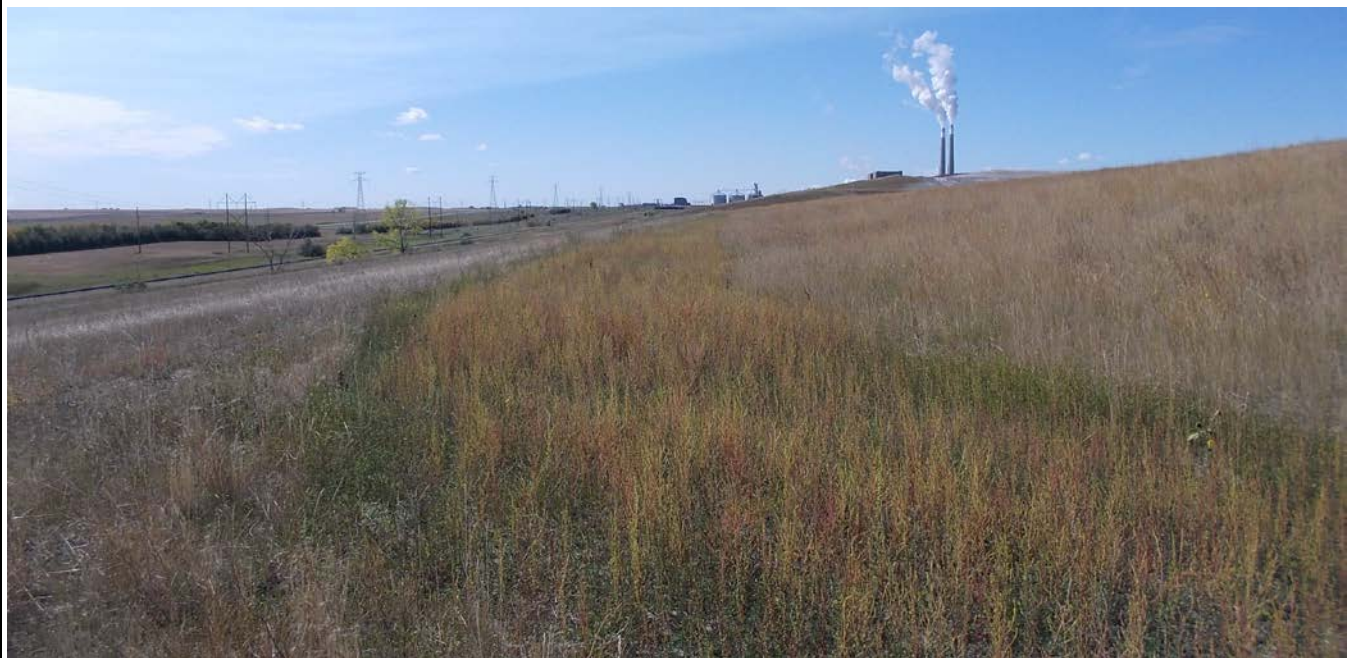
Photograph 26 (South downstream slope)
Surface water terrace channel on downstream slope (PDS 15 CCS SE16.JPG)
