Annual Inspection

Coal Creek Station – Upstream Raise 91 CCR Surface Impoundment

Great River Energy

Golder Associates Inc.

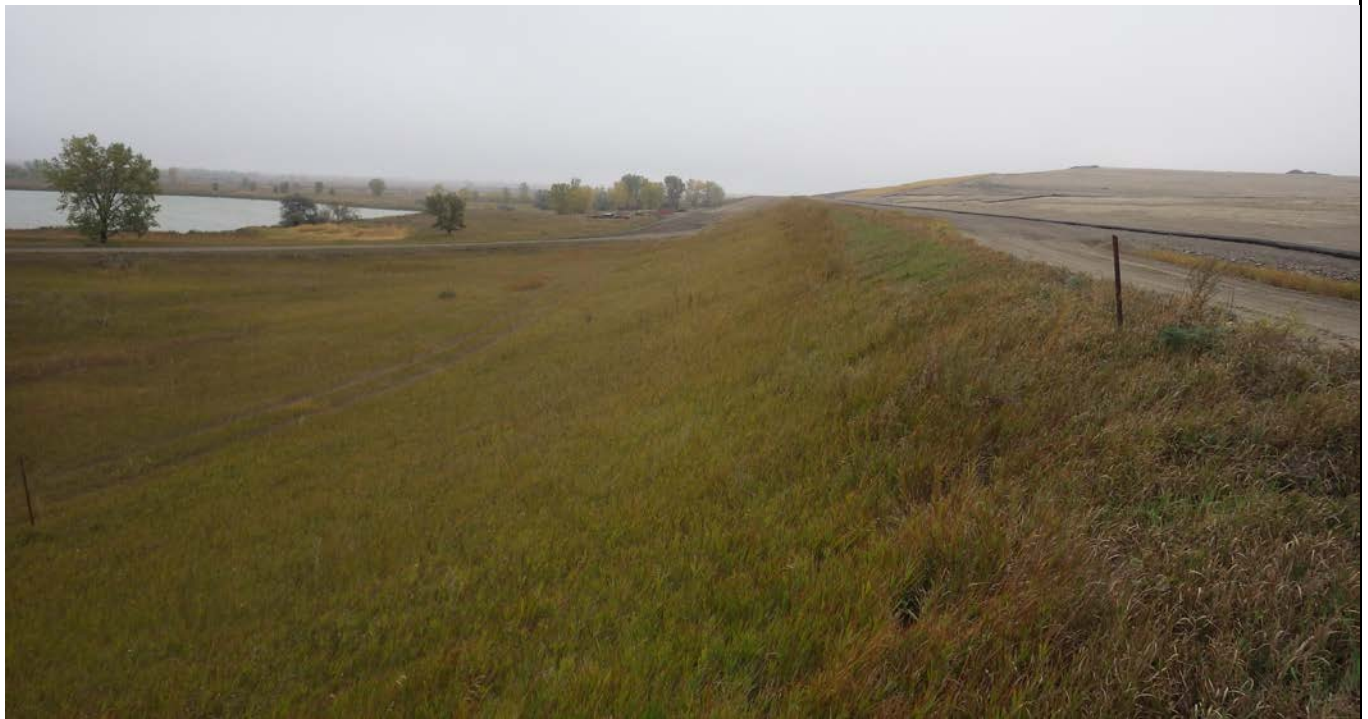
Photograph 1 (NW corner, downstream slope)
Grass vegetation on downstream slope (IMGP6353.JPG)

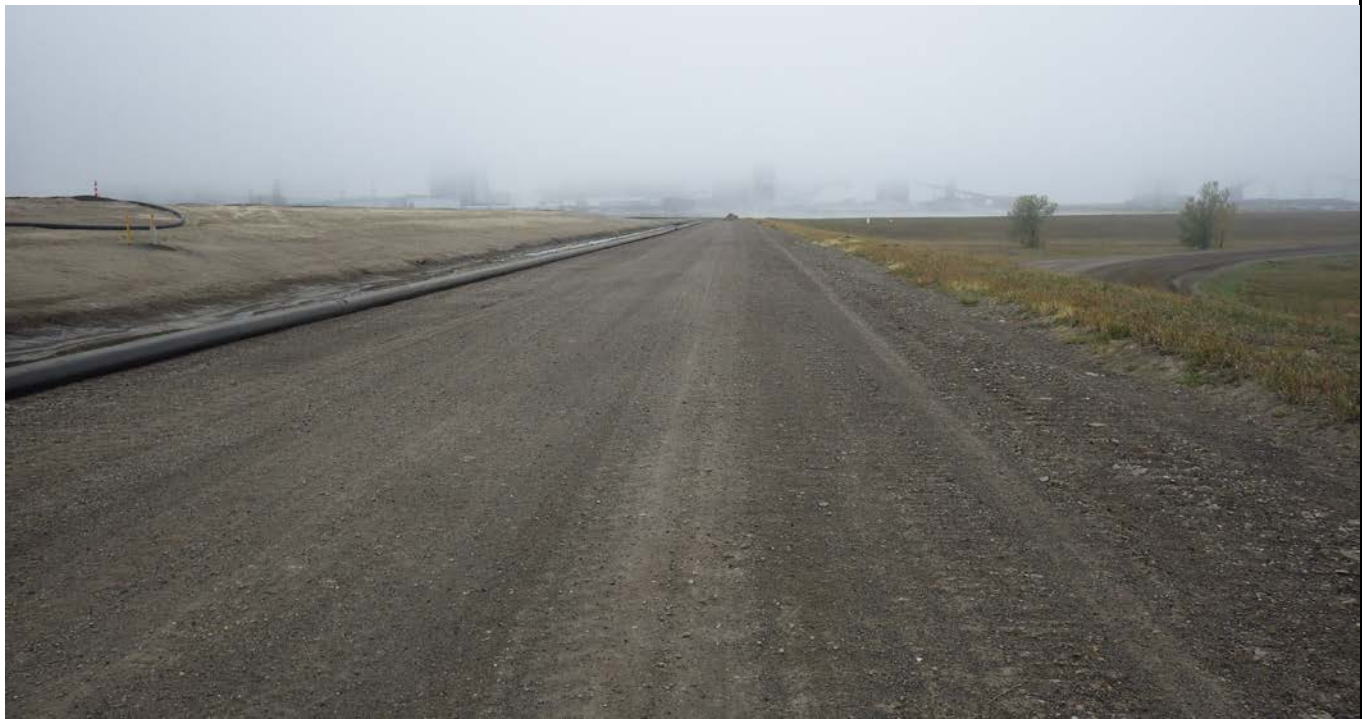
Photograph 2 (North haul road)
Gravel haul road surface (IMGP6359.JPG)

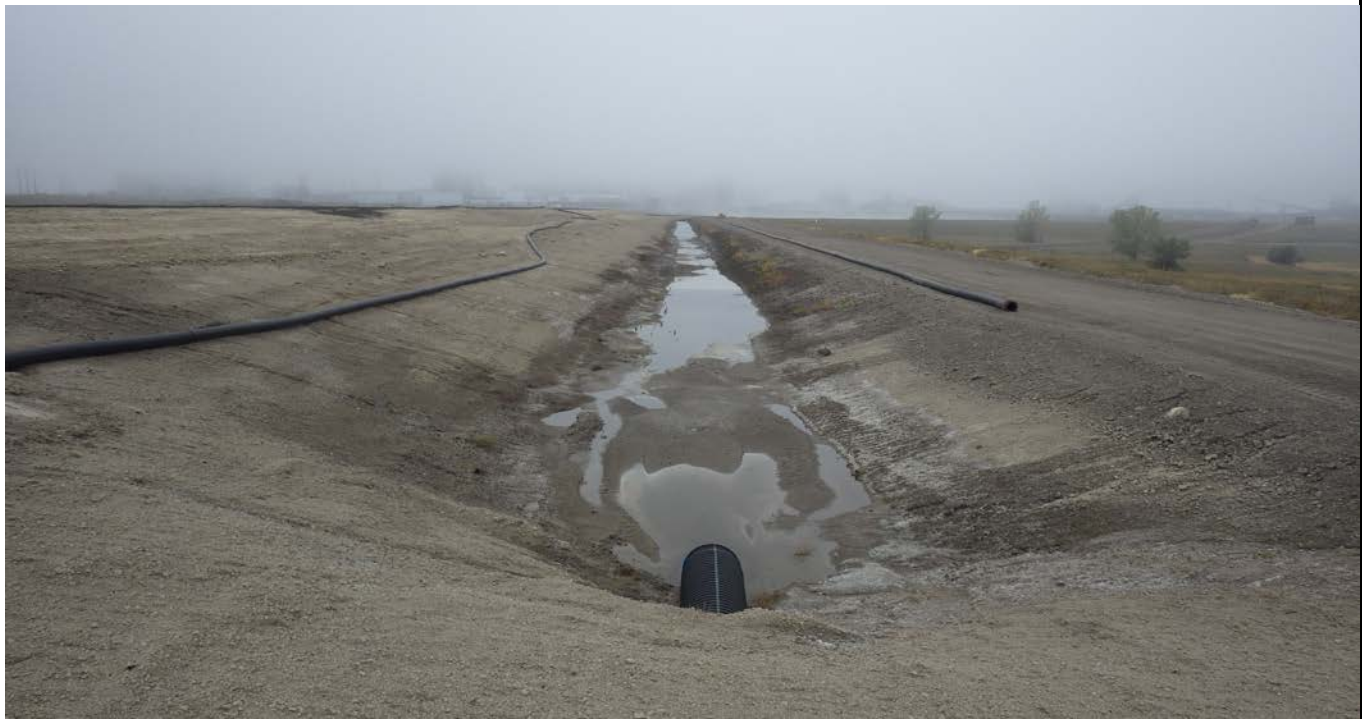
Photograph 3 (North upstream slope)
North perimeter ditch (looking west) (IMGP6362.JPG)

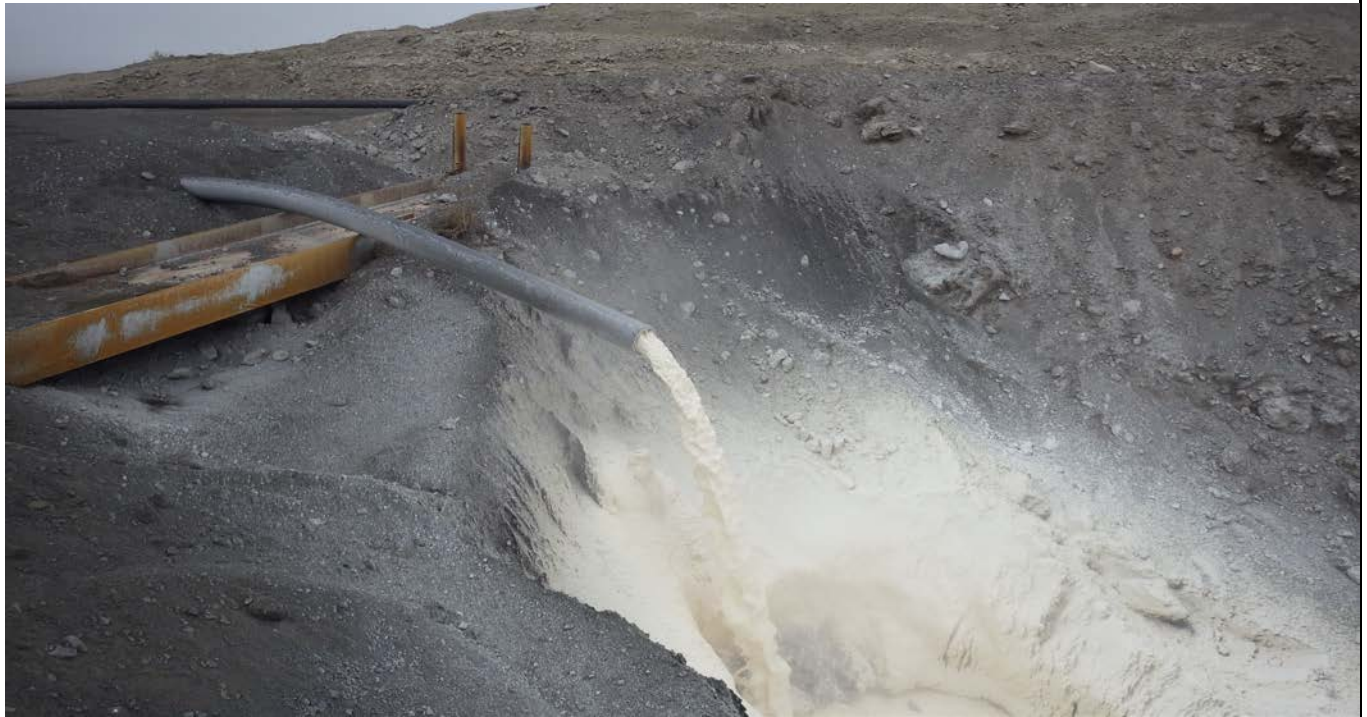
Photograph 4 (CCR placement)
Flue Gas Desulfurization (FGD) inflow pipe (IMGP6366.JPG)

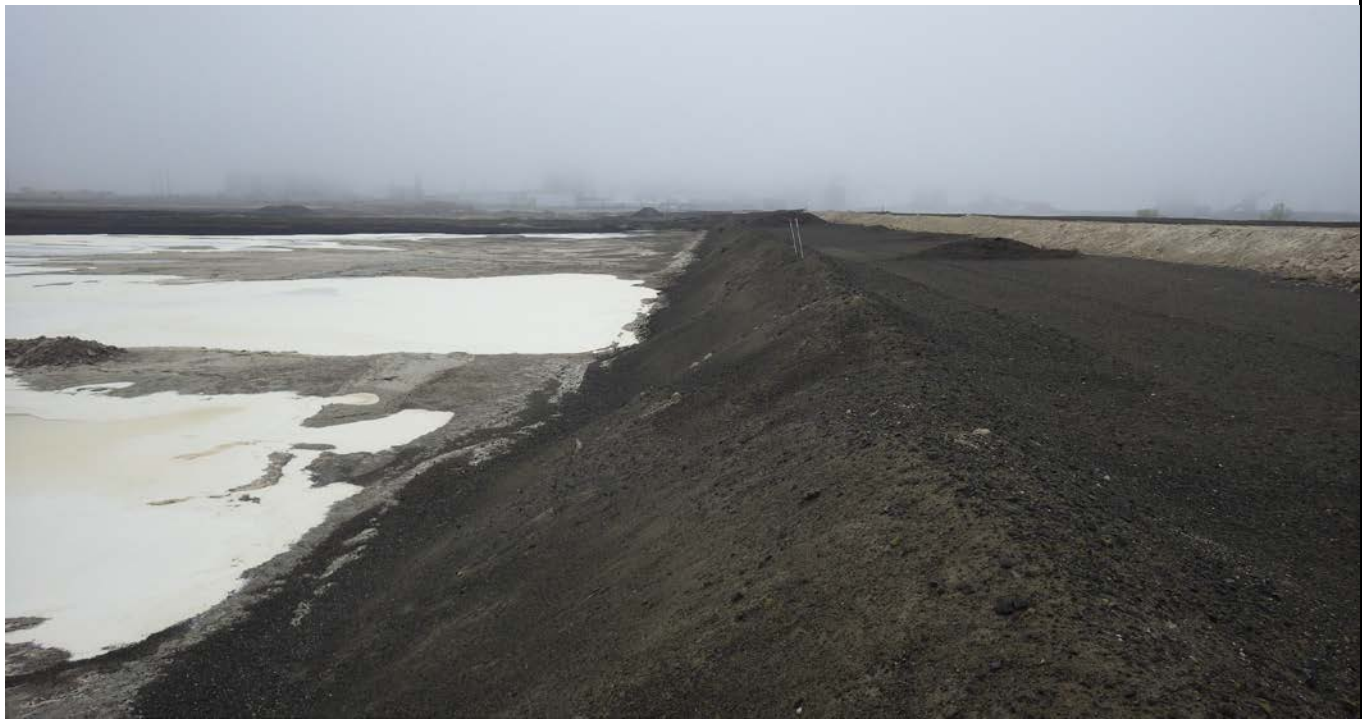
The CCR upstream slope is defined as the slope that toes out into the raise pool. The CCR upstream slope of Upstream Raise 91 is constantly changing as bottom ash and FGD material are deposited. Therefore, the CCR upstream slopes are temporary and dependent on the angle of repose of the bottom ash material. The vertical distance from the top of the bottom ash CCR upstream slope to the water/FGD material mixture is approximately 10 to 13 feet in most locations. The CCR upstream slopes appear to be in good condition with no signs of structural weakness.

Photograph 5 (CCR upstream slope)
CCR upstream slope (IMGP6367.JPG)

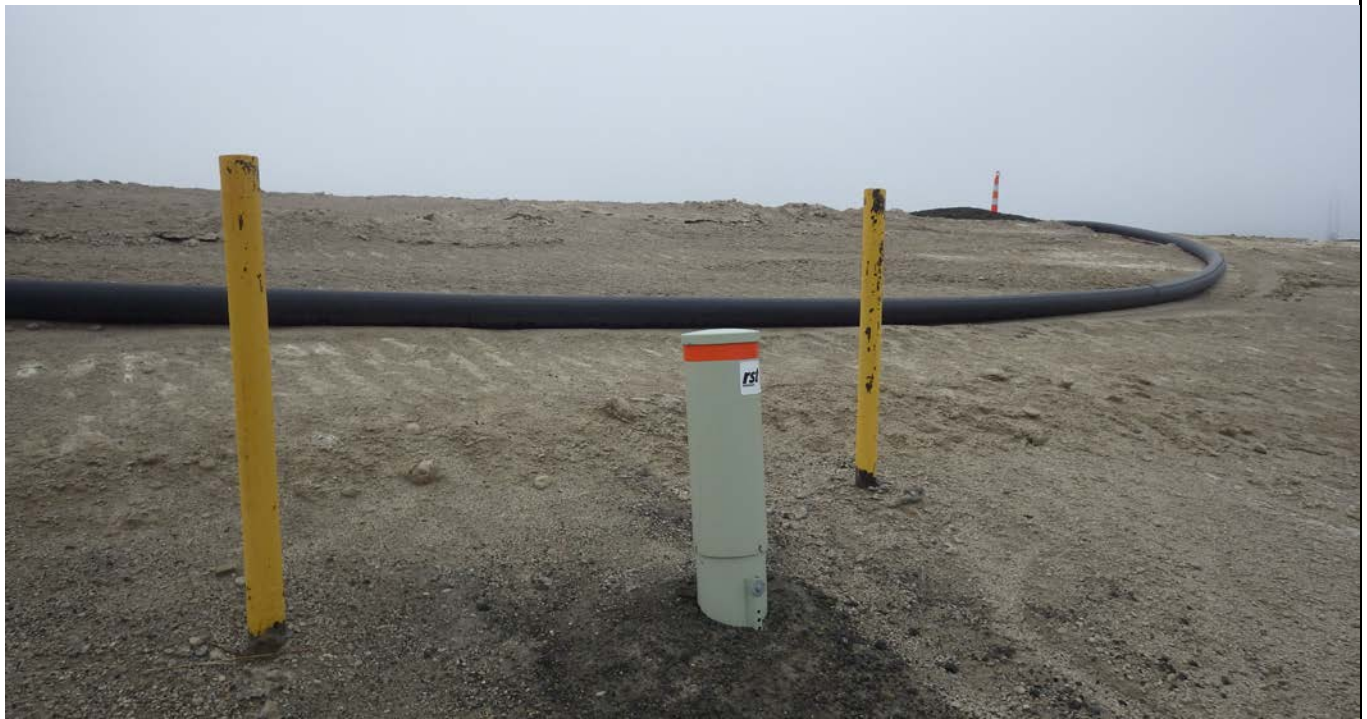
Photograph 6 (CCR downstream slope)
Vibrating Wire Piezometer (VWP) datalogger box (IMGP6369.JPG)

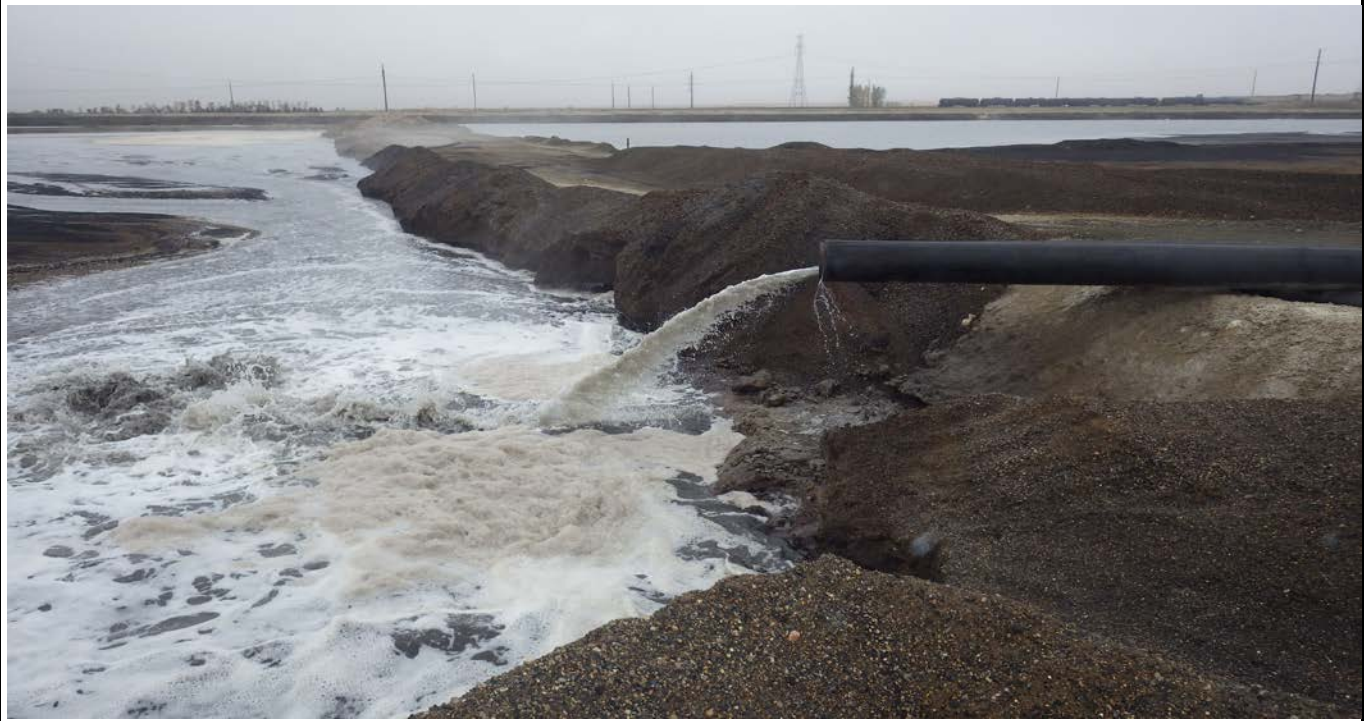
Photograph 7 (CCR placement)
Rejects and economizer ash inflow pipe (IMGP6370.JPG)

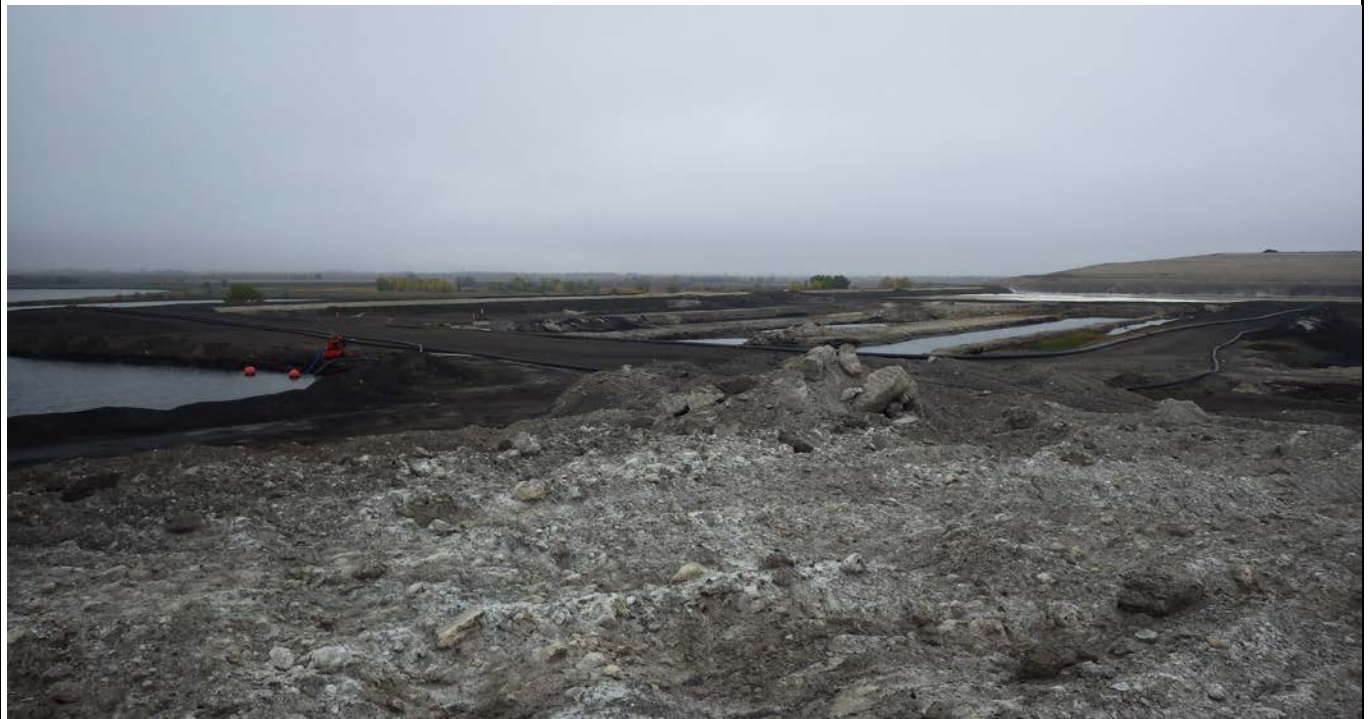
Photograph 8 (CCR placement from west side)
Upstream Raise 91 interior and CCR placement panorama (1 of 3) (IMGP6373.JPG)

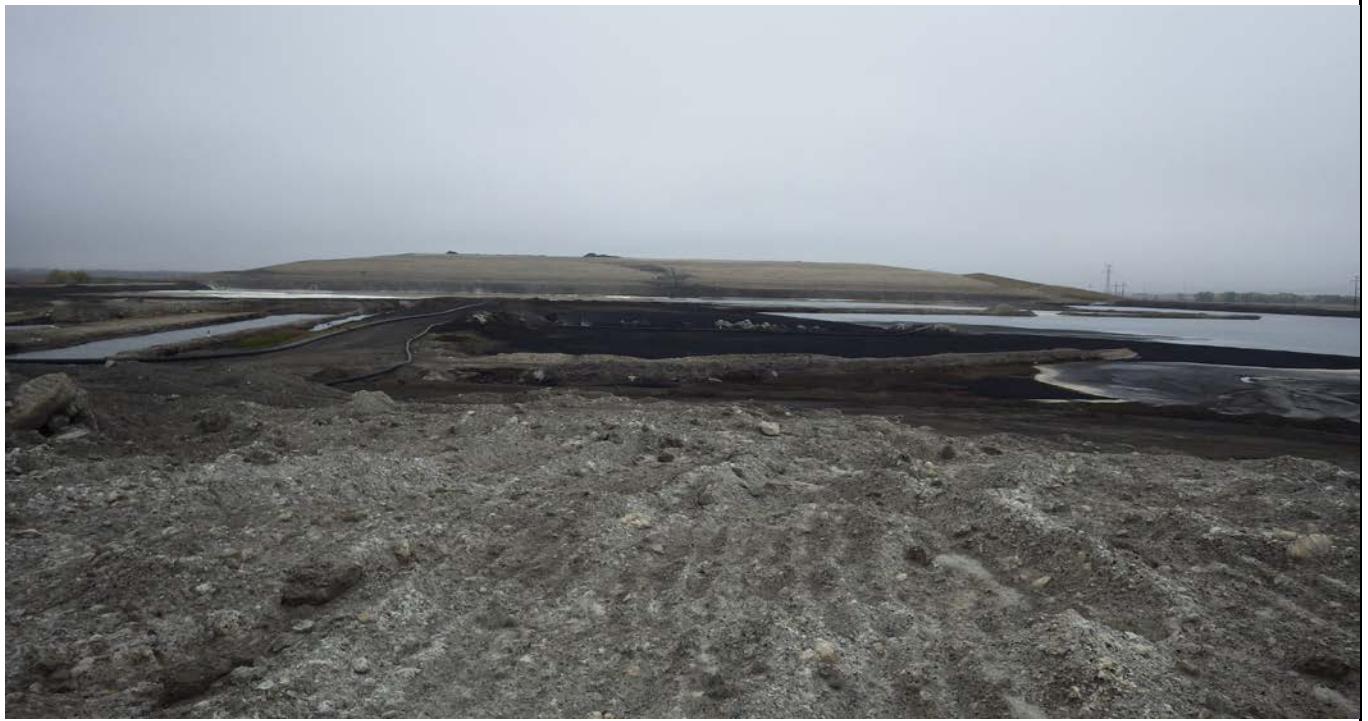
Photograph 9 (CCR placement from west side)
Upstream Raise 91 interior and CCR placement panorama (2 of 3) (IMGP6374.JPG)

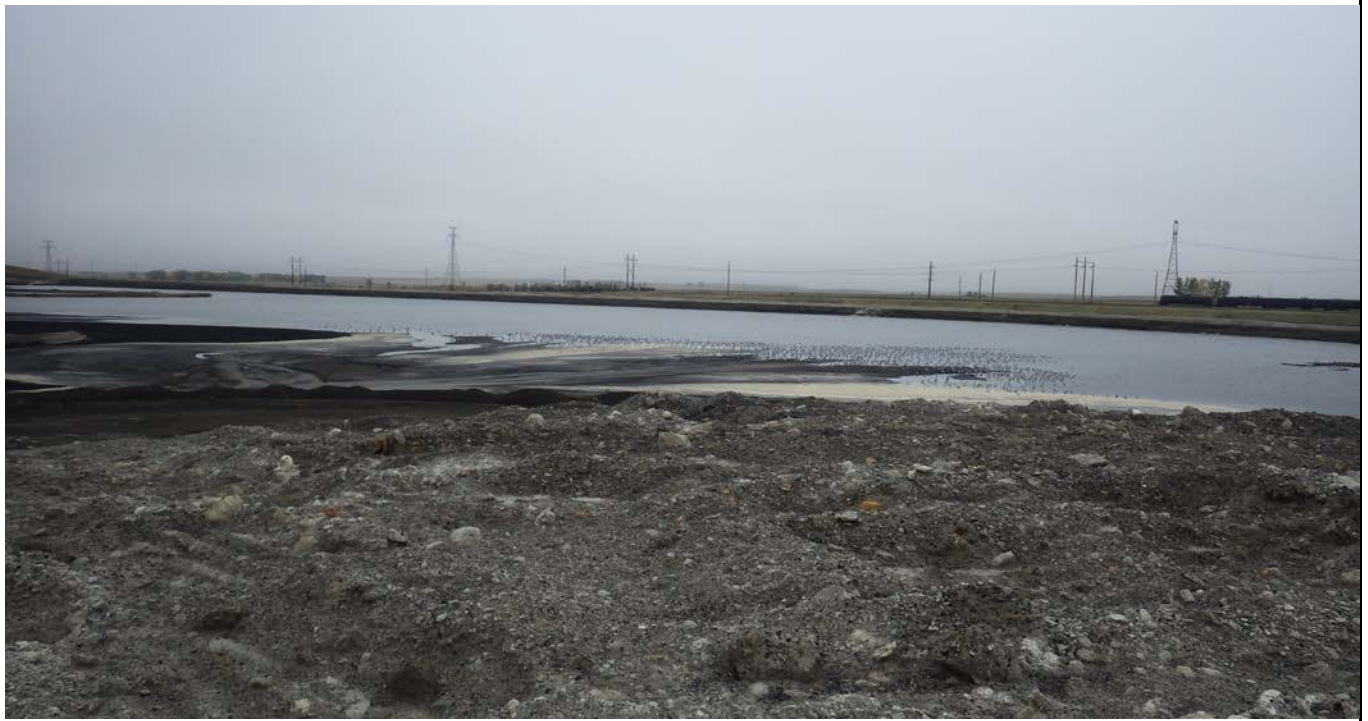
Photograph 10 (CCR placement from west side)
Upstream Raise 91 interior and CCR placement panorama (3 of 3) (IMGP6375.JPG)

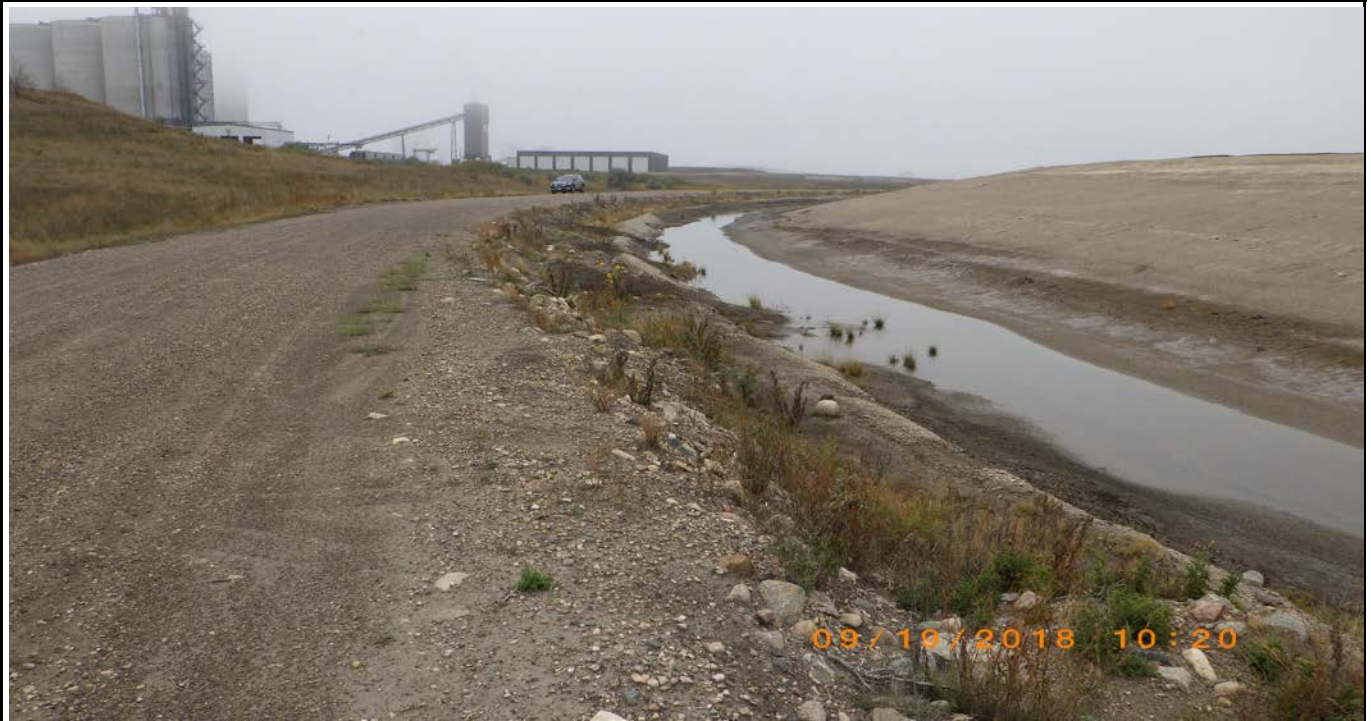
Photograph 11 (SW berm upstream slope)
Perimeter berm upstream slope and channel (5ccs.JPG)

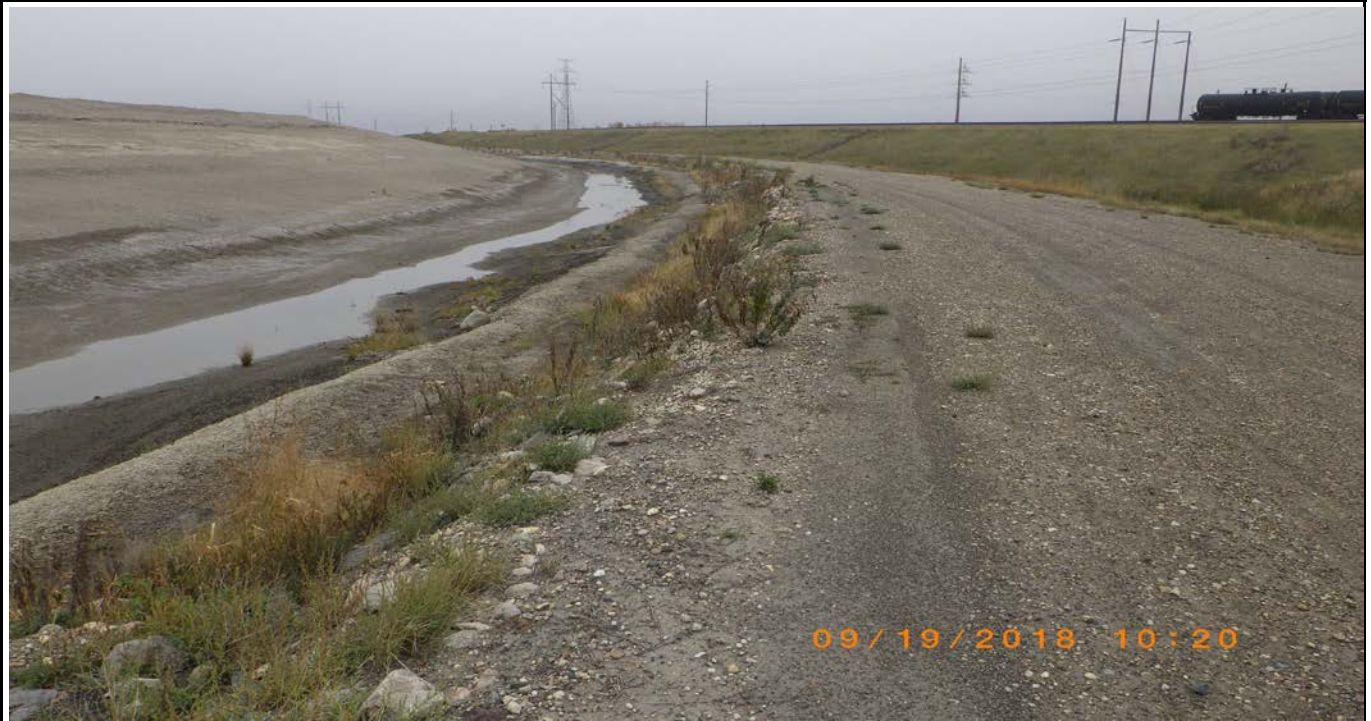
Photograph 12 (SW berm upstream slope)
Perimeter berm upstream slope and channel (6ccs.JPG)

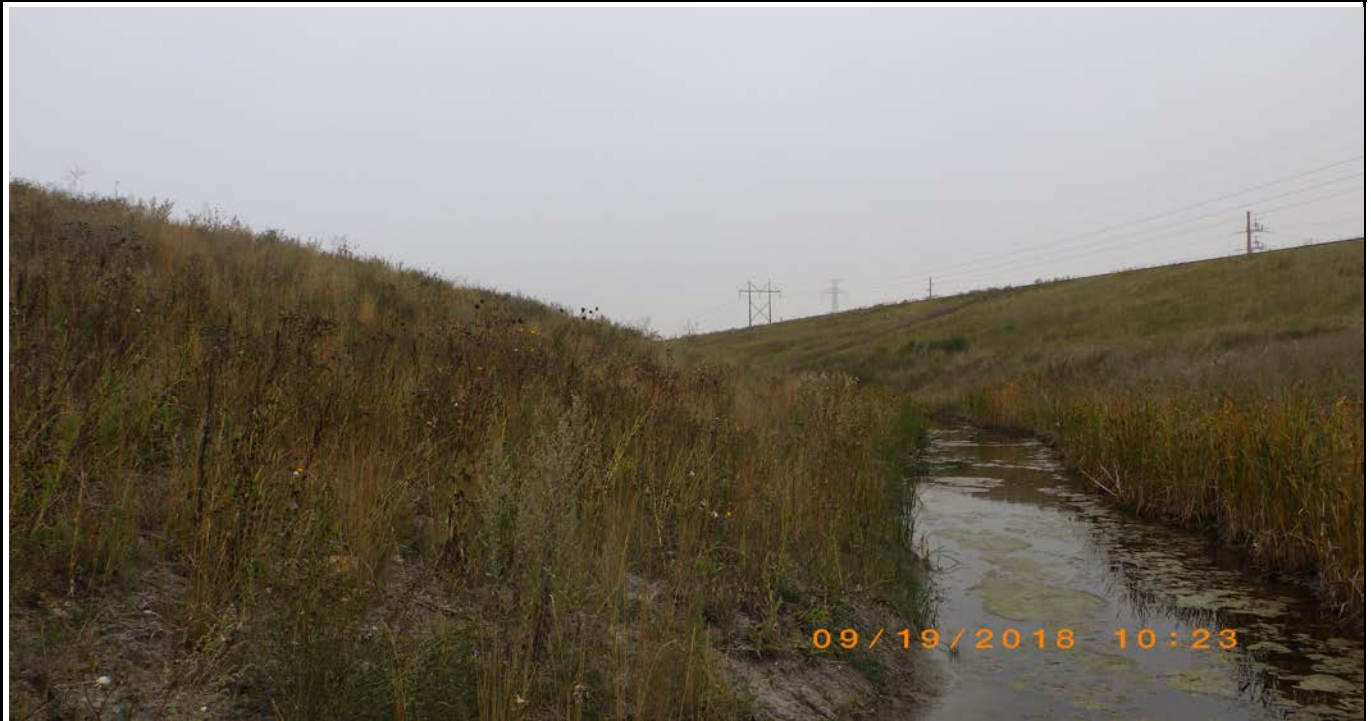
Photograph 13 (SW downstream slope)
Southwest downstream slope and surface water channel (<1 foot water) (9ccs.JPG)

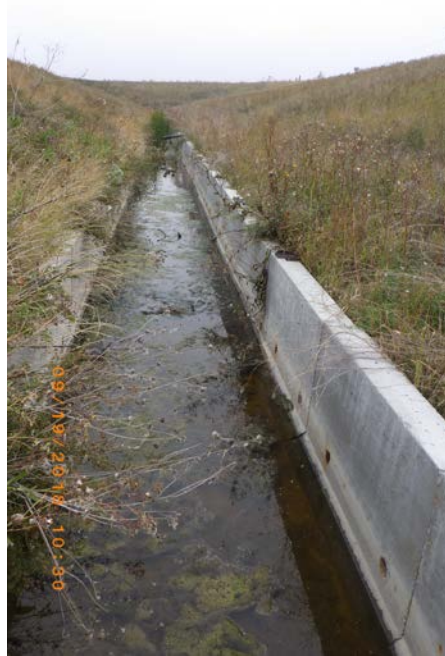
7. Toe				
a. Vegetation	X			Healthy grass and reeds
b. Rodent burrows	X			Mostly small burrows on south side
c. Seepage/sloughs/cracks/settlement		X		
d. Drainage conditions	X			Some standing water

Photograph 14 (South toe)
Approximately 1 foot of water in concrete surface water drainage (15ccs.JPG)

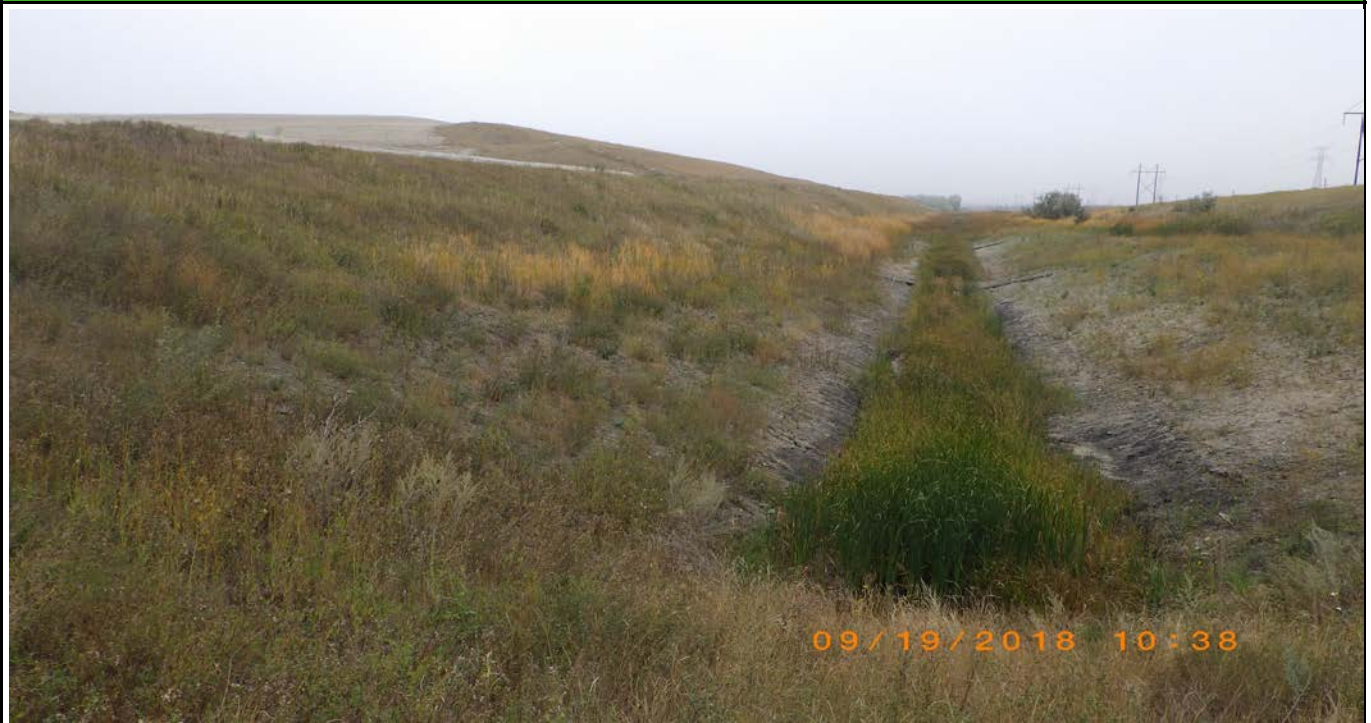
Photograph 15 (South toe)
South downstream slope and surface water ditch (18ccs.JPG)

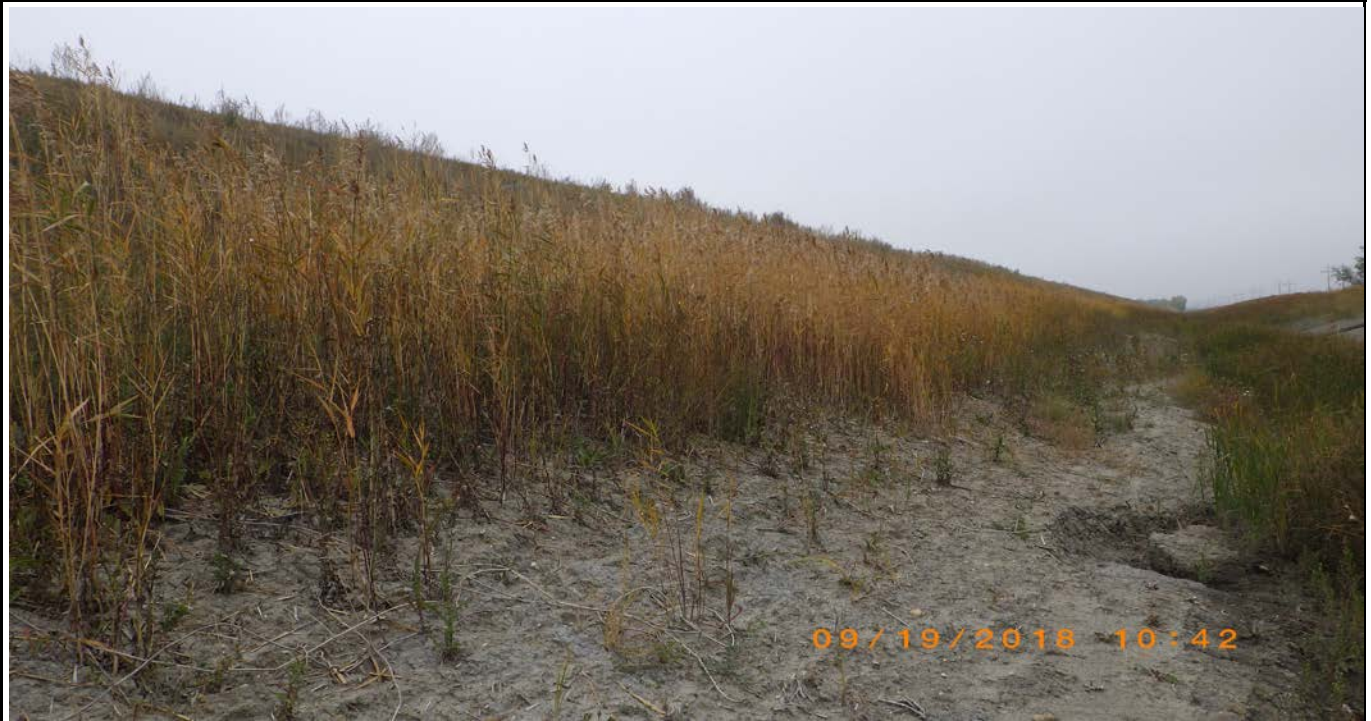
The berm downstream slopes range from 0 to 20 feet in height. In 2017, erosion rills were repaired and covered with erosion control blankets and several areas on the west and south berm downstream slopes were reseeded. Isolated areas continue to be sparsely vegetated; however, vegetative growth continues to improve and was more established during the 2018 inspection than during the 2017 inspection.

Photograph 16 (South toe)
Sparse vegetation on south downstream slope near the toe (21ccs.JPG)

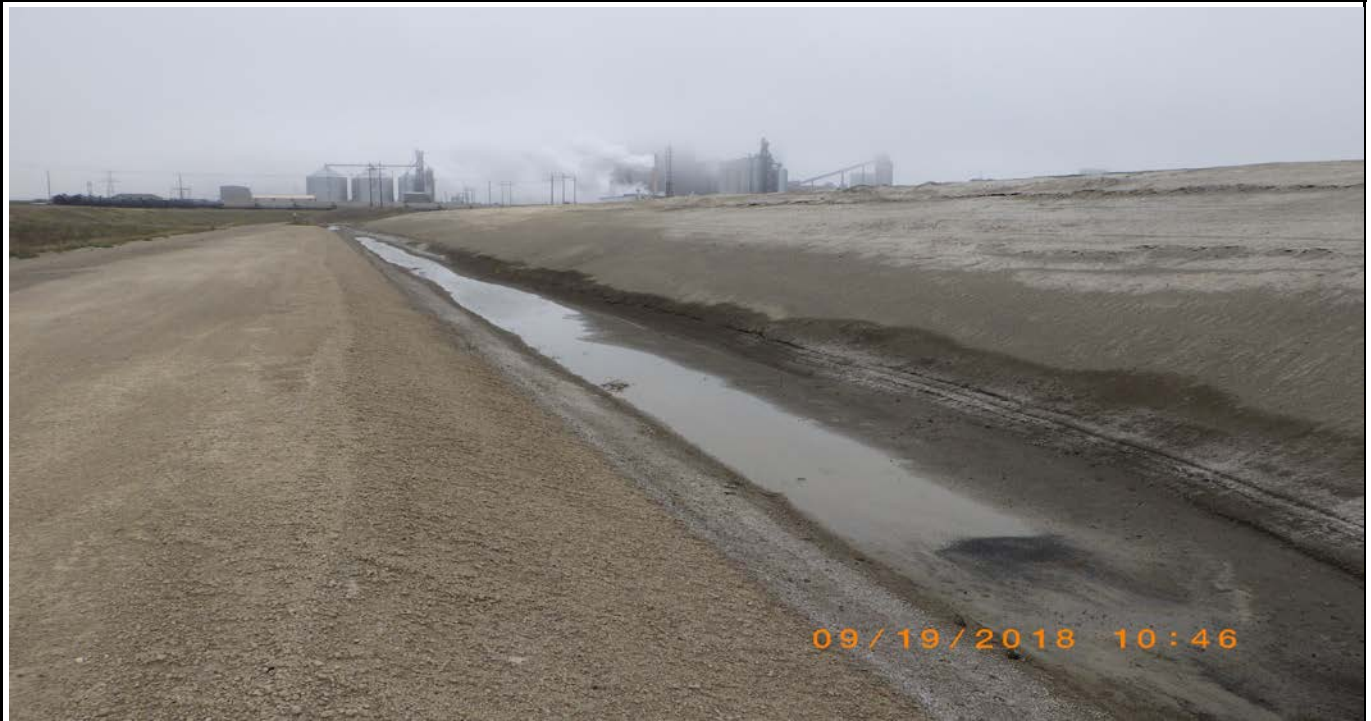
Photograph 17 (South berm upstream slope)
Perimeter berm upstream slope, channel, and CCR downstream slope (24ccs.JPG)

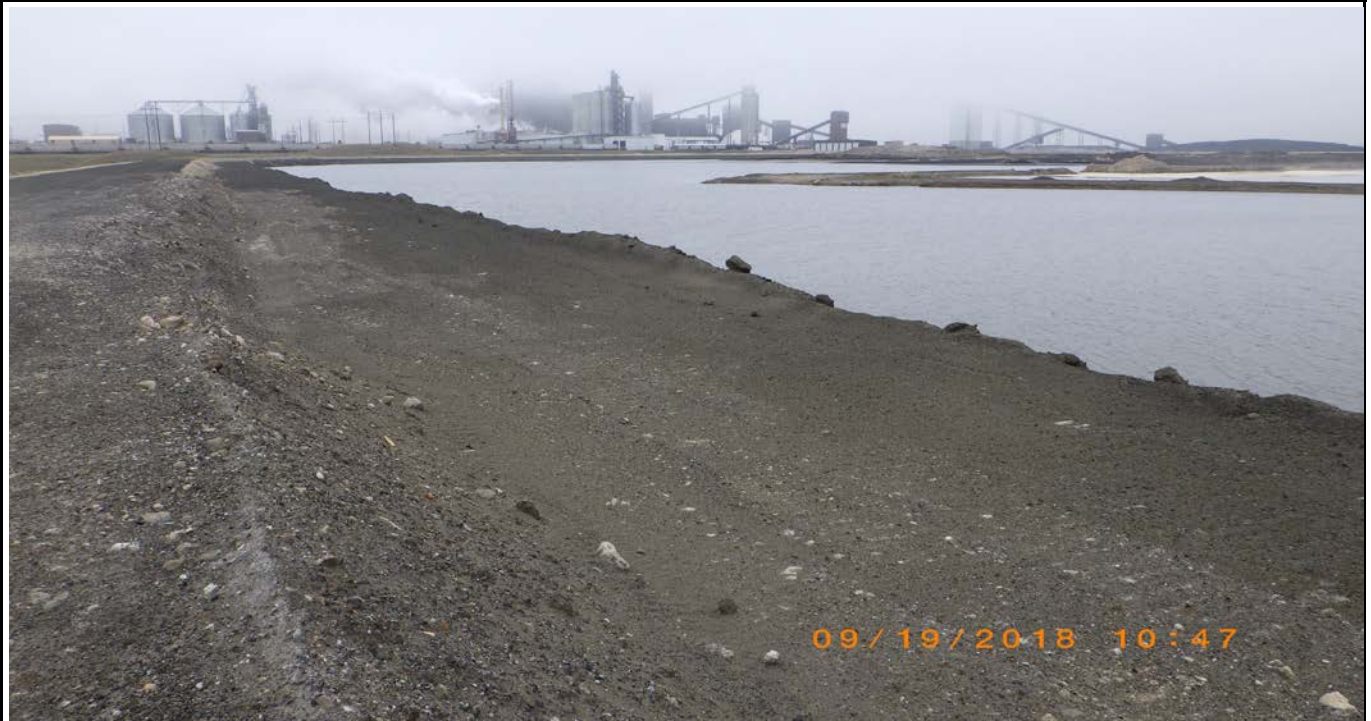
Photograph 18 (South CCR upstream slope)
CCR crest and Upstream Raise 91 interior (25ccs.JPG)

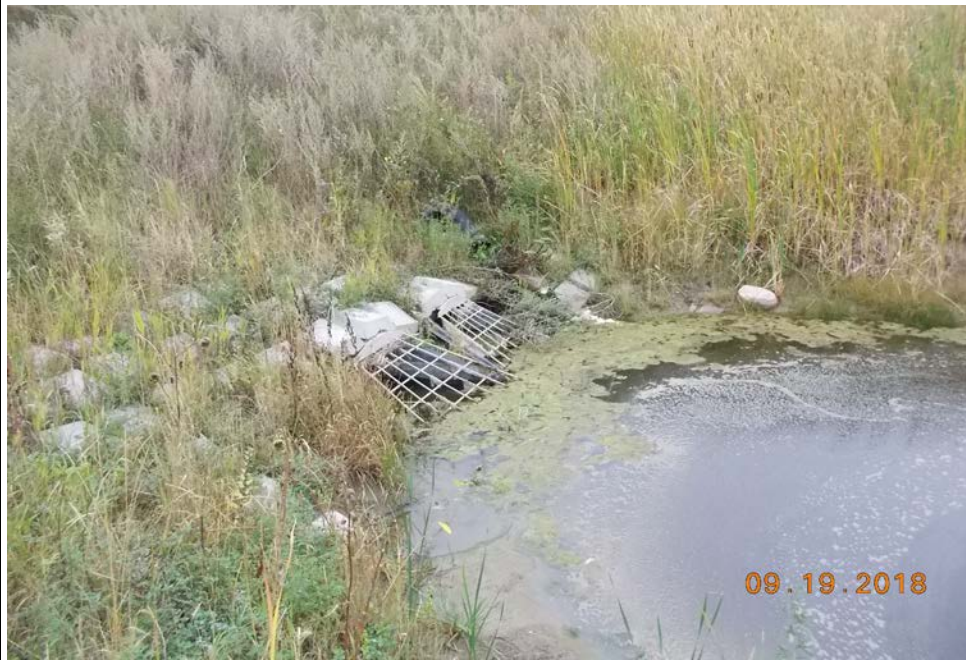
Photograph 19 (West toe and ditch)
Inlet side of surface water drainage culvert on west side of Upstream Raise 91 (2PDS.JPG)

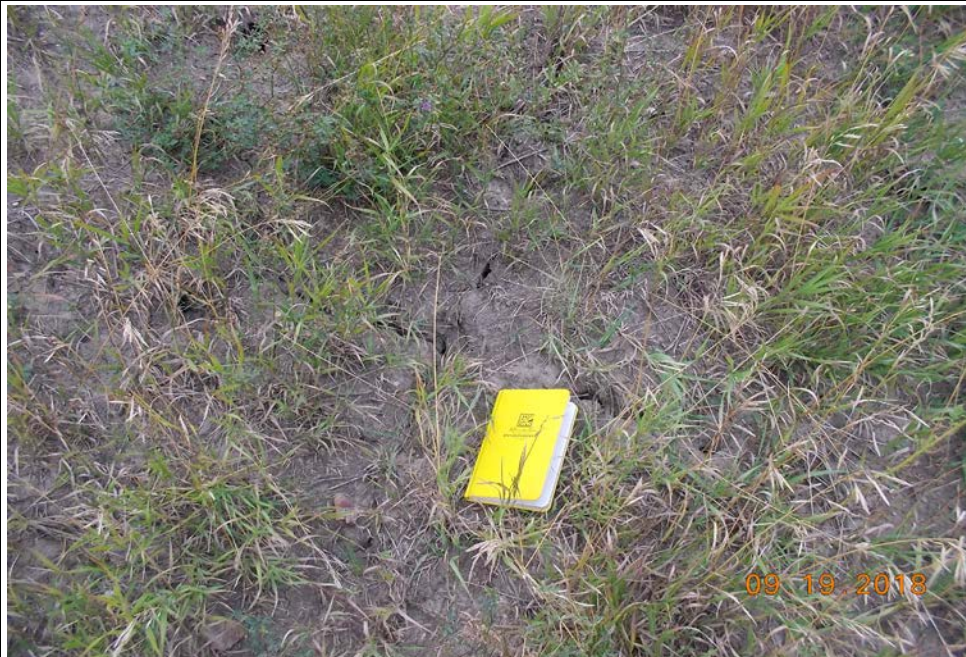
Photograph 20 (West downstream slope)
Minor erosion and sparse vegetation on west downstream slope (5PDS.JPG)

Minor maintenance items that may need to be continually addressed include repairing large animal burrows as they appear, monitoring erosion and vegetative success of the re-configured surface water channel along the west and south toe of the facility, clean-out of collected material in the contact water perimeter channels and maintaining gravity and culvert piping, repairing and re-seeding eroded areas on or adjacent to berm downstream slopes, and removal of any woody vegetation growing on the berm downstream slopes. In addition, the inflow and outflow piping should be monitored regularly and cleared of debris as required to ensure proper conveyance of water to and from the facility.

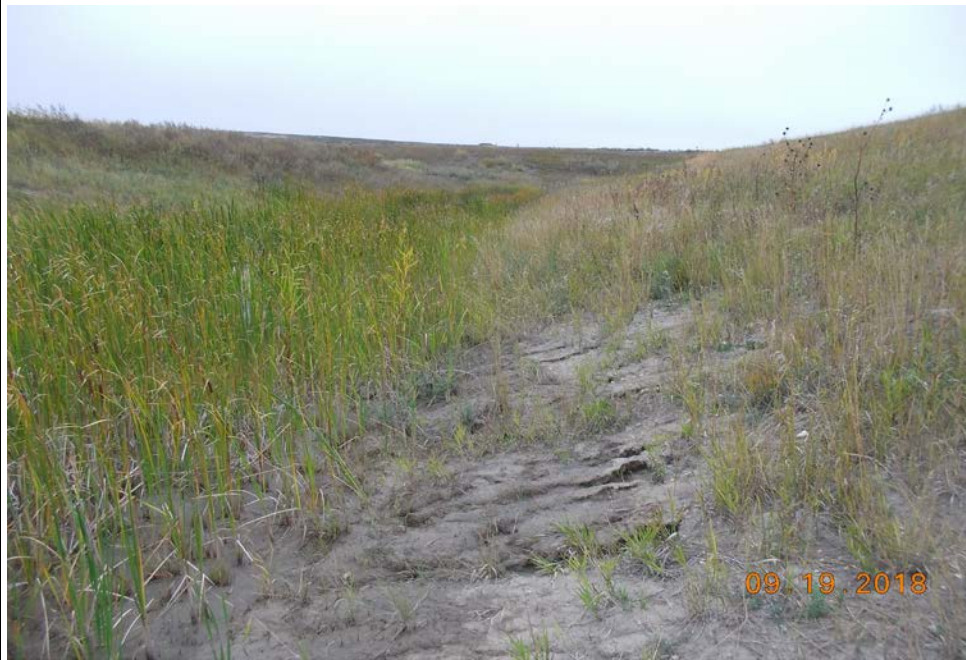
Photograph 21 (West downstream slope)
Minor erosion and sparse vegetation on west downstream slope (10PDS.JPG)

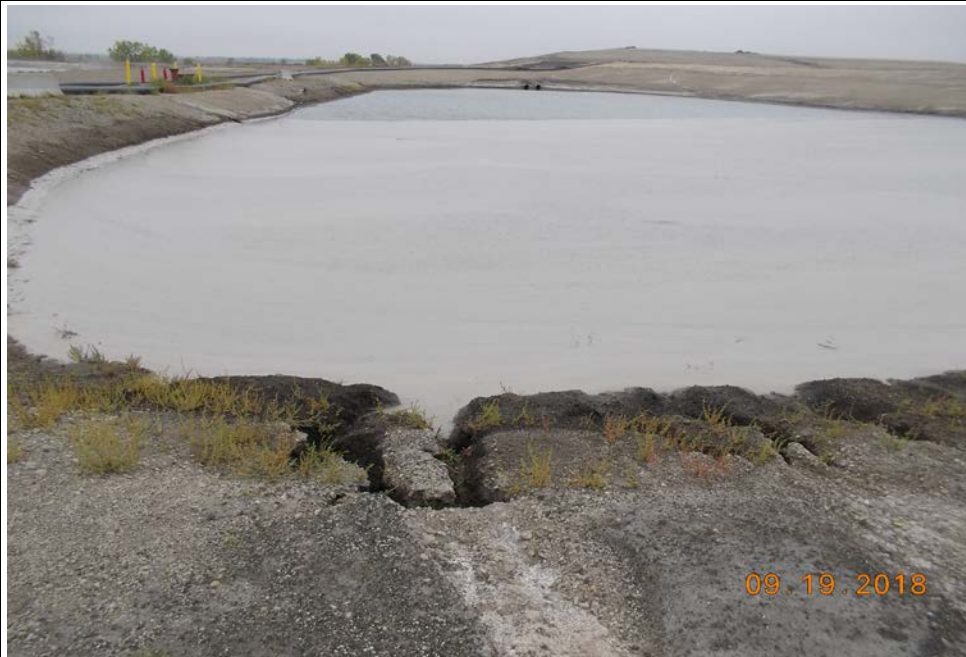
f. CCR Downstream slope erosion	X			Minor erosion of fly ash
g. CCR Downstream slope cracks/settlement		X		
5. Covered Downstream Slopes				No cover currently constructed

Photograph 22 (NW crest and pond)
Minor erosion of fly ash shell near northwest corner of Upstream Raise 91 (12PDS.JPG)

General Remarks: No significant issues. Minor maintenance includes addressing small burrows, maintaining fly ash protective cover, maintaining inflow and outflow piping, and addressing erosion as observed.

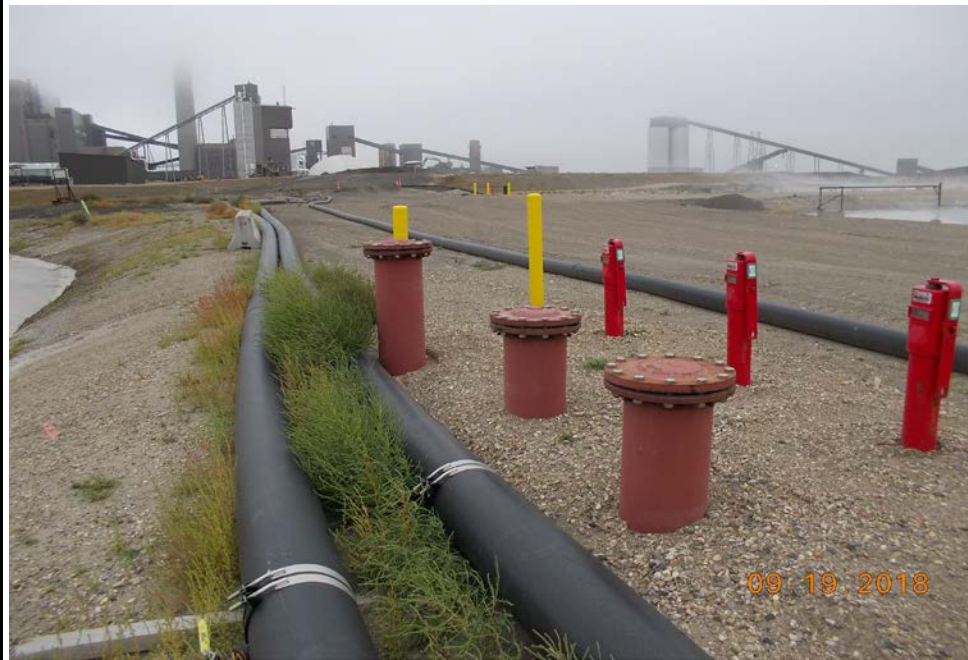
Photograph 23 (North berm upstream slope)
Cleanouts and valve controls for Upstream Raise 91 to Drains Pond System cross-over pipes (14PDS.JPG)

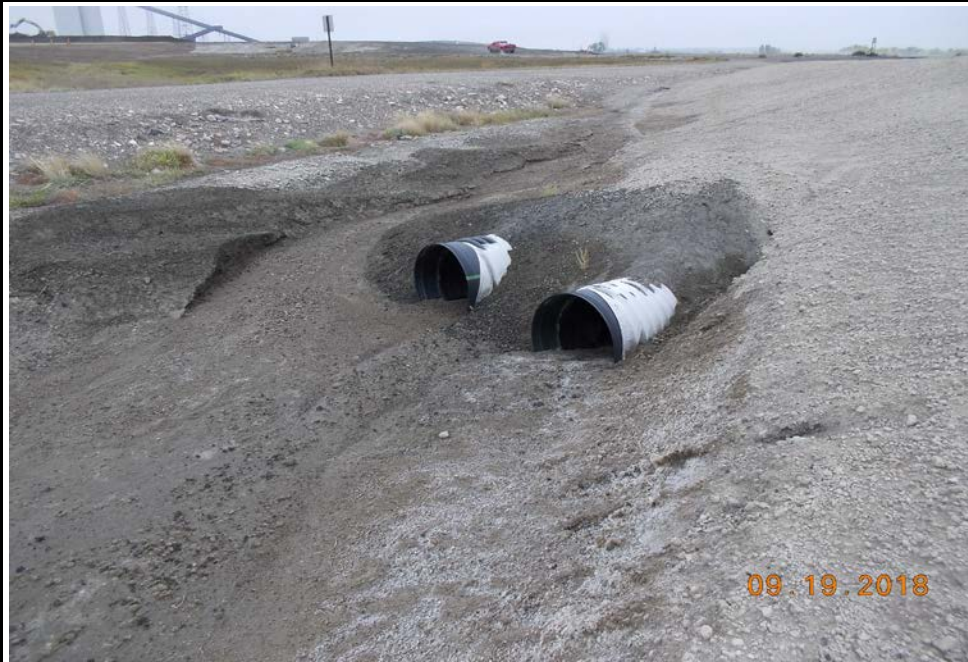
Photograph 24 (West upstream slope)
Perimeter channel contact water culverts (20PDS.JPG)
