Annual Inspection

Coal Creek Station – Upstream Raise 92 CCR Surface Impoundment

Great River Energy

January 2019

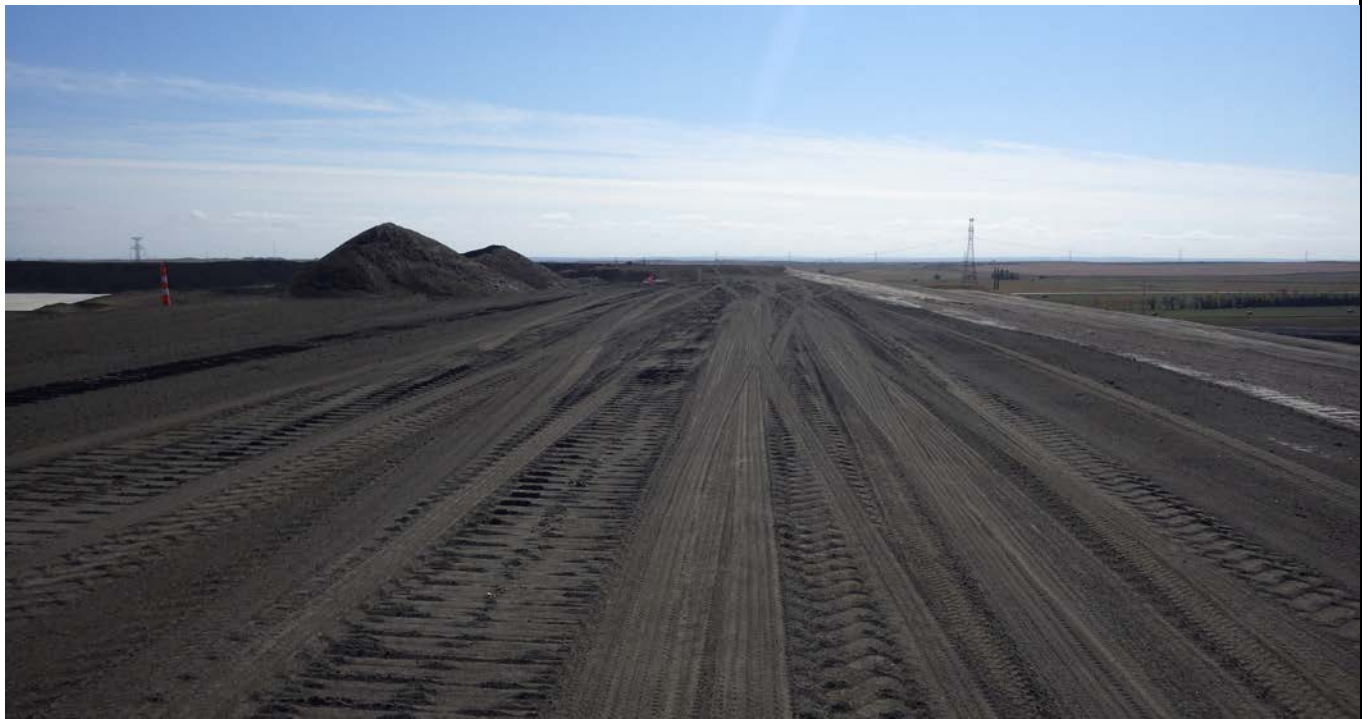
Photograph 1 (West CCR crest)
Bottom ash CCR crest (IMGP6384.JPG)

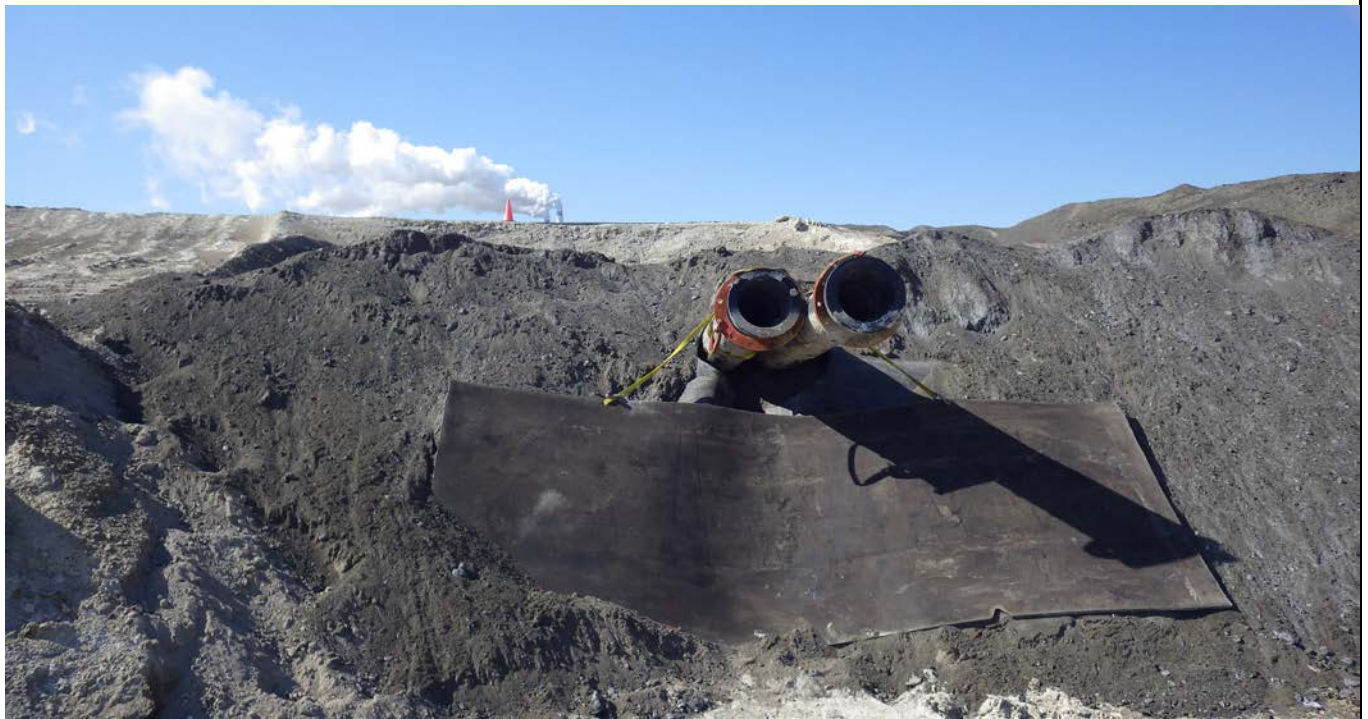
Photograph 2 (West CCR upstream slope)
Gravity drain outlet pipes (IMGP6390.JPG)

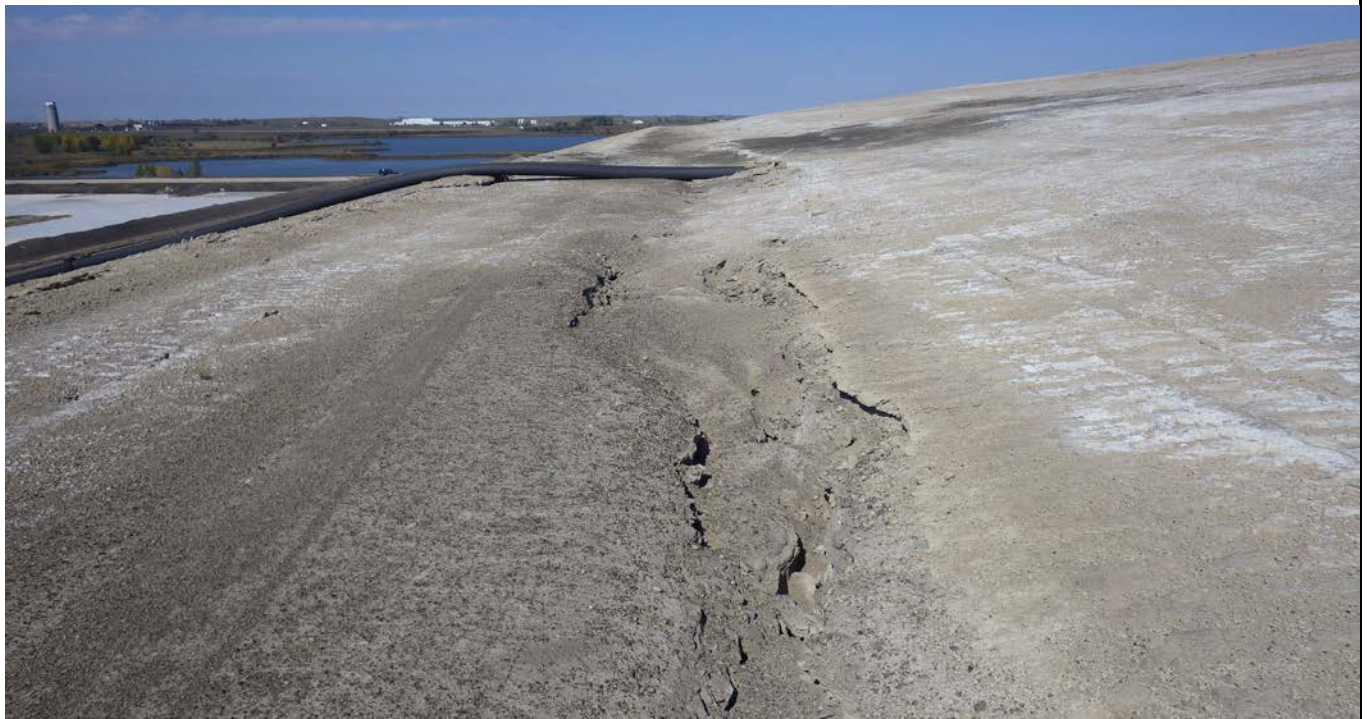
Photograph 3 (West CCR downstream slope)
Crack and erosion in fly ash CCR downstream slope (IMGP6392.JPG)

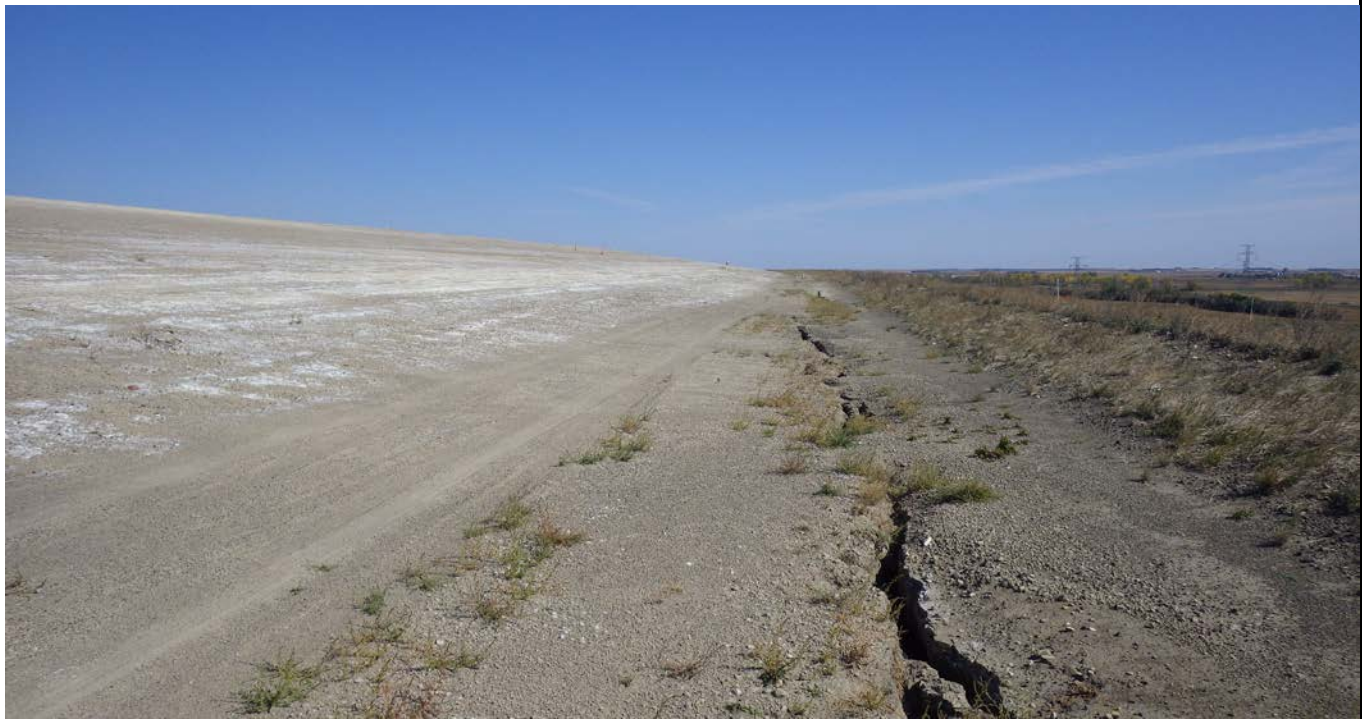
Photograph 4 (South CCR downstream slope)
Crack in fly ash bench (within the contact water separation channel) (IMGP6395.JPG)

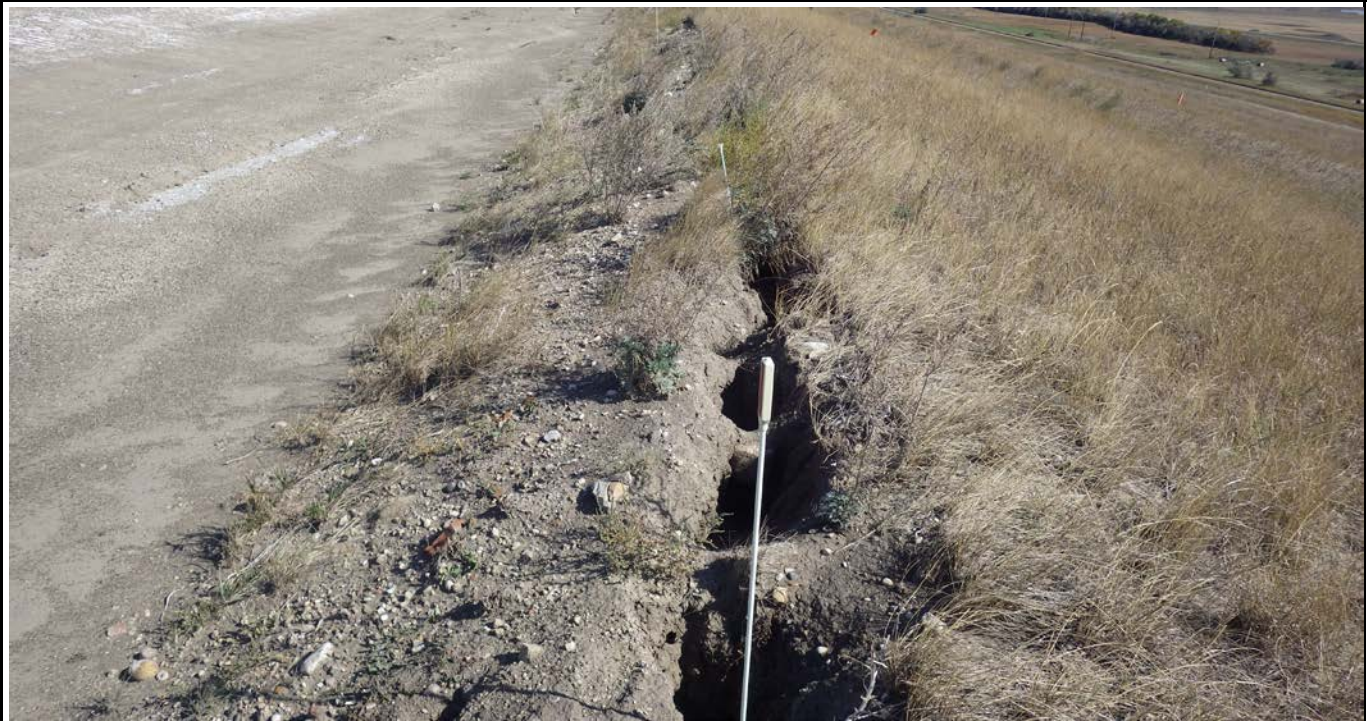
d. Downstream Slope seepage/sloughs/cracks/settlement	X			Cracks due to settlement of fly ash over FGD material at 1974 feet (no cracks noted below 1974 feet on covered slopes)

Photograph 5 (South CCR covered downstream slope)
Cracking of the final cover slope near the bench at elevation 1974 feet (IMGP6397.JPG)

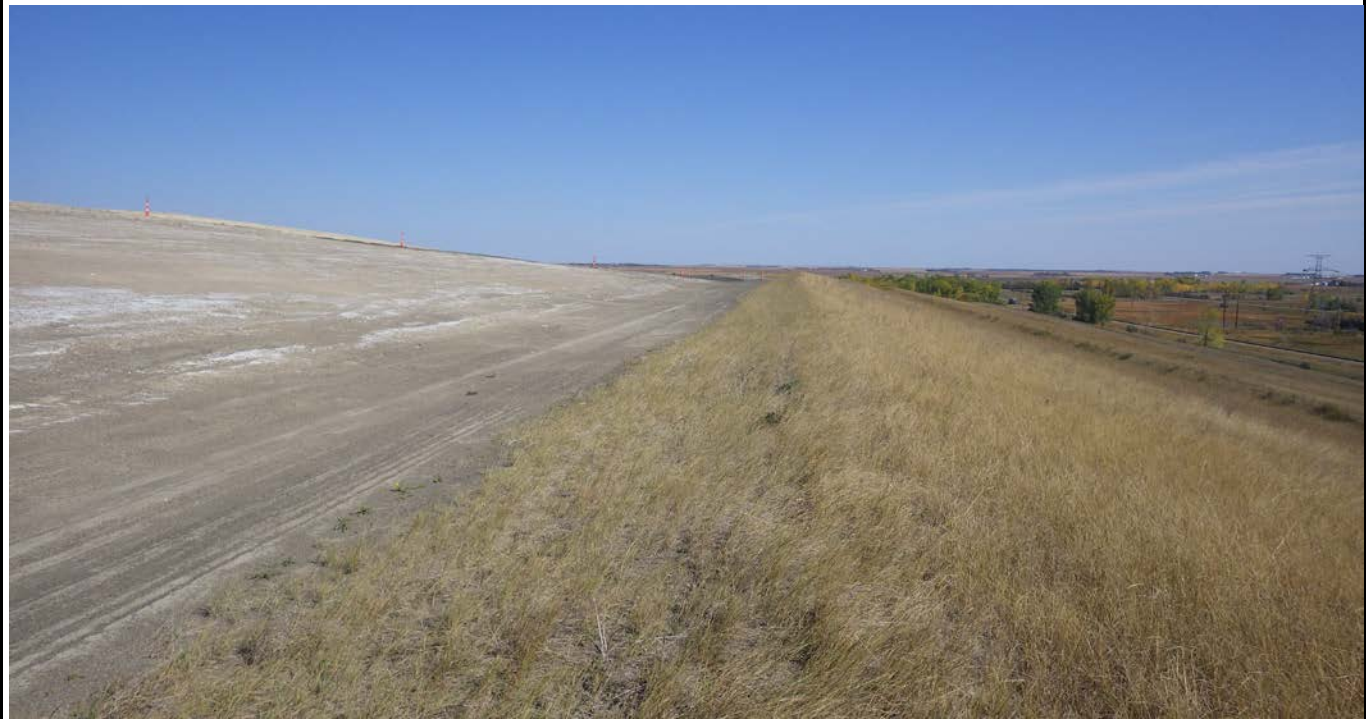
Photograph 6 (South CCR covered downstream slope)
South CCR downstream slope to final cover downstream slope (IMGP6404.JPG)

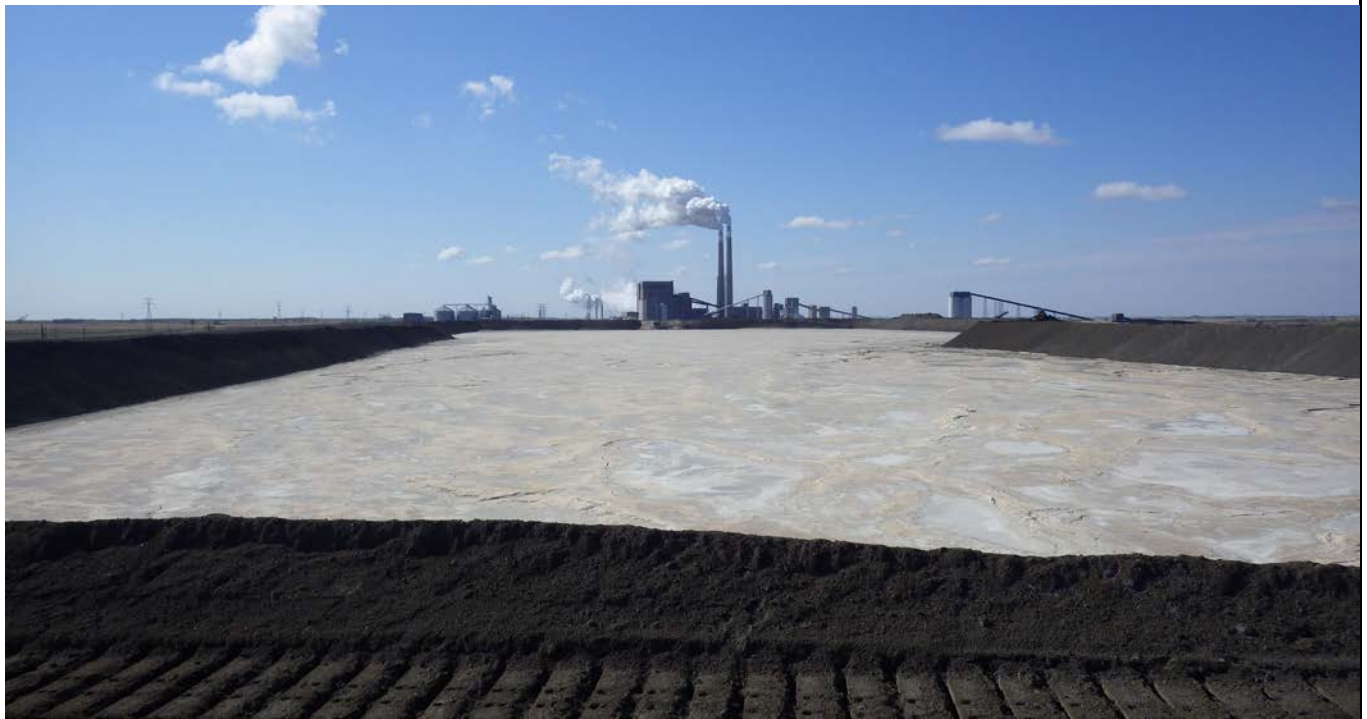
Photograph 7 (East CCR upstream slope)
Flue Gas Desulfurization (FGD) pool and bottom ash upstream CCR slopes (IMGP6407.JPG)

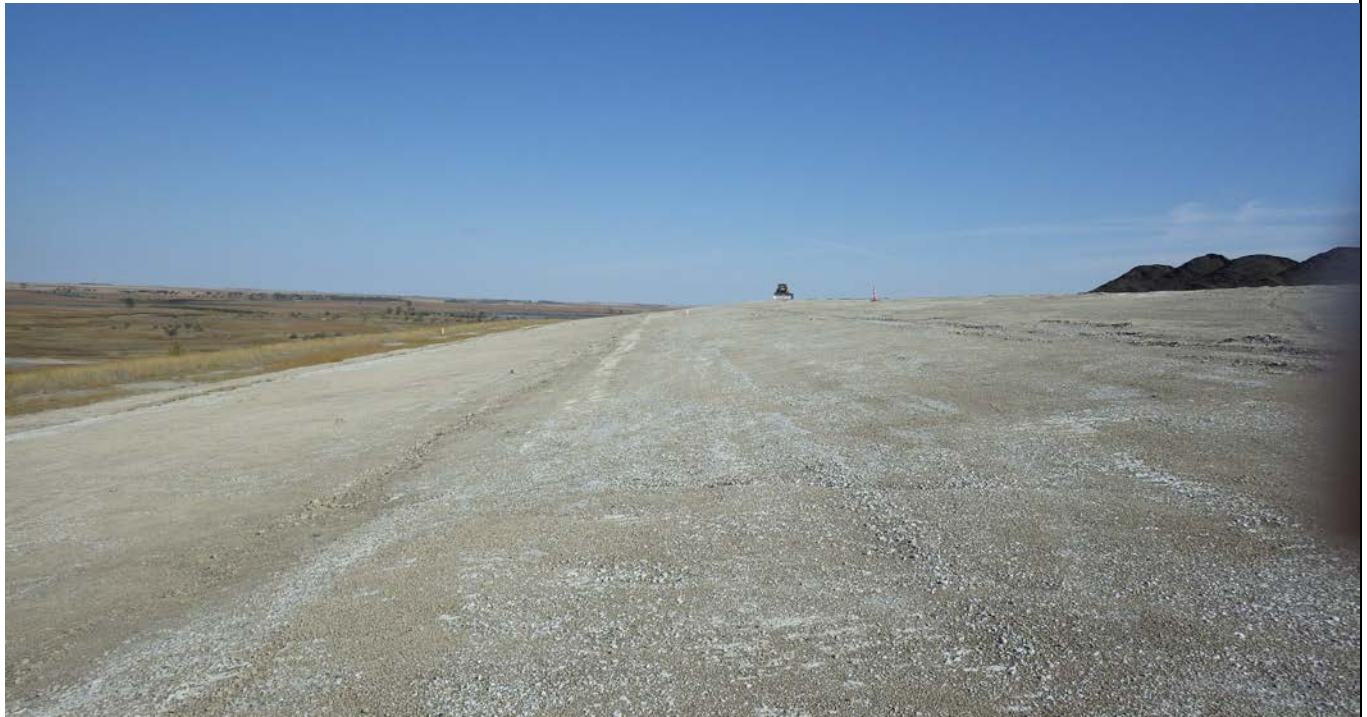
Photograph 8 (North CCR downstream slope)
Minor erosion of fly ash on CCR downstream slope (IMGP6424.JPG)

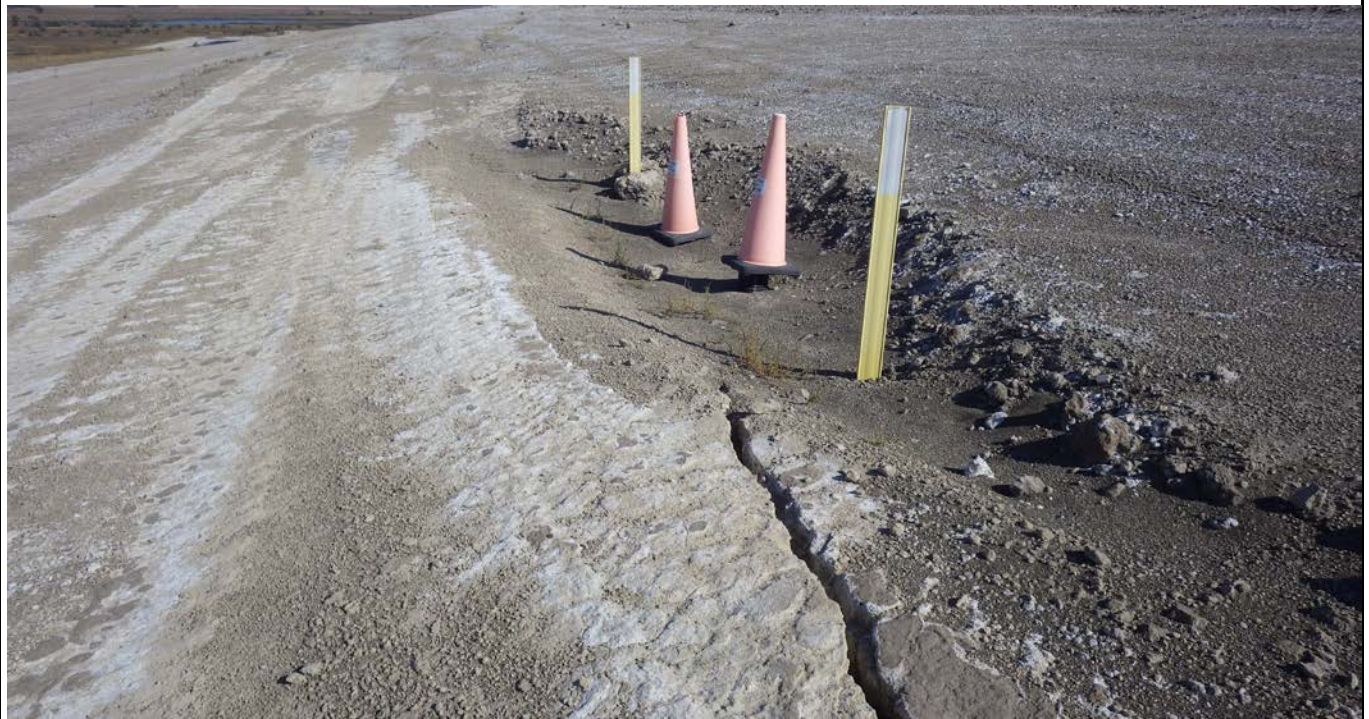
Photograph 9 (North CCR downstream slope)
Crack in fly ash near piezometers (IMG6425.JPG)

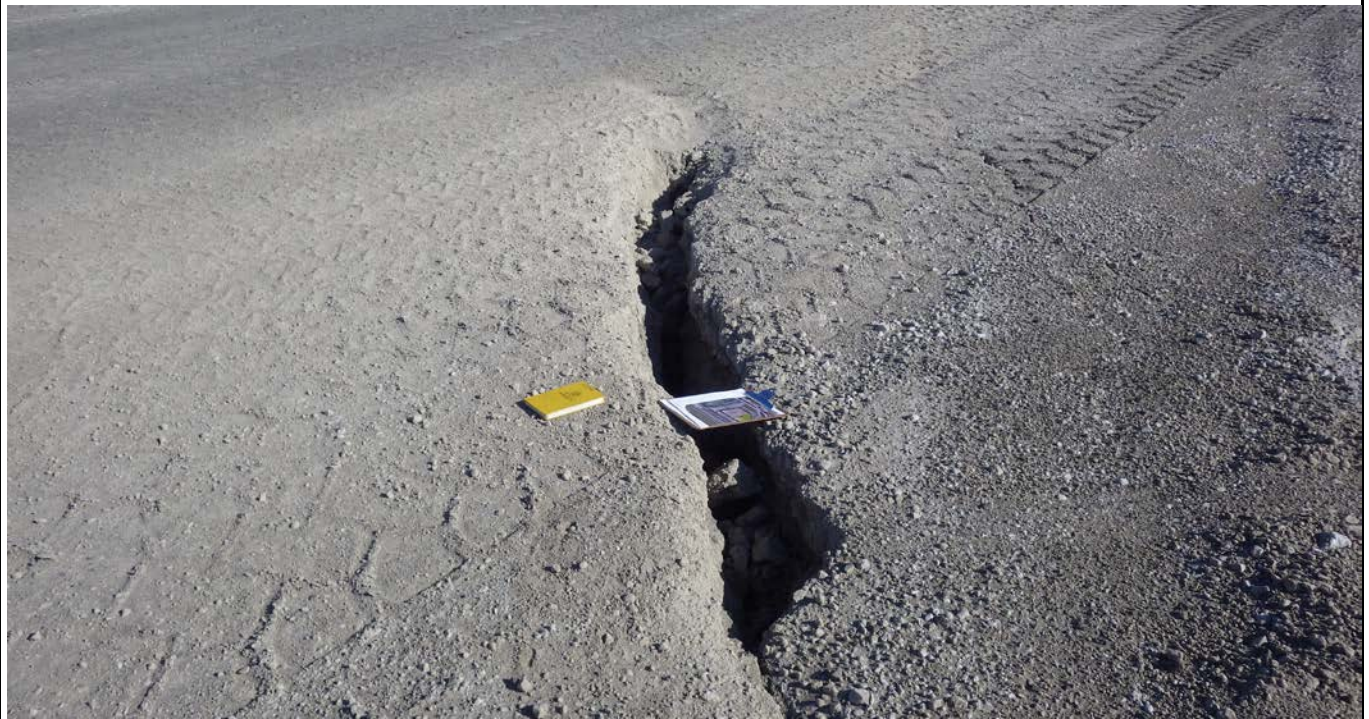
Photograph 10 (North CCR downstream slope)
Crack in fly ash CCR crest (approximately 10 inches wide) (IMG6427.JPG)

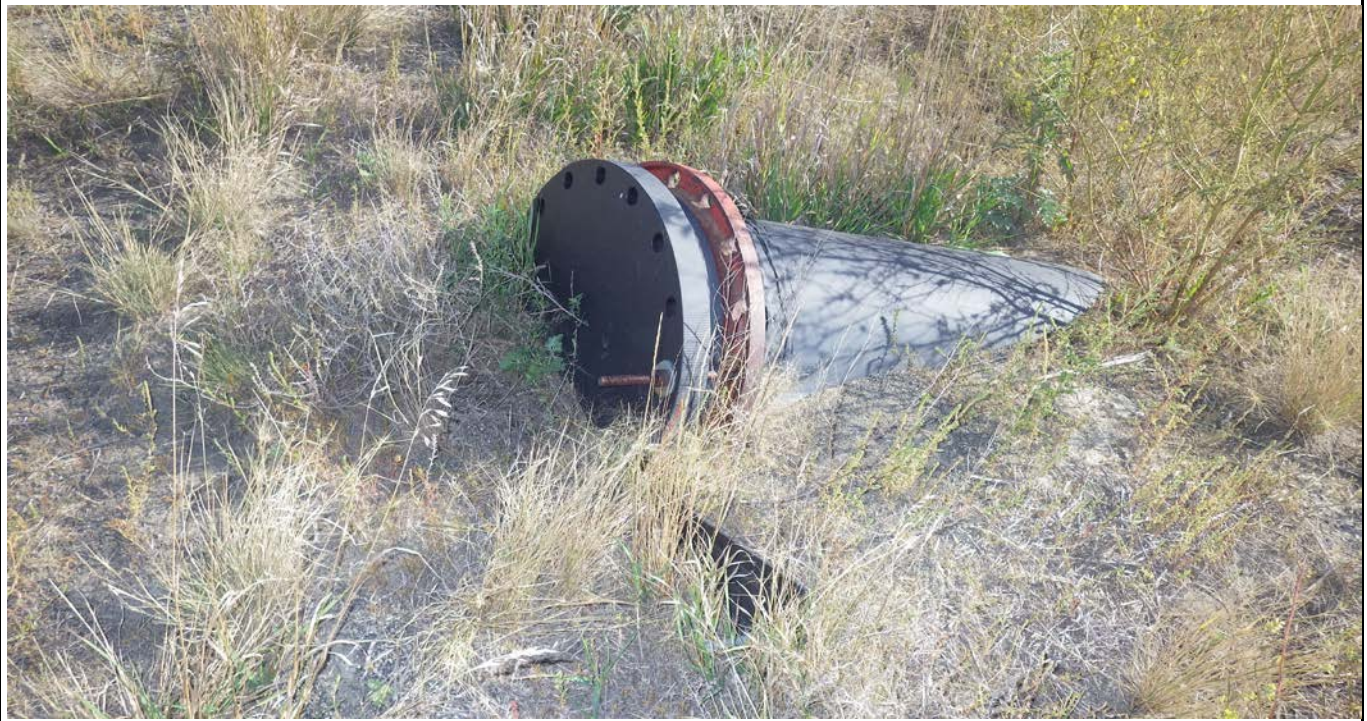
Photograph 11 (North CCR downstream slope)
Sump riser on east half of Upstream Raise 92 (IMGP6429.JPG)

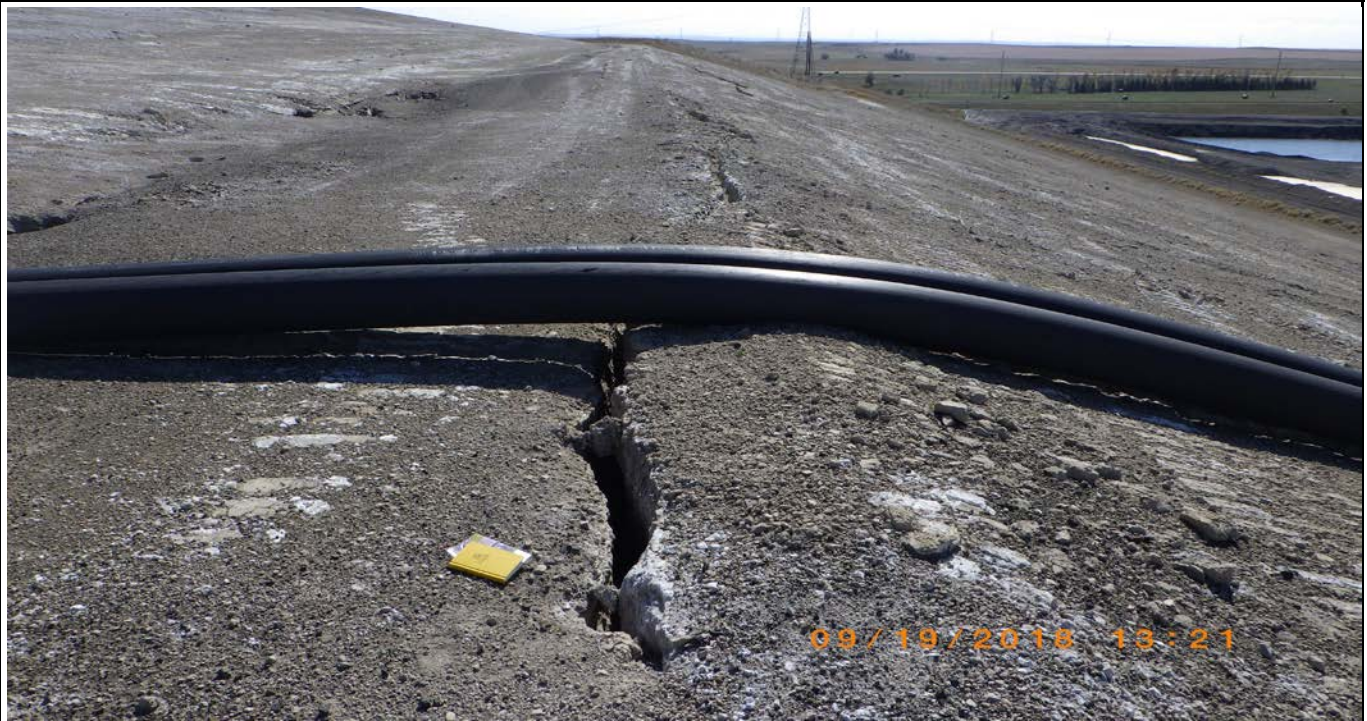
Photograph 12 (West CCR downstream slope)
Crack on CCR downstream slope bench at elevation 1974 feet (approximately 6 inches wide, 6 feet deep, 6 inches offset vertically) (6ccs.JPG)

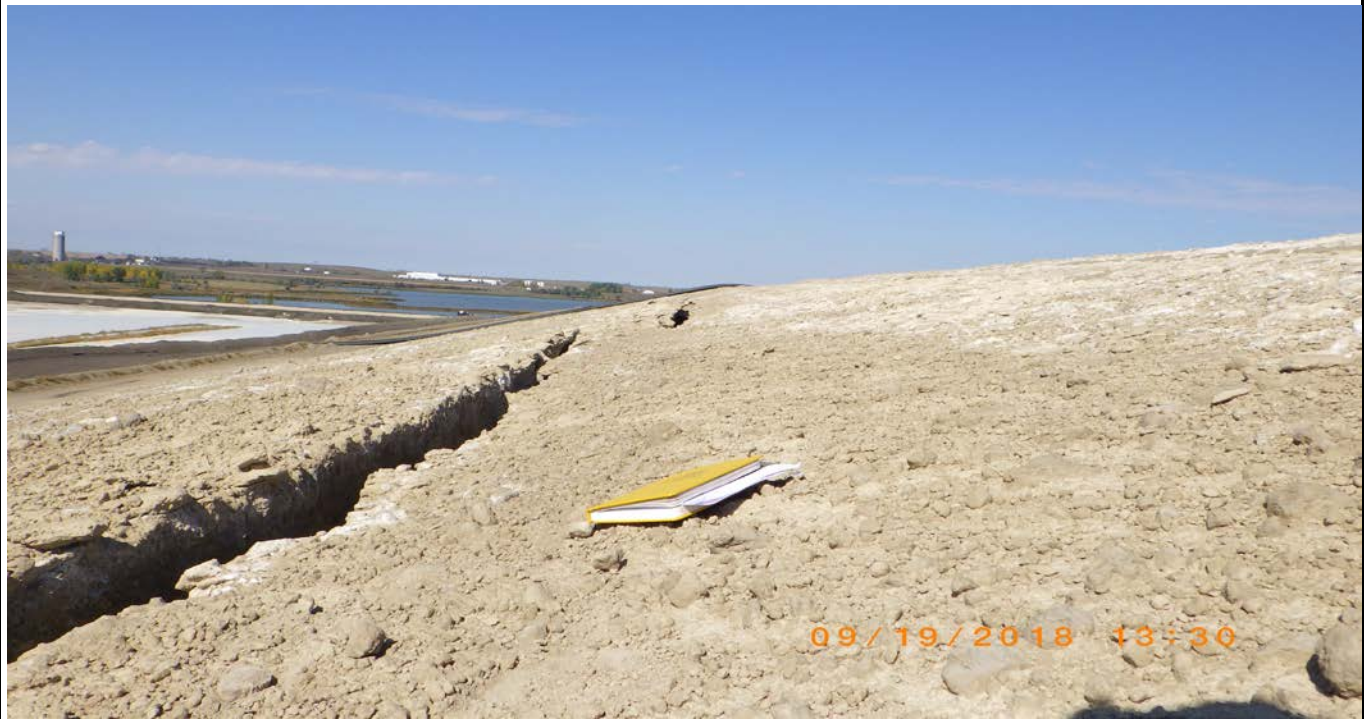
Photograph 13 (West CCR downstream slope)

Crack on CCR downstream slope bench at approximate elevation 1970 feet (approximately 4 inches wide, 3 feet deep, 4 inches offset vertically) (13ccs.JPG)

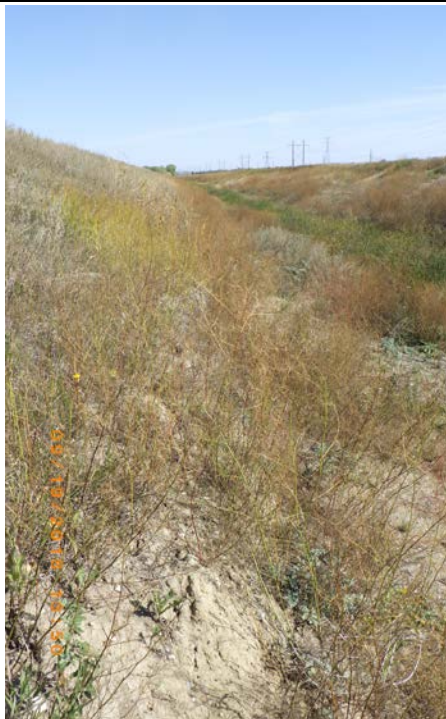
Photograph 14 (South downstream slope)

m. Downstream Slope seepage/sloughs/cracks/settlement		X		Minor over-steepening of slope near toe as a result of re-grading of the south drainage channel

Over-steepened toe (remnant of construction, no seepage present) (23ccs.JPG)

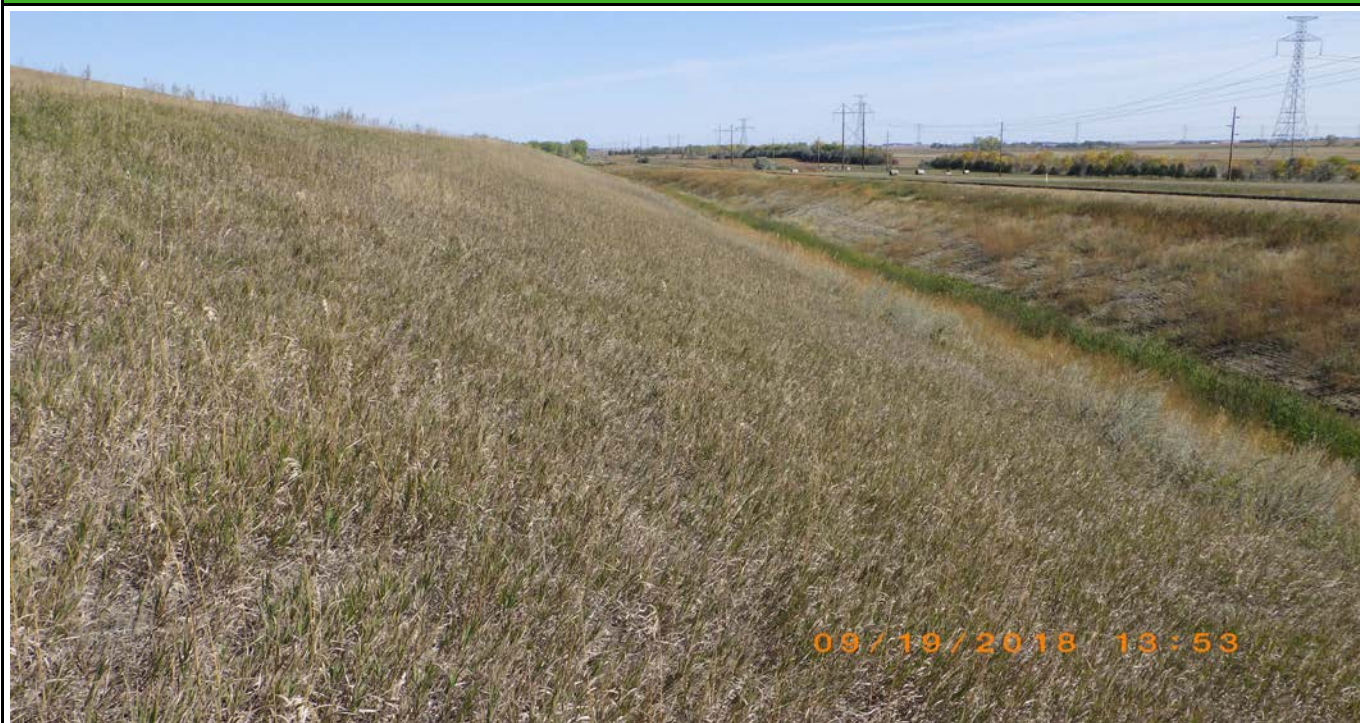
Photograph 15 (South berm downstream slope)
Typical berm downstream slope (26ccs.JPG)

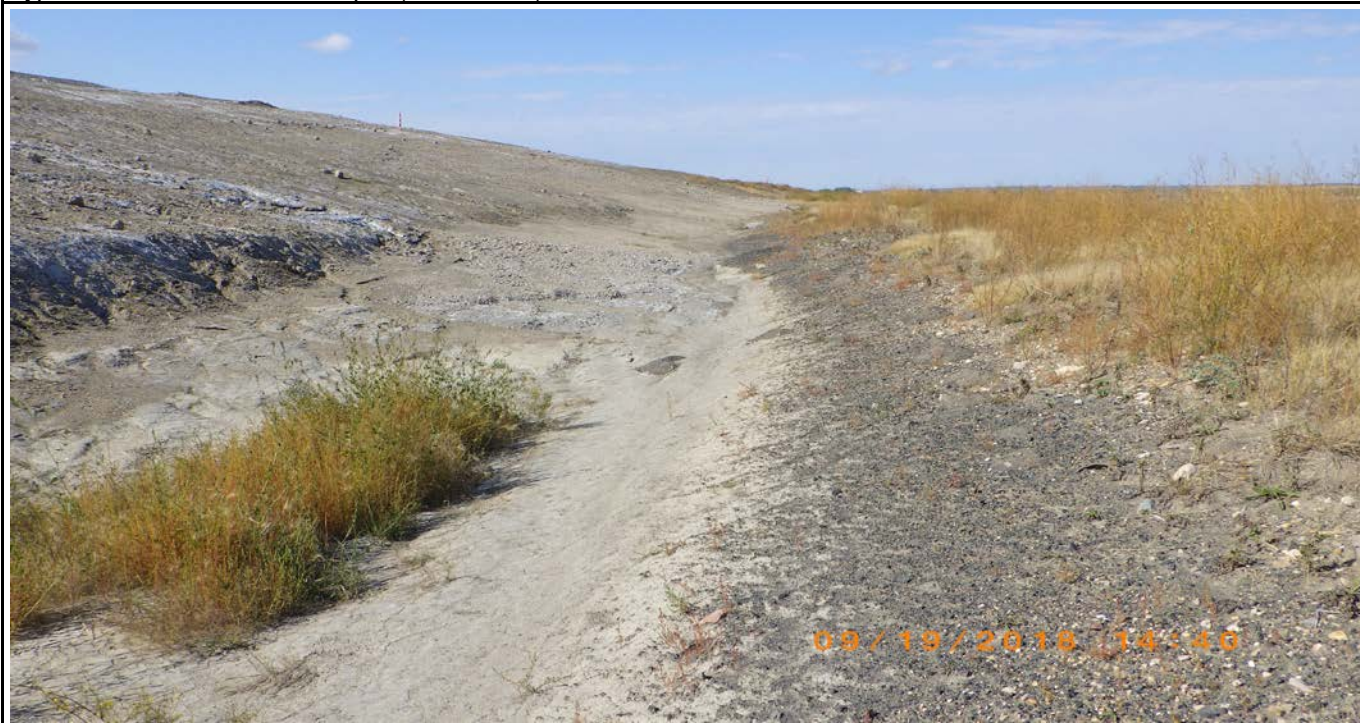
Photograph 16 (East CCR downstream slope)
Contact water ditch at elevation 1950 feet on east CCR downstream slope (48ccs.JPG)

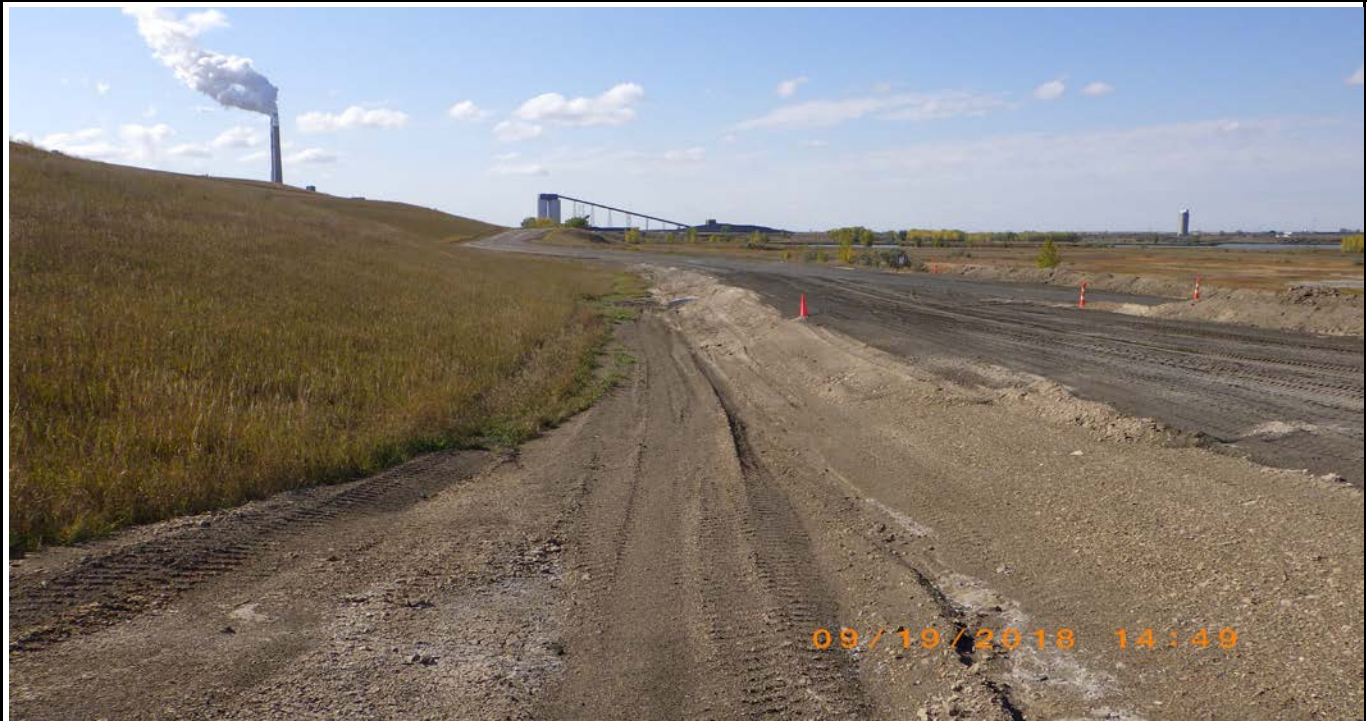
Photograph 17 (North downstream slope and haul road)
Contact water channel and recently installed culvert (53ccs.JPG)

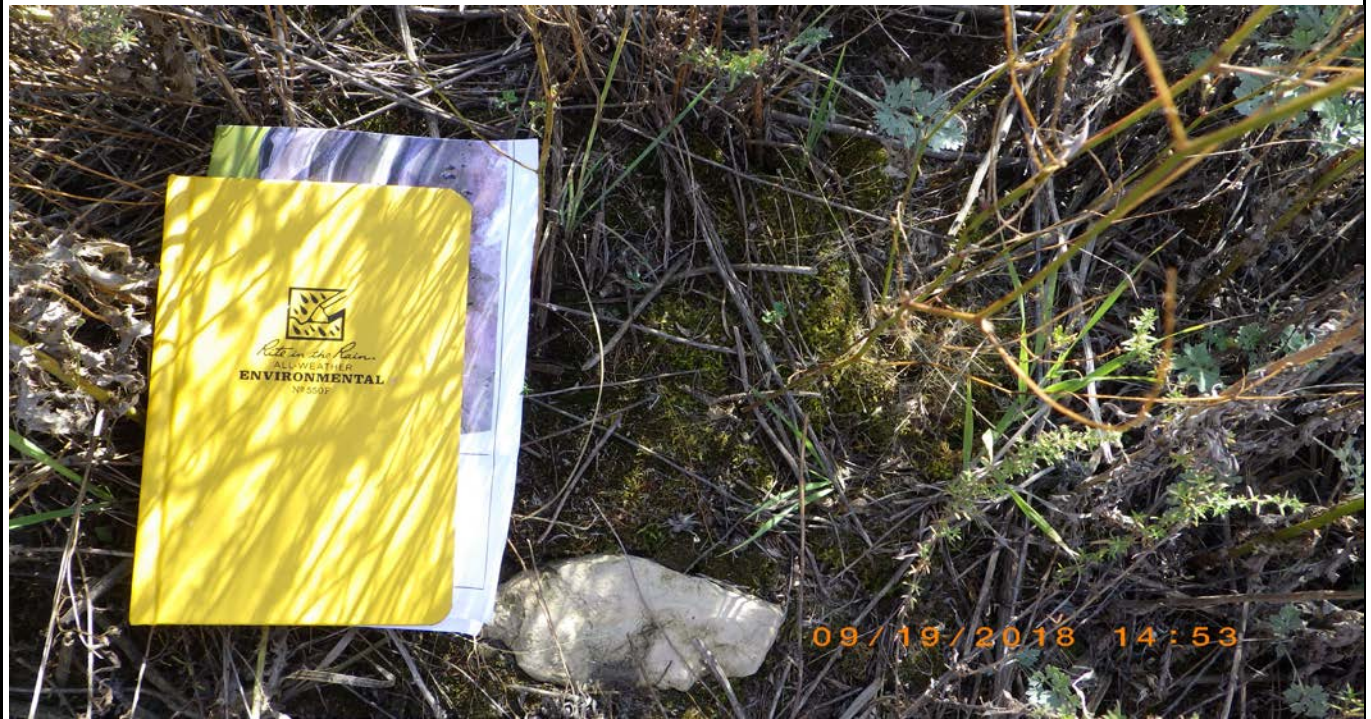
Photograph 18 (North downstream slope)
Mossy vegetation in grass (no seepage) (56ccs.JPG)

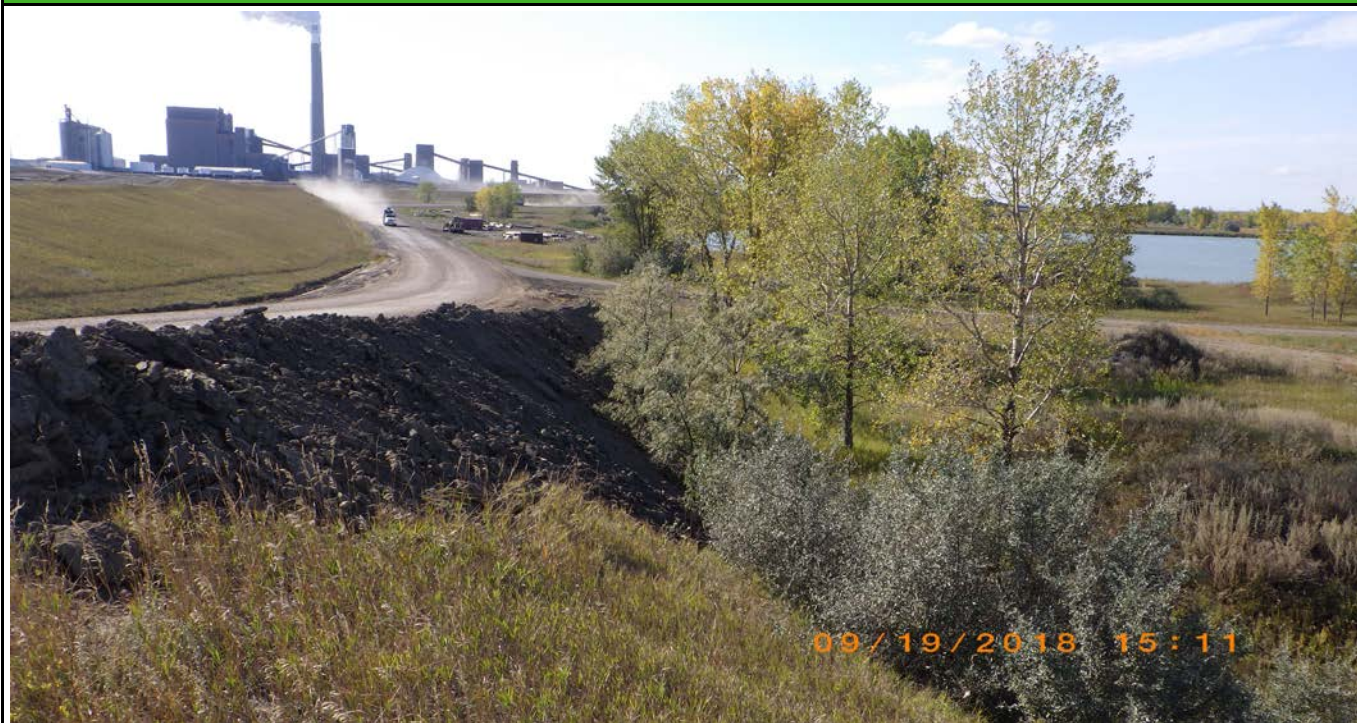
Photograph 19 (North berm downstream slope and haul road)
Steep downstream slope below recently re-constructed haul road ramp (66ccs.JPG)

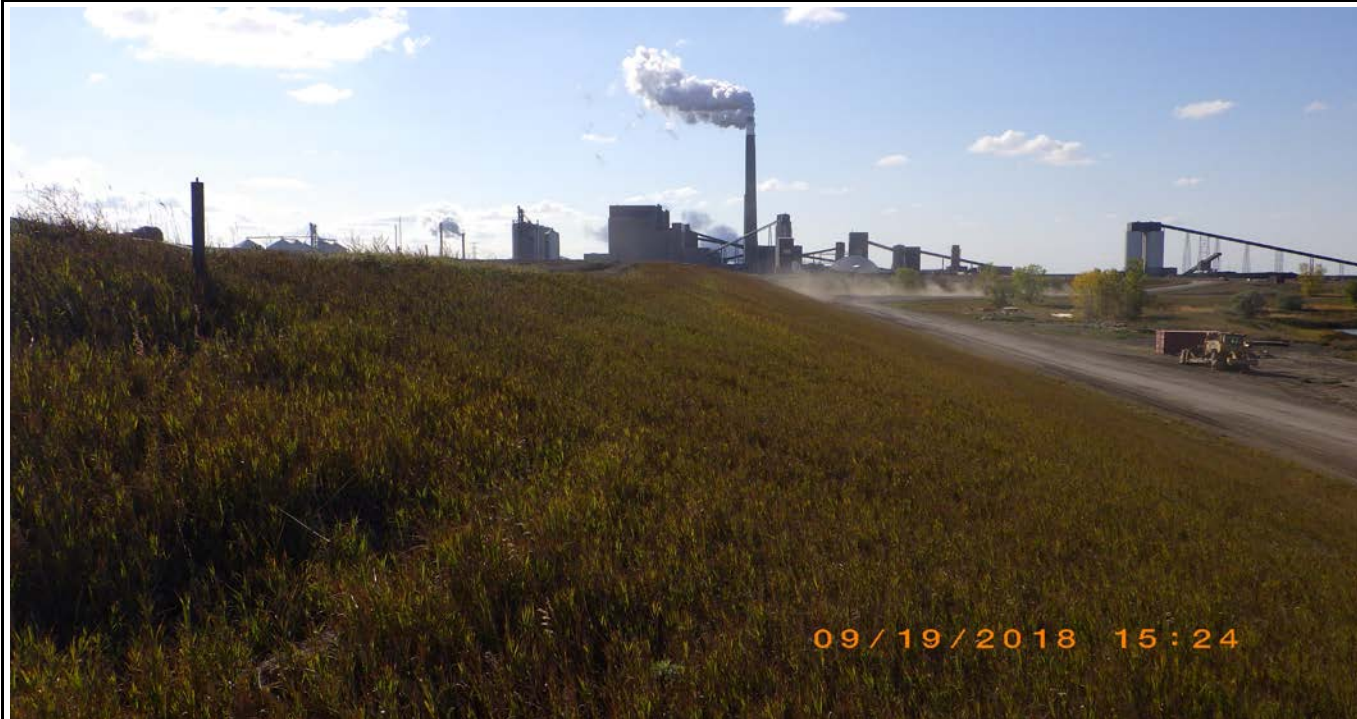
Photograph 20 (North berm downstream slope)
Typical berm downstream slope (69ccs.JPG)

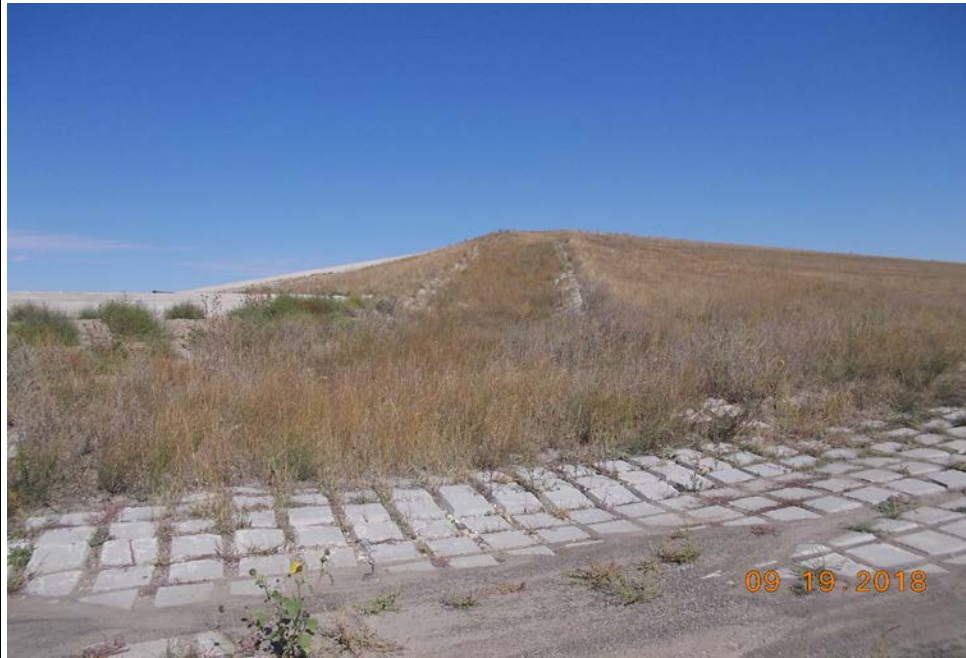
Photograph 21 (SW CCR covered downstream slope)
Articulated Concrete Block (ACB) downchute, thick vegetation between blocks along the slope (1PDS.JPG)

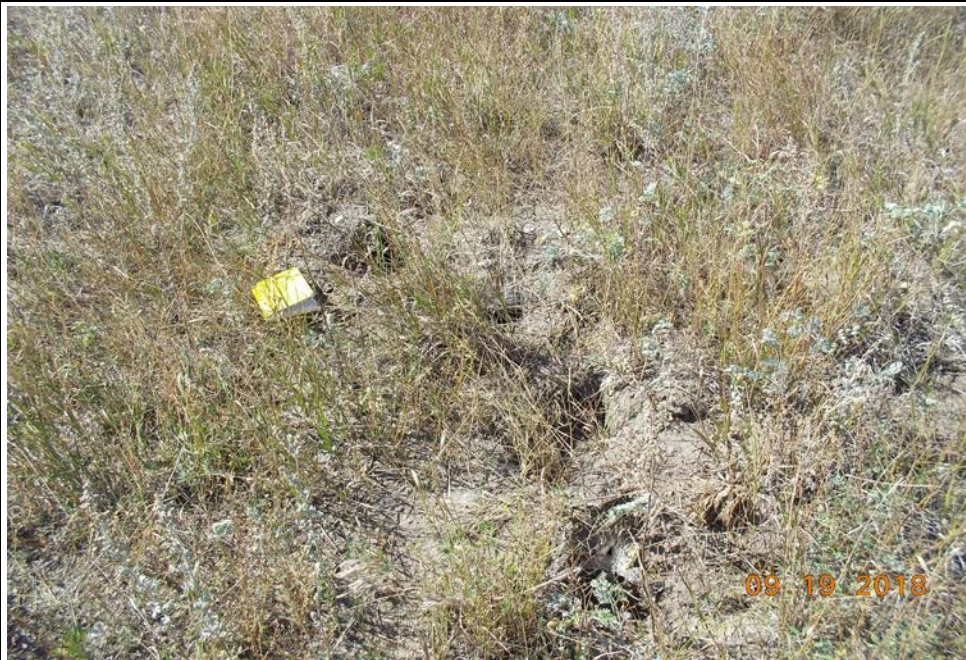
Photograph 22 (South CCR downstream slope)
Animal burrows near the perimeter road on the CCR downstream slope (9PDS.JPG)

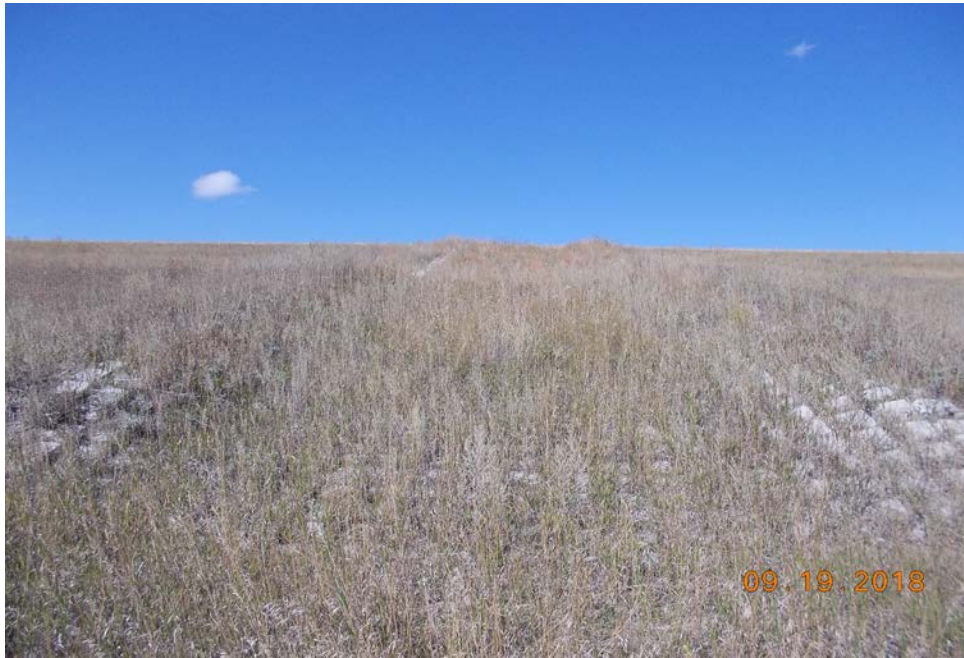
Photograph 23 (South CCR covered downstream slope)
Articulated Concrete Block (ACB) downchute on covered CCR downstream slope (19PDS.JPG)

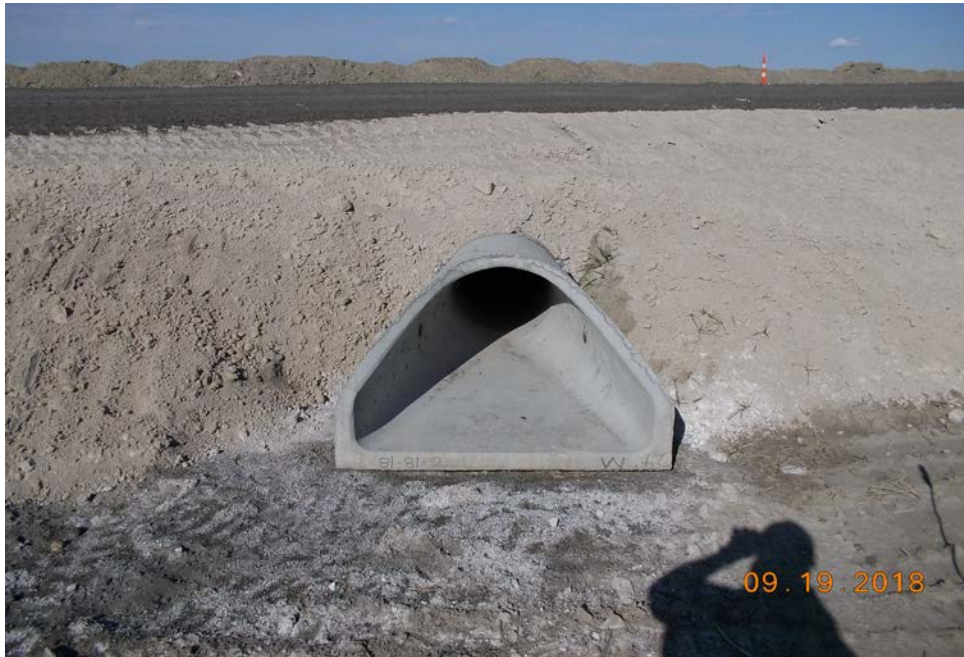
Photograph 24 (North contact water ditch and haul road)
Recently installed concrete culvert under north haul road (25PDS.JPG)
