Annual Inspection

Coal Creek Station – Upstream Raise 92 CCR Surface Impoundment

Great River Energy

January 2019

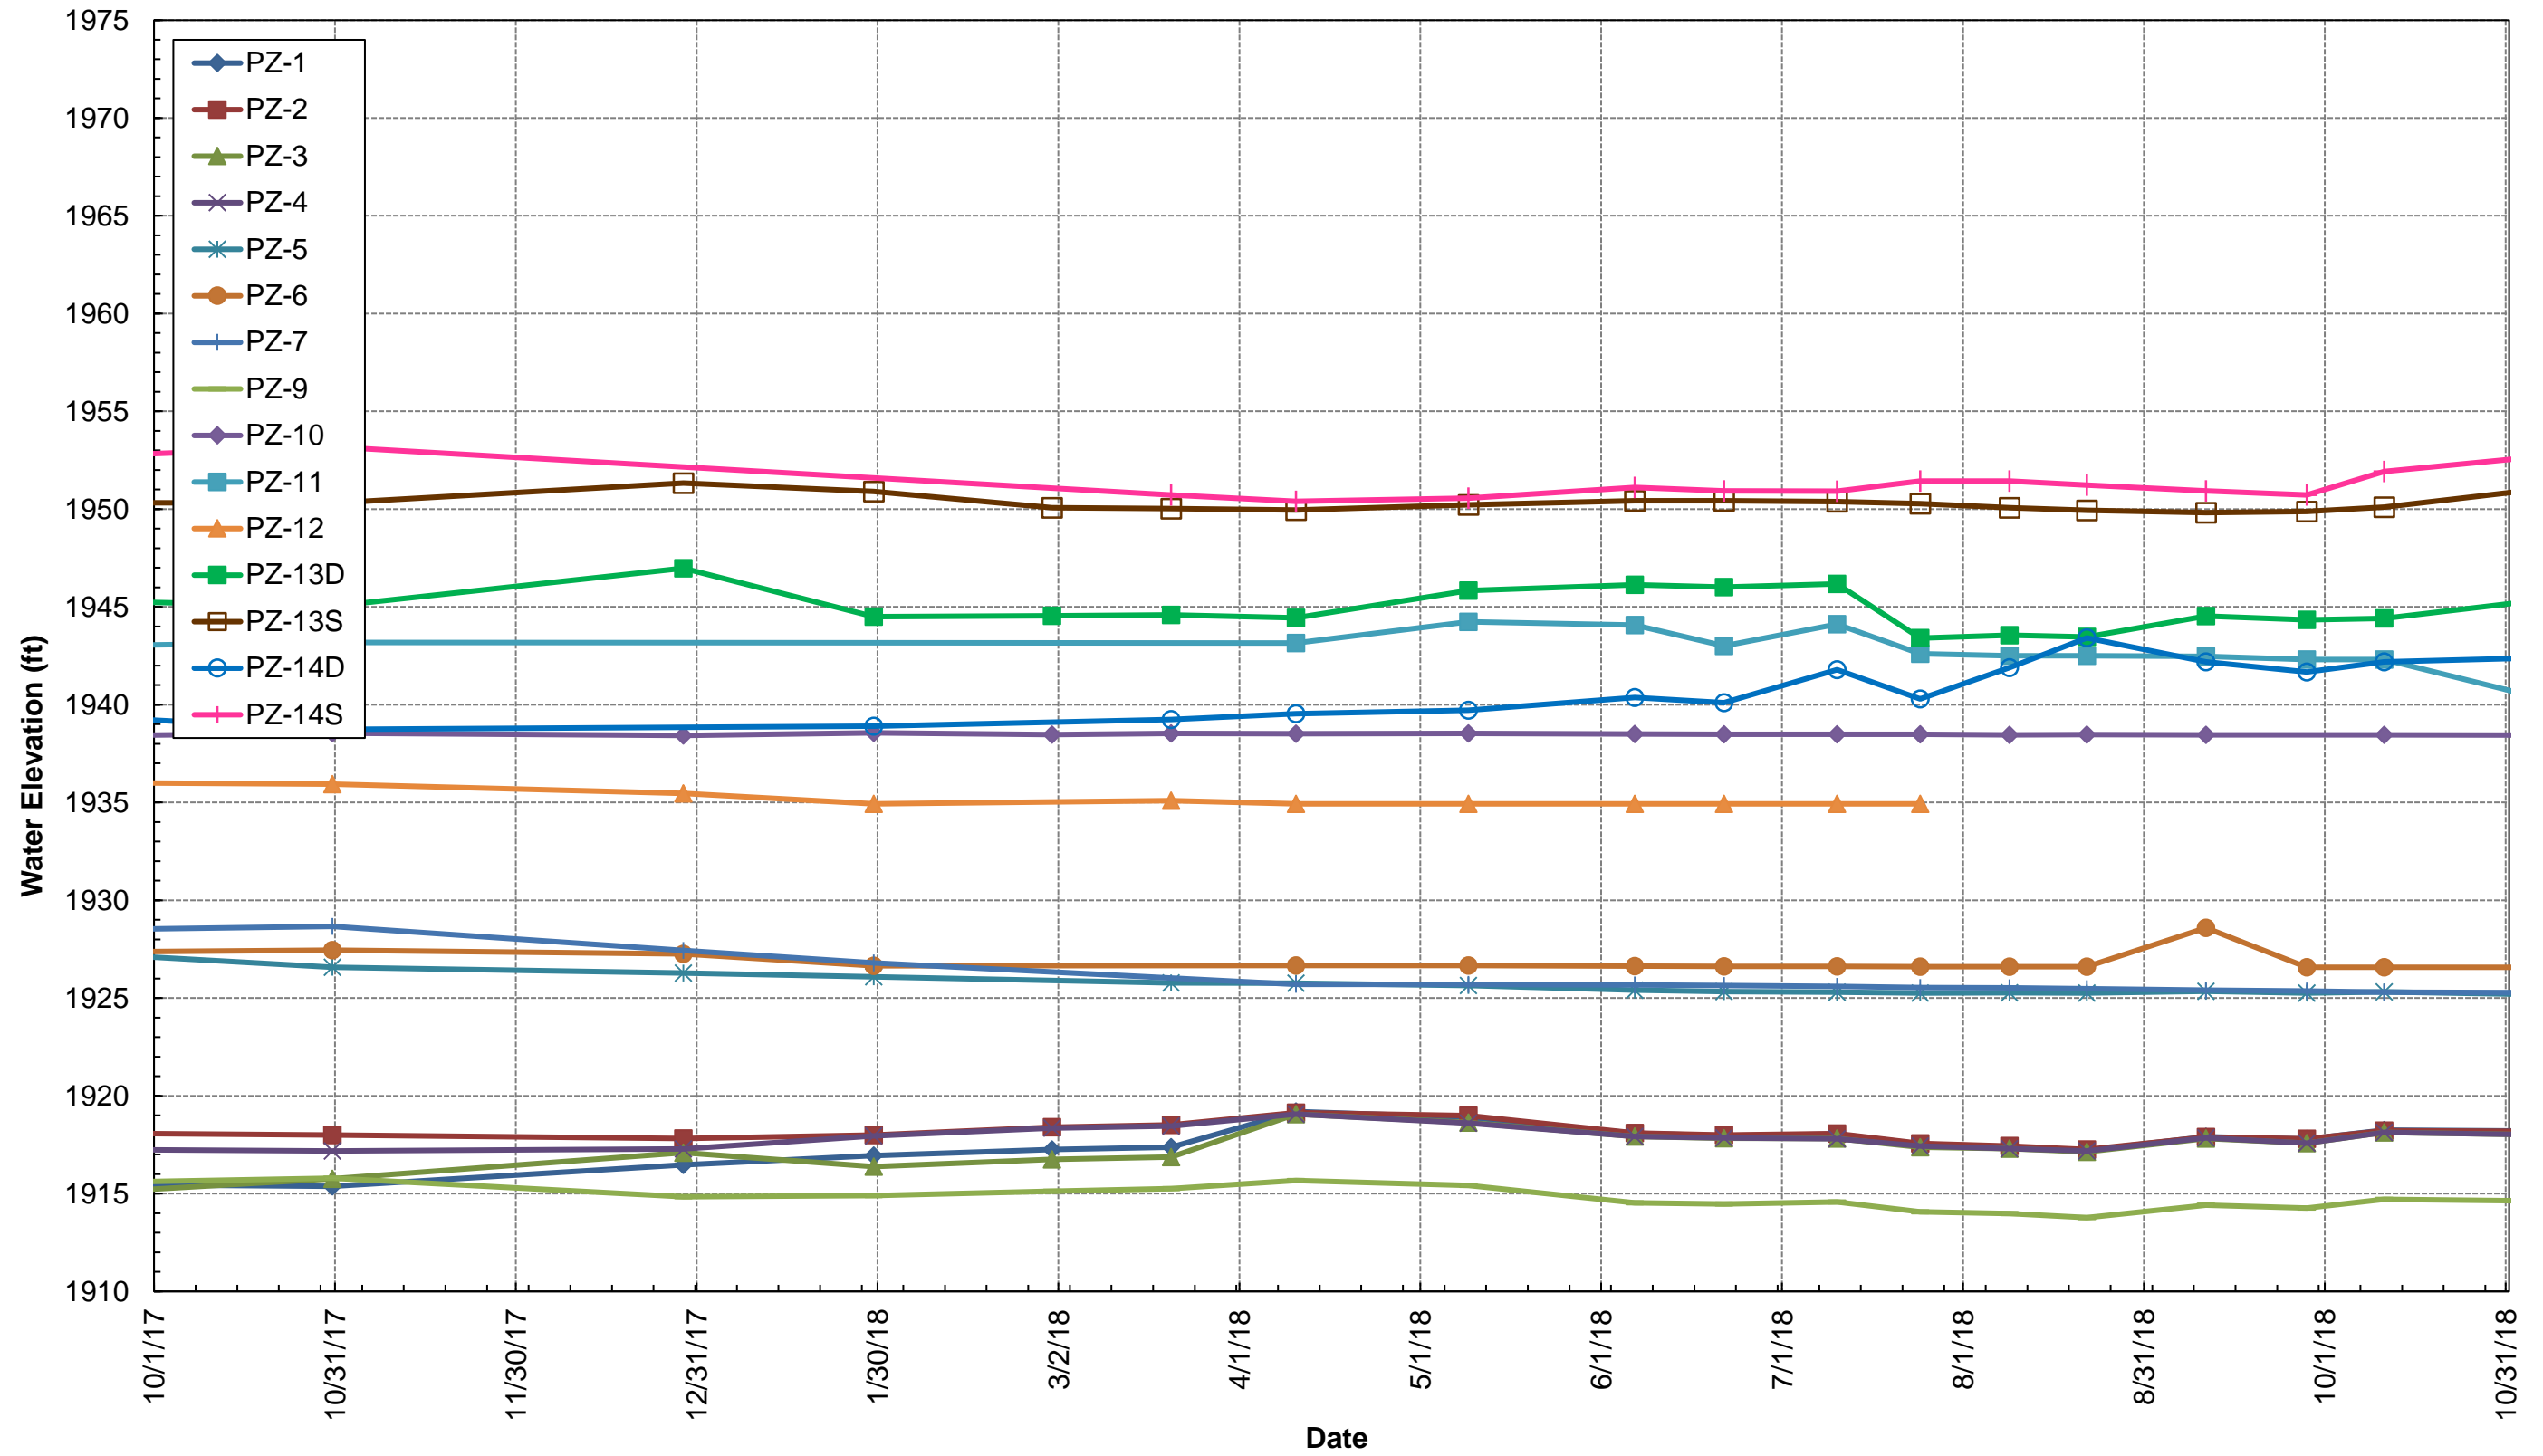
Upstream Raise 92 Piezometer Elevations

Piezometer measurements for the past year are included in Appendix D-1. Piezometers PZ-1 through PZ-12 were constructed near the perimeter bottom ash seepage piping and have historically fluctuated by less than approximately 3 feet as the facility height has increased. Piezometer PZ-12 has been noted to be dry during the second half of 2018, which may be due to FGD material being directed into Upstream Raise 91 during this time period. Piezometers PZ-13 (D and S) and PZ-14 (D and S) were constructed along the side slopes of the facility and show greater variability since installation as they are nearer to the FGD material pool in the center of the facility.

In 2016, piezometer PZ-13D rose approximately 15 feet, and has equilibrated at a new, higher level. Preliminary evaluation of Piezometer PZ-13D suggests that the casing may be damaged and connecting the water within the piezometer to a different zone than the screened portion of the piezometer. This piezometer will continue to be monitored, but may be removed from future monitoring if deemed to be damaged.

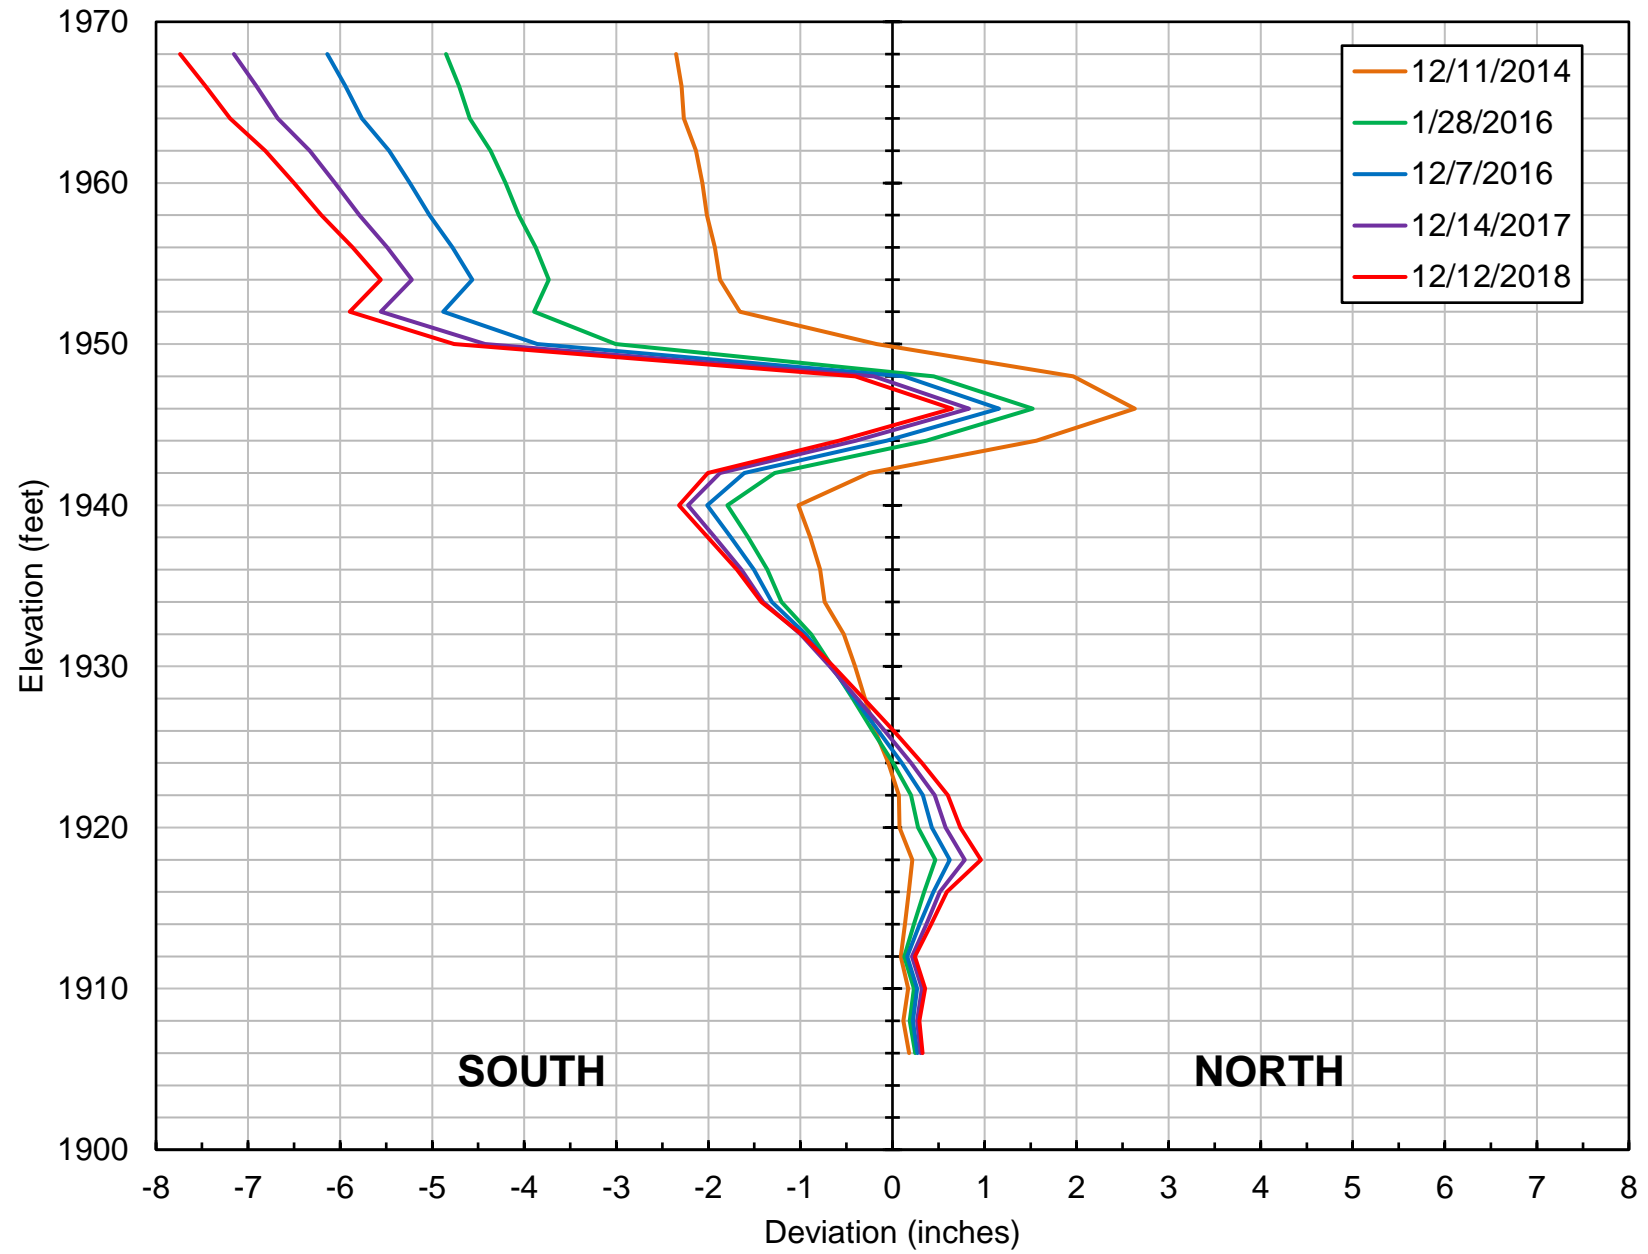
Upstream Raise 92
Inclinometer IN-3 Summary

Inclinometer measurements taken since 2014 are shown in Appendix D-2. Inclinometer measurements show a general trend that supports the consolidation of the FGD material in the middle of the facility. Consolidation of thicker zones of FGD material in the middle of the facility is greater than consolidation of FGD material zones near the perimeter. Therefore, the inclinometers show a trend of the rigid fly ash and bottom ash material settling toward the center of the facility. Inclinometers appear to show that movement is slowing as a majority of the loading of the facility moves inward, further from the inclinometers.
