# Annual Inspection

## *Stanton Station - Bottom Ash CCR Landfill*

### **Great River Energy**

January 2020

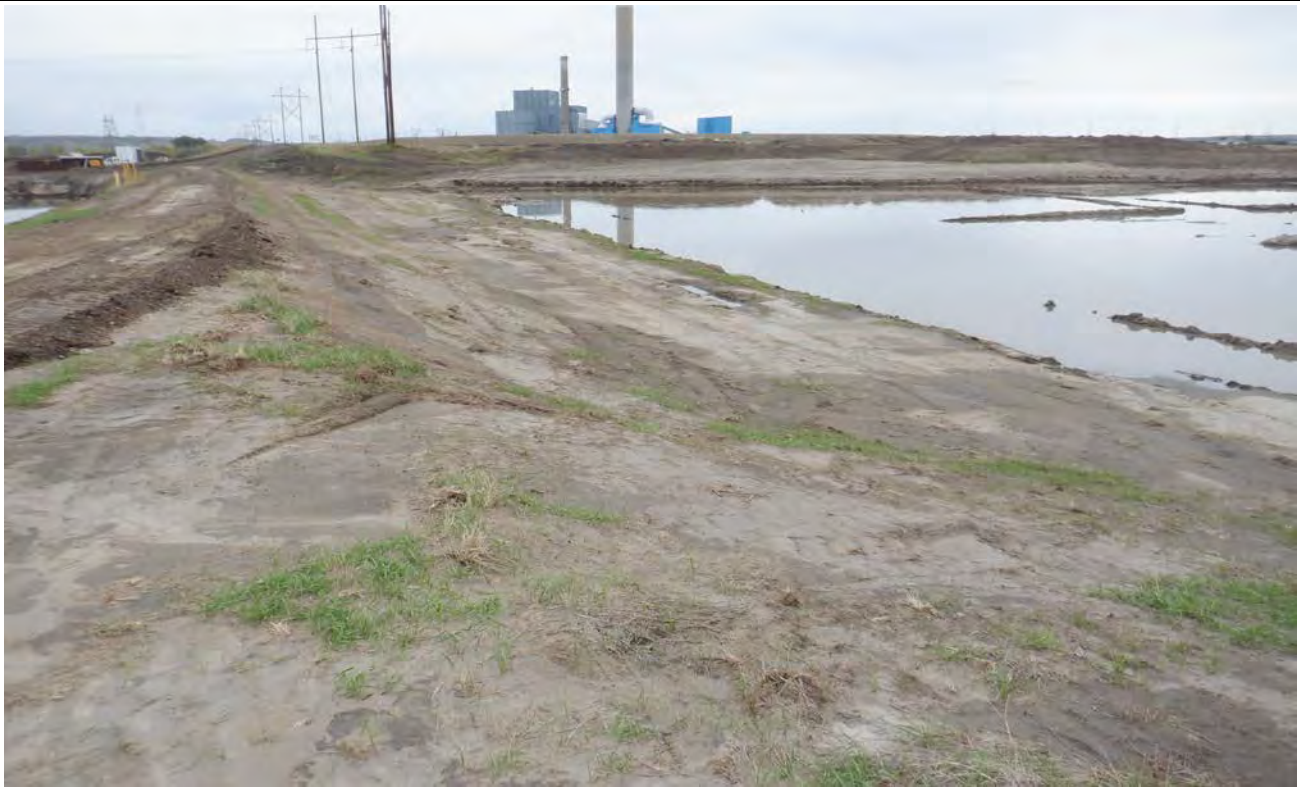
Photograph 1 (NW berm crest)

North crest and contact water at west end of Bottom Ash Landfill (north berm to be removed as part of restoration) (panoramic view - 1 of 3) (DSCF0620.JPG)

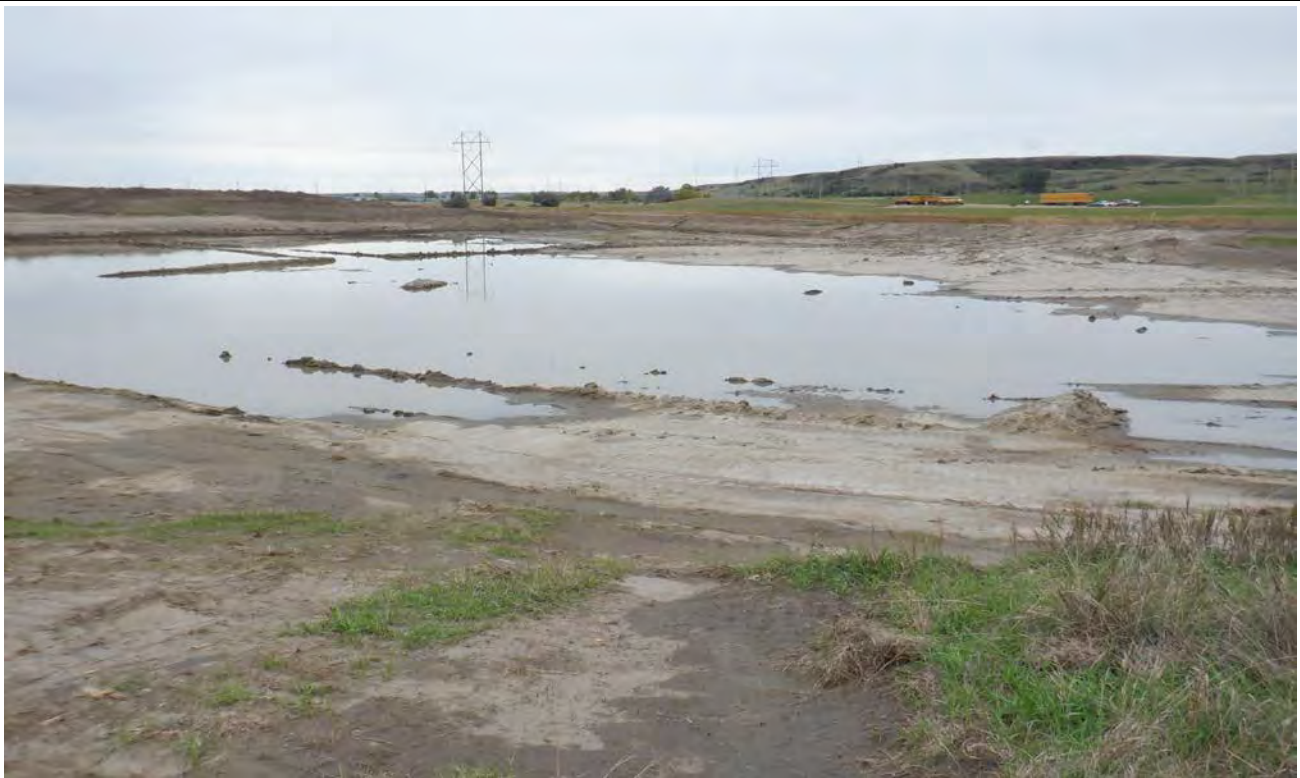
Photograph 2 (NW berm crest)

Contact water in west end of Bottom Ash Landfill (previously cleared and grubbed as part of restoration) (panoramic view - 2 of 3) (DSCF0621.JPG)

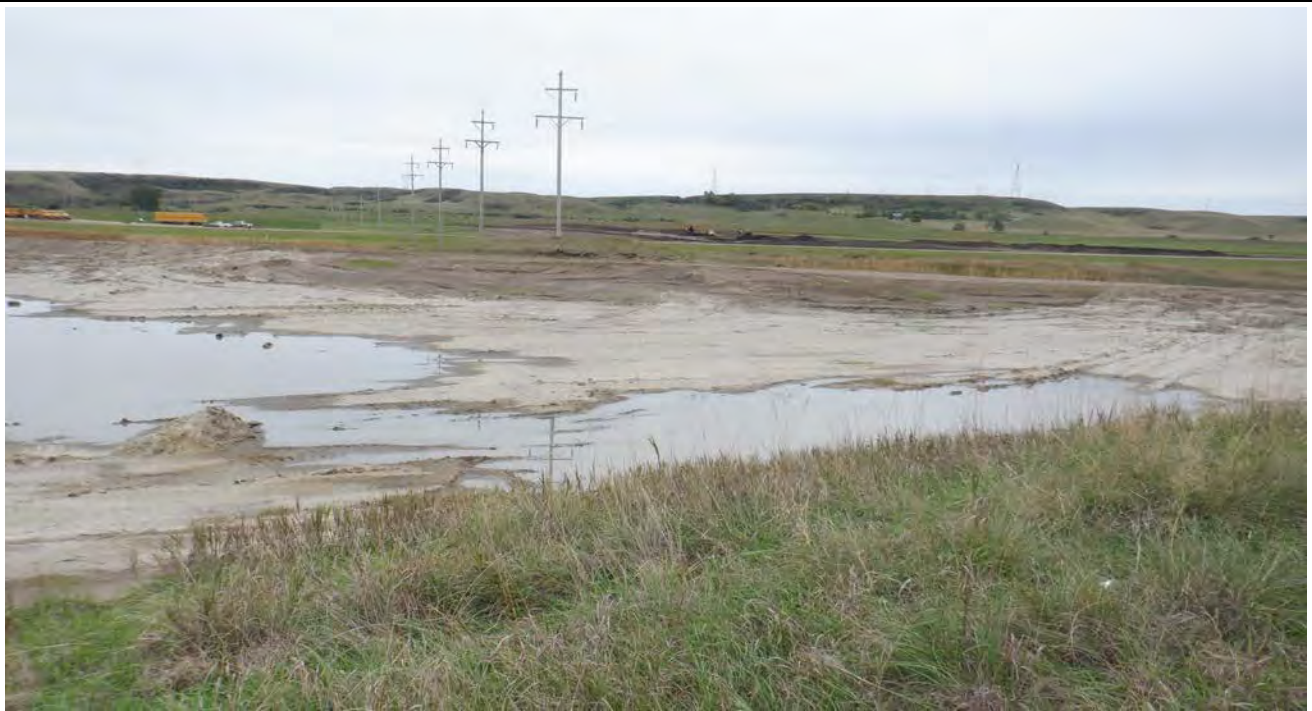
Photograph 3 (NW berm crest)  
Contact water in west end of Bottom Ash Landfill (previously cleared and grubbed as part of restoration)  
(panoramic view - 3 of 3) (DSCF0622.JPG)

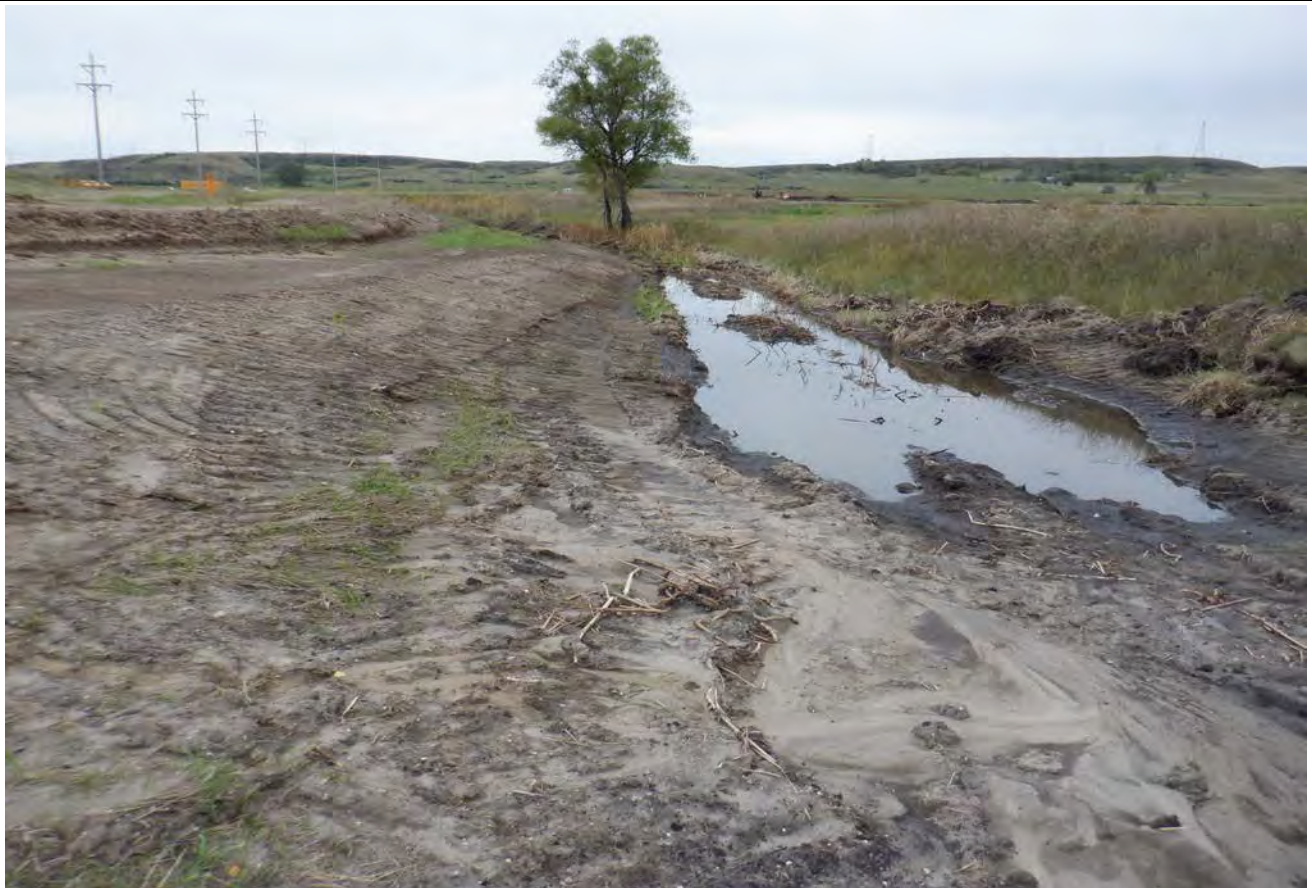
Photograph 4 (West downstream slope)  
West downstream slope (previously cleared and grubbed as part of restoration) (DSCF0623.JPG)

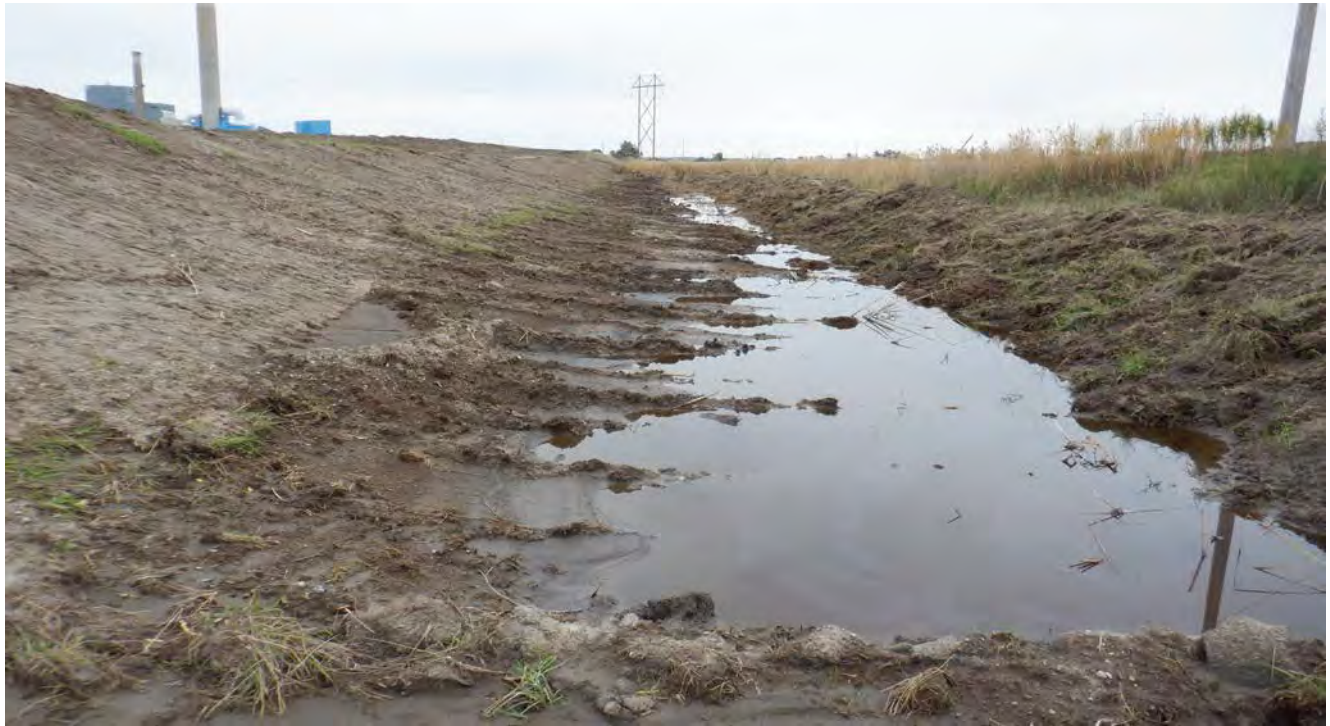
Photograph 5 (South downstream slope)  
South downstream slope and surface water ditch (previously cleared and grubbed as part of restoration)  
(DSCF0625.JPG)

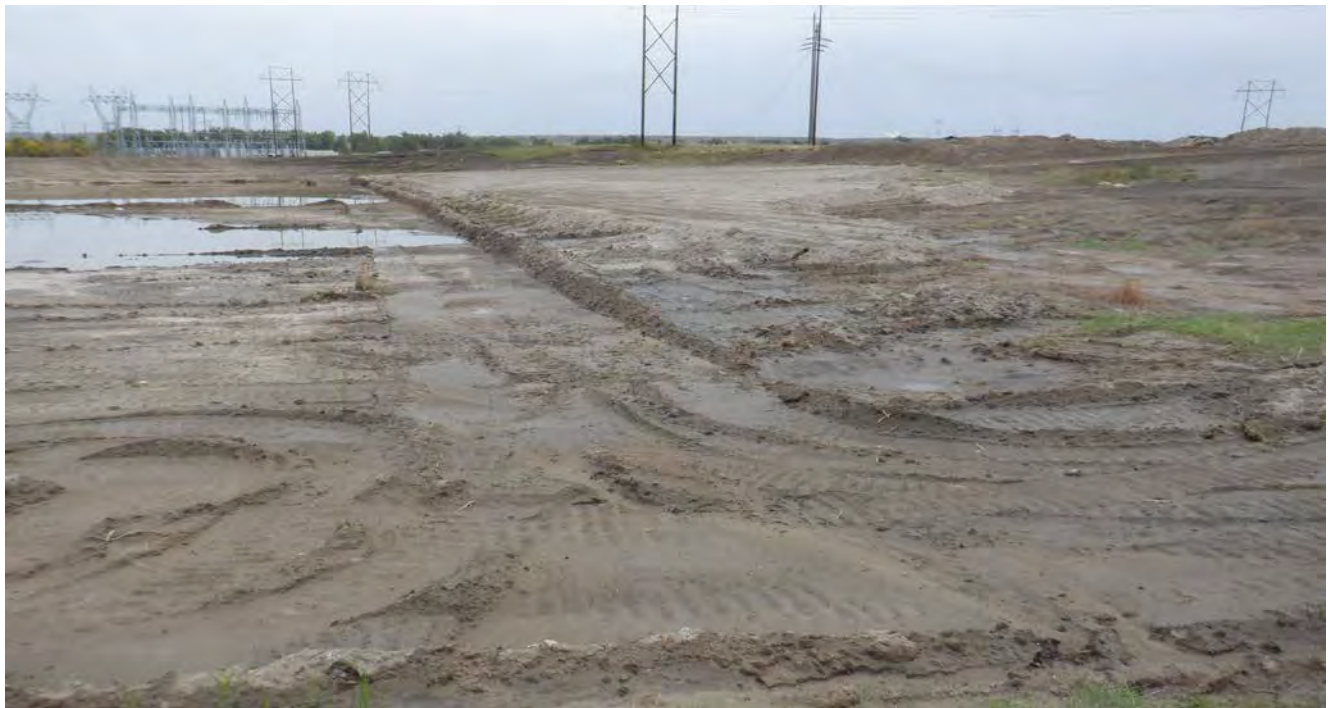
Photograph 6 (South berm crest)  
Approximate west end of consolidated Bottom Ash Landfill footprint to be closed with permitted material remaining in place (containment berm to be constructed as part of site restoration) (DSCF0626.JPG)

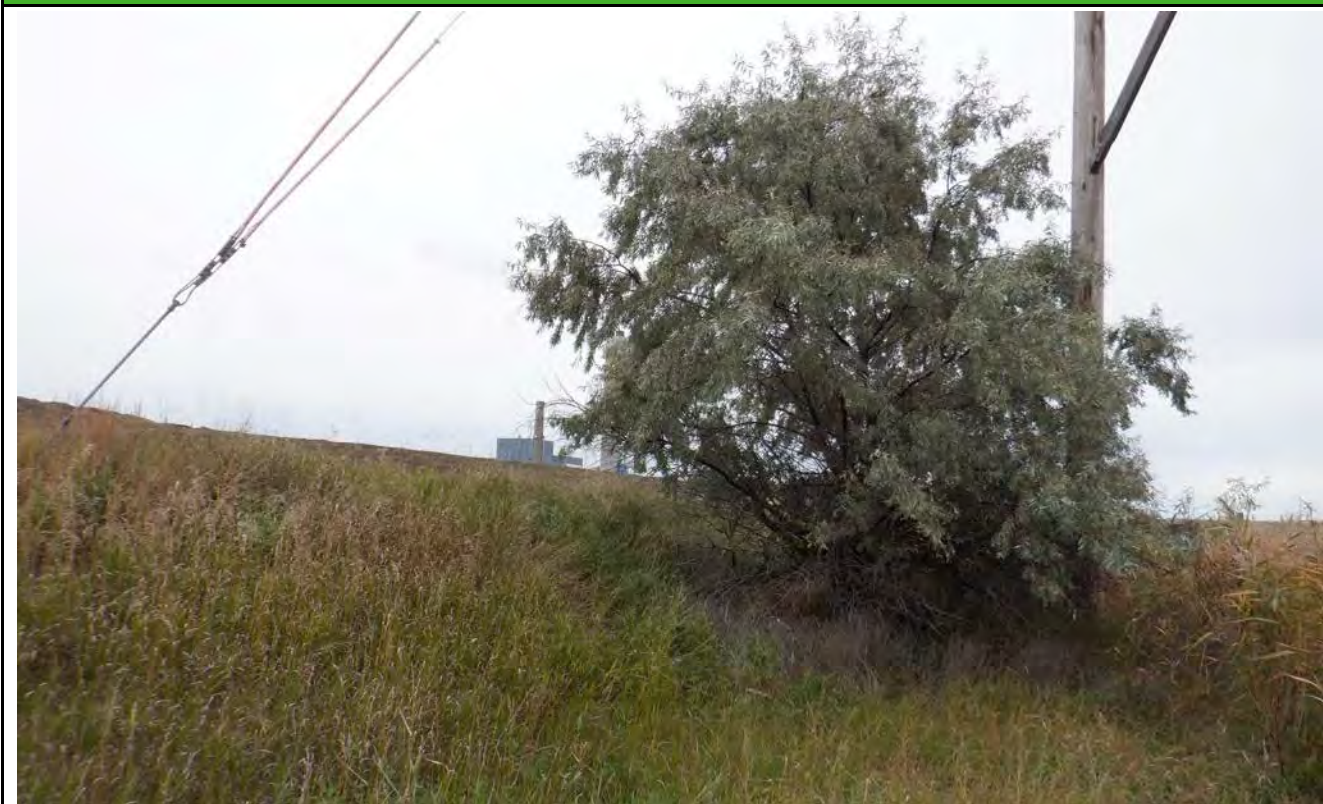
Photograph 7 (South downstream slope)  
Tree to be removed with site restoration activities (DSCF0628.JPG)

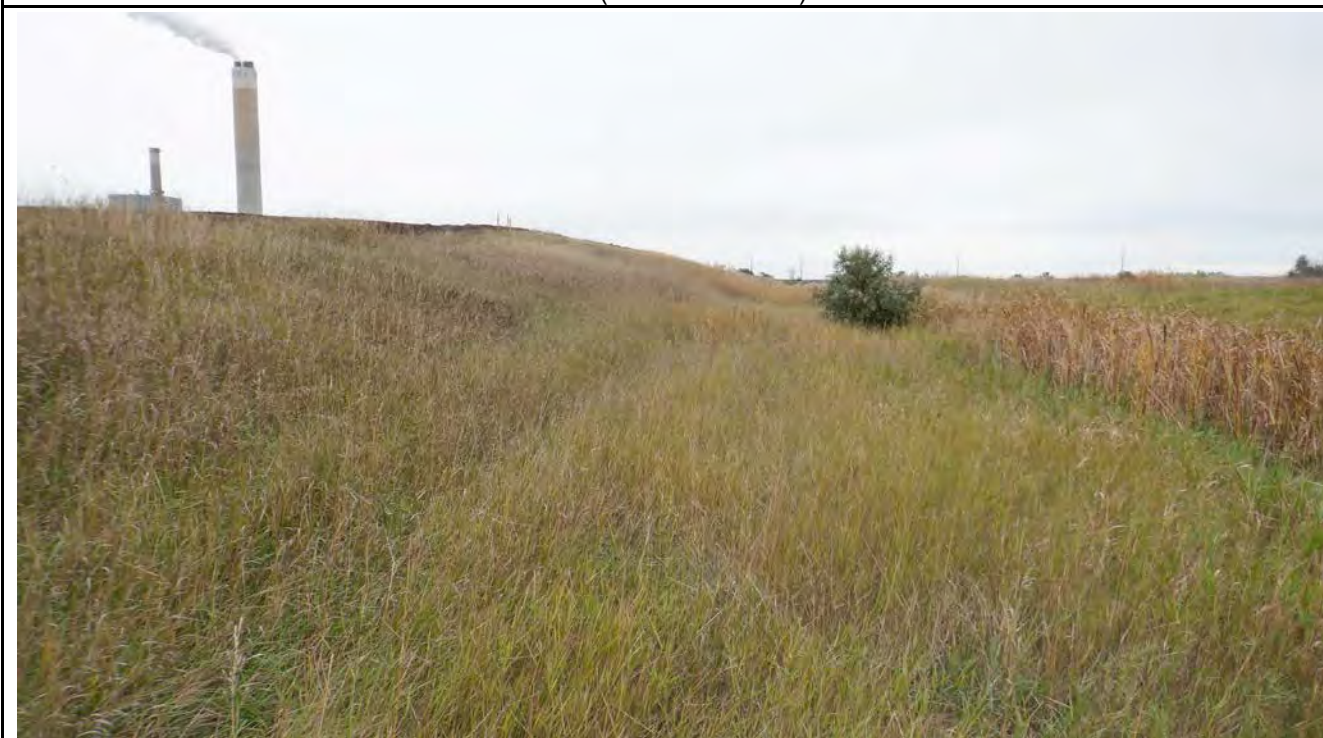
Photograph 8 (South downstream slope)  
Grass vegetation on the south downstream slope and woody vegetation to be removed as part of site restoration (DSCF0630.JPG)

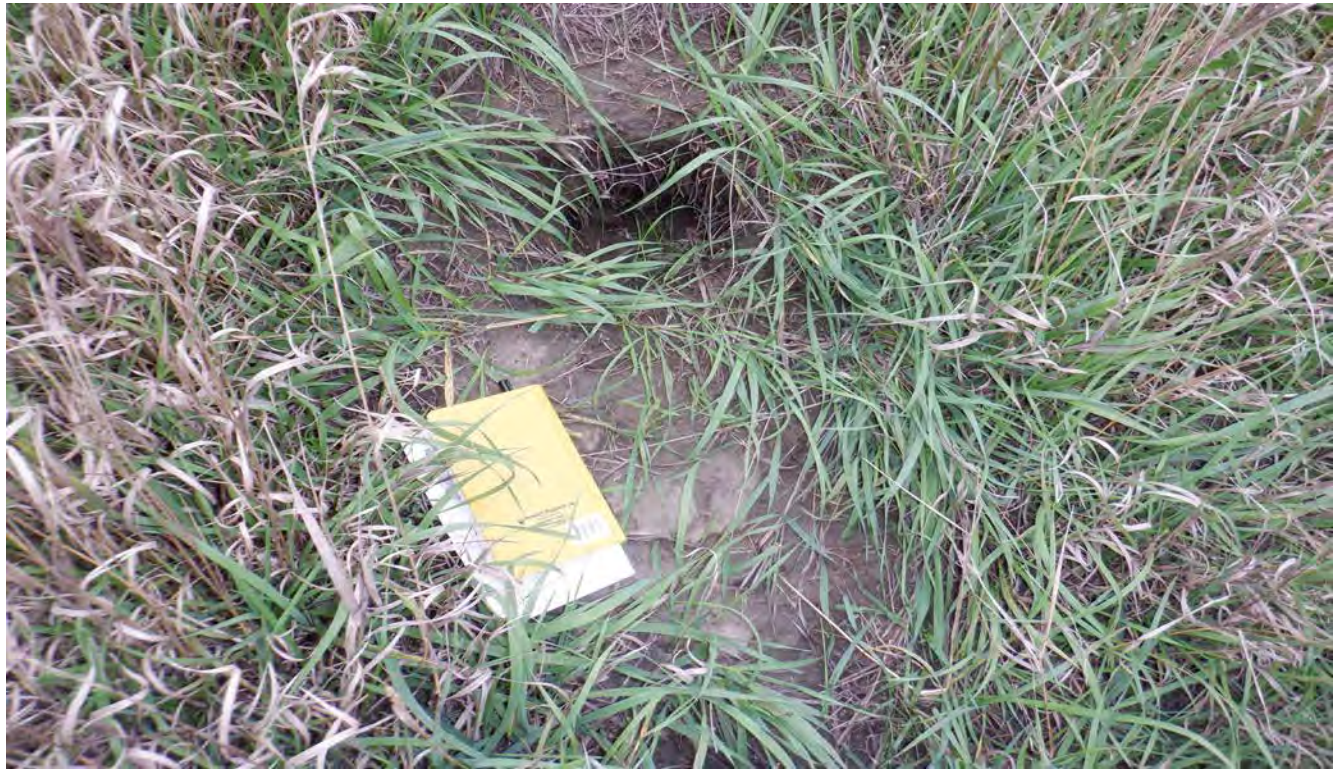
Photograph 9 (South toe)

The toe of the west and south perimeter berms is in a surface water drainage ditch that has some marshy vegetation and standing water. Some small animal burrows were noted near the toe of the slope, but there were no observed indications of seepage, settlement, or excessive vegetation at the toe of these slopes. The toes of the berm downstream slopes are in good condition.

Large animal burrow, approximately 8" in diameter, planned to be repaired as part of site restoration (DSCF0631.JPG)

Minor maintenance items that may need to be continually addressed include repairing larger animal burrows as they appear, repairing stormwater and/or contact water control features to control run-on and runoff, monitoring vegetative success of berm downstream slopes and slopes that have received final cover (when it has been completed in 2020), and removal of any woody vegetation growing on the berm downstream slopes.

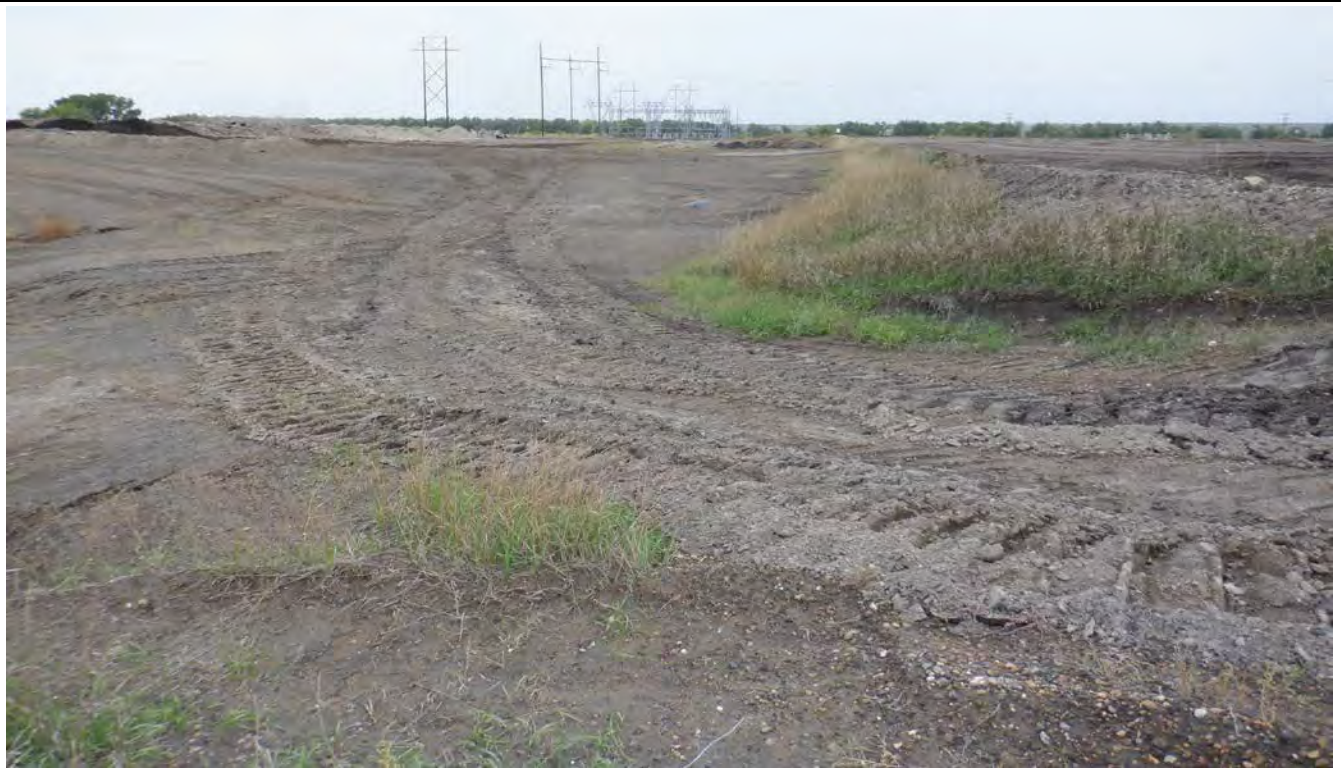
Photograph 10 (SE corner)

Interior Bottom Ash Landfill from the southeast corner (panoramic view - 1 of 2) (DSCF0632.JPG)

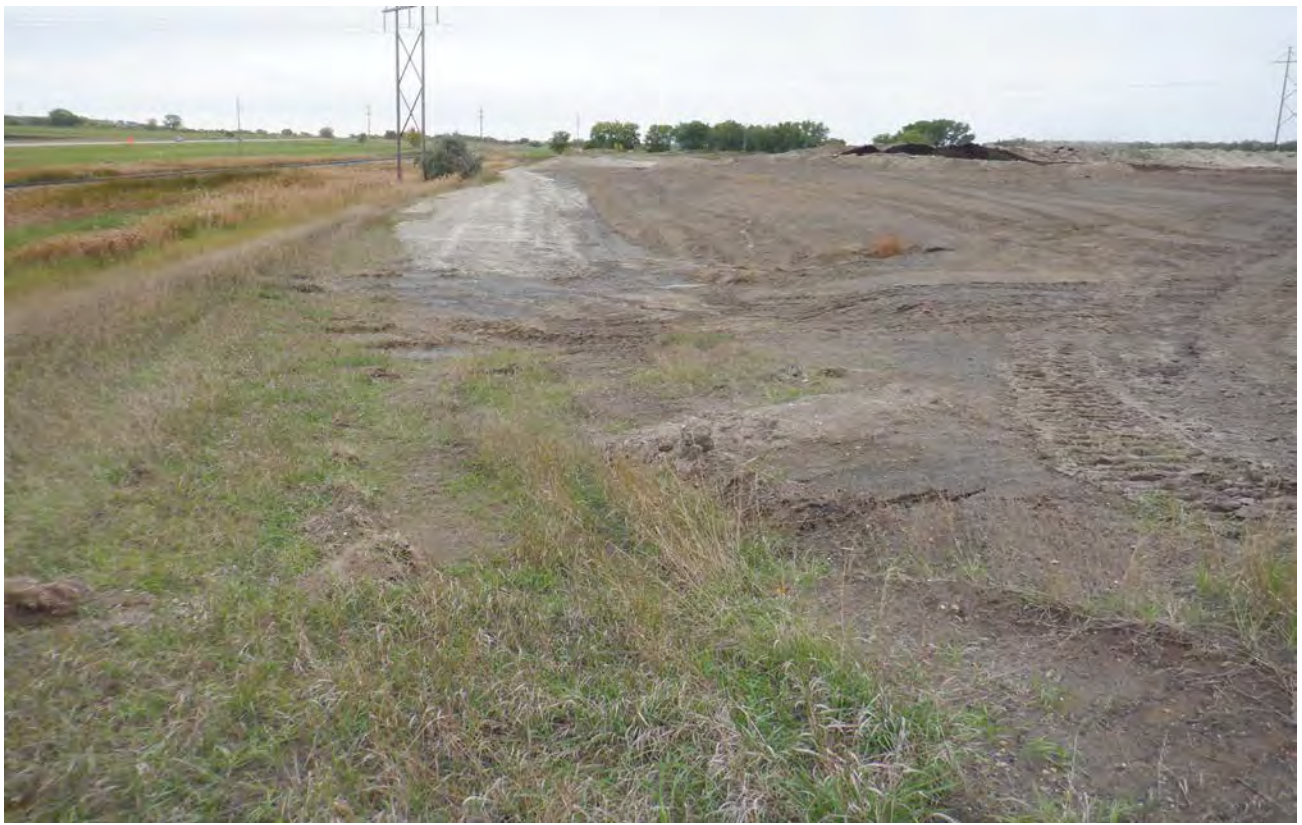
Photograph 11 (SE corner)

Interior Bottom Ash Landfill from the southeast corner (panoramic view - 2 of 2) (DSCF0633.JPG)

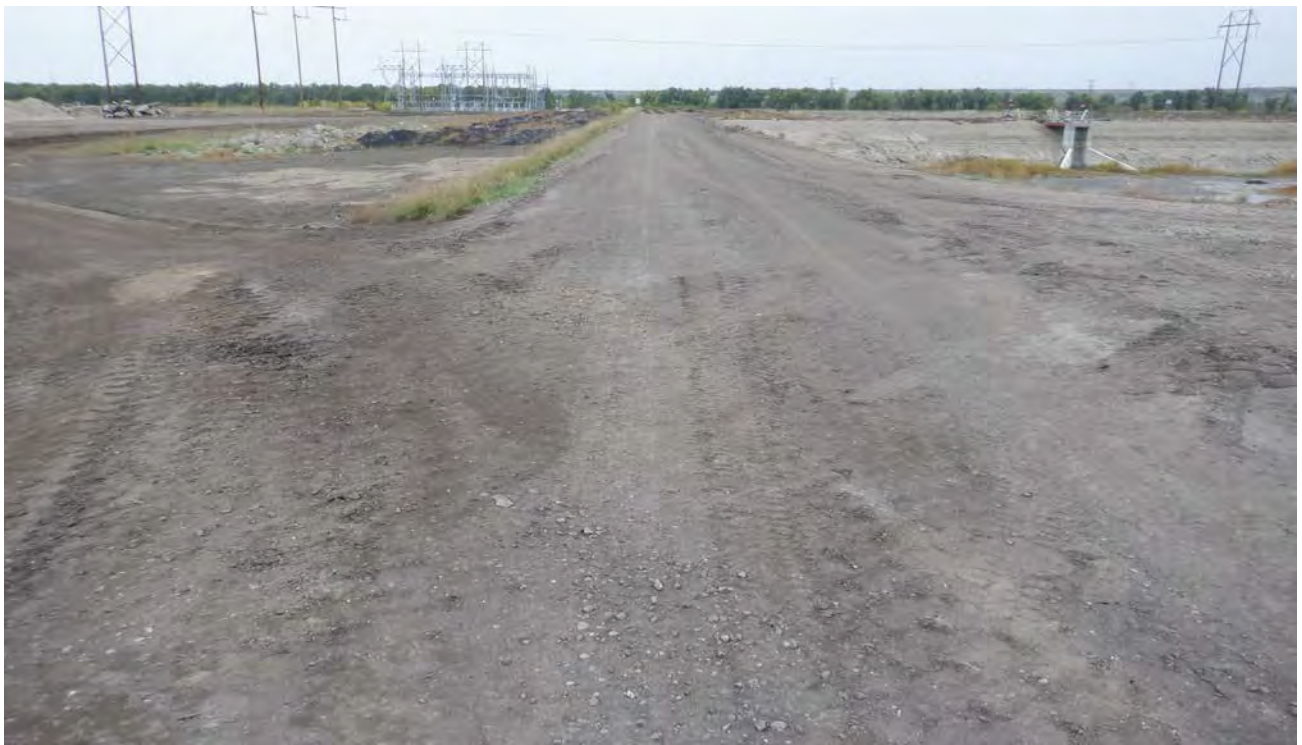
Photograph 12 (SE berm crest)

Bottom Ash Landfill east berm crest (shared berm to Bottom Ash Impoundment) (DSCF0634.JPG)

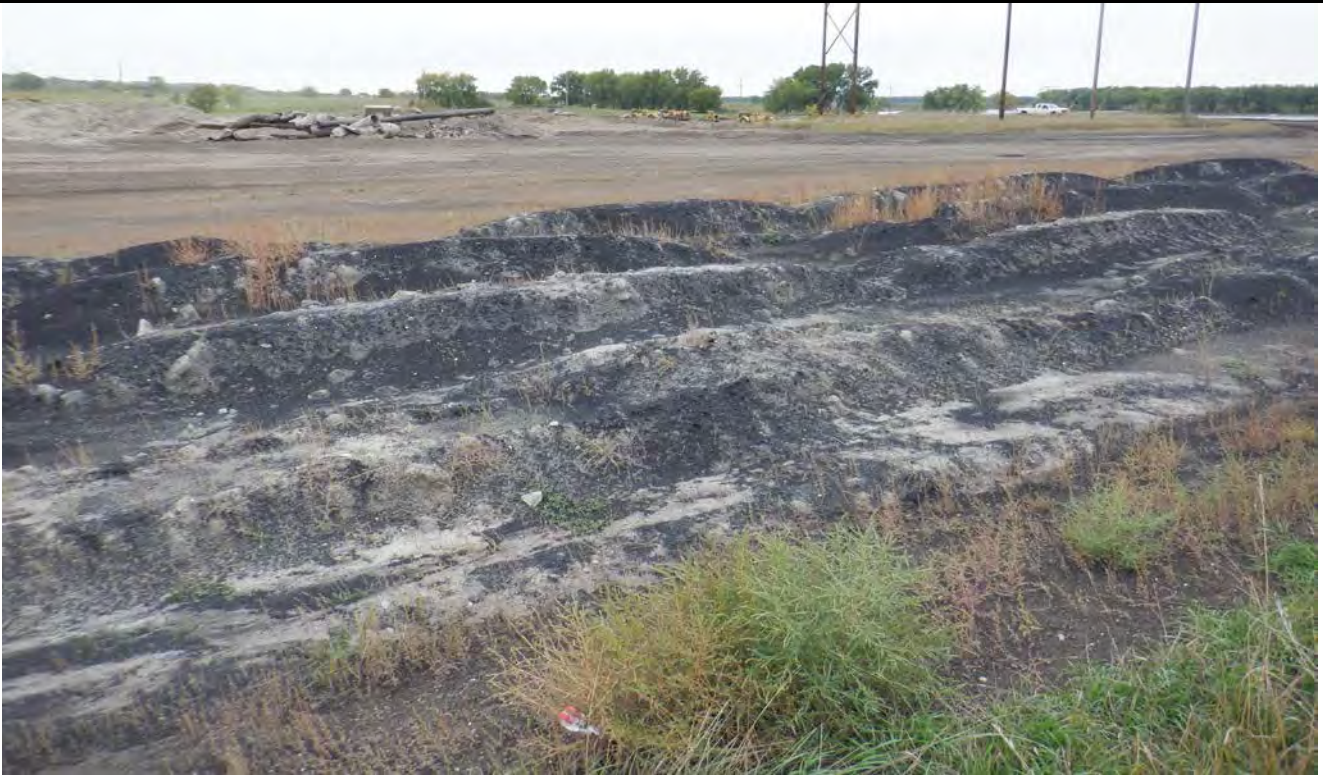
Photograph 13 (NE corner/east berm)  
Interior Bottom Ash Landfill restoration activities (DSCF0636.JPG)

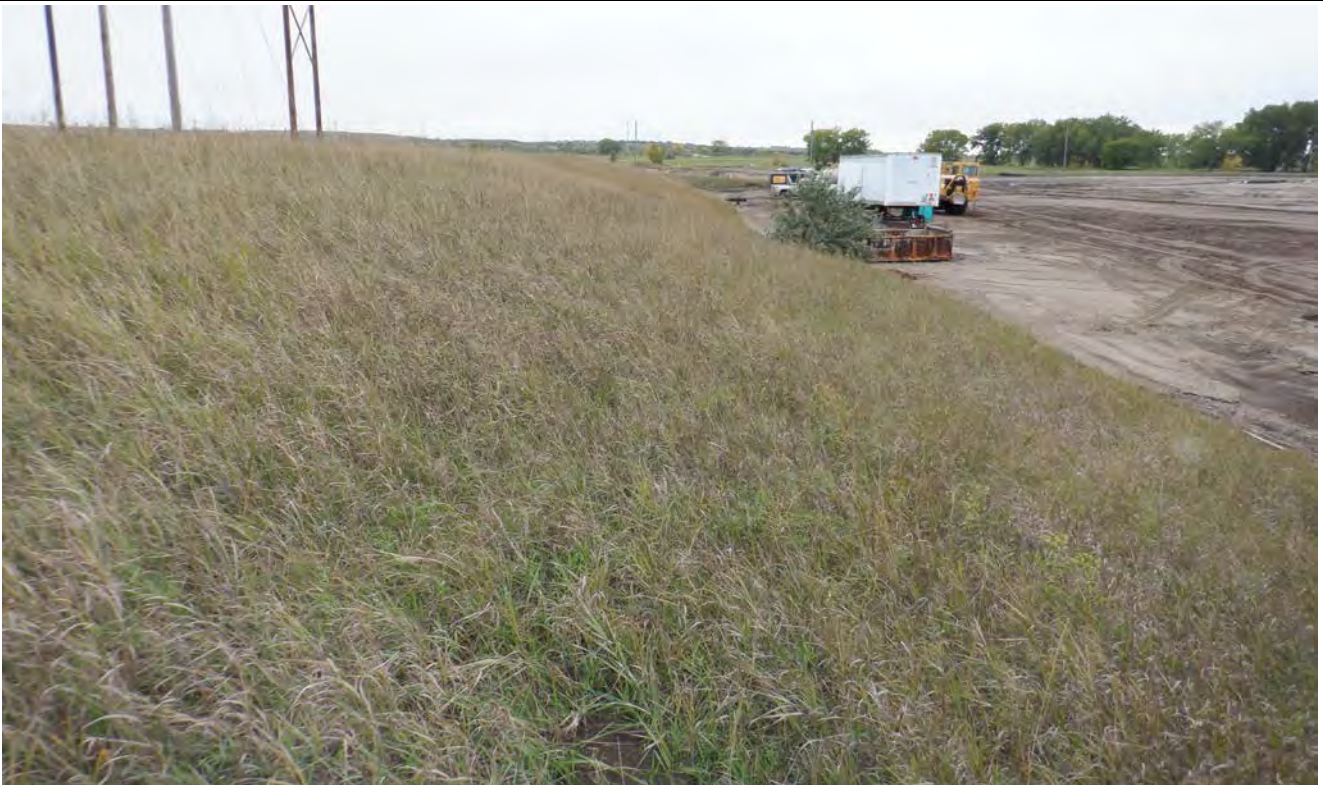
Photograph 14 (North downstream slope)  
Grass vegetation on the north downstream slope (DSCF0637.JPG)

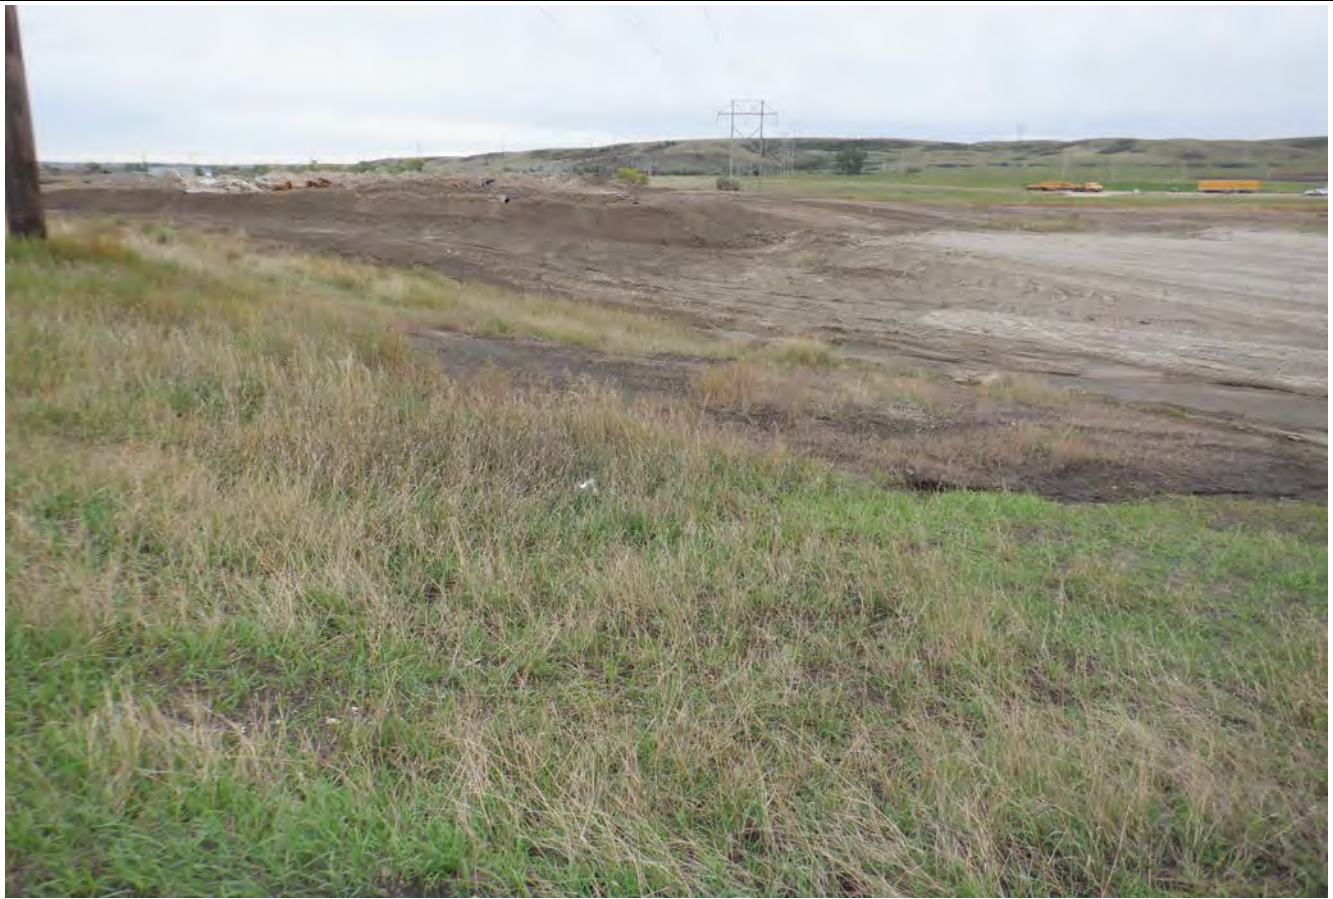
Photograph 15 (North berm crest)  
Interior Bottom Ash Landfill berm construction (DSCF0638.JPG)
