# Annual Inspection

## *Stanton Station - Bottom Ash CCR Surface Impoundment*

**Great River Energy**

January 2020

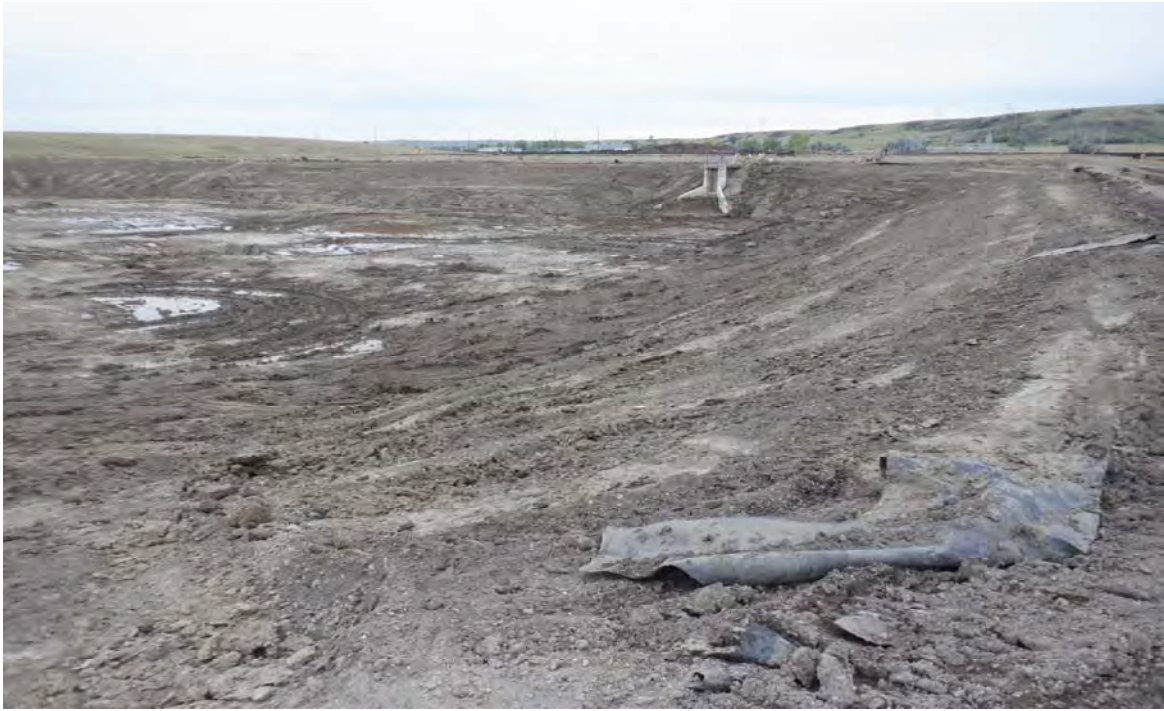
At the time of inspection, the north and center cell berm upstream slopes had been cleared of geomembrane and underlying soil as part of the closure by removal and site restoration activities. The berms associated with the north cell will be re-graded as a part of site restoration activities.

Photograph 1 (NW berm crest)  
Interior of north cell (bottom ash and liner system removed during restoration activities) (DSCF0639.JPG)

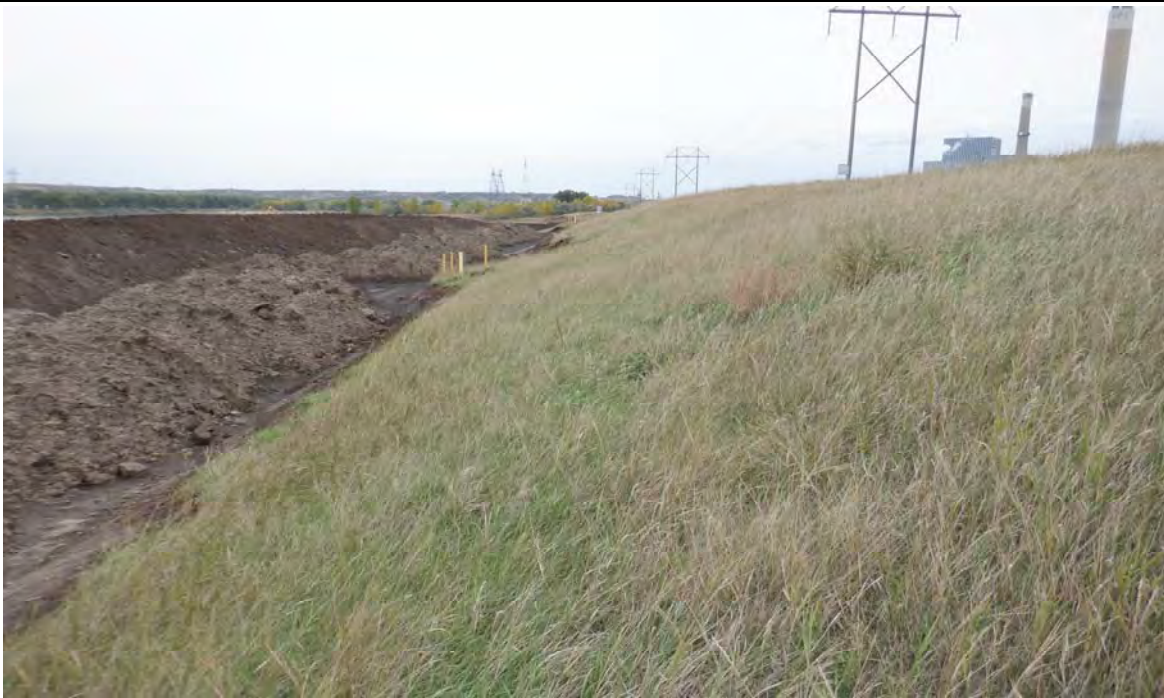
The berm downstream slopes on the north and east sides are approximately 20 feet high and the berm downstream slope on the west side is approximately 5 feet high; the slopes are graded at approximately 3:1. The north-facing slope is mostly well vegetated with grass, with a few small areas of bare ground along the east portion of the north-facing slope that may be susceptible to erosion. Small to medium size animal burrows were observed on the north berm downstream slopes. At the time of inspection, the east-facing slope had been cleared and grubbed and topsoil had been removed in preparation for re-grading associated with site restoration activities. This berm will be removed as a part of site restoration activities and grading will be tied in with overall site restoration grades. Berm downstream slopes are generally in good condition.

Photograph 2 (North downstream slope)  
Grass vegetation on north downstream slope and temporary stockpile at toe of slope related to site restoration activities (DSCF0641.JPG)

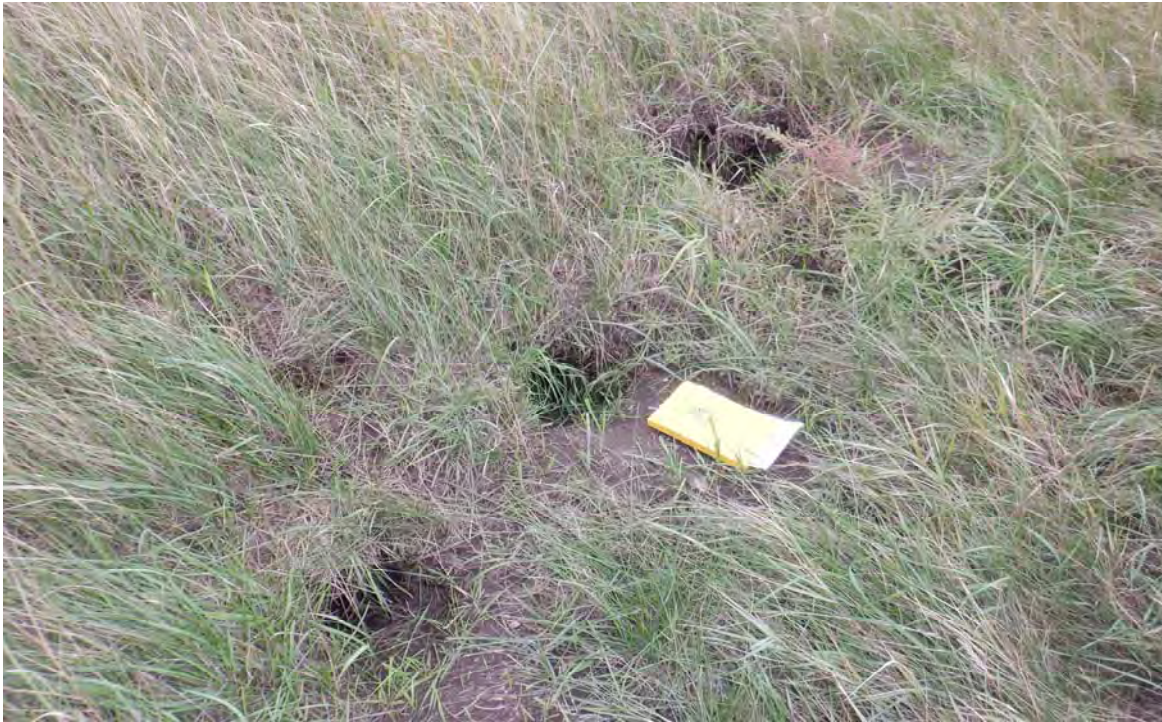
Photograph 3 (North upstream slope)  
Animal burrows on north downstream slope (DSCF0643.JPG)

Minor maintenance items that may need to be continually addressed include repairing larger animal burrows as they appear, monitoring vegetative success of berm downstream slopes and slopes that have received final cover, and removal of any woody vegetation growing on the berm downstream slopes.

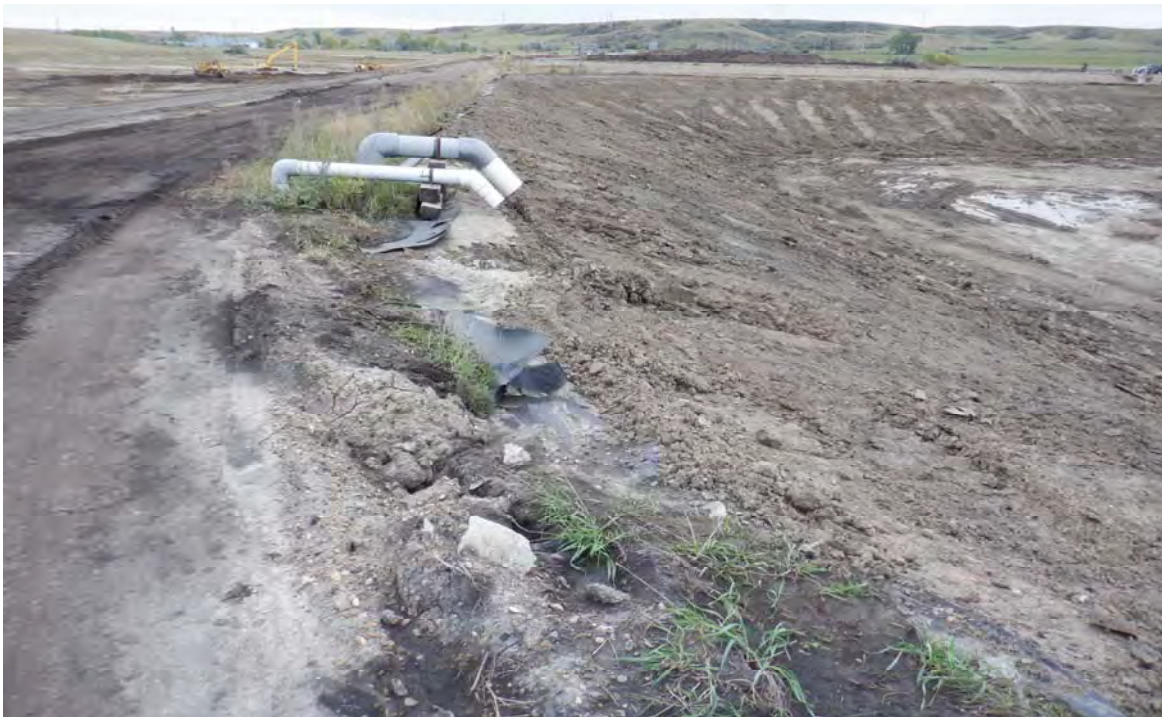
The retention pond inlet pipe and the coal pit sump inlet pipe were visible at the surface; however, these pipes have previously been abandoned below grade and the surface protrusions of this piping is to be removed as a part of site restoration activities. Outflow from the north cell was through the concrete outflow structure located on the south berm upstream slope. The structure was present at the time of inspection but is also going to be removed in 2019 as a part of site restoration activities.

Photograph 4 (NE berm crest)  
Historic inflow to the north cell (to be removed during restoration activities) (DSCF0645.JPG)

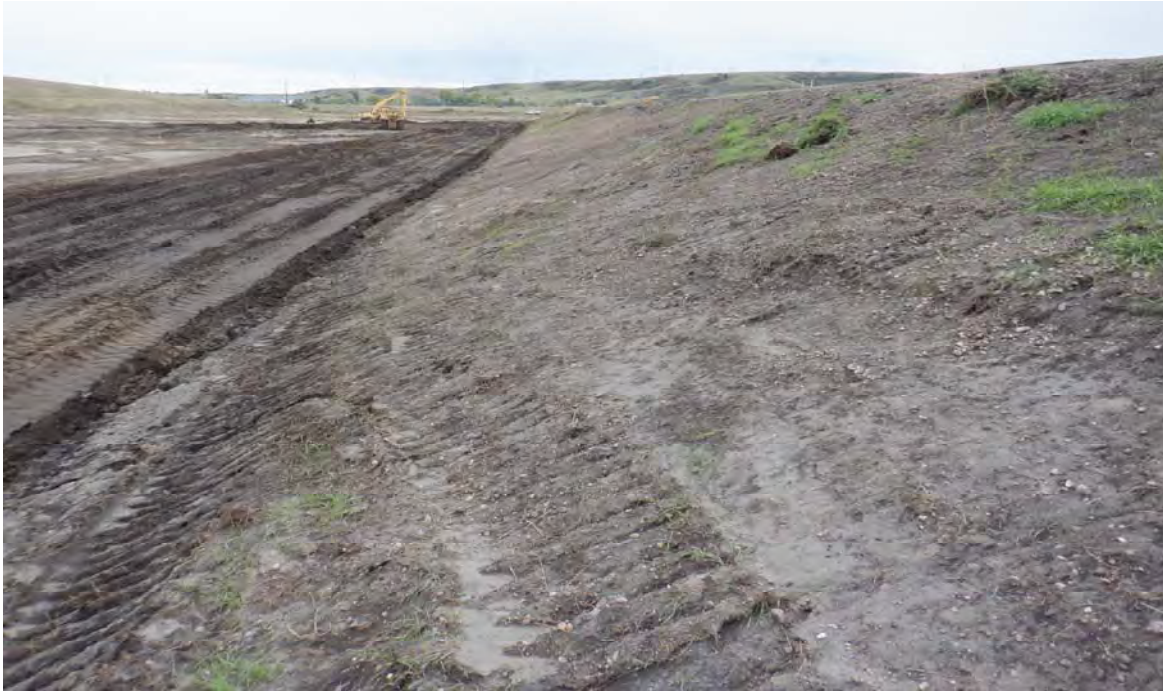
Photograph 5 (East downstream slope)  
Lower east downstream slope of the north cell (DSCF0647.JPG)

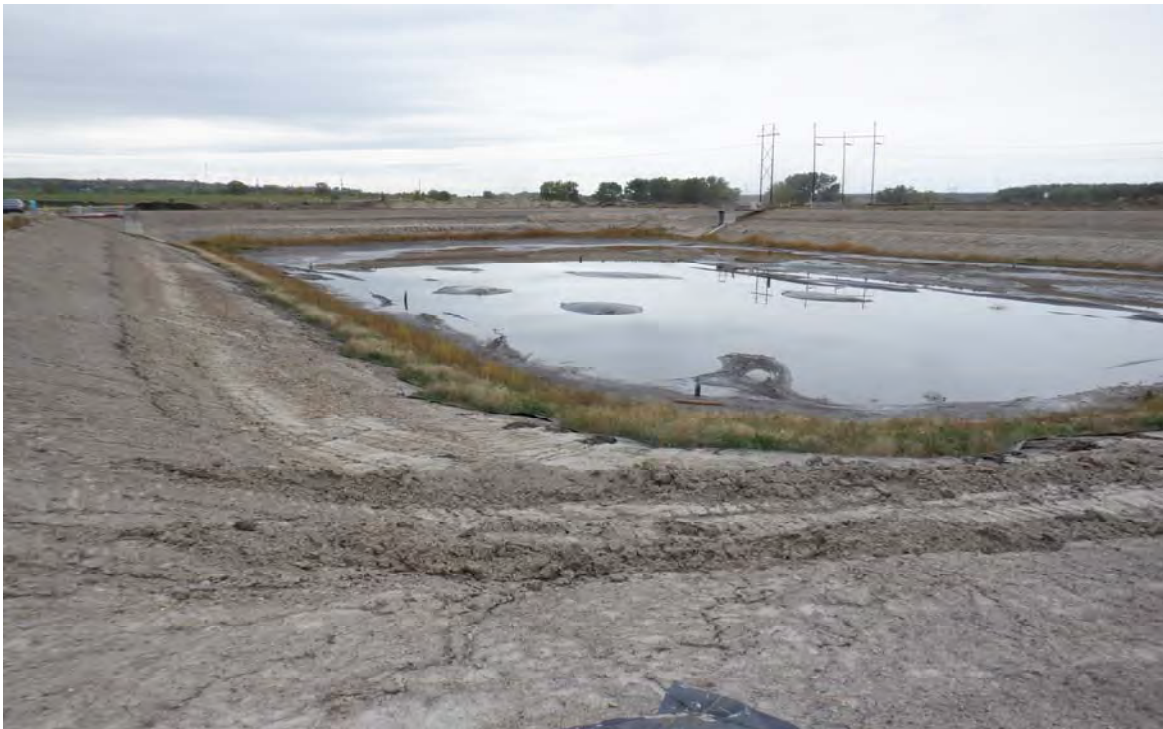
Photograph 6 (SE center cell berm crest)  
Interior of center cell (actively being dewatered during the inspection and geomembrane liner on side slopes removed as a part of restoration) (DSCF0650.JPG)

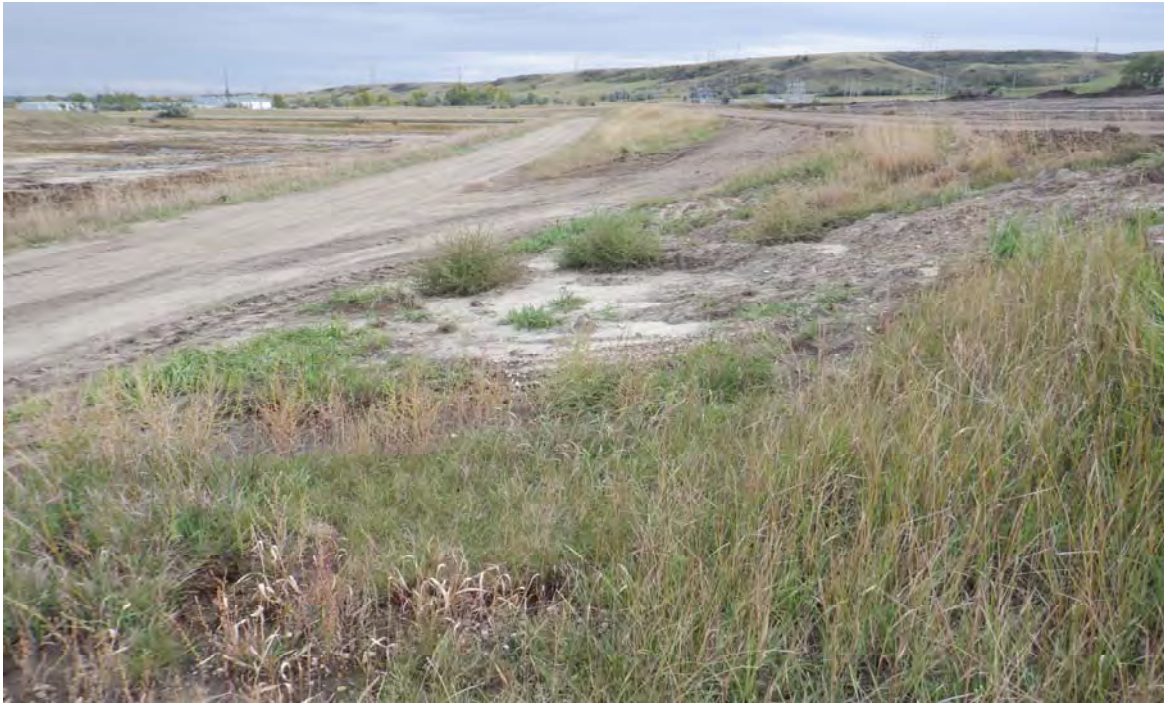
Photograph 7 (East downstream slope)  
Upper east downstream slope (DSCF0652.JPG)

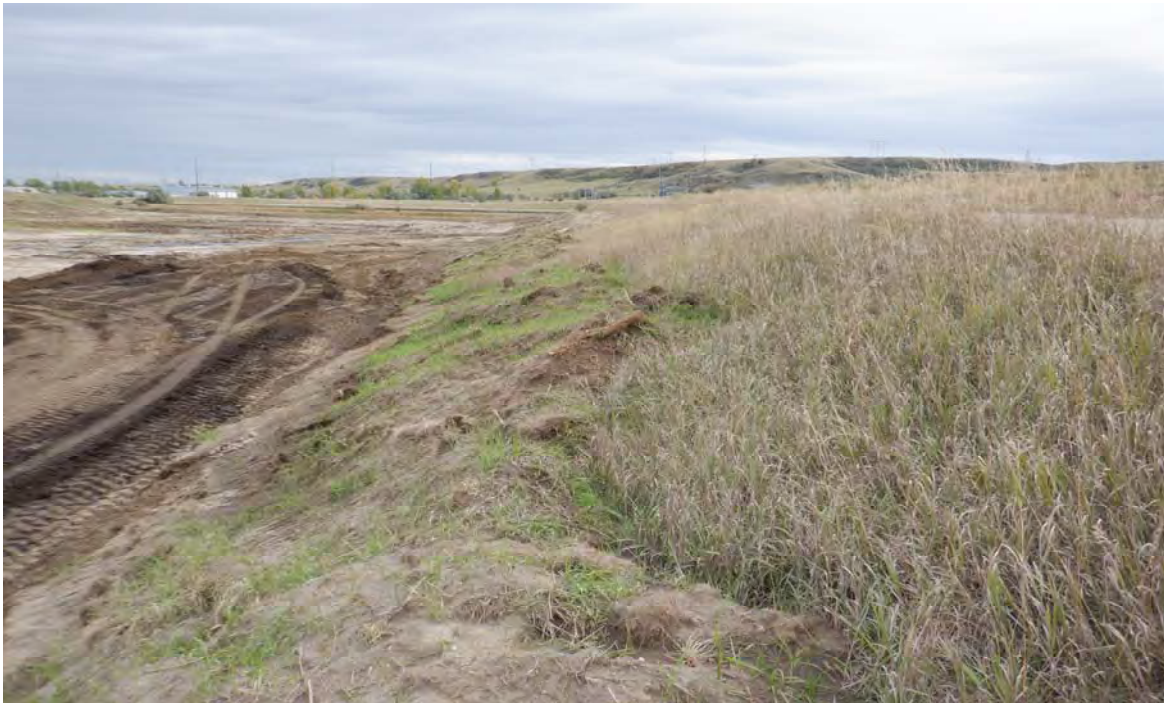
Photograph 8 (East downstream slope)  
Lower east downstream slope (DSCF0653.JPG)

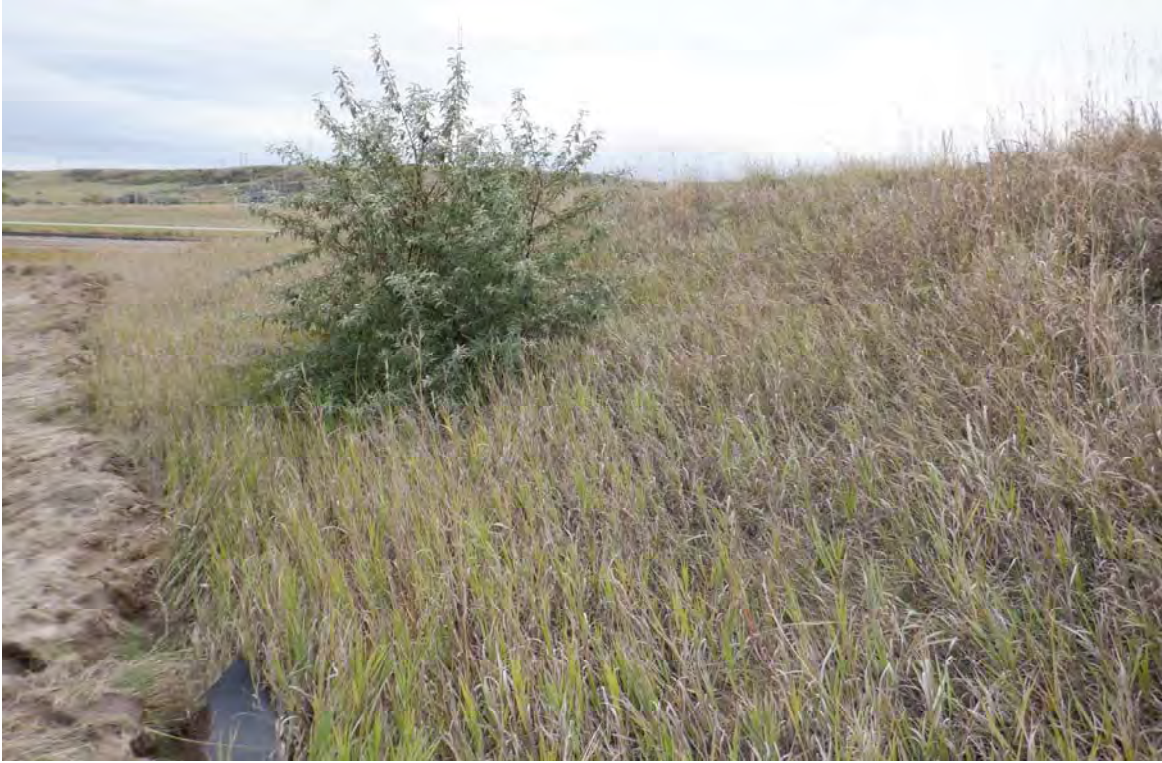
impoundment that are susceptible to erosion. A small tree was observed on the east-facing slope that should be removed. Several larger-sized (6 to 10-inch diameter) animal burrows were observed on the south berm downstream slopes and should be repaired. Berm downstream slopes are generally in fair condition due to the animal burrows noted during the inspection.

Photograph 9 (East downstream slope)  
Woody vegetation on east downstream slope of south cell (DSCF0656.JPG)

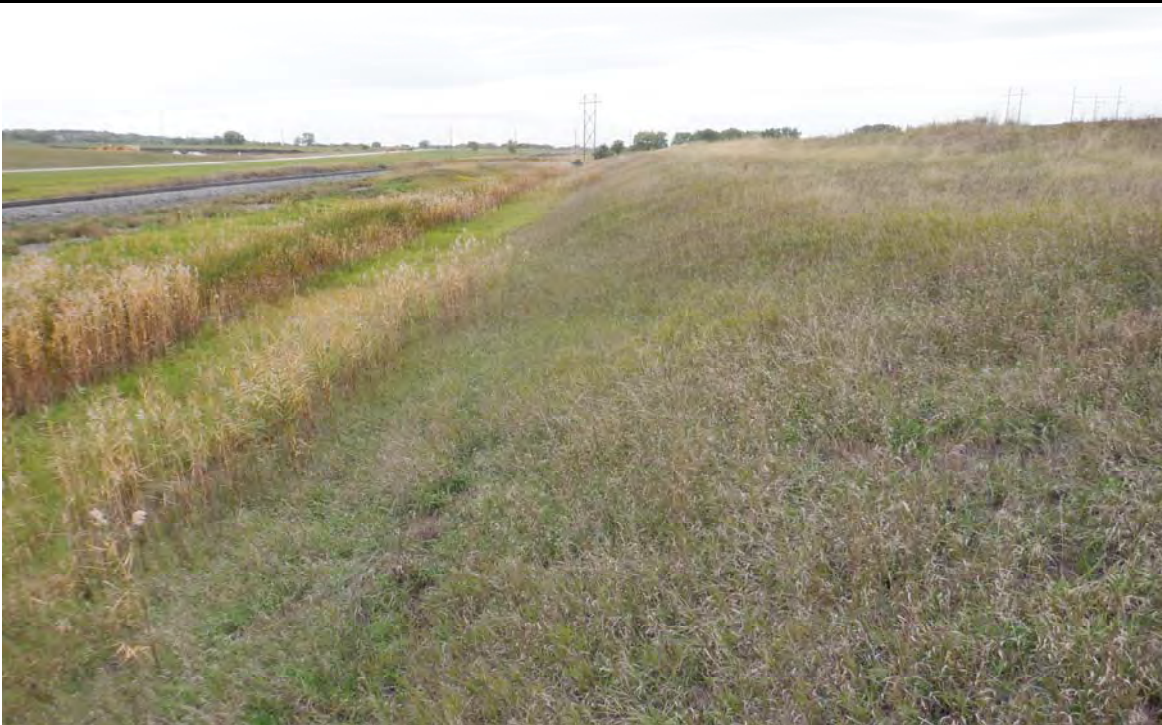
Photograph 10 (SE corner of south cell)  
Grass vegetation on south downstream slope (DSCF0657.JPG)

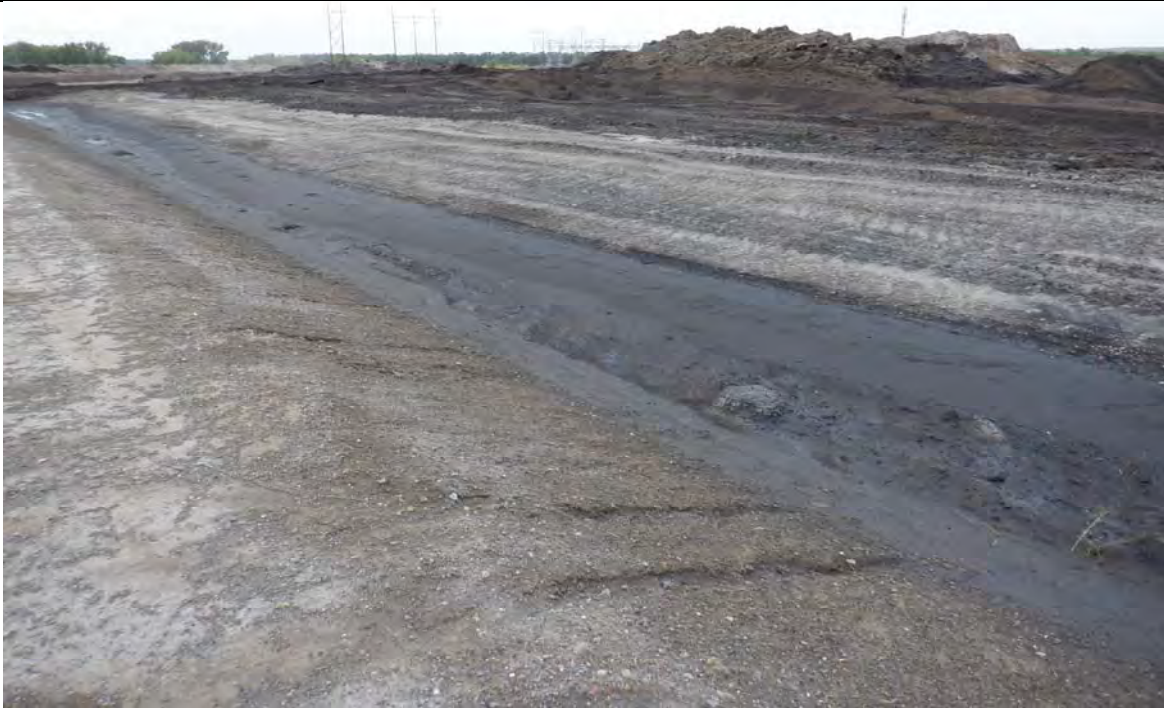
Only a small portion of the berm upstream slopes above the waste contained in the south cell (above elevation 1715 feet amsl) were visible during the inspection. The upstream geomembrane slopes were covered with bottom ash protective cover placed earlier in 2019 in preparation for closure of the south cell and were in generally good condition.

Photograph 11 (South berm crest)  
Interior of south cell (contact water control ditch and grading to achieve top of waste grades in preparation for closure) (DSCF0660.JPG)

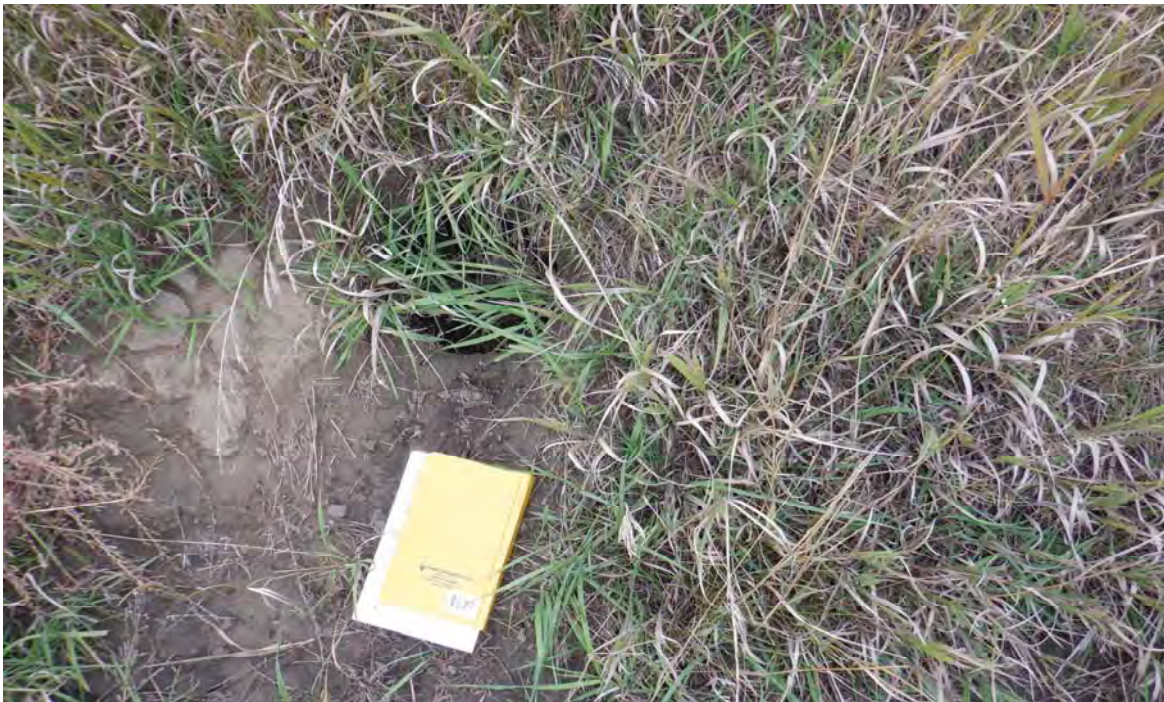
Photograph 12 (South downstream slope)  
Large animal burrow on south downstream slope (DSCF0662.JPG)

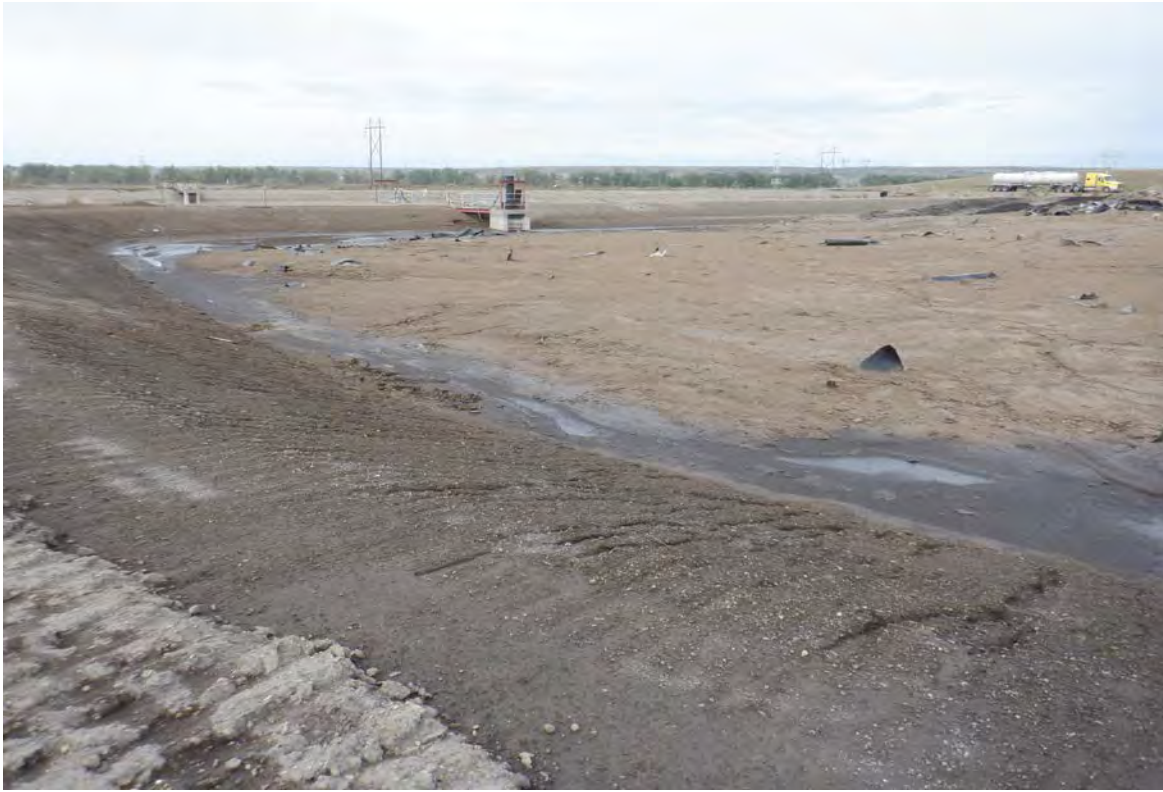
Outflow from the south cell was through the concrete outflow structure located on the north berm upstream slope. Piping connecting this structure to the center cell has previously been plugged and abandoned. Some potential minor leakage through the plugged pipe was observed during site closure activities and the outlet end of the piping was sealed with bentonite and concrete. The outflow structure is planned to be used as a sump to remove free water during closure of the south cell of the Bottom Ash Impoundment. The structure and sump piping visible during the inspection was in good condition with no signs of corrosion, erosion, or cracking.

Photograph 13 (SW south cell berm crest)  
Interior of south cell (CCR, CCR mixed soils, and geomembrane liner being placed to achieve closure grades during restoration activities) and south cell dewatering sump shown in the background at the existing concrete outfall structure (DSCF0663.JPG)
