Annual Inspection

Coal Creek Station - Drains Pond System CCR Surface Impoundment

Golder Associates Inc.

January 2020

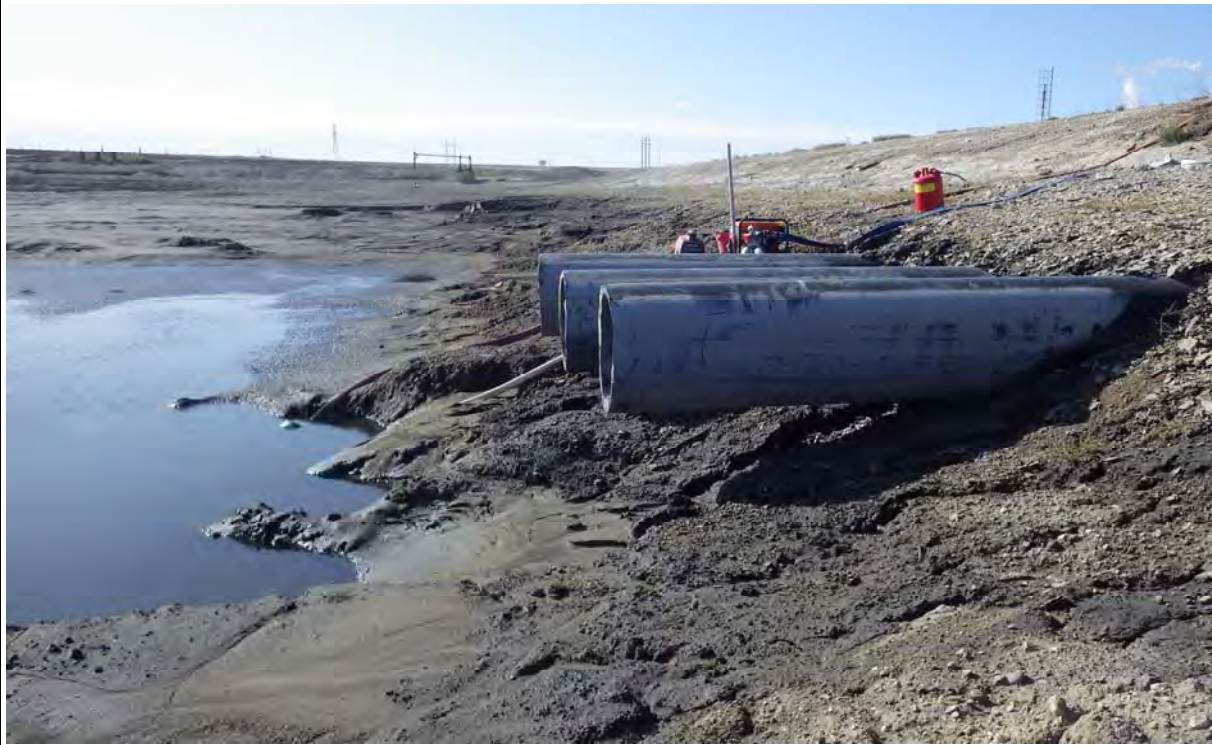
Photograph 1 (East cell west upstream slope)
Cross-over pipes from center cell to east cell (IMGP7003.JPG)

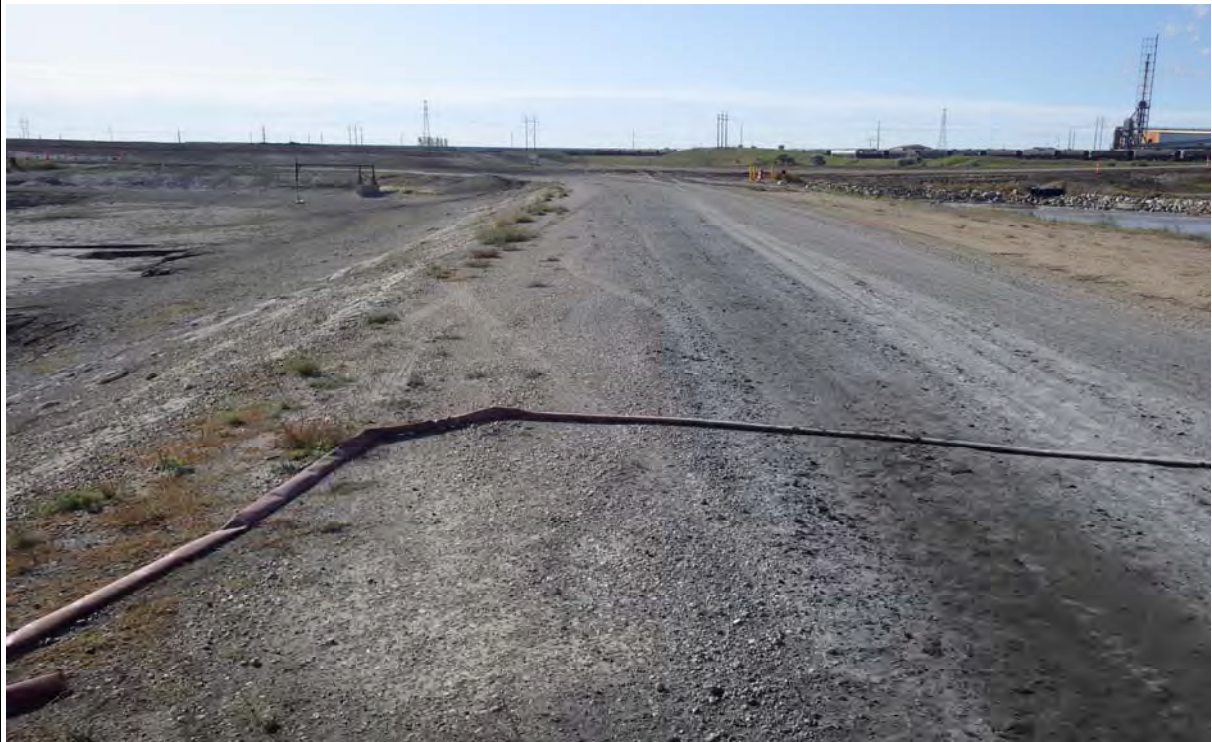
Photograph 2 (East cell west crest)
East cell to center cell berm crest (IMGP7005.JPG)

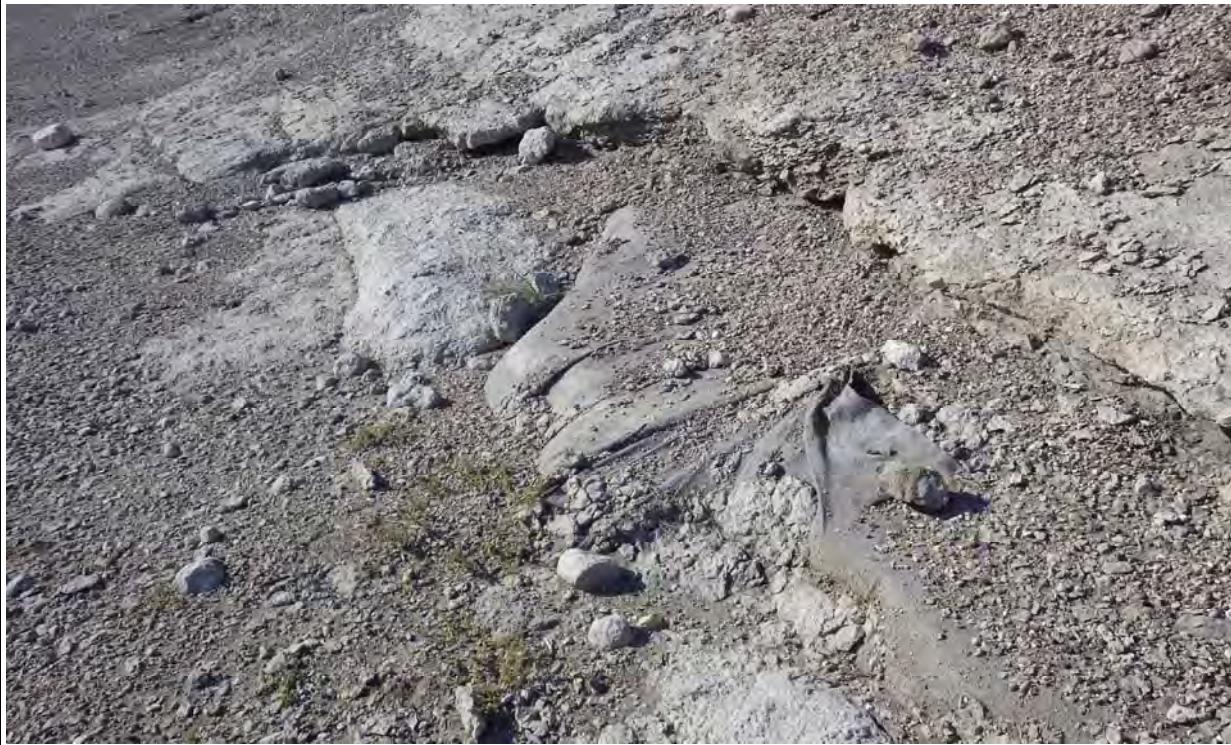
East cell slopes are being protected from erosion with a cemented fly ash layer from the floor up to the embankment crest. This cemented fly ash layer overlies a geotextile and a 1-foot protective sand layer and appeared to be competent with minor erosion observed in the fly ash layer on the west and south berm upstream slopes at the approximate typical water level of between elevation 1916 feet amsl and 1918 feet amsl (4 to 6 feet freeboard). The berm upstream slopes of the east cell appear to be in good condition. As part of the east cell operational improvements, the fly ash protective cover is planned to be repaired on the slopes as required.

Photograph 3 (East cell west upstream slope)
Exposed geotextile, upstream fly ash protective cover slope (IMGP7006.JPG)

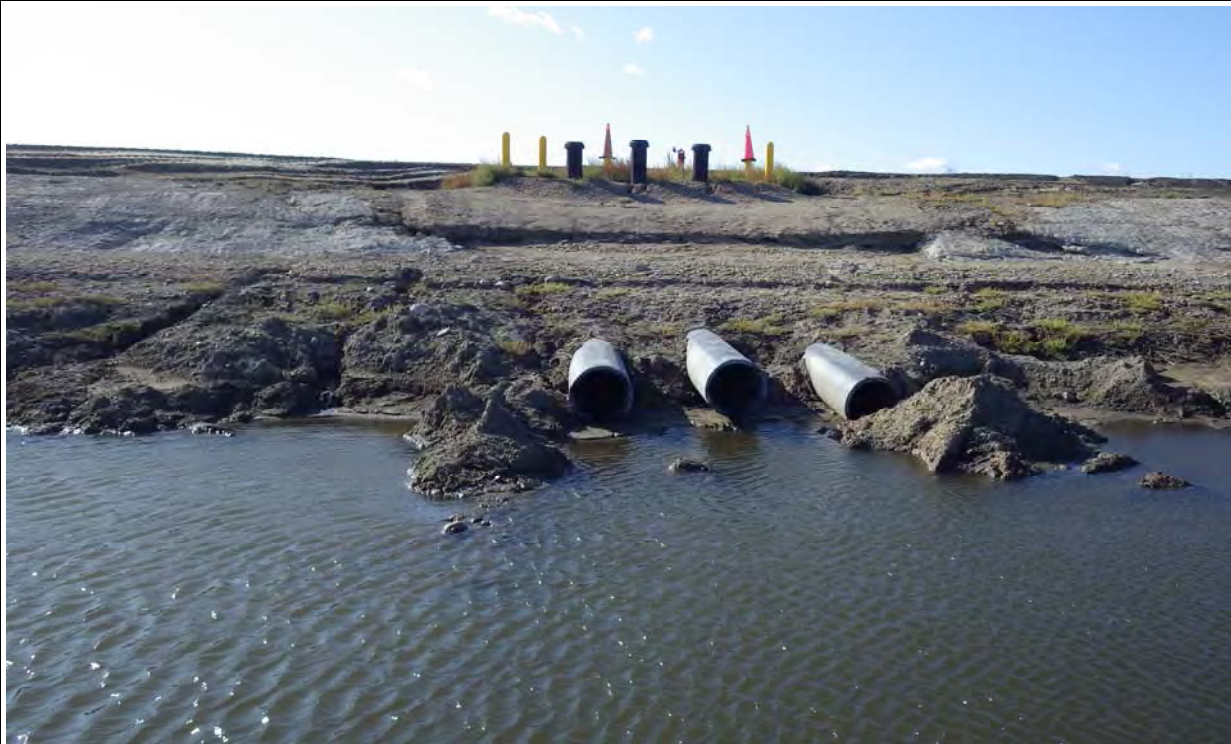
Photograph 4 (East cell south upstream slope)
Cross-over pipes from Upstream Raise 91 (IMGP7008.JPG)

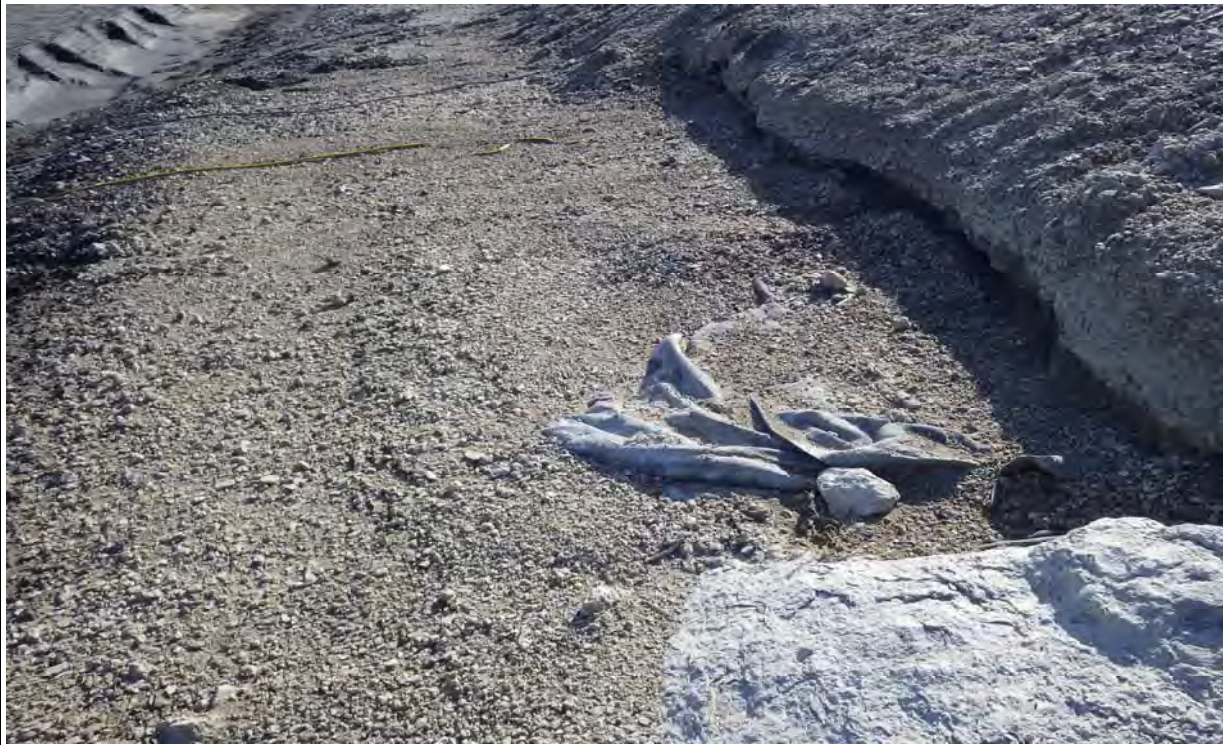
Photograph 5 (East cell south upstream slope)
Exposed geotextile, upstream fly ash protective cover slope (IMGP7009.JPG)

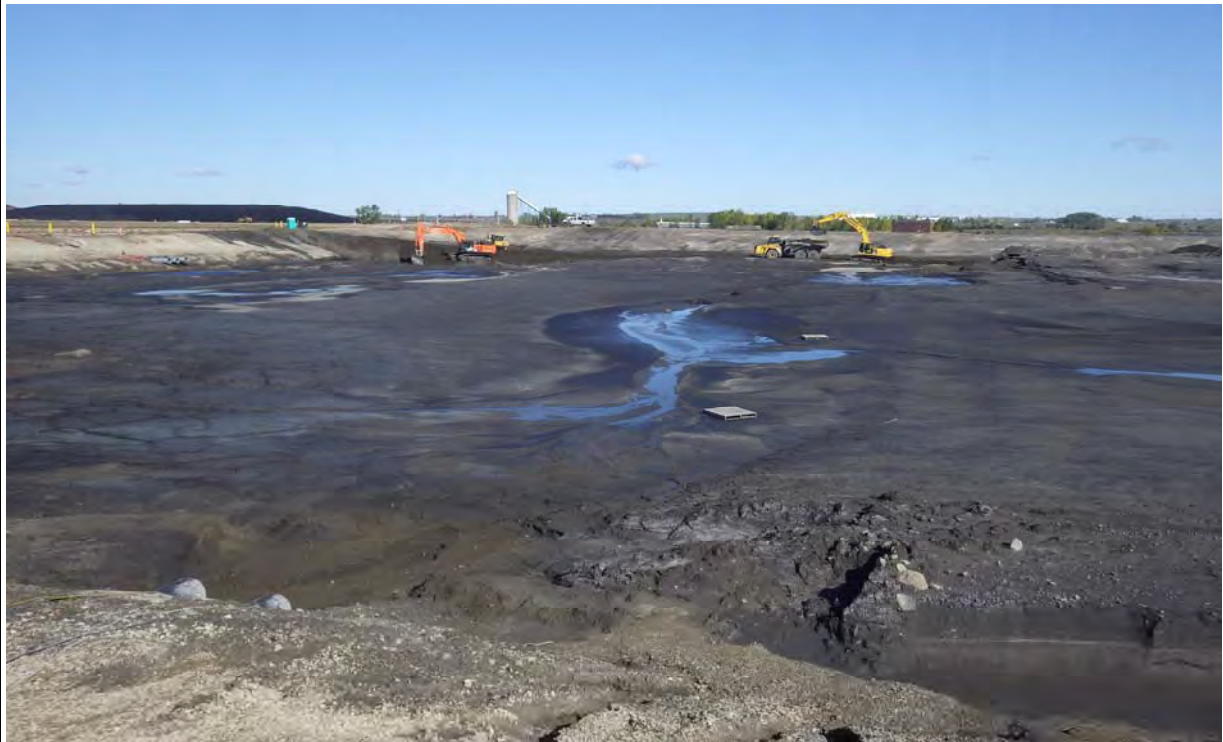
Photograph 6 (East cell south berm)
Inside of east cell from south side, sediment removal occurring on the north area of the east cell (IMGP7011.JPG)

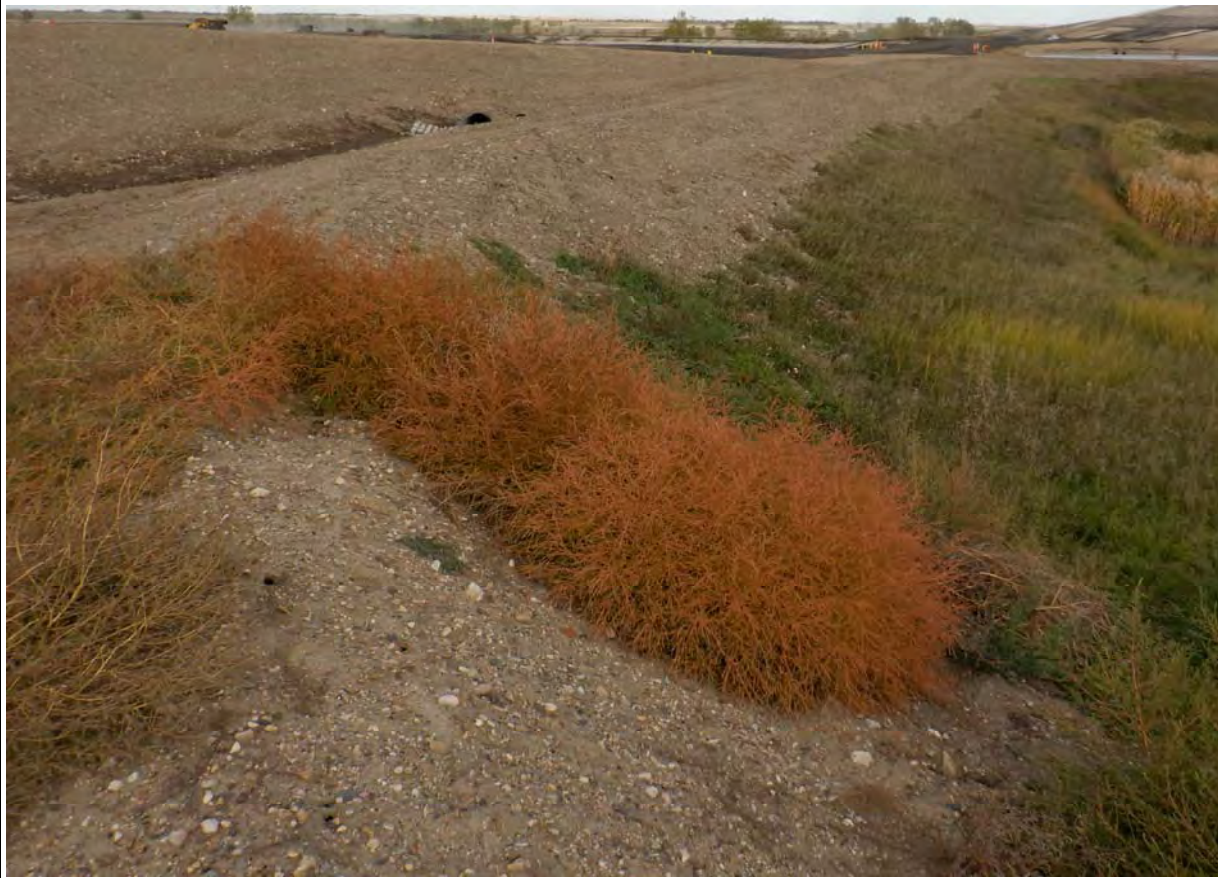
Photograph 7 (Center cell south downstream slope)
Contact water control berm and downstream slope (to be seeded) (DSCF0513.JPG)

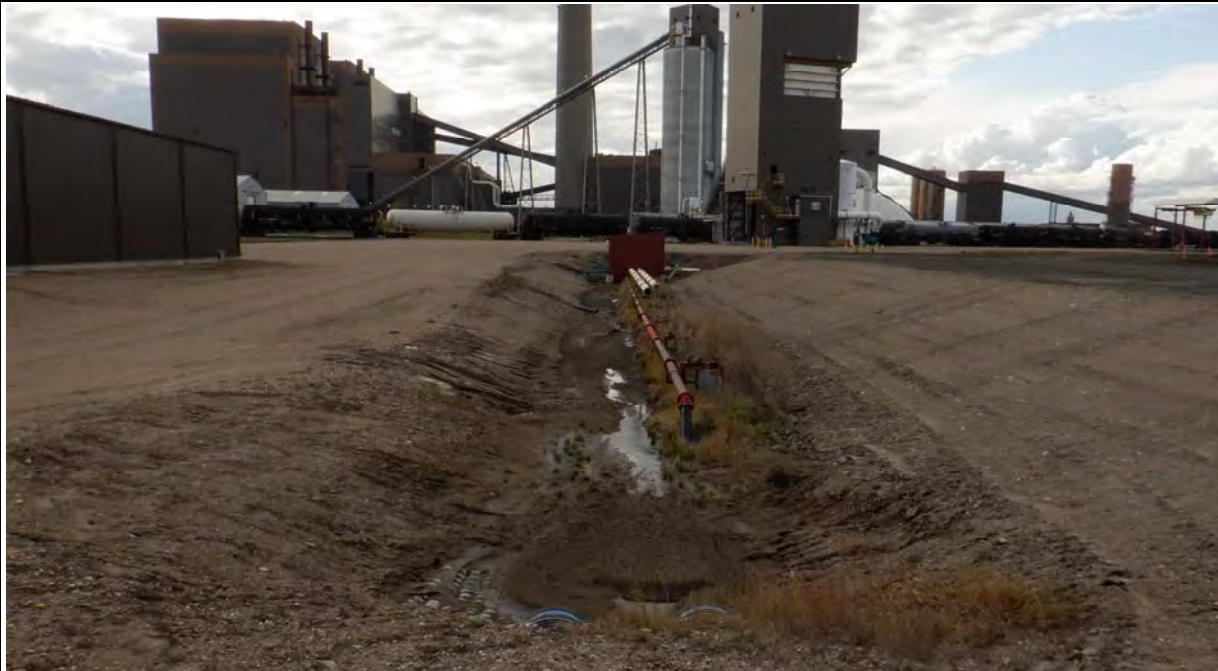
Photograph 8 (Center cell south downstream slope)
Bottom ash and flue-gas desulfurization pipelines and contact water drainage directed toward the center cell via culverts (DSCF0514.JPG)

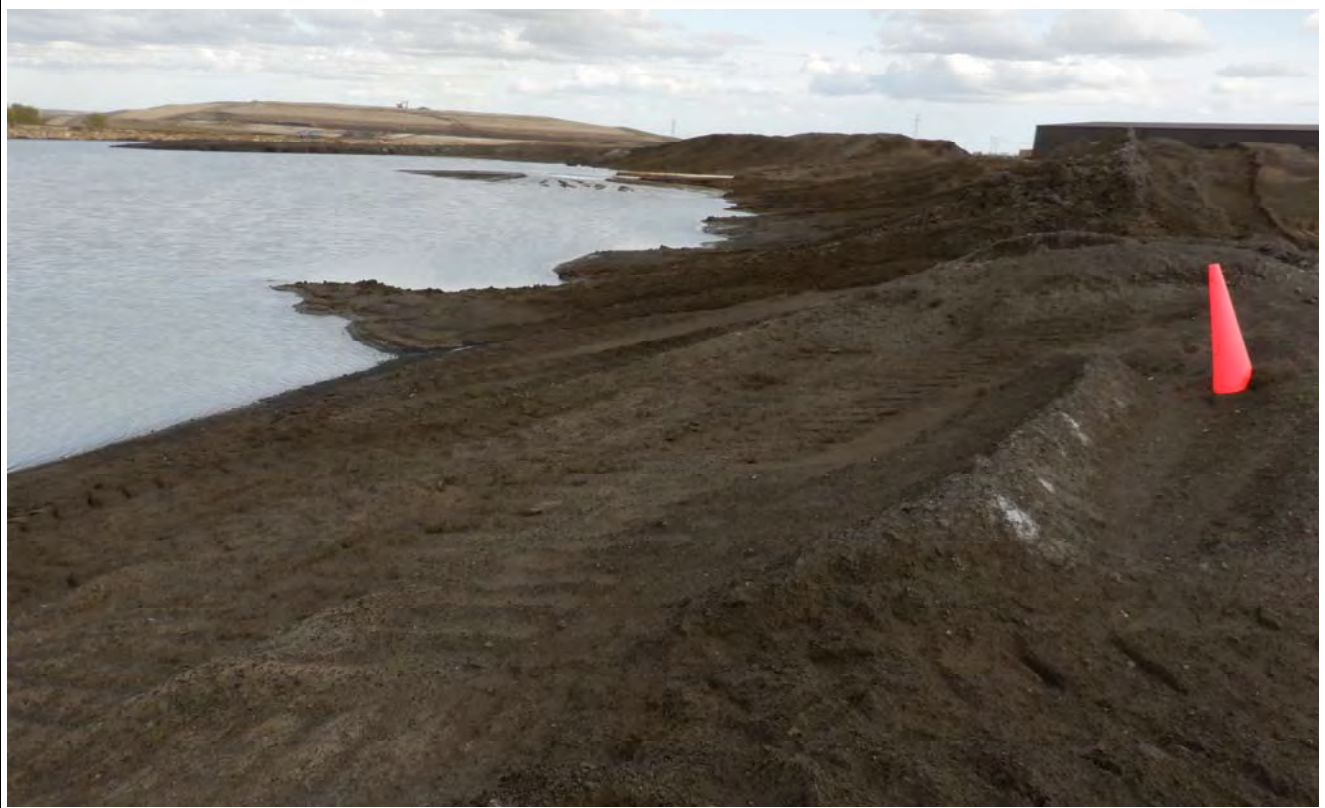
Photograph 9 (West cell west berm crest)
West cell interior (panoramic view, 1 of 2) (DSCF0519.JPG)

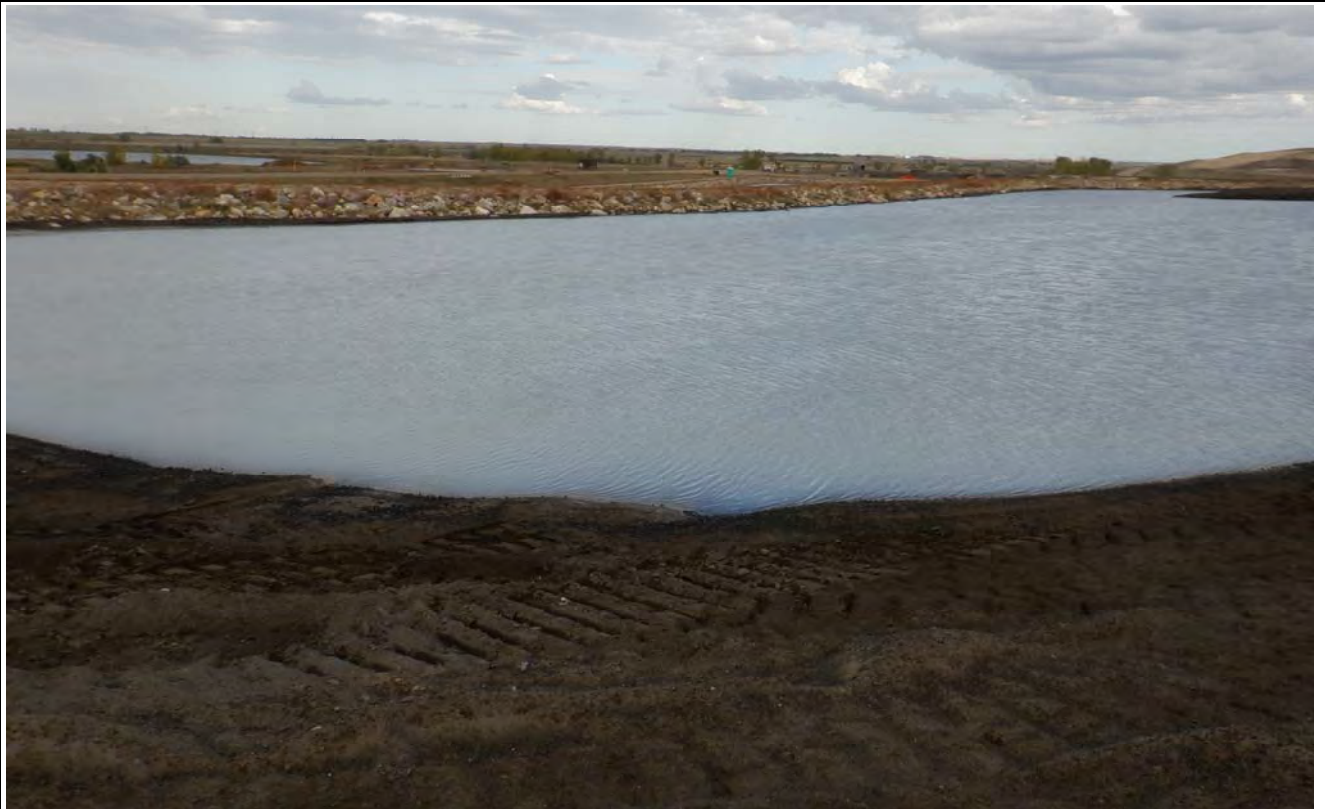
Photograph 10 (West cell west berm crest)
West cell interior, (panoramic view, 2 of 2) (DSCF0520.JPG)

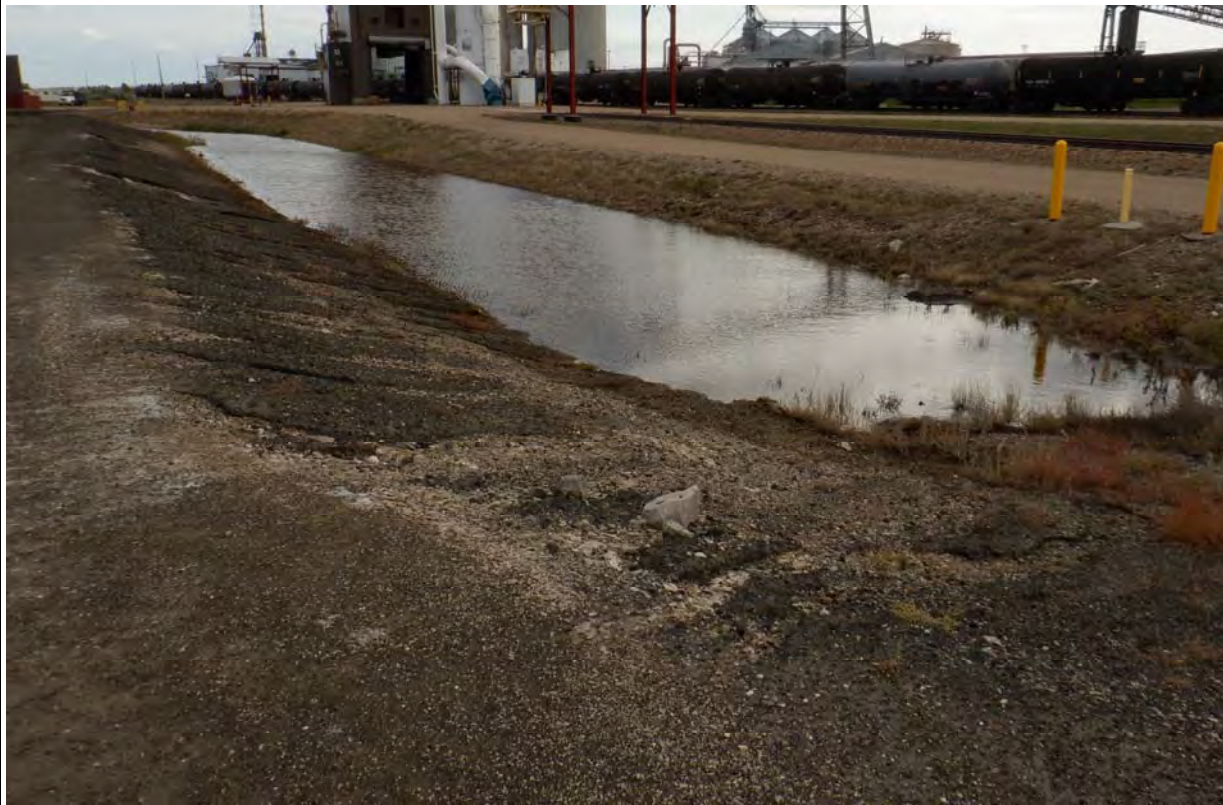
Photograph 11 (West cell west ditch)
West downstream slope and storm water drainage (DSCF0521.JPG)

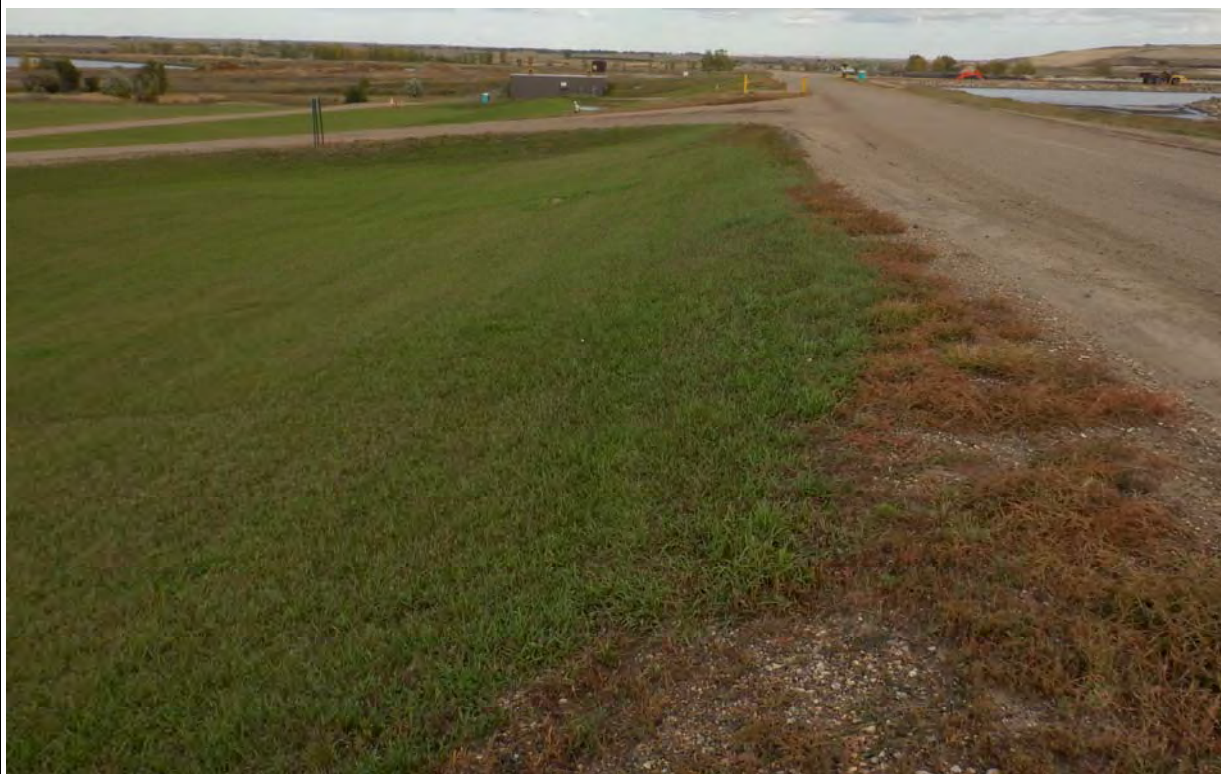
Photograph 12 (West cell north downstream slope and berm crest)
Haul road and downstream slope of berm in good condition (typical) (DSCF0523.JPG)

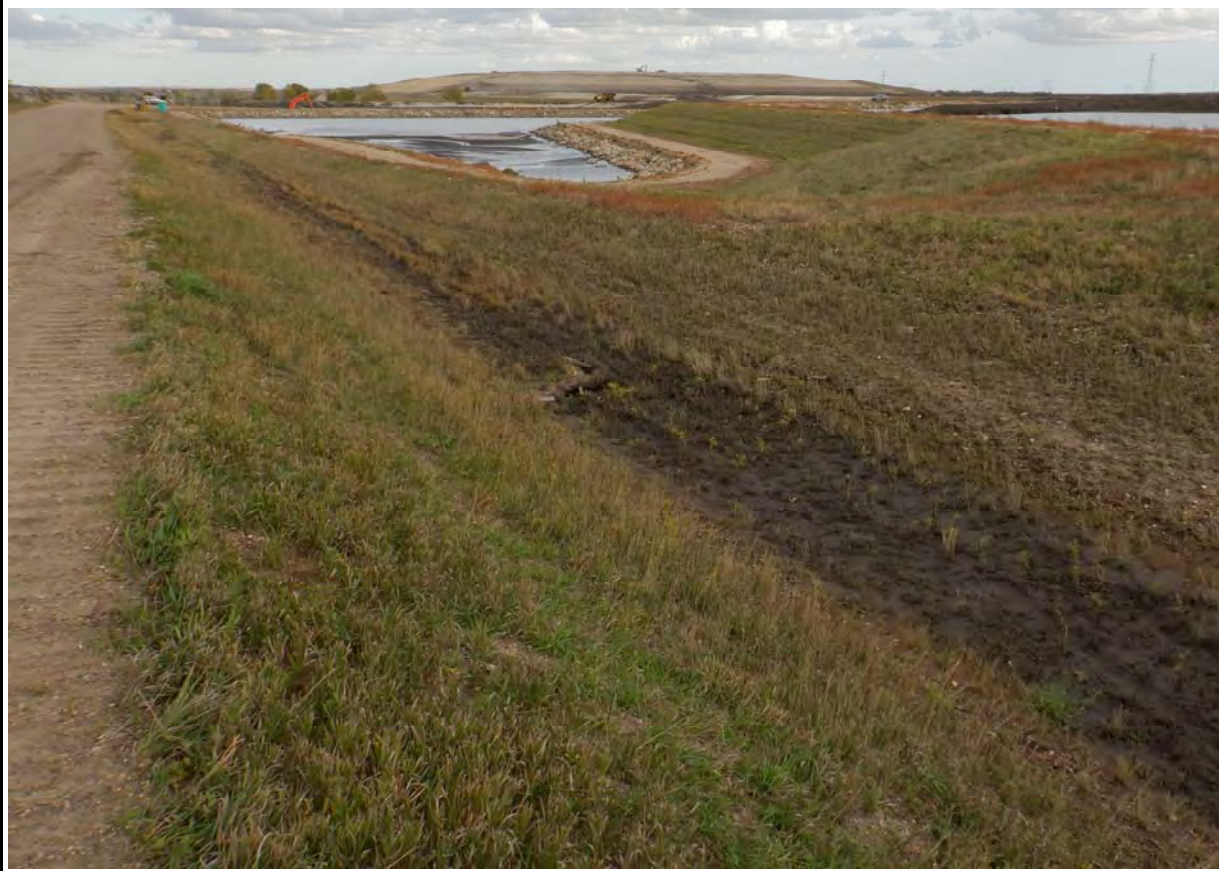
Photograph 13 (West cell and Center cell north ditch)
North side contact water drainage ditch and center cell berm, good condition (DSCF0525.JPG)

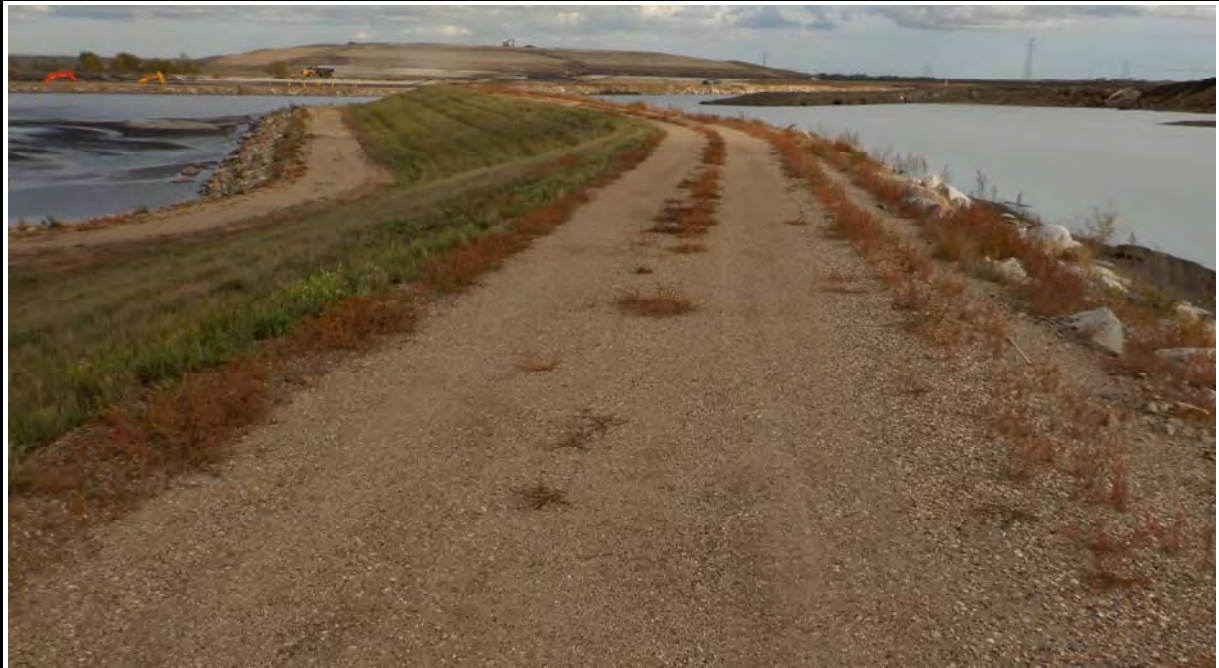
Photograph 14 (West cell east berm crest)
Crest road between center cell and west cell (gravel, good condition) (DSCF0526.JPG)

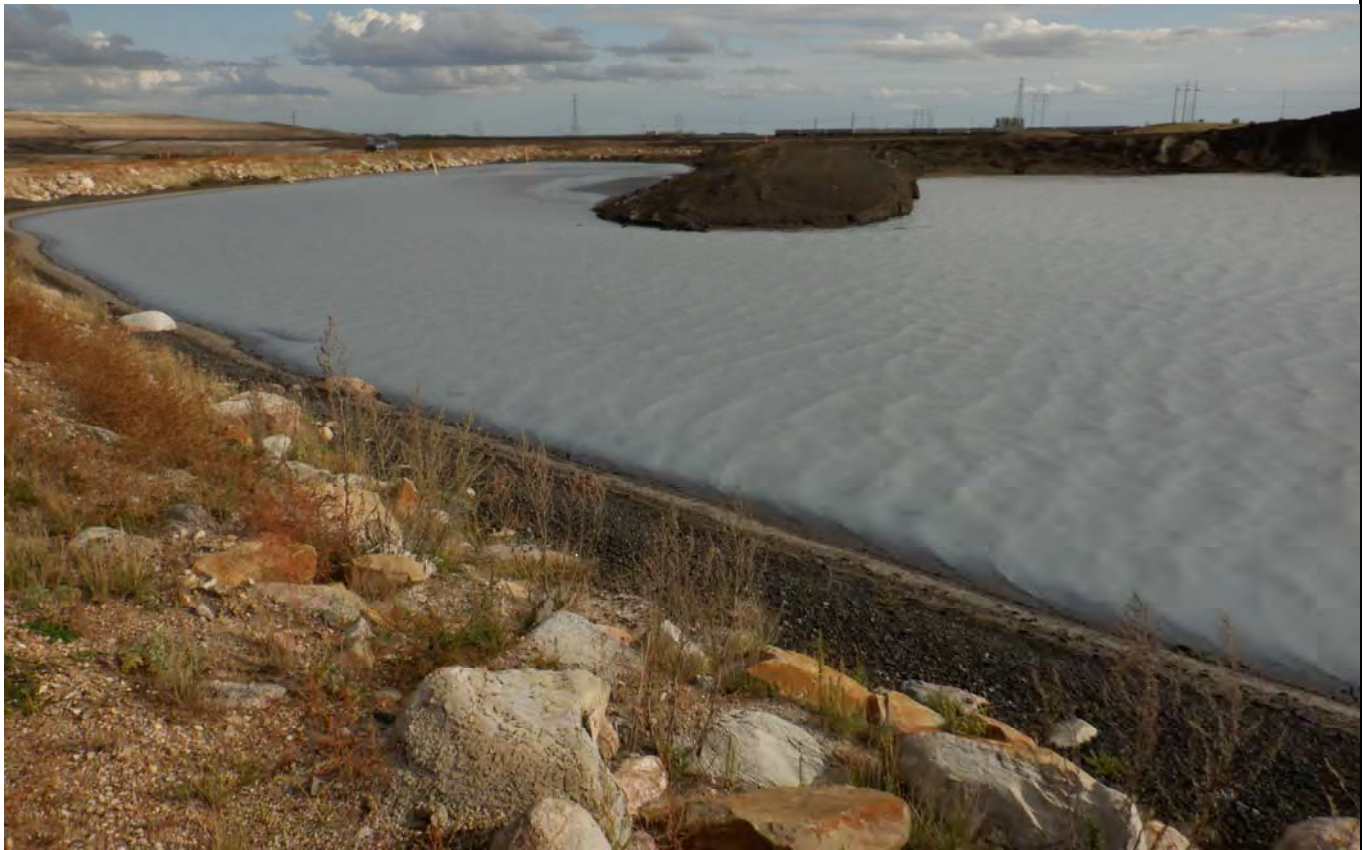
Photograph 15 (West cell to center cell berm crest)

West cell bottom ash deposition and process water routed to the decant piping to the center cell (DSCF0530.JPG)

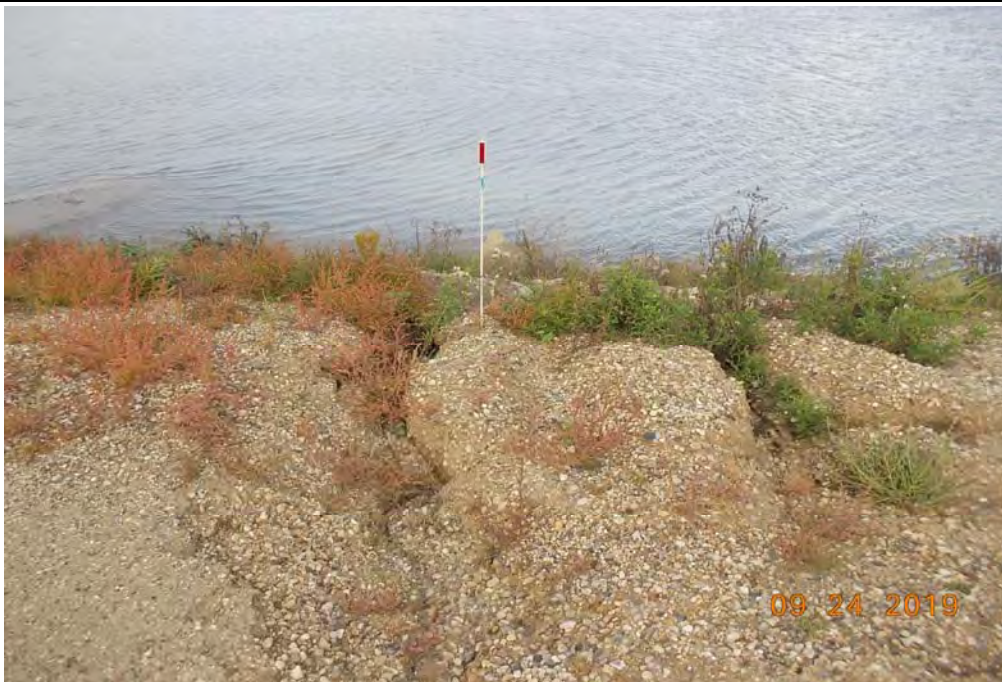
Photograph 16 (Center cell west upstream slope)

The observable berm upstream slopes appeared to match the design slopes of 3:1 with no observed sections of significant slope movement. The berm upstream slope along the south and west sides of the west cell were below temporarily stacked bottom ash materials and were not visible during the inspection. Center cell slopes and the east berm upstream slopes of the west cell are protected from erosion with a 1-foot thick fly ash layer from the floor to the embankment crest as well as riprap within the normal operating levels of the cells. At the time of inspection, the riprap and fly ash appeared to be in good condition. Minor erosion in the riprap was observed, especially on the west berm upstream slope of the center cell.

Erosion rills on west upstream slope of center cell (PDS DPS (3).JPG)

Minor maintenance items that may need to be continually addressed include repairing ruts that develop within the crest roads and ensuring that grades promote flow of contact water into the CCR facility footprints, repairing eroded areas of the berm upstream slope fly ash and riprap protection layers, monitoring berm downstream slopes for large animal burrows or erosion that may affect operations and reseeding as required, and removing sediment that accumulates within the facilities that negatively impacts operations. In addition, the inflow and outflow piping should be monitored regularly to ensure proper conveyance of water to and from the facility.

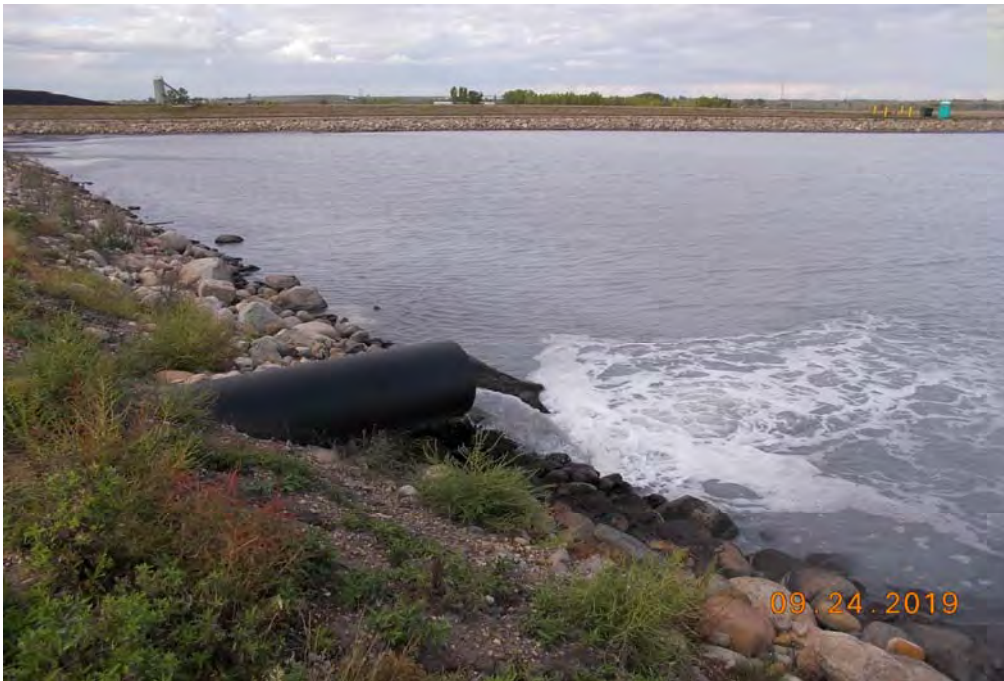
Photograph 17 (Center cell west upstream slope)
Inlet from west cell into center cell (PDS DPS (4).JPG)

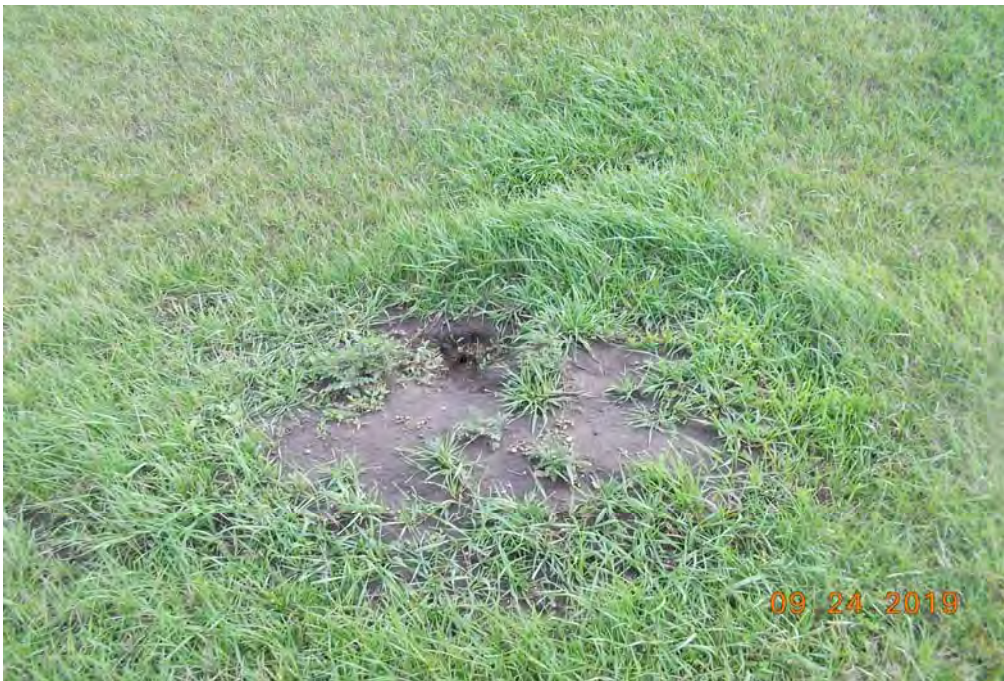
Photograph 18 (Center cell north downstream slope)
Large animal burrow (PDS DPS (11).JPG)

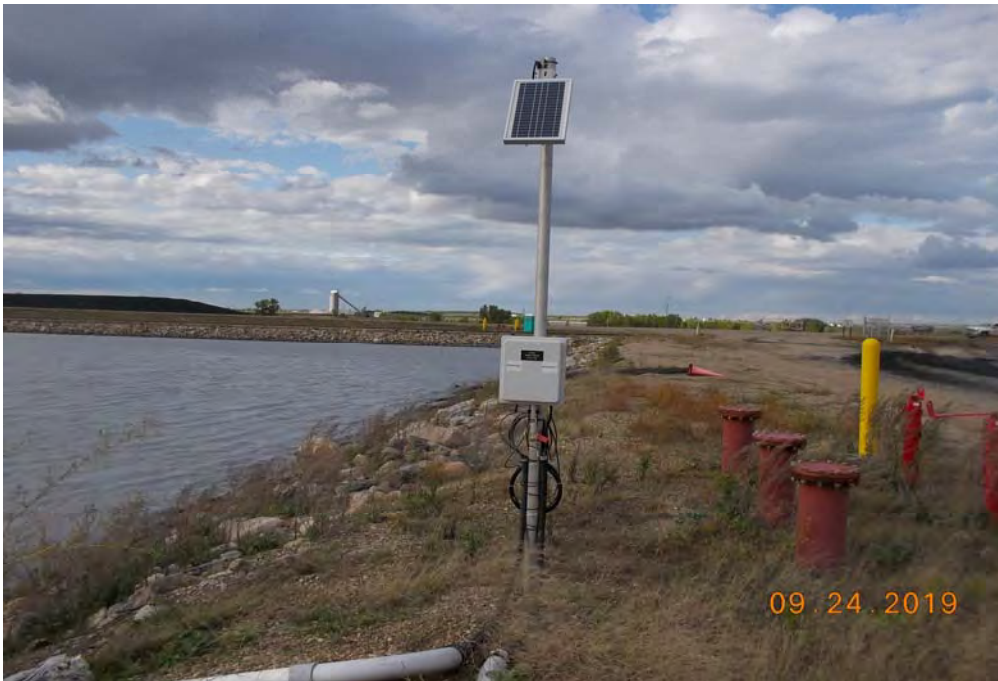
Photograph 19 (Center cell east berm crest)
Water level monitoring station for center and east cells, good condition (PDS DPS (19).JPG)

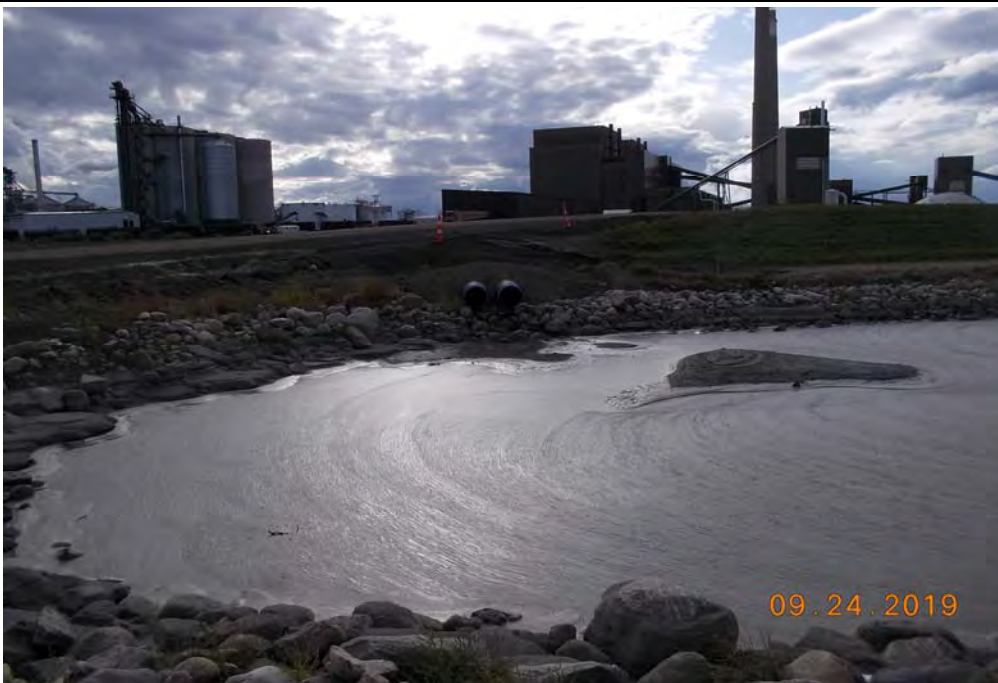
Photograph 20 (Center cell southeast berm crest)
Culvert pipe inlets to the south side of the center cell, no flow (PDS DPS (20).JPG)

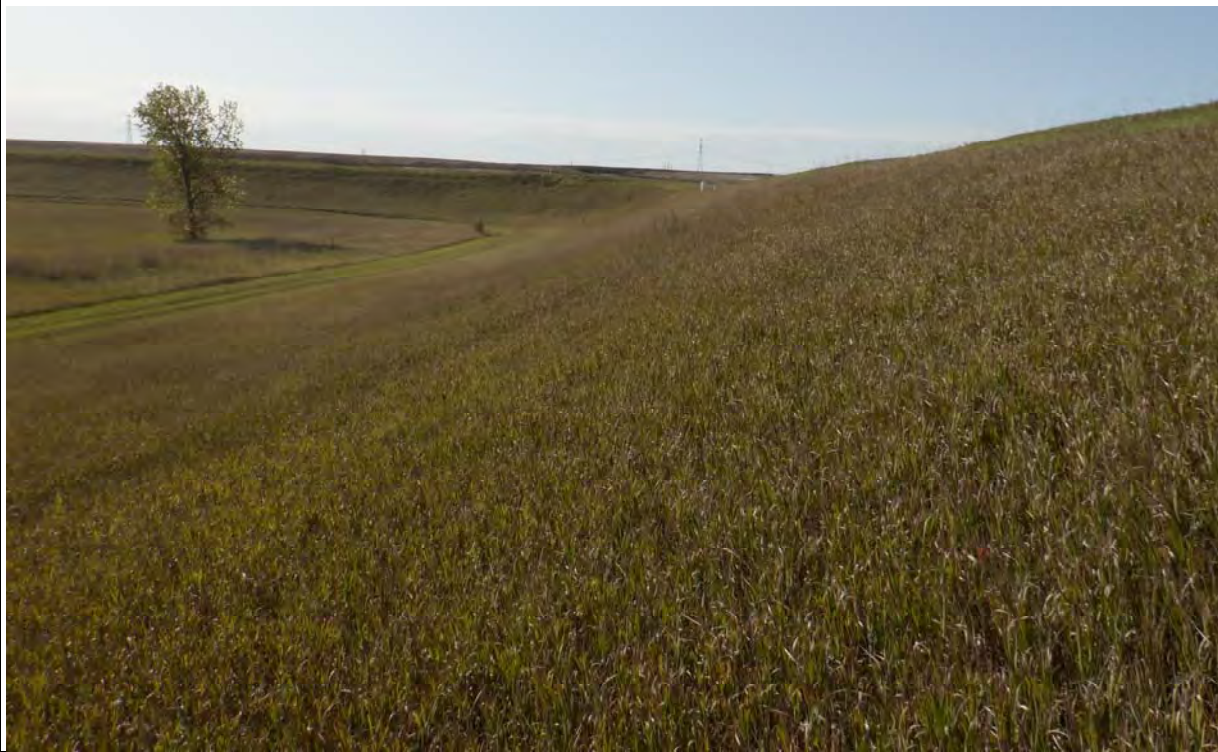
Photograph 21 (East cell east downstream slope)
East downstream slope, well vegetated (DSCF0553.JPG)

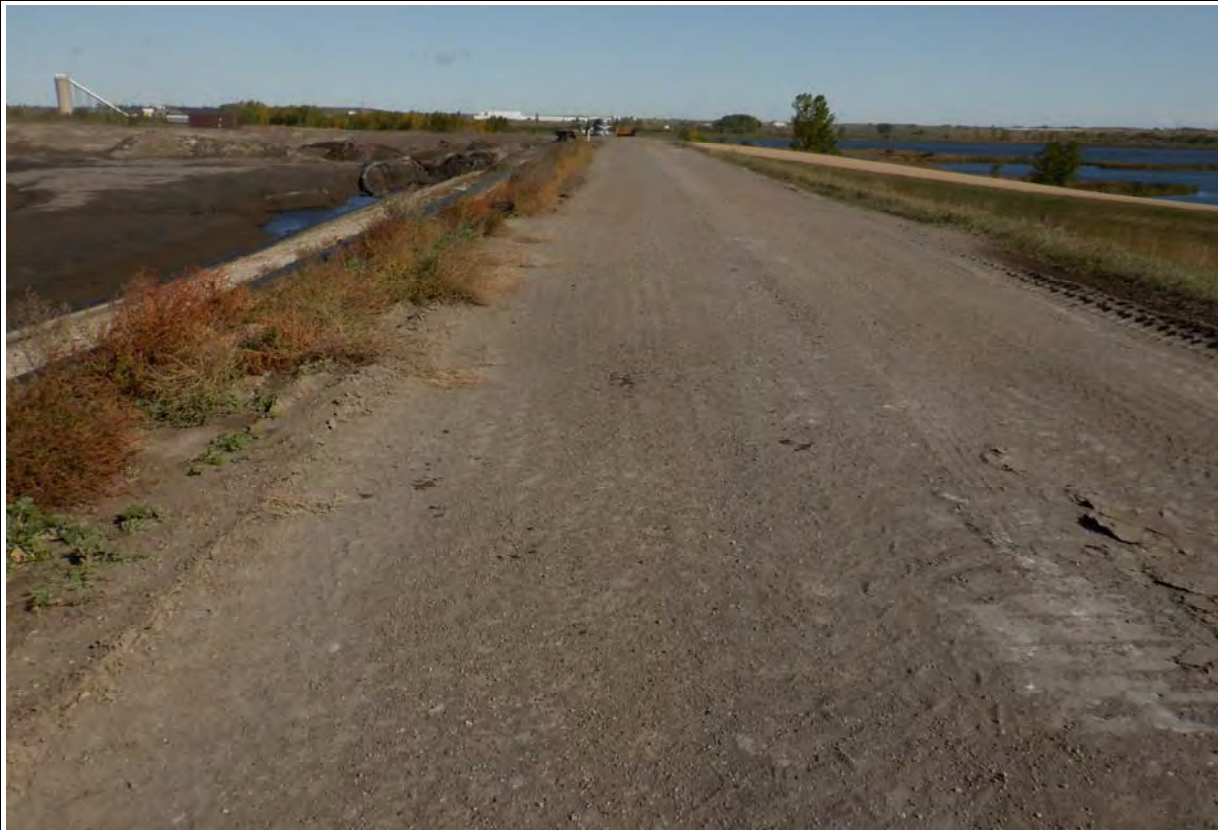
Photograph 22 (East cell east berm crest)
East berm crest of east cell (DSCF0557.JPG)
