# Annual Inspection

## *Coal Creek Station - Southeast Section 16 CCR Landfill*

### **Great River Energy**

January 2020

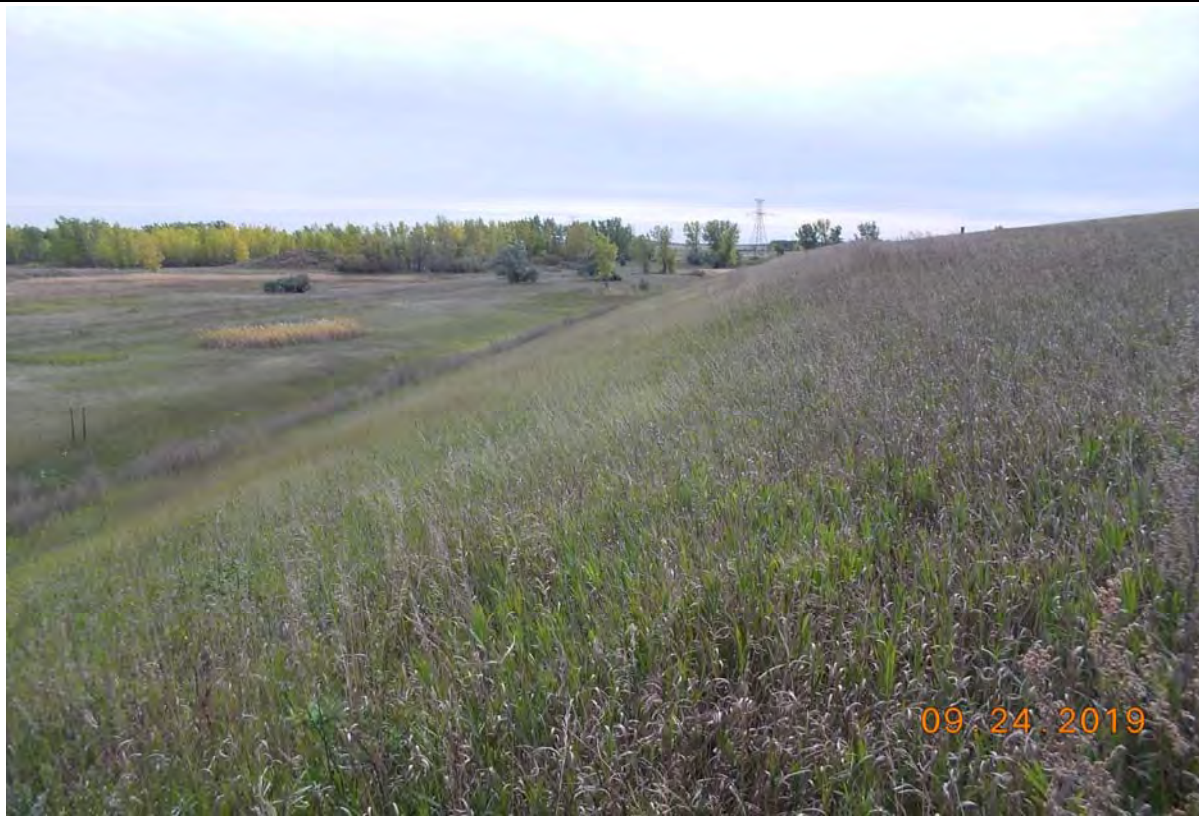
Photograph 1 (East downstream slope)  
East downstream slope, well-vegetated (PDS SE16 (1).JPG)

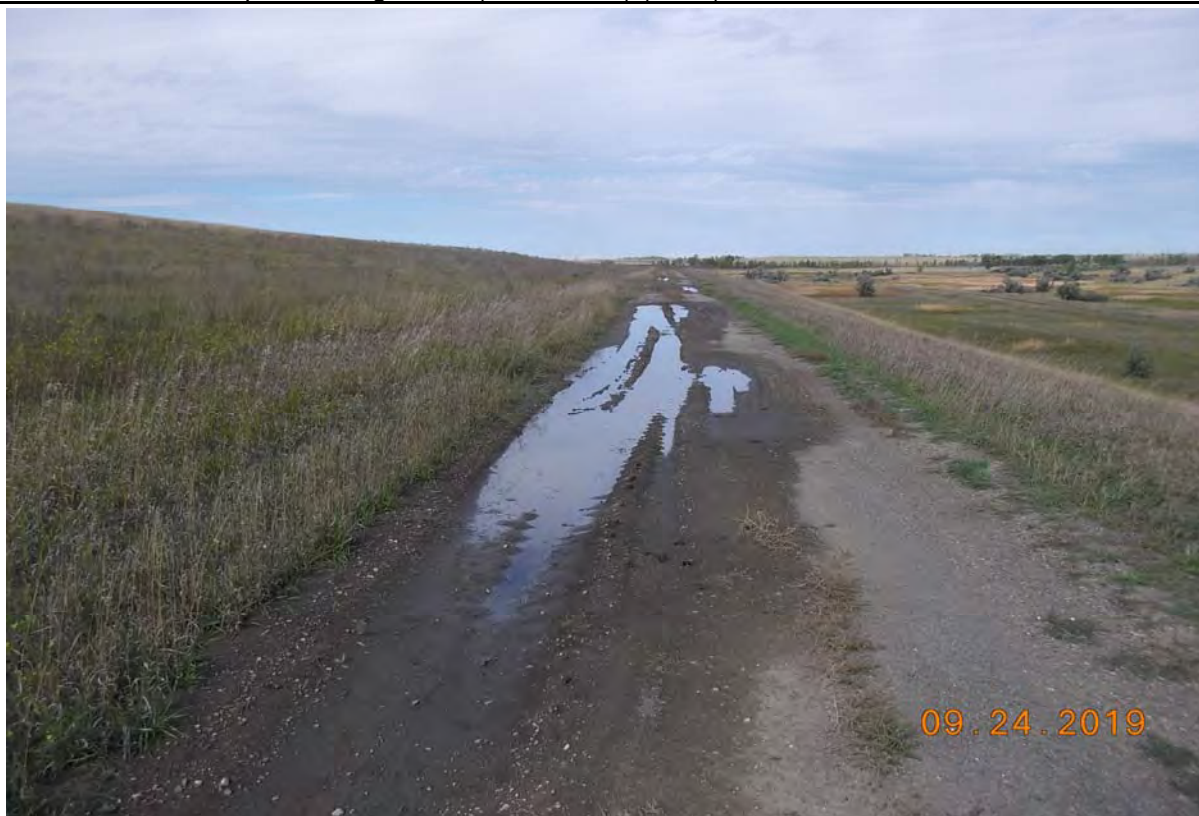
Photograph 2 (East berm crest access road)  
Standing water in access road on the east berm crest (PDS SE16 (6).JPG)

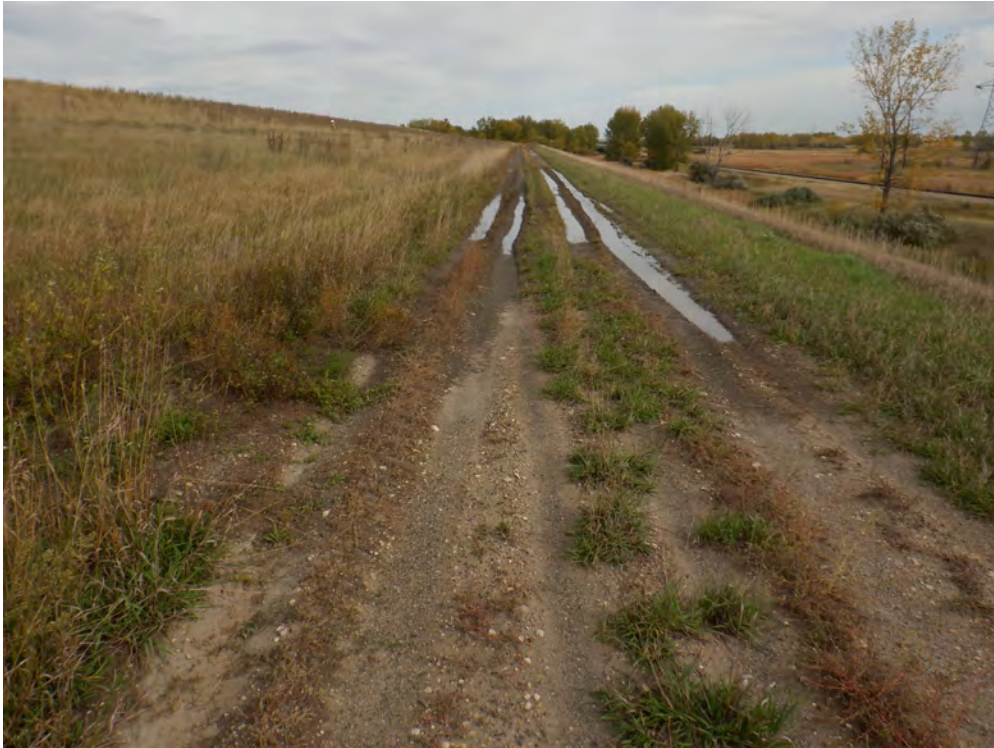
Photograph 3 (South berm crest access road)  
Standing water in access road on the south berm crest (DSCF0506.JPG)

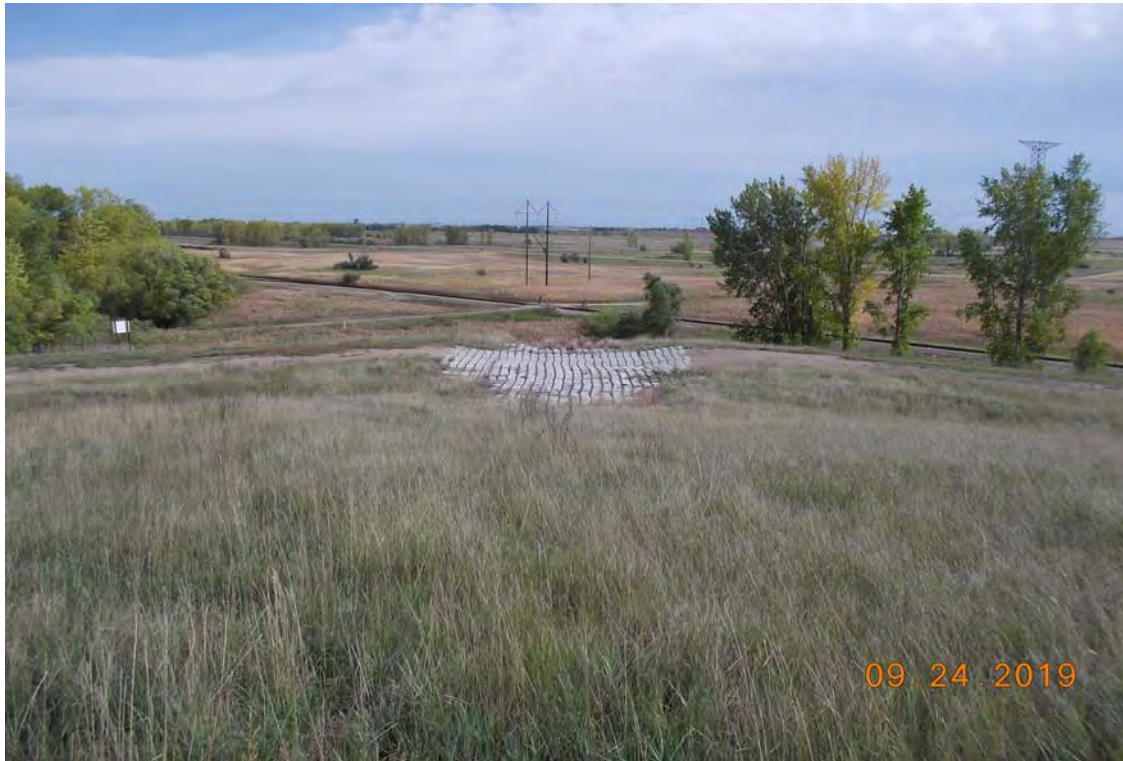
Photograph 4 (Southeast CCR downstream slope)  
Articulated Concrete Block (ACB) downchute on southeast corner, well-vegetated (PDS SE16 (10).JPG)

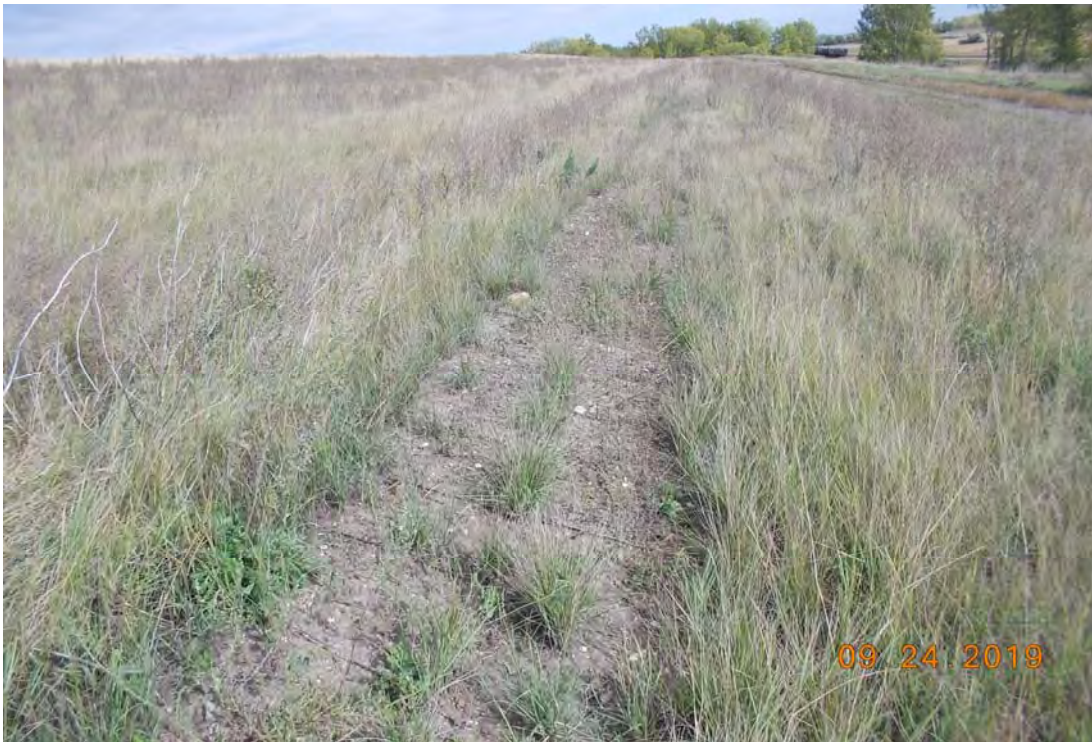
Photograph 5 (South CCR downstream slope (covered))  
Sparse vegetation on final cover of downstream slope side of terrace berm (PDS SE16 (13).JPG)

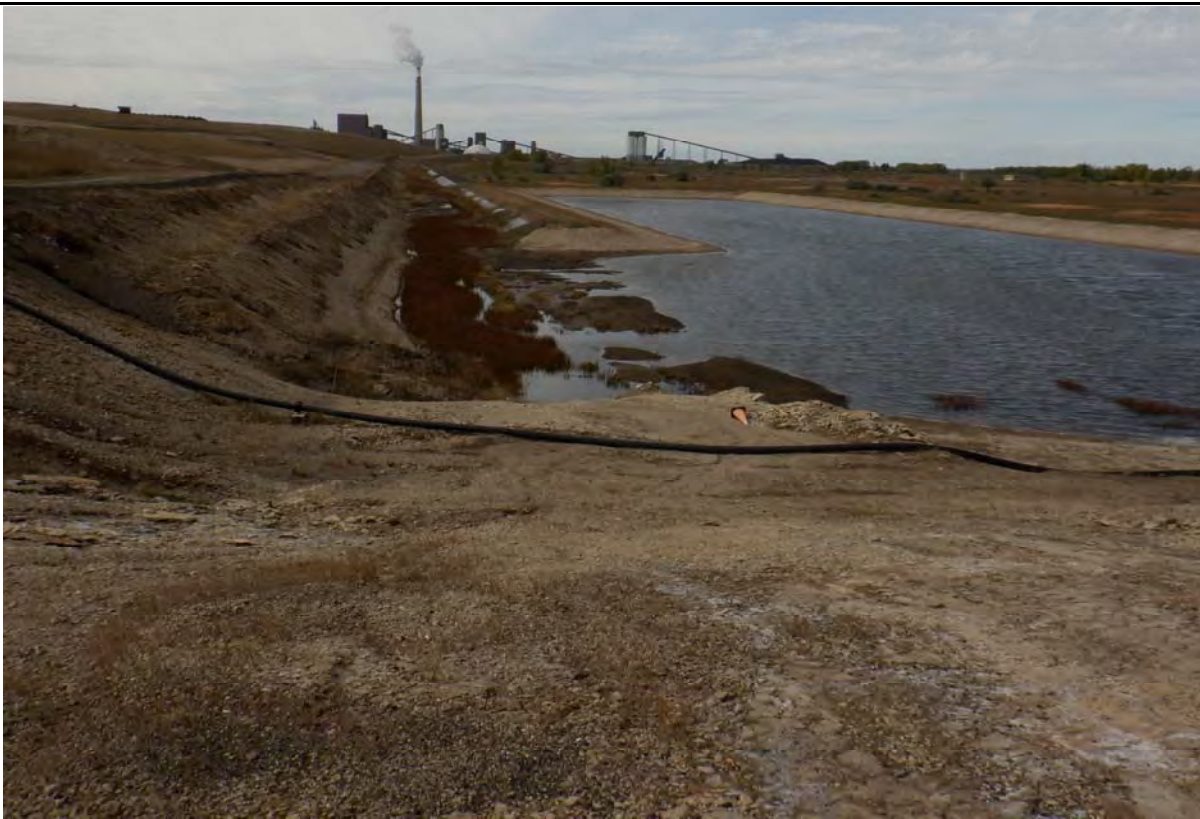
Photograph 6 (Southeast corner of contact water collection area)  
Contact water collection area (CWCA) and channel (DSCF0469.JPG)

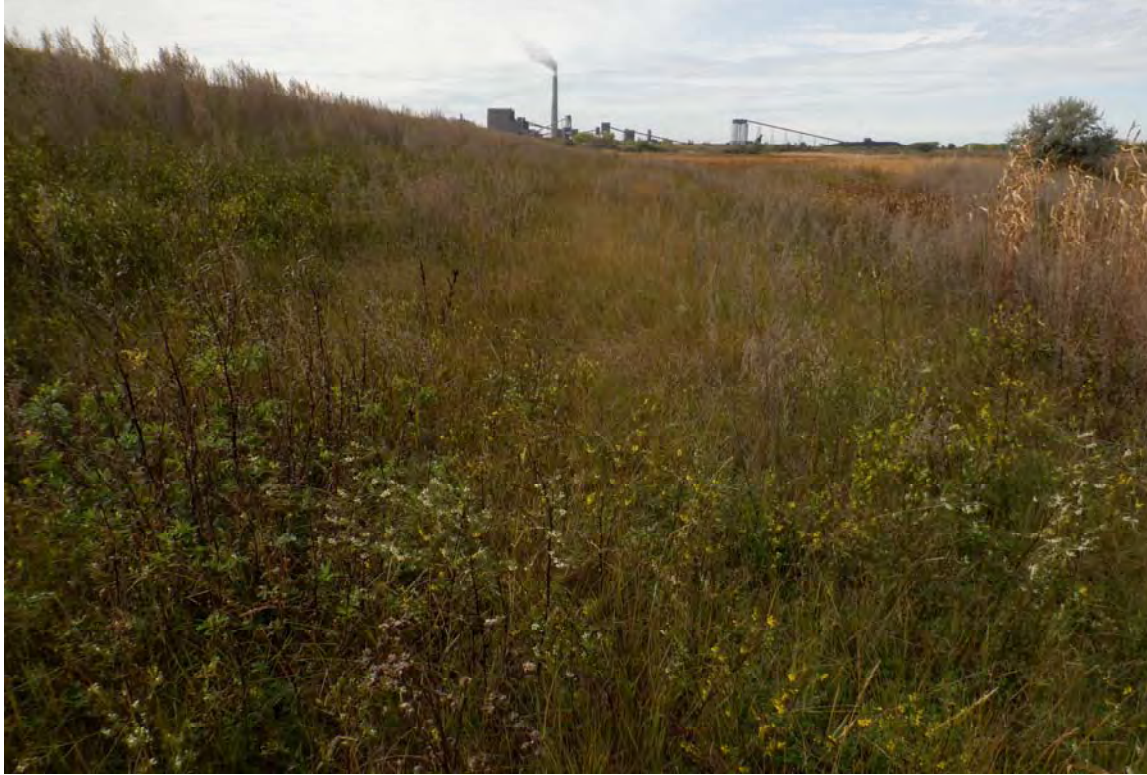
Photograph 7 (CWCA north downstream slope)  
North berm downstream slope and toe, typical (DSCF0471.JPG)

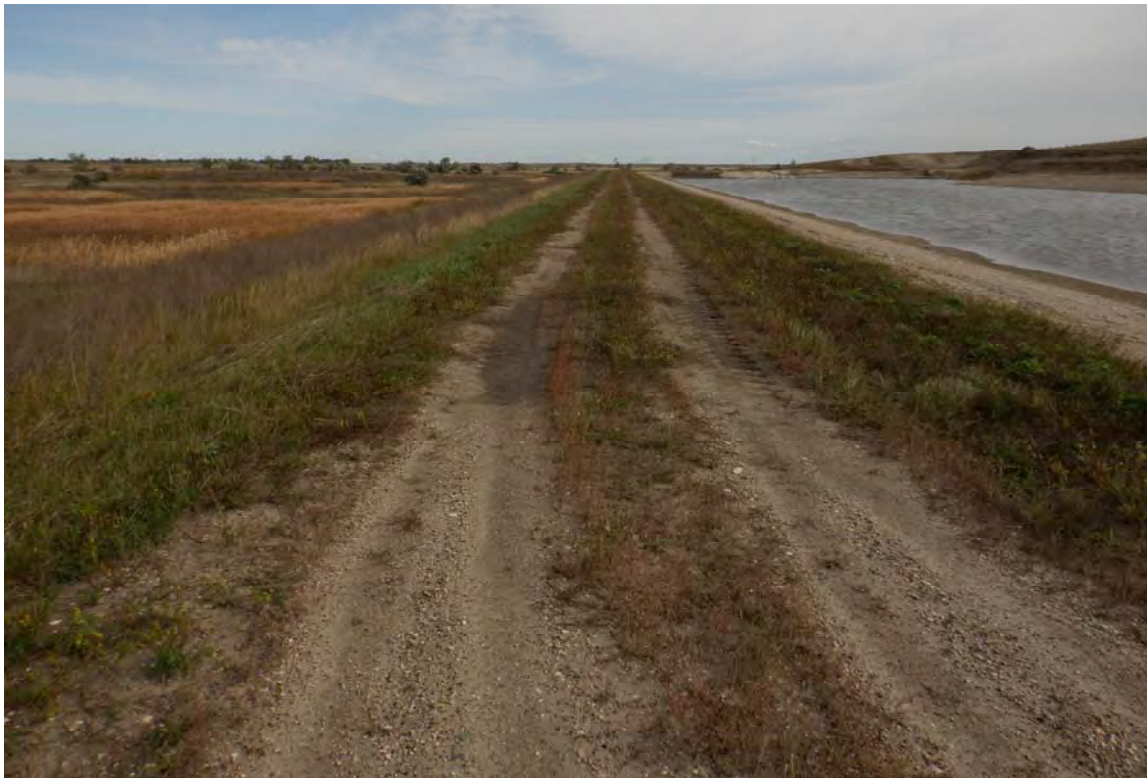
Photograph 8 (CWCA north berm crest)  
Contact water collection area crest (looking east) (DSCF0475.JPG)

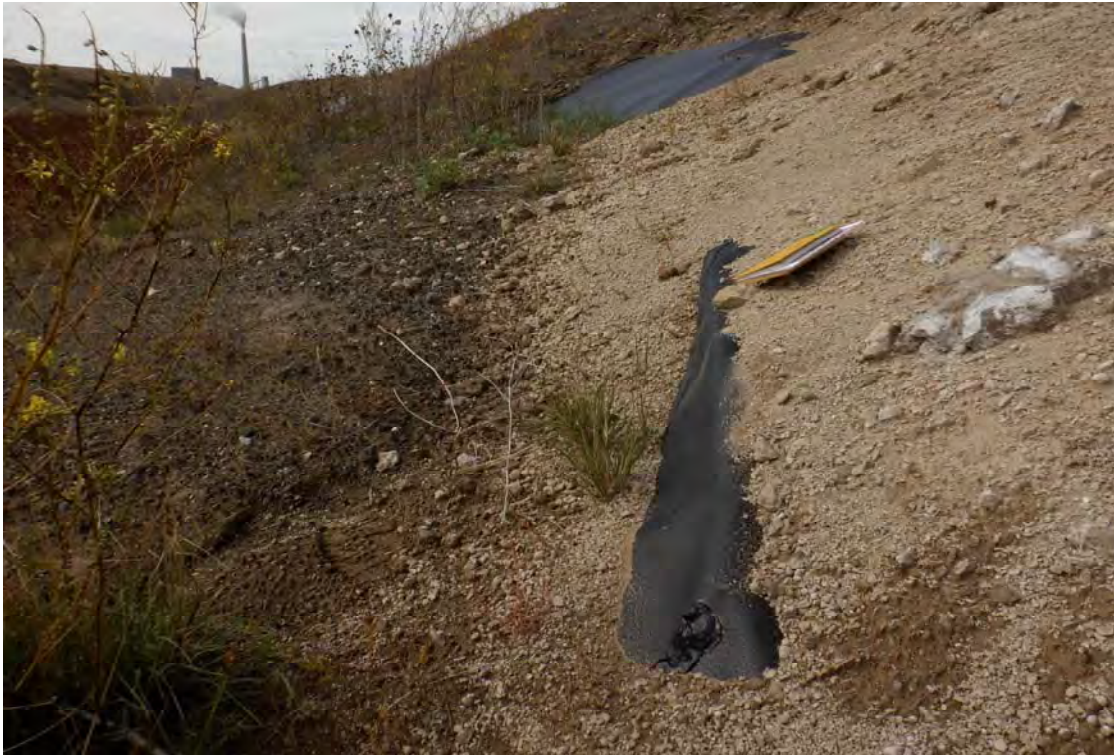
a. Erosion (exposed liner)	X			Exposed liner on north berm, minor damage to geomembrane on upper portion of berm.
b. Vegetation		X		
c. Rodent burrows		X

Photograph 9 (North CWCA channel)  
Wrinkle in exposed geomembrane liner on upstream slope (DSCF0479.JPG)

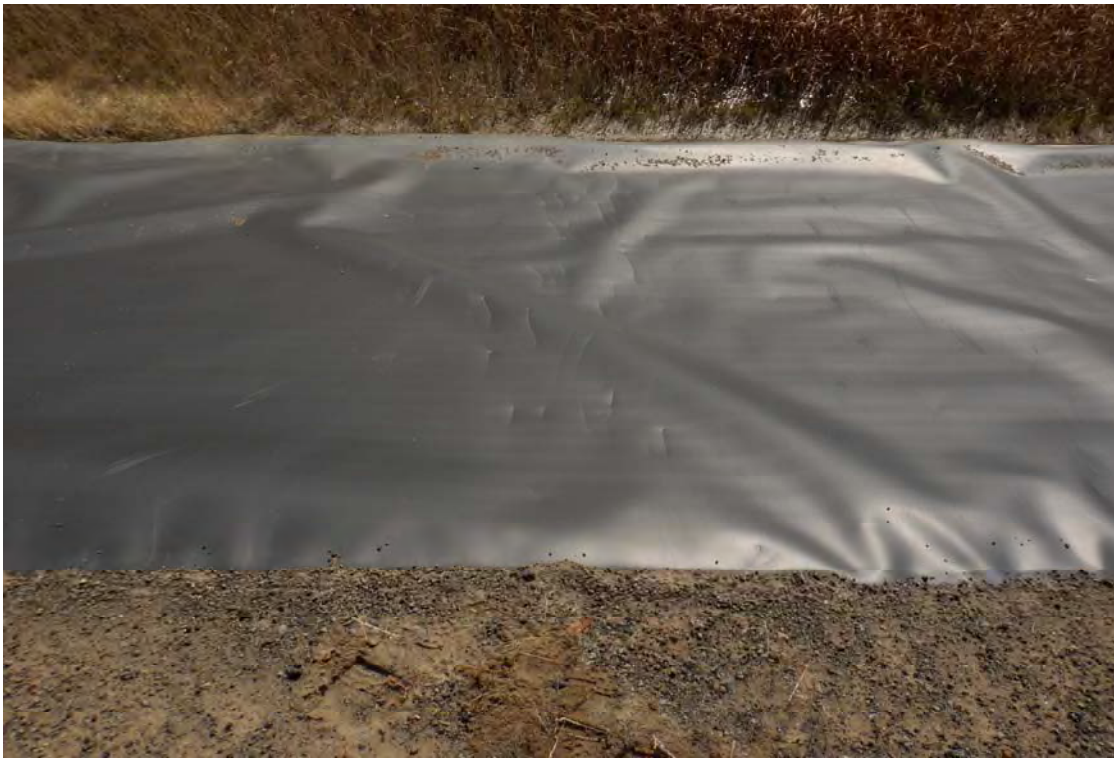
Photograph 10 (North CWCA channel)  
Exposed geomembrane on upstream slope of CWCA channel and damage from animals (DSCF0482.JPG)

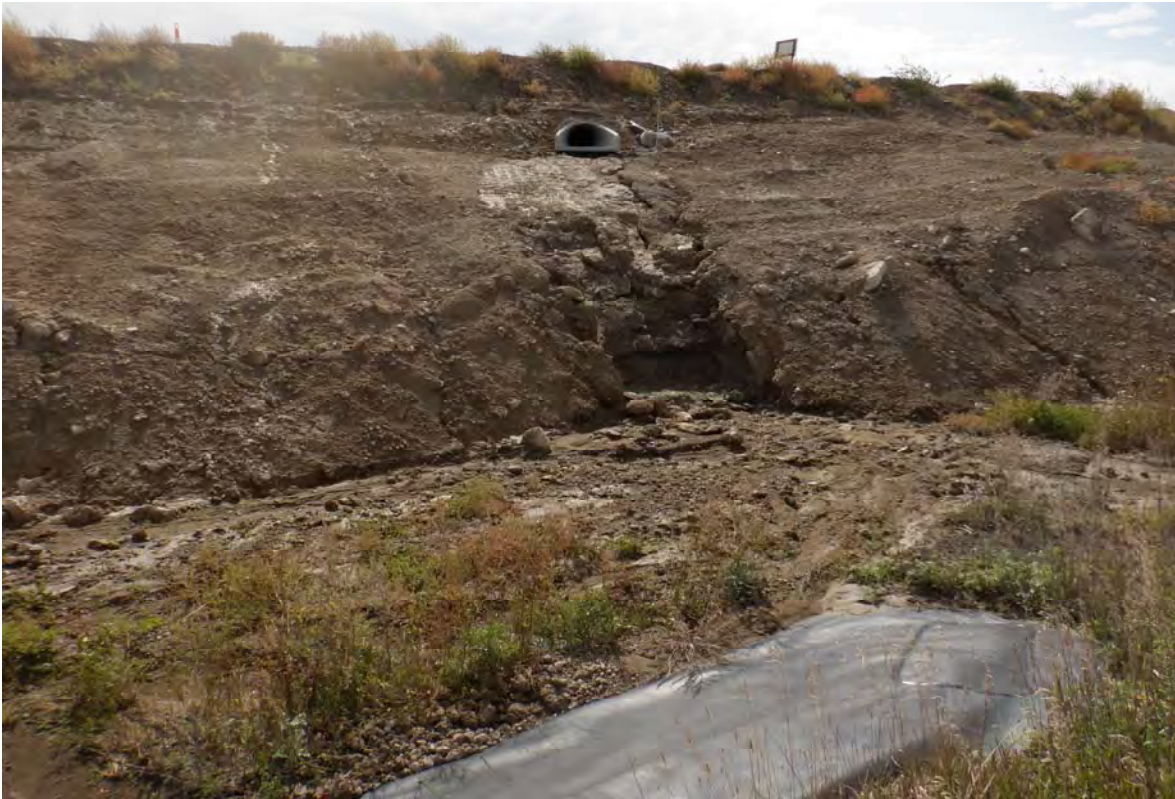
Photograph 11 (North CWCA channel)  
Erosion of fly ash below culvert, Upstream Raise 92 area to CWCA channel (DSCF0485.JPG)

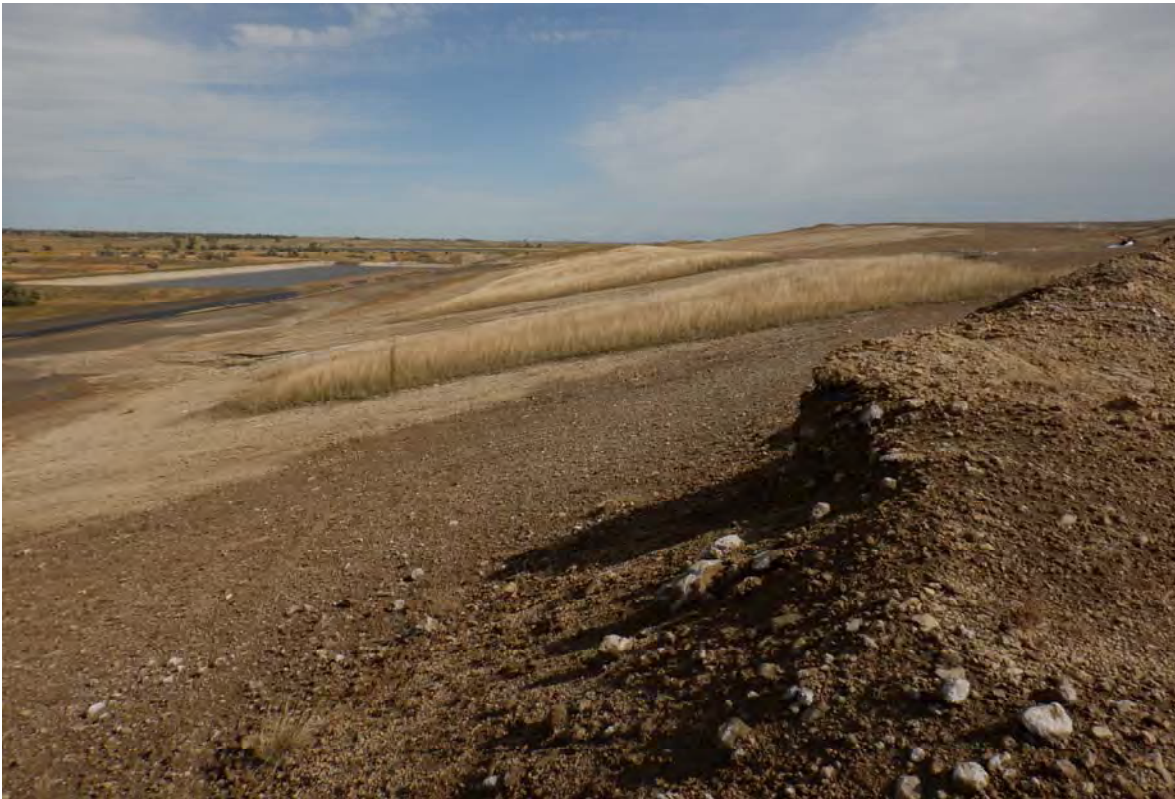
Photograph 12 (North CCR downstream slope)  
Temporary cover on north fly ash slope (DSCF0488.JPG)

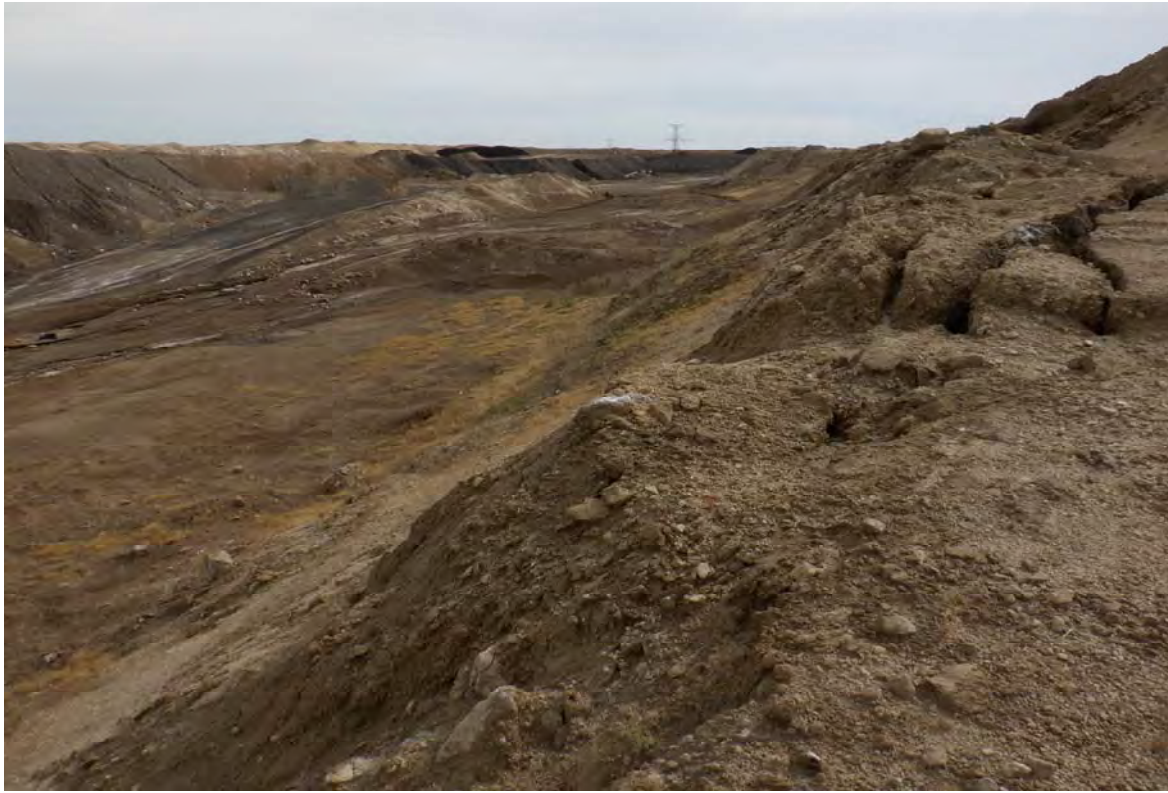
Photograph 13 (C&D area)  
Minor erosion on interior slopes to historic C&D access area of Southeast 16 (DSCF0495.JPG)

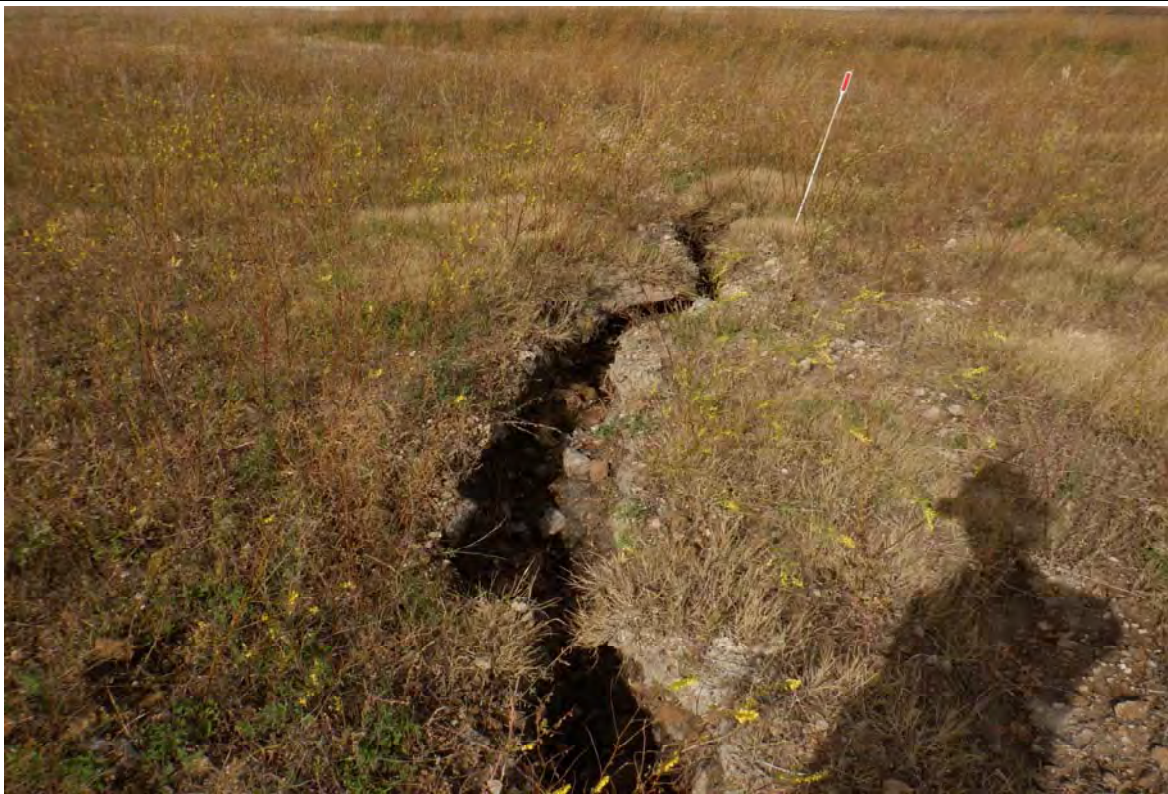
Photograph 14 (Northeast CCR downstream slope)  
Erosion rill in temporary cover on northeast CCR downstream slope (DSCF0499.JPG)

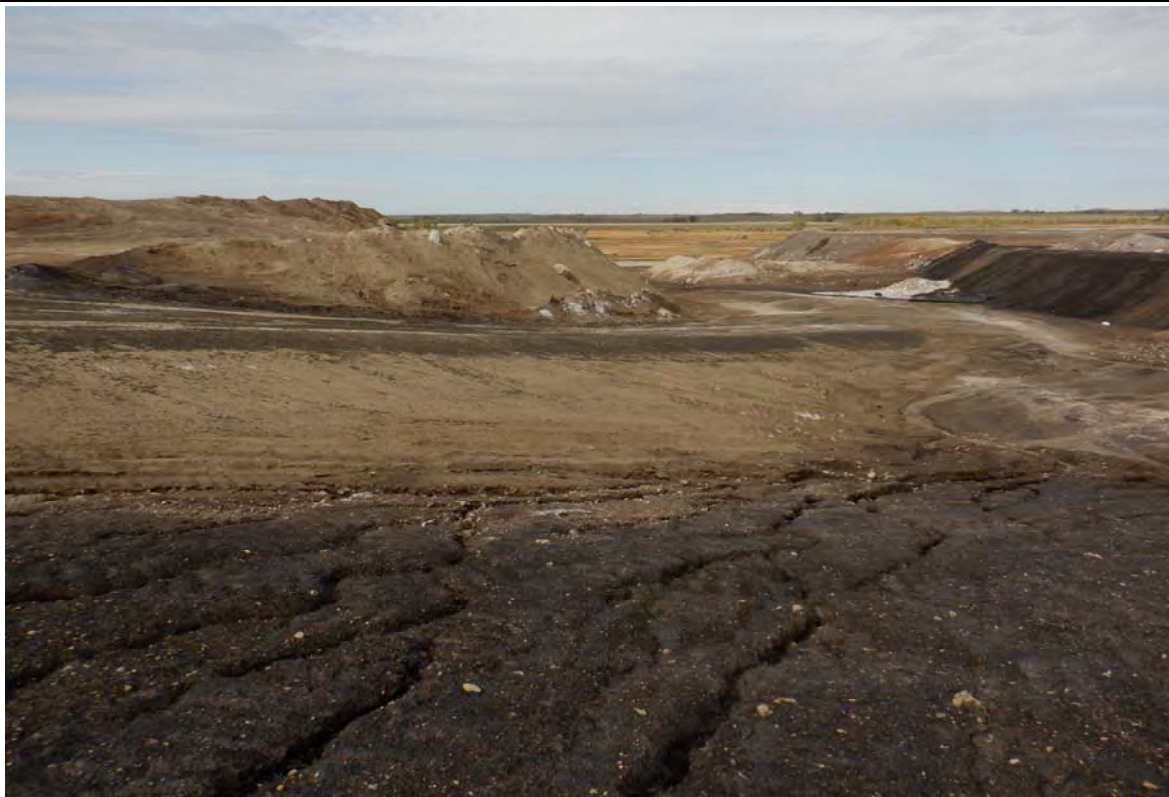
Photograph 15 (C&D area)  
Access road and deposition of C&D material within C&D area (DSCF0501.JPG)

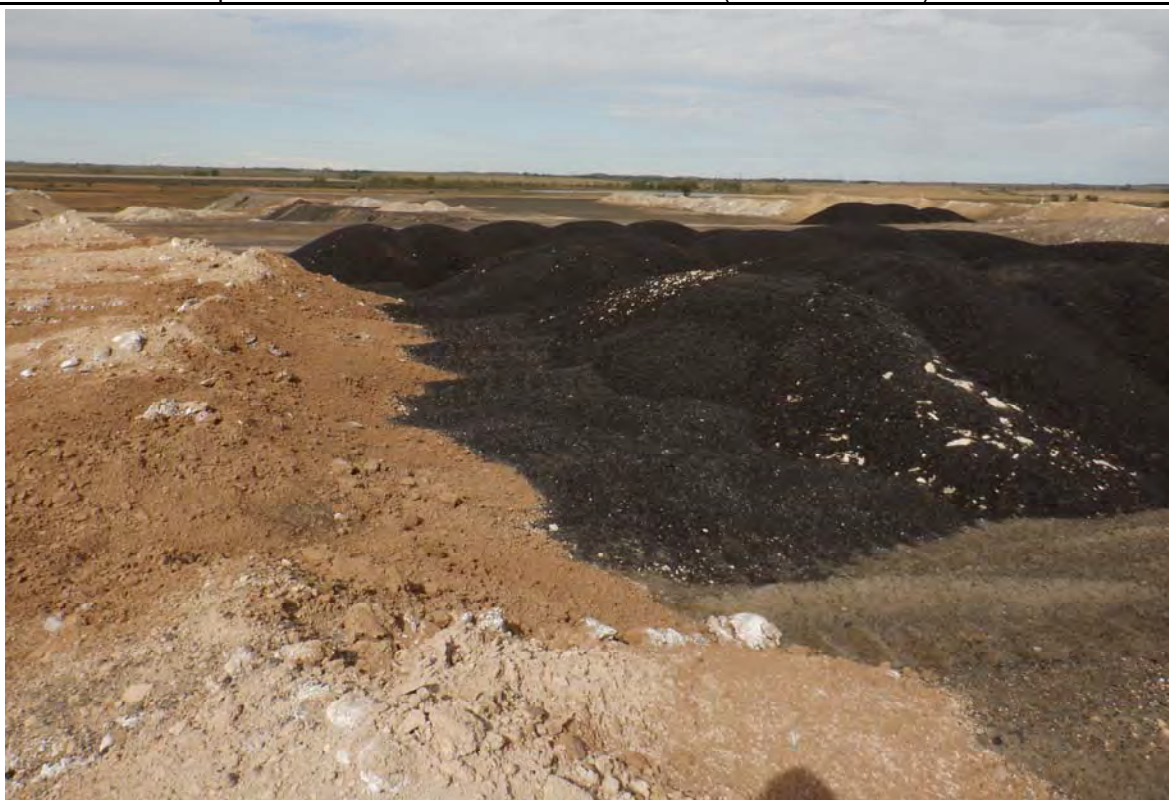
Photograph 16 (CCR placement)  
CCR material containment on west, south, and east sides of Southeast 16 (DSCF0502.JPG)

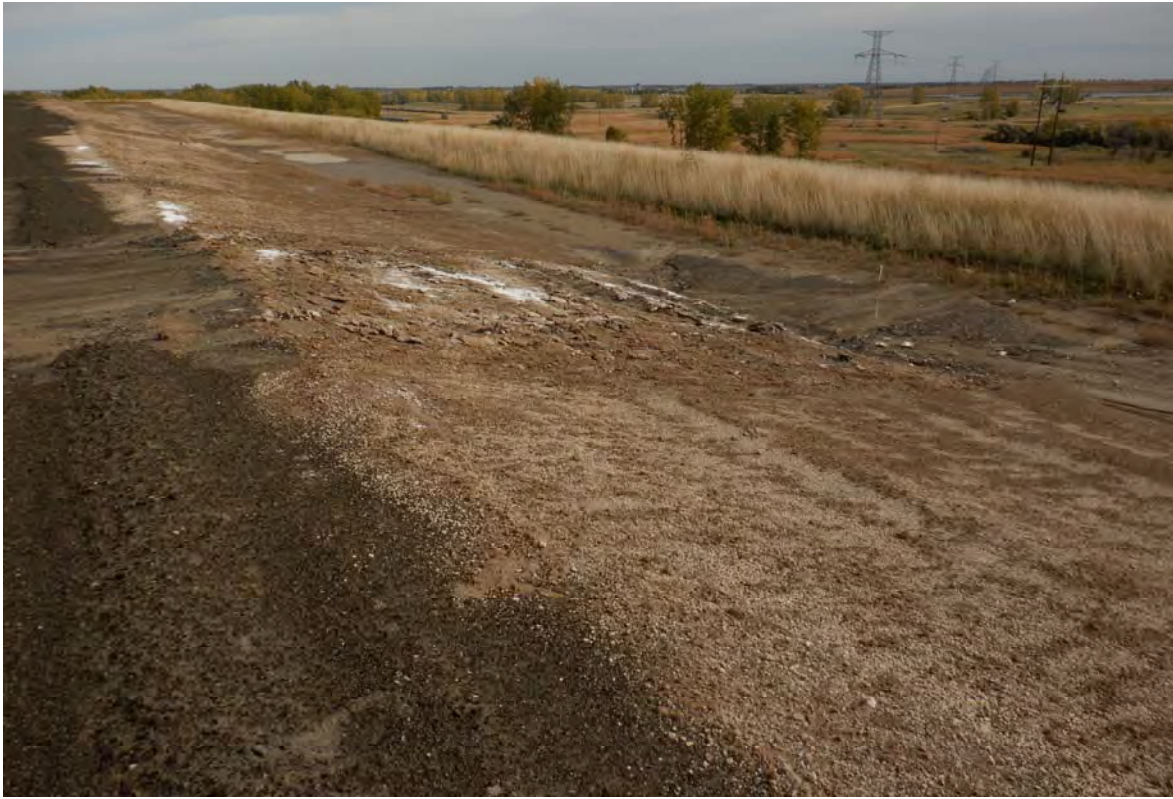
Photograph 17 (South CCR downstream slope (no cover))  
Erosion of fly ash on the south CCR downstream slope (DSCF0504.JPG)

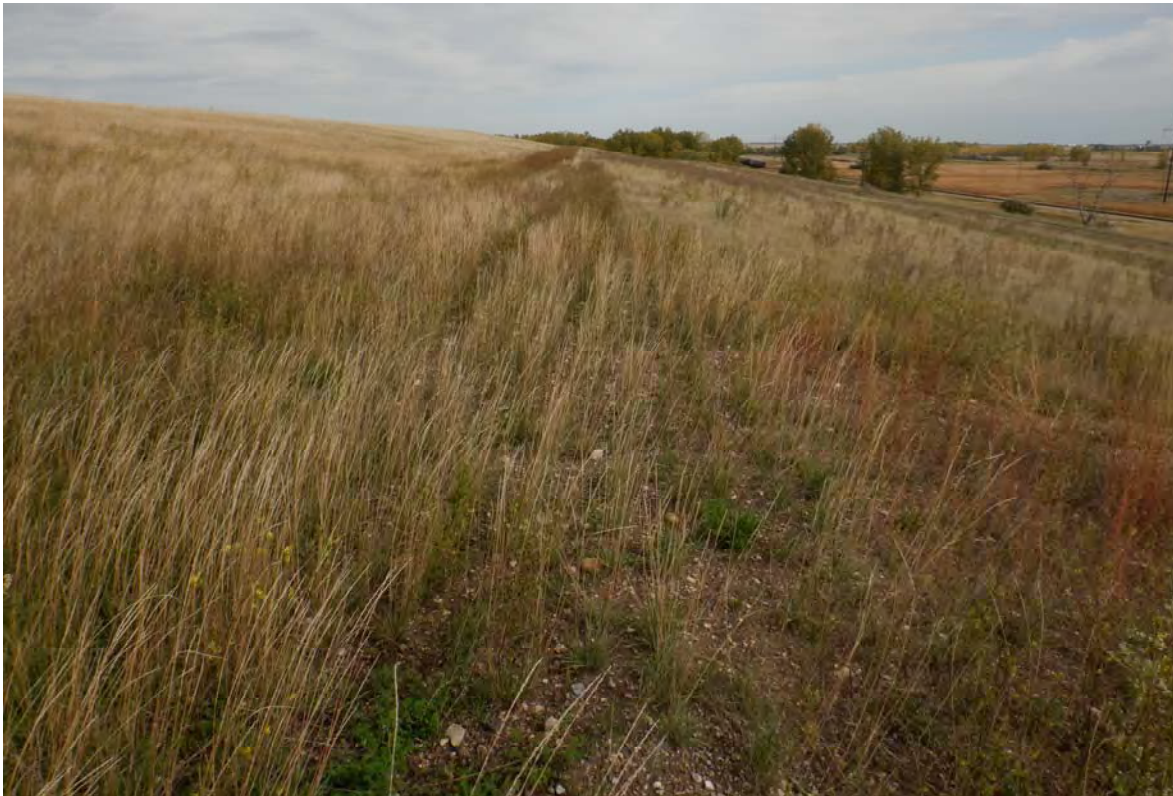
Photograph 18 (South CCR downstream slope (covered))  
South downstream slope final cover, minor sparse vegetation (DSCF0505.JPG)
