REPORT

Annual Inspection

Coal Creek Station - Upstream Raise 91 CCR Surface Impoundment

January 2020

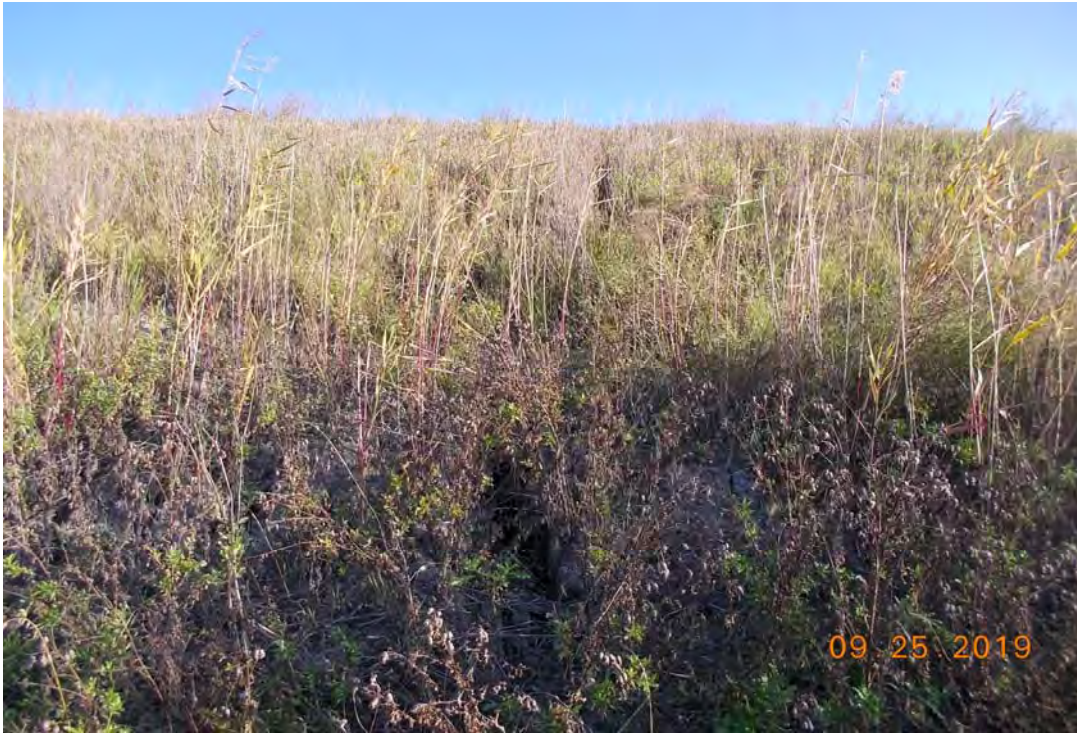
i. Crest rodent burrows		X		
j. Downstream slope erosion	X			Minor erosion rills.
k. Downstream slope rodent burrows	X			Small burrows.
l. Downstream slope vegetation	X			Healthy grass on north side, fair to good vegetation growth on south and west sides.

Photograph 1 (South berm downstream slope)
Large erosion rill on vegetated slope (PDS UR91 (5).JPG)

Minor maintenance items that may need to be continually addressed include repairing large animal burrows as they appear, monitoring erosion and vegetative success of the re-configured surface water channel along the west and south toe of the facility, clean-out of collected material in the contact water perimeter channels and maintaining gravity and culvert piping, repairing and re-seeding eroded areas on or adjacent to berm downstream slopes, and removal of any woody vegetation growing on the berm downstream slopes. In addition, the inflow and outflow piping should be monitored regularly and cleared of debris as required to ensure proper conveyance of water to and from the facility.

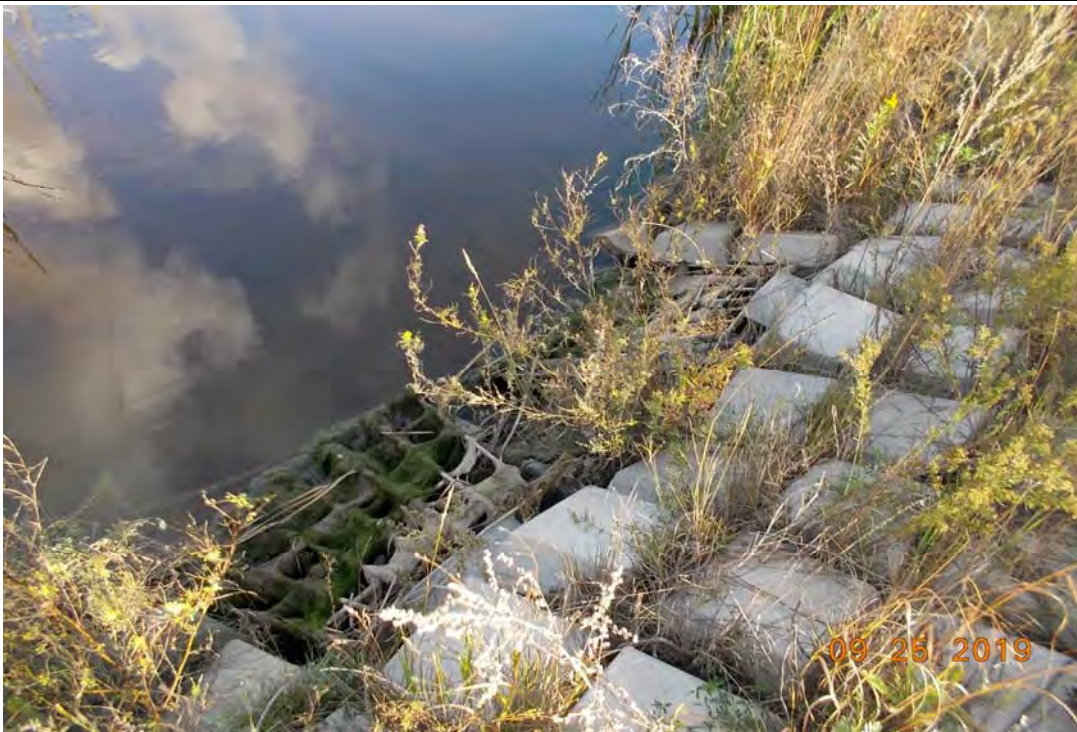
Additional pipelines and contact water control features (contact water perimeter channels and culverts) inside Upstream Raise 91 convey water to downstream facilities. These include a series of gravity drainage pipes, seepage pipes, and perimeter channels and culverts that transfer CCR conveyance water from the facility to the adjacent Drains Pond System. The gravity drains were constructed at the design elevation and appeared to be free from obstructions and in good working order. Seepage piping was below the elevation of the water and could not be observed. The culverts connecting the contact water perimeter channels were in fair condition at the time of the inspection, as sediment had accumulated at the culvert inlets.

Photograph 2 (Southwest toe and ditch)
Inlet side of surface water drainage culvert, algae on trash guard limiting full flow (PDS UR91 (15).JPG)

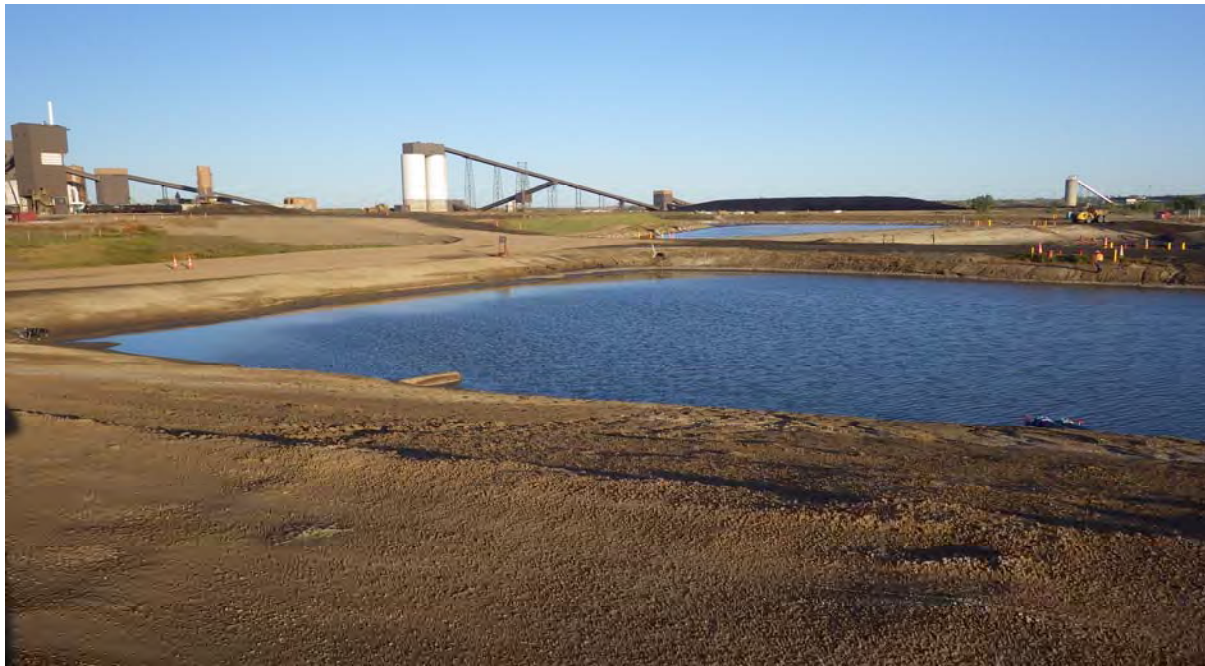
Photograph 3 (Northwest internal berm crest)
Northwest pool (panoramic view, 1 of 2) (IMGP6970.JPG)

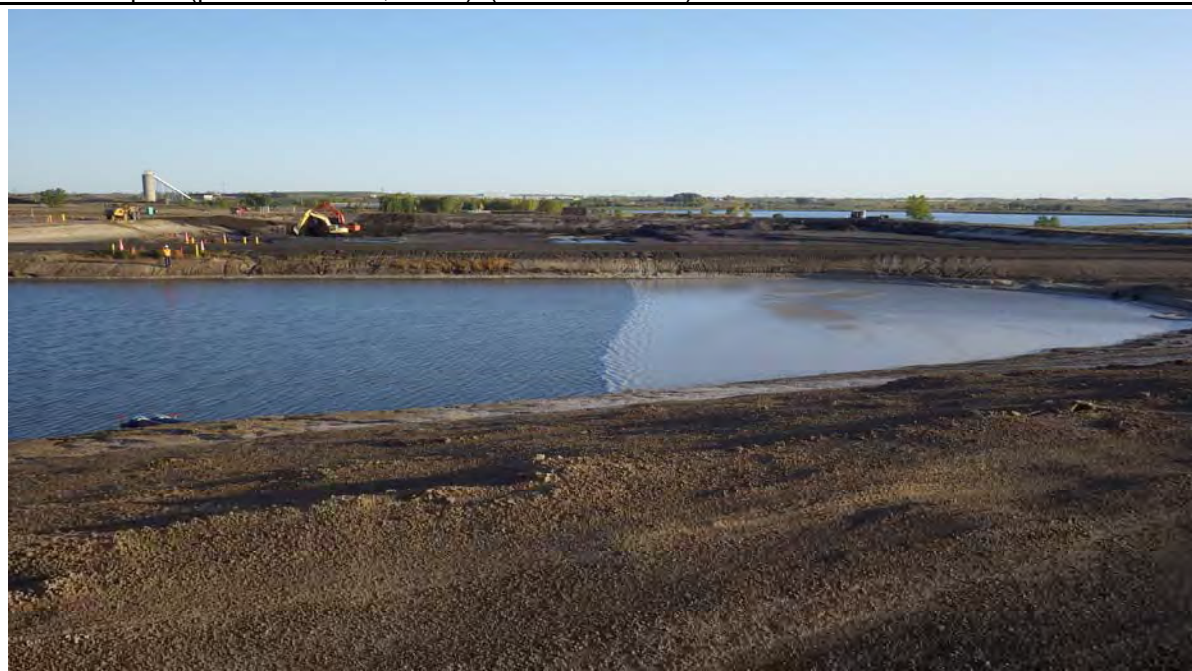
Photograph 4 (Northwest internal berm crest)
Northwest pool (panoramic view, 2 of 2) (IMGP6971.JPG)

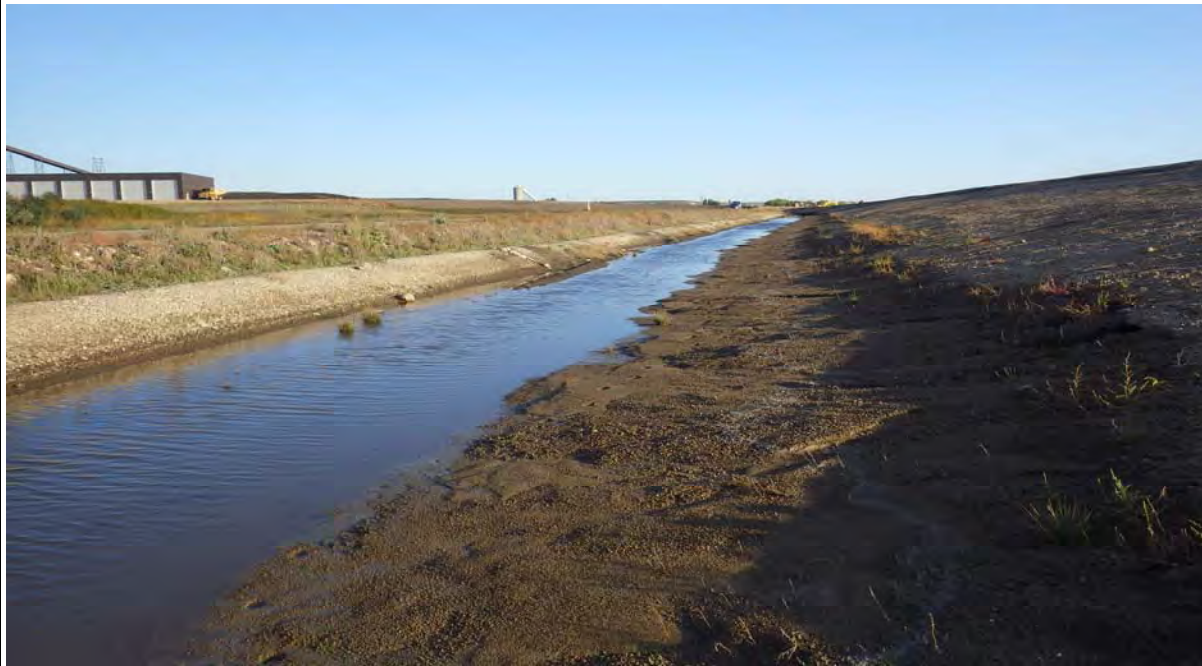
Photograph 5 (West CCR downstream slope)
Perimeter channel and CCR downstream slope saturated to approximately elevation 1919 feet
(IMGP6978.JPG)

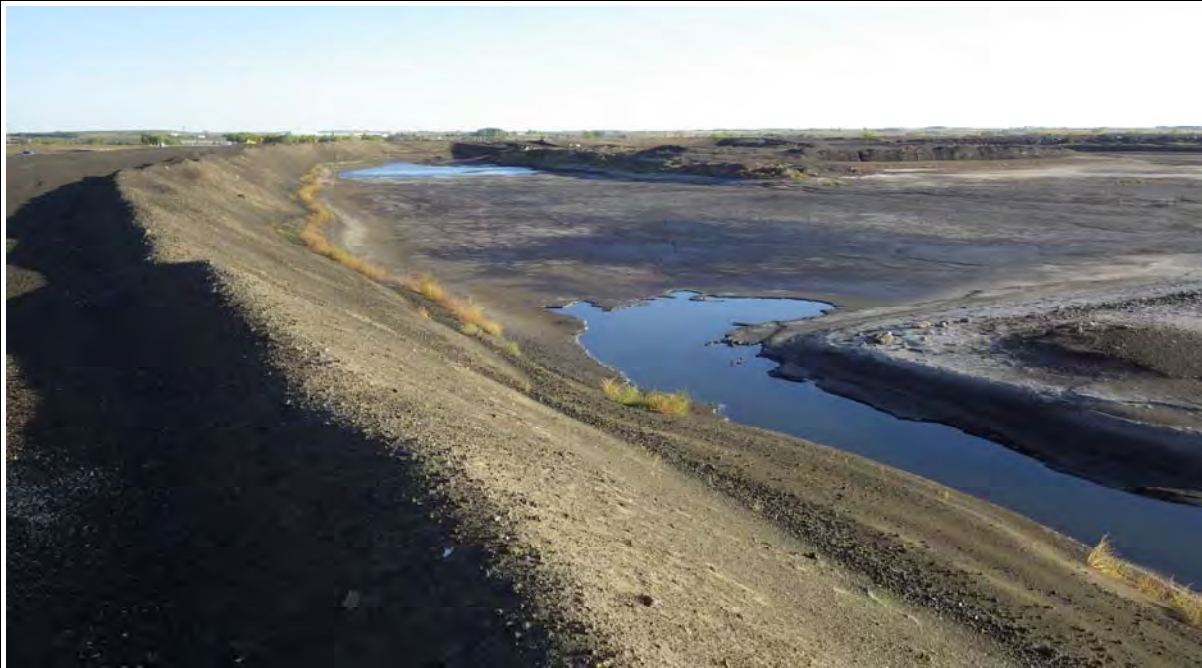
Photograph 6 (Southwest CCR berm crest)
Upstream Raise 91 interior and CCR upstream slope (IMGP6979.JPG)

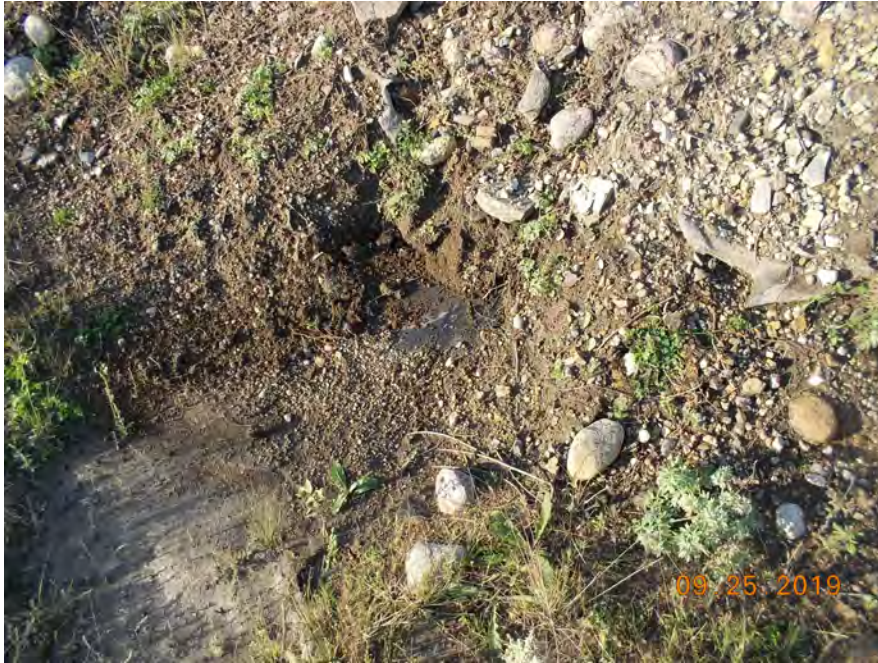
a. Upstream slope erosion (exposed liner)	X			Minor erosion of fly ash protective cover with geomembrane liner exposed in southwest corner.
b. Upstream slope rodent burrows		X

Photograph 7 (Southwest berm upstream slope)
Erosion of fly ash protective cover and exposed geomembrane (PDS UR91 (2).jpg)

General Remarks: No significant issues. Minor maintenance includes addressing small burrows, replacing and maintaining fly ash protective cover (especially in areas noted to have exposed geomembrane), maintaining and removing sediment from inflow and outflow piping, and addressing erosion as observed.

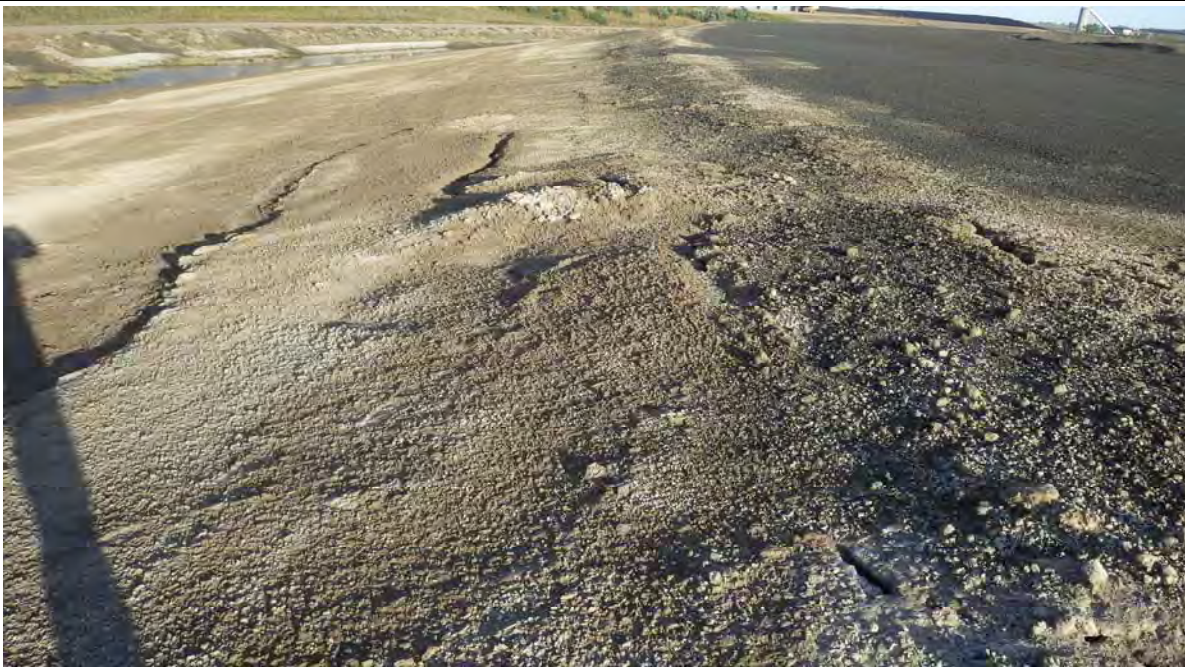
Photograph 8 (Southwest CCR downstream slope)
Minor cracking of reactive fly ash on the CCR downstream slope (IMGP6982.JPG)

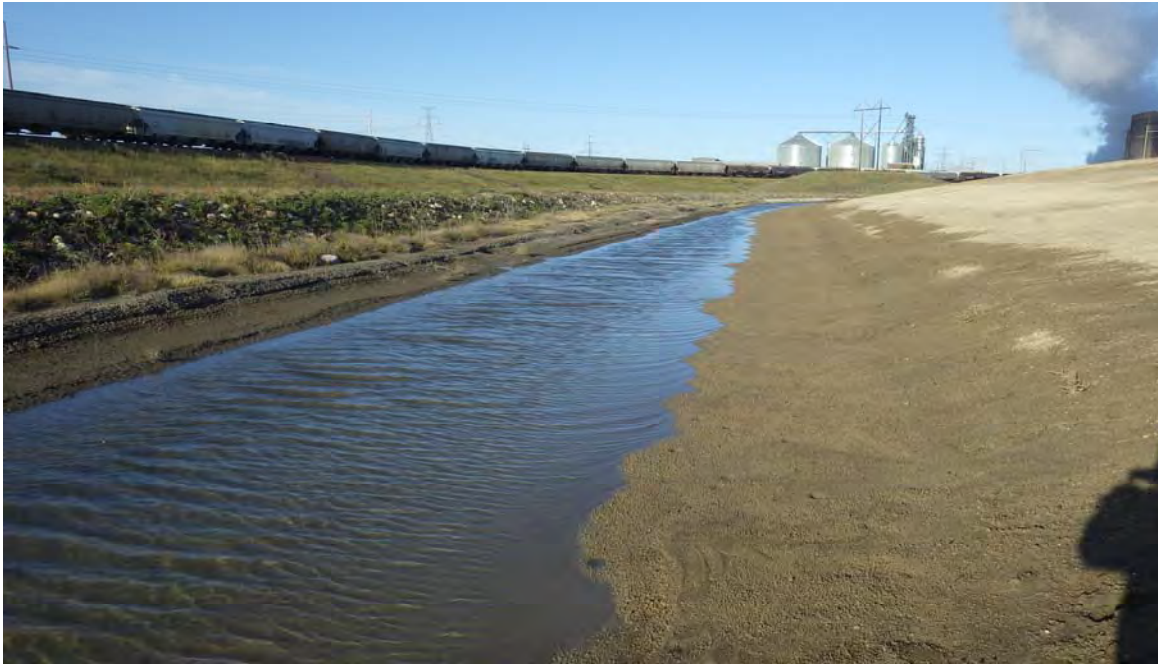
Photograph 9 (South CCR downstream slope)
Perimeter channel and downstream CCR slope saturated to approximately elevation 1919 feet
(IMGP6988.JPG)

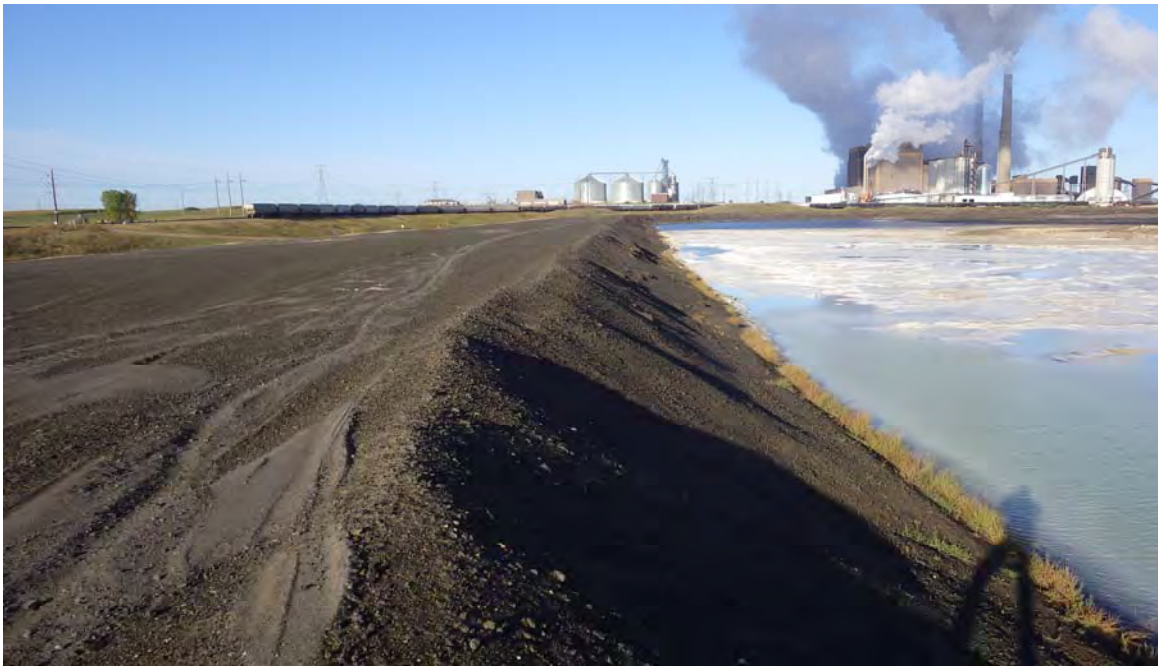
Photograph 10 (South CCR upstream slope and berm crest)
CCR berm crest, CCR upstream slope and Flue Gas Desulfurization (FGD) pool (IMGP6992.JPG)

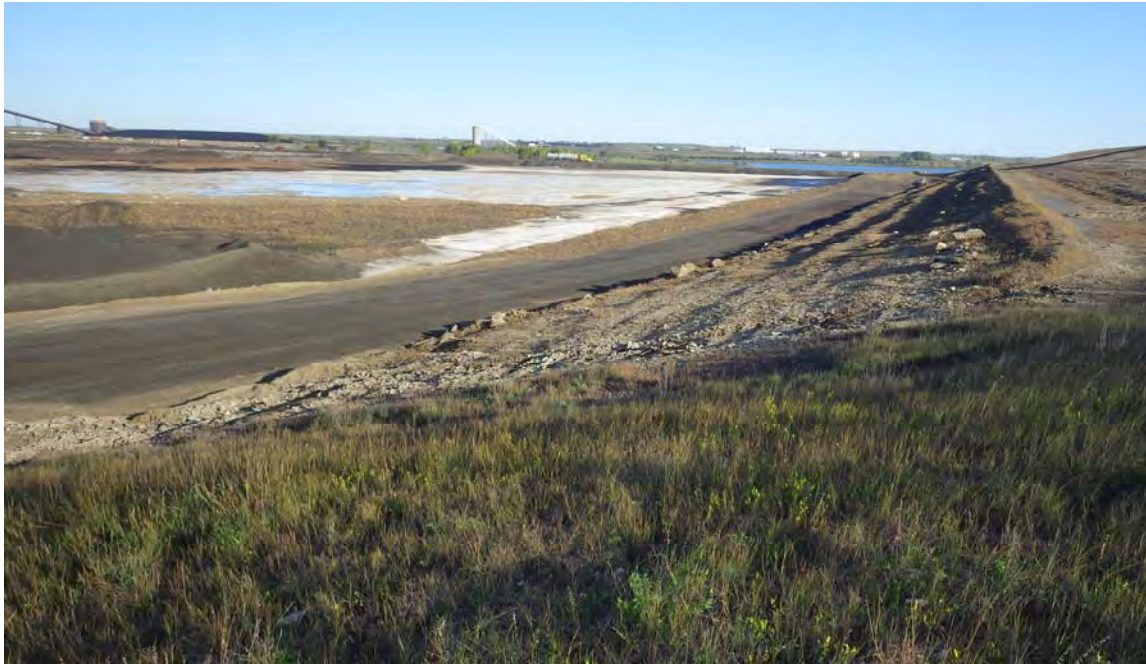
Photograph 11 (Southeast corner)
Upstream Raise 91 and Upstream Raise 92 shared CCR berm (IMG6994.JPG)

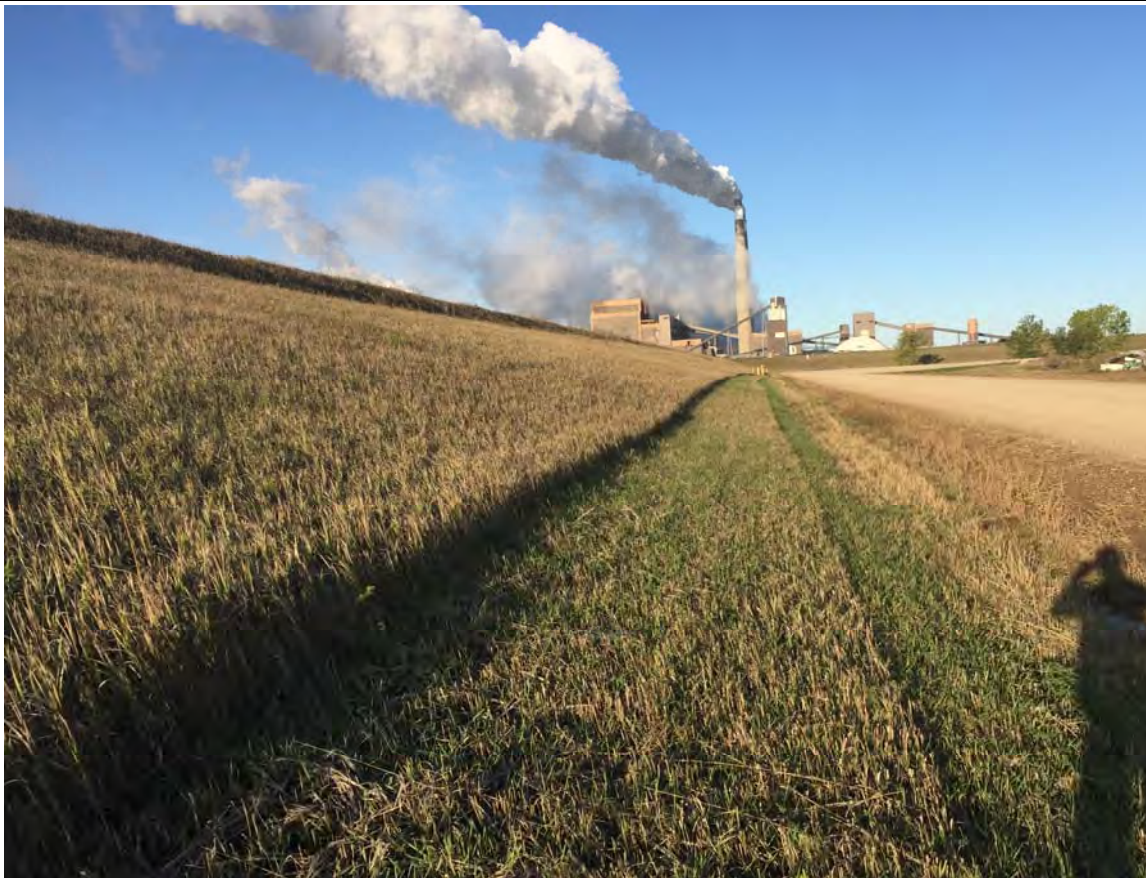
Photograph 12 (North downstream slope and toe)
Well-vegetated downstream slope and toe (2.JPG)

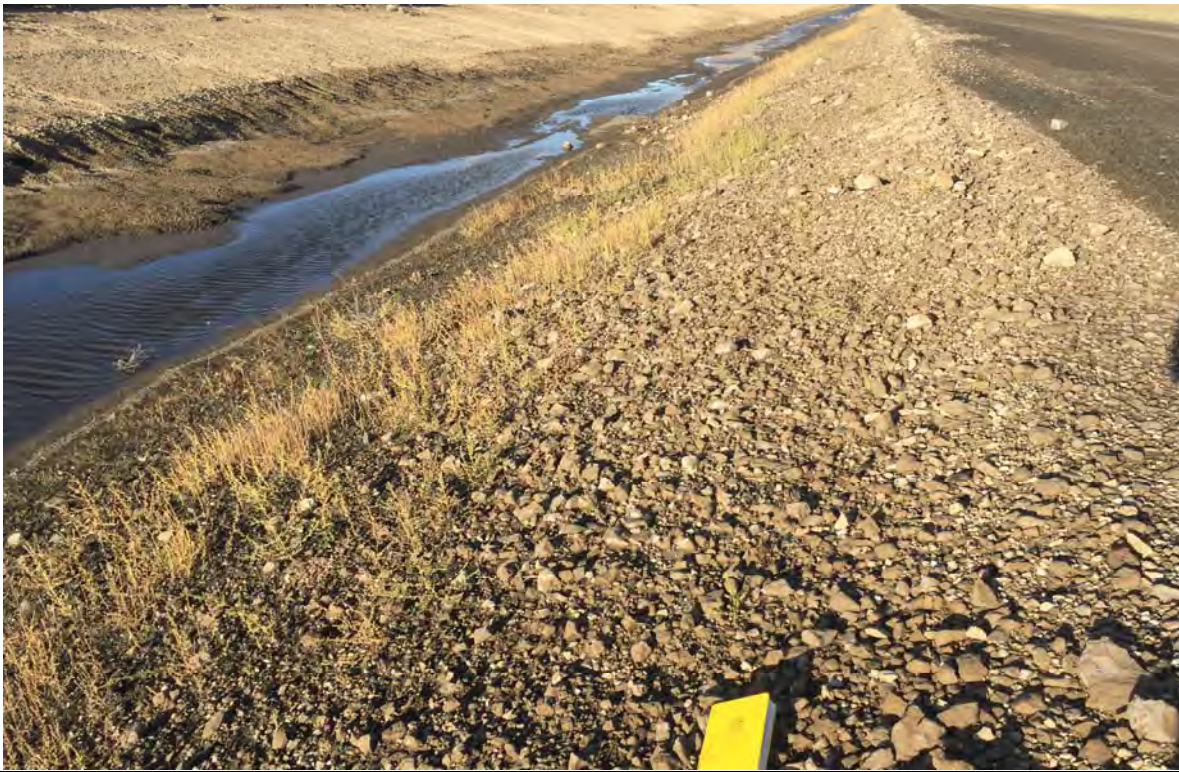
Photograph 13 (North perimeter ditch)
North berm upstream slope fly ash protective cover and perimeter channel (7.JPG)

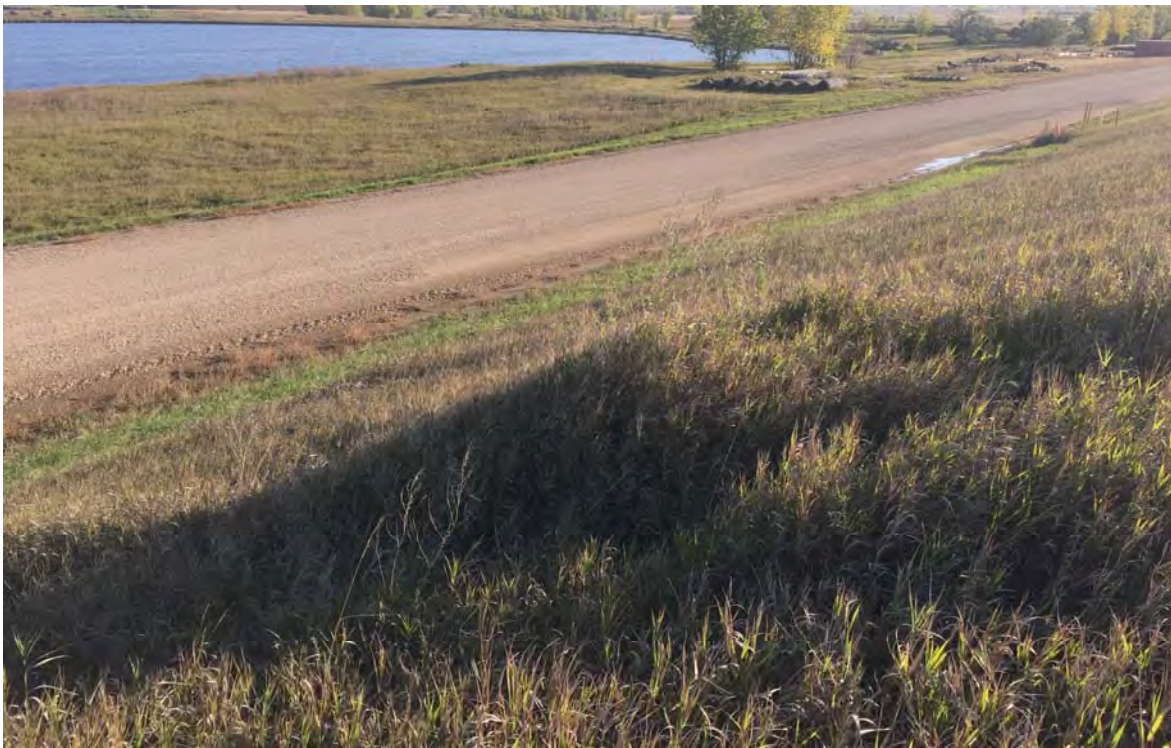
Photograph 14 (North downstream slope and toe)
Irregular slope geometry on the north downstream slope, well-vegetated (11.JPG)

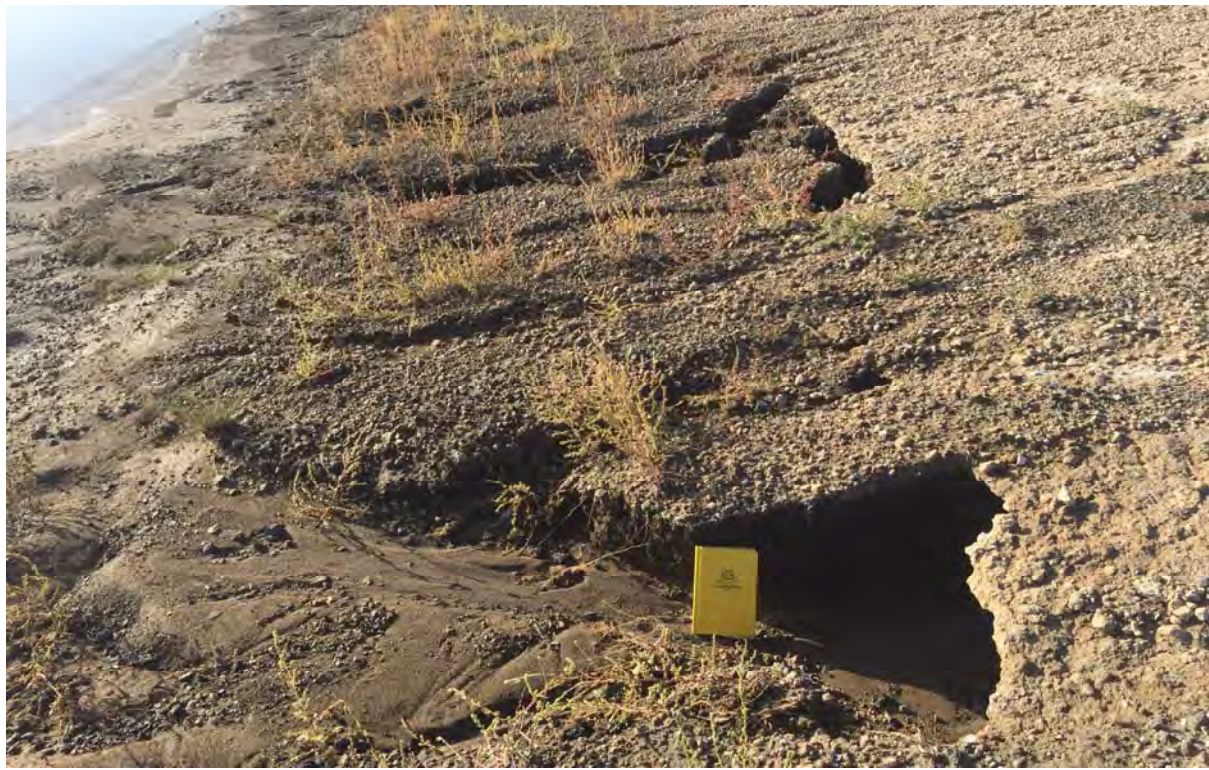
Photograph 15 (Northwest berm crest)
Erosion of berm upstream fly ash slope near the northwest contact water pool of Upstream Raise 91 (18.JPG)

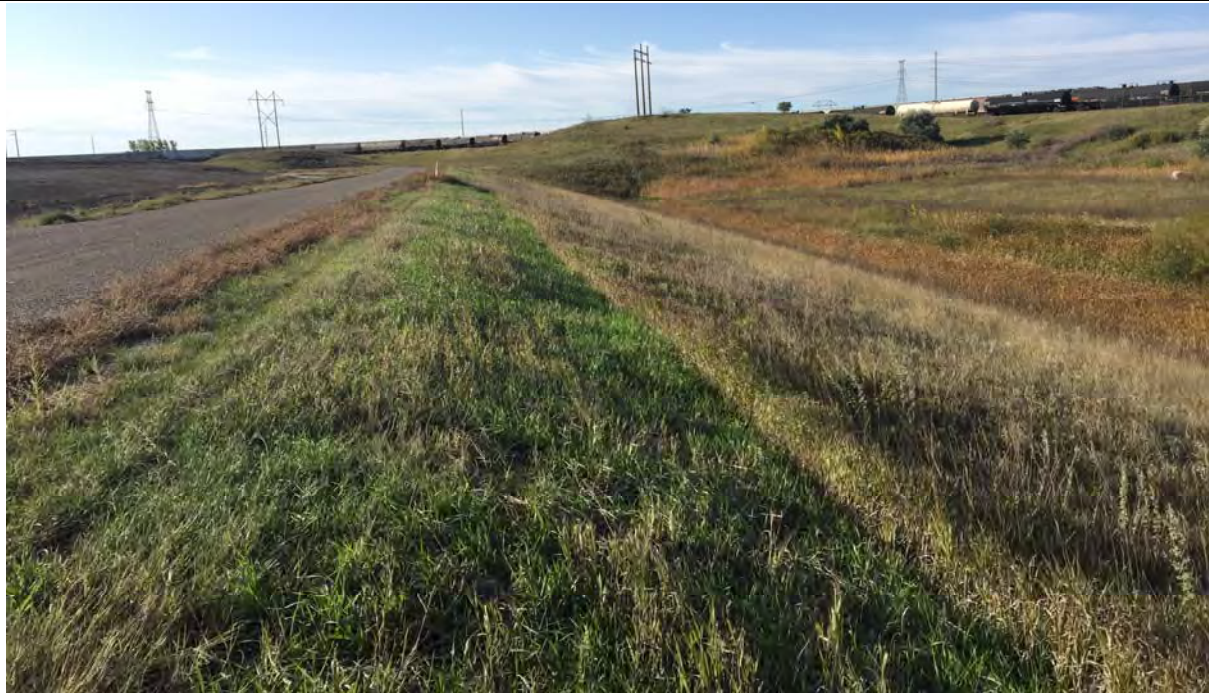
Photograph 16 (West downstream slope)
Berm crest and downstream slope, well-vegetated (24.JPG)

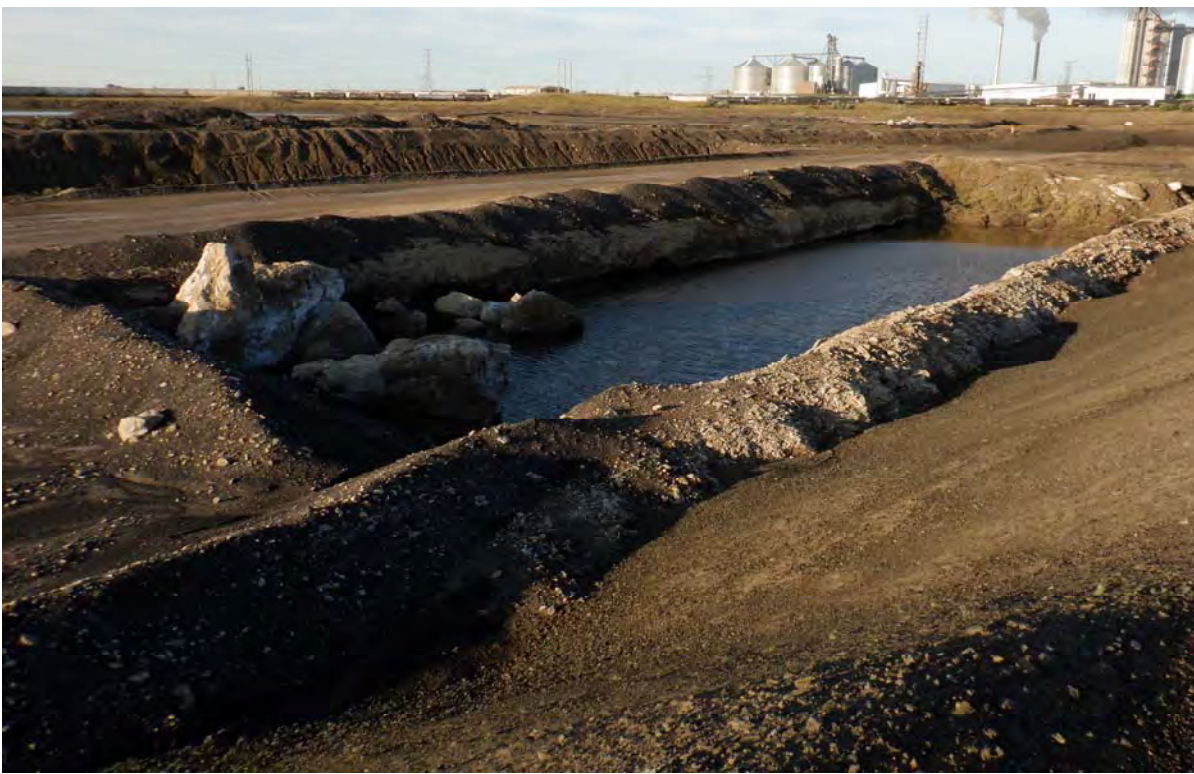
Photograph 17 (North CCR upstream slope)
Upstream Raise 91 interior and CCR placement (DSCF0540.JPG)

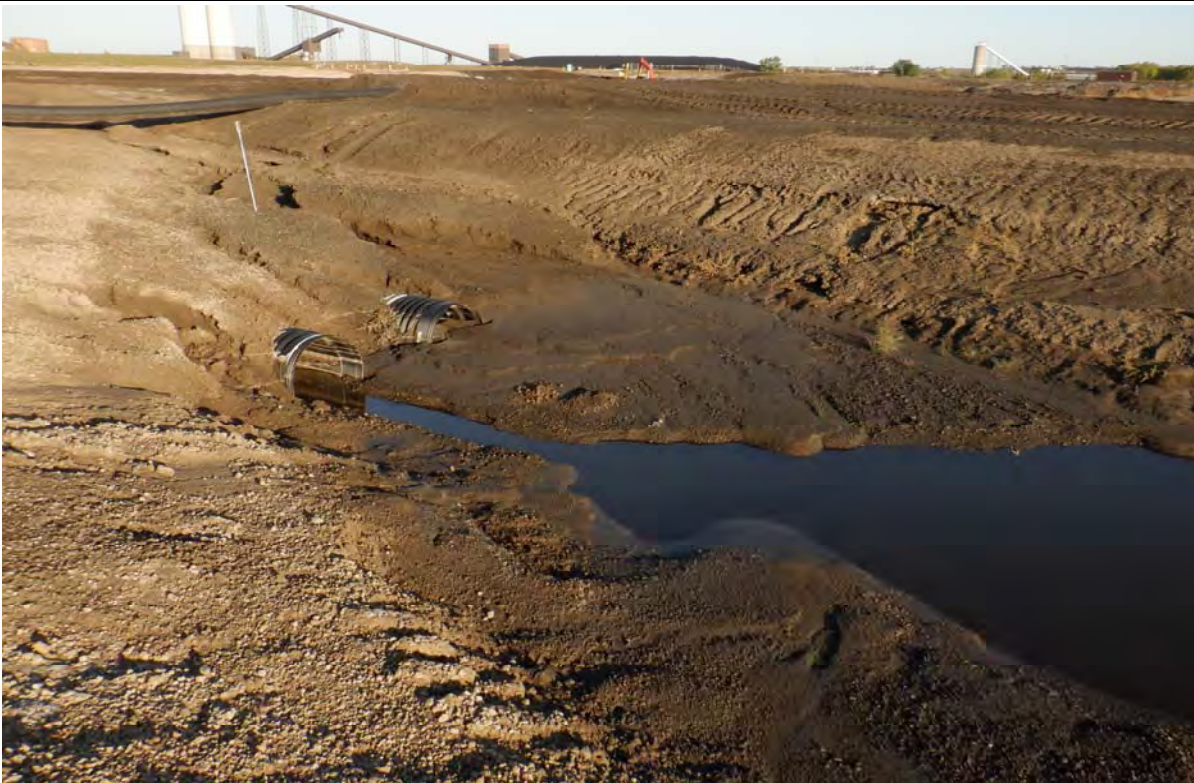
Photograph 18 (North perimeter ditch)
Inlet perimeter ditch culverts to northwest contact water pool (DSCF0542.JPG)

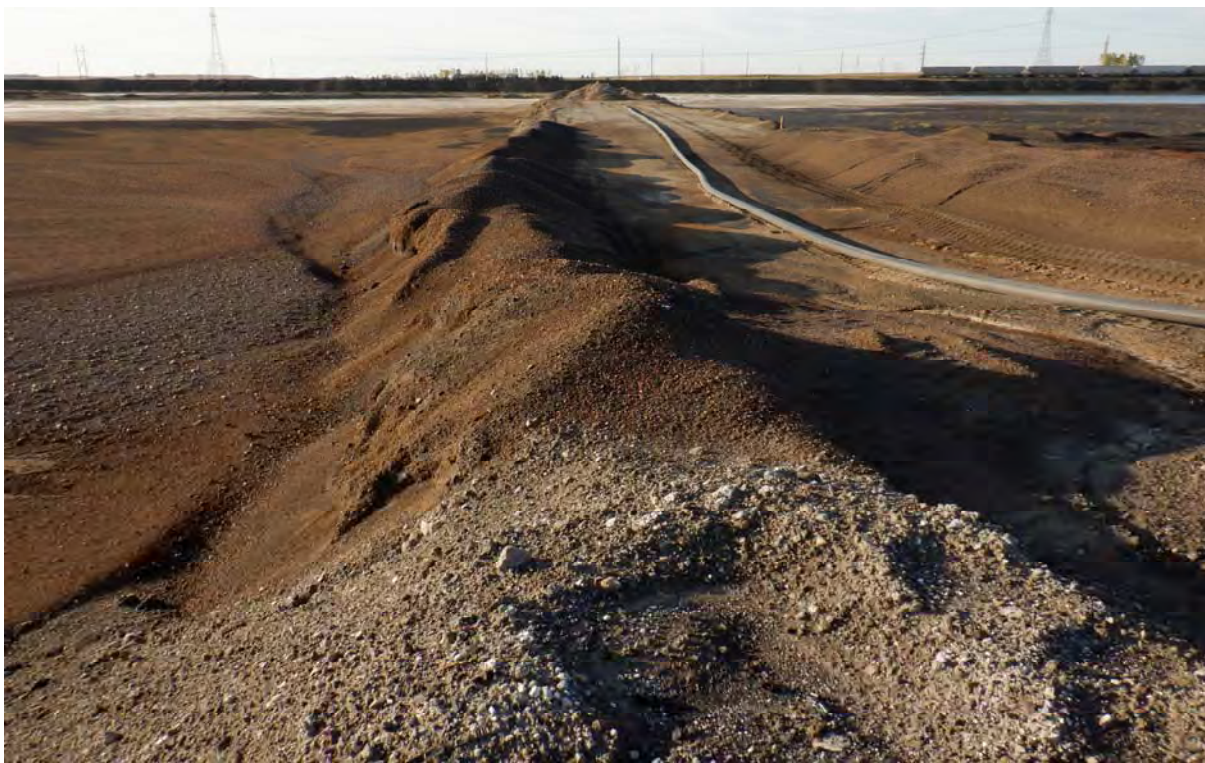
Photograph 19 (Upstream Raise interior)
Upstream Raise 91 interior and FGD inflow pipe (DSCF0544.JPG)

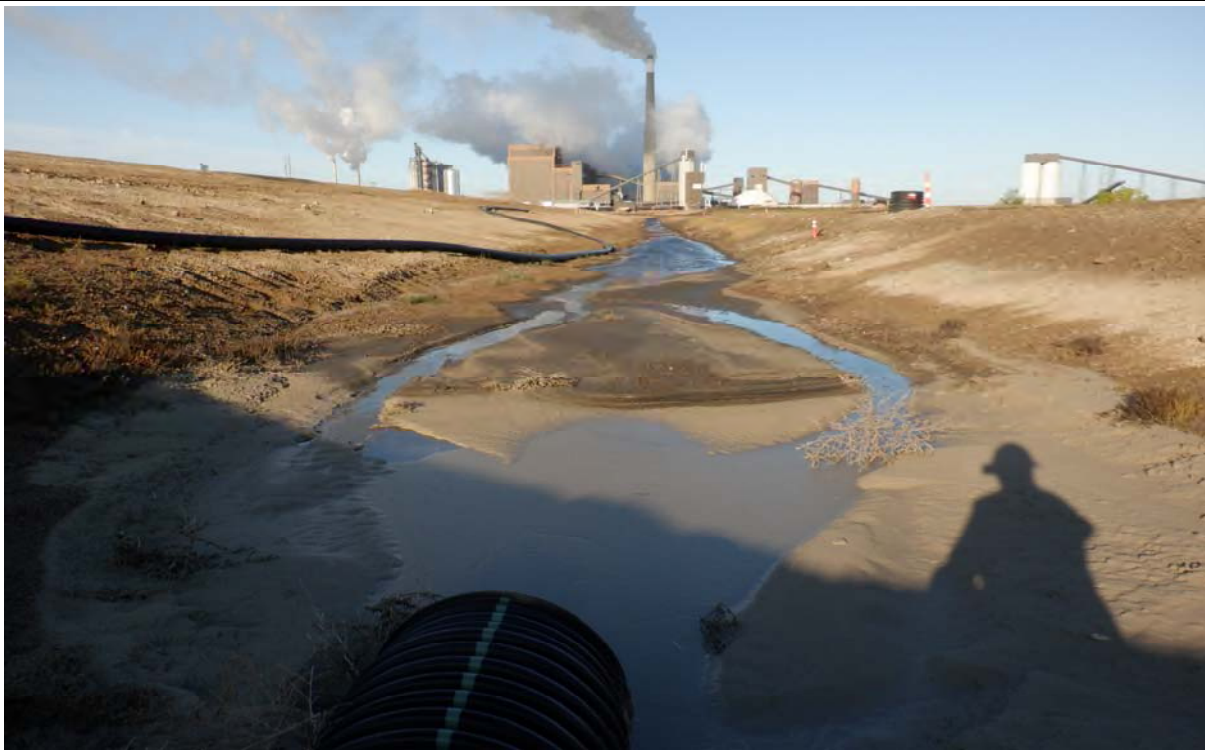
Photograph 20 (North perimeter ditch)
Culvert and drainage from Upstream Raise 92 in perimeter ditch (DSCF0546.JPG)

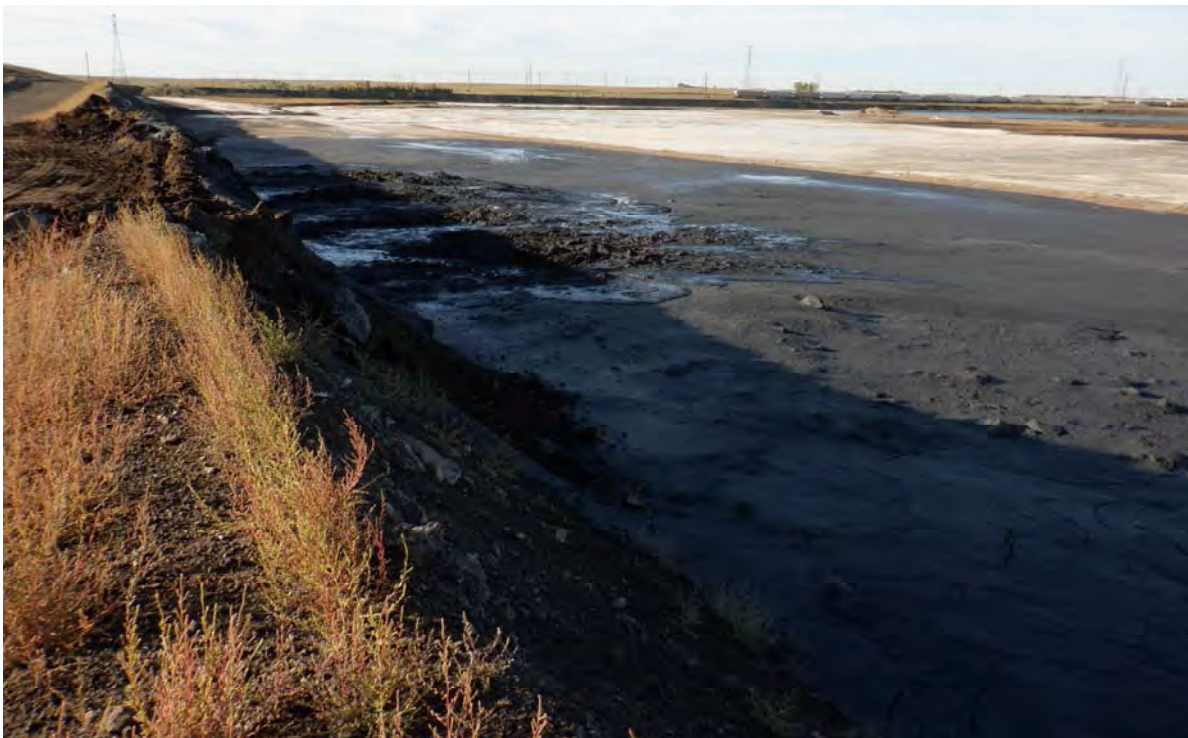
Photograph 21 (East CCR berm crest and upstream slope)
CCR material deposition on east side of Upstream Raise 91 (DSCF0548.JPG)

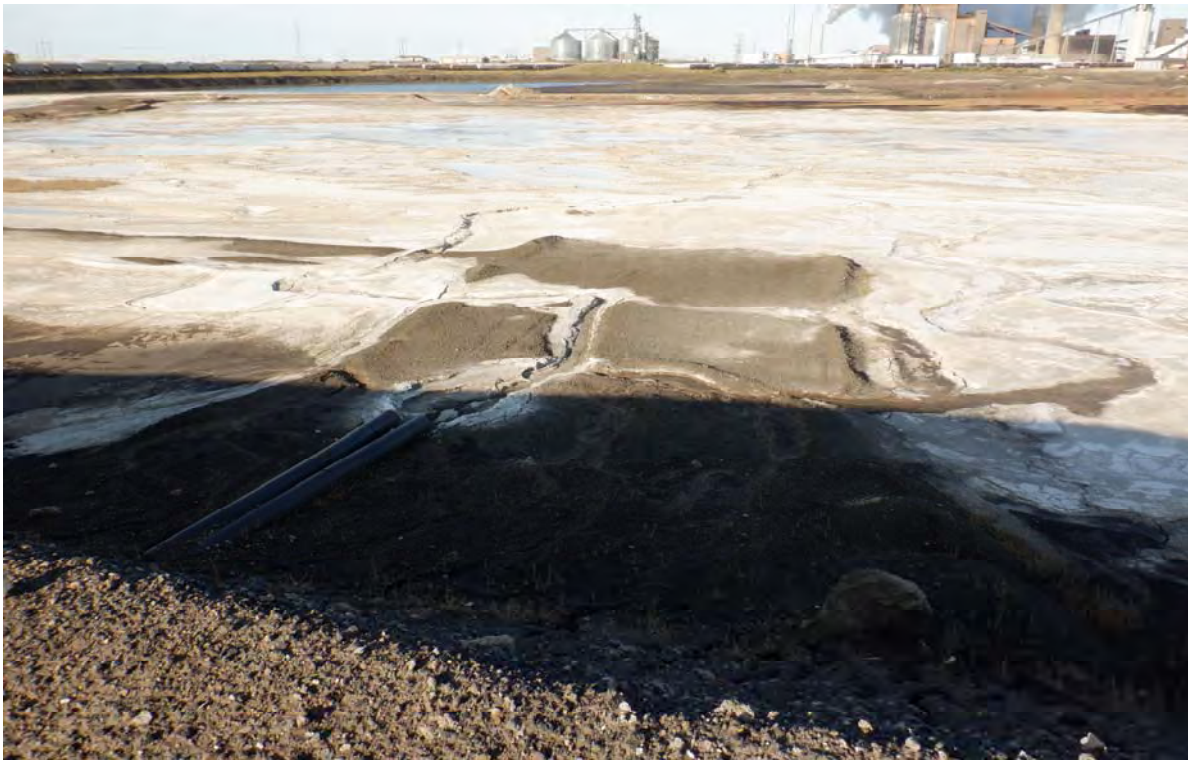
Photograph 22 (East CCR berm crest and upstream slope)
Inflow piping from Upstream Raise 92 (DSCF0549.JPG)

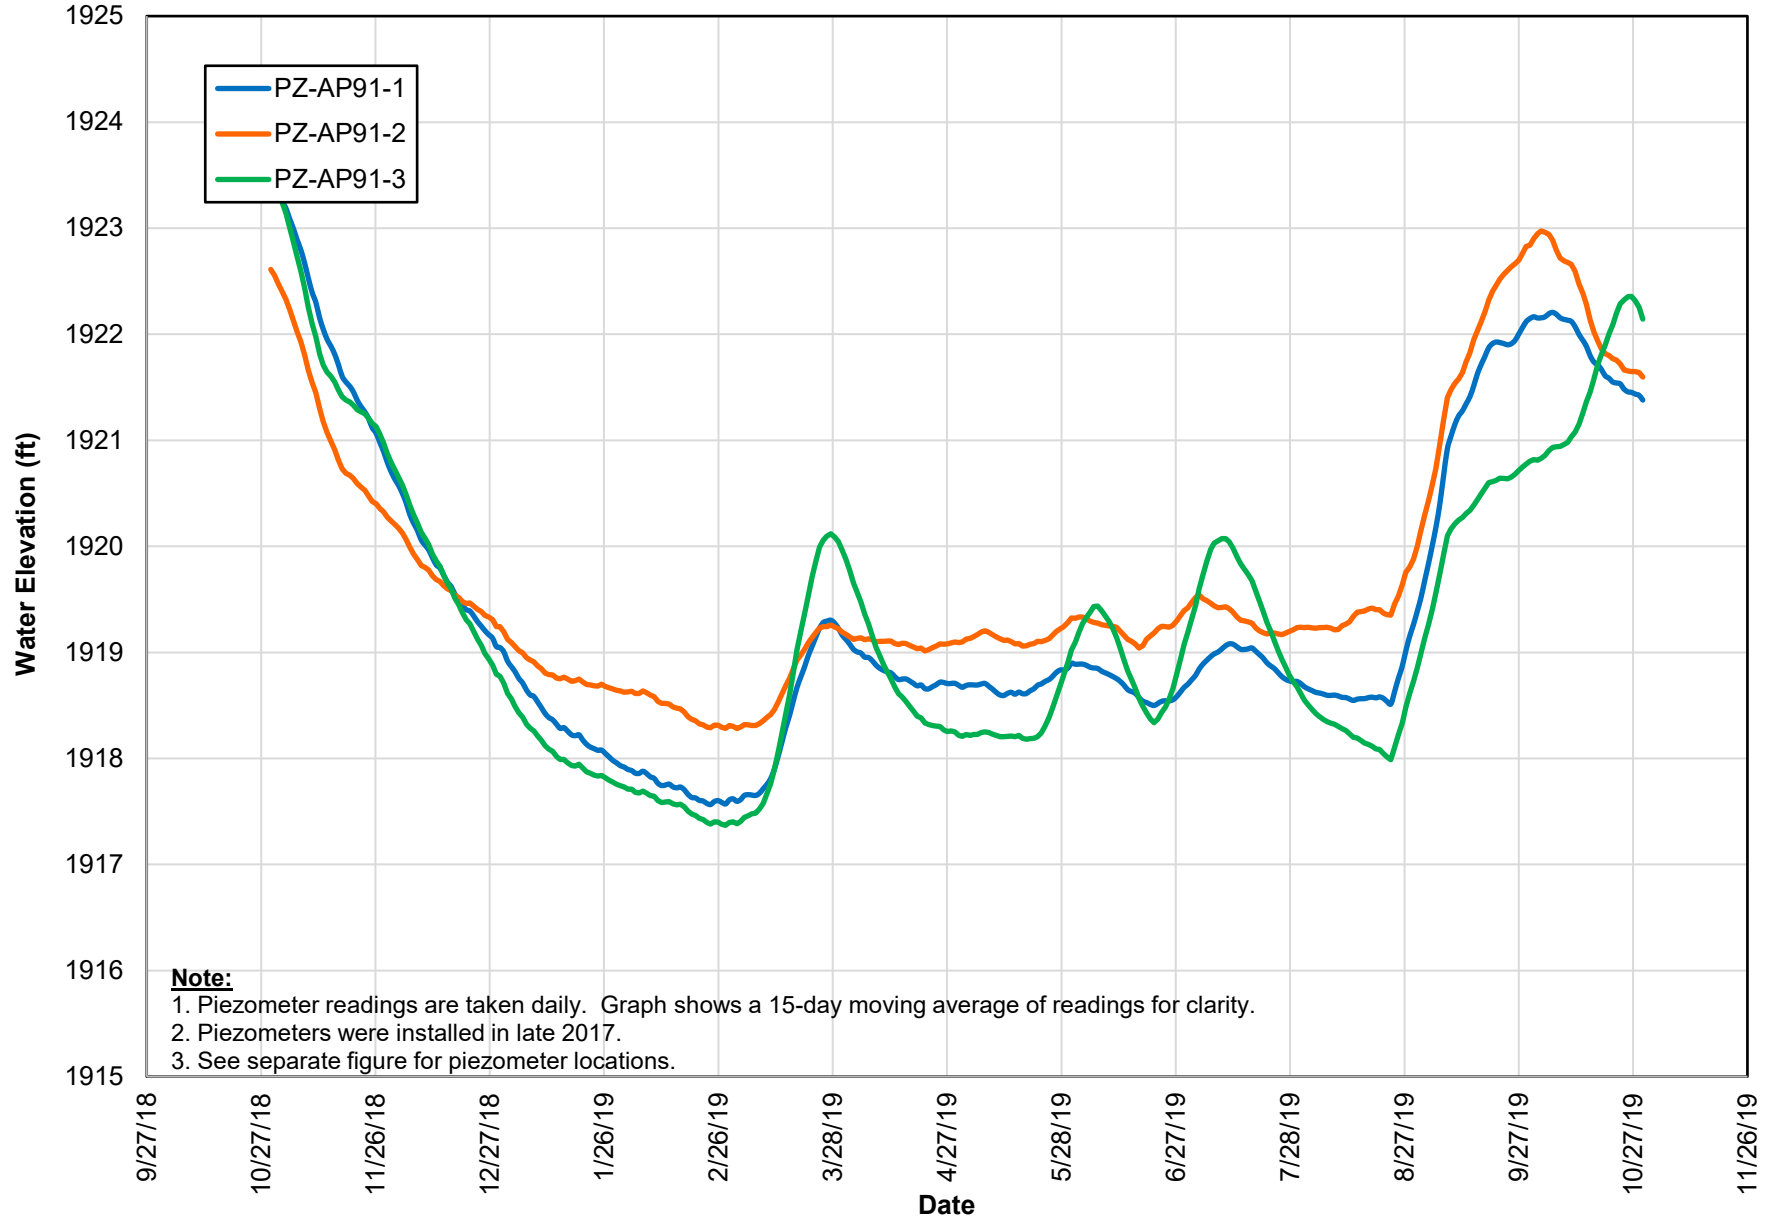
Upstream Raise 91 Piezometer Elevations

Piezometer measurements for the last year are included in Appendix D. GRE deposited FGD material in Upstream Raise 92 for a majority of 2019, as noted by the drop in piezometer water levels in late 2018. Fluctuations in water levels, especially in the late summer of 2019 are likely a result of significant rain events and isolation and dewatering of the Drains Pond System east cell for sediment removal.
