# Annual Inspection

## *Coal Creek Station - Upstream Raise 92 CCR Surface Impoundment*

### **Great River Energy**

January 2020

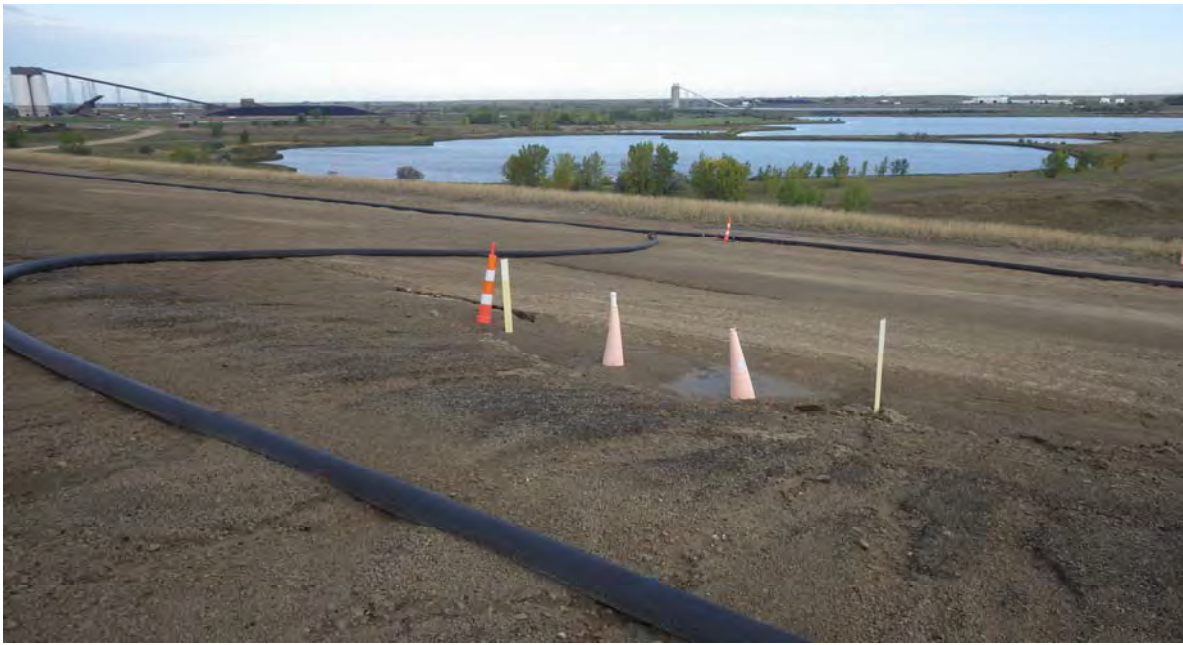
Photograph 1 (North CCR downstream slope (no cover))  
Crack in fly ash near piezometers (IMGP6856.JPG)

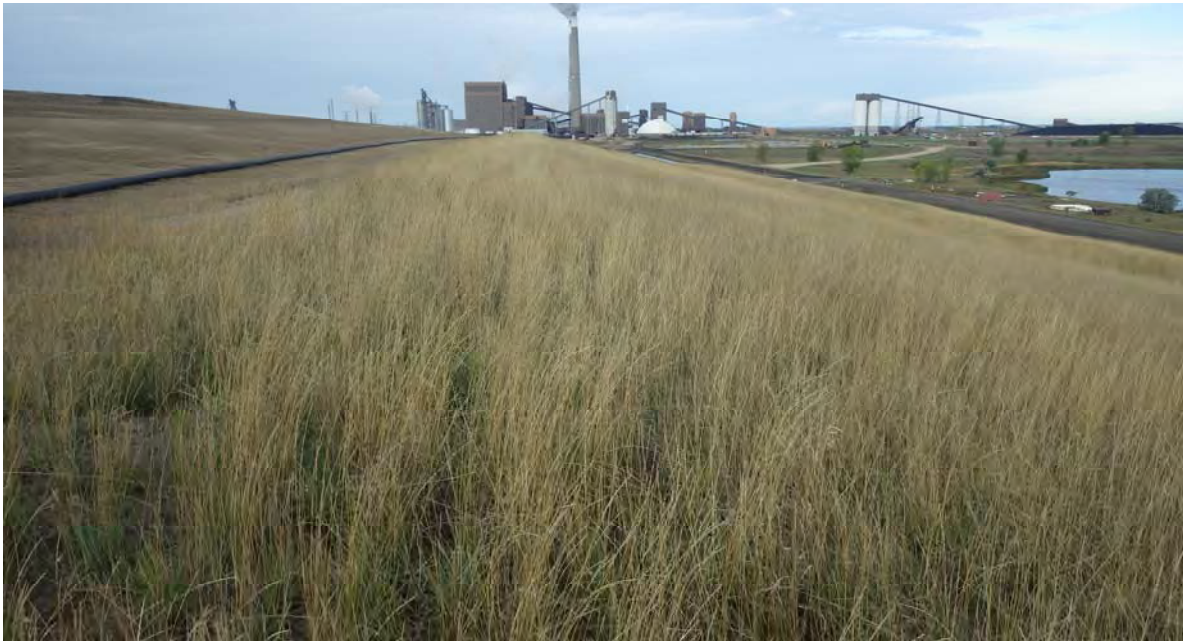
Photograph 2 (North CCR downstream slope)  
Temporary cover on north CCR slope (IMGP6859.JPG)

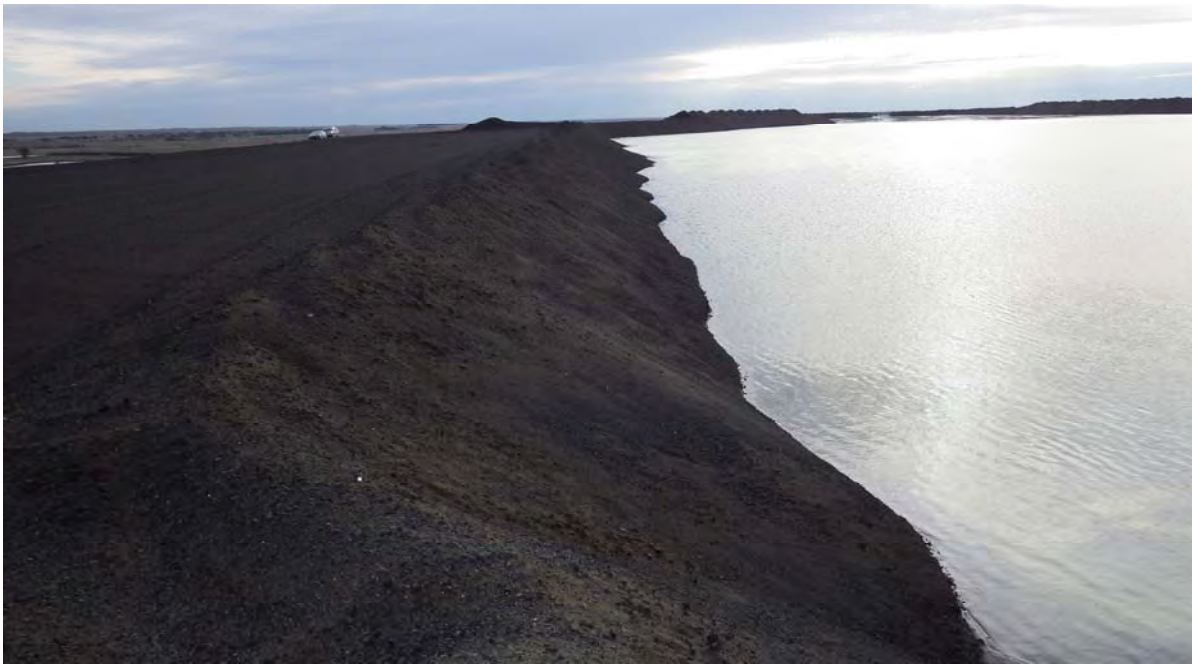
Photograph 3 (Northwest CCR crest and upstream slope)  
Bottom ash berm crest and upstream slope on northwest Flue Gas Desulfurization (FGD) Pool corner  
(IMGP6862.JPG)

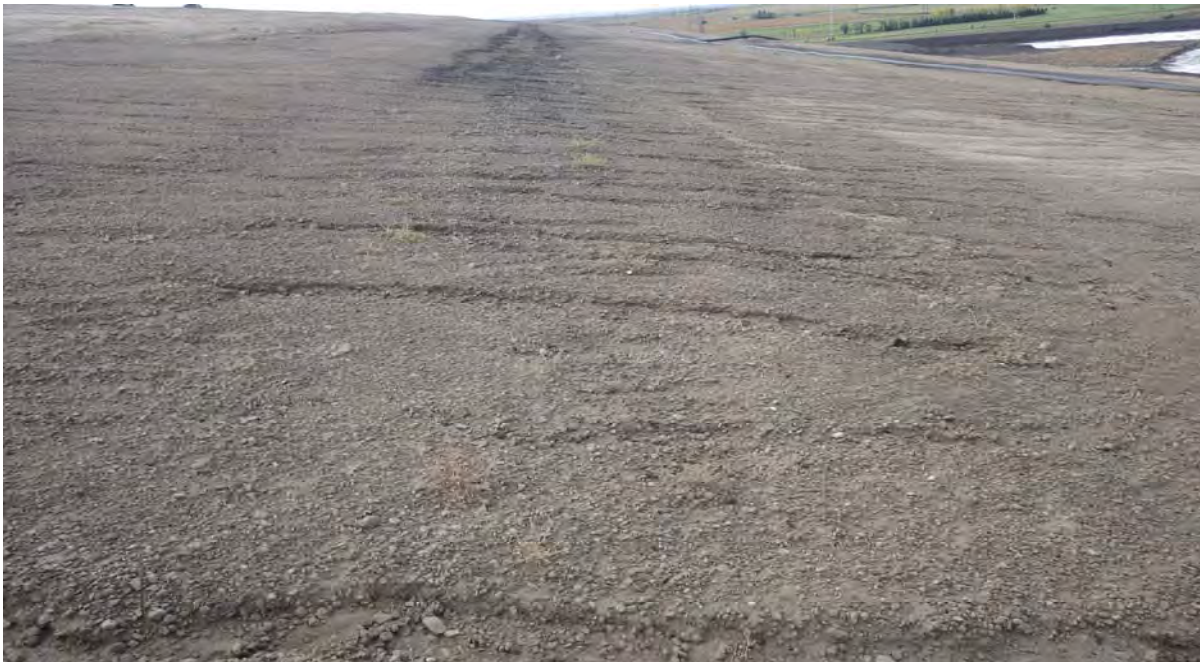
Photograph 4 (West CCR downstream slope (no cover))  
Minor fly ash erosion on west downstream slope (IMGP6865.JPG)

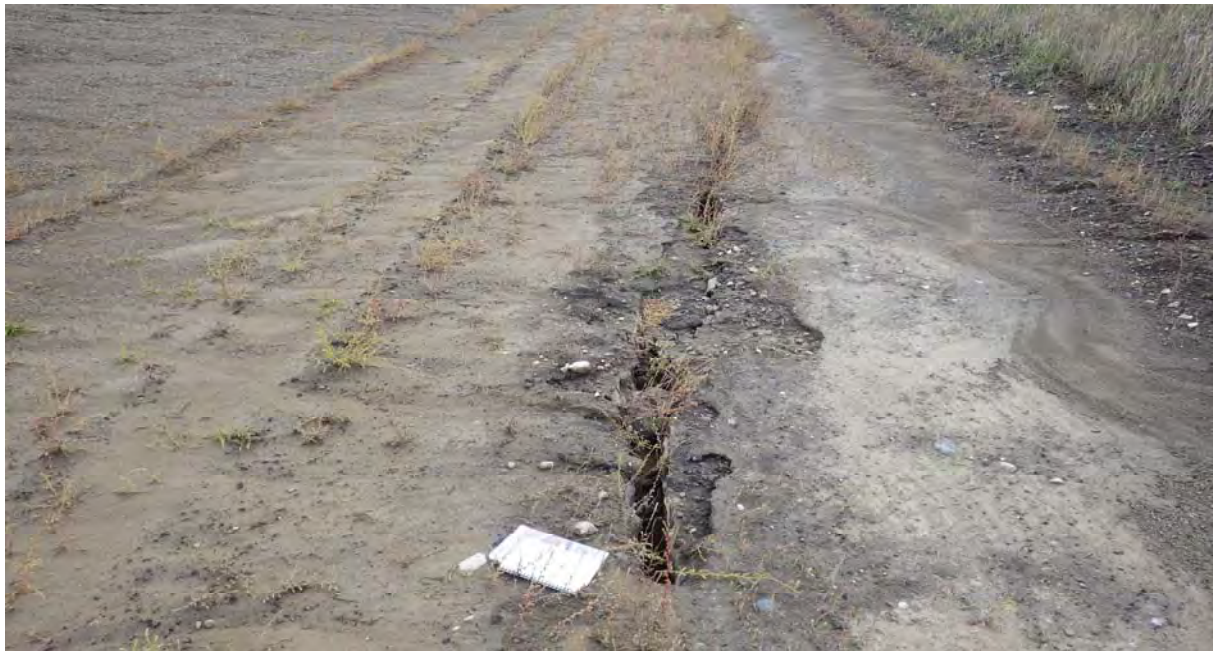
Photograph 5 (South CCR downstream slope (no cover))  
Cracking along south side within the contact water control ditch (IMGP6874.JPG)

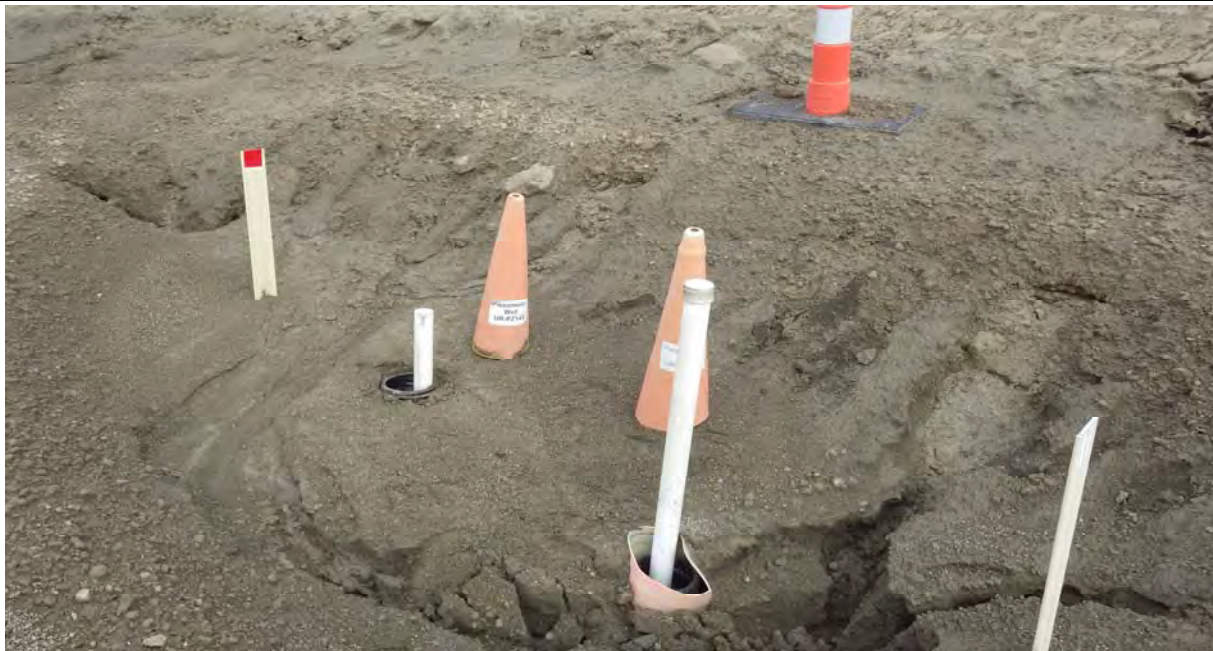
Photograph 6 (South CCR downstream slope (no cover))  
Cracking and erosion of fly ash around piezometers (IMGP6876.JPG)

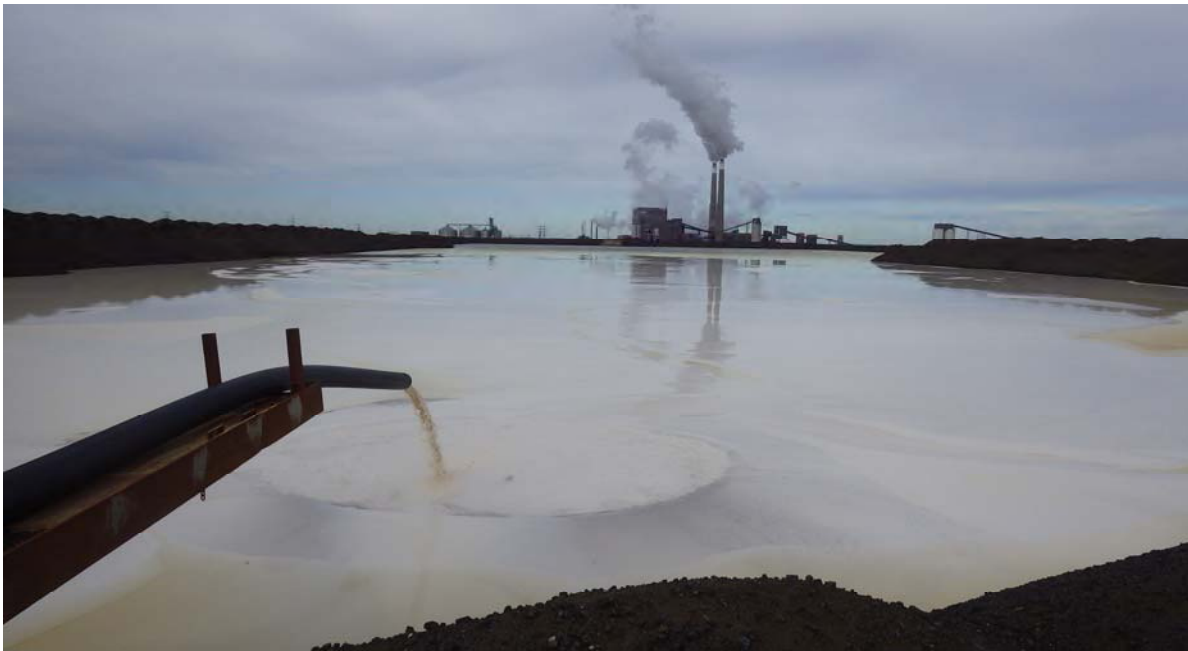
Photograph 7 (East side FGD Pool)

Hydraulic deposition of FGD material on east side of Upstream Raise 92 (IMGP6889.JPG)

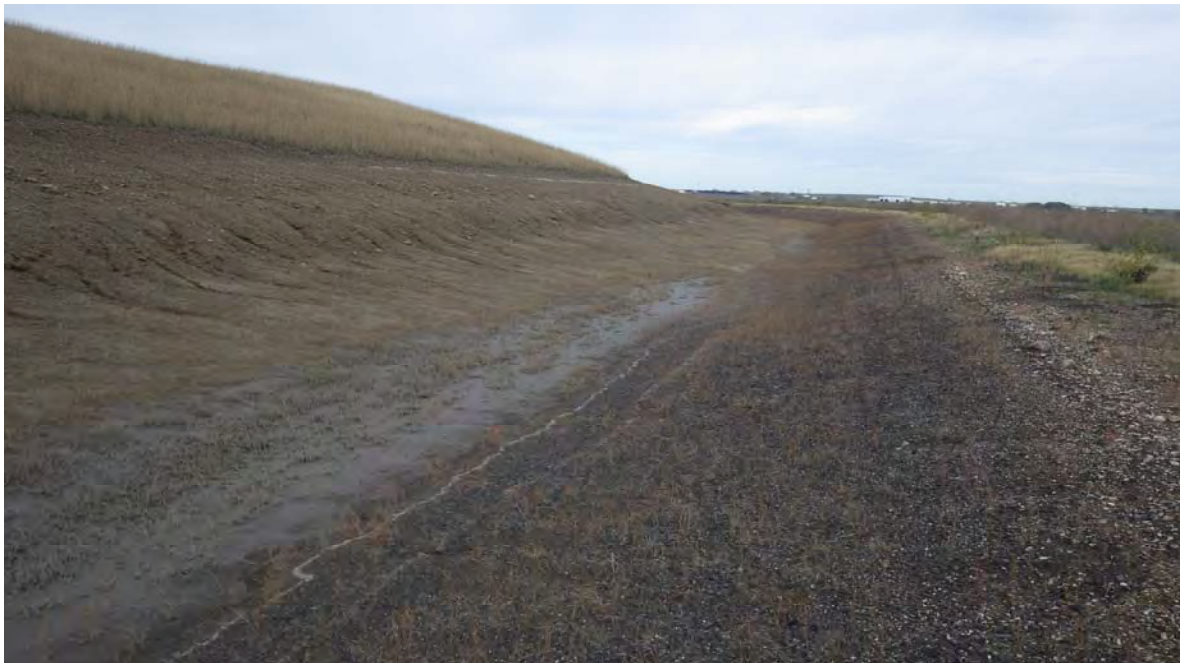
Photograph 8 (East CCR downstream slope (no cover))

Contact water ditch at elevation 1950 feet on east downstream slope (IMGP6892.JPG)

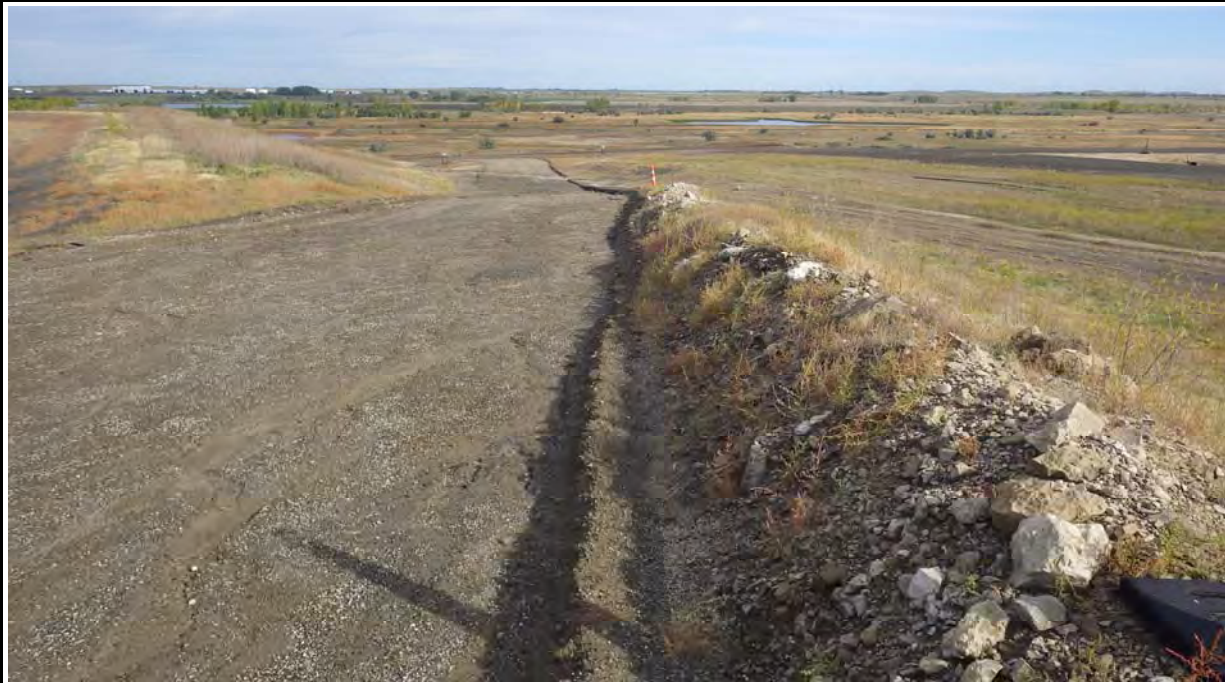
Photograph 9 (East haul ramp)  
Safety berm along portion of east ramp (IMGP6894.JPG)

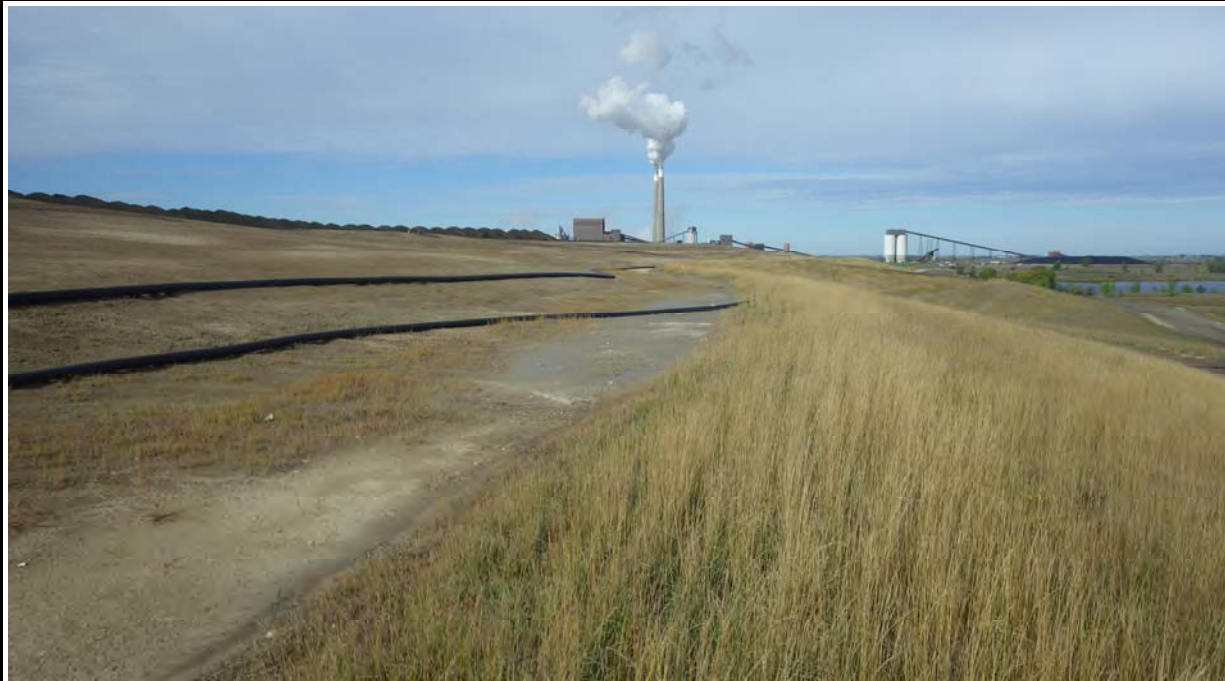
Photograph 10 (North CCR downstream slope)  
Contact water control ditch and temporary cover below elevation 1950 feet (IMGP6896.JPG)

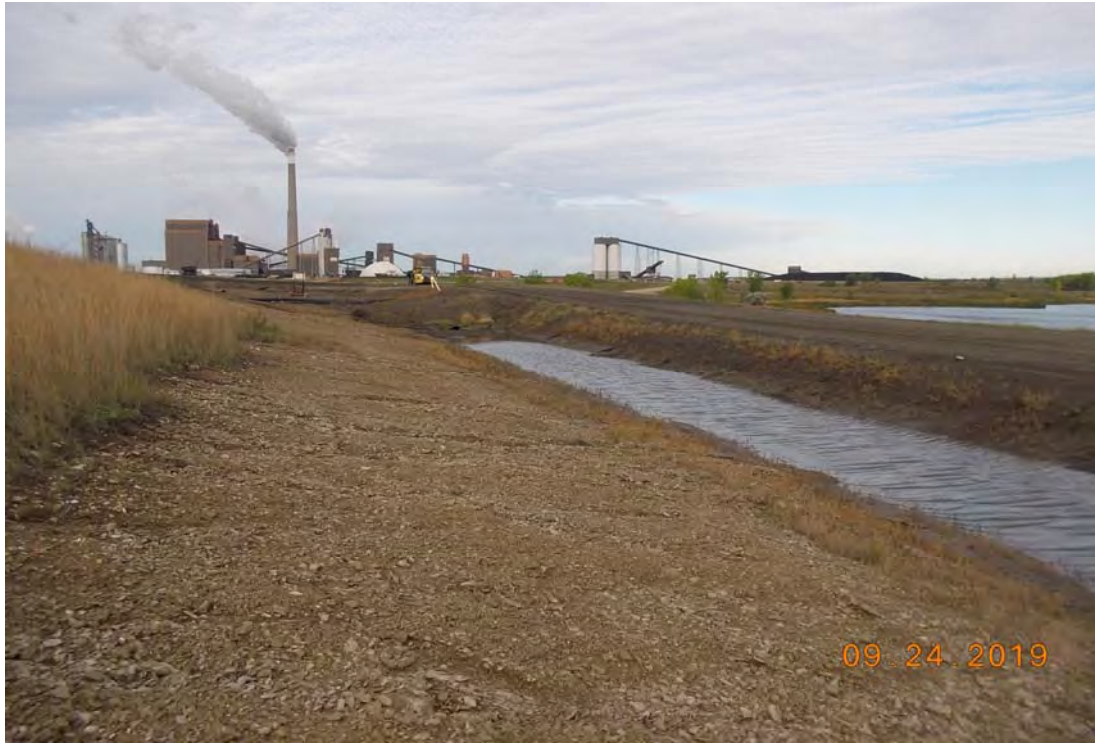
The outflows from Upstream Raise 92 consist of a series of gravity drainage pipes and culverts that transfer CCR conveyance water from the facility to the adjacent Upstream Raise 91. Over time, the gravity drainage pipes can become clogged with material and new pipes are installed to convey water between the facilities. At the time of the inspection, gravity drainage pipes appeared to be in good condition and were located above the impounded water within Upstream Raise 92 in preparation for drainage to start at a specified level. The culvert connecting the drainage ditch on the northwest side of Upstream Raise 92 to Upstream Raise 91 was in fair condition, as sediment had accumulated in this perimeter channel and at the culvert inlet.

Photograph 11 (North CCR downstream slope)  
Perimeter contact water control ditch and partially plugged HDPE culvert directing contact water to  
Upstream Raise 91 (PDS UR92 (5).JPG)

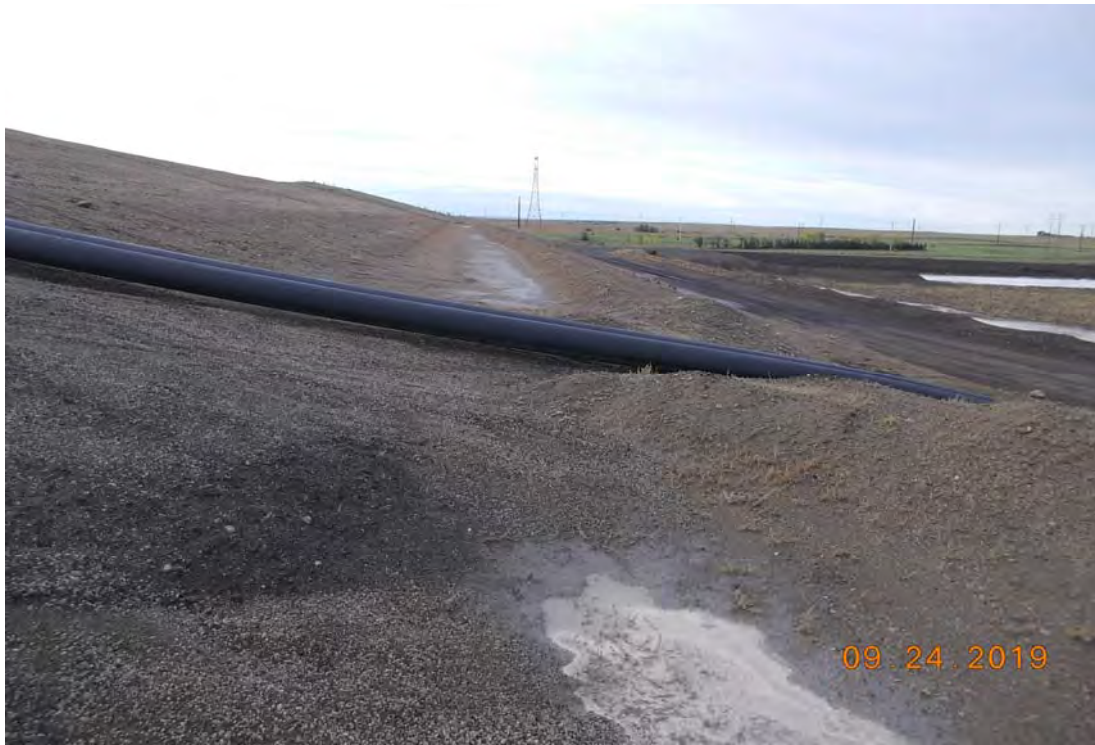
Photograph 12 (West CCR downstream slope (no cover))  
Gravity drains between Upstream Raise 92 and Upstream Raise 91 (PDS UR92 (8).JPG)

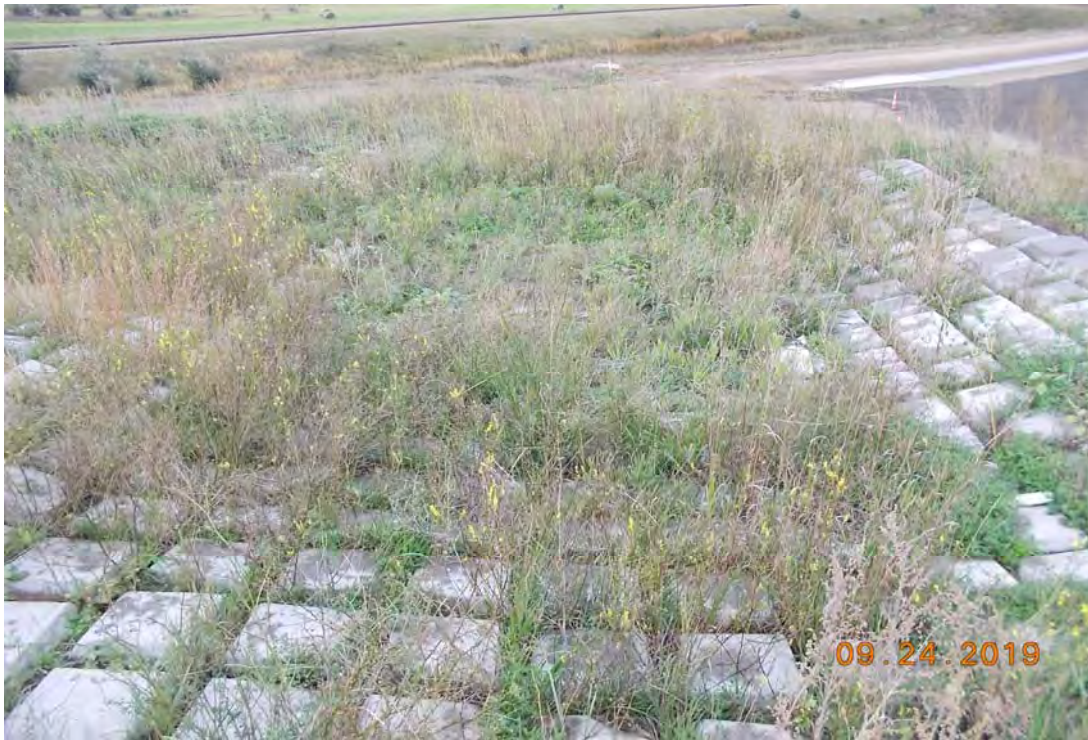
Photograph 13 (Southwest downstream downchute channel)  
Articulated Concrete Block (ACB) downchute channel with established vegetation (PDS UR92 (10).JPG)

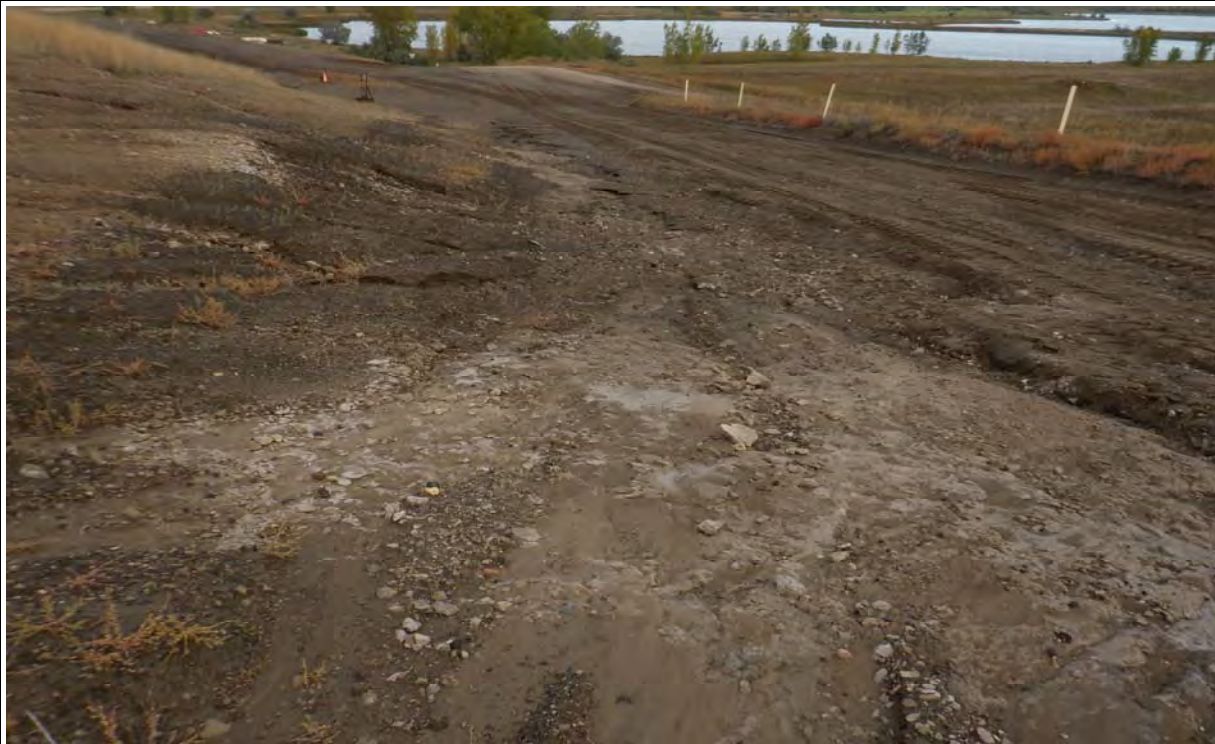
Photograph 14 (North haul ramp)  
Minor erosion of fly ash along inside of ramp (north side) (DSCF0414.JPG)

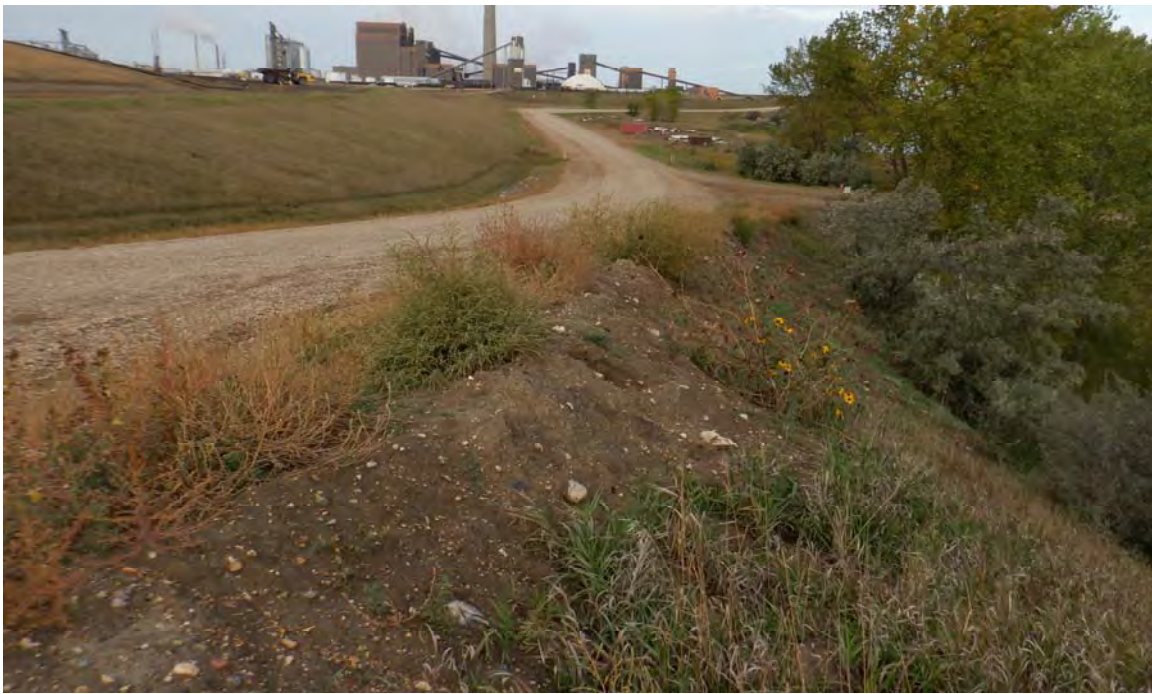
Photograph 15 (North haul ramp)

Ramp had been temporarily steepened on north side for added width (DSCF0420.JPG)

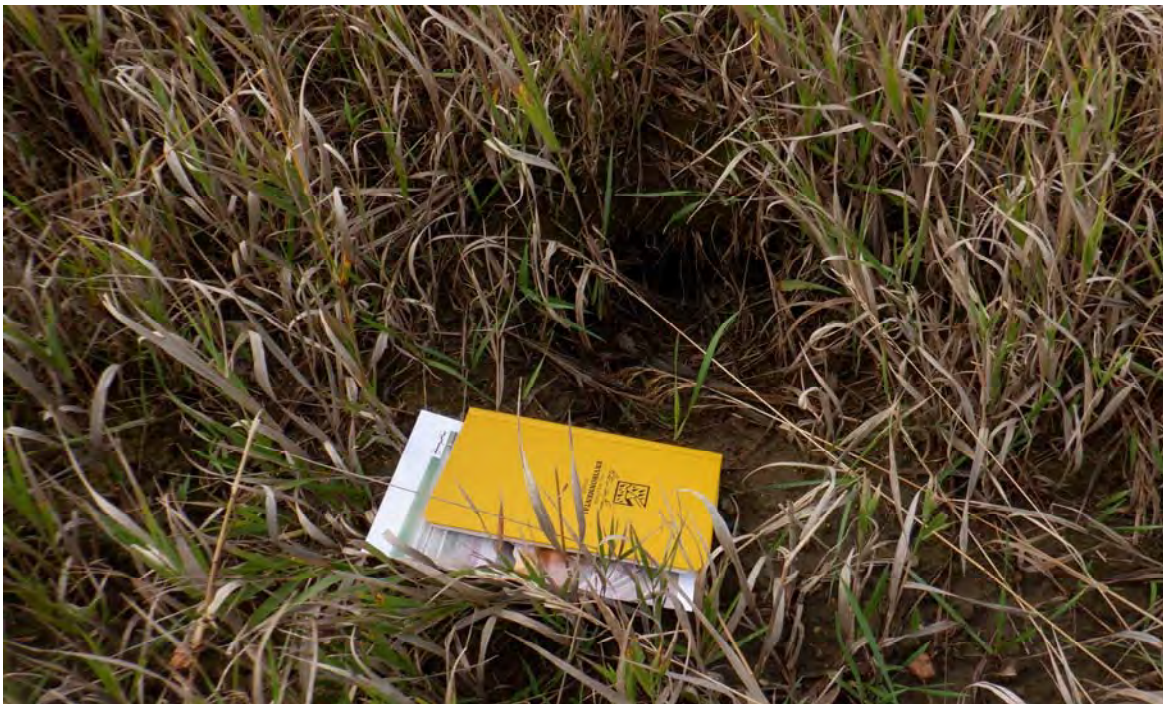
Photograph 16 (North berm downstream slope)

The berm downstream slopes of Upstream Raise 92 below the original and expansion berms are heavily vegetated with native grasses. Occasional animal burrows up to approximately six inches in diameter were observed on the north and south berm downstream slopes. There is no noticeable significant erosion, cracks, or scarps on these grassy slopes and they appear to be in good condition.

Animal burrow, approximately 6 inches in diameter (DSCF0421.JPG)

Minor maintenance items that may need to be continually addressed include monitoring the size and shape of cracks in CCR downstream slope and CCR crest of the facility, repairing large animal burrows as they appear, monitoring erosion and vegetative success of the re-configured surface water channel along the south toe of the facility (including construction to complete downchute channels and hydraulic jump basins prior to final cover of the entirety of Upstream Raise 92), clean-out of collected material in the perimeter channels and maintaining gravity and culvert piping between Upstream Raise 91 and Upstream Raise 92, re-seeding of CCR downstream slopes with final cover, and removal of any woody vegetation growing on the berm downstream slopes. In

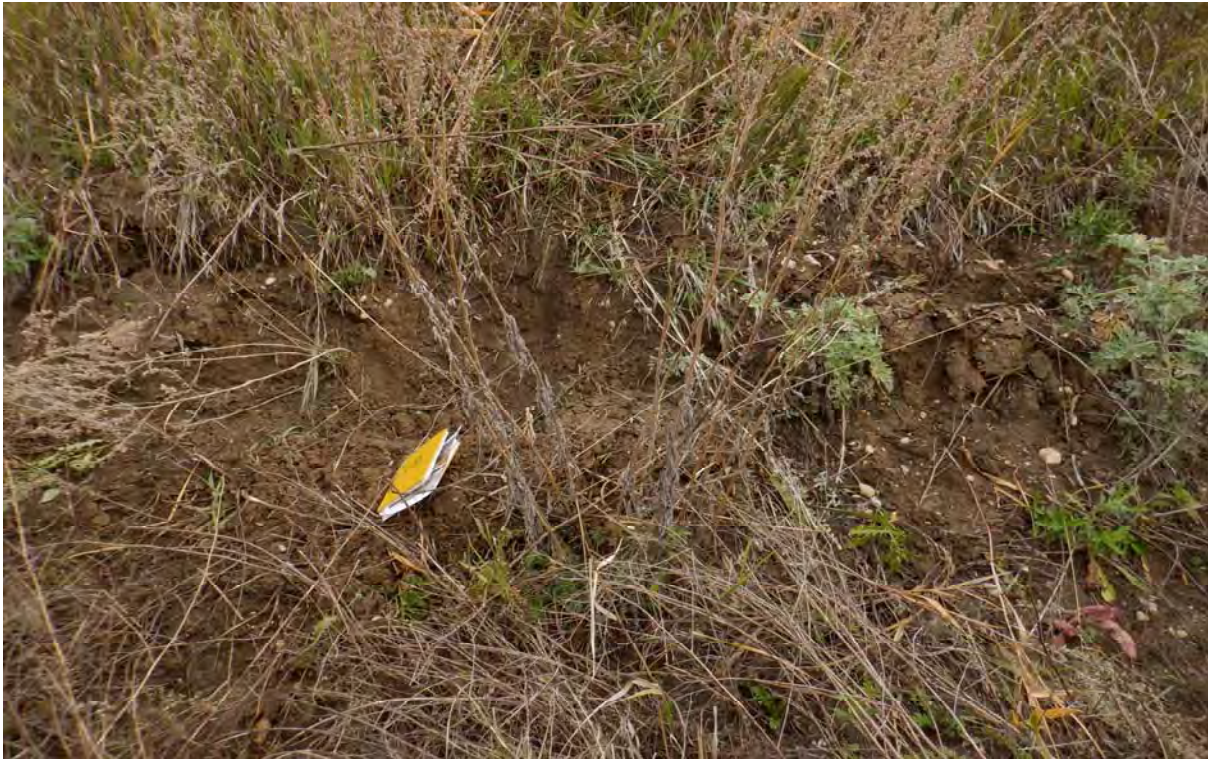
Photograph 17 (South berm downstream slope and toe)  
Oversteepened toe of slope area (DSCF0439.JPG)

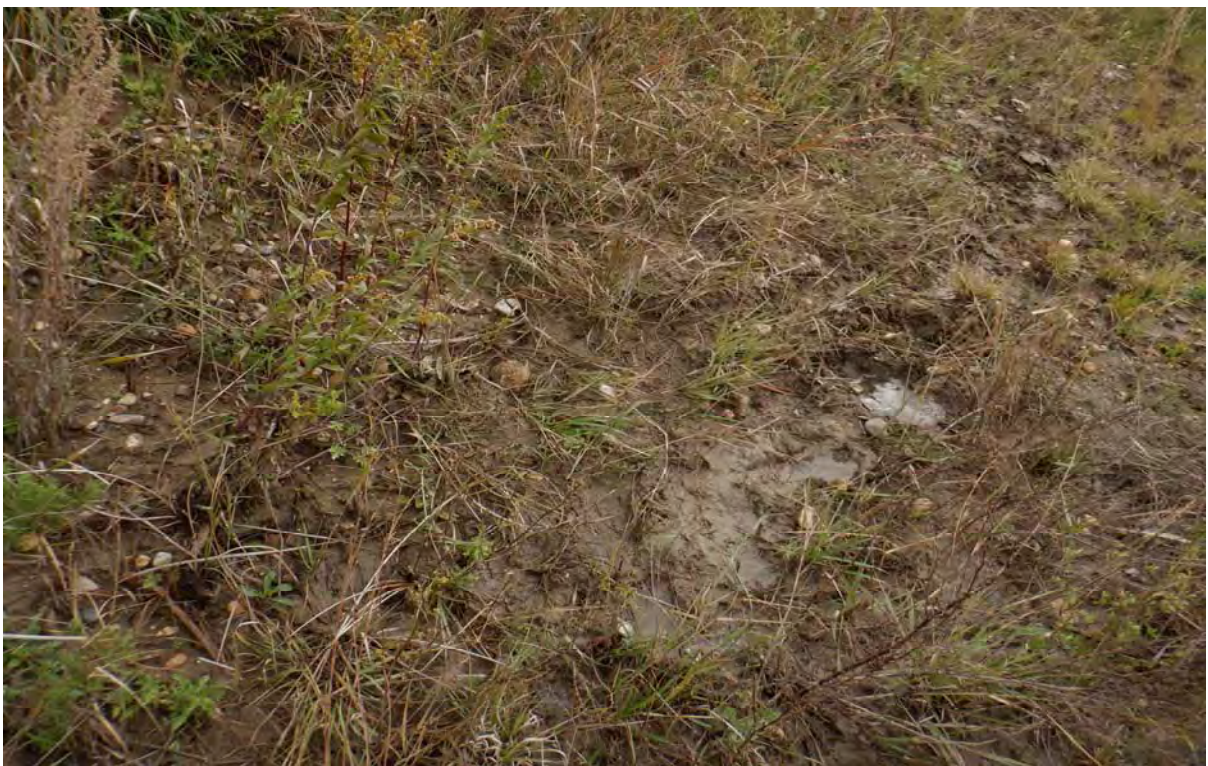
A seep was noted on the south berm downstream slope of Upstream Raise 92 approximately 10 feet from the toe of the slope. The seep was located at the approximate historic location of the toe drain that was a part of the original design of the impoundment berms prior to geomembrane liner construction (see Section 2.3). The localized wet area was approximately 10 feet wide and 20 feet long and generally had a zone of saturated soft clay at the surface (uppermost 3 to 4 inches) underlain with a layer of gravel/cobbles intermixed with clay. Continued monitoring of the seep following the annual inspection indicated that the seep location had moved down the slope after several days and was not visible after approximately 10 days. These observations appear to support that the seep was likely a result of recent significant rainfall infiltrating the perimeter berm. The area will continue to be monitored as a part of the weekly inspections of the facility.

Photograph 18 (South berm downstream slope)  
Extents of seep area on berm downstream slope of Upstream Raise 92 (DSCF0443.JPG)

**General Remarks:** Seepage was noted on the south downstream perimeter berm slope. The location of the seep should be monitored as a part of the weekly inspections of the facility. Cracking of fly ash within the facility was noted and should be expected due to settlement of the FGD material. Minor maintenance includes addressing small burrows, maintaining fly ash protective cover, maintaining inflow and outflow piping, and addressing vegetative success of the cover and erosion as observed.

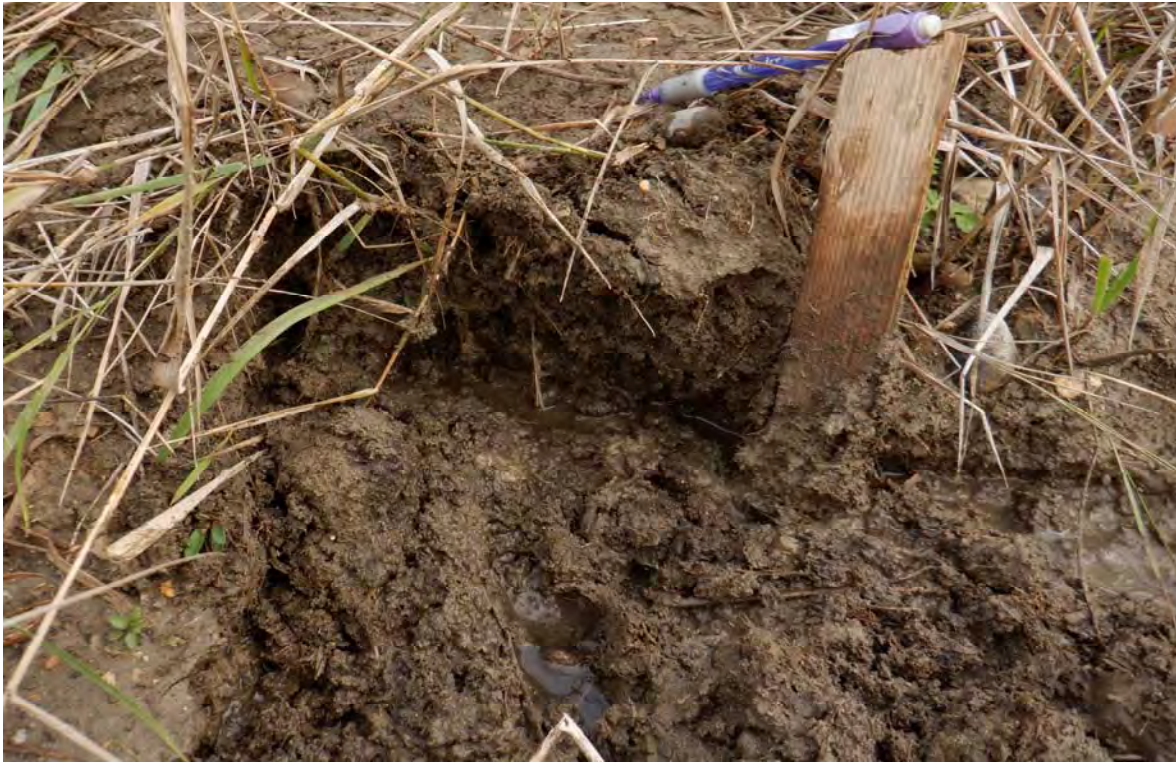
Photograph 19 (South berm downstream slope)

Seep on downstream slope with upper 3-4 inches of soft clay underlain by cobble/gravel and clay (DSCF0445.JPG)

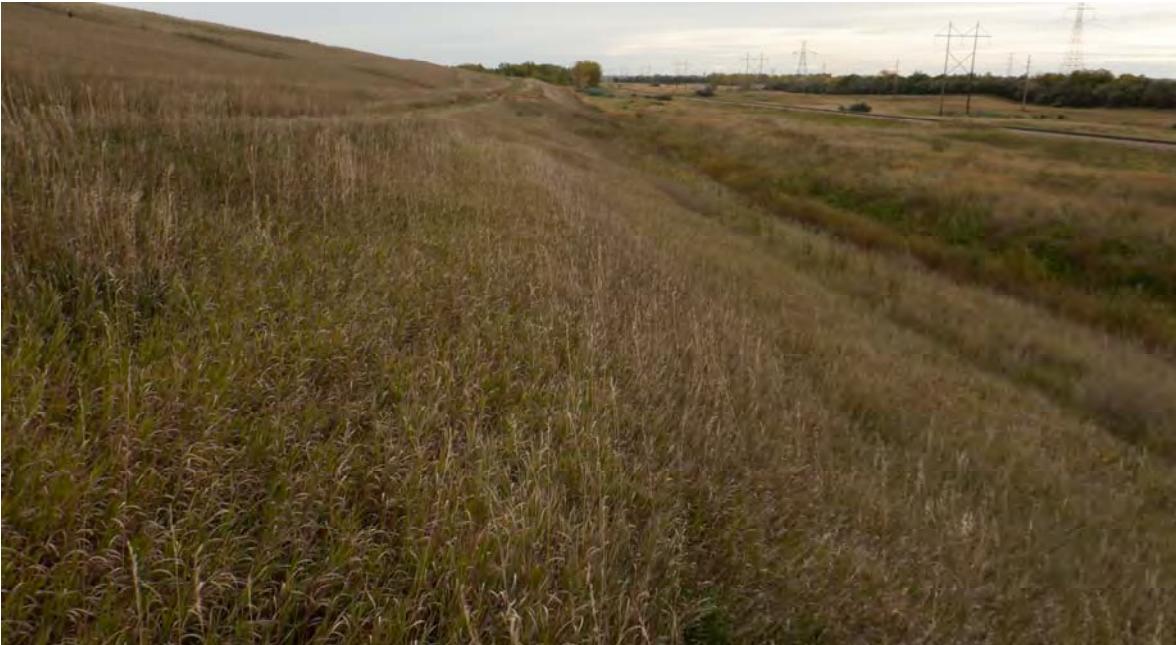
Photograph 20 (South berm downstream slope)

Irregular-shaped downstream slope, well-vegetated (DSCF0449.JPG)

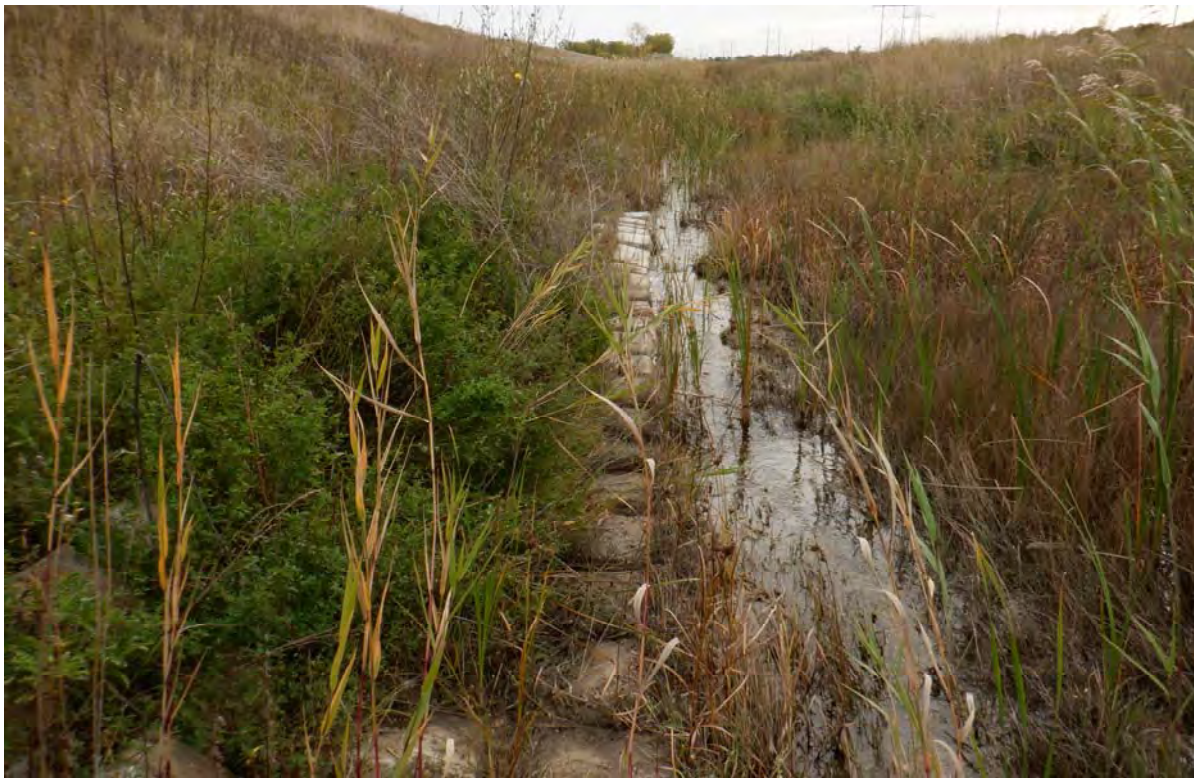
Photograph 21 (South berm downstream slope and toe)  
ACB completed to the toe of the berm downstream slope instead of across the south drainage channel, minor woody vegetation (DSCF0452.JPG)

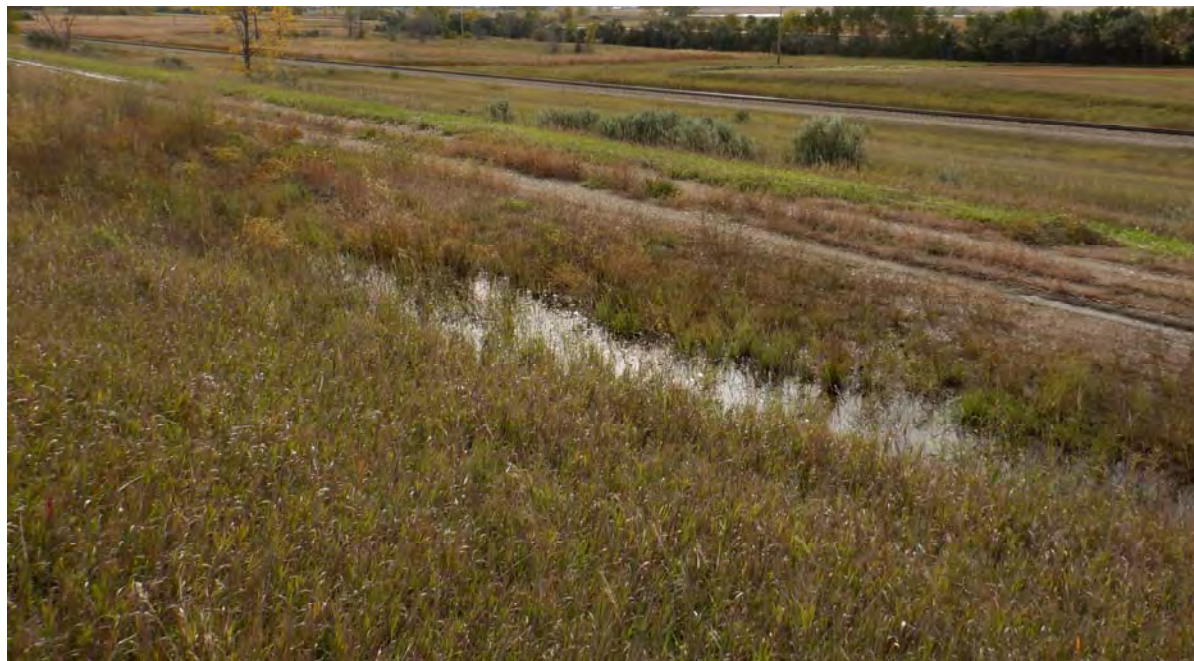
The surface water drainage at the toe of the slope on the south side of Upstream Raise 92 had some marshy vegetation and standing water. The surface water drainage ditch in this area was recently modified to promote flow toward site surface water drainages and therefore portions of this ditch were not yet well-vegetated. The presence of some standing water in this surface water drainage ditch was noted due to the low average slope of this ditch and the fact that it is near typical groundwater levels. Side slopes of this drainage ditch are also relatively steep near the toe, but did not show signs of movement. The toe may need to be regraded and reseeded in the future to limit erosion. In addition, the downchute channels should be extended and hydraulic jump basins constructed on the south side of the facility to limit erosion when final cover is constructed over the entirety of Upstream Raise 92.

Photograph 22 (Southeast CCR downstream slope (covered))  
Standing water at southeast toe of CCR downstream slope (covered) above perimeter road (DSCF0457.JPG)

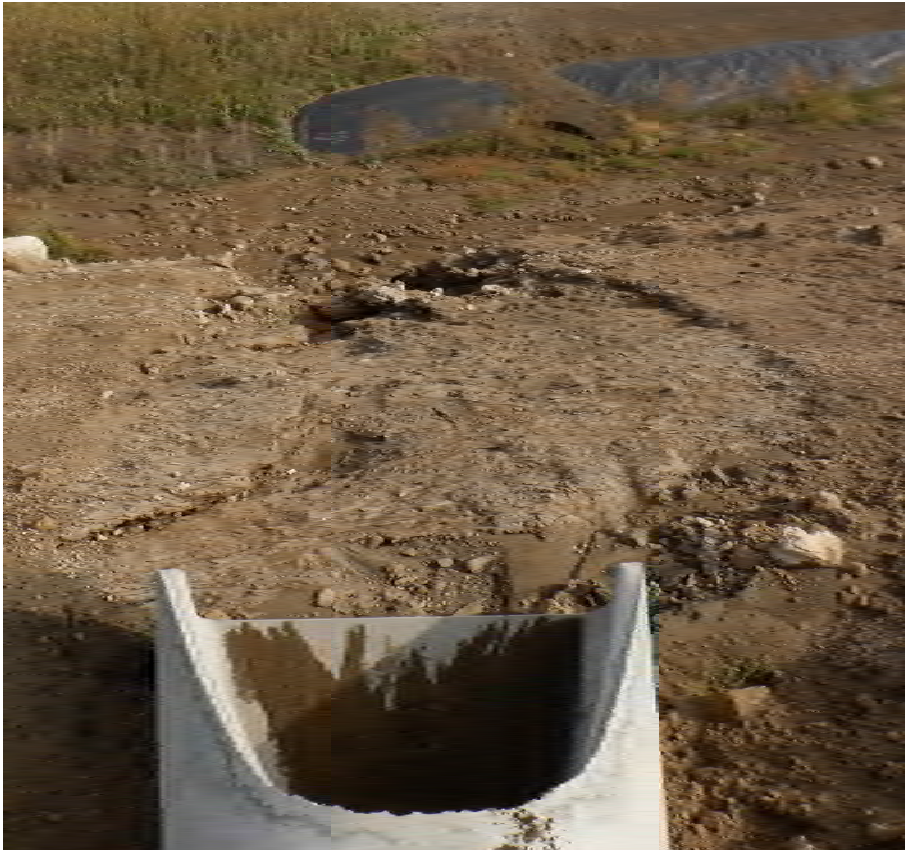
Photograph 23 (North berm downstream slope)  
Culvert outlet conveying contact water from Upstream Raise 92 to Southeast 16 contact water channel (DSCF0461.JPG)

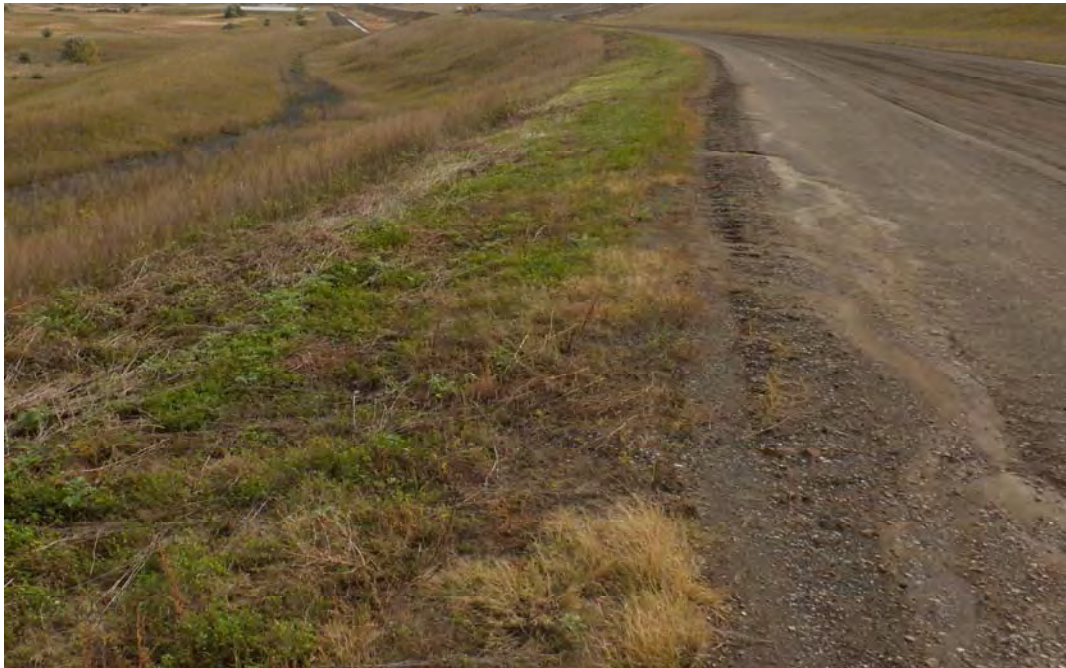
Photograph 24 (North berm downstream slope and haul road to Southeast 16)  
Haul road and contact water control channel (DSCF0466.JPG)
