# Annual Inspection

## *Coal Creek Station - Upstream Raise 92 CCR Surface Impoundment*

### **Great River Energy**

January 2020

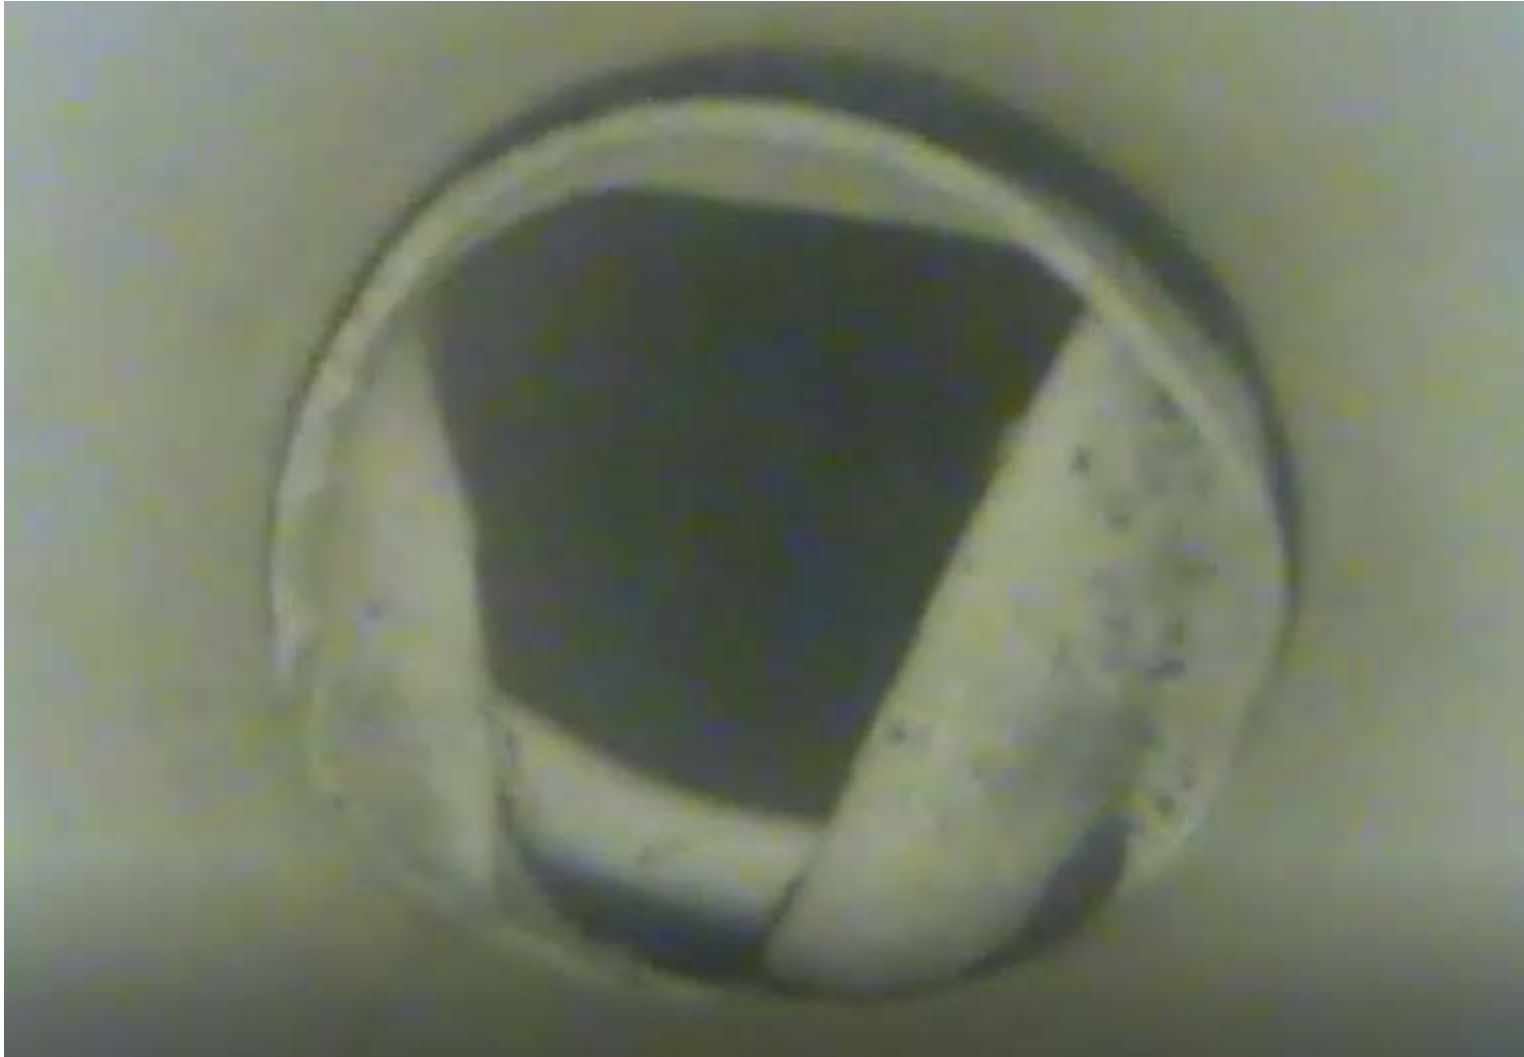
**Upstream Raise 92  
PZ-13D Damage  
Photograph 1**

In 2016, water levels within piezometer PZ-13D rose approximately 15 feet abruptly. This piezometer was evaluated with a downhole camera on July 23, 2019 and was determined to be damaged approximately 53 feet from the top of the piezometer (broken casing). As such, this piezometer was removed from future monitoring. Appendix D-2 contains photographs from the field investigation that show damage to Piezometer PZ-13D.
