# Annual Inspection

## *Stanton Station - Bottom Ash CCR Landfill*

### **Great River Energy**

January 2021

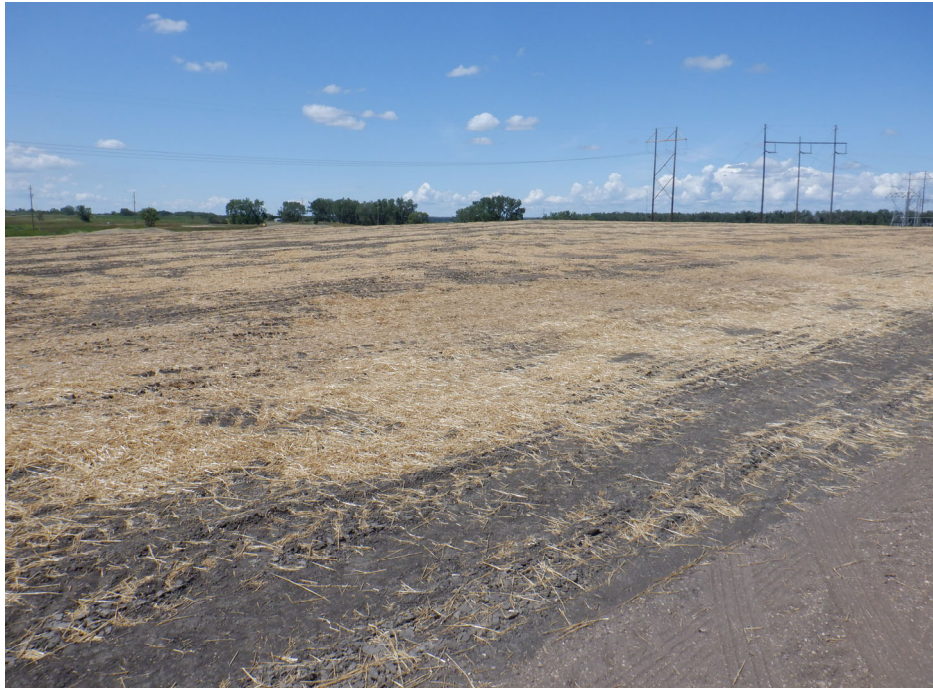
Photograph 1 (East Final Cover Slope)  
Bottom ash landfill closed and covered. (IMG\_DSCF1005.JPG)

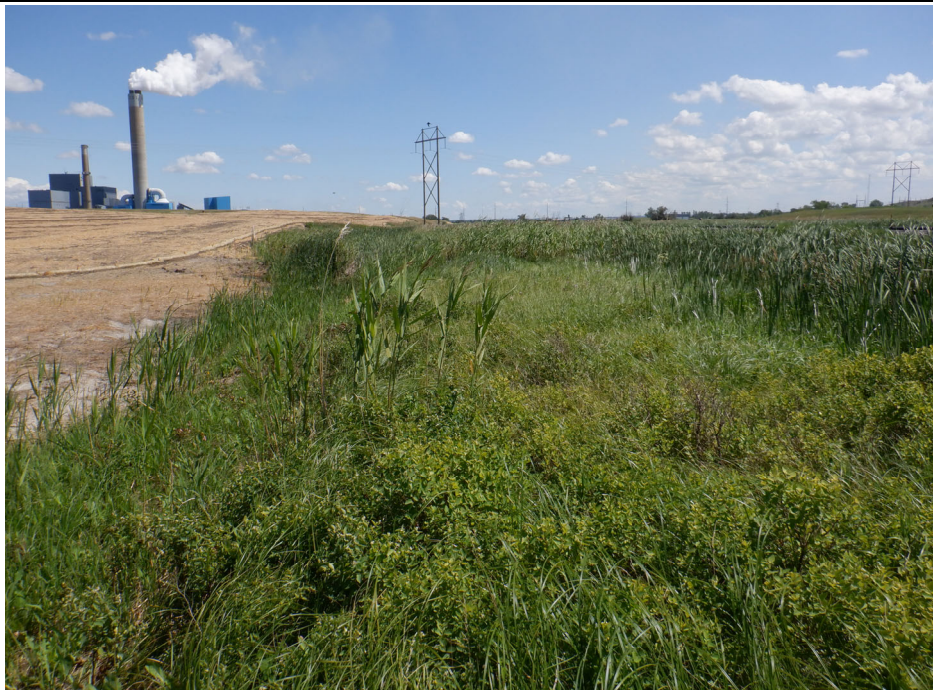
The toe of the south perimeter berm is in a surface water drainage ditch that has some marshy vegetation and standing water. Some small animal burrows were noted near the toe of the slope, but there were no observed indications of seepage, settlement, or excessive vegetation at the toe of these slopes. The toe of the east, north, and west perimeter berms were recently seeded and mulched as part of site closure and restoration activities. The toes of the berm downstream slopes are in good condition. Recently seeded and mulched areas will be monitored for erosion and vegetative success during future inspections in accordance with the Closure and Post-Closure Plan (Golder 2019).

Photograph 2 (South Perimeter Berm Toe)  
Vegetation in surface water drainage ditch. (IMG\_DSCF1024.JPG)

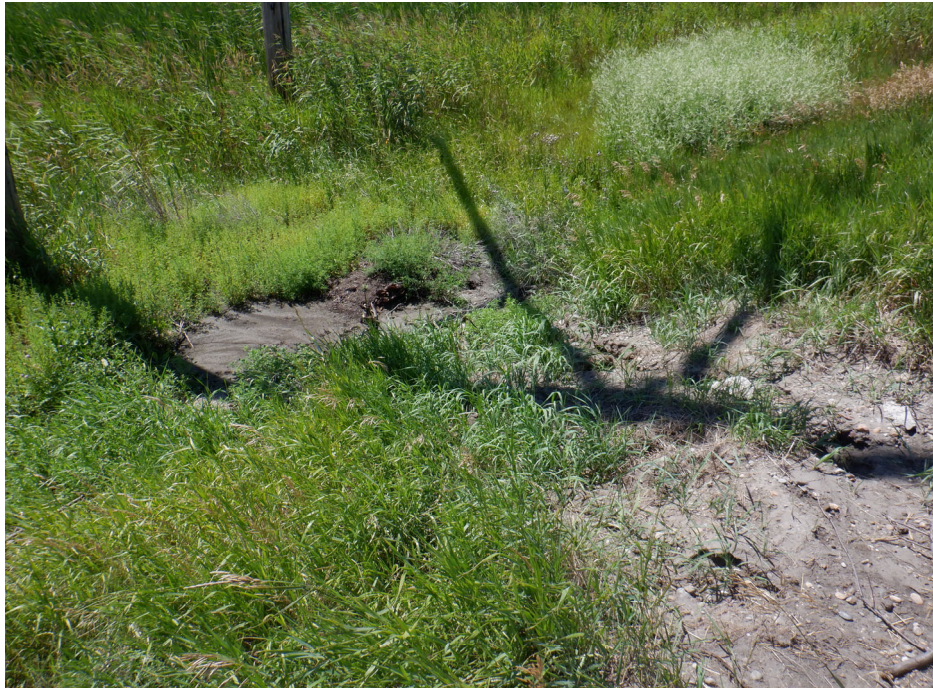
The berm downstream slopes on the north and south sides are between approximately 5 feet and 10 feet high and have slopes of approximately 3:1. Slopes that were not impacted by site restoration grading are well vegetated with grass but do contain numerous, but mostly small, animal burrows.

Photograph 3 (South Perimeter Berm Downstream Slope)  
Small rodent burrows on the slope and near the toe of the facility. (IMG\_DSCF1011.JPG)

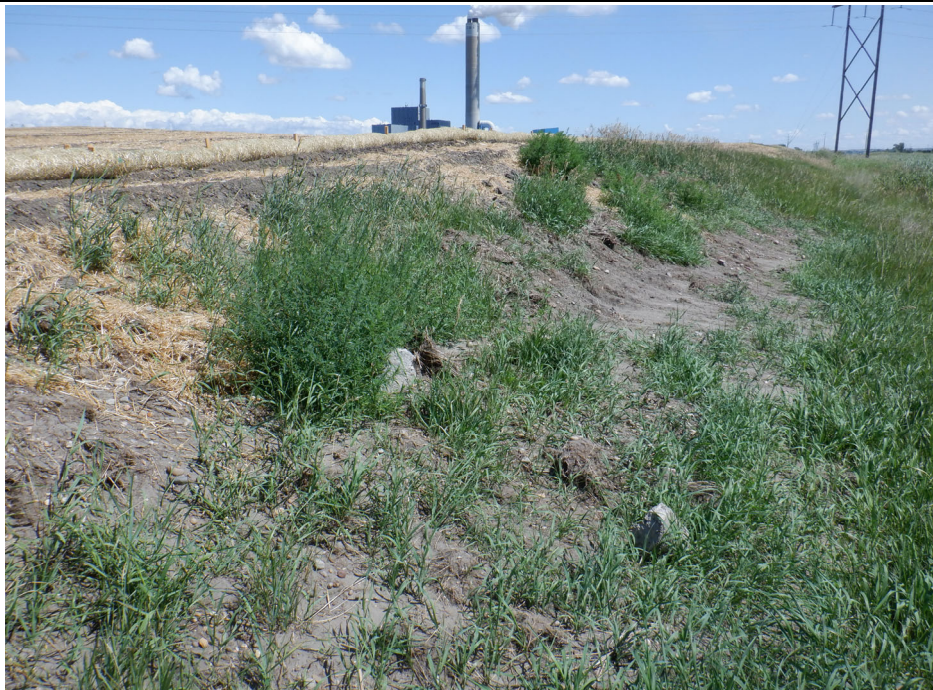
Photograph 4 (South Perimeter Berm Downstream Slope)  
Minor erosion and bare vegetation on the southern downstream slope. (IMG\_DSCF1014.JPG)

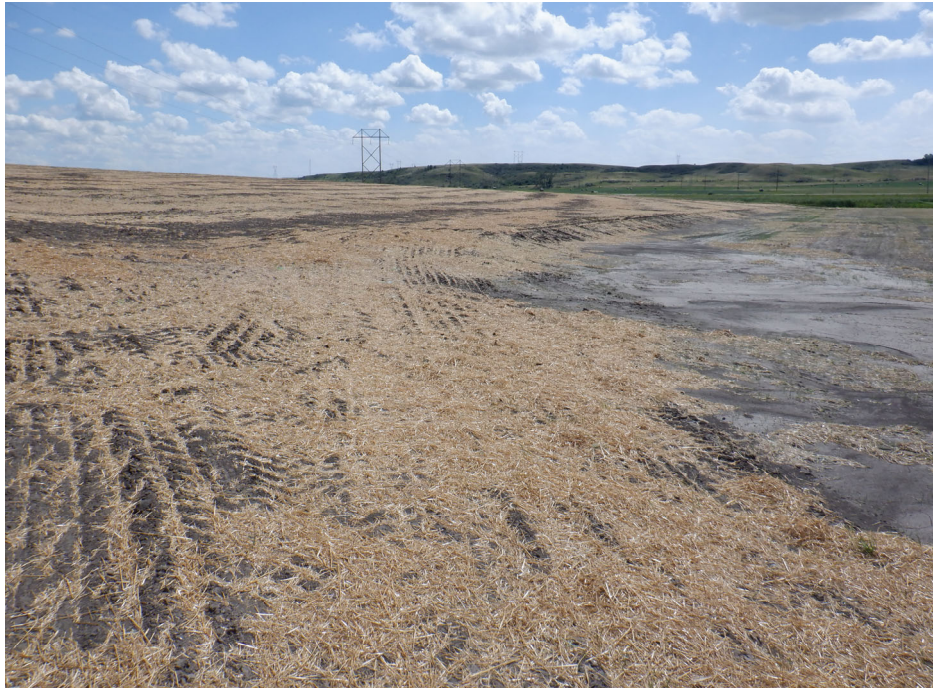
Photograph 5 (West Perimeter Berm Downstream Slope and Toe)  
Recently seeded and mulched downstream slope/toe and final cover (background). (IMG\_DSCF1039.JPG)

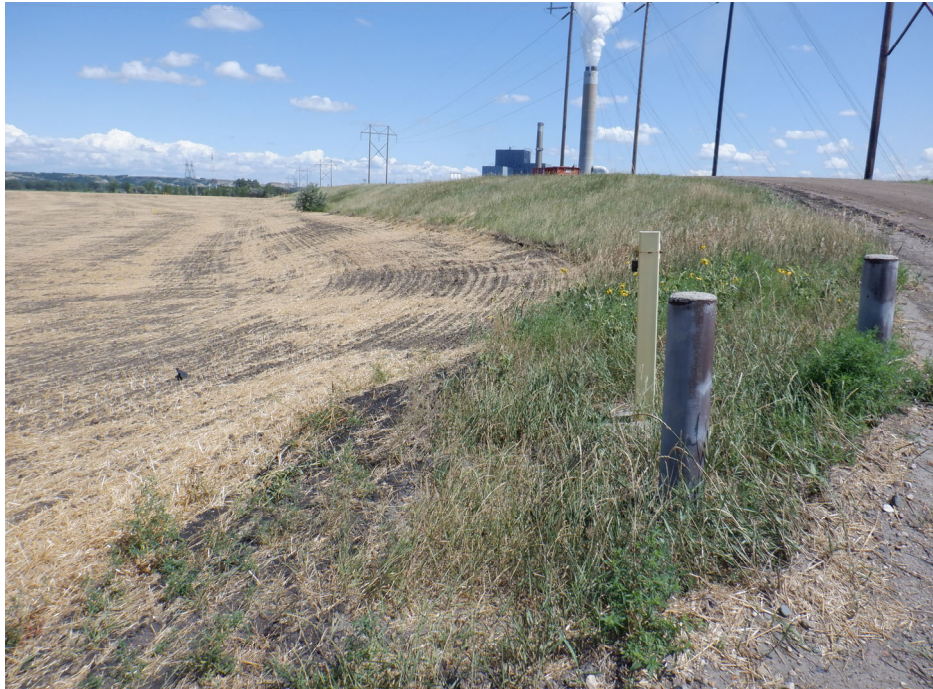
Photograph 6 (North Perimeter Berm Downstream Slope and Toe)  
Well vegetated perimeter berm downstream slope and recently seeded and mulched toe.  
(IMG\_DSCF1041.JPG)

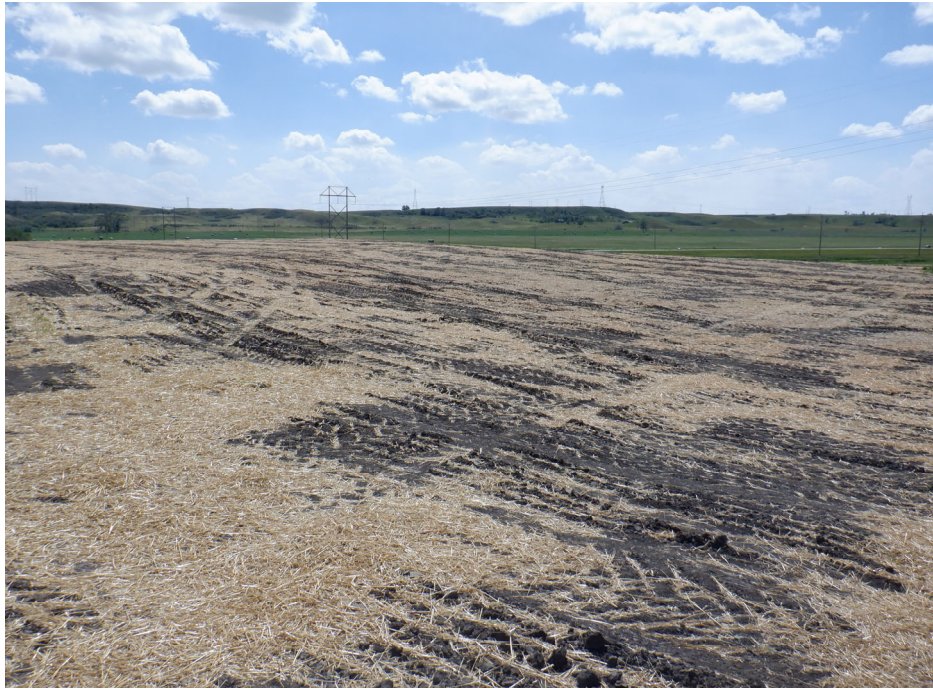
Photograph 7 (Final Cover)  
Recently seeded and mulched final cover. (IMG\_DSCF1048.JPG)

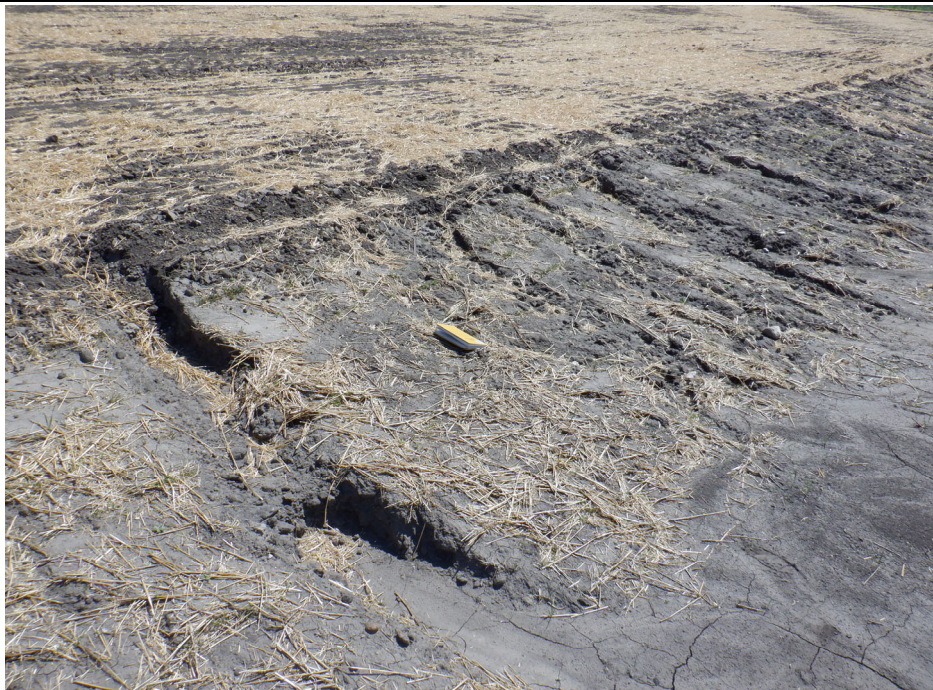
As part of closure, a new three-foot high soil berm was constructed on the west end of the consolidated landfill footprint. The downstream slopes for this new west berm were recently seeded and mulched as part of site closure and restoration activities. At the time of inspection, this berm appeared to be experiencing minor erosion as noted by several erosion rills along the slope.

Photograph 8 (West Perimeter Berm Downstream Slope)  
Minor erosion of recently seeded and mulched perimeter berm downstream slope. (IMG\_DSCF1038.JPG)

The berm downstream slopes of the Bottom Ash Landfill appear to be in fair condition. Recently seeded and mulched slopes will be monitored for erosion and vegetative success during future inspections in accordance with the Closure and Post-Closure Plan (Golder 2019). Additional soil will be added and the area re-seeded as required during the post-closure period.

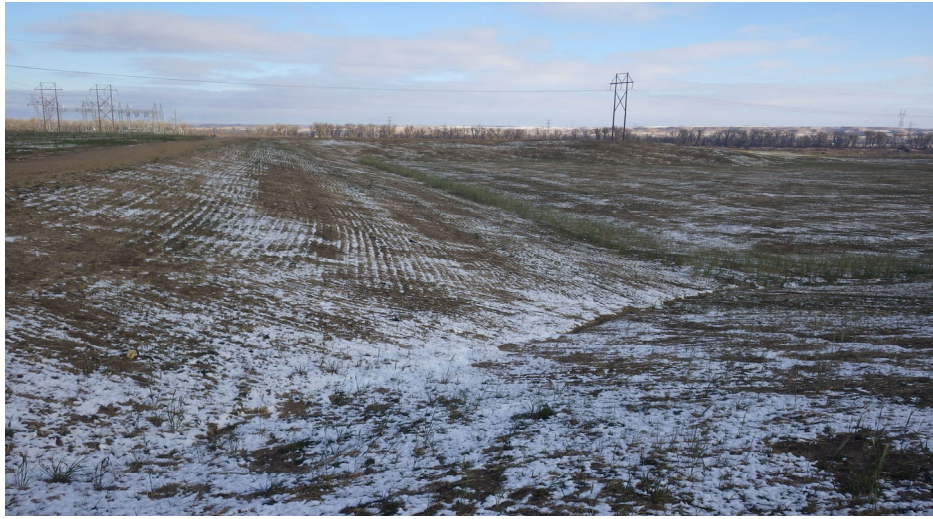
Photograph 9 (East Perimeter Berm Downstream Slope and Toe)  
Recently seeded and mulched area (vegetation beginning to grow, October 2020). (IMG\_7387.JPG)

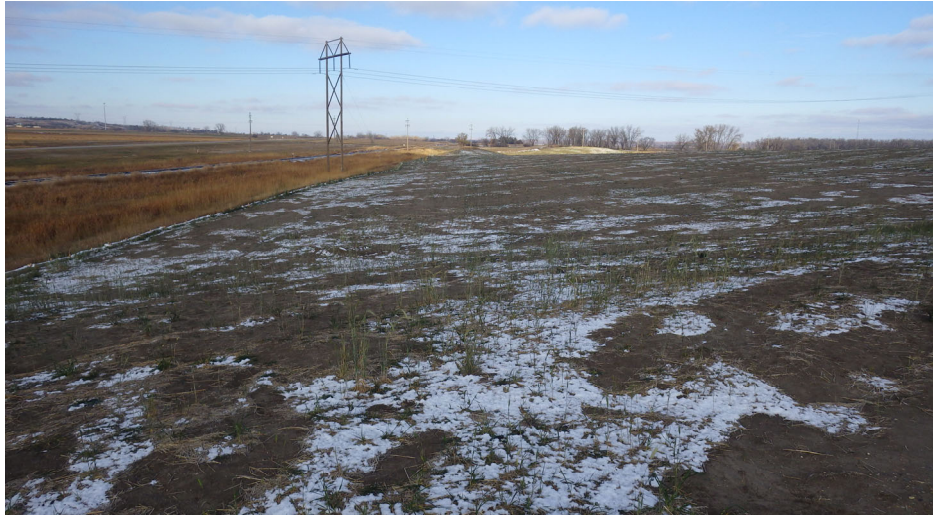
Photograph 10 (South Final Cover Slope)  
Recently seeded and mulched area (vegetation beginning to grow, October 2020). (IMG\_7391.JPG)
