# Annual Inspection

## *Stanton Station - Bottom Ash CCR Surface Impoundment*

**Great River Energy**

January 2021

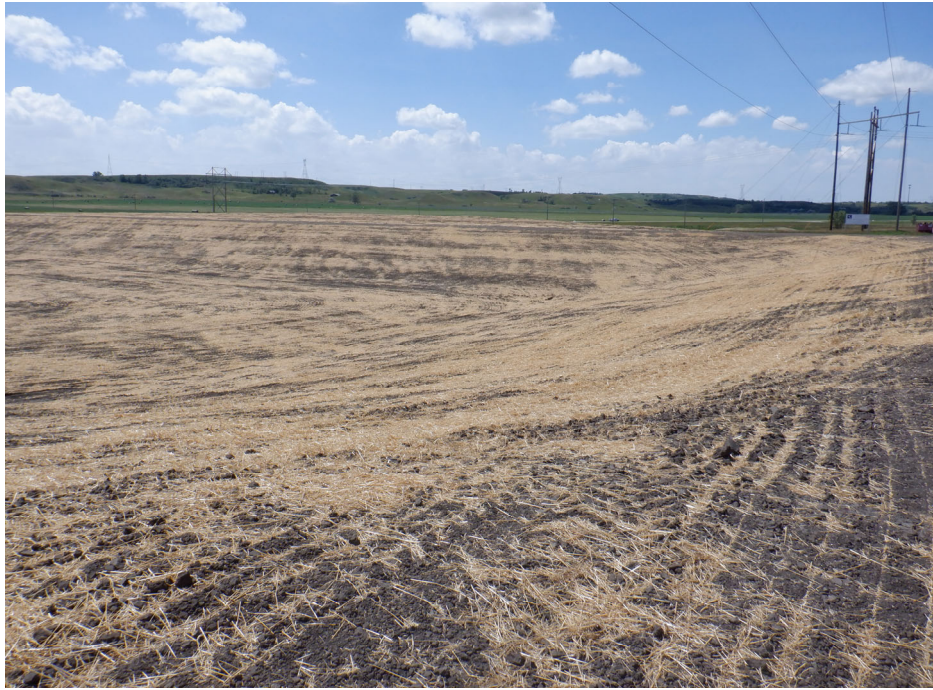
Photograph 1 (NE berm crest of historic north cell)  
Interior of north cell and center cell (bottom ash, liner system, and a portion of the underlying clay removed during restoration activities). (IMG\_DSCF0954.JPG)

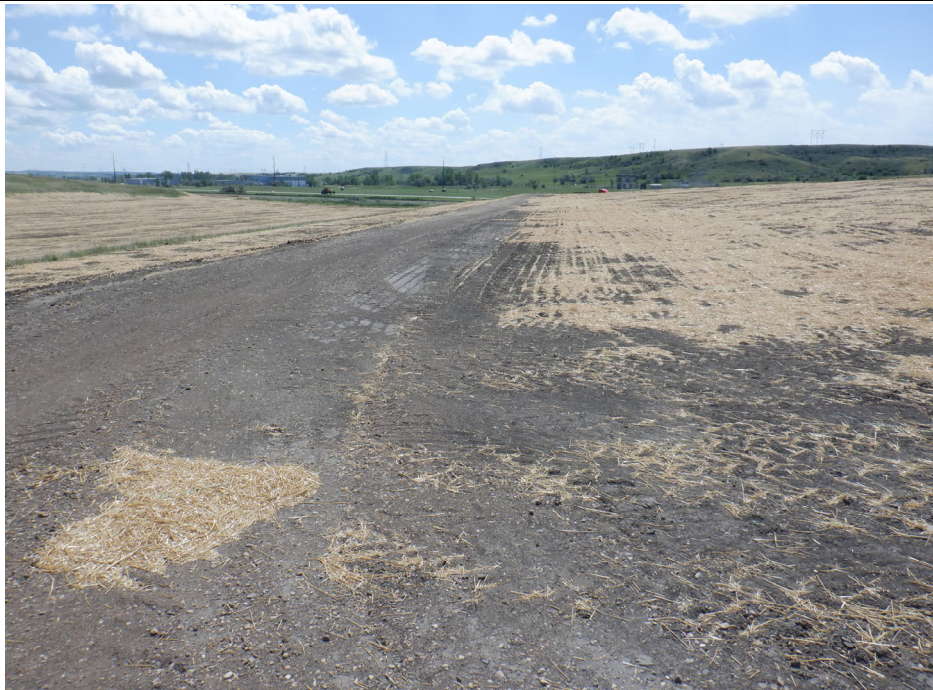
Photograph 2 (NE berm crest of south cell)  
East berm access road with no signs of damage and recently seeded and mulched east final cover crown area. (IMG\_DSCF0966.JPG)

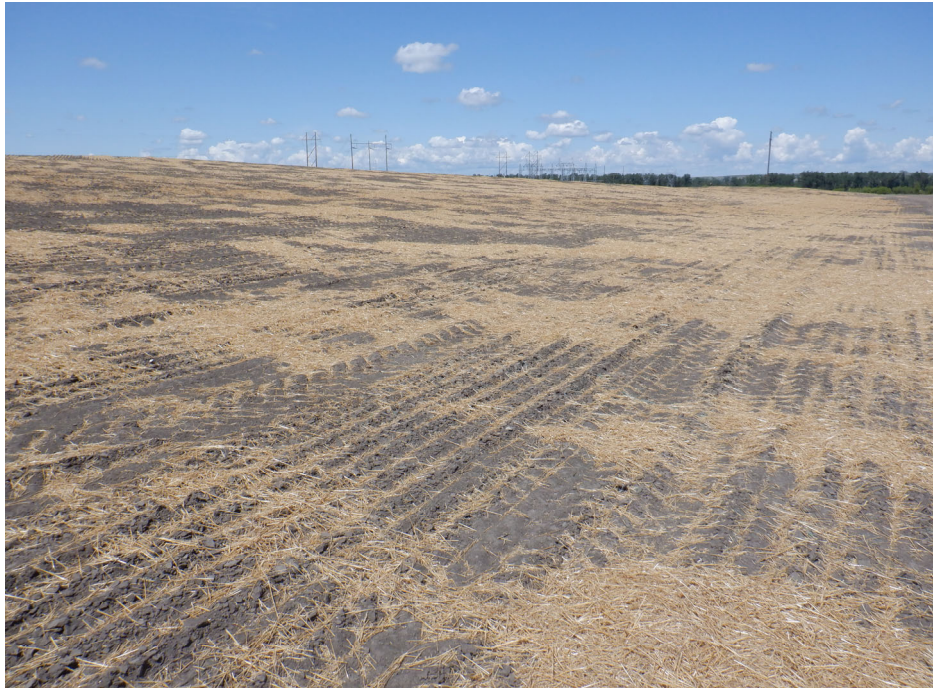
Photograph 3 (East side of south cell)  
South cell final cover recently seeded and mulched. (IMG\_DSCF0967.JPG)

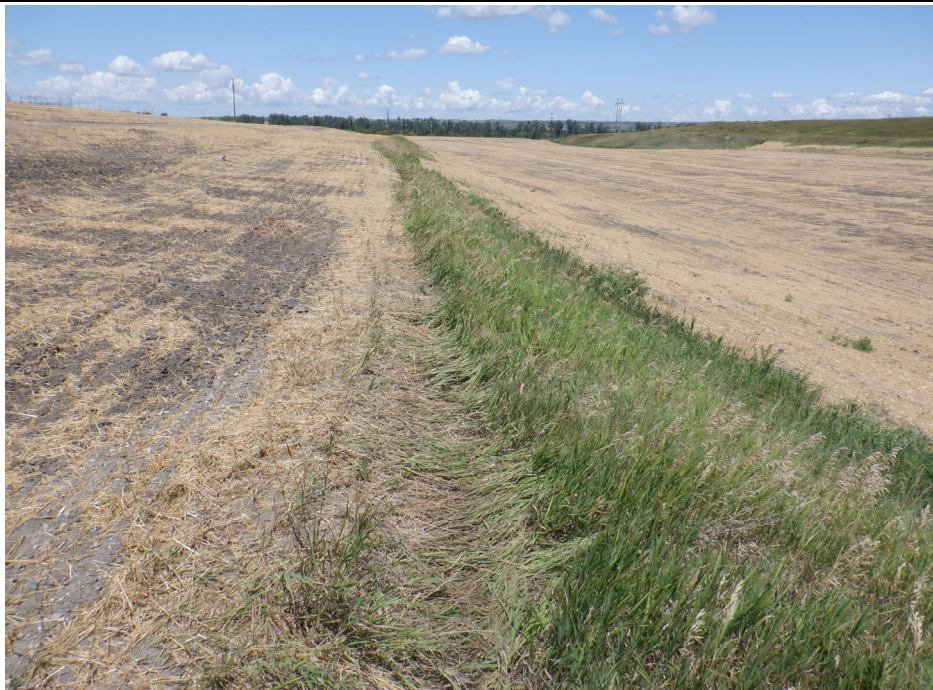
Photograph 4 (South cell east berm downstream slope)  
Lower east berm downstream slope with historic well-established grass vegetation mid-slope and recently seeded and mulched areas on the upper slope and near the toe of the slope. (IMG\_DSCF0972.JPG)

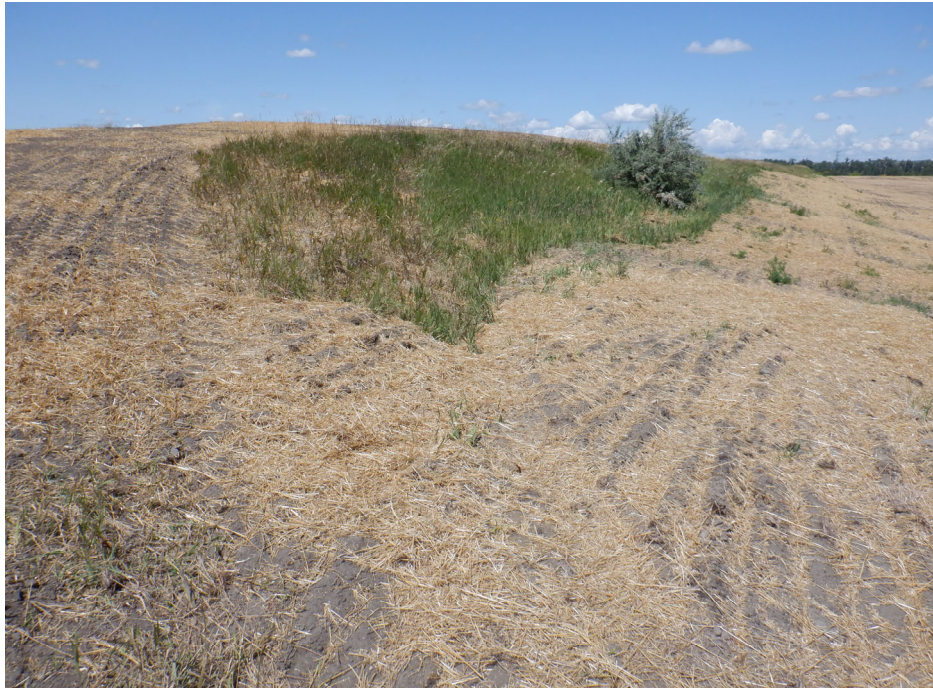
Photograph 5 (South cell east berm downstream slope)  
Woody vegetation on east downstream slope of south cell. (IMG\_DSCF0973.JPG)

Minor maintenance items that may need to be continually addressed include repairing larger animal burrows as they appear, repairing erosion caused by stormwater, monitoring vegetative success of berm downstream slopes

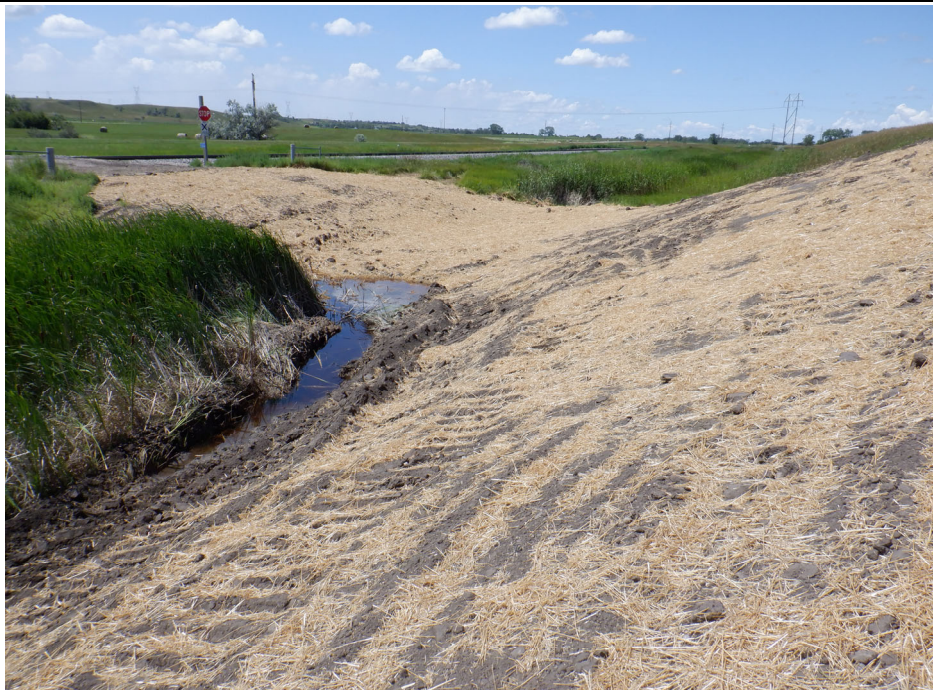
Photograph 6 (Southeast corner of south cell)  
Drainage ditch at the toe of the south slope of the south cell and recently seeded and mulched lower berm downstream slopes. (IMG\_DSCF0974.JPG)

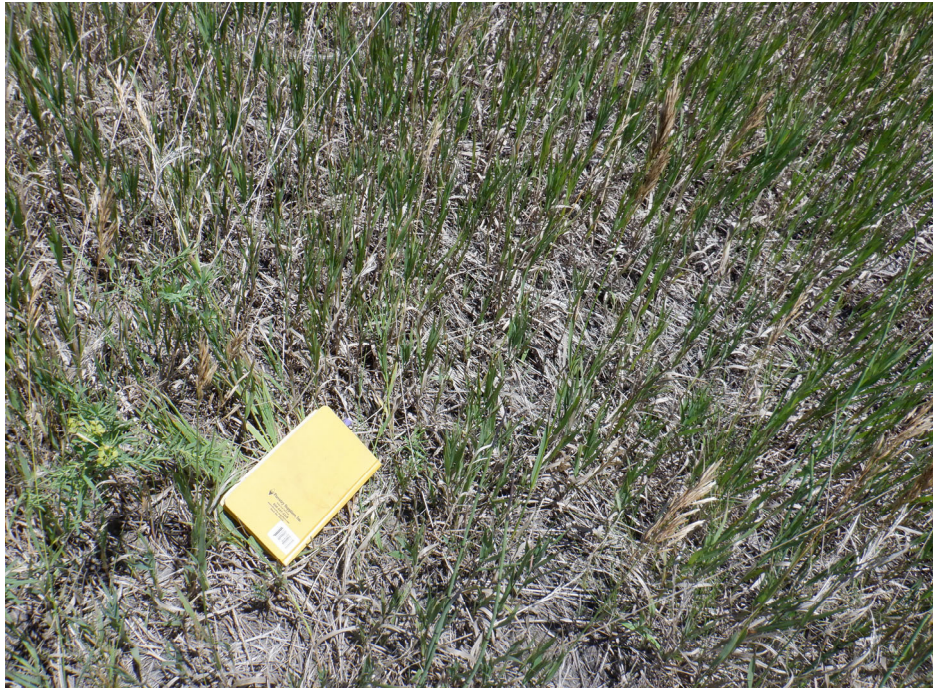
Photograph 7 (South berm downstream slope)  
Grass vegetation on south downstream slope. (IMG\_DSCF0977.JPG)

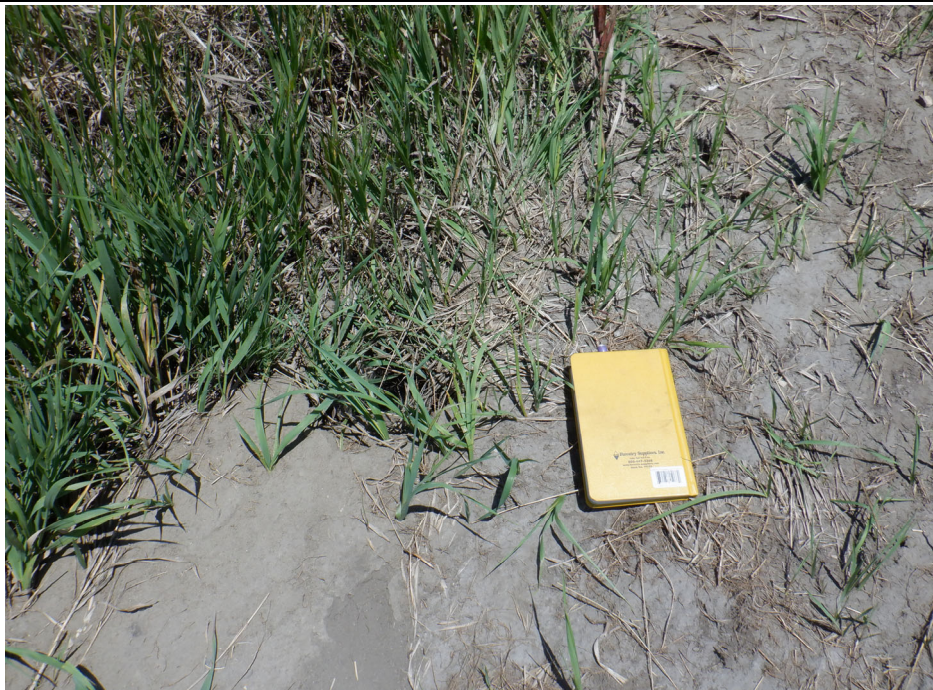
b. Vegetation	X			Grass, few bare spots, minor woody vegetation
c. Rodent burrows	X			Few 2" to 6" animal burrows
d. Cracks/settlement/scarps		X		
e. Drain conditions			X

Photograph 8 (South berm downstream slope)  
Small animal burrow on south downstream slope. (IMG\_DSCF0978.JPG)

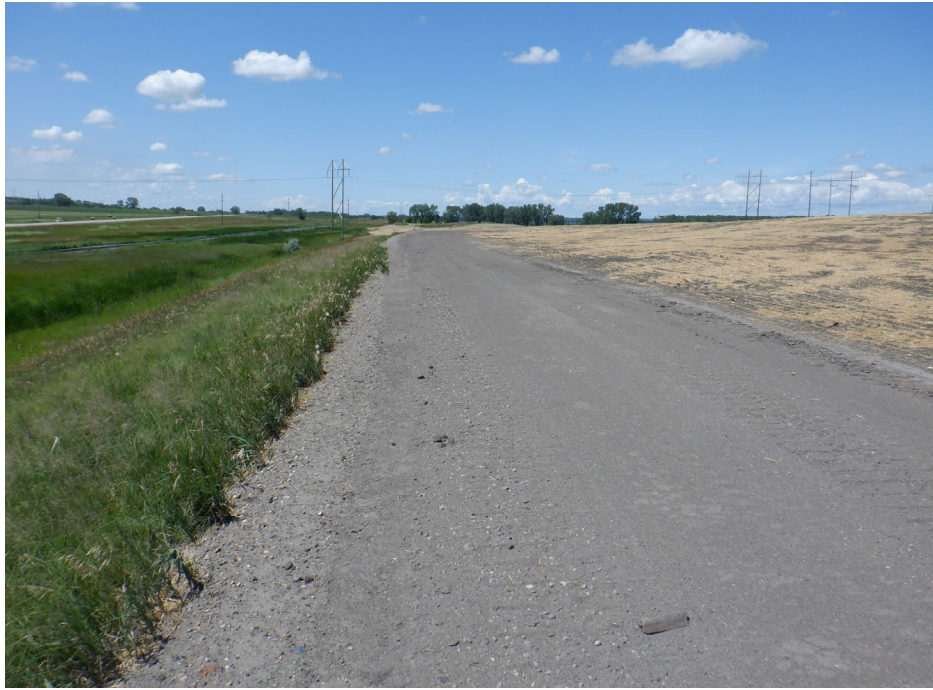
Photograph 9 (South berm crest)

Grass vegetation on south downstream slope, south berm access road in good condition, and recently seeded and mulched south final cover crown area. (IMG\_DSCF0983.JPG)

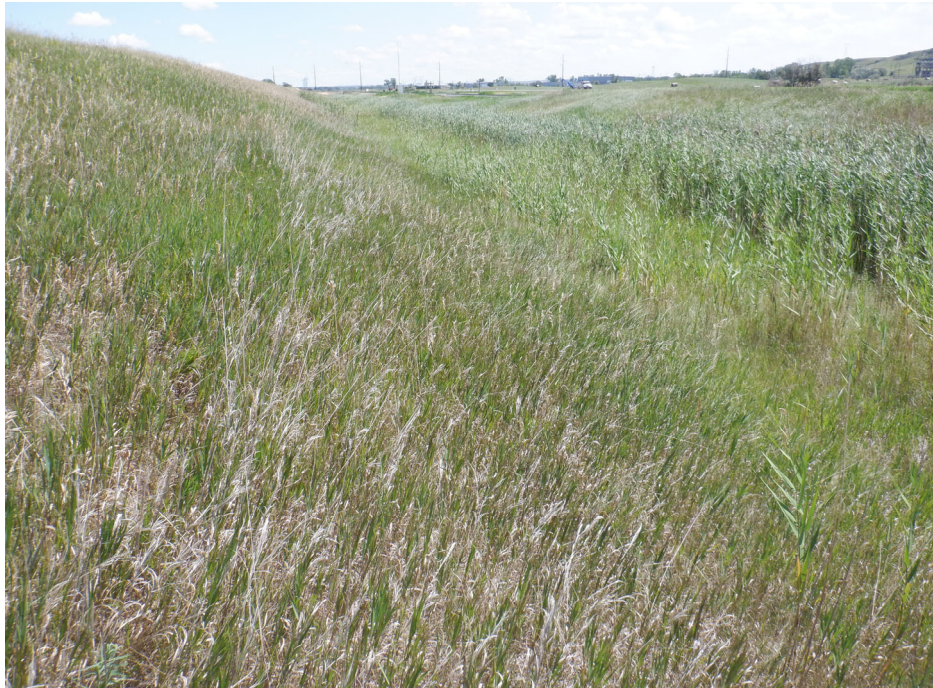
Photograph 10 (South cell south slope)

Grass vegetation on south downstream slope (typical). (IMG\_DSCF0992.JPG)

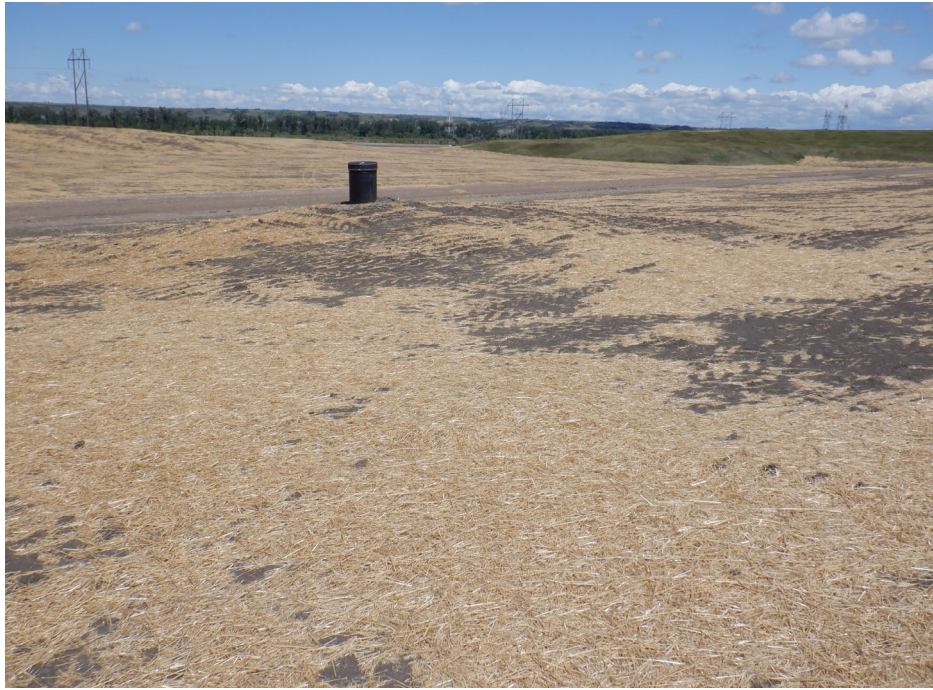
Photograph 11 (Top of south cell)  
Top of final cover recently seeded and mulched and south cell sump riser pipe. (IMG\_DSCF0995.JPG)

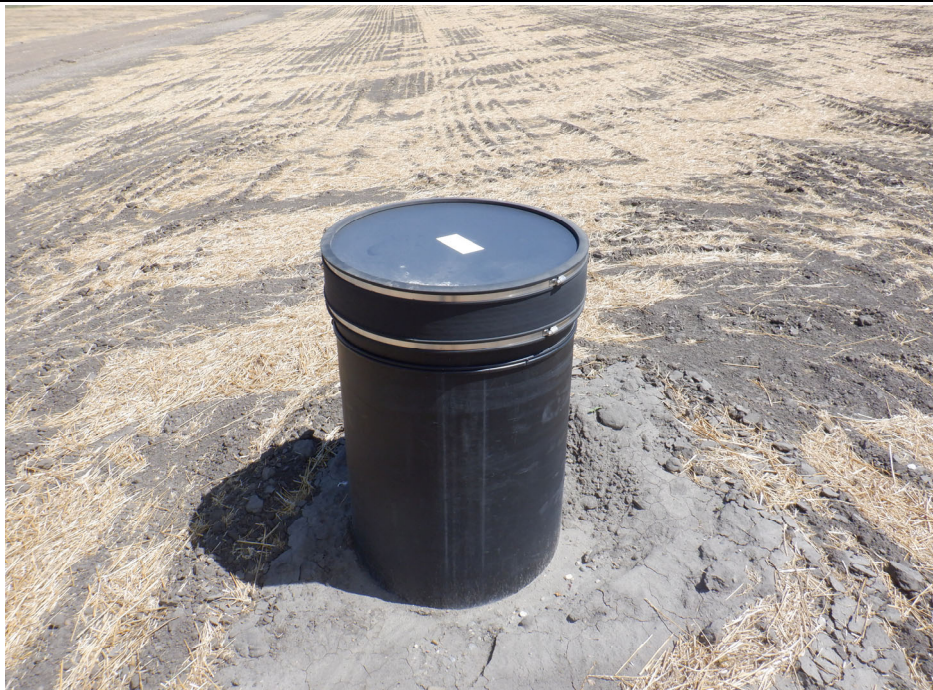
The historic outflow structure was incorporated into the design of the sump to remove pore water during the post-closure period of the south cell of the Bottom Ash Impoundment. The sump riser piping was visible during the inspection and was in good condition with no signs of settlement, erosion, or cracking.

Photograph 12 (Top of south cell)  
South cell sump riser pipe with removable sump cap in place. (IMG\_DSCF0997.JPG)

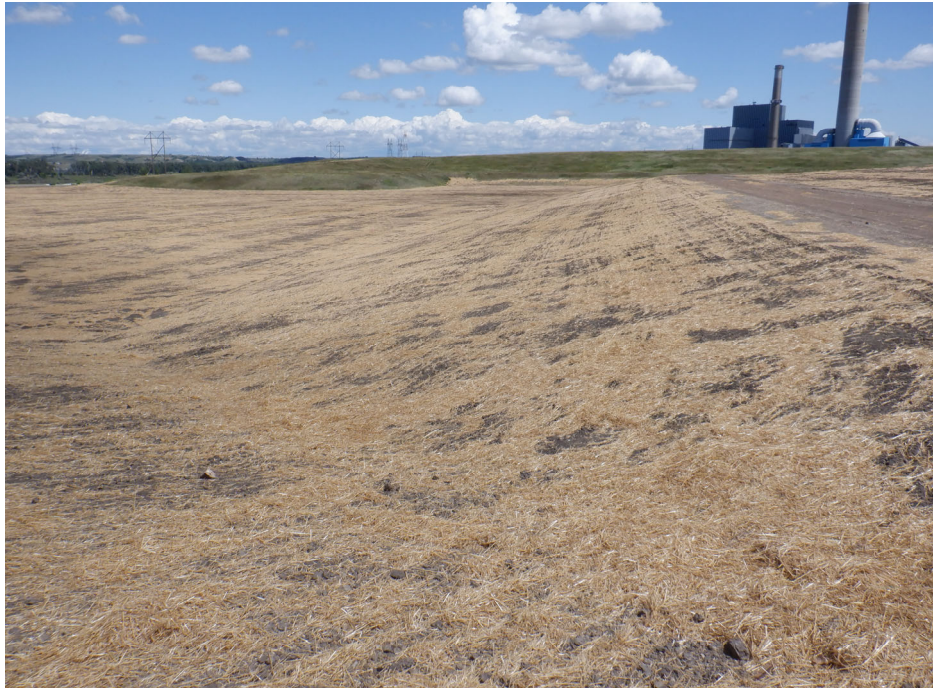
Photograph 13 (South cell north downstream berm)

Recently seeded and mulched downstream berm of the south cell (this area was historically occupied by the center cell that was closed by removal). (IMG\_DSCF1001.JPG)

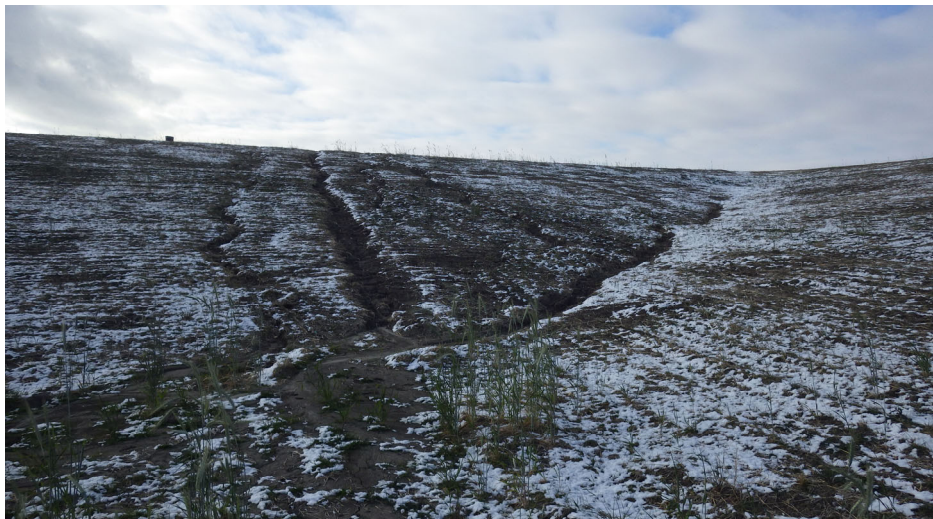
Photograph 14 (North berm downstream slope)

e. Exposed to heavy traffic	X			During closure
f. Damage from vehicles/machinery		X		
<b>6. Downstream slope</b>				
a. Erosion	X			Minor erosion (particularly on newly seeded north berm)

Erosion rills and new vegetation. (IMG\_7386.JPG)

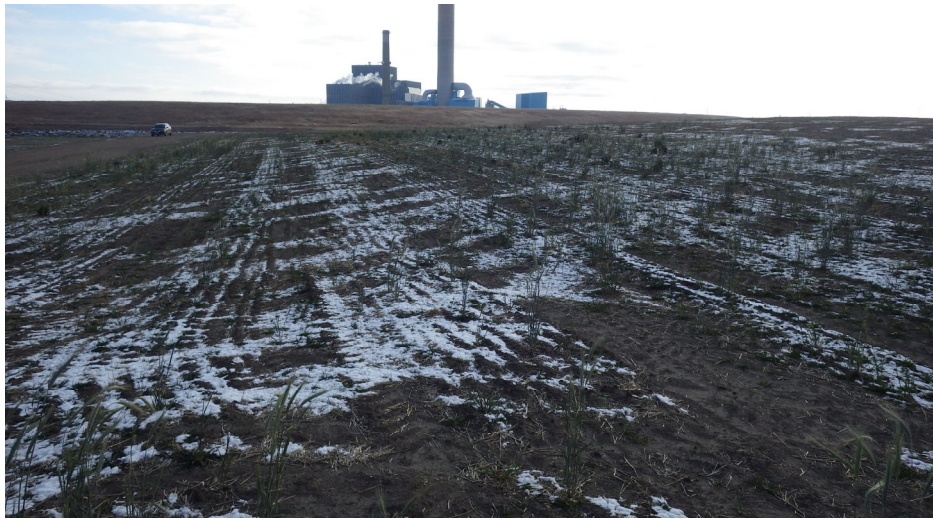
Photograph 16 (South cell north side)  
New vegetation on final cover. (IMG\_7389.JPG)
