Annual Inspection

Coal Creek Station - Drains Pond System CCR Surface Impoundment

Great River Energy

January 2021

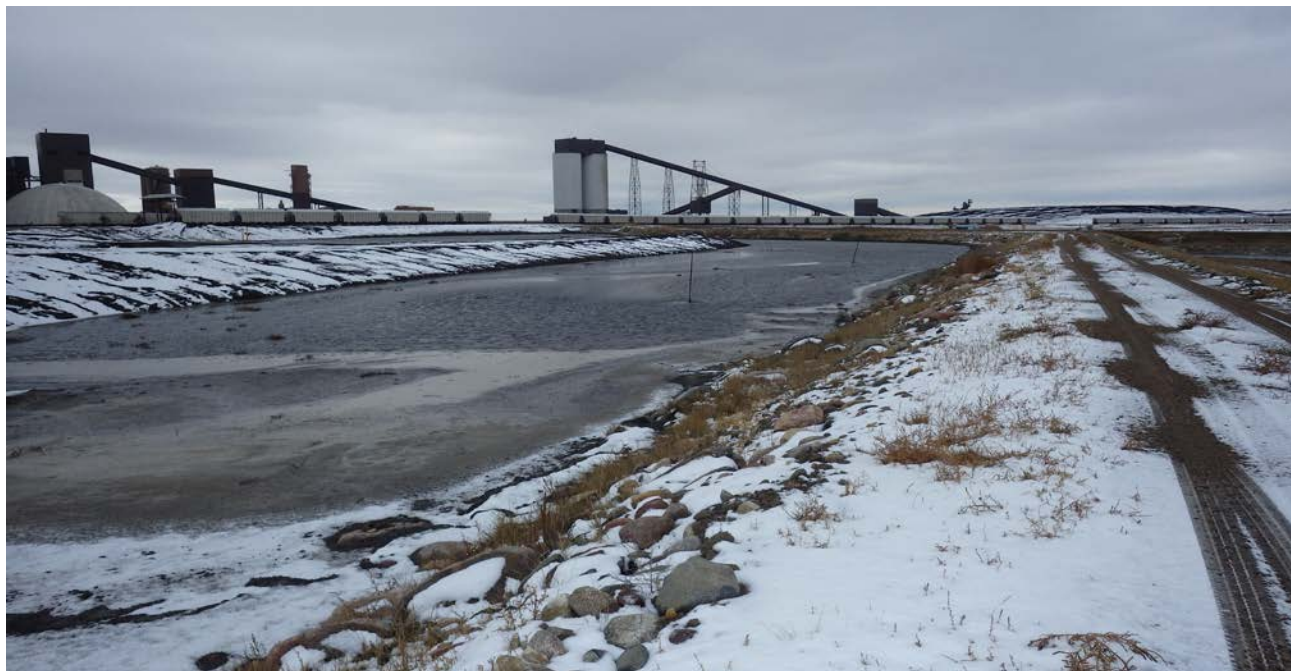
Photograph 1 (West cell east berm)

Upstream slope and crest road with riprap and gravel, good condition. (IMG_7354.JPG)

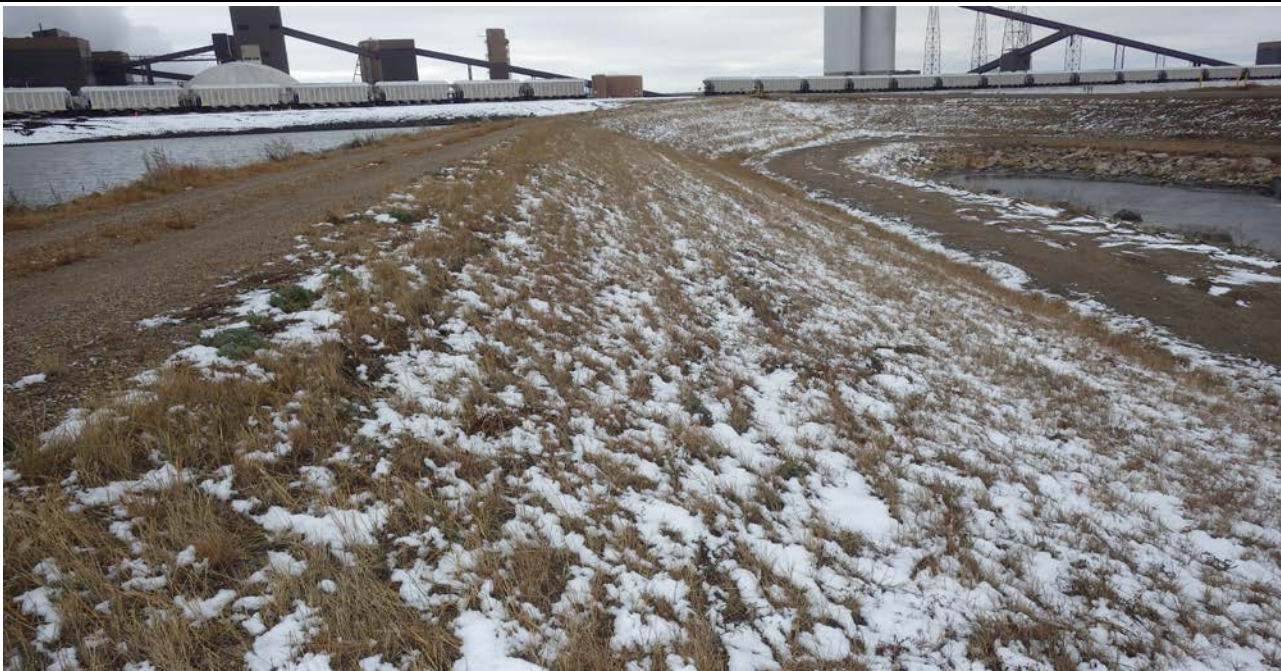
Photograph 2 (West cell east berm)

Downstream slope and crest road with vegetation and gravel, good condition. (IMG_7357.JPG)

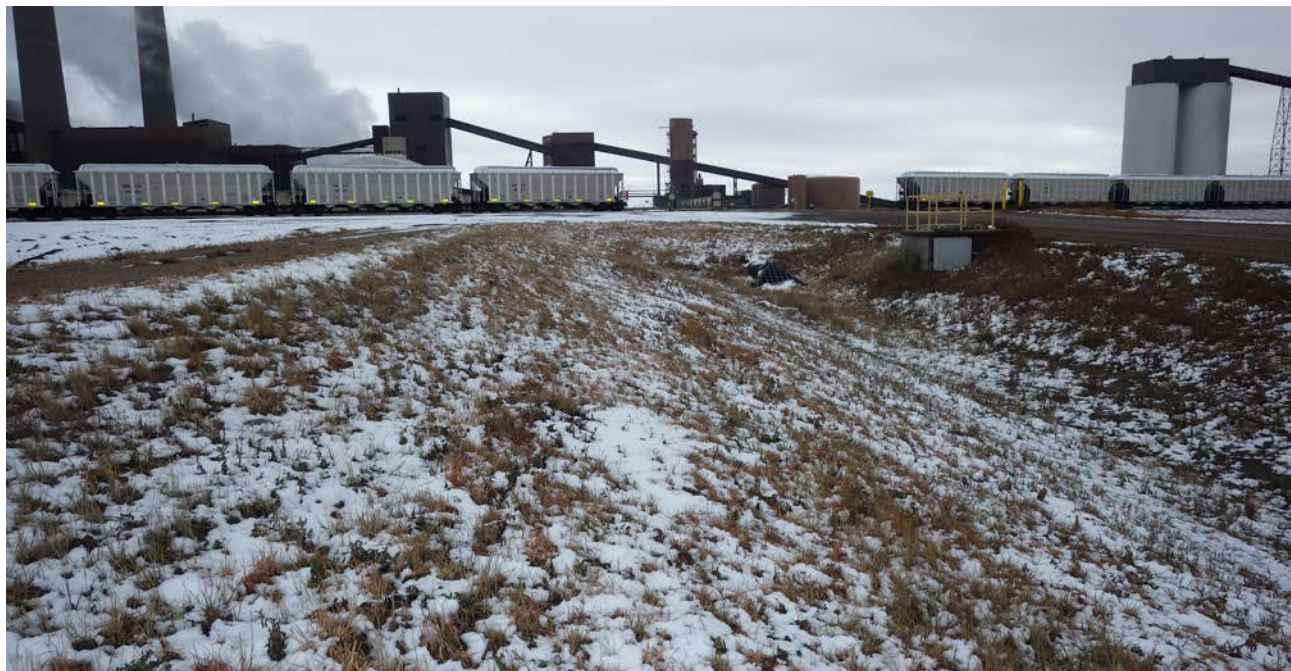
Photograph 3 (West cell north berm)
Stormwater drainage on north side of west cell, good condition. (IMG_7359.JPG)

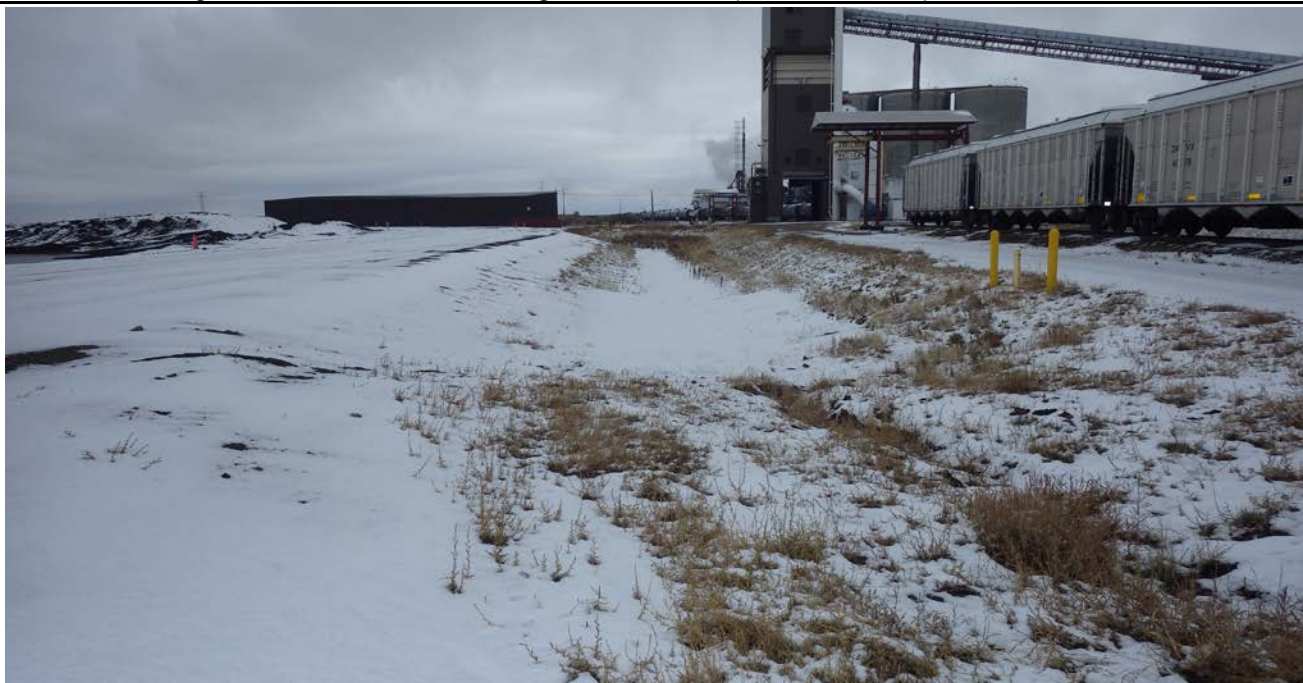
Photograph 4 (West cell west berm)
Downstream slope and stormwater drainage, poor vegetation on slope. (IMG_7360.JPG)

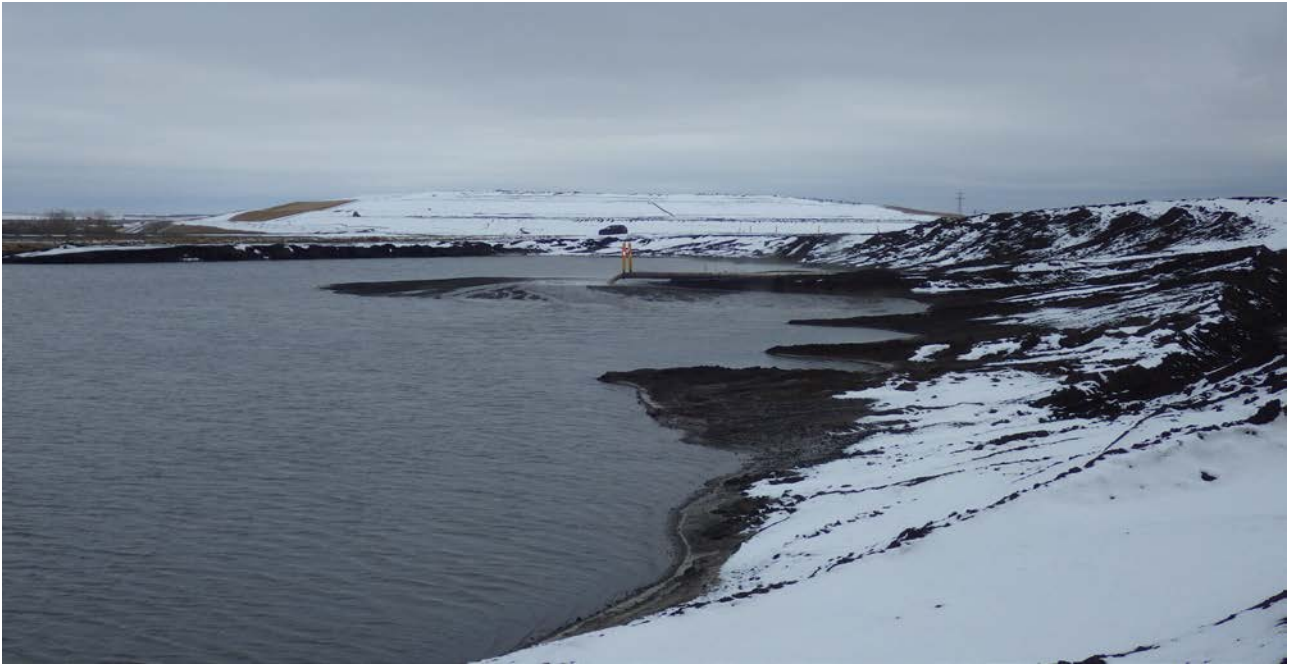
Photograph 5 (West cell interior)
Bottom ash deposition. (IMG_7363.JPG)

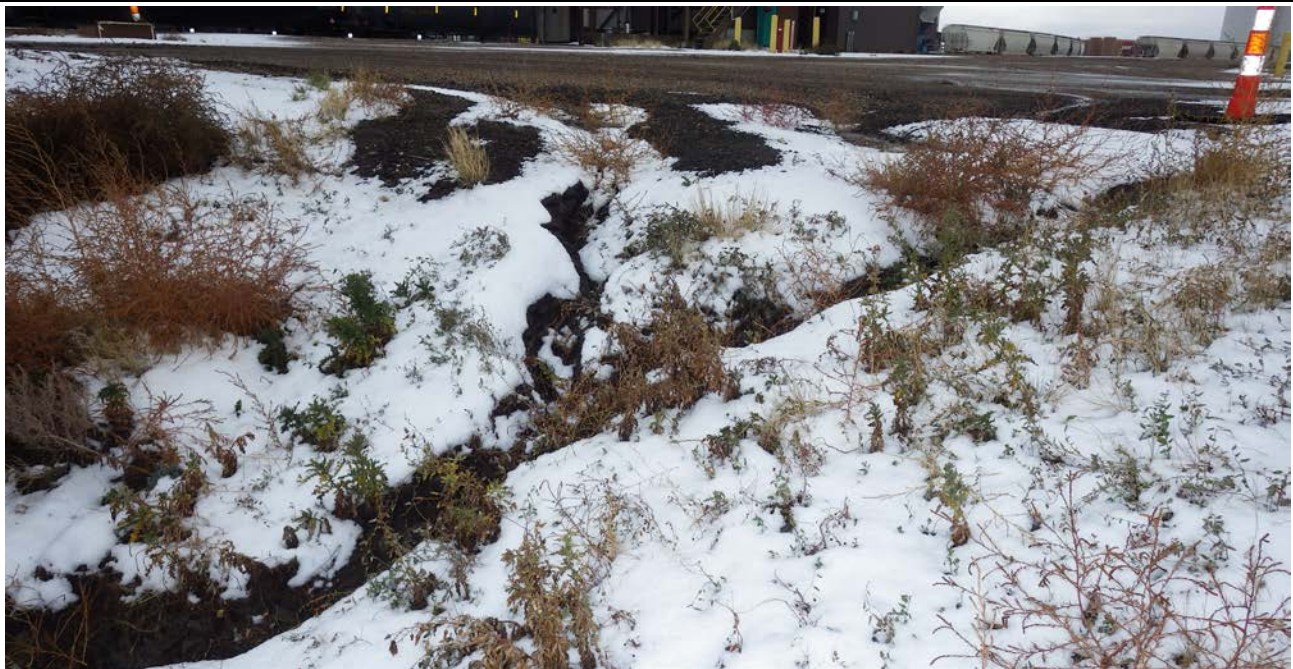
downstream slope had erosion rills associated with runoff from the access road. These erosion rills should be filled in and this area re-seeded. Golder did not observe indications of seepage, sloughing, cracking, significant erosion, excessive settlement, or vegetation that seemed to be thriving abnormally. The berm downstream slope of the west cell appeared to be in fair condition.

Photograph 6 (West cell south berm)
Downstream slope, erosion rill. (IMG_7367.JPG)

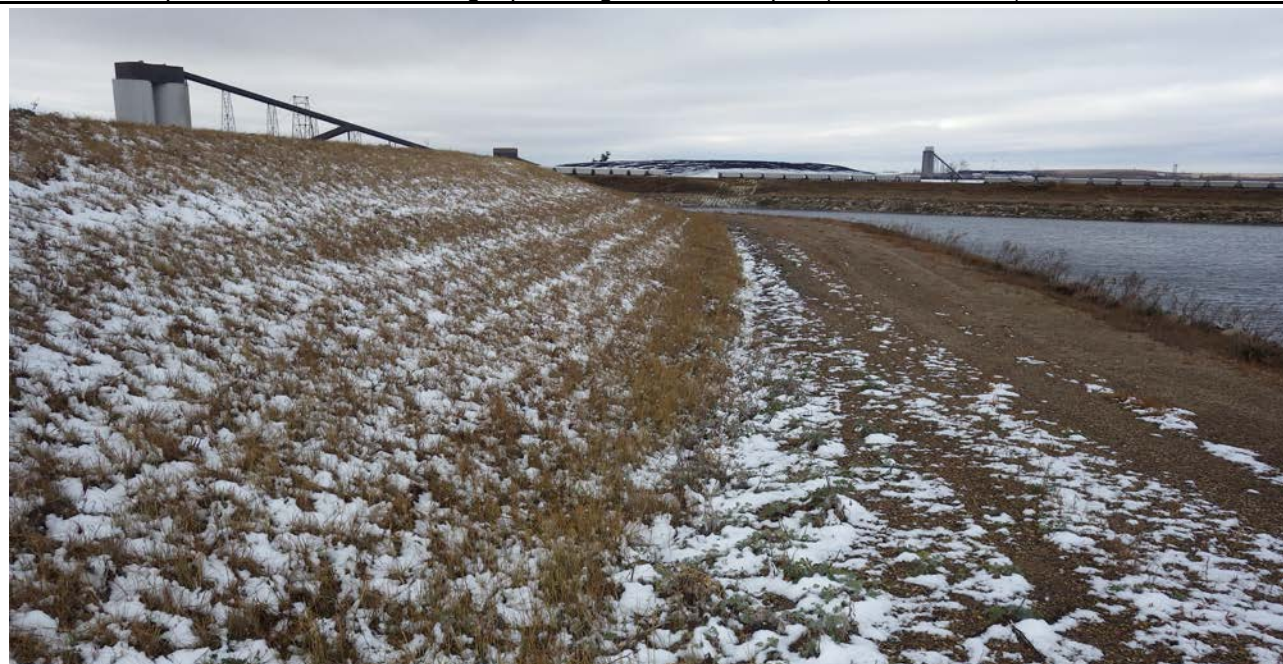
Photograph 8 (West cell east berm, center cell west berm)

Downstream slope and crest road with vegetation and gravel, good condition. (IMG_7372.JPG)

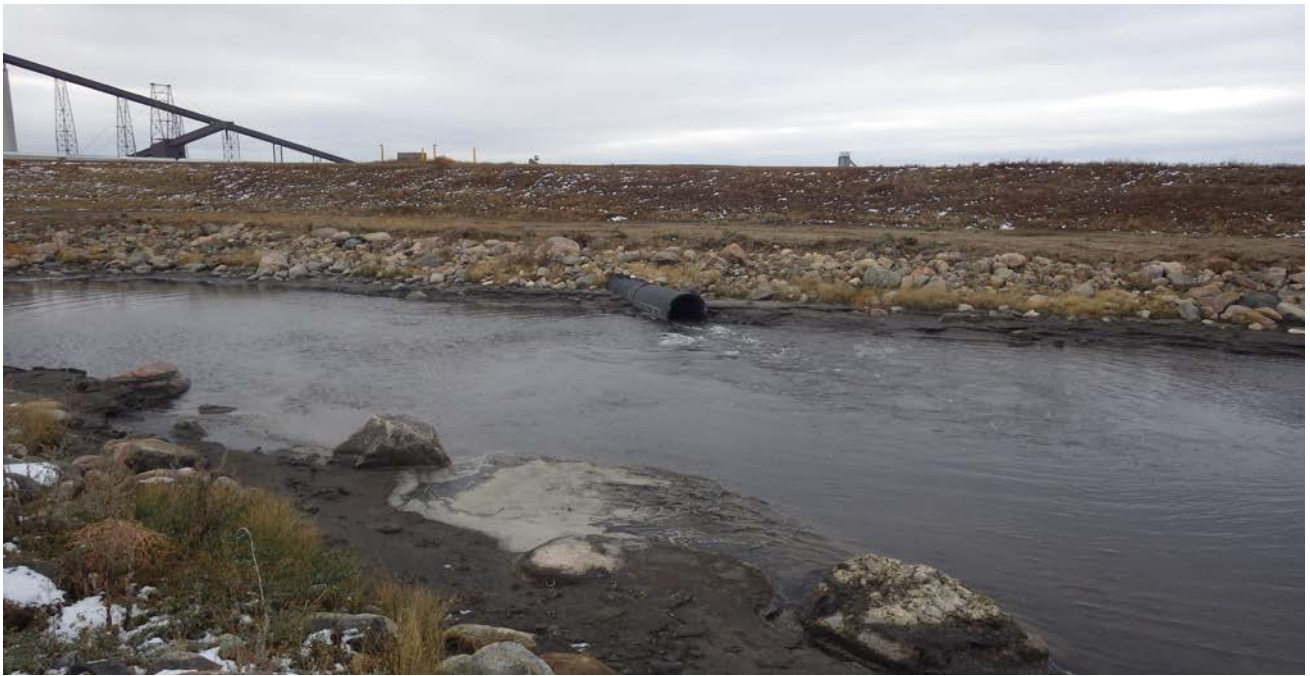
Photograph 9 (Center cell)
Plant drains inlet to the center cell. (IMG_7373.JPG)

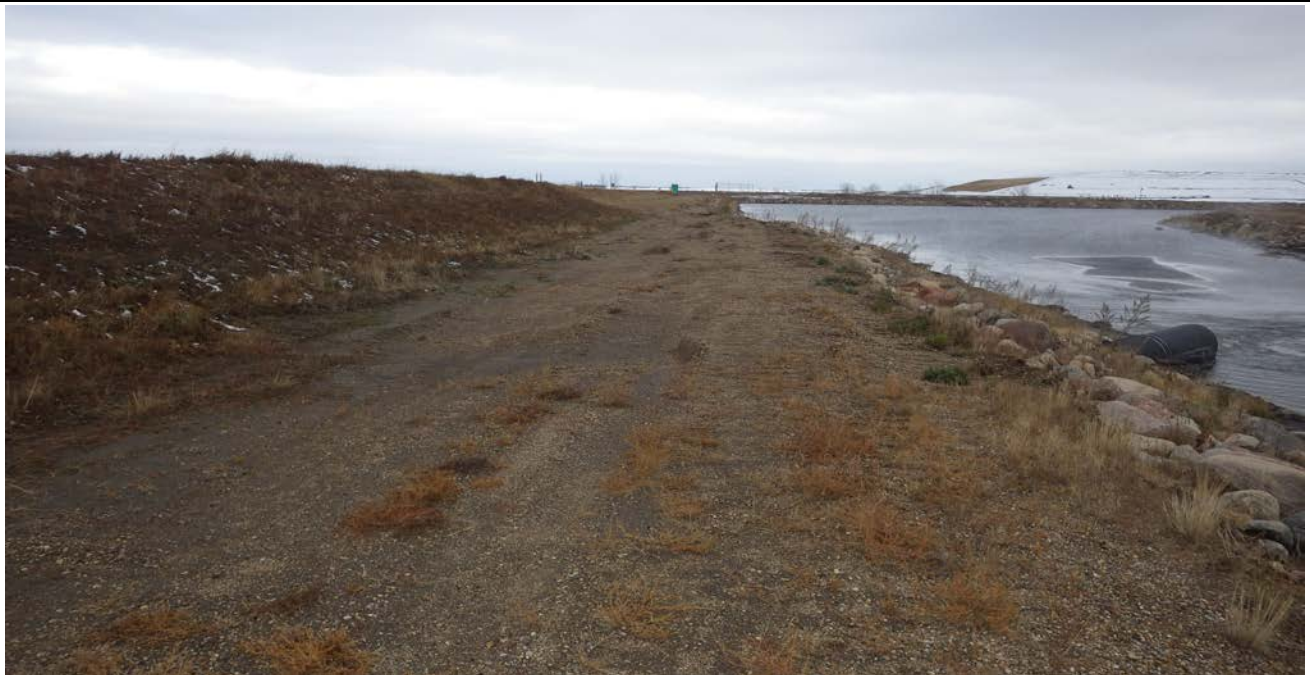
Photograph 10 (Center cell north berm)
Crest road and upstream slope with gravel and riprap, good condition. (IMG_7375.JPG)

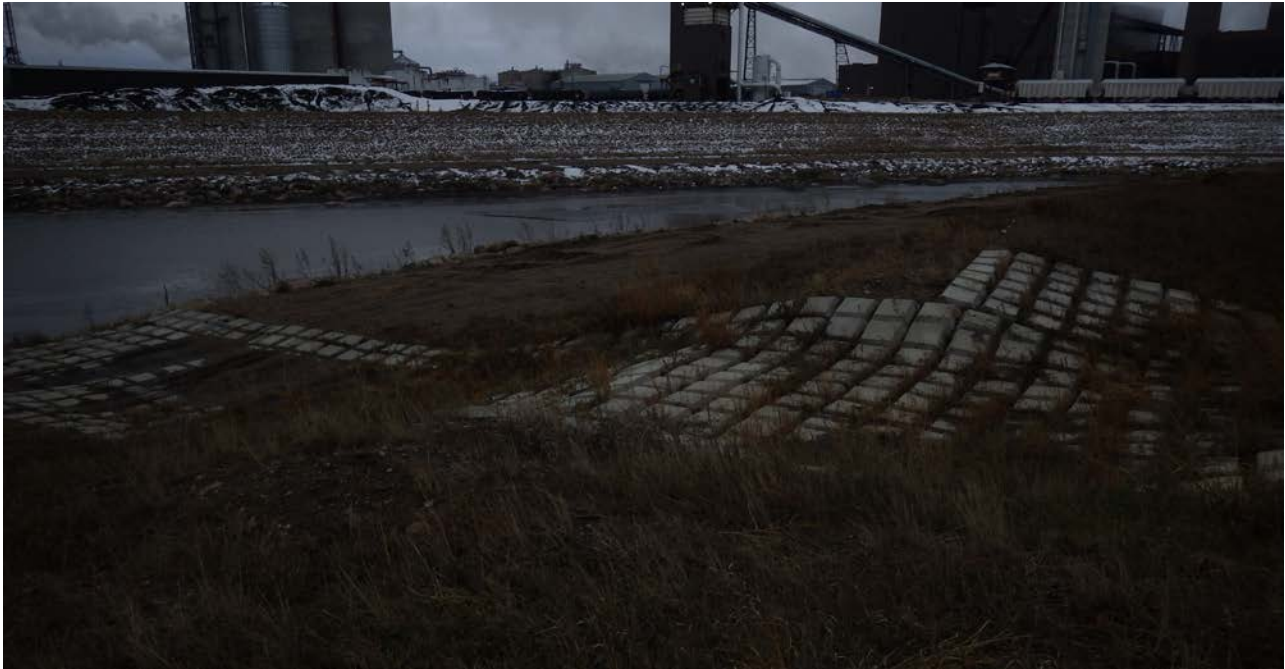
Photograph 11 (Center cell north berm)
Stormwater downchute channel (concrete block armoring), good condition. (IMG_7377.JPG)

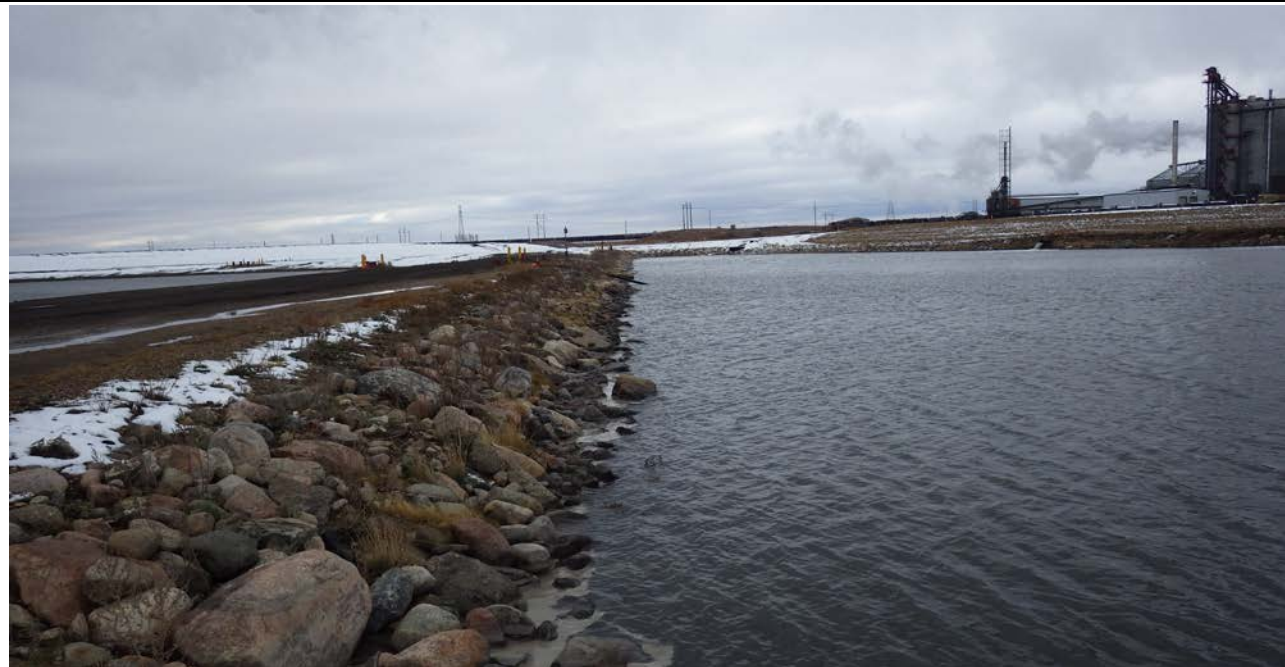
Photograph 12 (Center cell east berm)
Upstream slope with riprap, good condition. (IMG_7378.JPG)

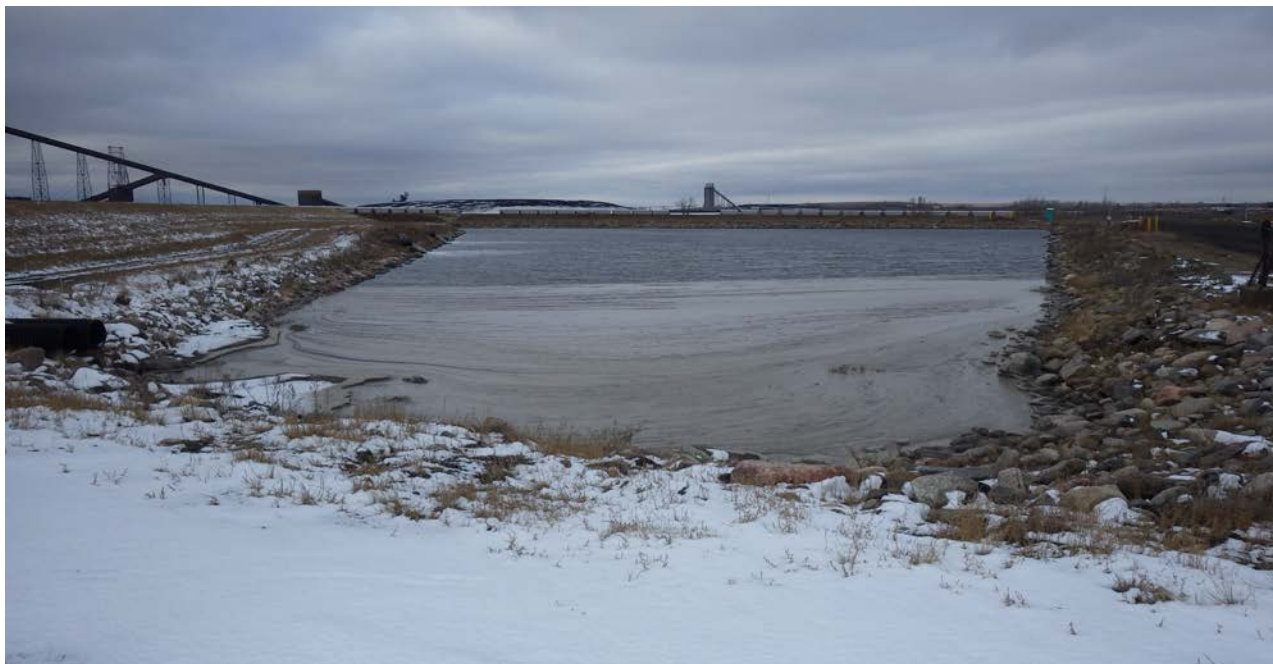
Photograph 13 (Center cell)
View from south end, upstream slope riprap in good condition. (IMG_7381.JPG)

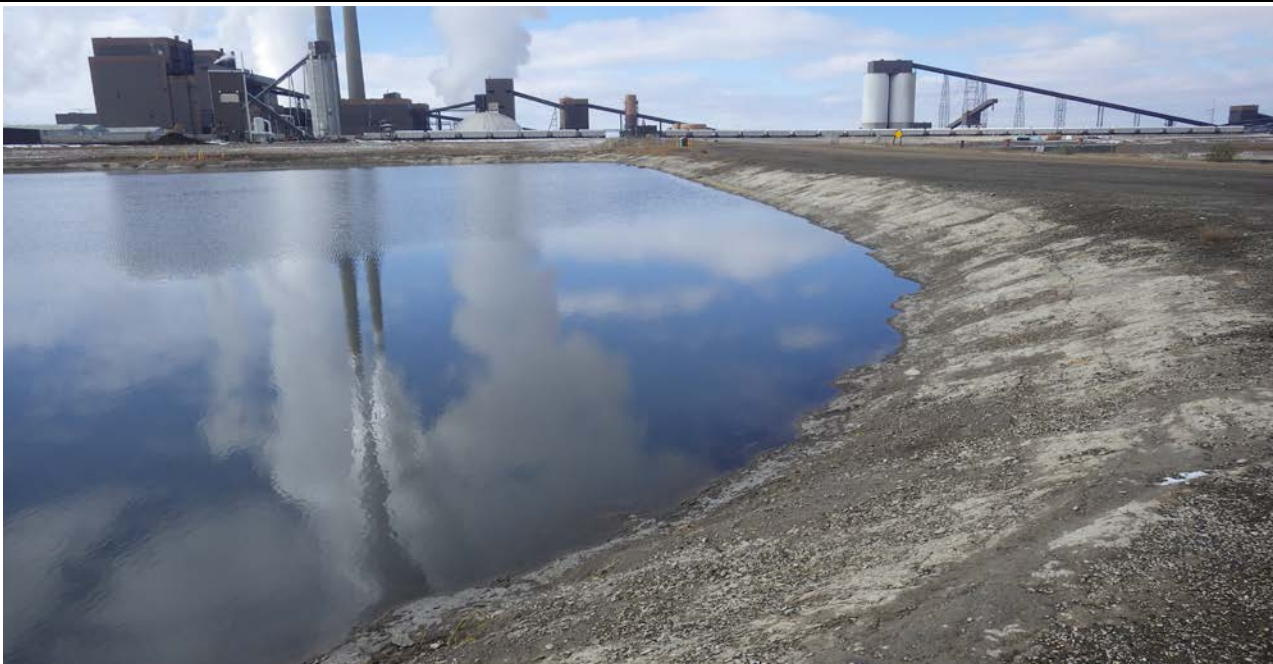
Photograph 14 (East cell north berm)
Upstream slope fly ash protective cover, good condition. (IMG_7440.JPG)

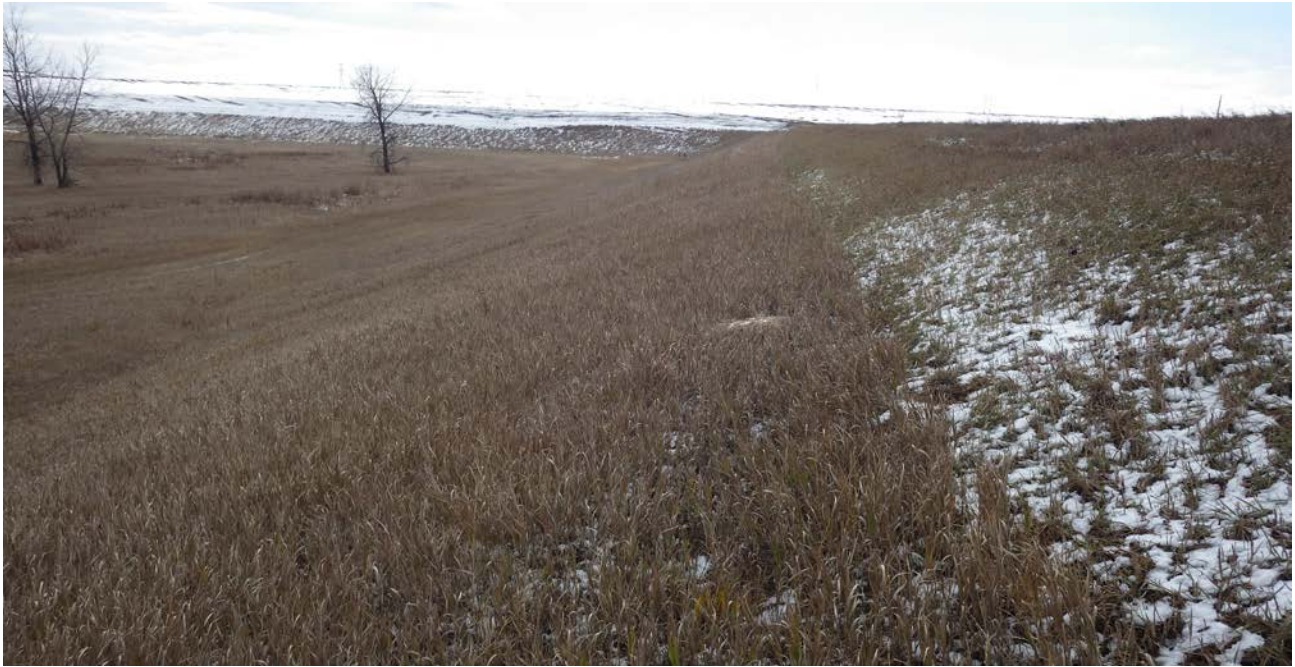
Photograph 15 (East cell east berm)
Downstream slope and toe, good vegetation. (IMG_7441.JPG)

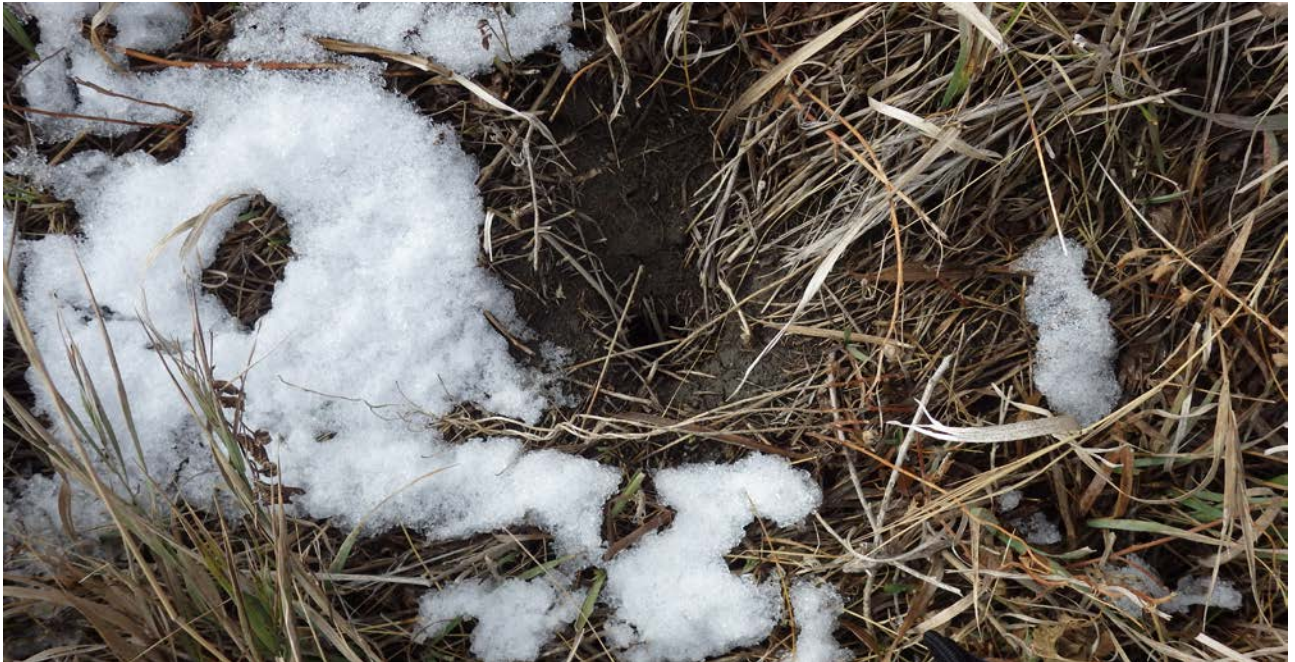
c. Rodent burrows	X			Small burrows on east and north downstream slopes
d. Cracks/settlement/scarps		X		
e. Drain conditions			X	
f. Seepage		X		
7. Toe

Photograph 16 (East cell east berm)
Downstream slope, small animal burrow. (IMG_7442.JPG)

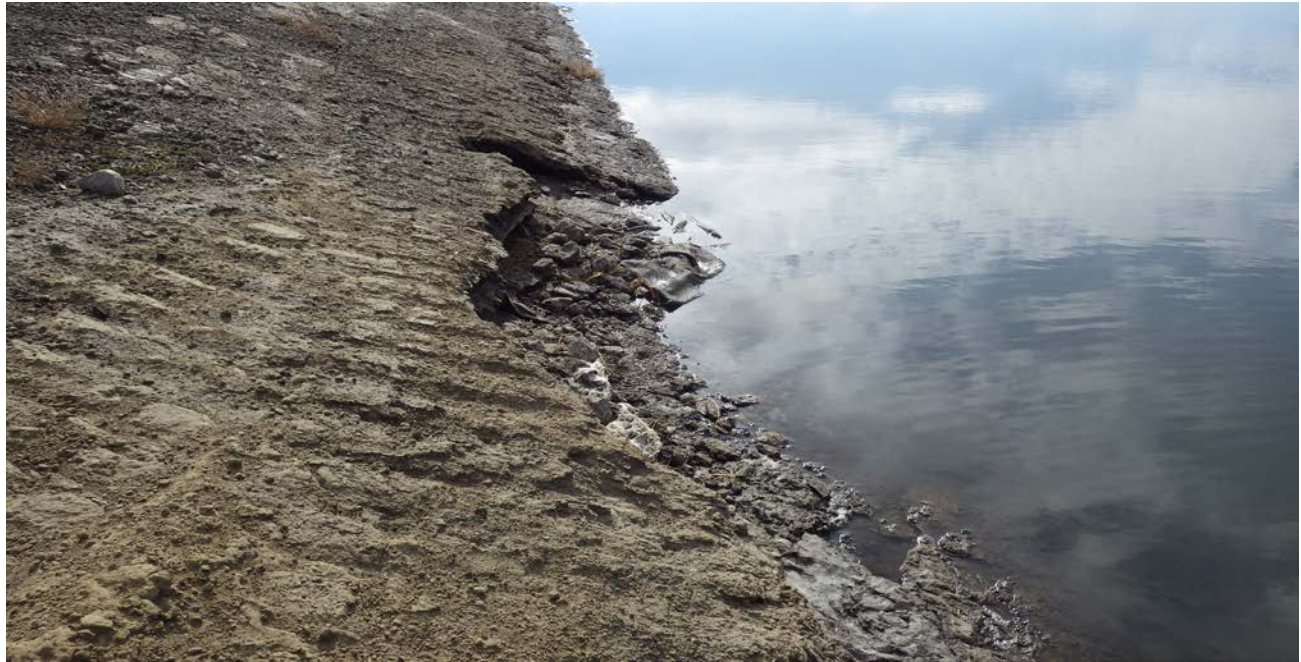
4. Upstream slope				
a. Erosion – liner exposed?		X		
b. Rodent burrows		X		
c. Vegetation		X		
d. Cracks/settlement		X		
e. Riprap/other erosion protection	X			Erosion of fly ash protective cover in east cell (isolated spots)

Photograph 17 (East cell east berm)
Upstream slope fly ash protective cover, minor erosion at water line. (IMG_7443.JPG)

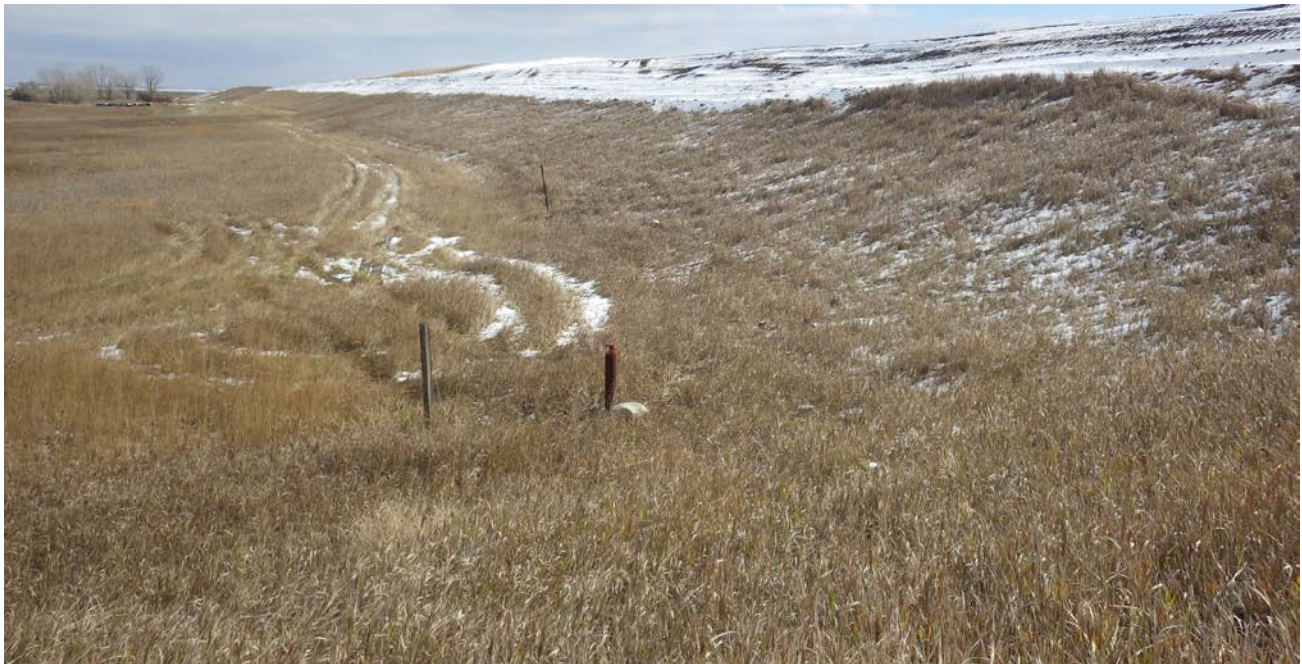
Photograph 18 (East cell east berm)
Downstream slope and toe, good vegetation. (IMG_7445.JPG)

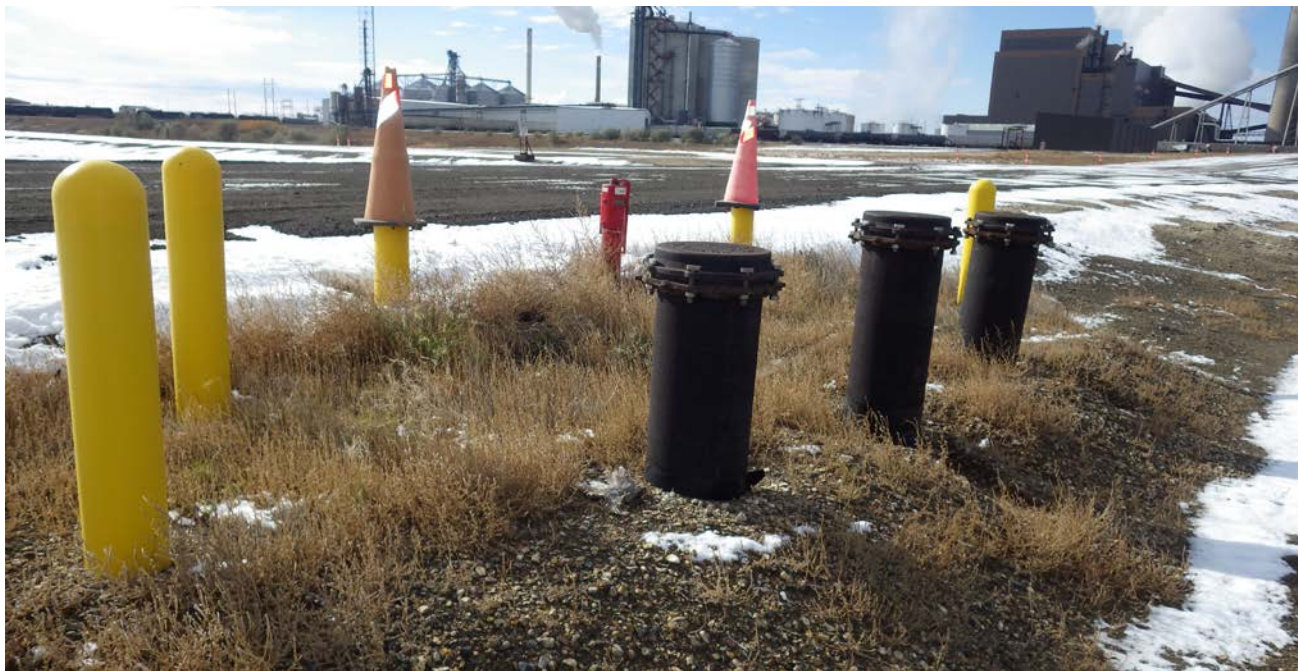
Photograph 19 (East cell south berm)
Cross-over pipe cleanouts and valve control. (IMG_7446.JPG)

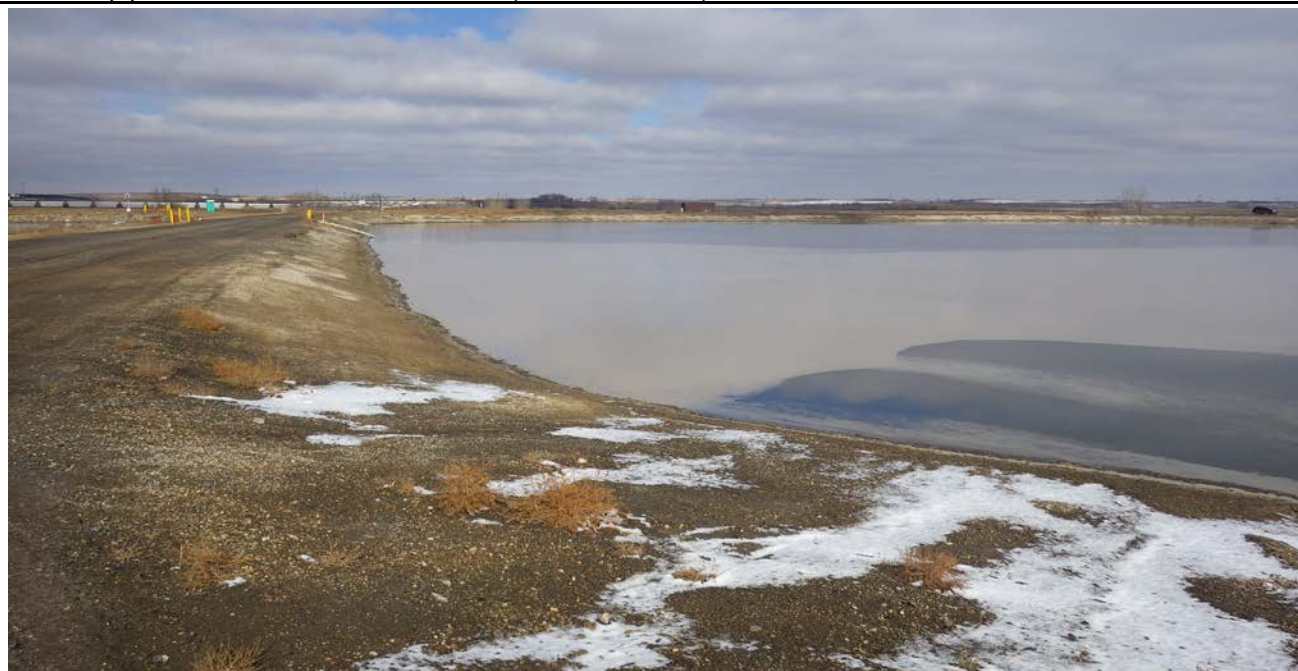
Photograph 20 (East cell west berm)
Upstream slope and crest road, fly ash protective cover and gravel, good condition. (IMG_7448.JPG)

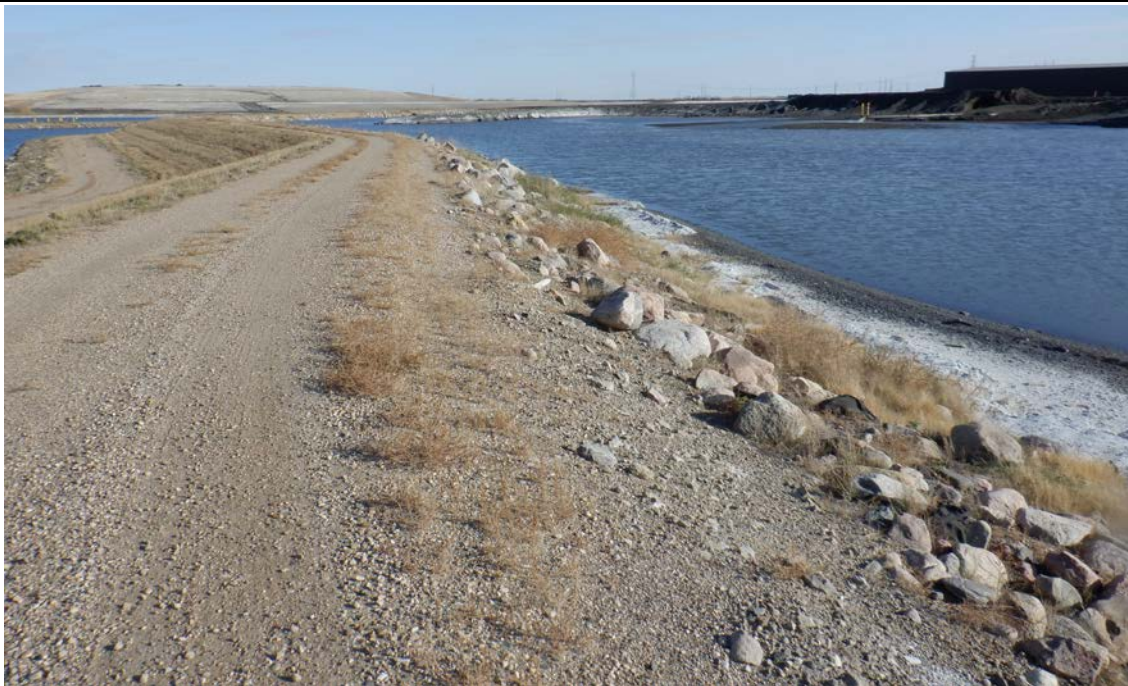
Photograph 21 (West cell east berm)
Berm crest between west and center cells, and west cell upstream slope riprap in good condition.
(IMG_DSCF1792.JPG)

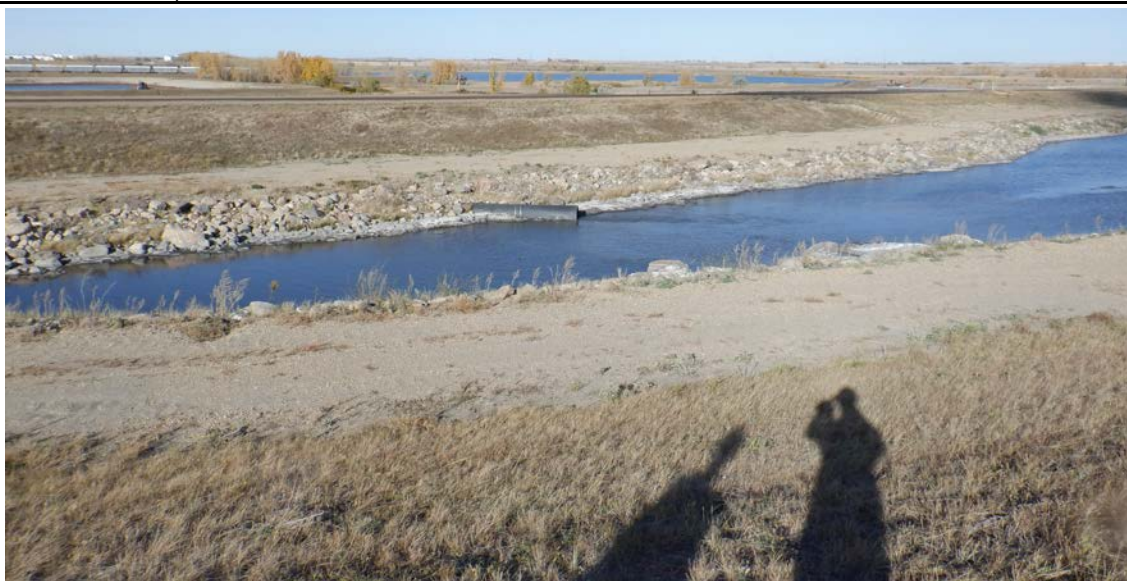
Photograph 22 (Center cell north berm)
Center cell upstream slope and plant drains inlet in good condition. (IMG_DSCF1794.JPG)

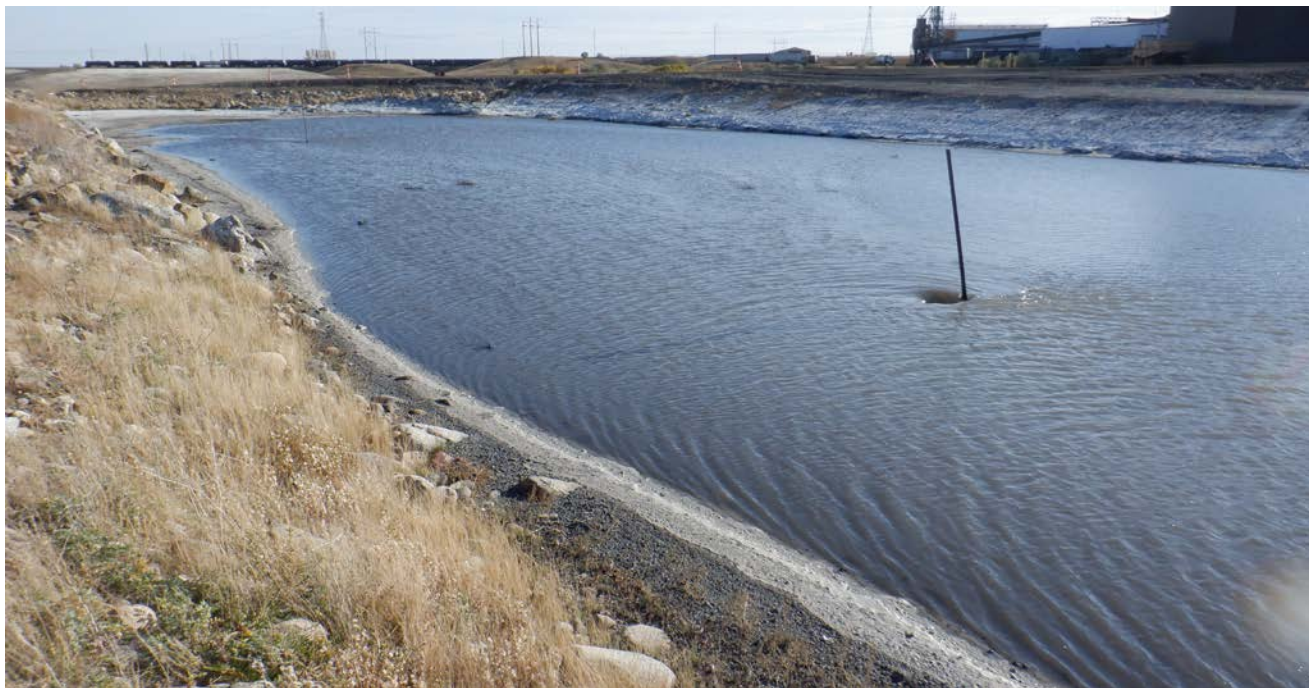
Photograph 23 (West cell east berm, center cell west berm)
West cell upstream slope and decanting of water to center cell. (IMG_DSCF1795.JPG)

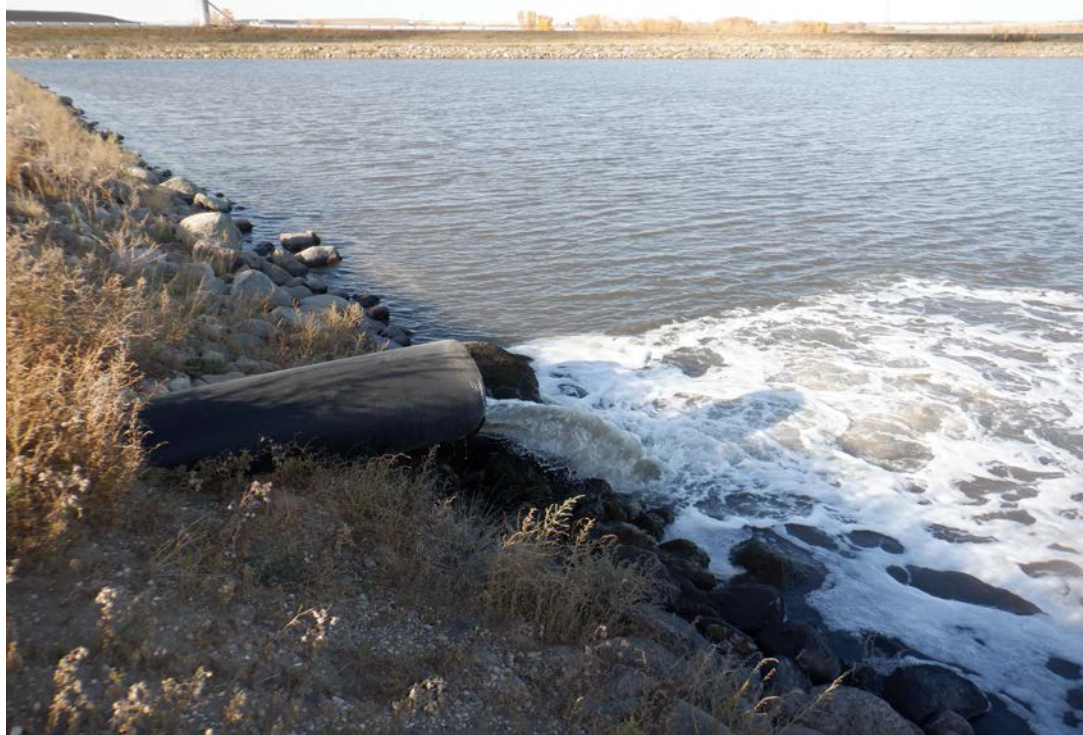
Photograph 24 (Center cell west upstream slope)
Inlet from west cell into center cell. (IMG_DSCF1796.JPG)
