Annual Inspection

Coal Creek Station - Southeast Section 16 CCR Landfill

Great River Energy

January 2021

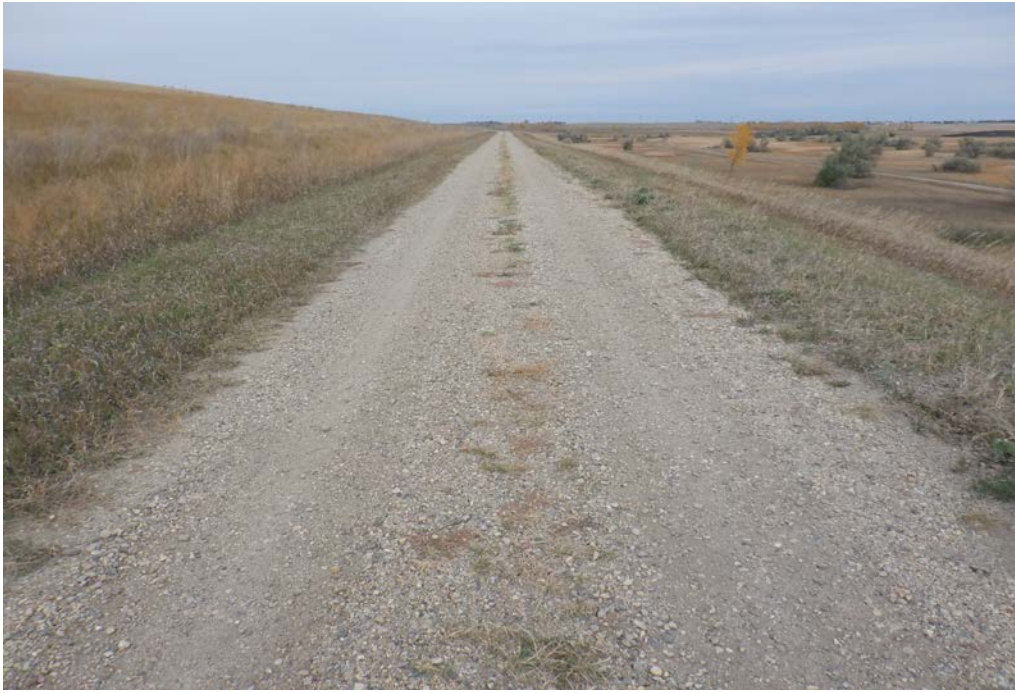
Photograph 1 (East berm crest)
Perimeter access road on the berm crest, good condition. (IMG_DSCF1659.JPG)

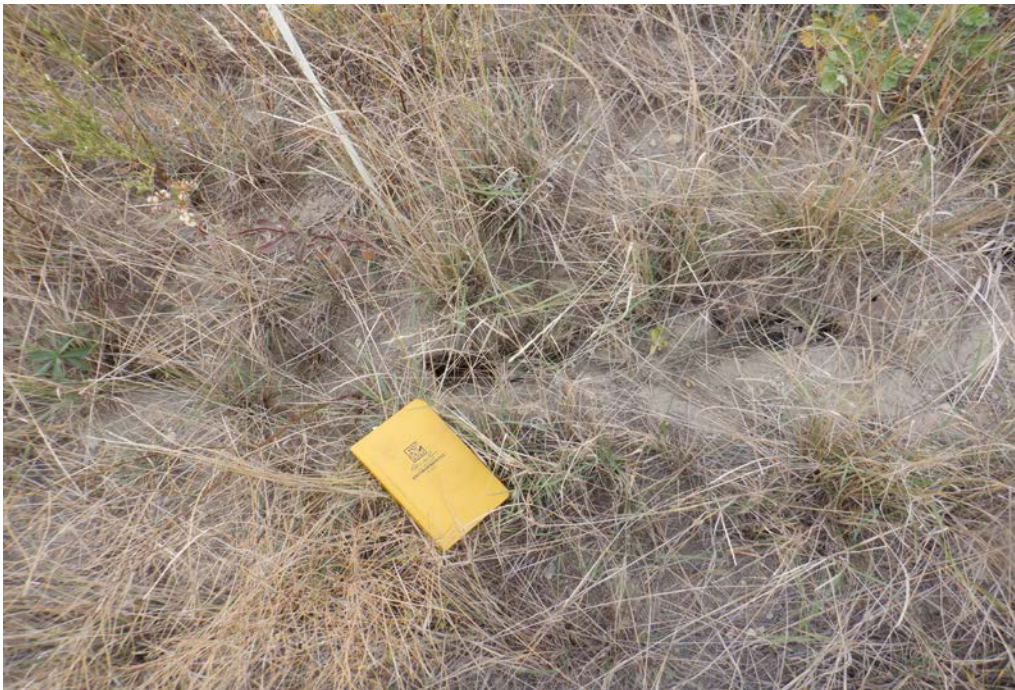
Photograph 2 (East CCR downstream slope (Temporary cover))
Animal burrows on temporary cover. (IMG_DSCF1664.JPG)

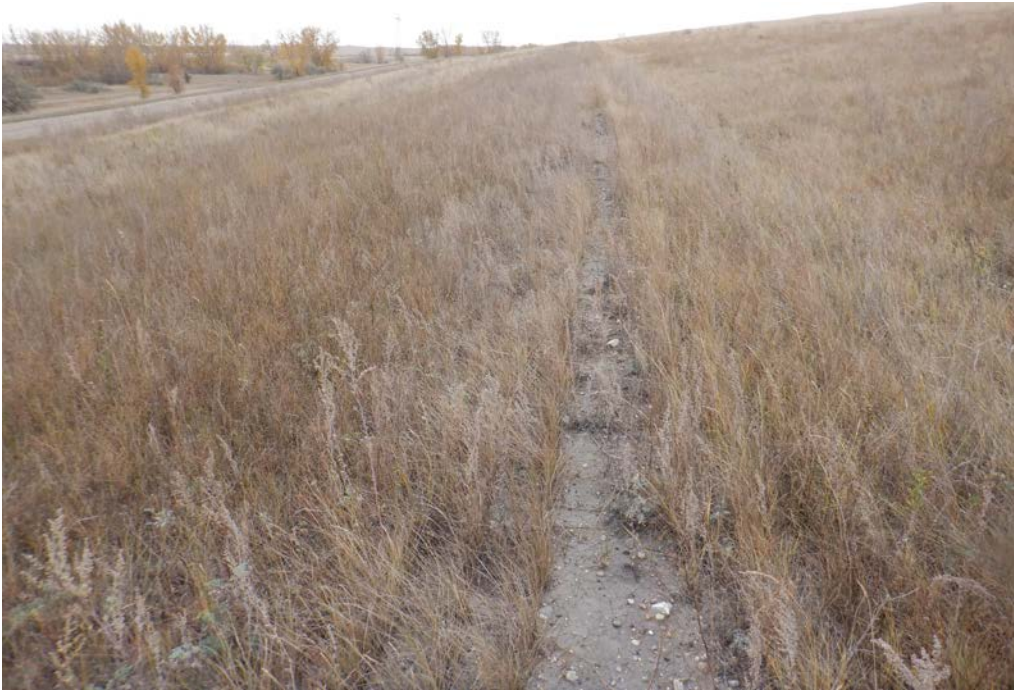
The east and south CCR downstream slopes of Southeast 16 have final cover to an elevation of 1925 feet amsl with terrace channels and downchute drainage channels along the side slopes. This final cover was installed in 2015 and had fair native grass vegetative growth. Golder recommends that isolated areas receive additional topsoil and be re-seeded, especially along the crests of the terrace channels where vegetation appears poorest.

Photograph 3 (East final cover slope)
Sparse vegetation along terrance channel. (IMG_DSCF1666.JPG)

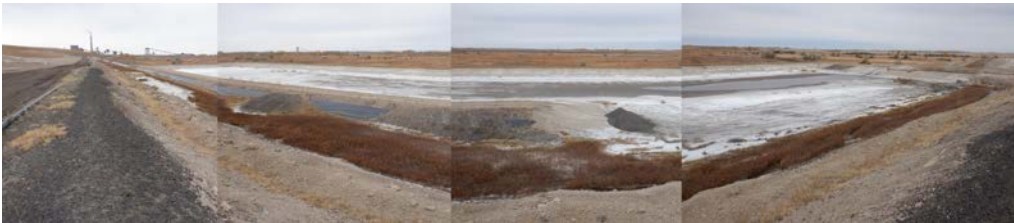
Photograph 4 (Contact Water Collection Channel)
Panoramic view of contact water collection area. (IMG_DSCF1671-1674.JPG)

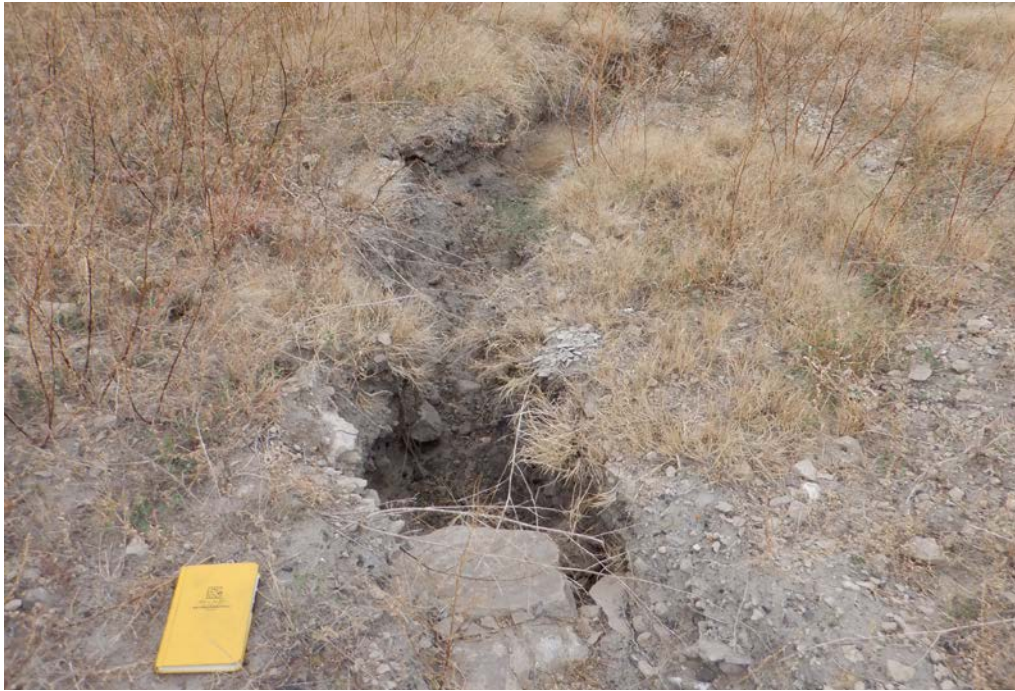
Portions of CCR downstream slopes on the north, east and south sides of Southeast 16 have temporary cover installed as of late 2016. These areas had fair vegetation (a combination of grassy vegetation and weeds) and minor erosion on the soil surface below (one area in the northeast corner had a relatively large erosion rill).

Photograph 5 (North CCR downstream slope (Temporary cover))
Erosion rill from contact water ditch. (IMG_DSCF1675.JPG)

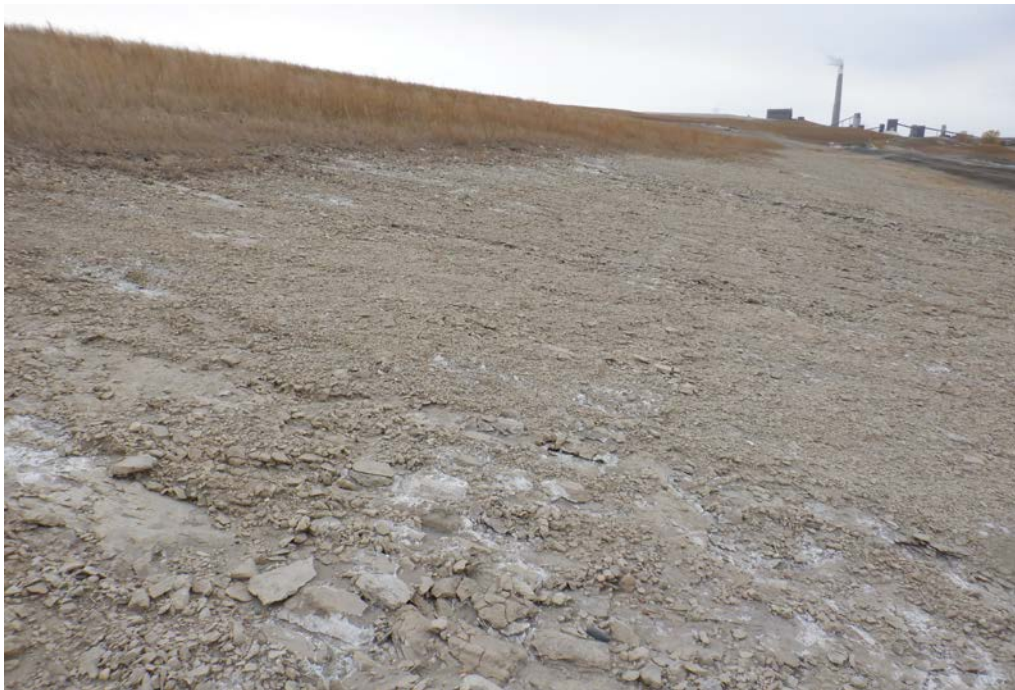
Photograph 6 (North CCR downstream slope)
Minor erosion of fly ash slope. Upper temporary cover in good condition.

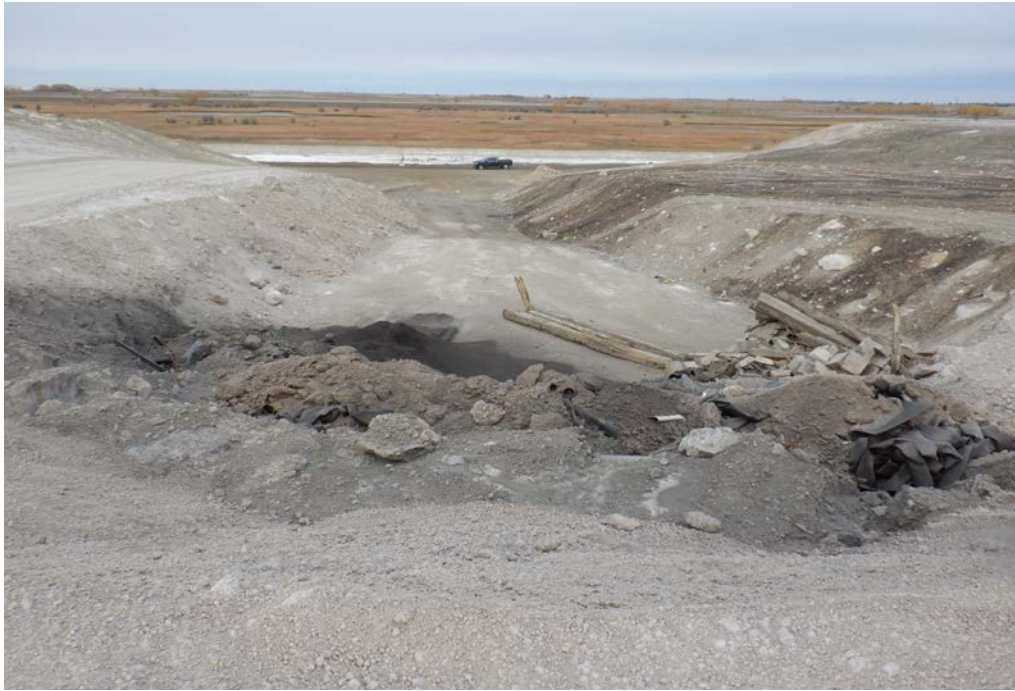
Photograph 7 (C&D Area)
C&D disposal area. (IMG_DSCF1695.JPG)

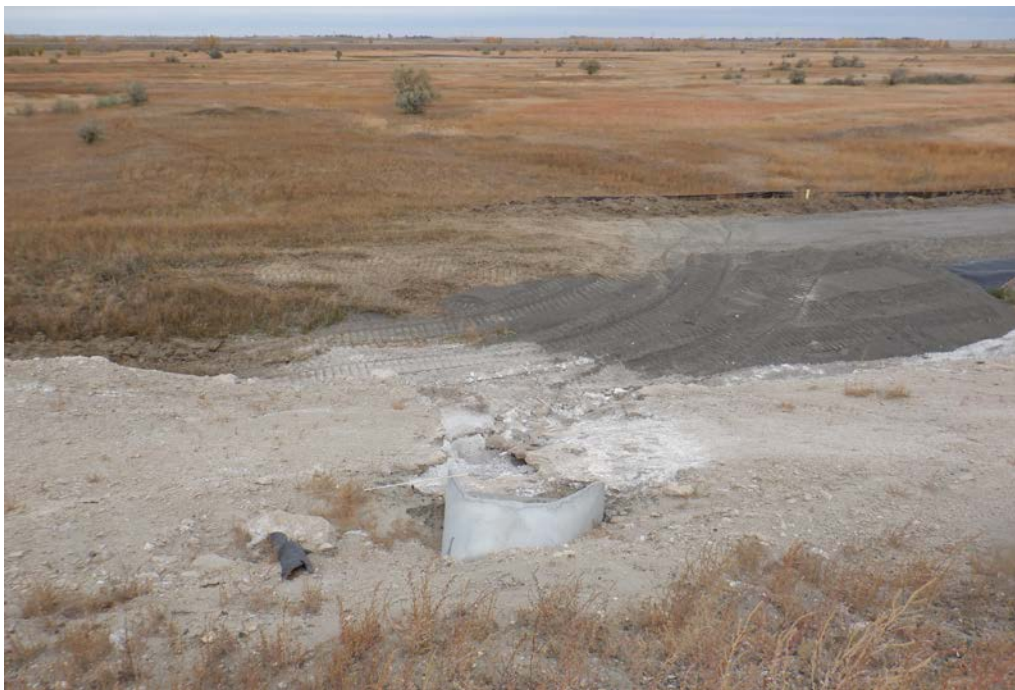
Photograph 8 (Northwest entrance)
Erosion around culvert outlet to Contact Water Collection Channel. (IMG_DSCF1689.JPG)

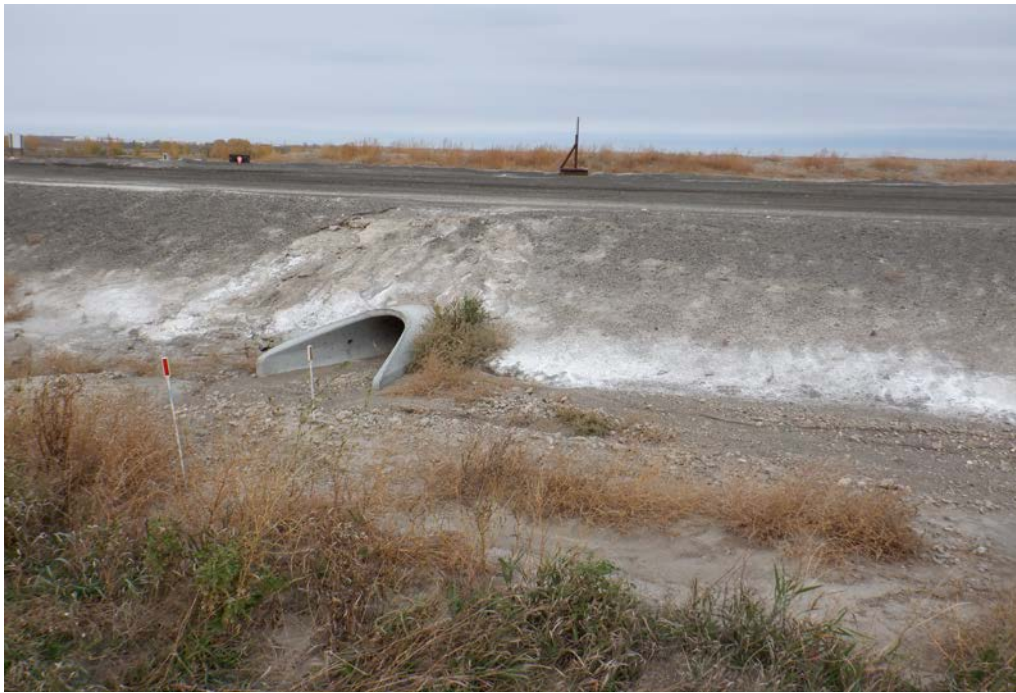
Photograph 9 (Northwest entrance)
Concrete culvert and surface water drainage ditch. (IMG_DSCF1691.JPG)

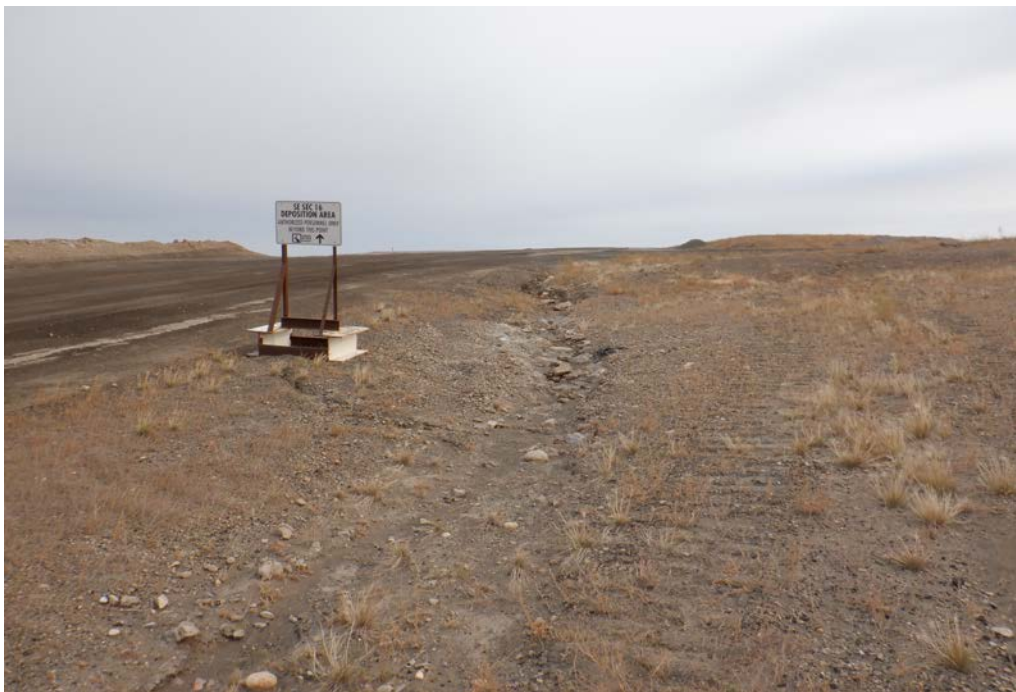
Photograph 10 (Northwest access ramp)
Minor erosion along road to SE16 deposition area. (IMG_DSCF1693.JPG)

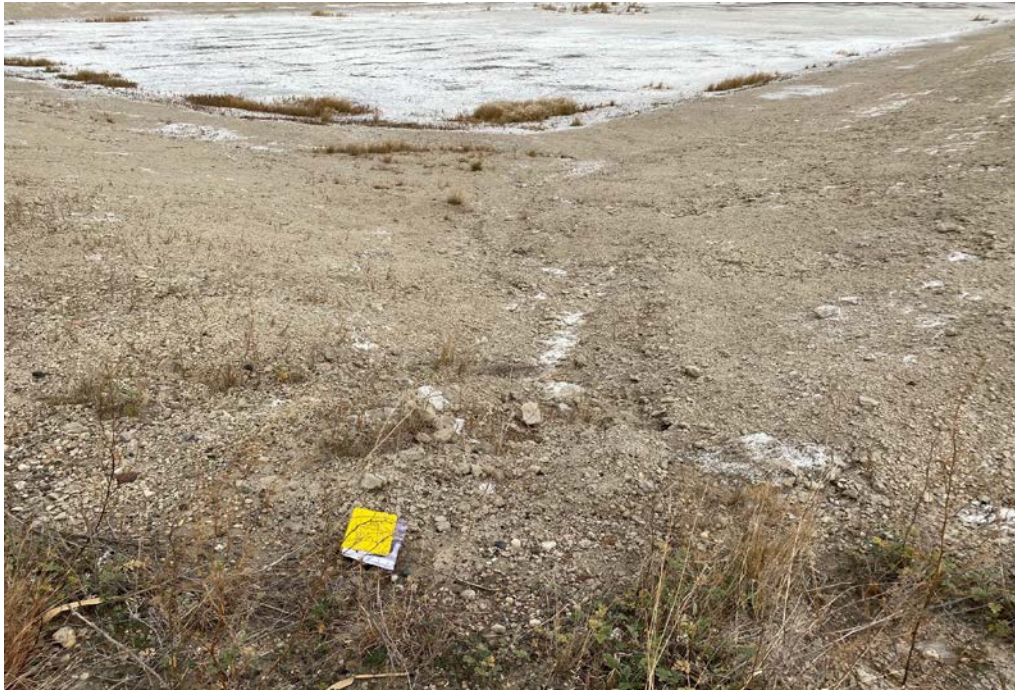
Photograph 11 (Contact water collection area perimeter berm upstream slope)
Minor erosion of fly ash slope. (IMG_AD7P.JPG)

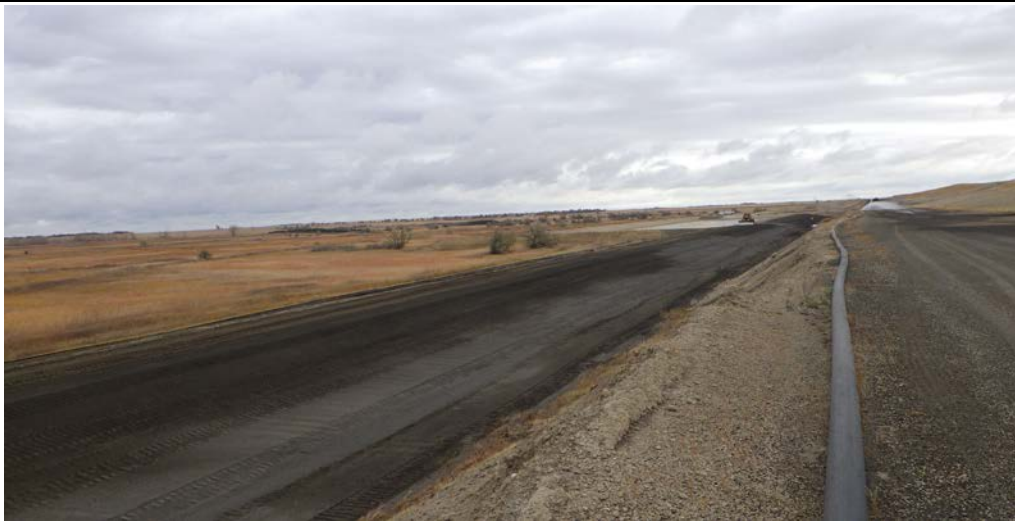
Photograph 12 (Haul Road)
Protective cover (bottom ash) placed over exposed liner within the contact water collection channel. (IMG_RIMG0551.JPG)

the geomembrane liner along much of the north berm upstream slope and a minor area on the floor of the contact water collection area was inspected for damage and repaired, and CCR was placed in the area as protective cover over the exposed geomembrane liner system. Golder personnel were onsite during repairs and construction of protective cover and after construction was complete, the berm upstream slopes of Southeast 16 appear to be in good condition.

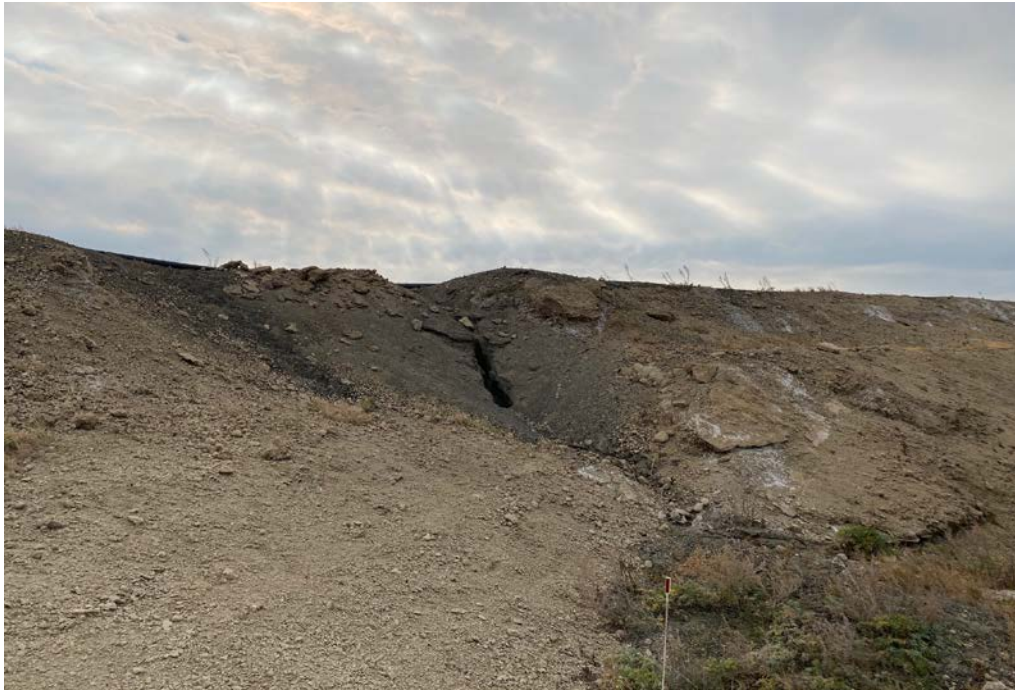
Photograph 13 (North CCR downstream slope (no cover))
Erosion of fly ash on SE16 north CCR downstream slope. (IMG_AD15P.JPG)

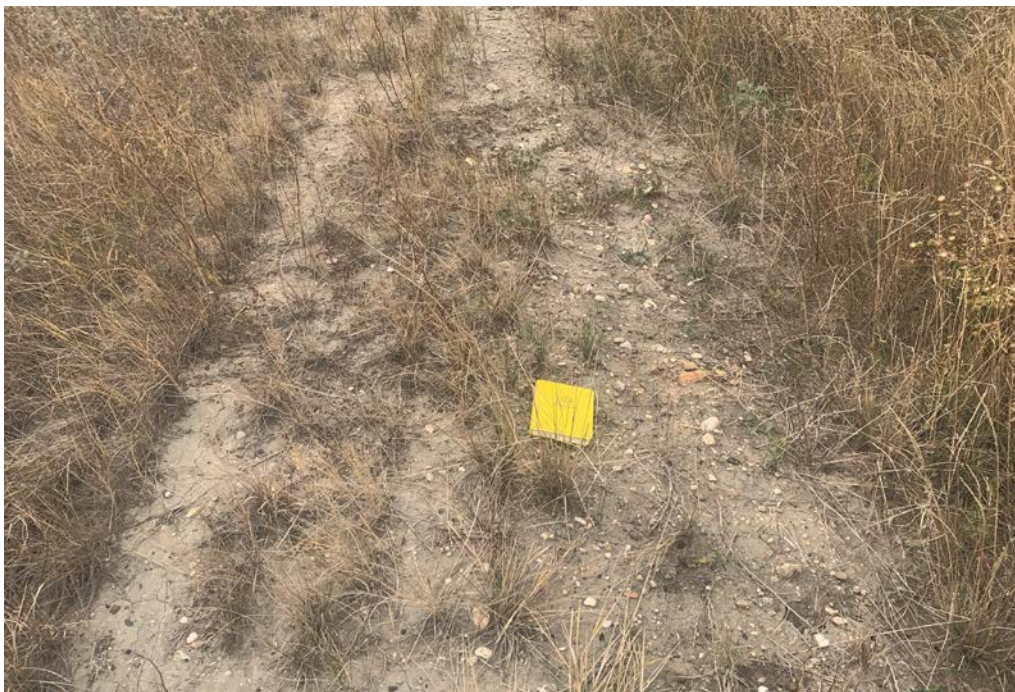
Photograph 14 (South final cover slope)
Sparse vegetation on the crest of the southern terrace channel. (IMG_4581.JPG)

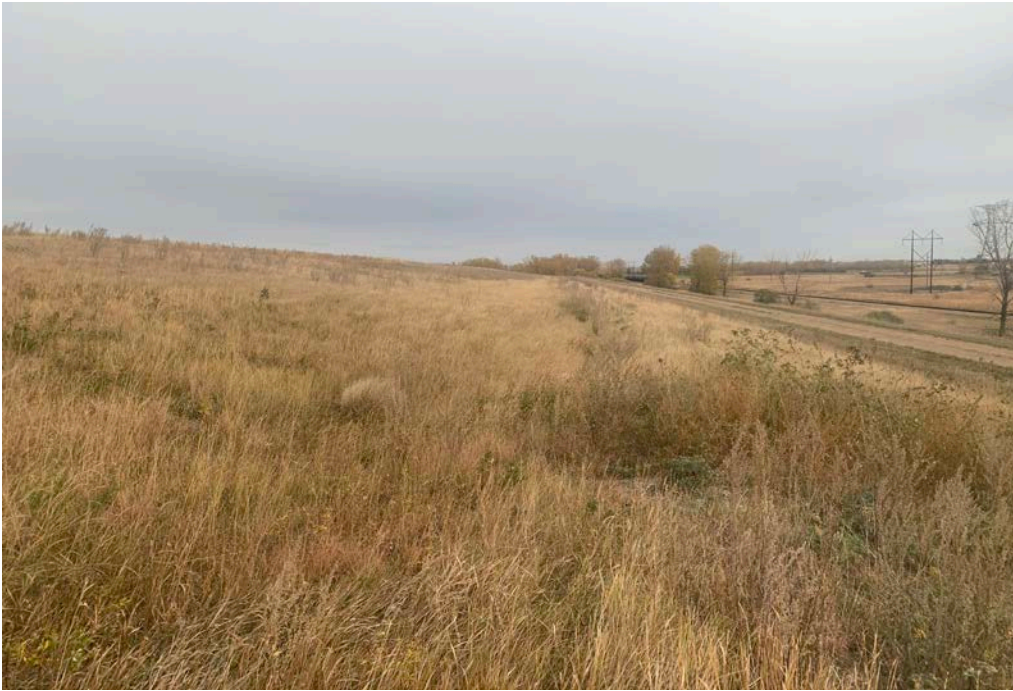
Photograph 15 (South final cover slope)
Well vegetated final cover (typical final covered slopes) (IMG_4582.JPG)

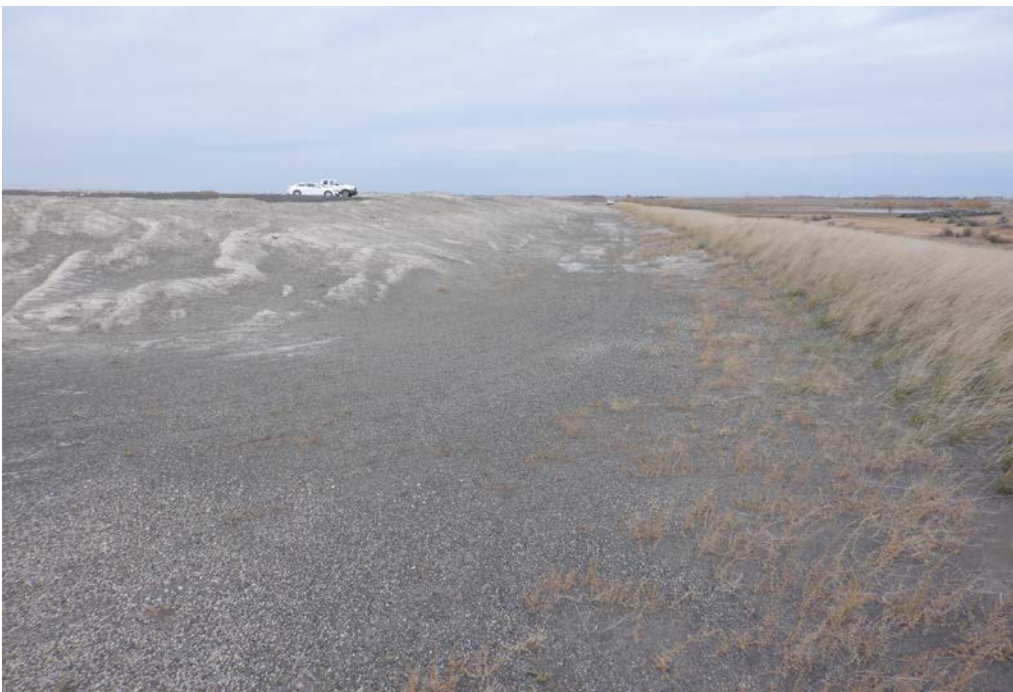
Photograph 16 (East CCR downstream slope)
Contact water containment ditch. (DSCF1655.JPG)

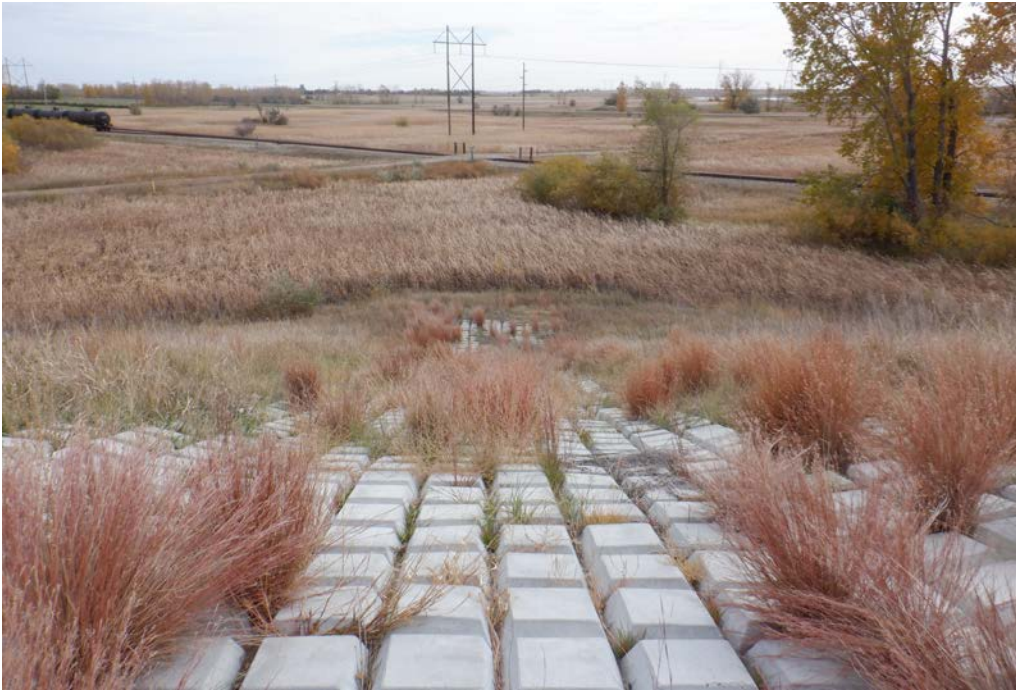
Photograph 17 (Southeast perimeter berm downstream slope)
Southeast downchute channel. (DSCF1657.JPG)

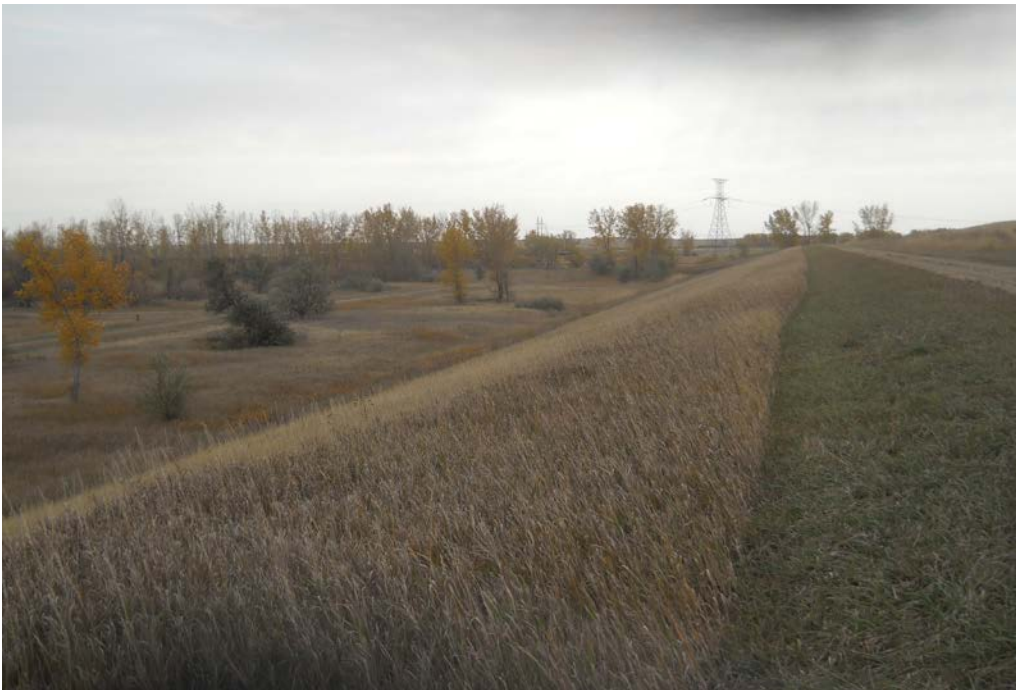
Photograph 18 (East perimeter downstream slope and toe)
Well vegetated perimeter berm downstream slope. (3.JPG)
