Annual Inspection

Coal Creek Station - Upstream Raise 91 CCR Surface Impoundment

Great River Energy

January 2021

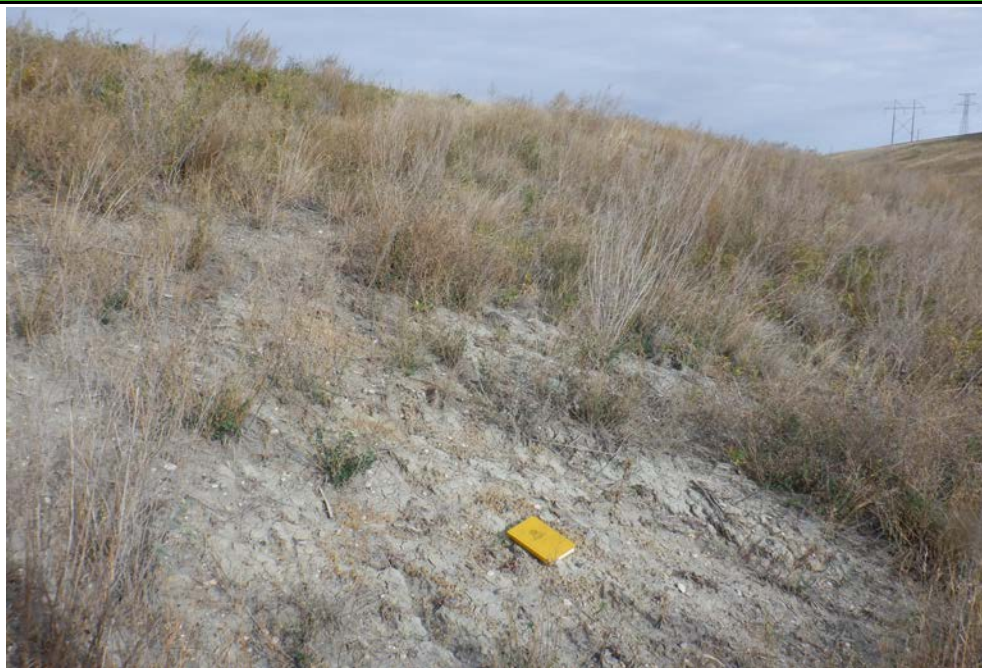
Photograph 1 (South berm downstream slope)
Isolated area of sparse vegetation on downstream slope. (IMG_DSCF1699.JPG)

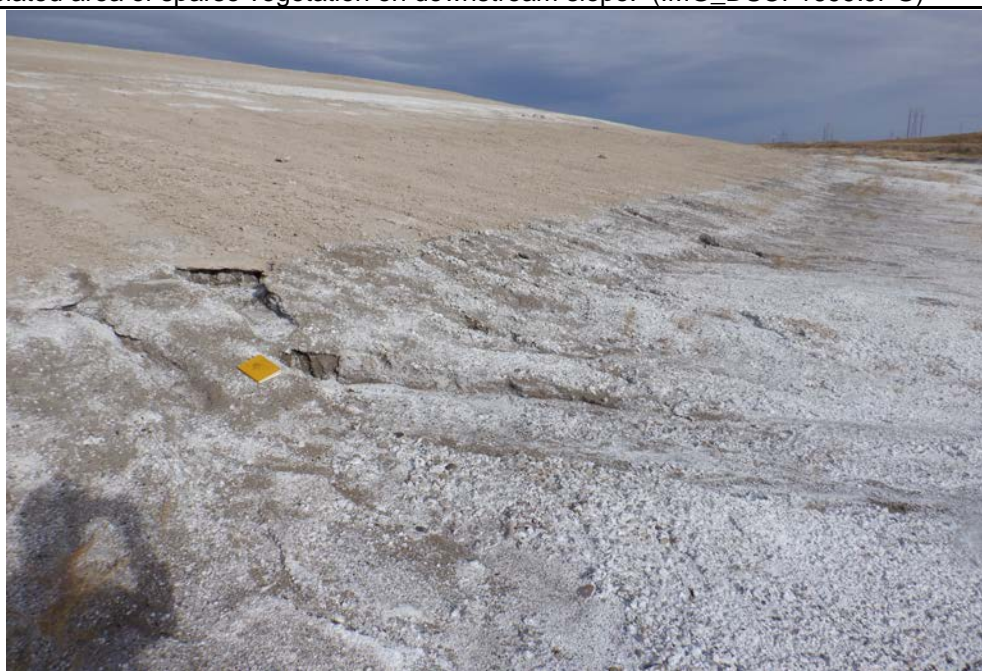
Photograph 2 (South CCR downstream slope (no cover))
Minor erosion of fly ash. (IMG_DSCF1700.JPG)

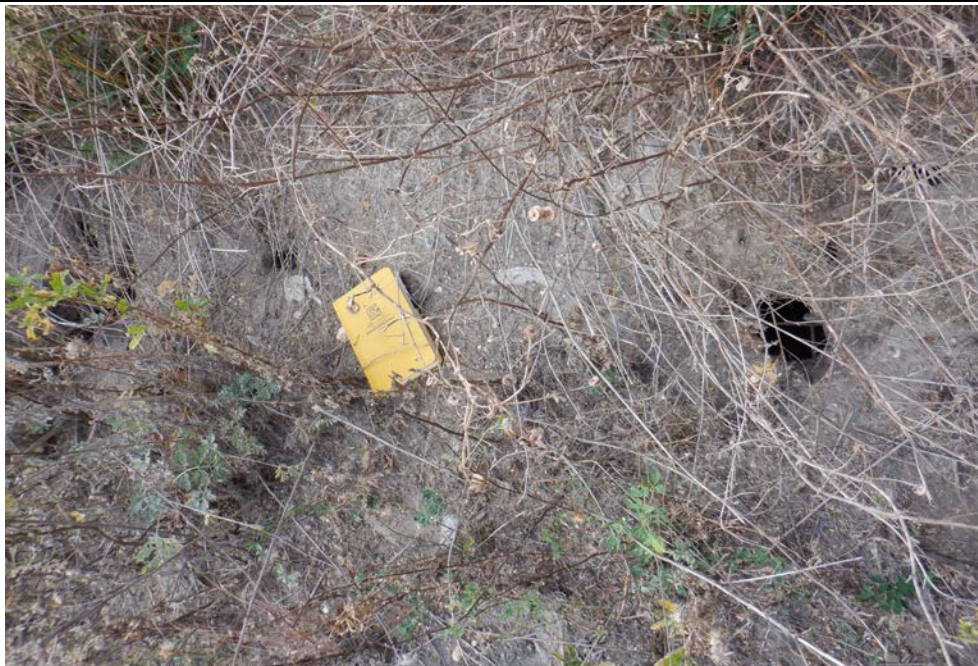
Photograph 3 (South berm downstream slope)
Small (~2-inch diameter) animal burrows on downstream slope. (IMG_DSCF1714.JPG)

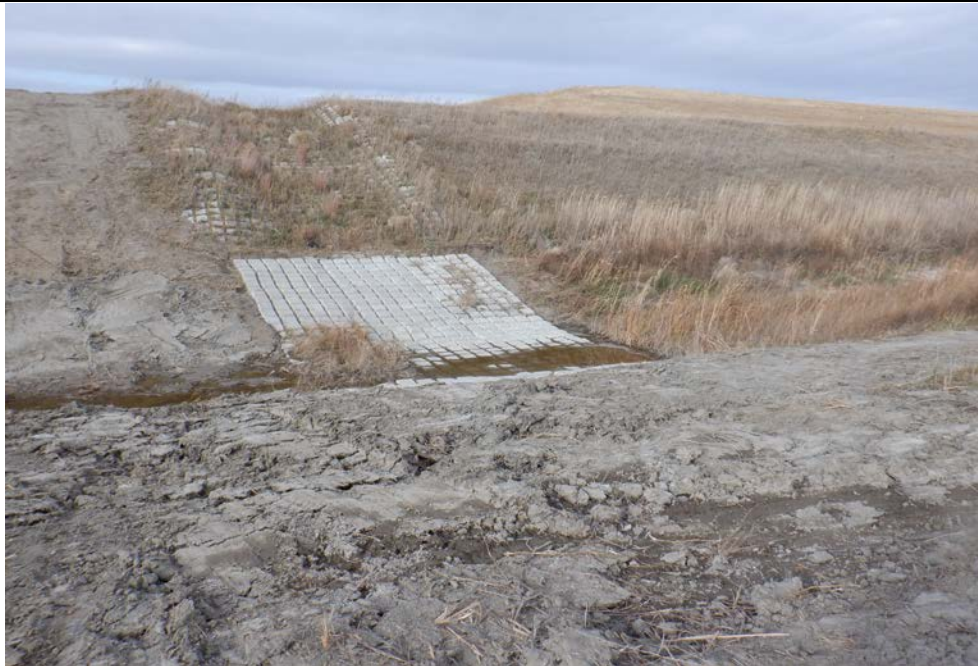
Photograph 4 (South berm downstream slope and site surface water drainage ditch)
Downchute channel and recently constructed hydraulic jump basin requiring reseeding. (IMG_DSCF1719.JPG)

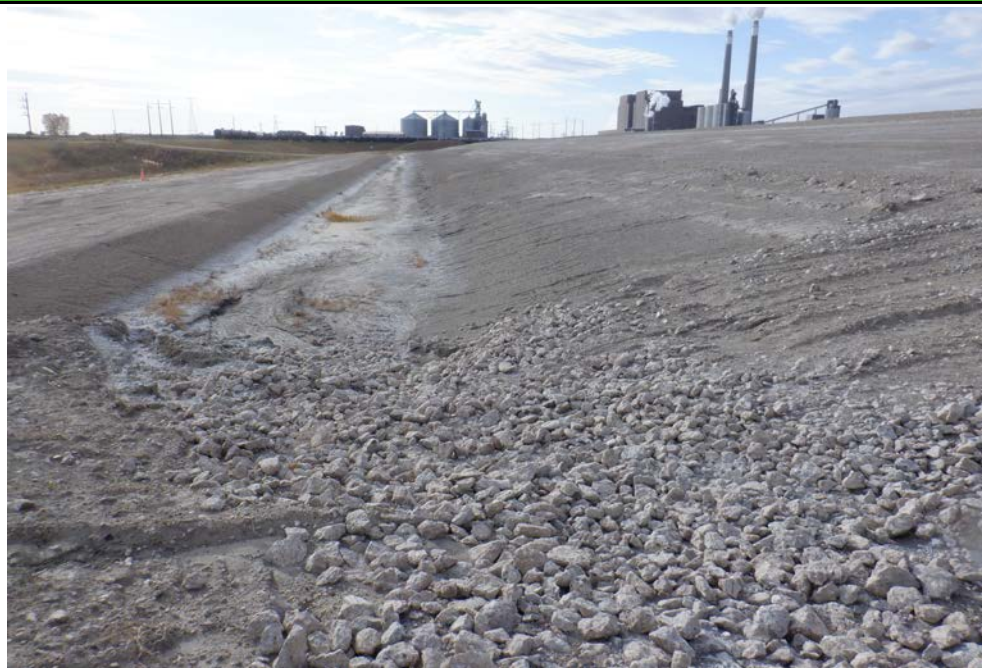
Photograph 5 (South perimeter channel)
Concrete rubble erosion protection at southeast end of contact water channel.

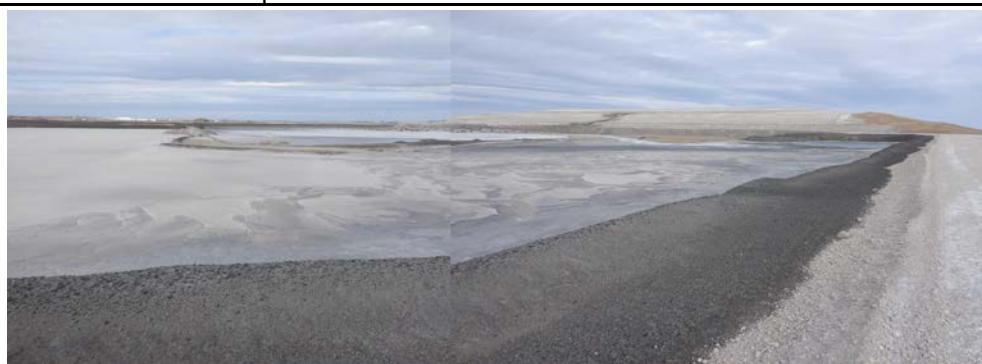
Photograph 6 (South CCR crest and CCR upstream slope)
Interior of Flue Gas Desulfurization (FGD) material containment area. (IMG_DSCF1712-

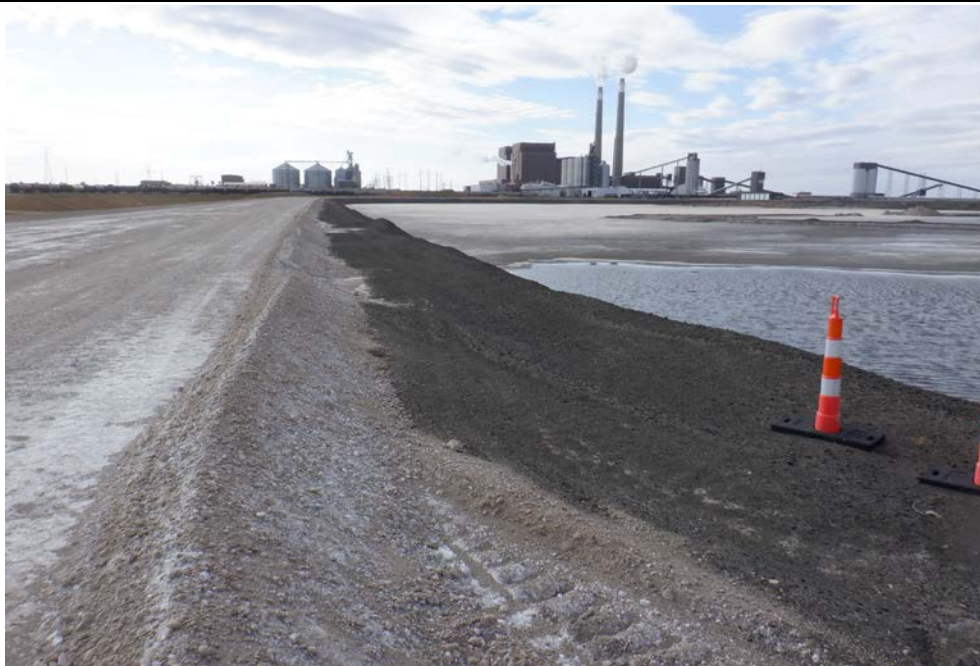
Photograph 7 (South CCR crest and CCR upstream slope)
CCR upstream slope and crest in good condition. (IMG_DSCF1724.JPG)

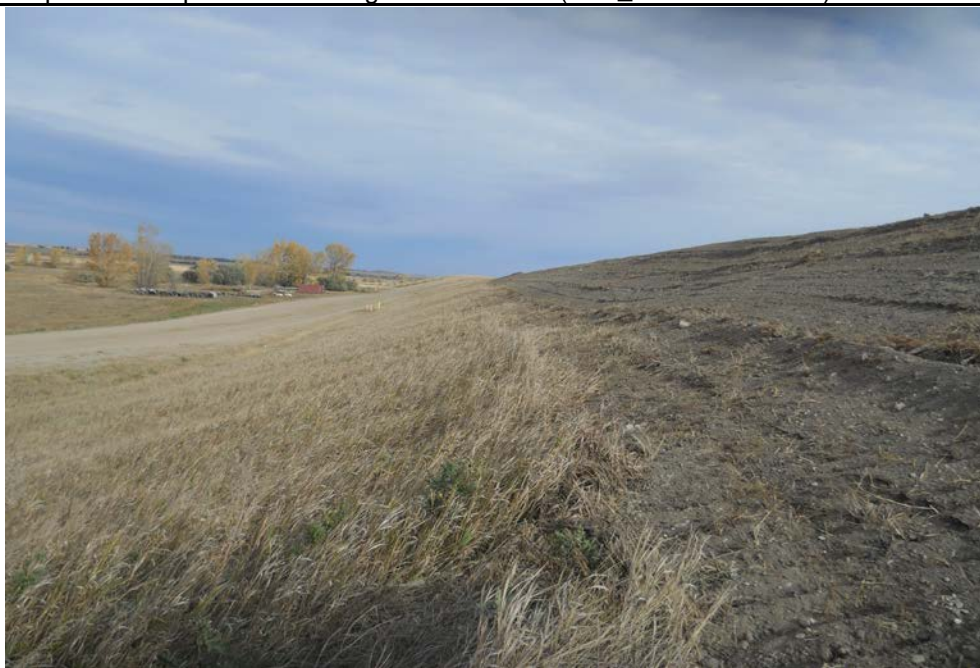
Photograph 8 (North perimeter berm downstream slope)
Well-vegetated downstream slope and seed/mulch from recent haul road safety berm construction. (IMG_AD3.JPG)

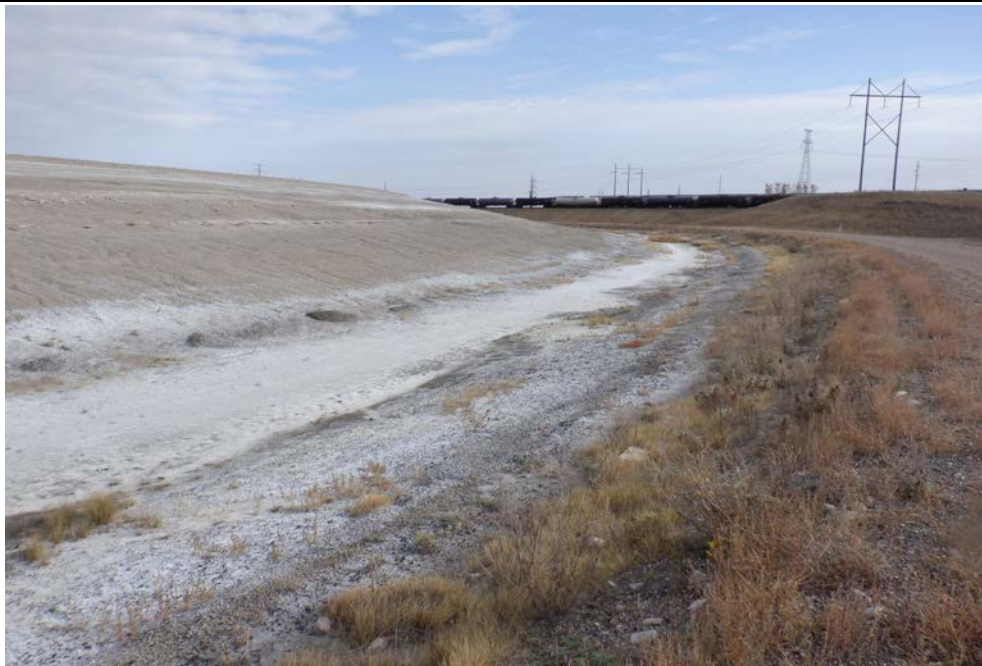
Photograph 9 (Southwest CCR downstream slope)
Downstream CCR slope, perimeter contact water channel (dry), and perimeter berm upstream slope with a minor amount of vegetation present. (IMG_DSCF1696.JPG)

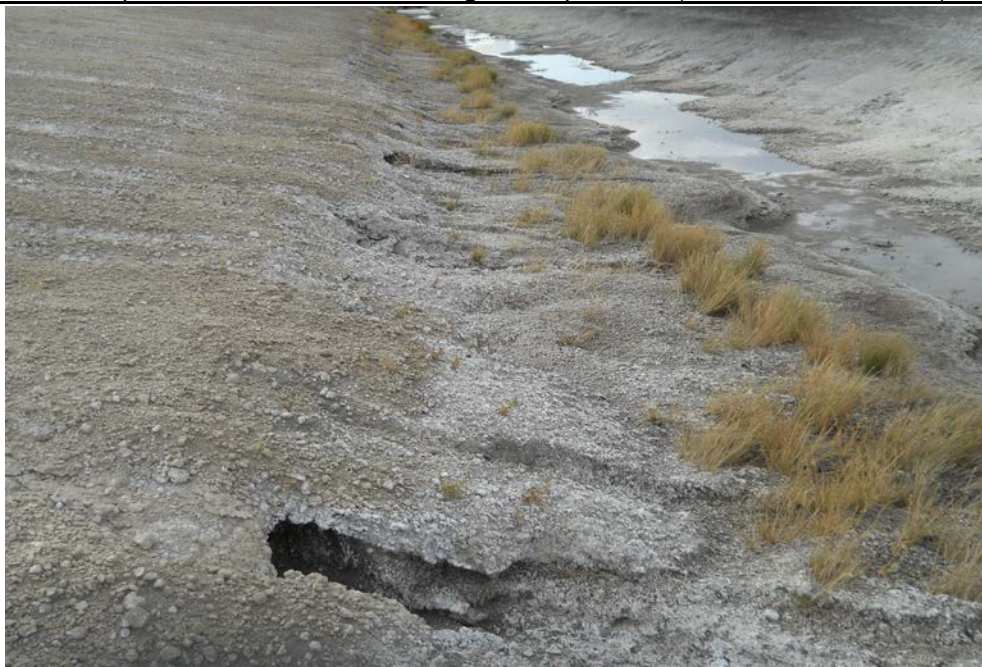
Photograph 10 (North CCR downstream slope)
Minor erosion in fly ash to the perimeter contact water channel. (IMG_AD14.JPG)

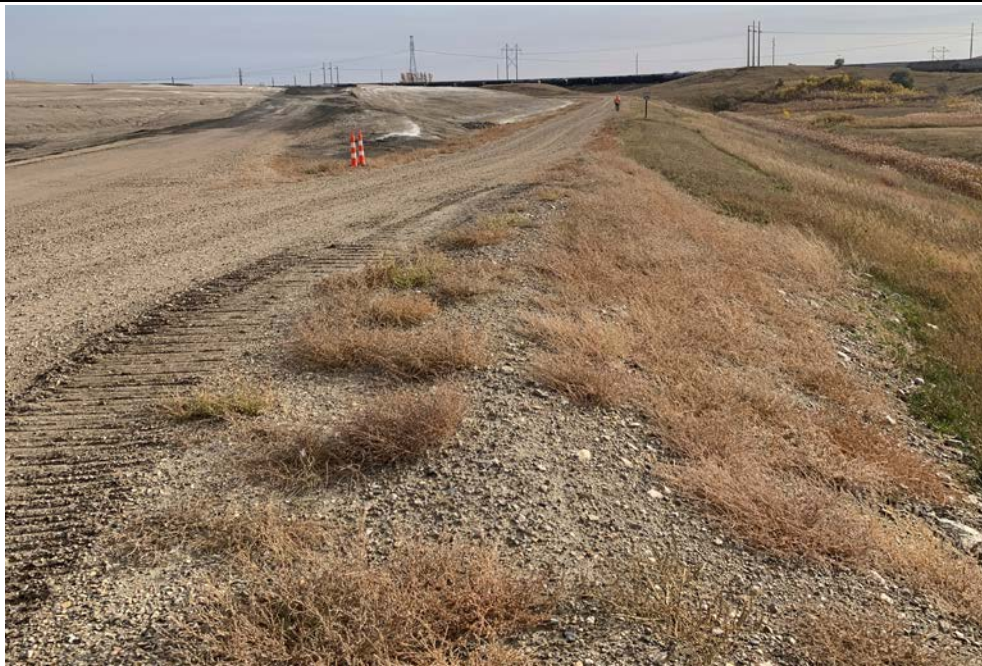
Photograph 11 (West perimeter berm crest and downstream slope)
Well-vegetated perimeter downstream slope. Perimeter berm crest in good condition.

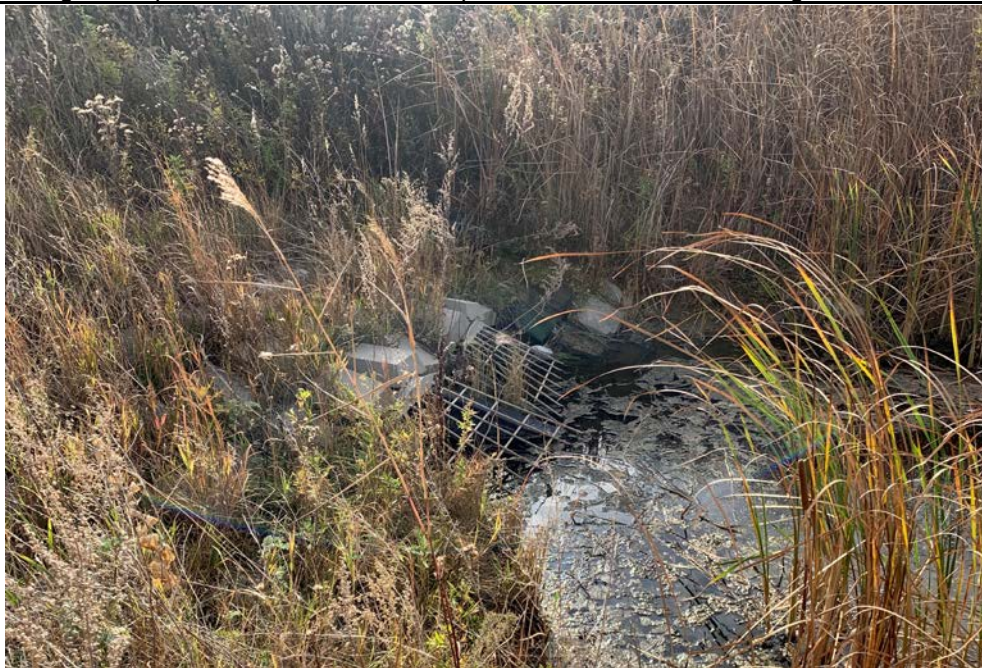
Photograph 12 (West Ditch)
West site surface water drainage ditch and culvert inlet. (IMG_4591.JPG)

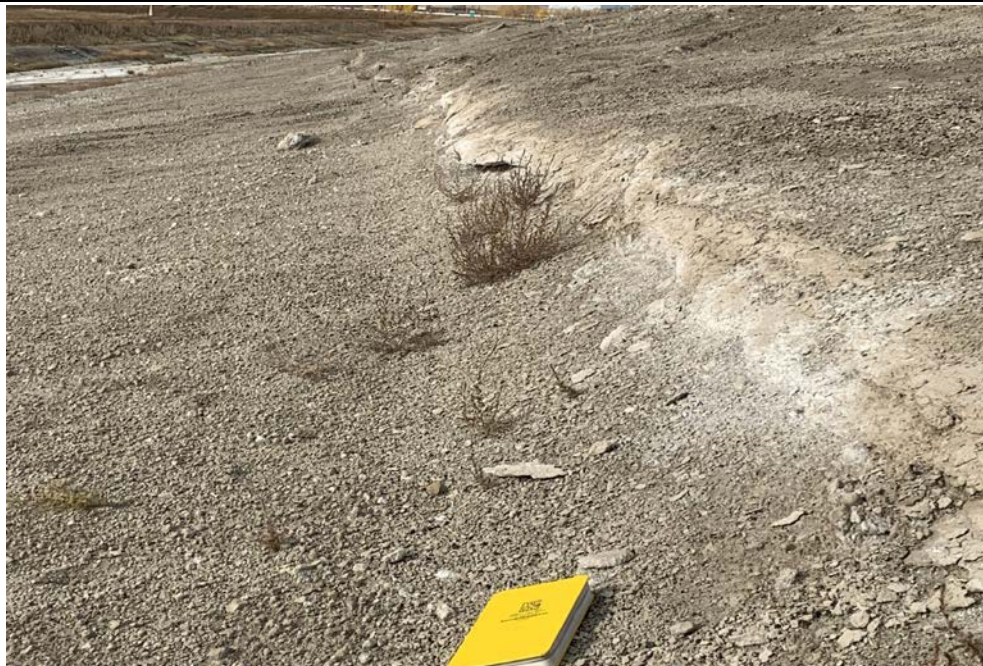
Photograph 13 (Northwest CCR downstream slope)
Minor erosion of fly ash. (IMG_4599.JPG)

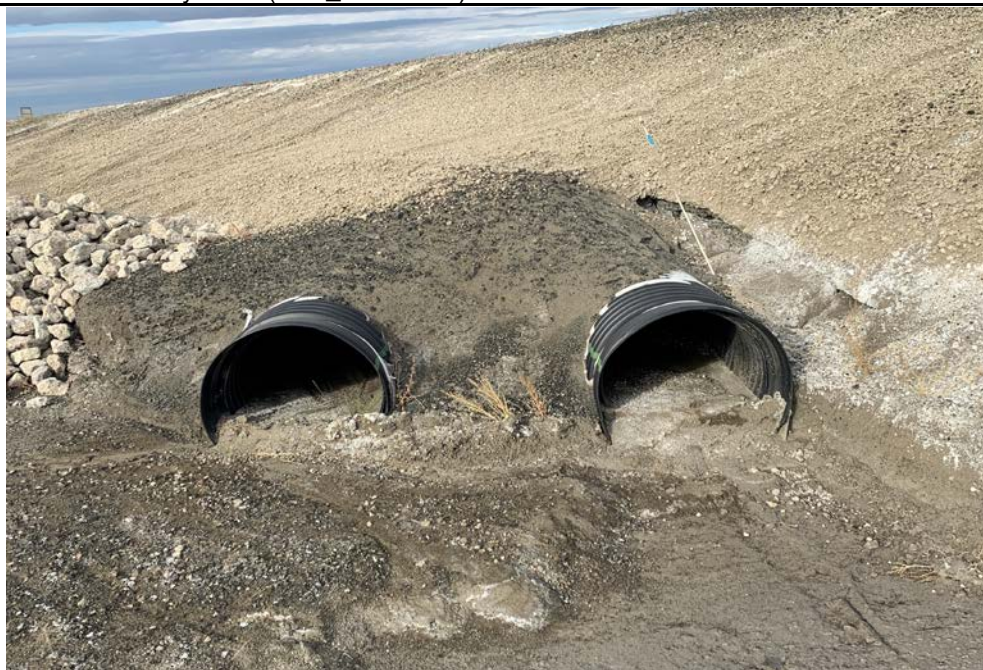
Photograph 14 (Northwest CCR downstream slope)
Contact water culvert partially filled with sediment. (IMG_4601.JPG)

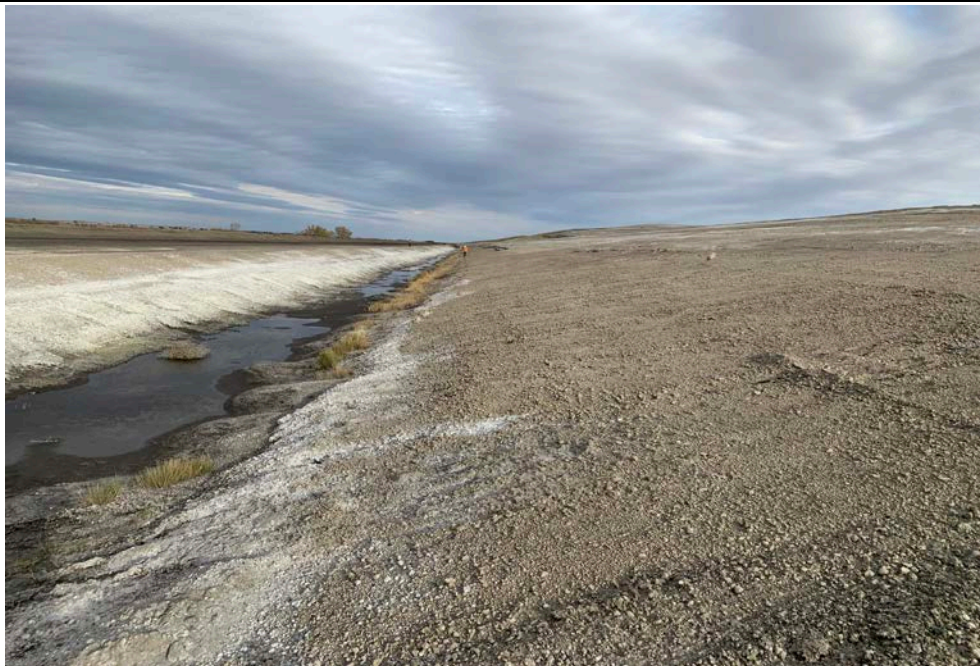
Photograph 15 (North CCR downstream slope)
Perimeter contact water control channel. (IMG_4602.JPG)

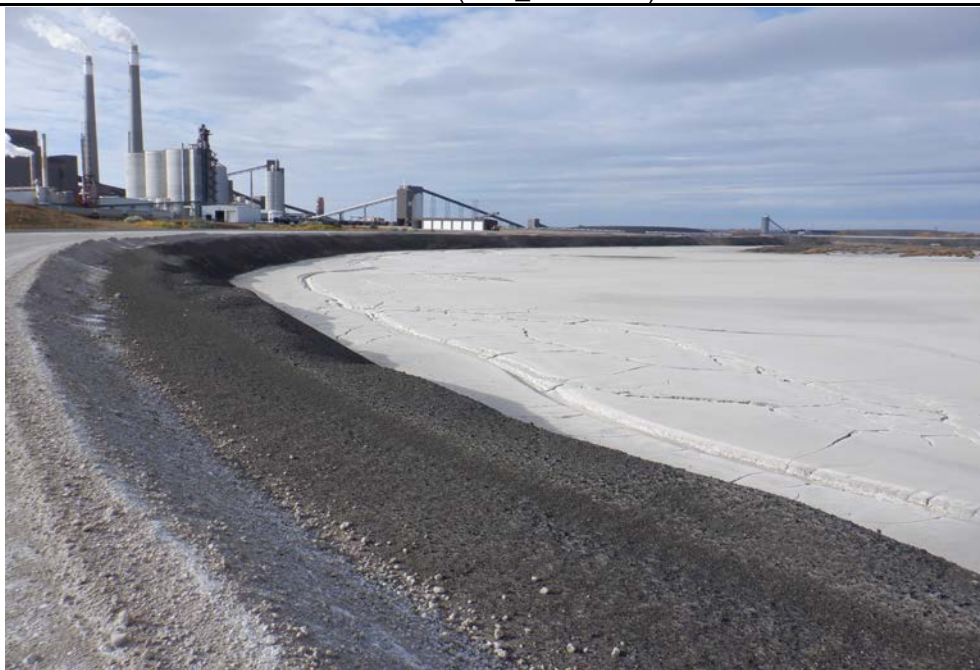
Photograph 16 (South CCR upstream slope/crest)
CCR upstream slope and crest in goo condition. (IMG_DSCF1702.JPG)

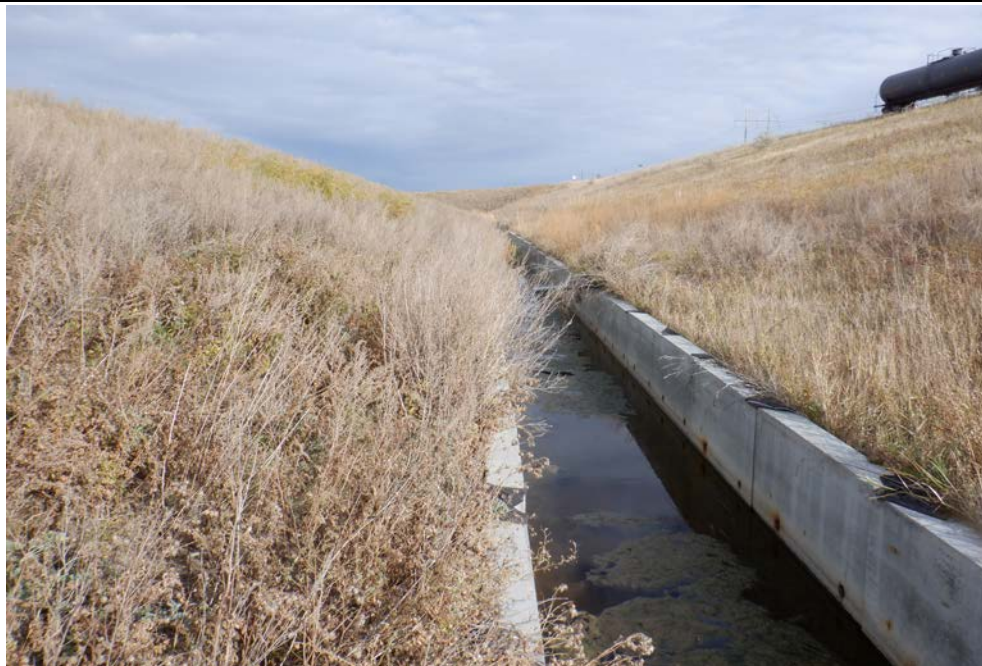
Photograph 17 (Perimeter berm downstream slope and toe)
Site surface water drainage ditch and well-vegetated perimeter berm downstream slope.
(DSCF1704.JPG)

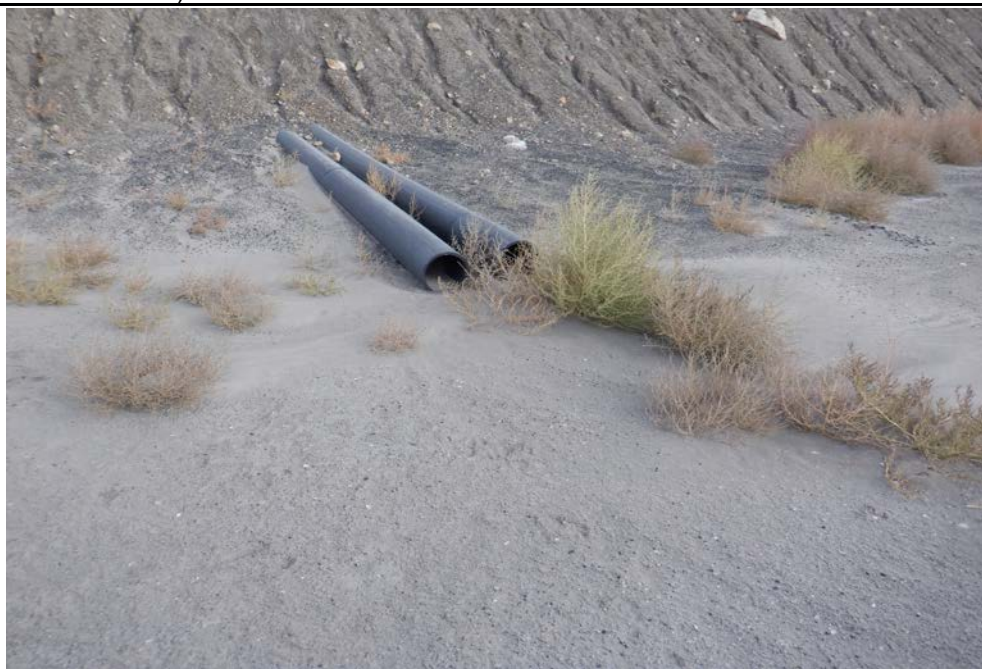
Photograph 18 (Inflow piping)
Gravity drain inflow piping from Upstream Raise 92 in good condition. (DSCF1726.JPG)

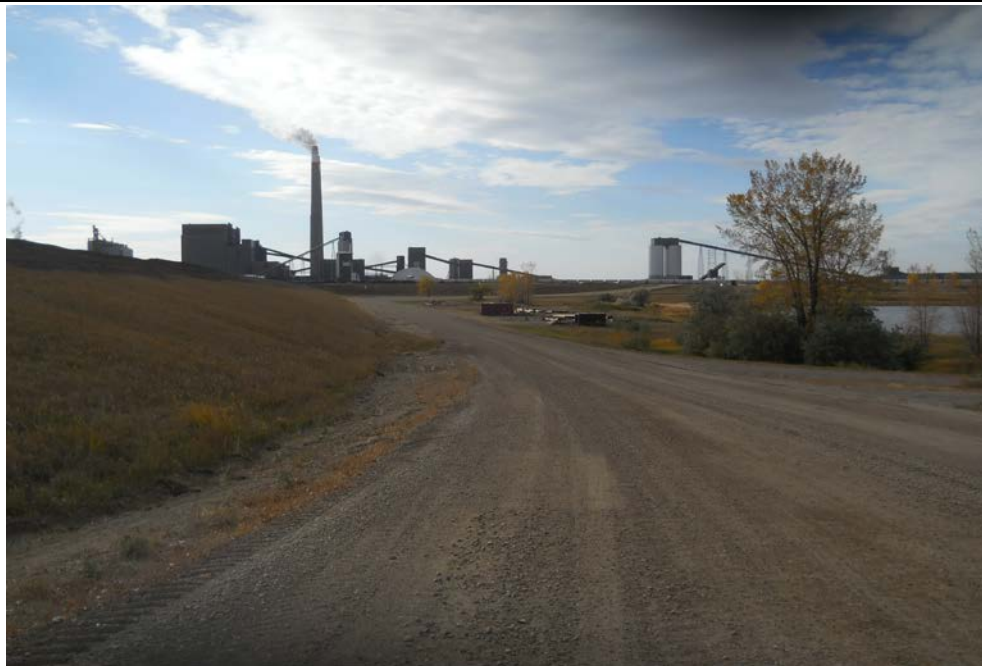
Photograph 19 (North perimeter berm downstream slope and toe)
Well-vegetated grass downstream slope of toe in good condition. (10.JPG)

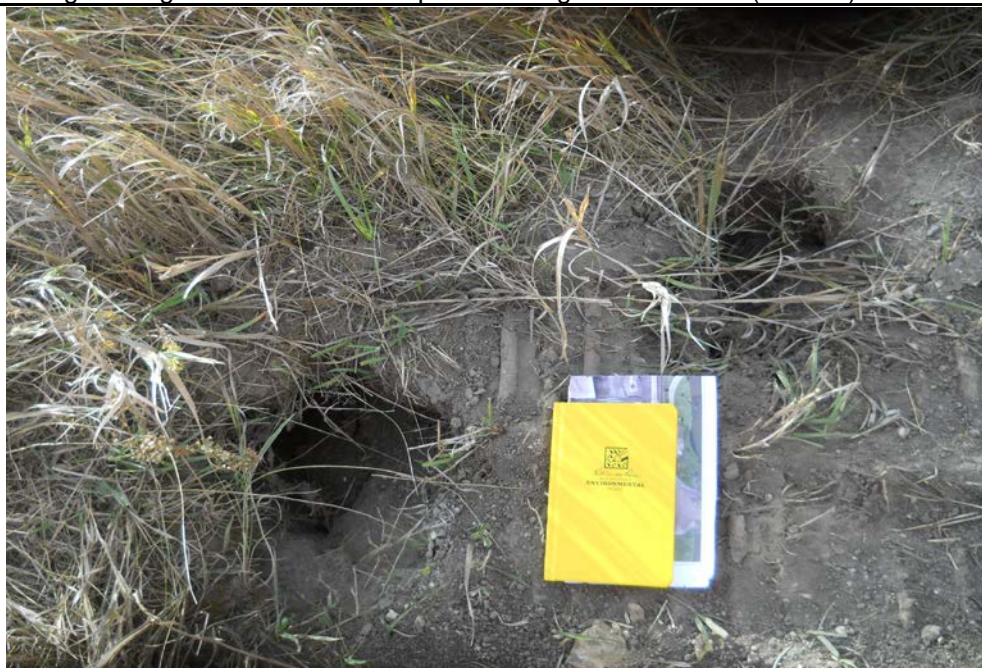
Occasional animal burrows, including a few burrows up to 6 inches in diameter, were observed on the north, west, and south berm downstream slopes. Golder did not observe indications of seepage, sloughing, cracking, significant erosion, excessive settlement, or vegetation that seemed to be thriving abnormally. The berm downstream slopes appeared to be in good condition.

Photograph 20 (North perimeter berm downstream slope)
Animal burrows (approximately 6-inch diameter). (9.JPG)

Minor maintenance items that may need to be continually addressed include repairing large animal burrows on perimeter berms as they appear, repairing and re-seeding eroded areas on or adjacent to berm downstream slopes, removal of any woody vegetation growing on the berm downstream slopes, and clean-out of collected material in the contact water perimeter channels and maintaining gravity and culvert piping. In addition, the inflow and outflow piping should be monitored regularly and cleared of debris as required to ensure proper conveyance of water to and from the facility.
