# Annual Inspection

## *Coal Creek Station - Upstream Raise 92 CCR Surface Impoundment*

**Great River Energy**

January 2021

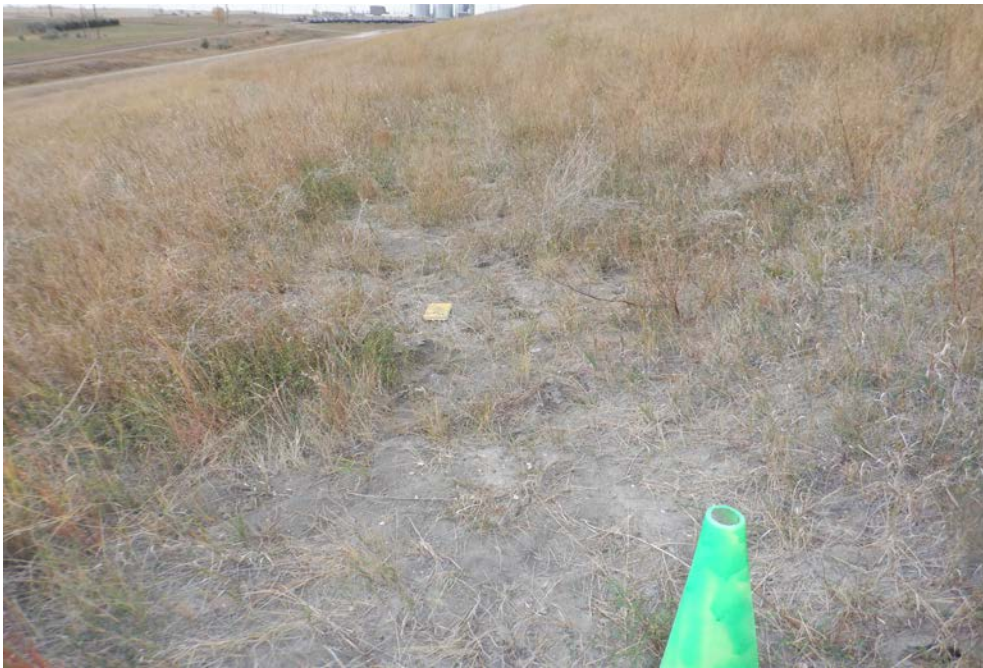
Photograph 1 (South CCR Downstream Slope (covered))  
Animal burrows and sparse vegetation on downstream slope. (IMG\_DSCF1743.JPG)

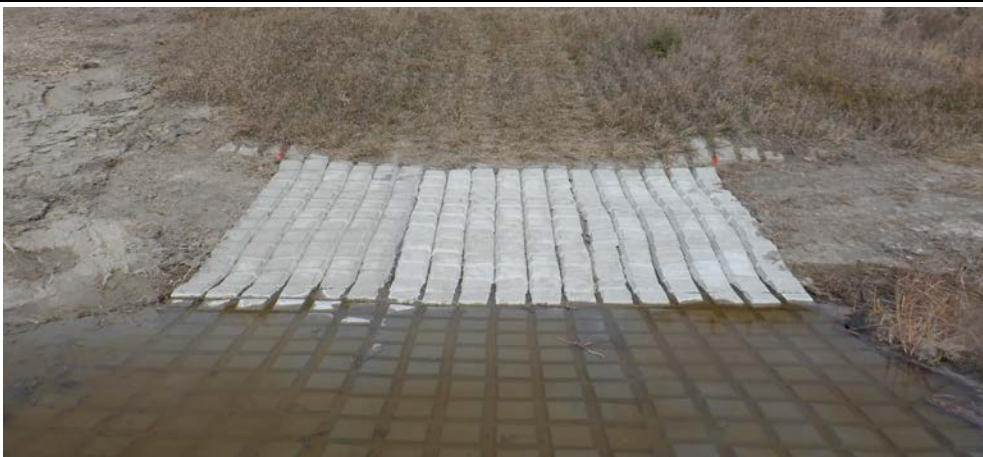
Photograph 2 (South perimeter berm downstream slope and south ditch)  
Downchute channel and recently constructed hydraulic jump basin in good condition. (IMG\_DSCF1747.JPG)

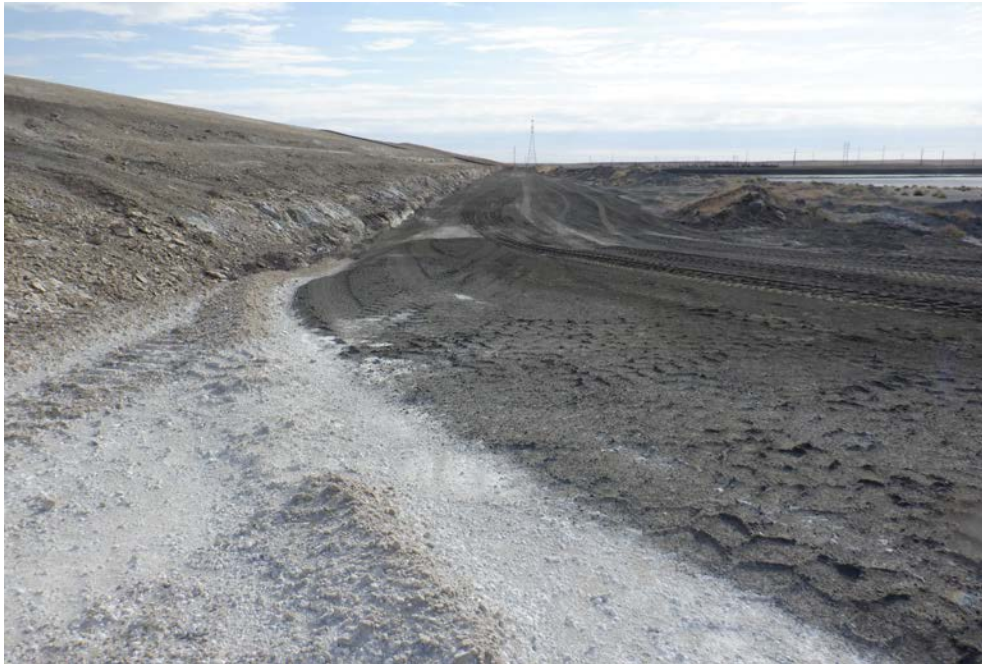
Photograph 3 (West CCR downstream slope (road))  
Road between UR91 and UR92. (IMG\_DSCF1751.JPG)

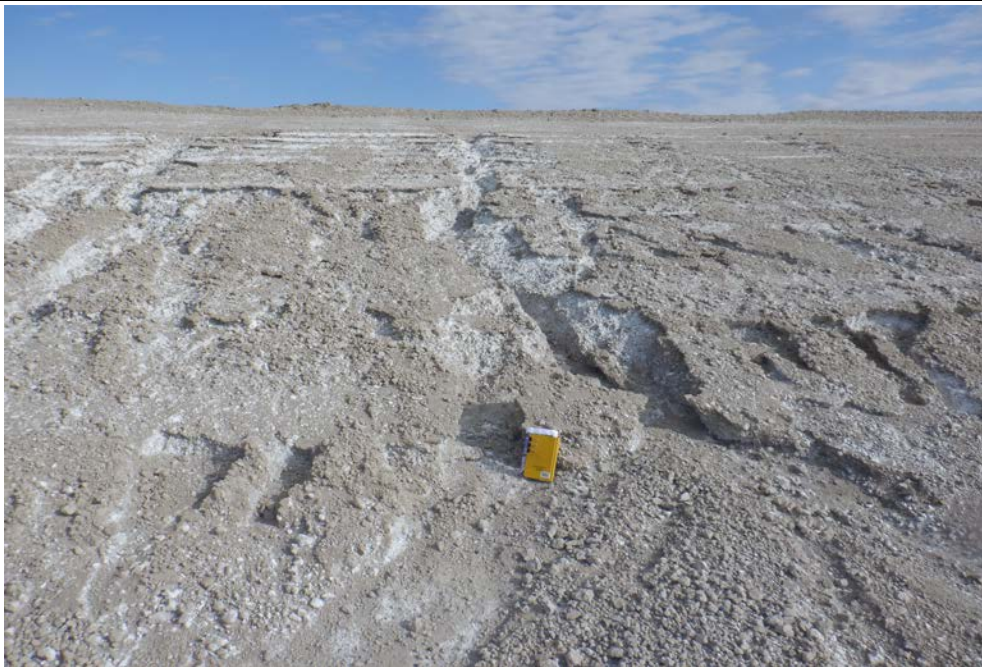
Photograph 4 (West CCR downstream slope (no cover))  
Minor fly ash erosion near elevation 1998 feet on west downstream slope.  
(IMG\_DSCF1754.JPG)

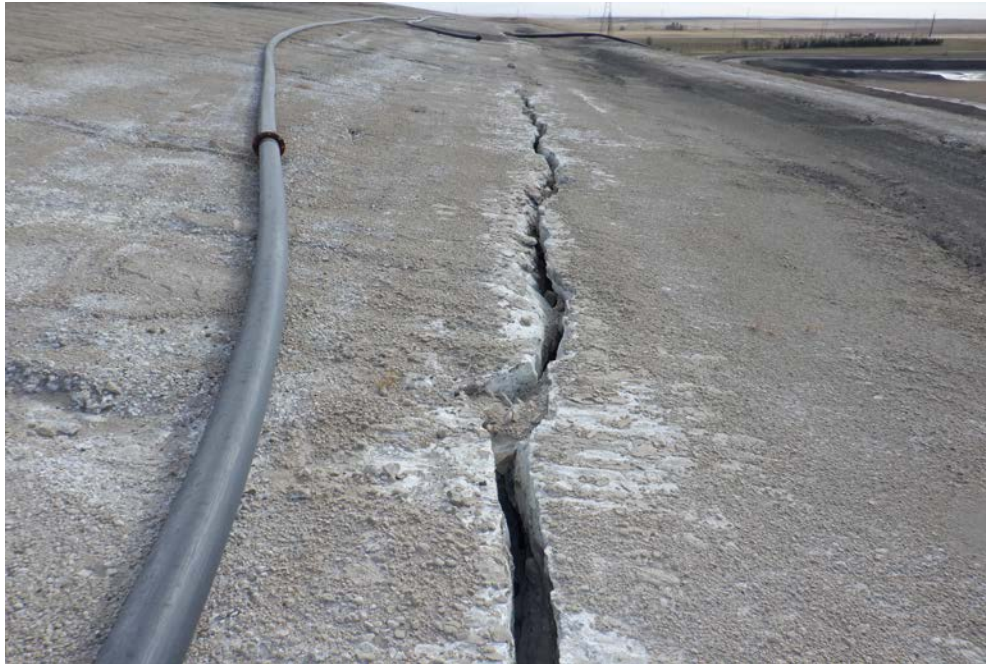
Cracks noted on the surface of the CCR downstream slopes (most prevalent between elevations 1974 feet amsl and 1998 feet amsl) were between approximately 1 and 12 inches wide, up to several feet deep, and up to several hundred feet long. The cracks are expected and can be attributed to consolidation of FGD material on the interior of the facility and the relatively rigid bottom ash and fly ash exterior of the facility. These cracks are continually observed and evaluated by onsite operations personnel for changes to the shape, offset, or length of the features, and the installed instrumentation (inclinometers and piezometers) provides additional information regarding the performance of the facility with respect to the design.

Photograph 5 (West CCR downstream slope (no cover))  
Approximately 6-inch wide crack in fly ash within the bench at elevation 1974 feet.  
(IMG\_DSCF1757.JPG)

Minor maintenance items that may need to be continually addressed include monitoring the size and shape of cracks in CCR downstream slopes and the CCR crest of the facility, repairing large animal burrows as they appear, monitoring erosion and vegetative success of areas near recently placed articulated concrete block mats and the surface water channel along the south toe of the facility, clean-out of collected material in the perimeter channels and maintaining gravity and culvert piping between Upstream Raise 91 and Upstream Raise 92, re-seeding of CCR downstream slopes with final cover, and removal of any woody vegetation growing on the berm downstream slopes. In addition, the inflow and outflow piping should be monitored regularly to ensure proper conveyance of water to and from the facility.

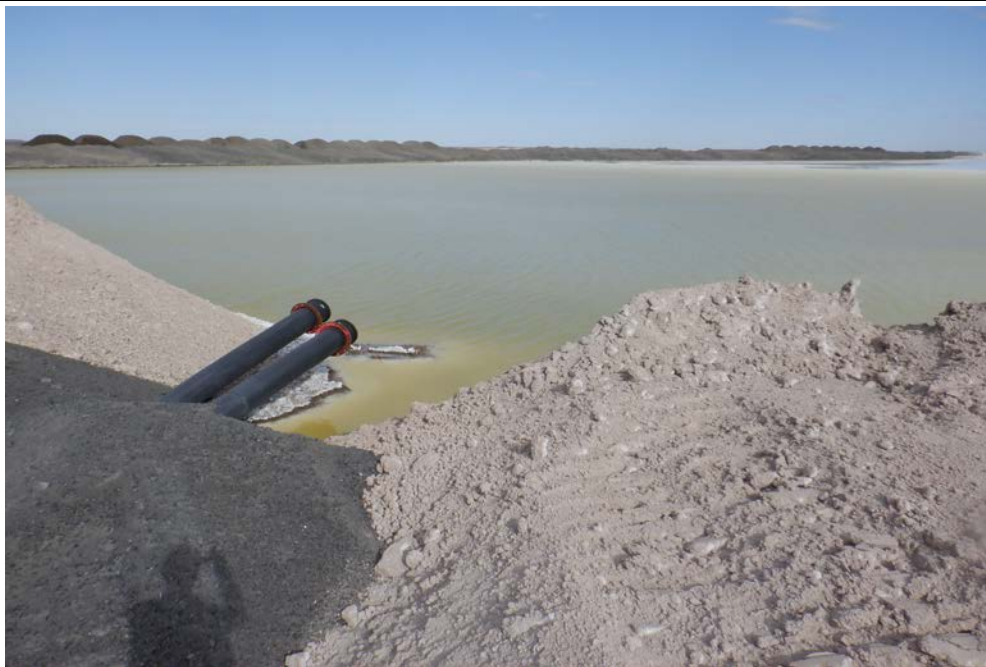
The outflows from Upstream Raise 92 consist of a series of gravity drainage pipes and culverts that transfer CCR conveyance water from the facility to the adjacent Upstream Raise 91. At the time of the inspection, gravity drainage pipes appeared to be in good condition and were located above the impounded water within Upstream Raise 92 in preparation for drainage to start at a specified level. The culvert connecting the drainage ditch on the northwest side of Upstream Raise 92 to Upstream Raise 91 was in good condition and the inlet to the culvert was recently armored with concrete rubble to protect the culvert inlet from damage.

Photograph 6 (East CCR upstream slope (no cover))  
Gravity drain piping inlet to Upstream Raise 91. (IMG\_DSCF1767.JPG)

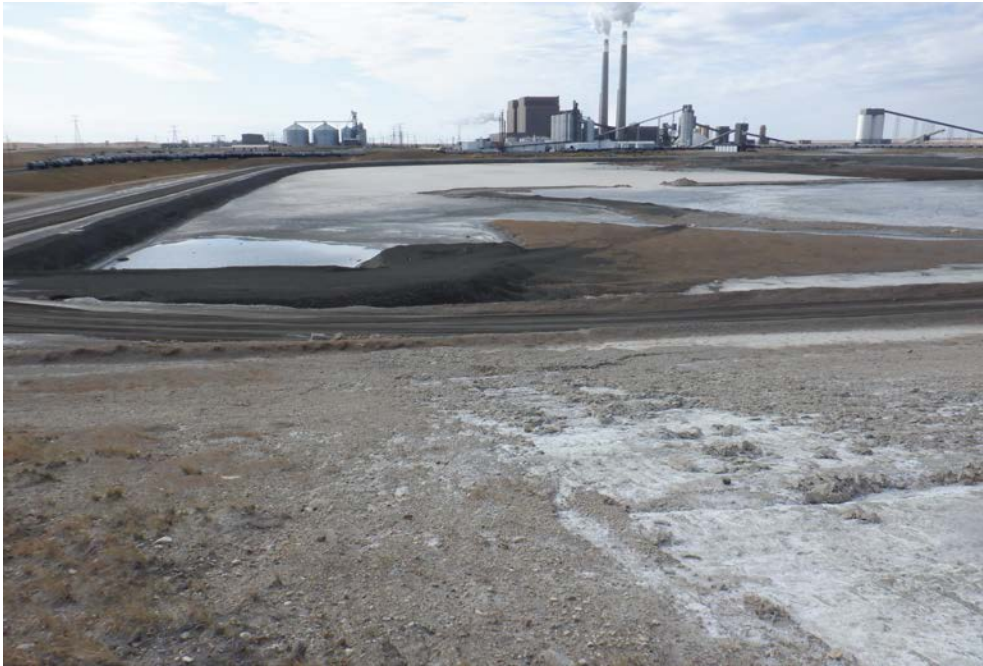
Photograph 7 (West CCR downstream slope)  
Minor erosion of fly ash in southwest corner between elevations 1950 feet and 1974 feet.  
(IMG\_DSCF1762.JPG)

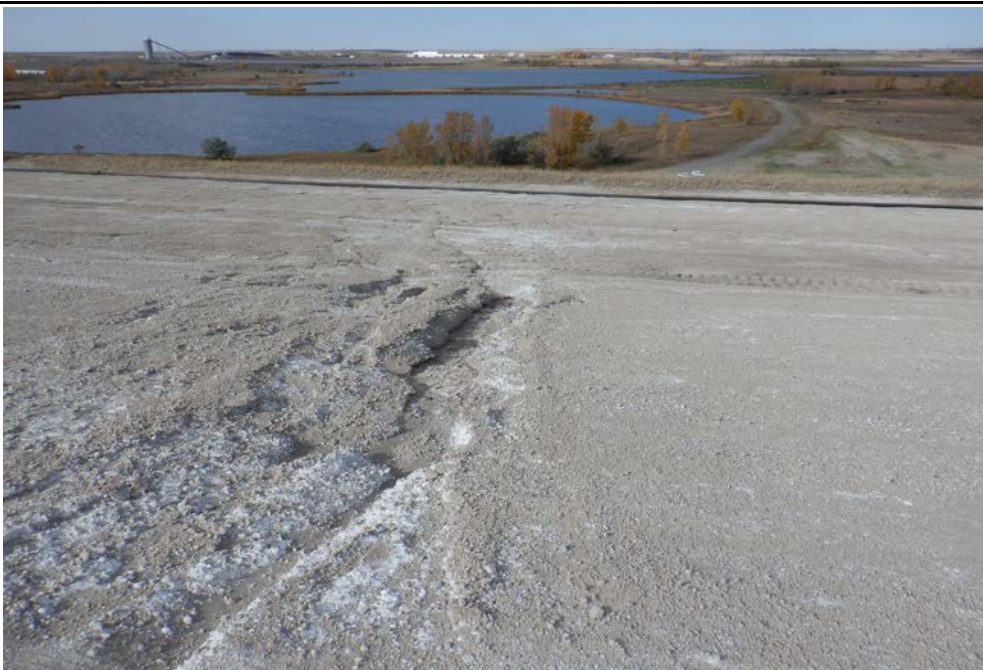
Photograph 8 (North CCR downstream slope)  
Erosion of fly ash below elevation 1998 feet. (IMG\_DSCF1771.JPG)

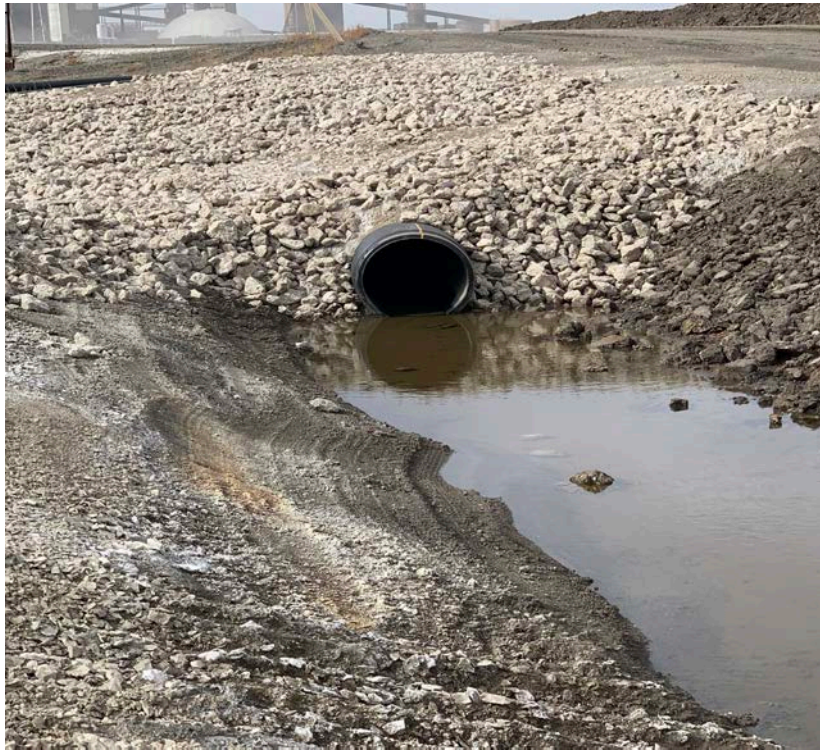
Photograph 9 (North CCR downstream slope)  
Perimeter contact water channel and culvert to Upstream Raise 91. (IMG\_BP15.JPG)

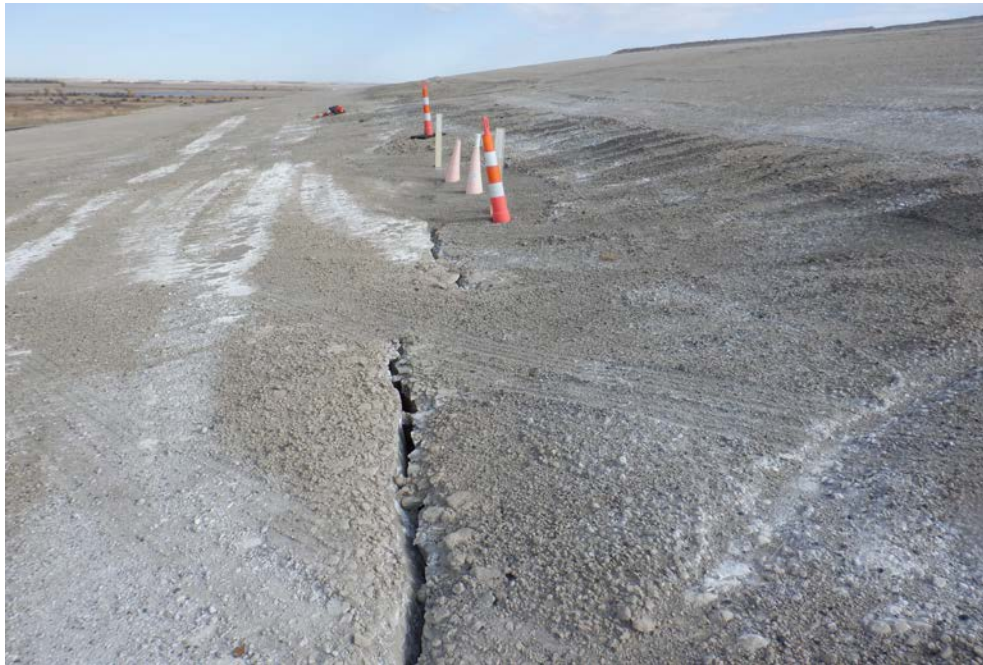
Photograph 10 (North CCR downstream slope (no cover))  
Cracking and erosion of fly ash around piezometers. (IMG\_DSCF1774.JPG)

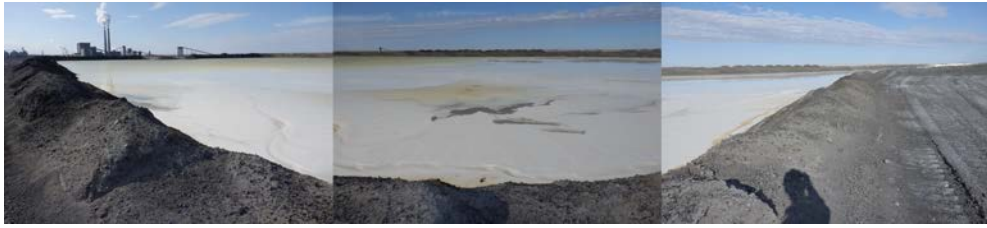
Photograph 11 (South CCR upstream slope )  
Panoramic of Upstream Raise 92 CCR upstream slope and FGD pool. (IMG\_DSCF1787-1789.JPG)

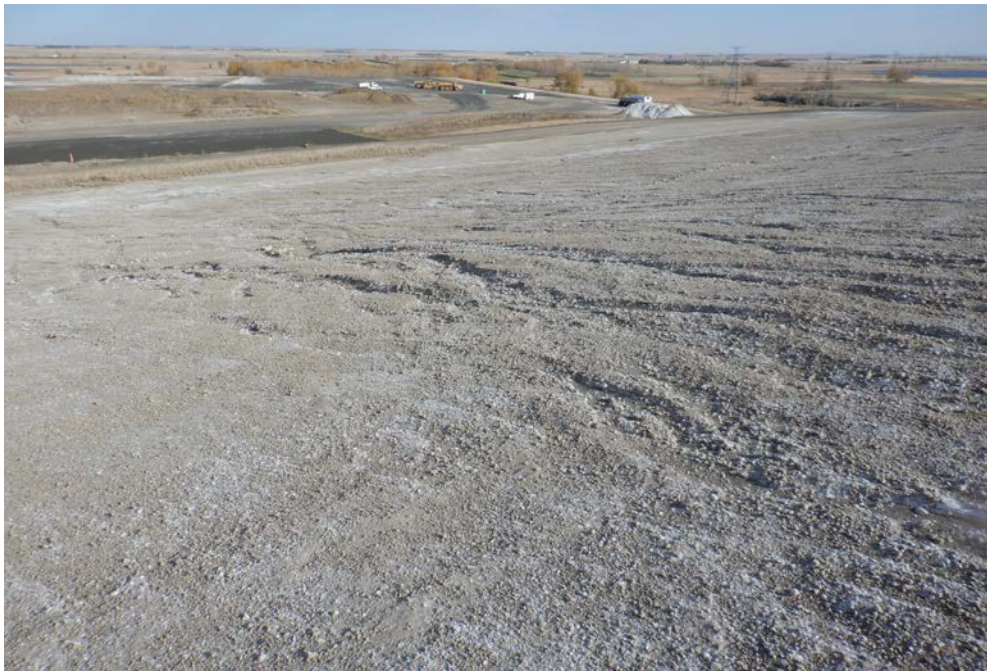
Photograph 12 (East CCR downstream (no cover))  
Minor erosion of fly ash. (IMG\_DSCF1783.JPG)

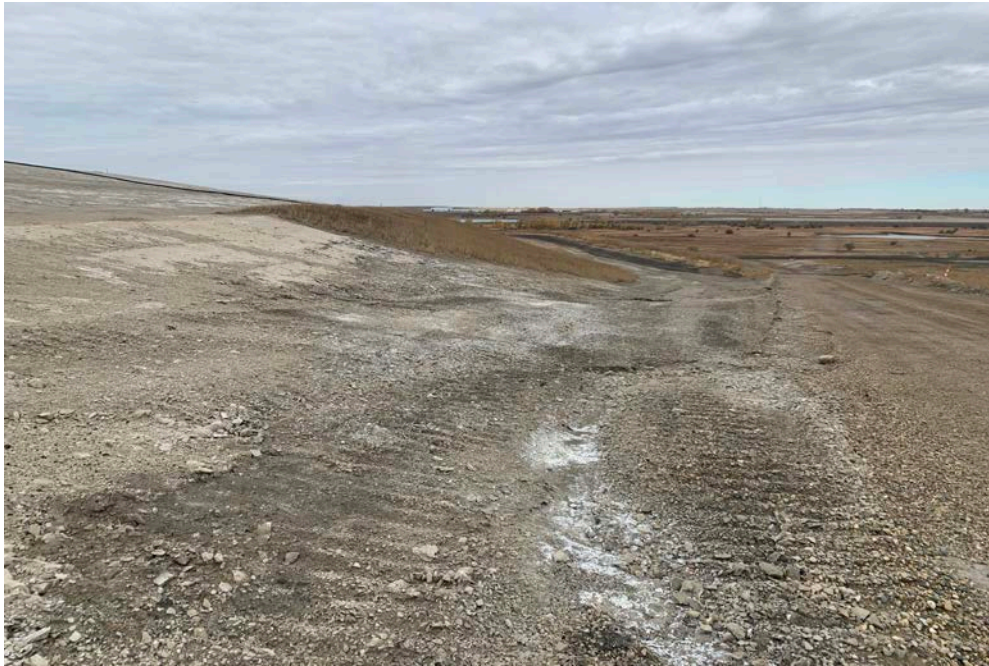
Photograph 13 (East CCR downstream slope (no cover))  
Minor fly ash erosion on the east slope above the haul road. (IMG\_DP1.JPG)

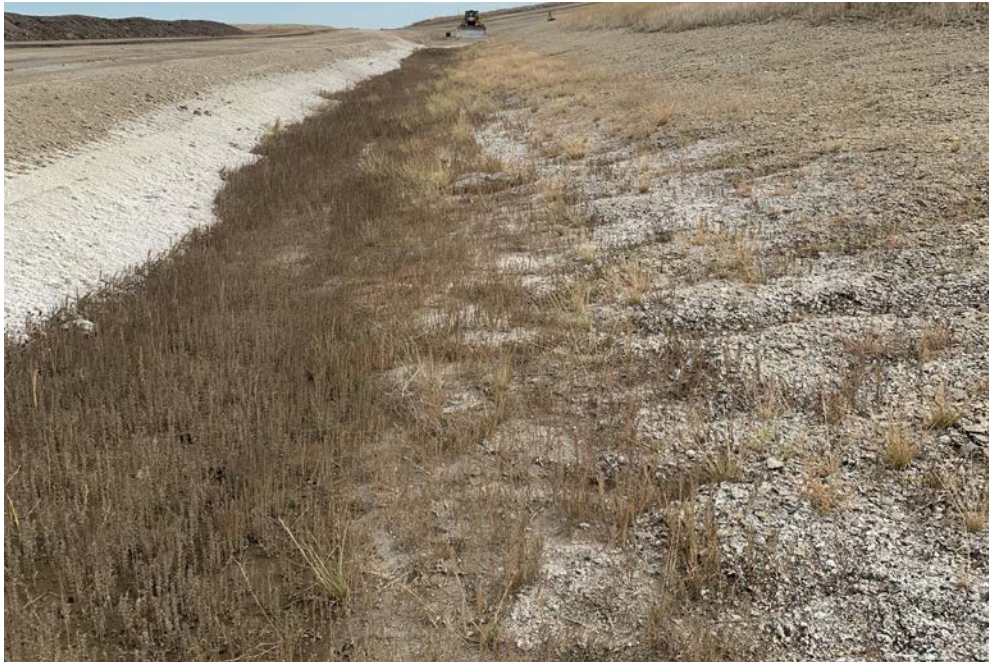
Photograph 14 (North CCR downstream slope (no cover))  
Contact water channel with sparse vegetation. (IMG\_DP14.JPG)

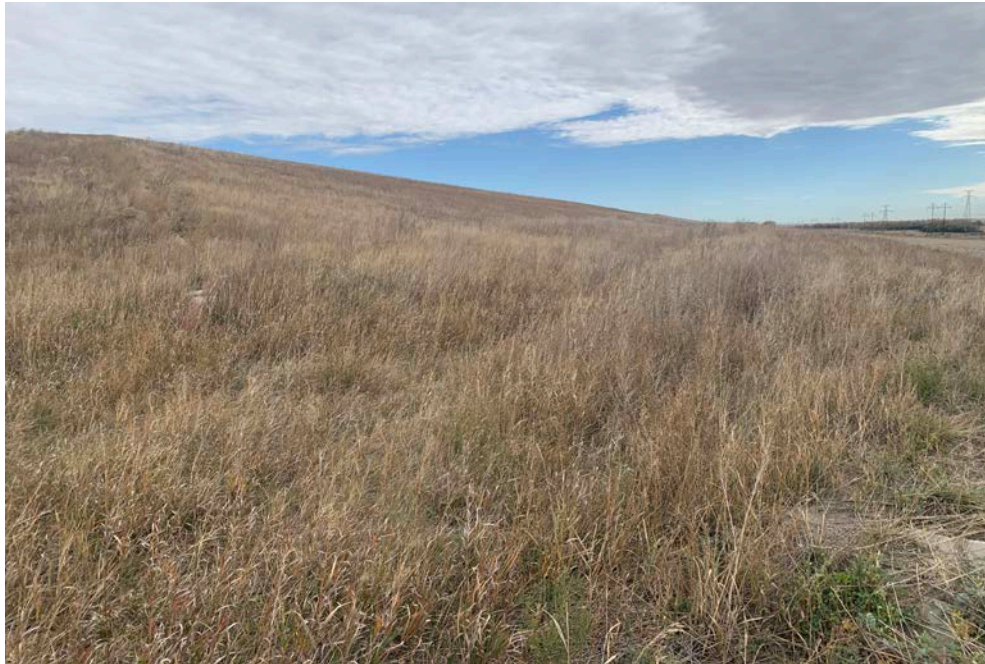
Photograph 15 (South CCR downstream slope (final cover))  
Well-vegetated final cover terrace channel. (IMG\_4638.JPG)

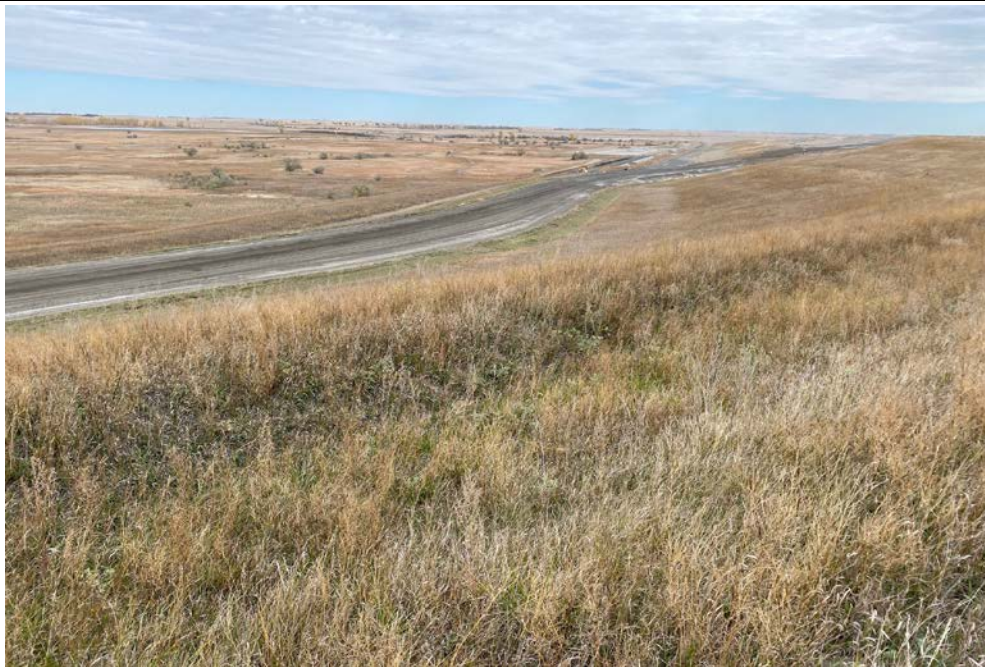
Portions of CCR downstream slopes on the north side of Upstream Raise 92 have temporary cover. These areas were well vegetated with grass and weeds but had experienced some minor erosion. The CCR downstream slopes with temporary cover appeared to be in generally good condition to aid in controlling erosion of the outer fly ash “shell” and limit wind-blown fugitive dust.

Photograph 16 (North CCR downstream slope (temporary cover))  
Temporary vegetative cover on north slope, fair to good grass coverage.  
(IMG\_AD13P.JPG)

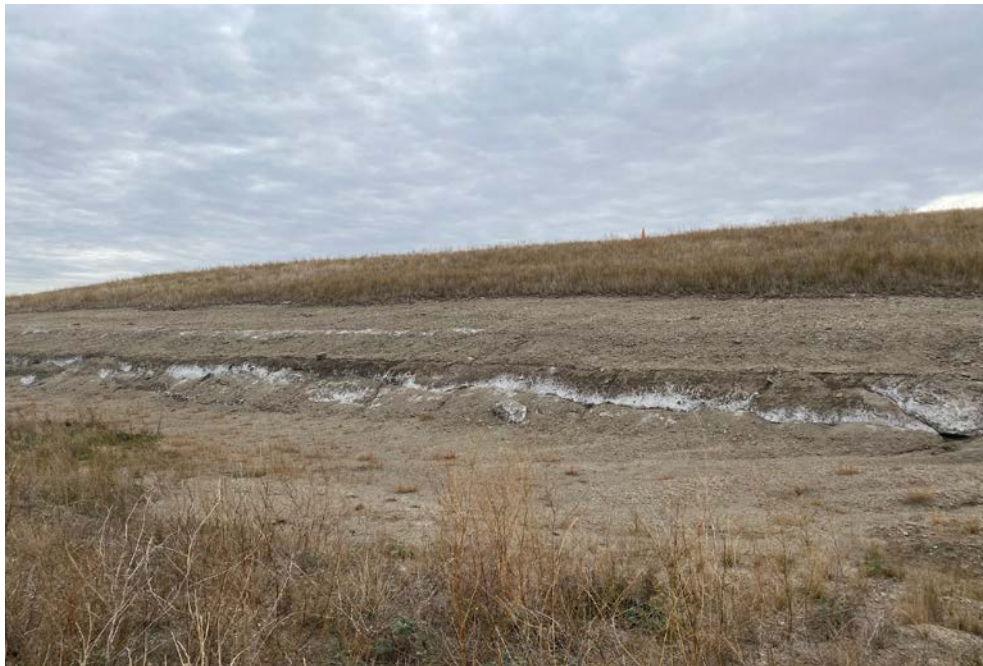
Photograph 17 (North CCR downstream slope (no cover/temporary cover))  
Temporary cover and contact water contaminant channel. (IMG\_AD14P.JPG)

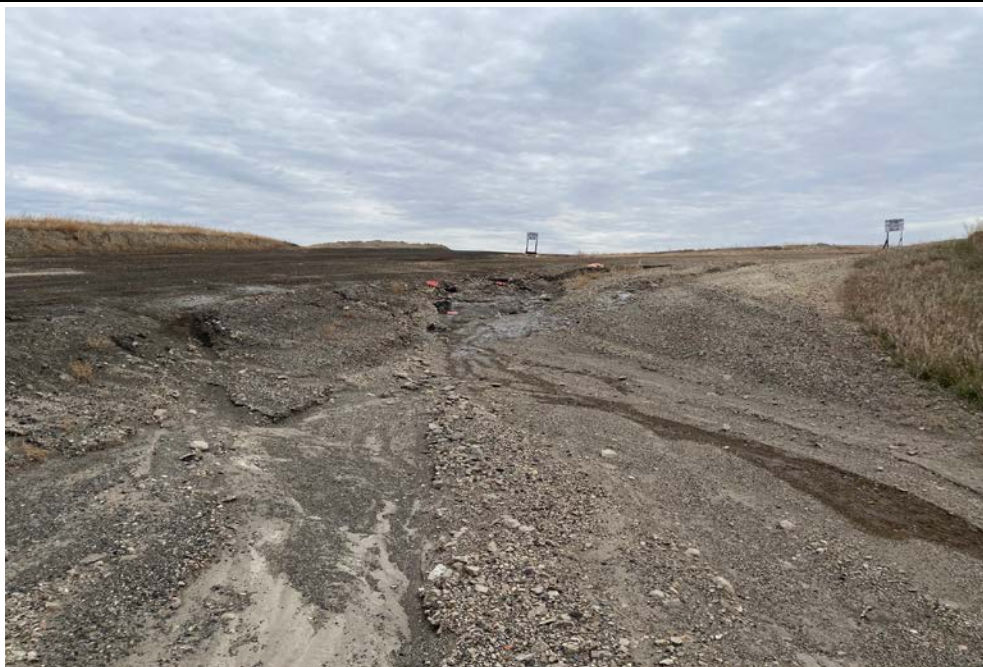
Photograph 18 (East CCR upstream slope (road))  
Erosion on the corner of the main east/west haul route to the southeast corner of  
Upstream Raise 92. (IMG\_AD15P.JPG)

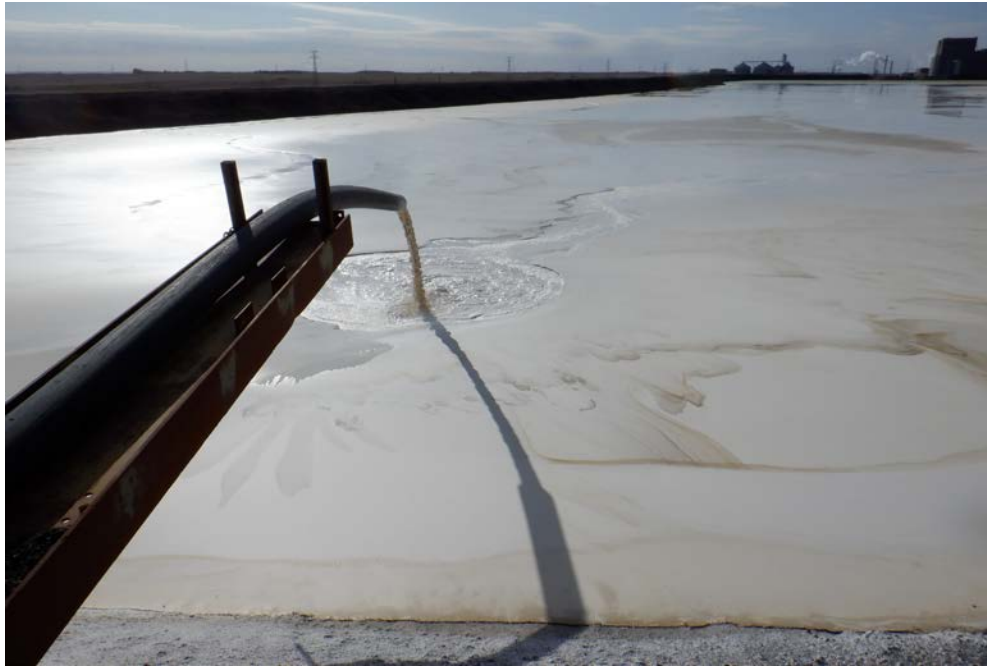
Photograph 19 (East side FGD pool )  
Hydraulic deposition of FGD material on east side of Upstream Raise 92.  
(IMG\_DSCF1782.JPG)

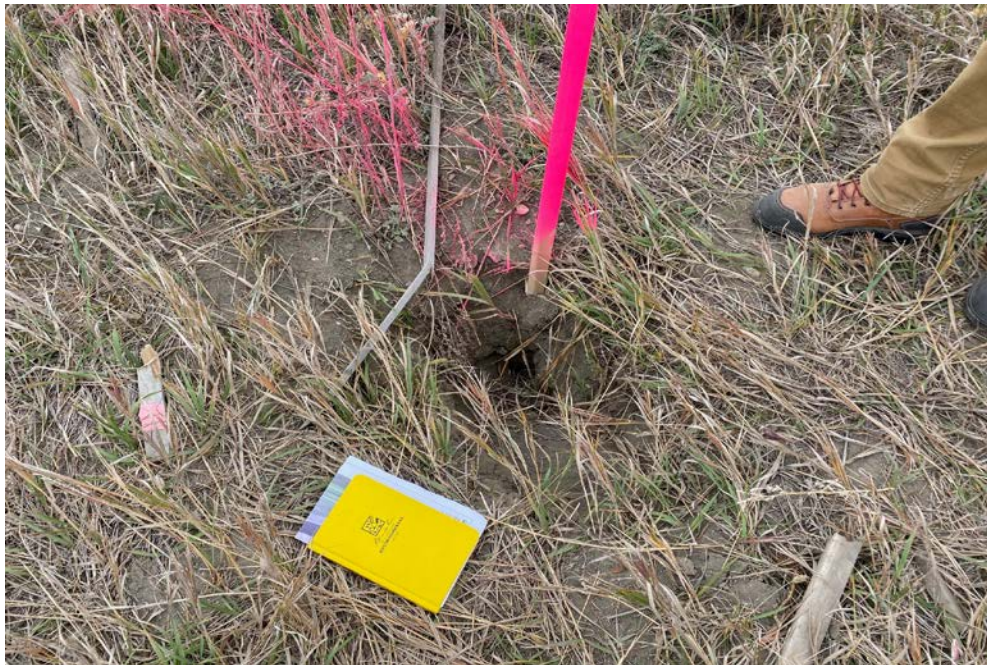
The berm downstream slopes of Upstream Raise 92 below the original and expansion berms are heavily vegetated with native grasses. Occasional animal burrows up to approximately 6 inches in diameter were observed on the north and south berm downstream slopes. Articulated concrete block was recently placed prior to the inspection in two locations and disturbed areas were noted adjacent to the articulated concrete block. These areas were seeded after completion of construction and will be monitored for erosion and vegetative success. There is no noticeable significant erosion, cracks, or scarps on these grassy slopes, and they appear to be in good condition. The seep noted and described as a part of the 2019 annual visual inspection was not noted to exist in 2020.

Photograph 20 (South perimeter berm downstream slope)  
Animal burrow. (IMG\_AD11P.JPG)

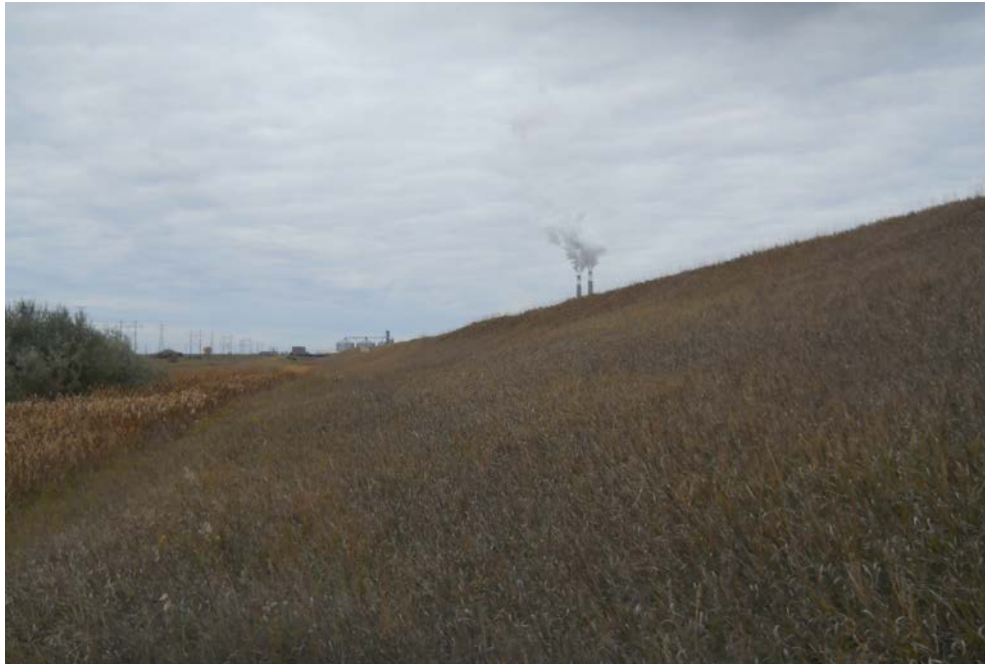
Photograph 21 (South perimeter berm downstream slope)  
Well-vegetated (grass) perimeter berm downstream slope. (IMG\_AD16.JPG)

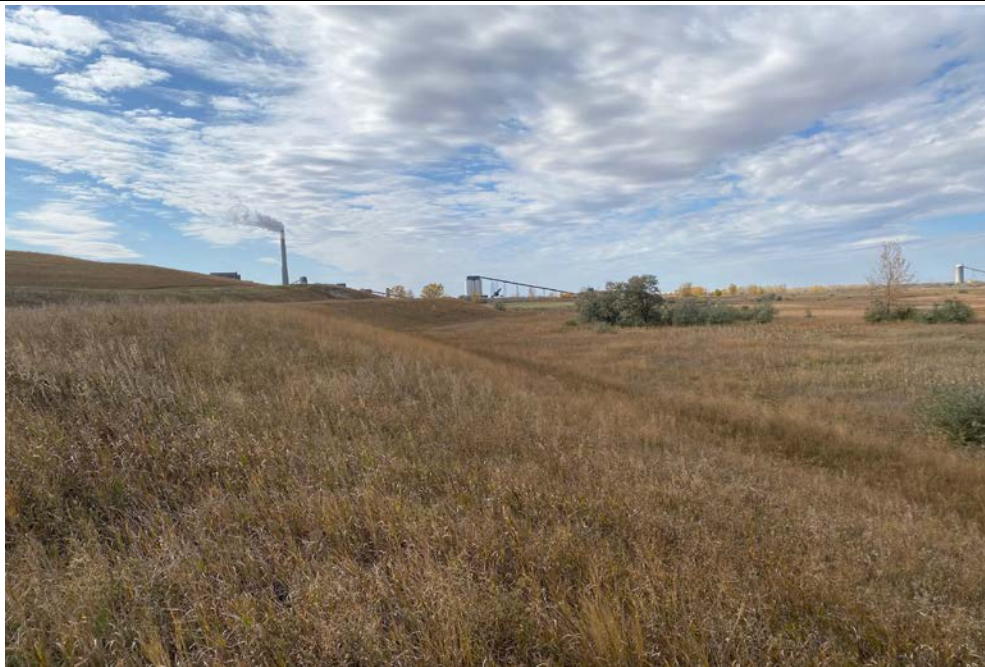
Photograph 22 (North perimeter berm downstream slope)  
Well-vegetated (grass) perimeter berm downstream slope and toe. (IMG\_AD20P.JPG)
