2021 Annual Inspection

Coal Creek Station - Drains Pond System CCR Surface Impoundment

Great River Energy

January 2022

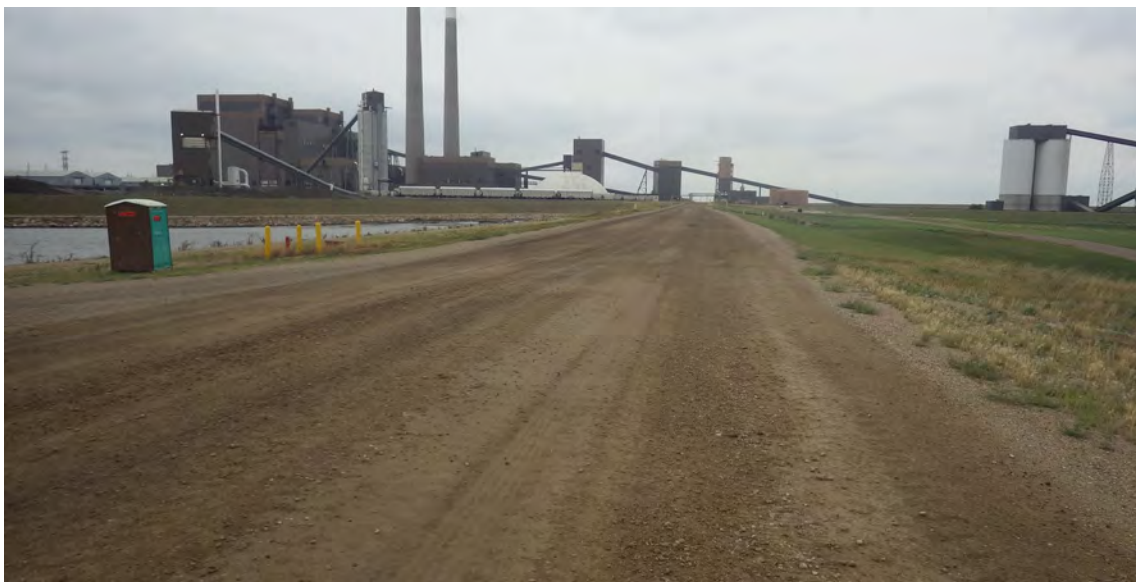
Photograph 1 (West cell, north crest)
Gravel haul road north of center cell and west cell. (IMGP8045.JPG)

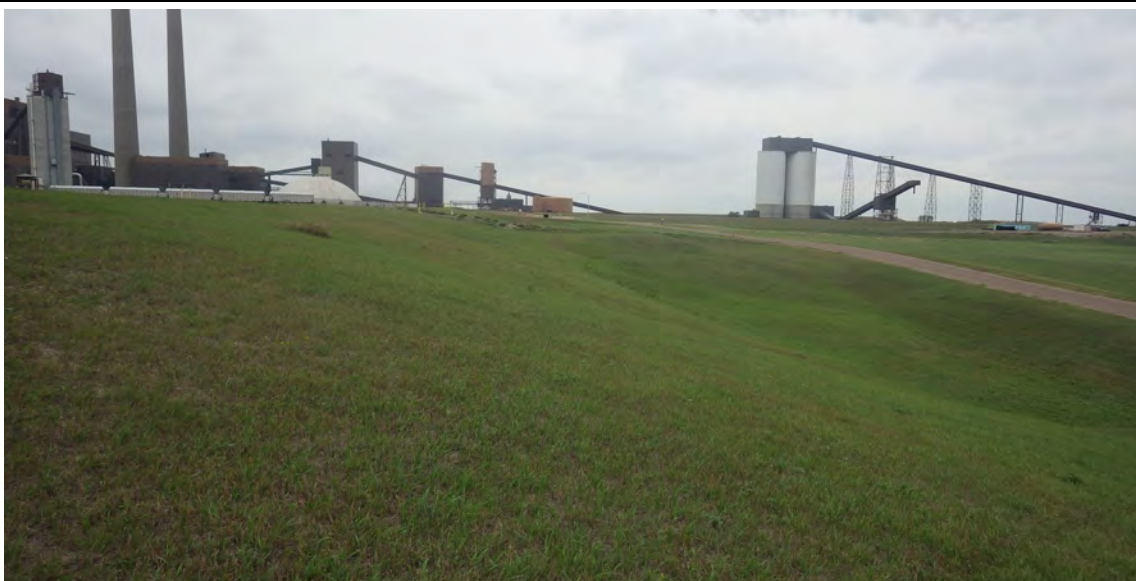
Photograph 2 (West cell, north downstream slope)
Well vegetated north downstream slope of west cell, good condition. (IMGP8046.JPG)

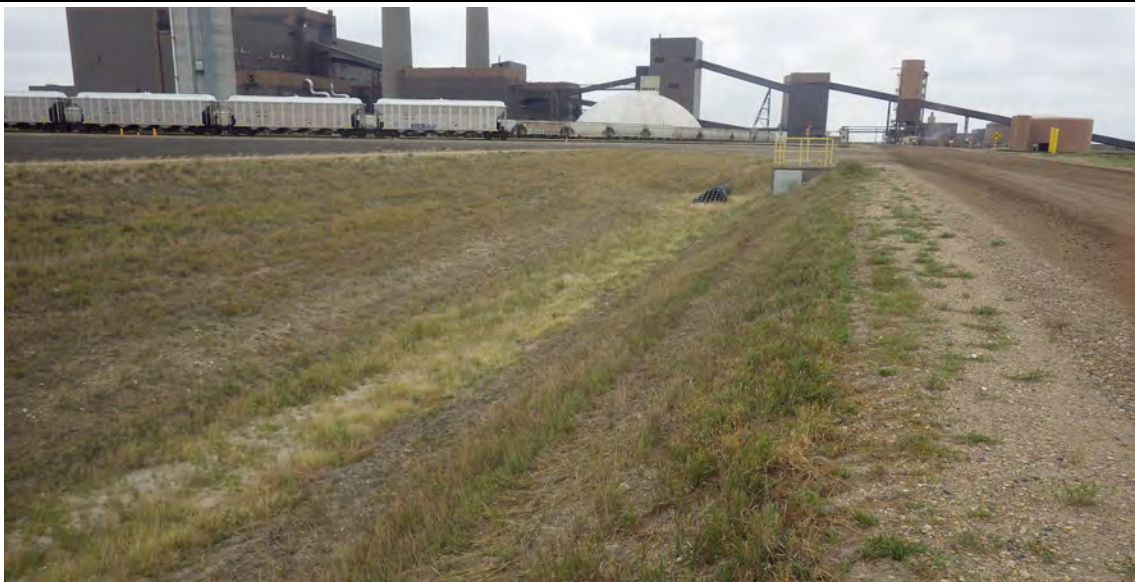
Photograph 3 (West cell, north ditch)
Surface water ditch north of the west cell, clear of obstructions. (IMGP8049.JPG)

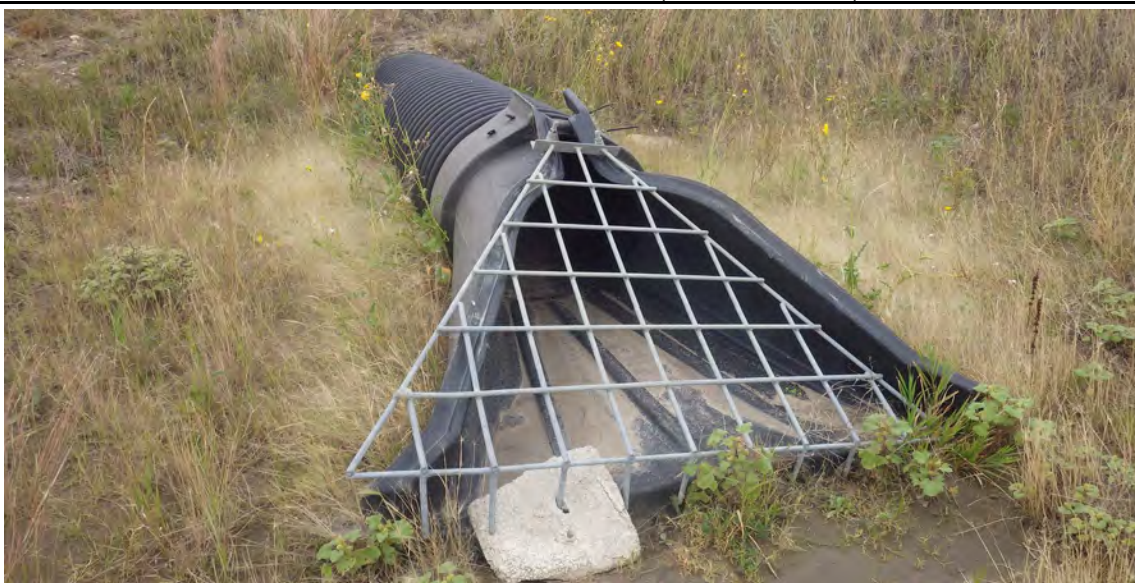
Photograph 4 (West cell, north ditch)
Culvert outlet in the northwest corner of west cell, trash rack partly disconnected. (IMGP8050.JPG)

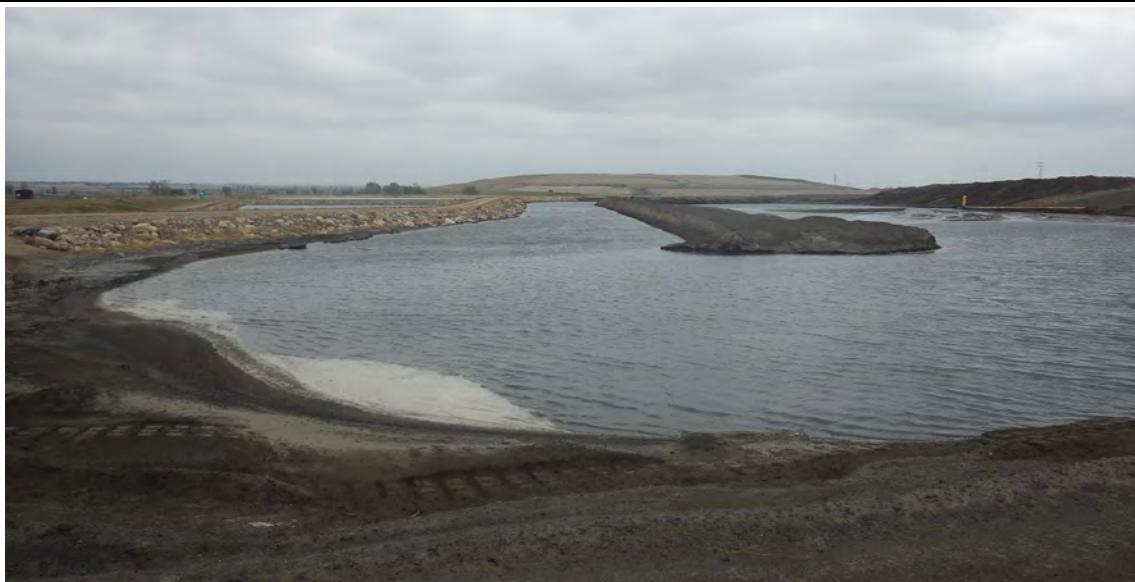
Photograph 5 (West cell)
West cell interior, bottom ash sediment control berm. (IMGP8052.JPG)

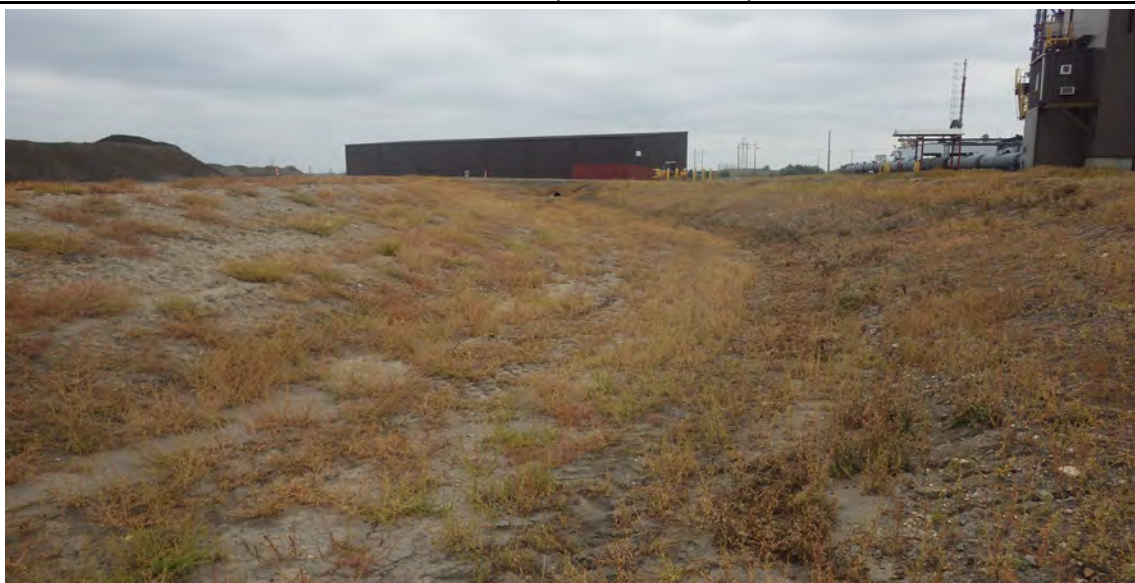
The berm downstream slopes of the west cell range from 0 to 11 feet in height. The west cell shares its east berm with the center cell, although the shared berm has a berm downstream slope from the elevated west cell down to the lower center cell. This berm appeared to be in good condition and was well vegetated with grass. The west downstream slope is shallow, and a surface water drainage ditch is located along this side. At the time of the inspection, there was fair vegetation along this west slope. The north berm downstream slope is heavily vegetated with native grasses. The south downstream slope was re-graded in 2019 and has fair vegetative growth but may benefit from re-seeding. Golder did not observe indications of seepage, sloughing, cracking, significant erosion, excessive settlement, or vegetation that seemed to be thriving abnormally. The berm downstream slope of the west cell appeared to be in fair condition.

Photograph 6 (West cell, west downstream slope)
Downstream slope and stormwater drainage ditch, fair vegetation on slope. (IMGP8054.JPG)

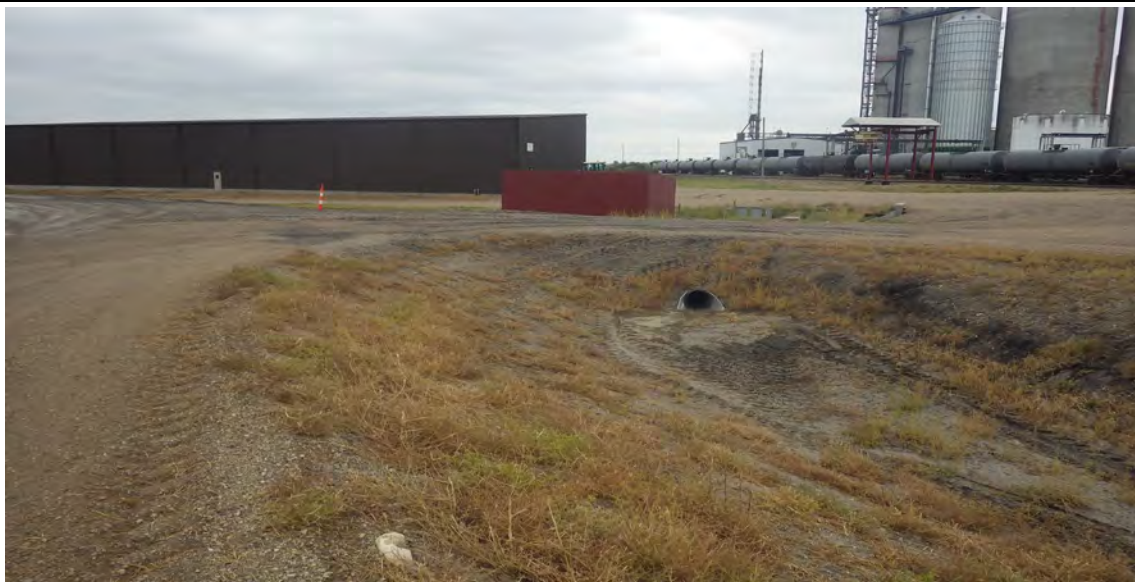
Photograph 7 (West cell, west downstream slope)
Culvert inlet from the west stormwater drainage ditch to the ash line ditch, clear of obstructions. (IMGP8055.JPG)

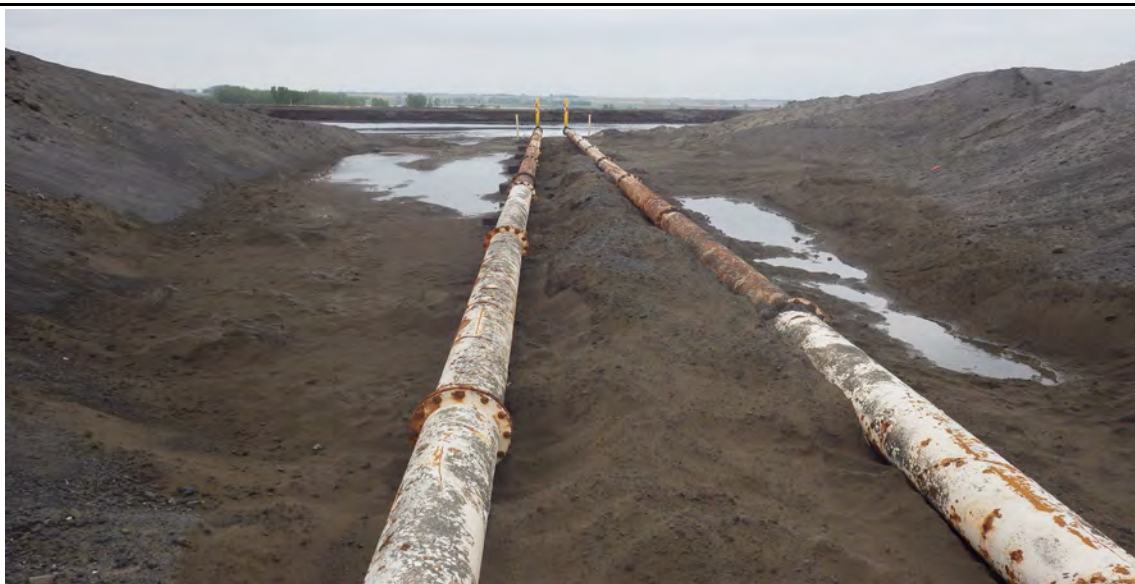
Photograph 8 (West cell, southwest upstream slope)
Ash lines into the west cell. (IMGP8056.JPG)

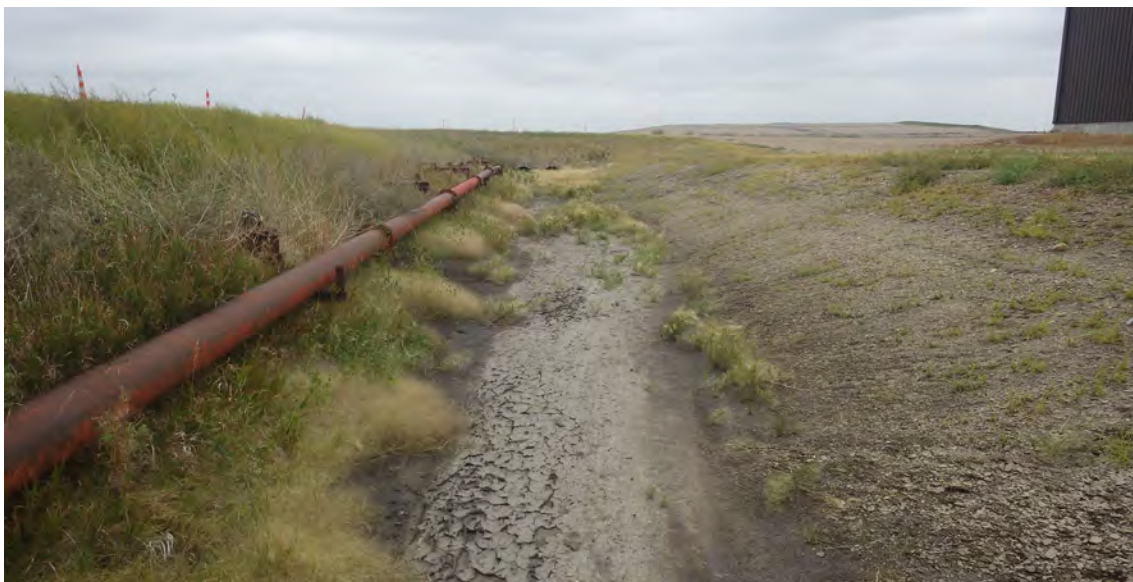
Photograph 9 (West cell, south downstream slope)

Ash lines ditch looking east, free from obstructions, downstream slope well vegetated. (IMGP8060.JPG)

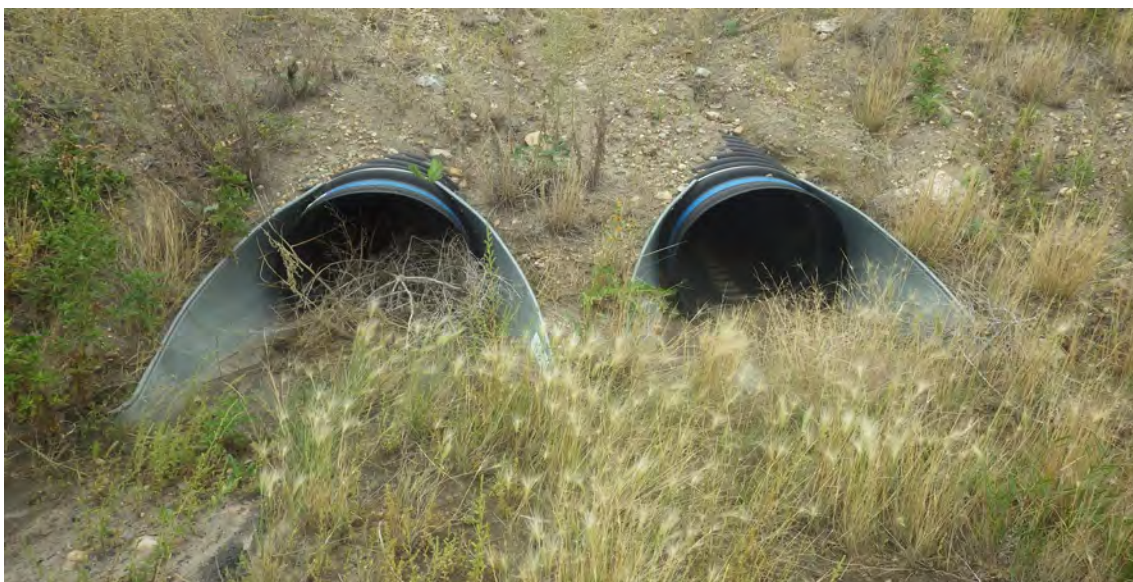
Photograph 10 (West cell, south downstream slope)

The above-ground pipes observed appeared to be in good condition with no noticeable settlement, cracking, or significant corrosion. Minor erosion was observed around the surface water culvert inlet on the south side of the west cell. The downchute channel on the north side of the center cell is in good condition. In addition, in November 2020, the downstream slope and ditch on the west side of the west cell was re-graded and a culvert was installed to promote drainage of potential contact water south of the west cell and through the channel and culverts into the center cell of the Drains Pond System.

Culvert inlet, minor vegetation at the inlet and some erosion on the north side of culverts. (IMGP8062.JPG)

Minor maintenance items that may need to be continually addressed include repairing ruts that develop within the crest roads, ensuring that grades promote flow of contact water into the CCR facility footprints, repairing eroded areas of the berm upstream slope fly ash and riprap protection layers, monitoring berm downstream slopes for large animal burrows or erosion that may affect operations and reseeding as required, and removing sediment that accumulates within the facilities that negatively impacts operations. In addition, the inflow and outflow piping should be monitored regularly to ensure proper conveyance of water to and from the facility.

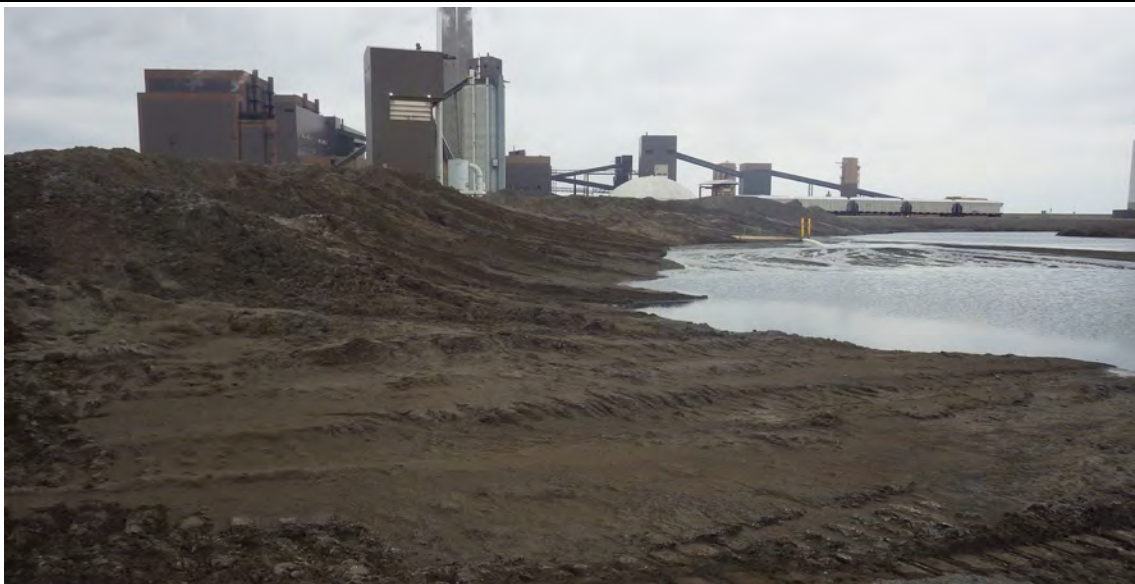
Photograph 11 (West cell)
Bottom ash inflow and stockpiles. (IMGP8063.JPG)

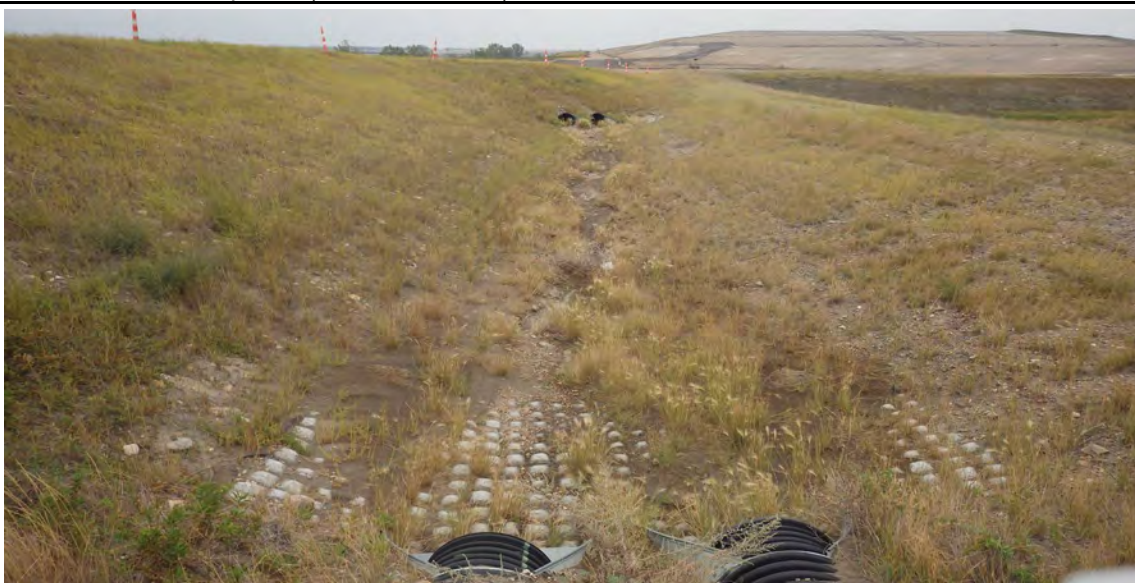
Photograph 12 (West cell, south downstream slope)
Culverts and erosion protection south of the west cell, good condition. (IMGP8064.JPG)

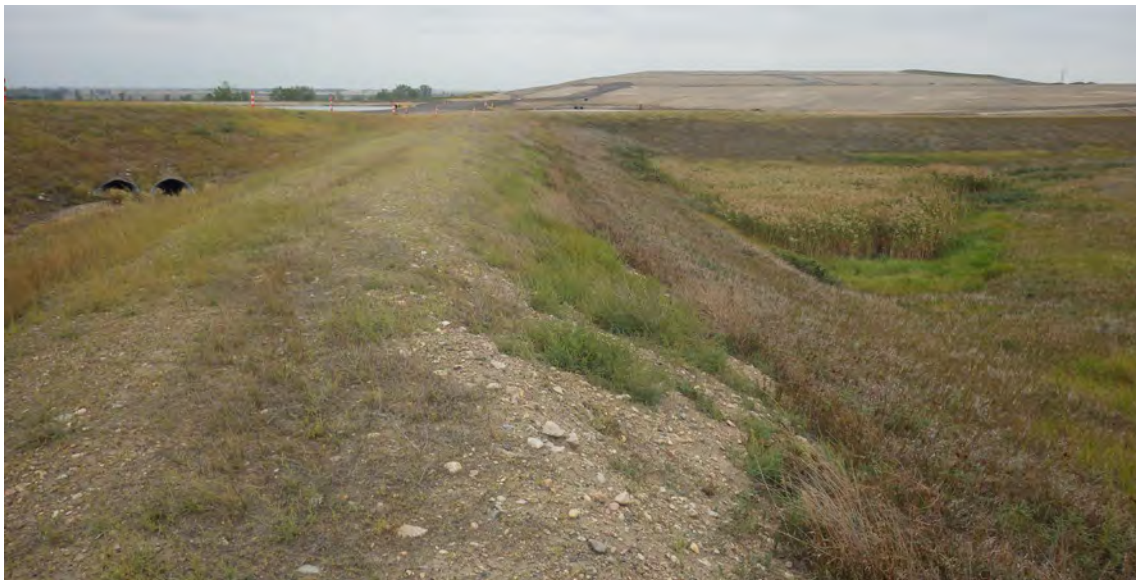
Photograph 13 (West cell, south downstream slope)
South side of the west cell downstream slope, fair vegetation. (IMGP8066.JPG)

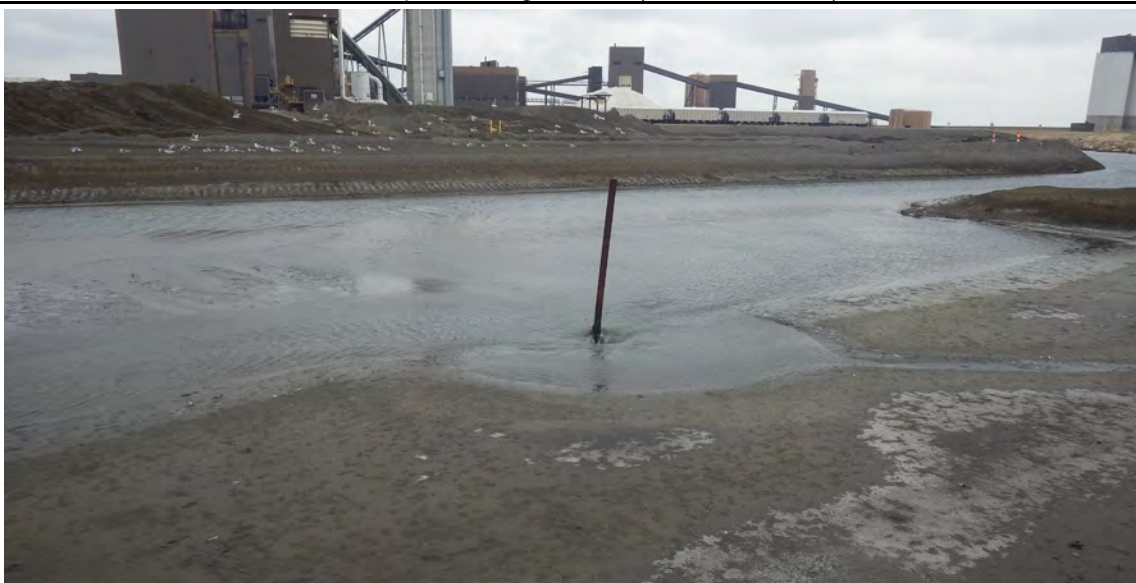
Photograph 14 (West cell, east upstream slope)
North decant inlet to center cell. (IMGP8069.JPG)

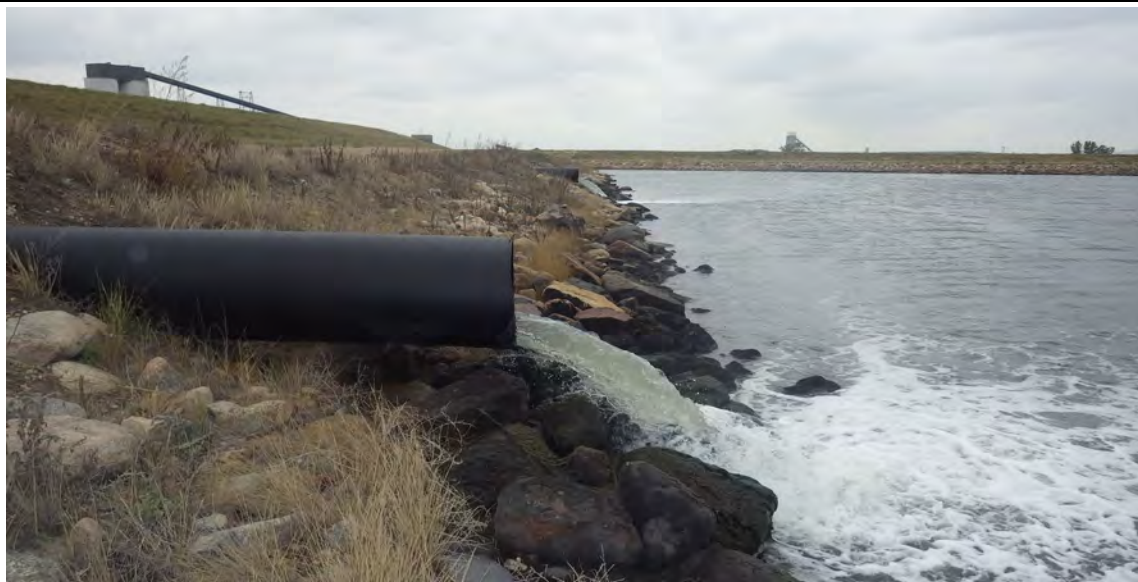
Photograph 15 (Center cell, west upstream slope)
Decant outlets to center cell. (IMGP8070.JPG)

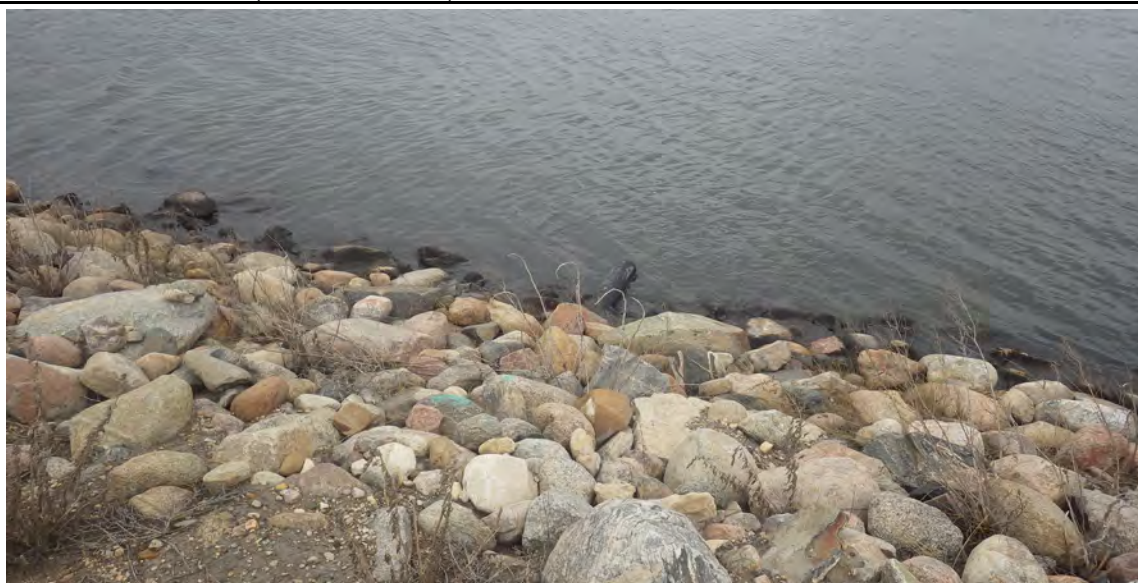
Photograph 16 (Center cell, west upstream slope)
West upstream slope, good condition. (IMGP8071.JPG)

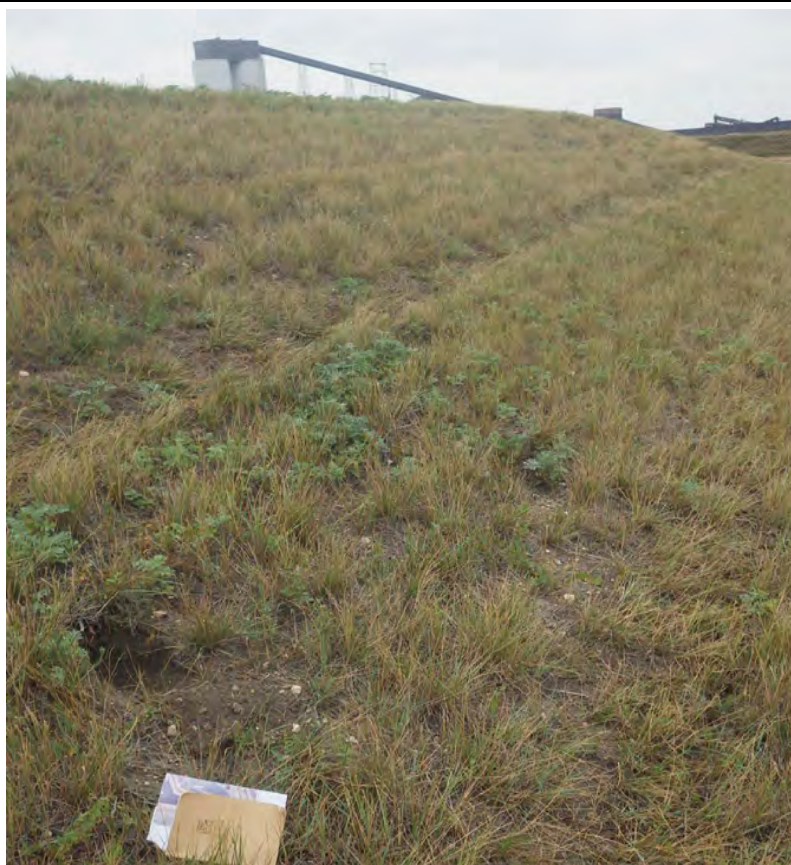
Photograph 17 (West cell, east downstream slope)
Grass slope between the center cell and west cell, small animal burrow. (IMG8072.JPG)

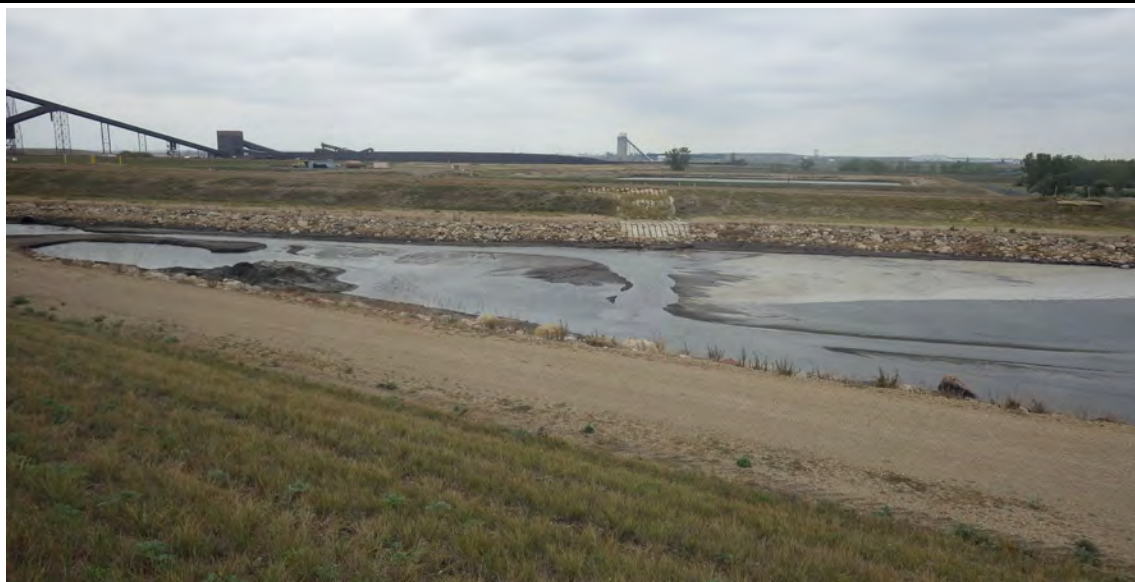
Photograph 18 (Center cell, northwest upstream slope)
Stormwater drainage downchute and plant drains inlet to the center cell. (IMG8074.JPG)

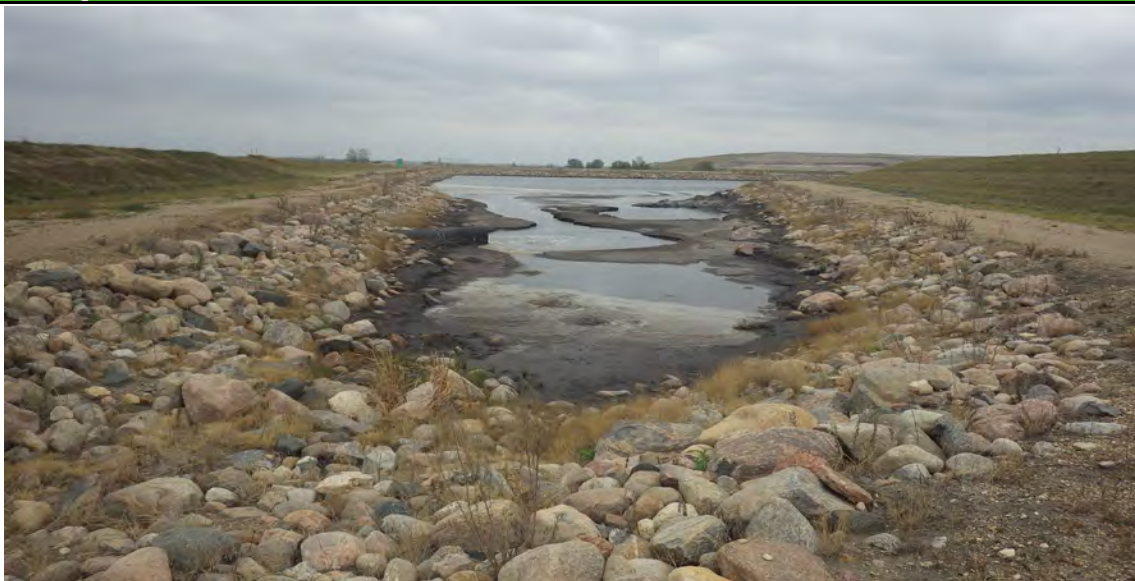
Photograph 19 (Center cell, northwest upstream slope)
Center cell upstream slope in good condition, sediment accumulation around plant drains inlet. (IMGP8076.JPG)

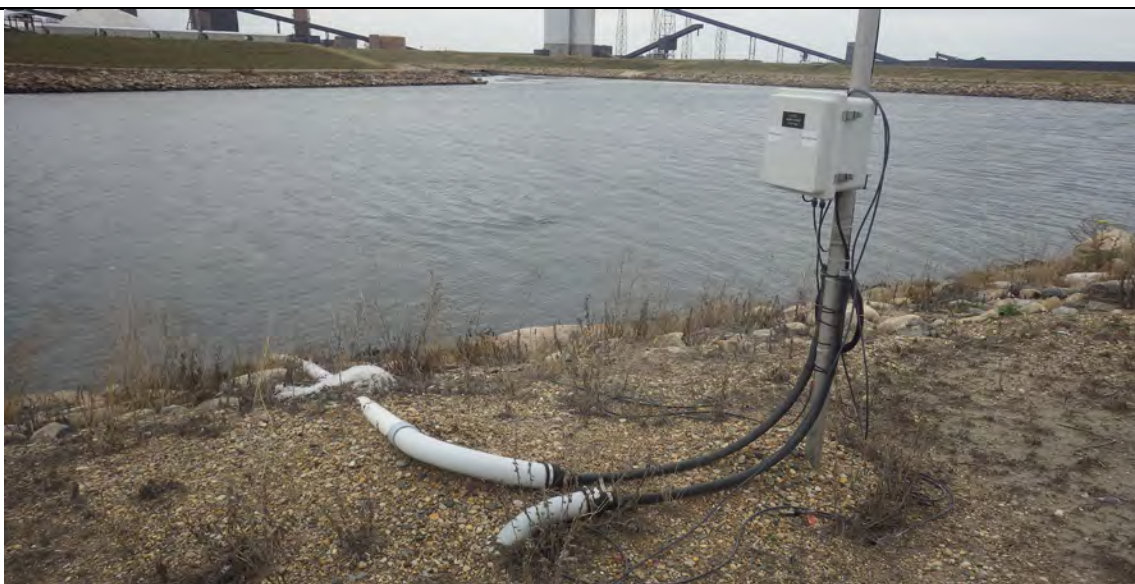
Photograph 20 (Center cell, west upstream slope)
Center cell and east cell water level measurement station. (IMGP8079.JPG)

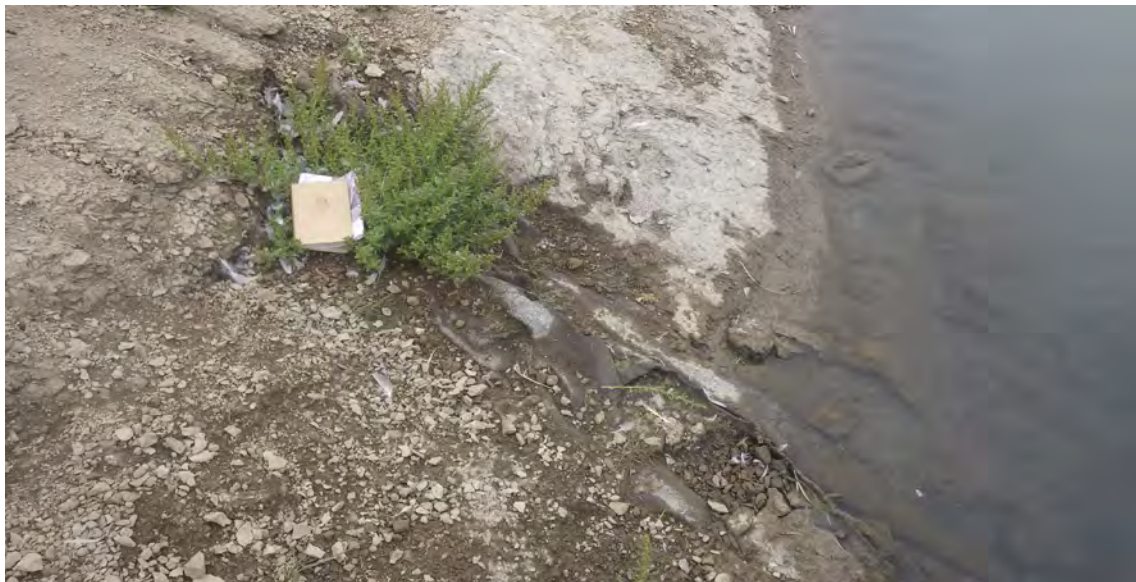
The observable berm upstream slopes appeared to match the design slopes of 3:1 with no observed sections of significant slope movement. The berm upstream slope along the south and west sides of the west cell were below temporarily stacked bottom ash materials and were not visible during the inspection. Center cell slopes and the east berm upstream slopes of the west cell are protected from erosion with a 1-foot-thick fly ash layer from the floor to the embankment crest as well as riprap within the normal operating levels of the cells. At the time of inspection, the riprap appeared to be in good condition and minor erosion was noted on the fly ash protective cover.

Photograph 21 (East cell, upstream slope)
Erosion of fly ash protective cover, minor exposed geotextile. (IMGP8080.JPG)

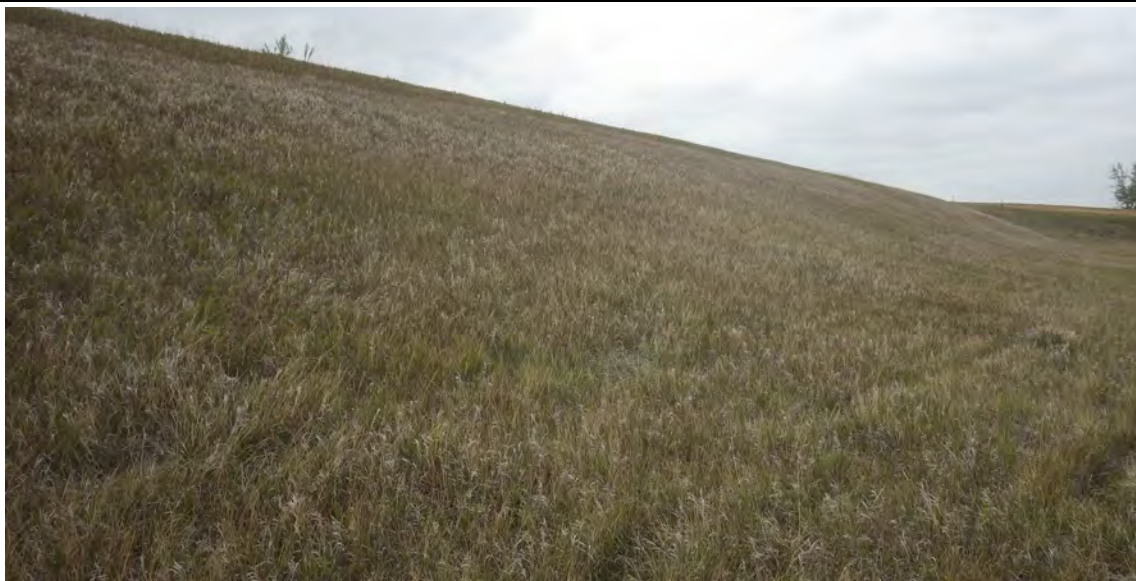
Photograph 22 (East cell, east downstream slope)
Well vegetated east cell downstream slope and toe, good condition. (IMGP8083.JPG)

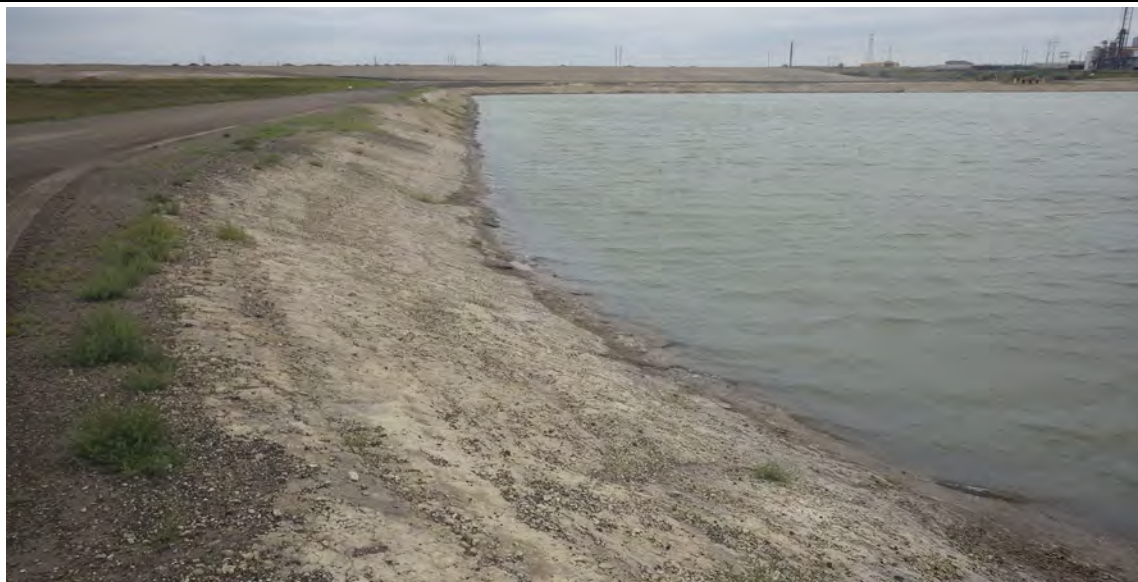
Photograph 23 (East cell, east upstream slope)

East cell upstream slope, fly ash protective cover in good condition. (IMGP8085.JPG)
