REPORT**2021 Annual Inspection***Coal Creek Station – Southeast Section 16 CCR Landfill*

Great River Energy

Golder Associates USA Inc.

January 2022

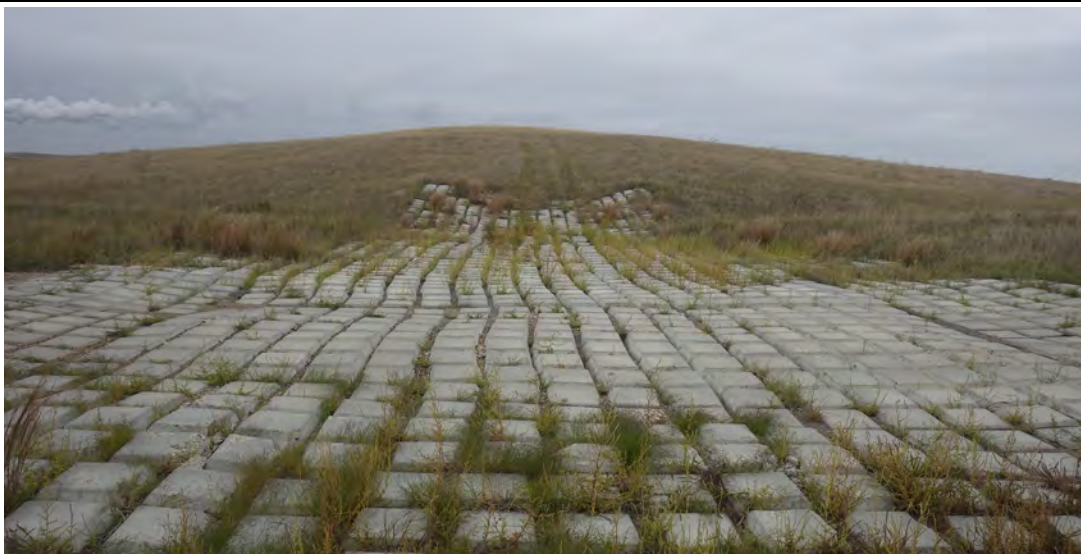
Photograph 1 (Southeast perimeter, downchute)
Looking upslope, articulated concrete block in good condition. (IMGP7987.JPG)

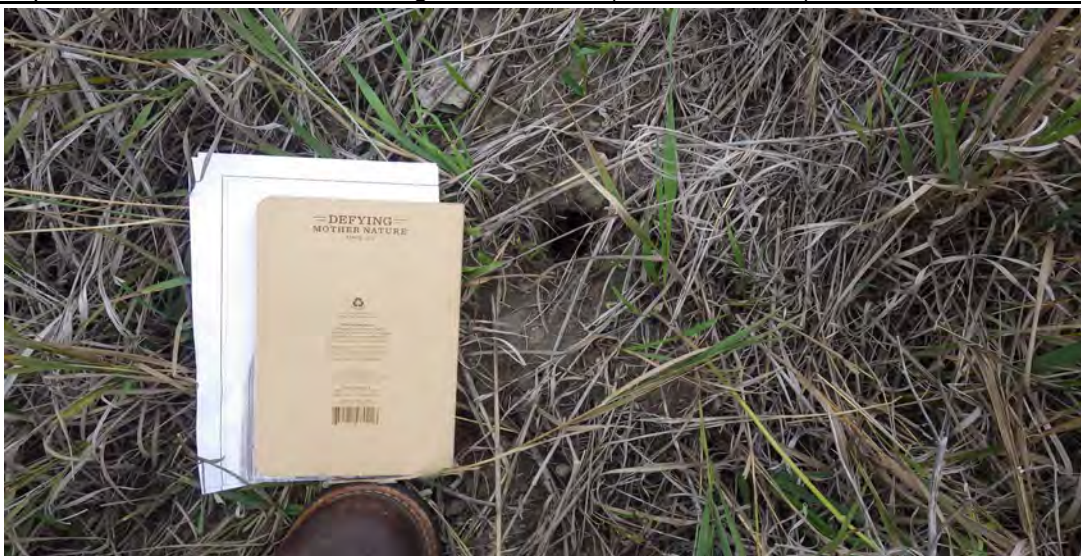
The berm downstream slopes on the south and east sides had good vegetation. Some small animal burrows were identified along the berm downstream slope, particularly in the southeast corner. The north berm downstream slope was recently covered with growth medium and topsoil. After one year of growth, most of the vegetation on this slope consisted of weeds and GRE should consider reseeding this area to promote growth of native grasses. Golder did not observe indications of seepage, sloughing, cracking, or excessive settlement on the berm downstream slopes. The berm downstream slopes on the south and east sides appeared to be in good condition, and the berm downstream slope on the north side of Southeast 16 was in fair condition.

Photograph 2 (Southeast perimeter downstream slope)
Small animal burrow. (IMGP7988.JPG)

Minor maintenance items that may need to be continually addressed include repairing large animal burrows as they appear, monitoring erosion along CCR slopes, repairing rutted perimeter roads to maintain access, reseeding poorly vegetated CCR downstream slopes where final cover has been placed, removing woody vegetation growing on the berm downstream slopes and toes, and placing CCR over exposed geomembrane liner, particularly in the contact water collection area.

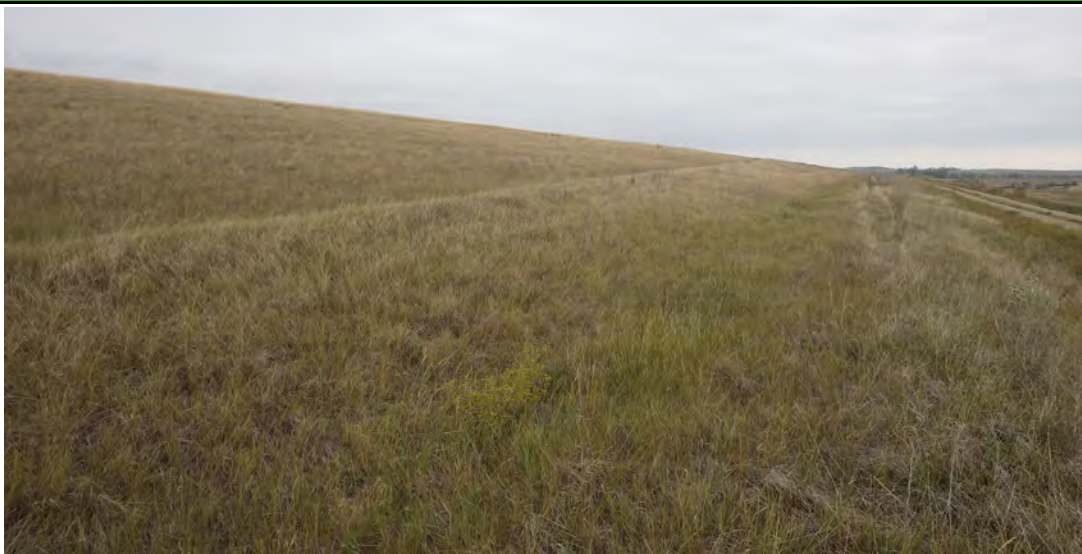
Photograph 3 (East CCR downstream slope with final cover)
East side of final cover slope, good condition. (IMGP7990.JPG)

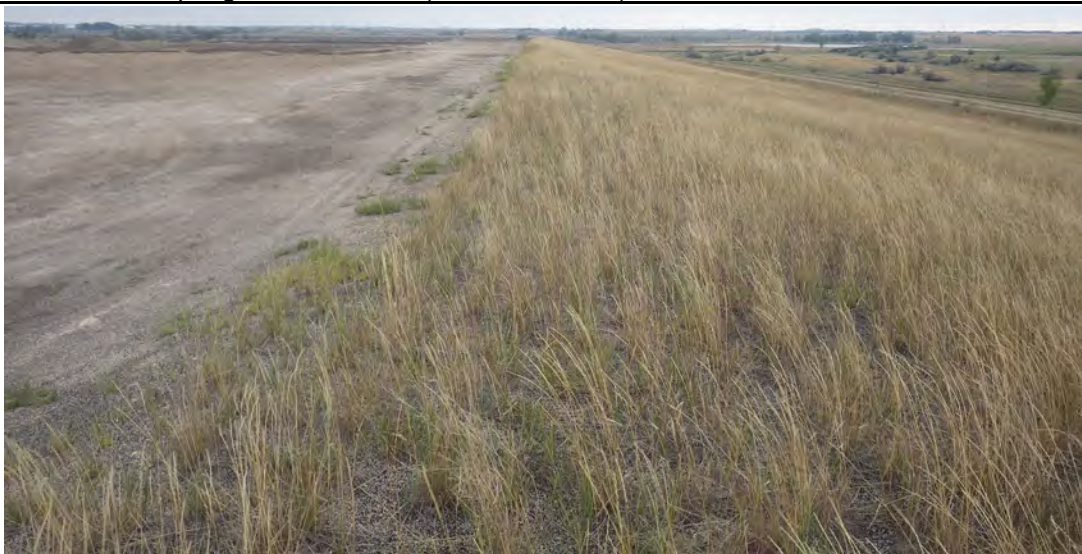
Photograph 4 (East CCR downstream slope and crest)
Contact water separation berm in good condition. Wind blown ash on temporary cover slopes. (IMGP7992.JPG)

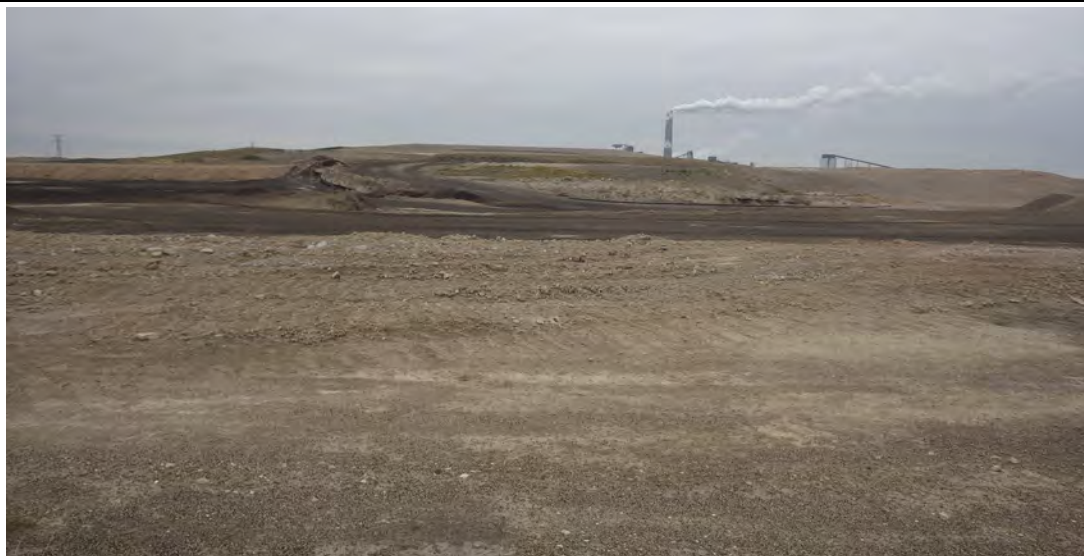
Photograph 5 (Southeast 16 from east)
Active deposition area of Southeast 16, good condition. (IMG7999.JPG)

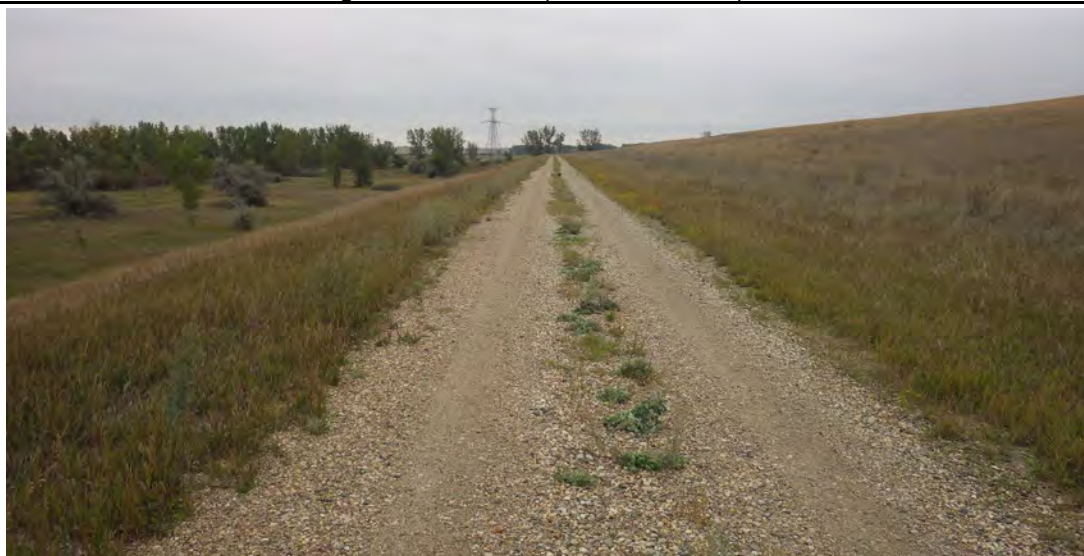
Photograph 6 (East perimeter access road)
Perimeter berm gravel road, good condition. (IMG8002.JPG)

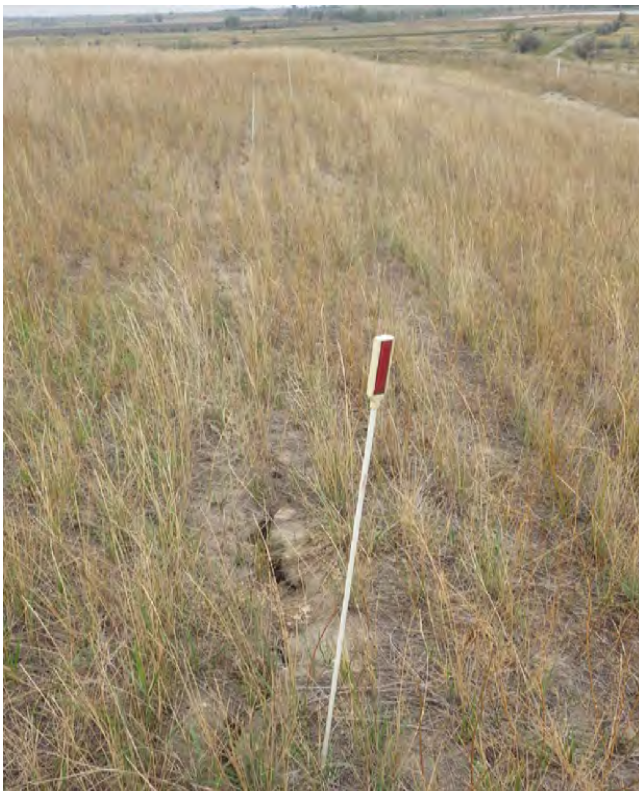
Photograph 7 (East CCR downstream slope, temporary cover)

Portions of CCR downstream slopes on the north, east, and south sides of Southeast 16 have temporary cover installed as of late 2016. These areas had fair vegetation (a combination of grassy vegetation and weeds) and minor erosion on the soil surface below. However, these CCR downstream slopes with temporary cover appeared to be in generally good condition to aid in controlling erosion of the outer fly ash "shell" and limit wind-blown fugitive dust. A minor crack was noted in the temporary cover on the east side of Southeast 16 at a consistent elevation. The crack is not affecting safe access or inspection of the facility.

Minor crack in temporary cover slope, fair vegetation on temporary cover downstream slope. (IMGP8003.JPG)

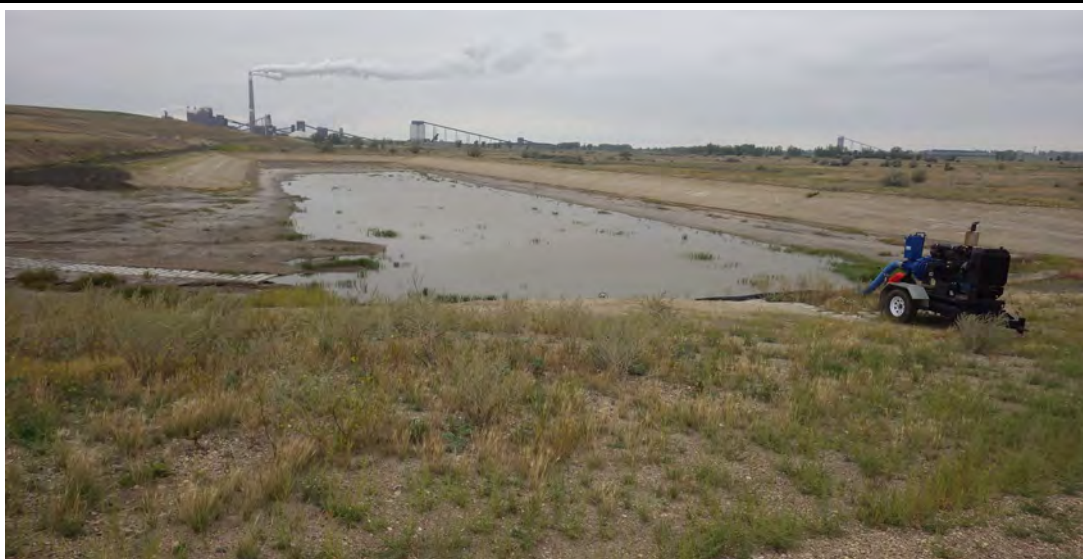
Photograph 8 (Contact water collection area)

Contact water collection area and sump, protection cover good condition. (IMGP8008.JPG)

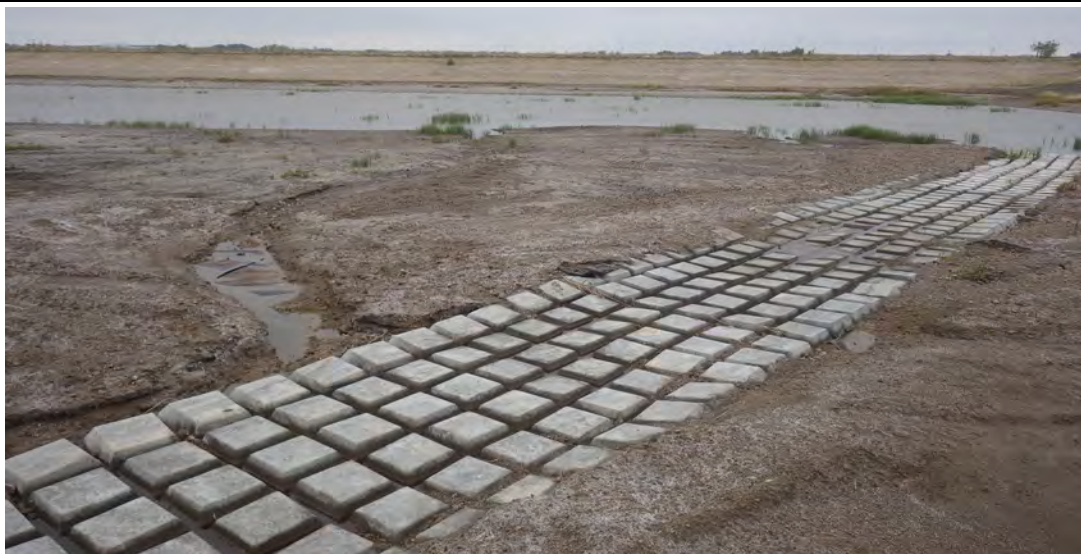
Photograph 9 (Contact water collection area)

Minor area of exposed geomembrane in contact water collection area, near articulated concrete block reinforcement. (IMGP8010.JPG)

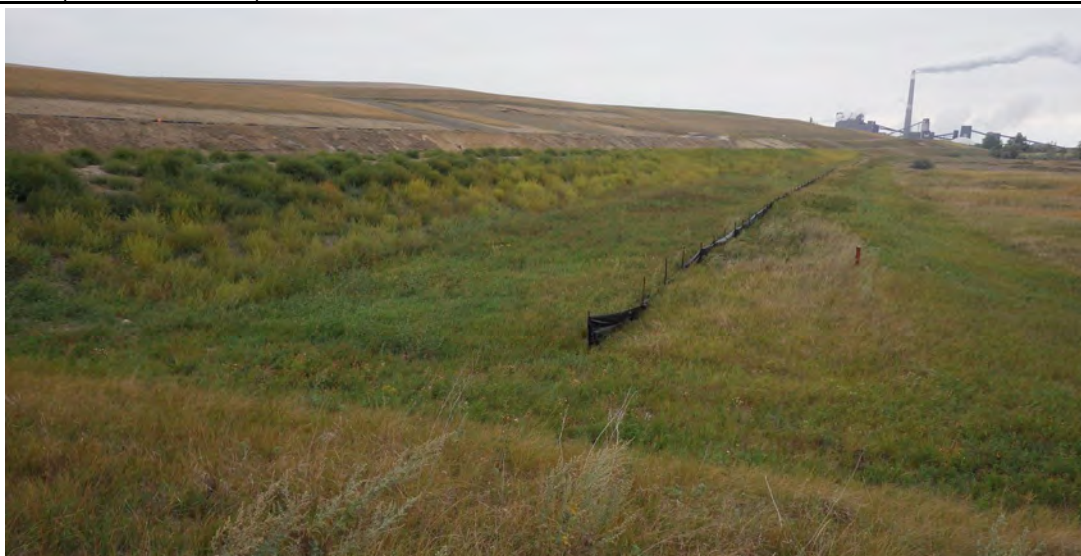
Photograph 10 (North perimeter downstream slope)

Contact water collection area downstream slope, fair vegetation, mostly weeds. (IMGP8015.JPG)

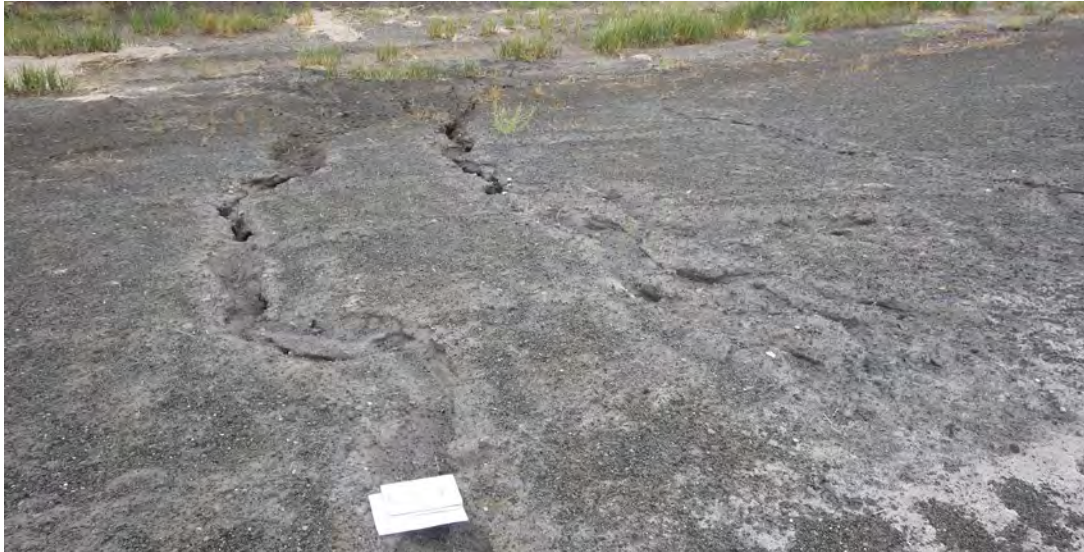
Photograph 11 (North perimeter downstream slope)
Minor erosion of the bottom ash upstream slope, no liner visible (typical of approximately 5 locations on north perimeter berm upstream slope). (IMGP8019.JPG)

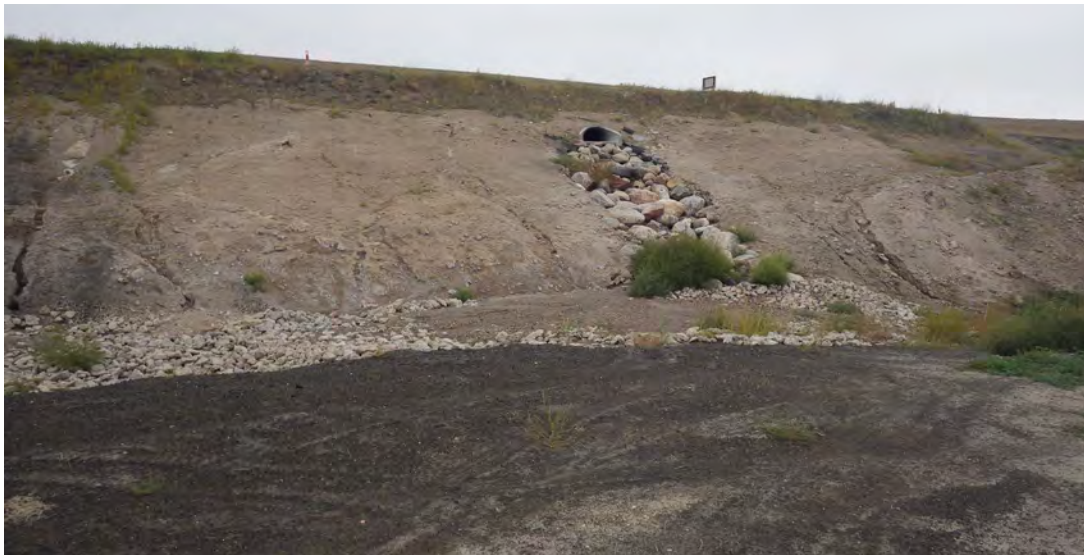
Photograph 12 (North CCR downstream slope)
Culvert outlet to contact water collection area, armoring in good condition. (IMGP8021.JPG)

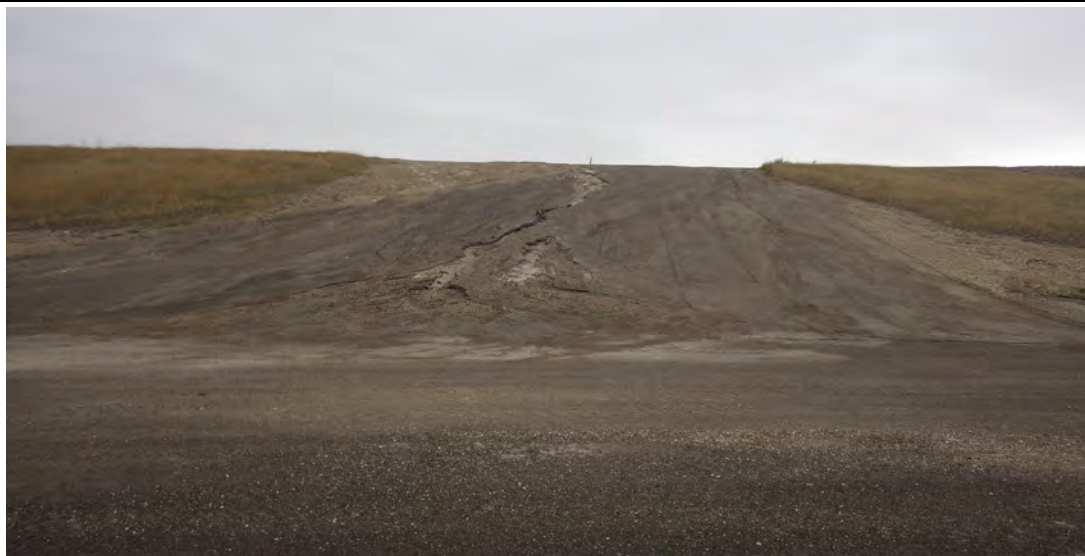
Photograph 13 (North CCR downstream slope)
Minor erosion on slope reinforced with fly ash, fair condition. (IMGP8025.JPG)

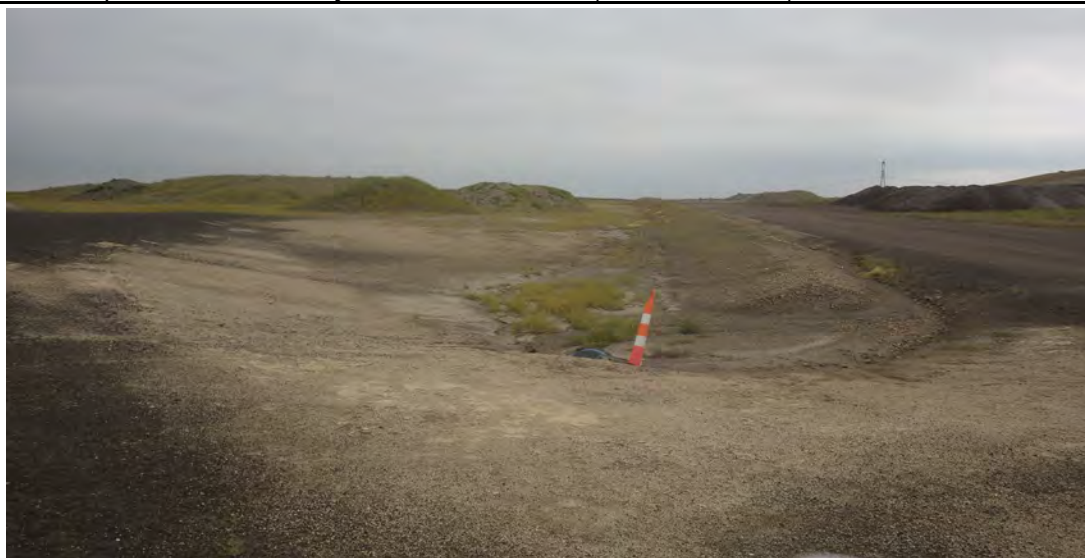
Photograph 14 (Southeast 16 from north)
Active deposition area of Southeast 16 and culvert to north, good condition. (IMGP8027.JPG)

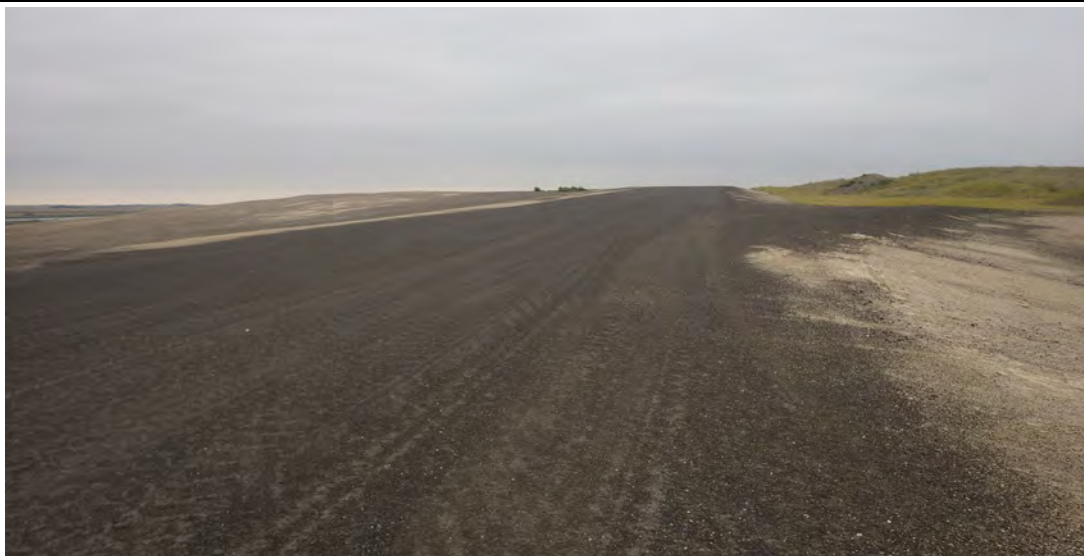
Photograph 15 (Southeast 16 interior haul road)
Haul road to CCR and C&D disposal location in good condition. (IMGP8029.JPG)

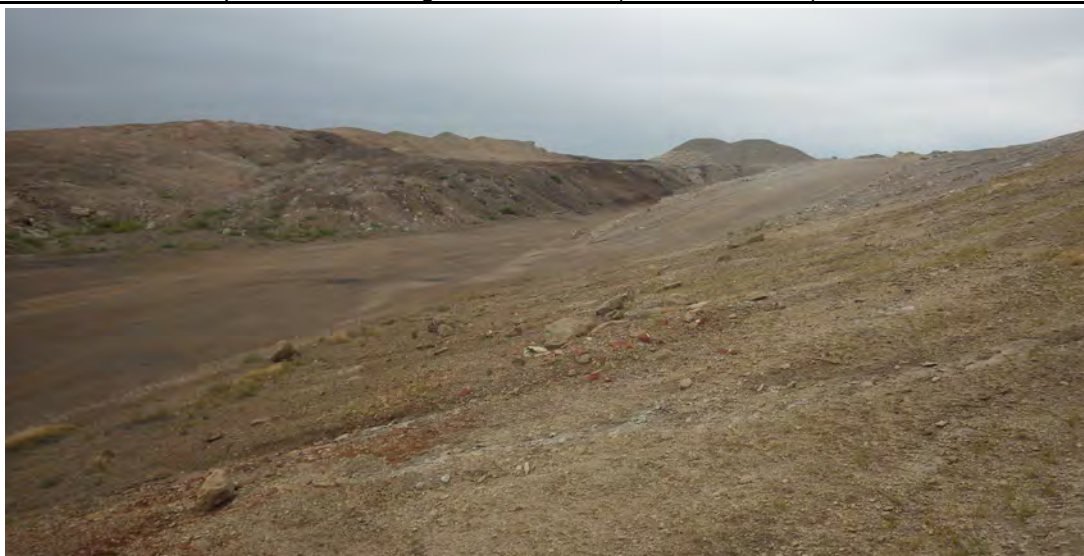
Photograph 16 (Southeast 16 from north)
Minor erosion of fly ash at historic entrance to C&D disposal area. (IMGP8031.JPG)

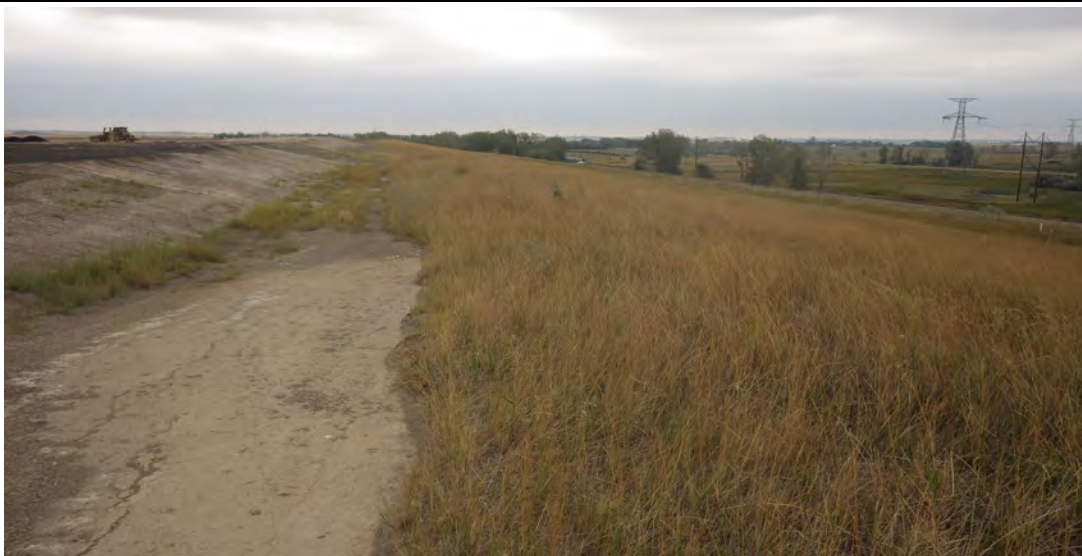
Photograph 17 (South CCR downstream slope and crest)
Contact water separation berm and temporary cover in good condition. (IMGP8036.JPG)

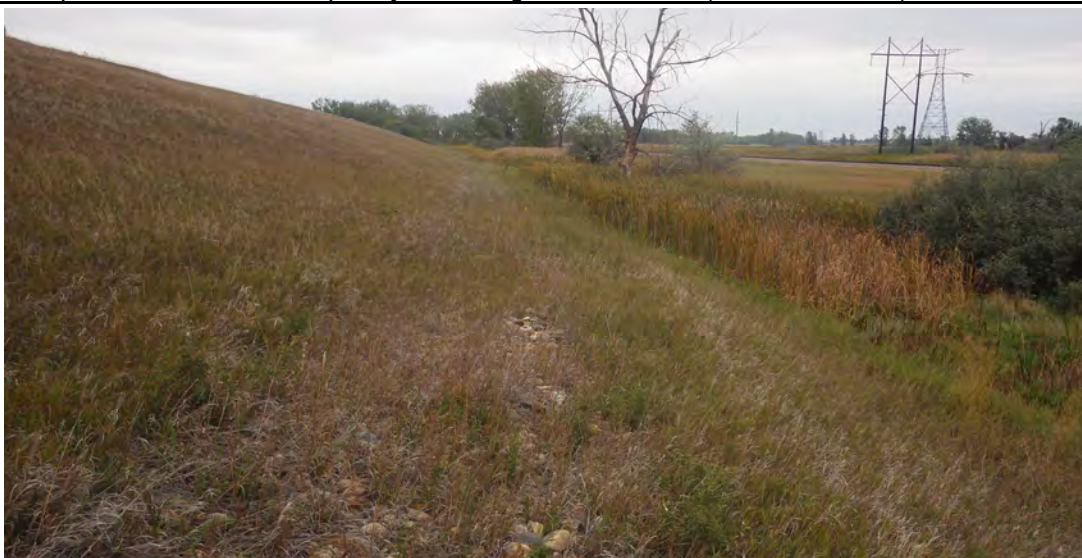
Photograph 18 (South perimeter downstream slope and toe)
Well vegetated original toe drain and drainage channel along toe. (IMGP8040.JPG)
