REPORT**2021 Annual Inspection***Coal Creek Station - Upstream Raise 91 CCR Surface Impoundment*

Great River Energy

21451024-19-R-0

January 2022

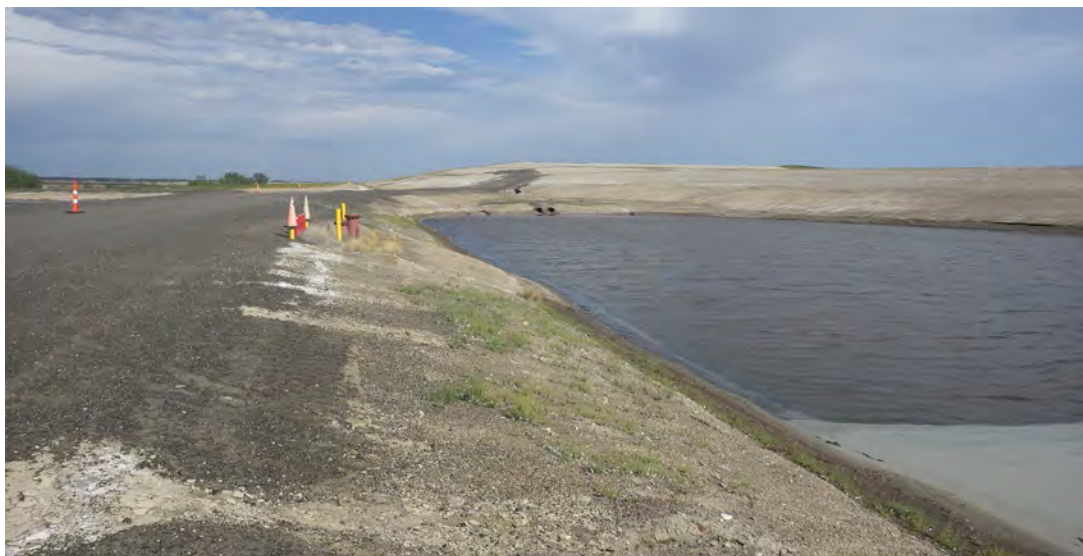
Photograph 1 (North perimeter berm upstream slope and crest)
Haul road and fly ash protective cover on upstream perimeter berm slope in good condition. (IMGP7898.JPG)

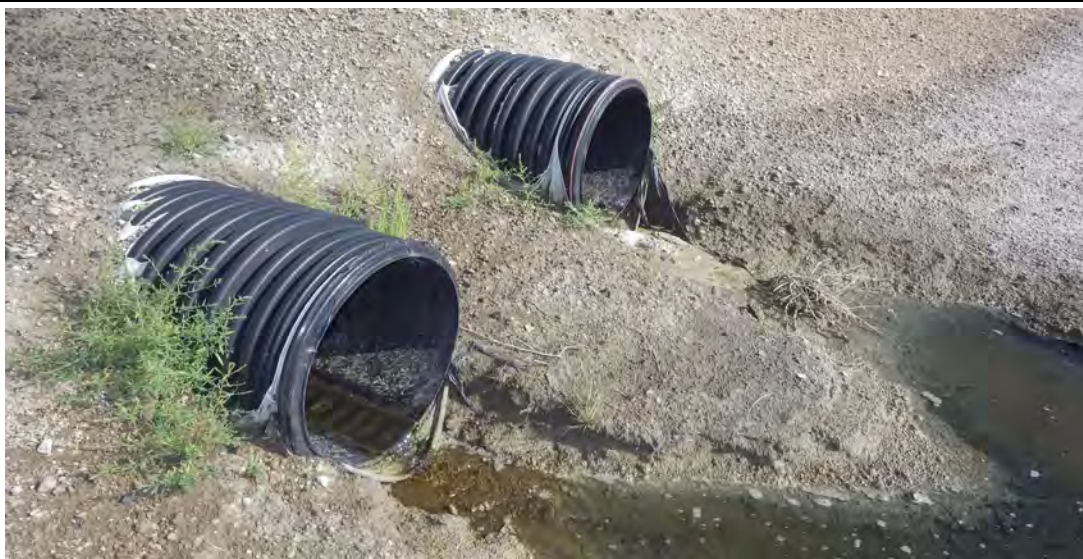
Photograph 2 (North perimeter berm upstream slope)
Culvert outlets from north perimeter ditch. (IMGP7901.JPG)

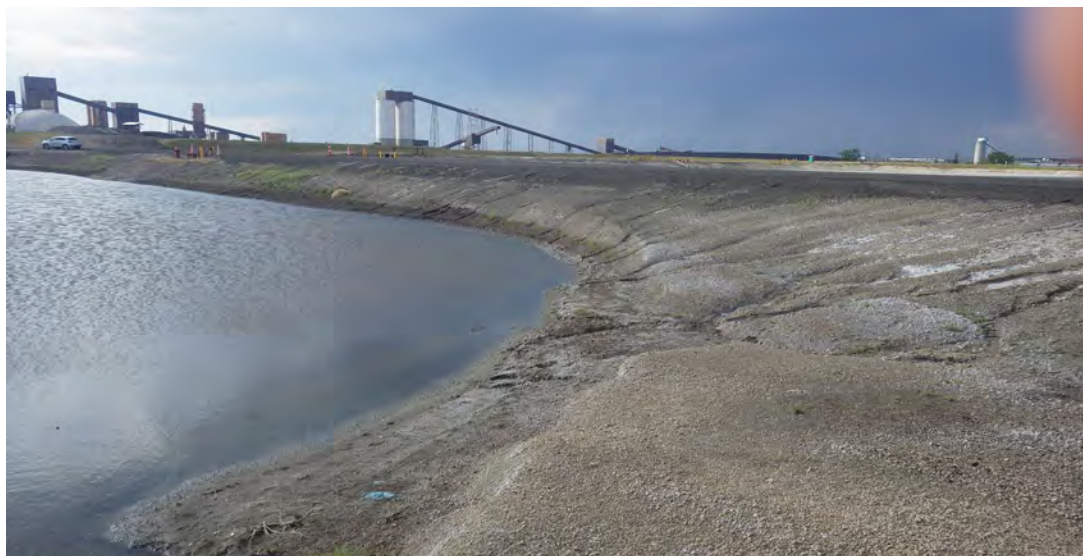
Photograph 3 (North perimeter berm upstream slope)
Minor erosion of fly ash protective cover on upstream slope. (IMGP7902.JPG)

Minor maintenance items that may need to be continually addressed include repairing large animal burrows on perimeter berms as they appear, repairing and re-seeding eroded areas on or adjacent to berm downstream slopes, removal of any woody vegetation growing on the berm downstream slopes, and clean-out of collected material in the contact water perimeter channels and maintaining gravity and culvert piping. In addition, the inflow and outflow piping should be monitored regularly and cleared of debris as required to ensure proper conveyance of water to and from the facility.

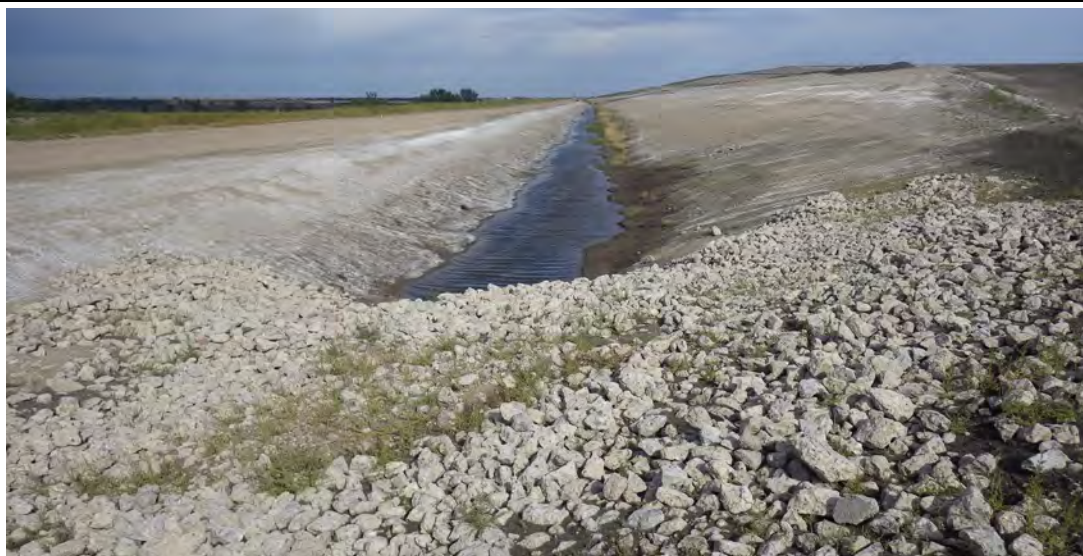
Additional pipelines and contact water control features (contact water perimeter channels and culverts) inside Upstream Raise 91 convey water to downstream facilities. These include a series of gravity drainage pipes, seepage pipes, and perimeter channels and culverts that transfer CCR conveyance water from the facility to the adjacent Drains Pond System. The gravity drains are moved as operations progress and appeared to be free from obstructions and in good working order. Seepage piping was below the elevation of the water and could not be observed. The culverts connecting the contact water perimeter channels were in fair condition at the time of the inspection, with some sediment accumulated at the culvert inlets.

Photograph 4 (North perimeter berm crest, upstream slope, and CCR downstream slope)
North perimeter ditch with approximately 6 to 12 inches of standing water and concrete rubble erosion protection near culvert inlets. (IMGP7903.JPG)

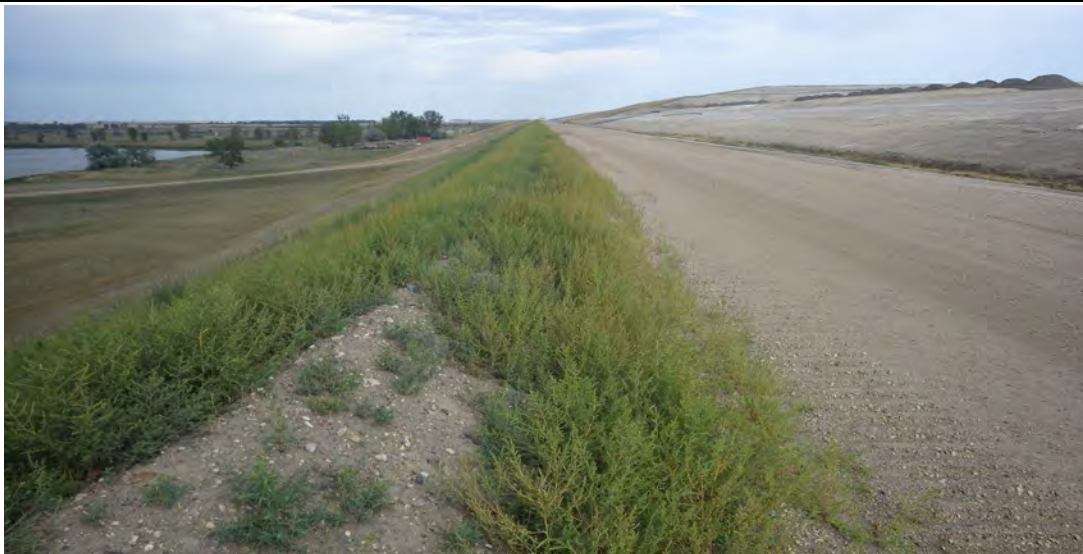
Photograph 5 (North perimeter berm downstream slope and crest)
North safety berm. (IMGP7904.JPG)

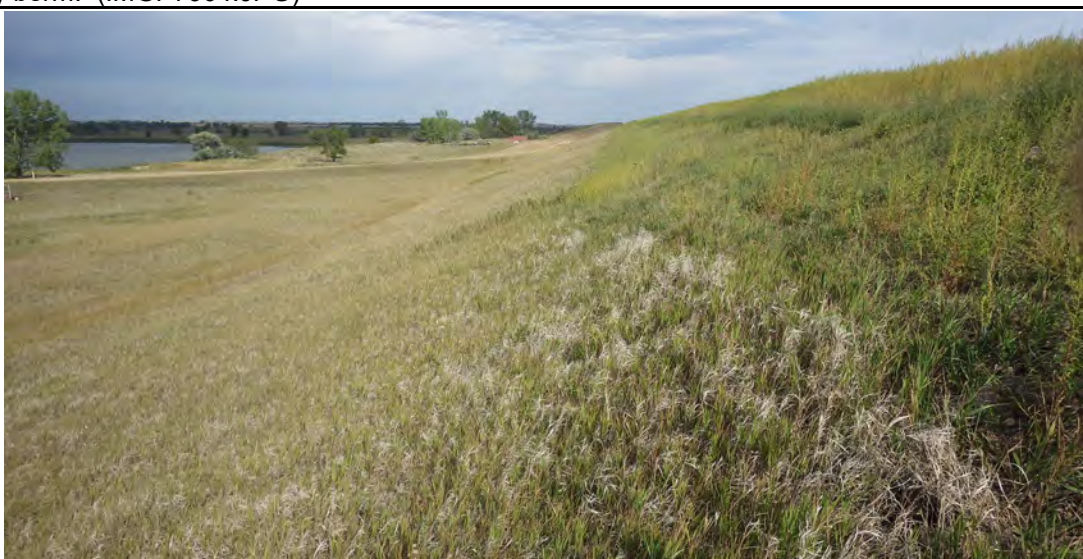
Photograph 6 (North perimeter berm downstream slope)
Downstream slope well vegetated with grass, safety berm near crest has mostly weedy vegetation, overall good condition. (IMGP7905.JPG)

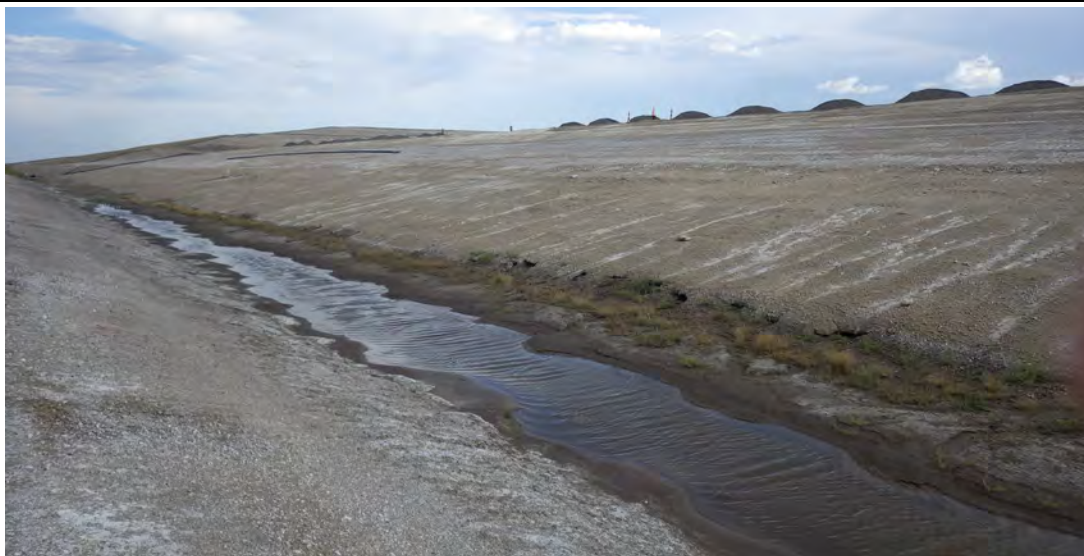
Photograph 7 (North CCR downstream slope)
Minor erosion of fly ash CCR downstream slope and 6 to 12 inches of water present in perimeter ditch.
(IMGP7910.JPG)

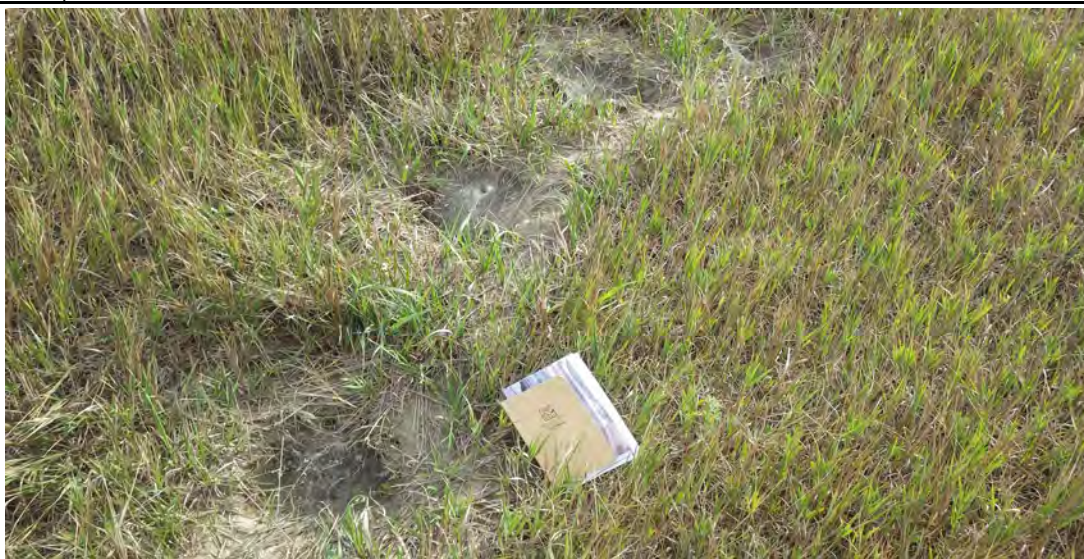
Animal burrows, including a few burrows up to 6 inches in diameter, were observed on the north berm downstream slopes. Golder did not observe indications of seepage, sloughing, significant erosion, excessive settlement, or vegetation that seemed to be thriving abnormally. The berm downstream slopes appeared to be in good condition.

| k. Downstream slope rodent burrows | X | | | Many animal burrows, especially noted on north slope. |

Photograph 8 (North perimeter berm downstream slope)
Animal burrows (approximately 6 inches diameter) (IMGP7911.JPG)

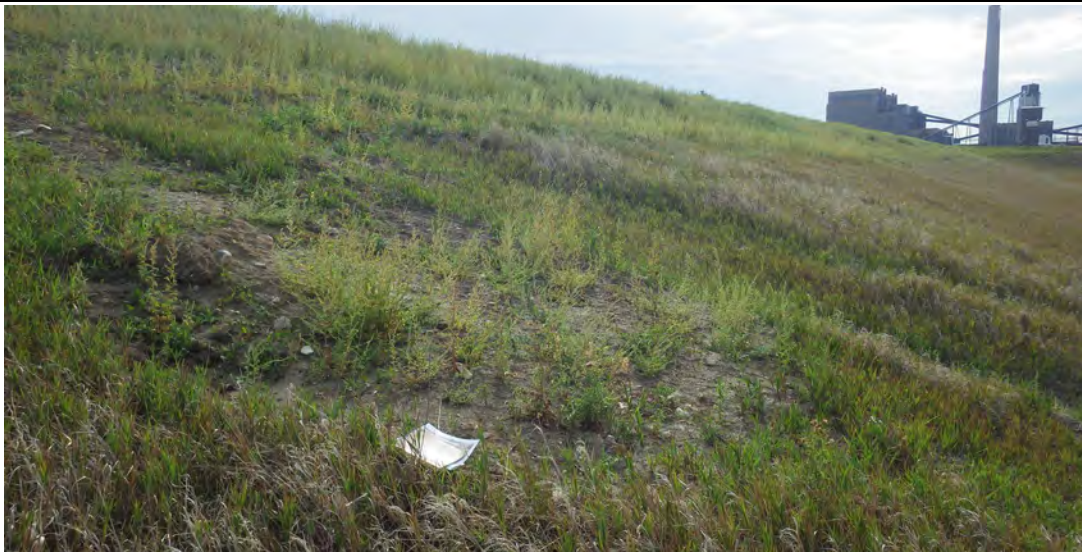
Photograph 9 (North perimeter berm downstream slope)
Irregular grades from safety berm construction and weedy vegetation. (IMGP7912.JPG)

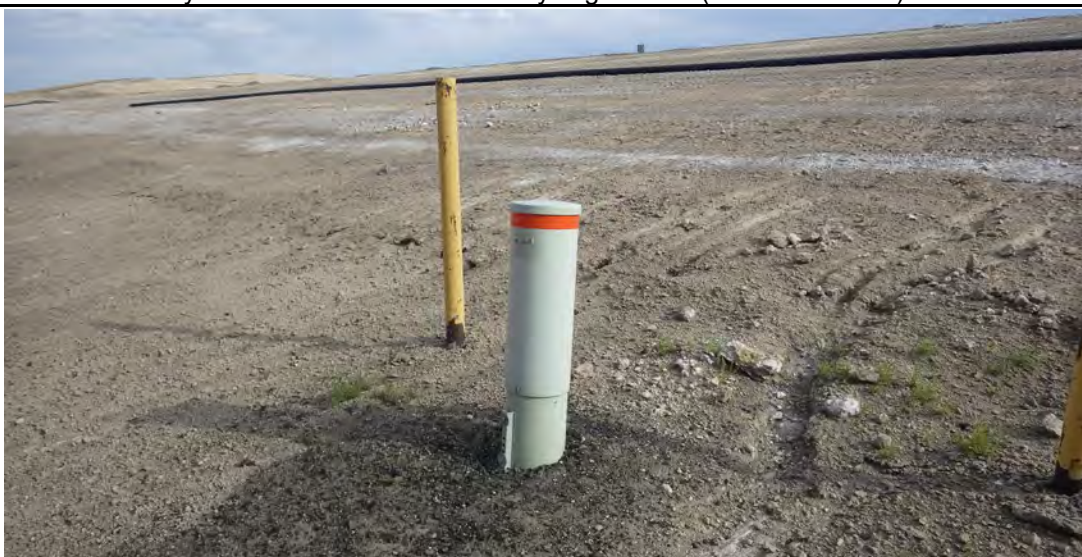
Photograph 10 (North CCR downstream slope)
Vibrating wire piezometer datalogger box. (IMGP7913.JPG)

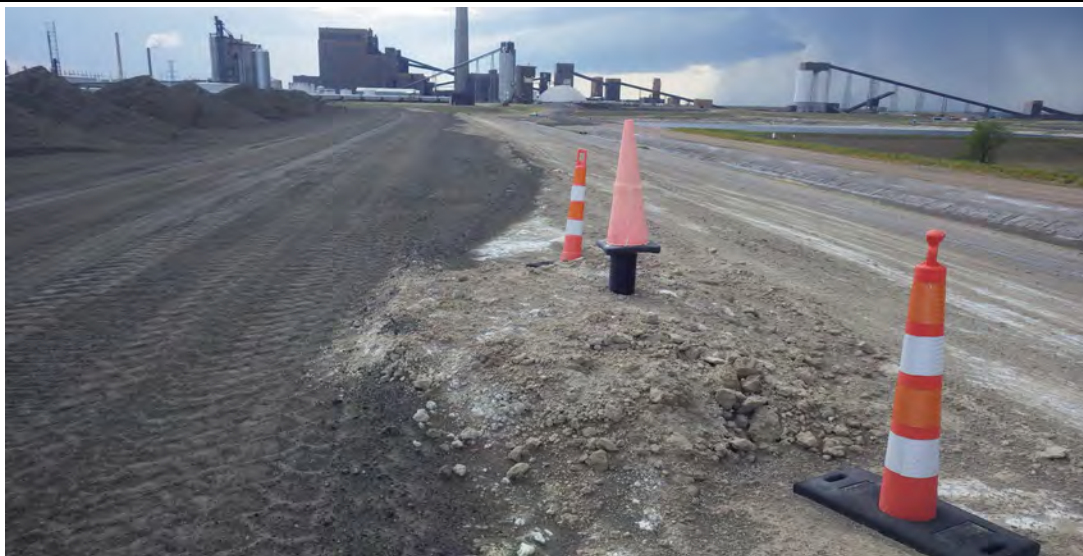
Photograph 11 (North CCR crest)
Standpipe piezometer PZ-15, north side. (IMGP7914.JPG)

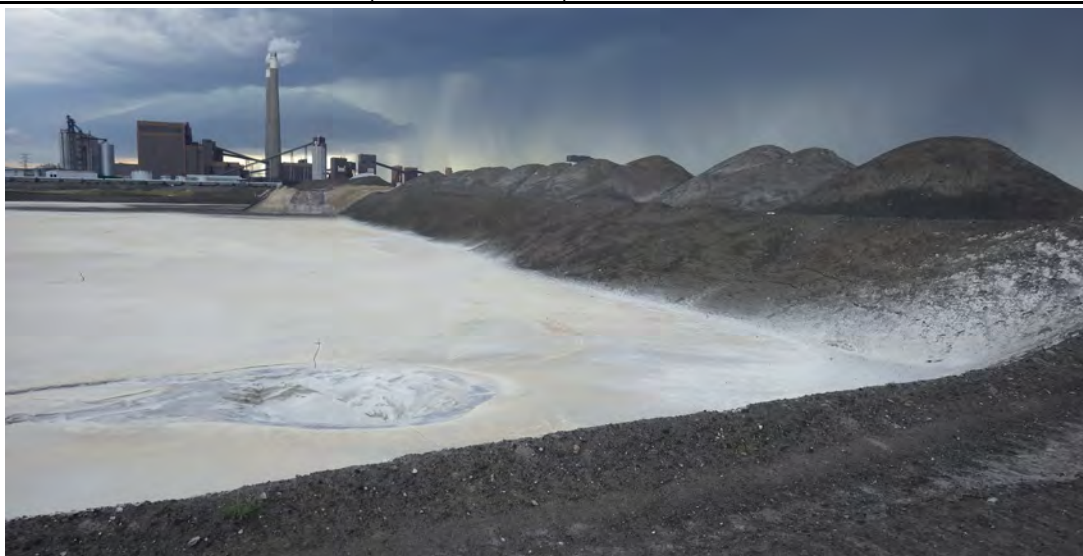
Photograph 12 (North CCR upstream slope)
CCR upstream slope and FGD deposition area, good condition. (IMGP7923.JPG)

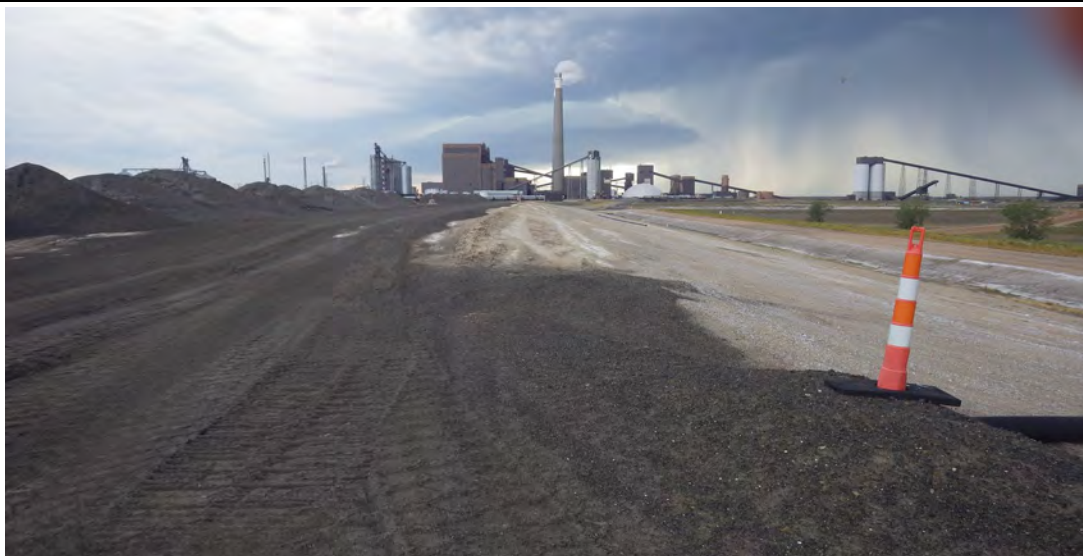
Photograph 13 (North CCR crest)
Bottom ash and fly ash haul road, good condition. (IMGP7925.JPG)

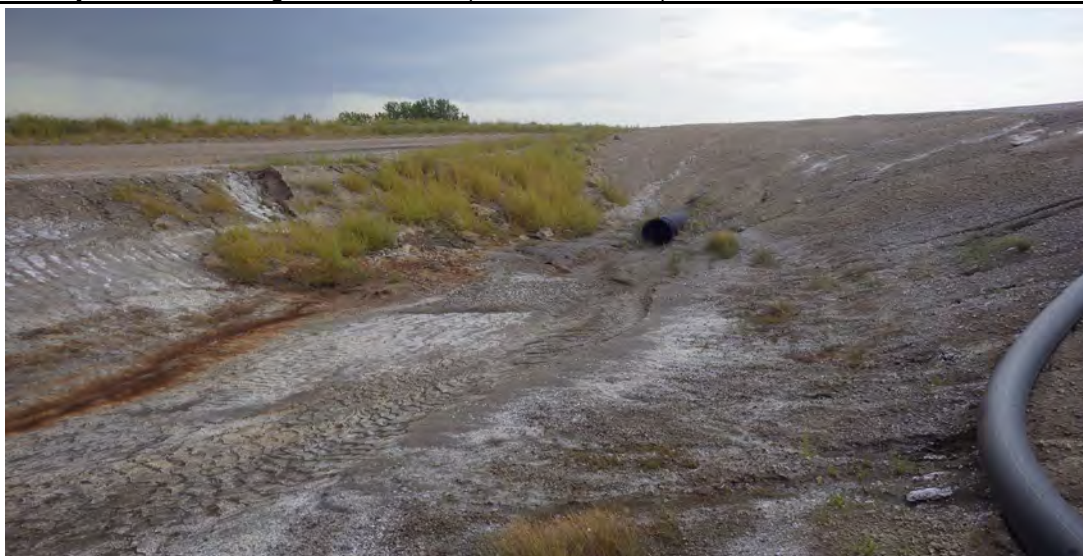
Photograph 14 (North CCR downstream slope)
Culvert inlet from Upstream Raise 92 north perimeter ditch, free from obstructions. (IMGP7926.JPG)

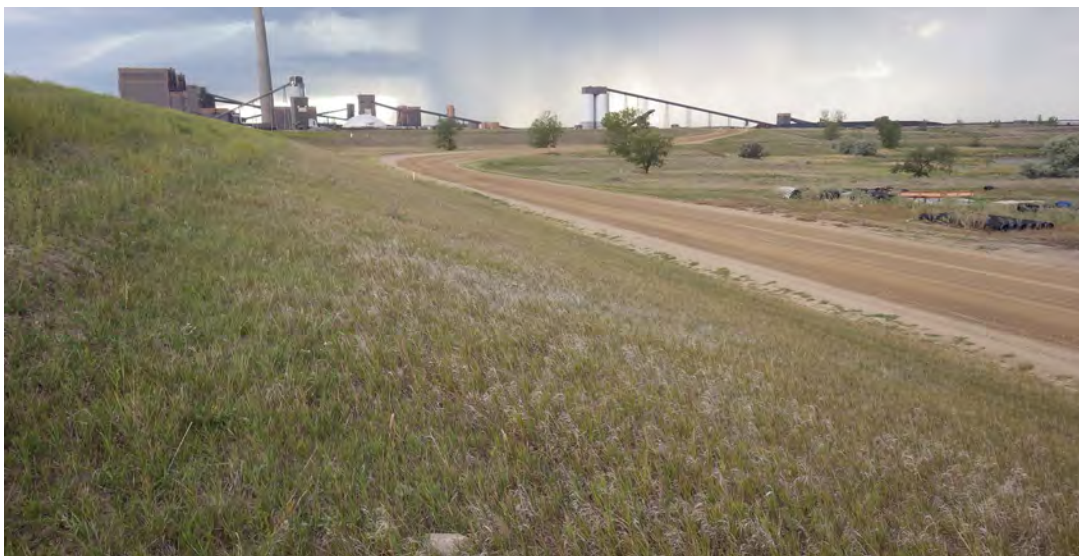
Photograph 15 (North perimeter berm downstream slope)
Good vegetation on downstream slope. (IMGP7930.JPG)

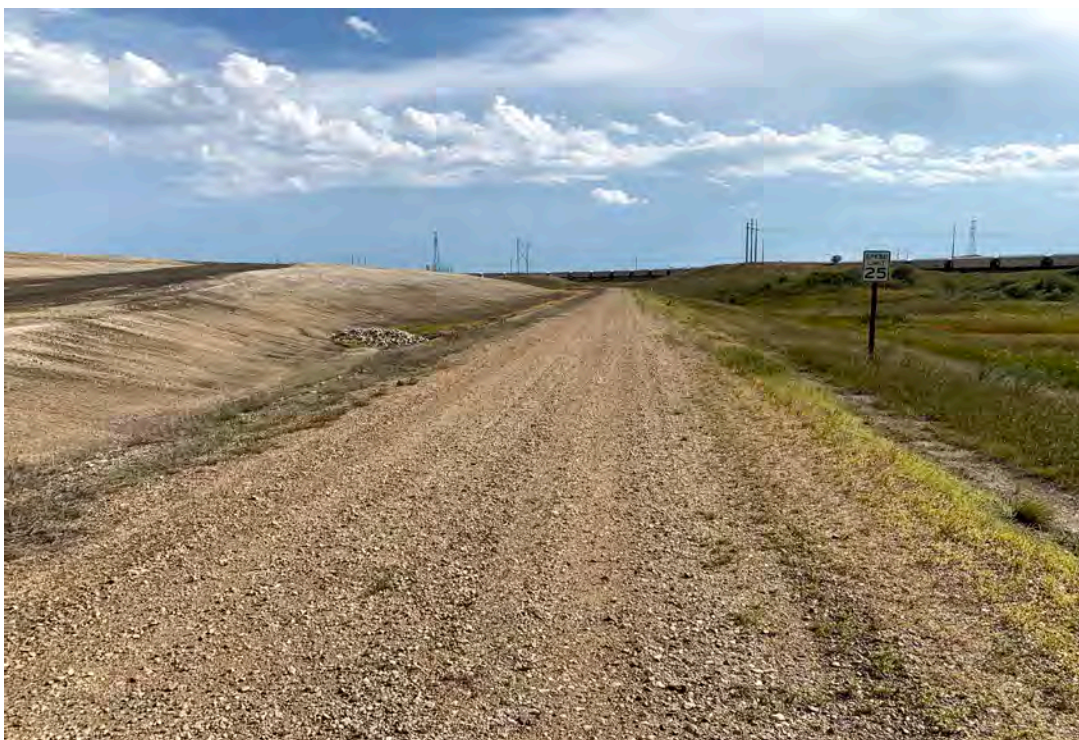
Photograph 16 (West perimeter berm crest)
Perimeter berm crest, gravel in good condition. (IMGP2787.JPG)

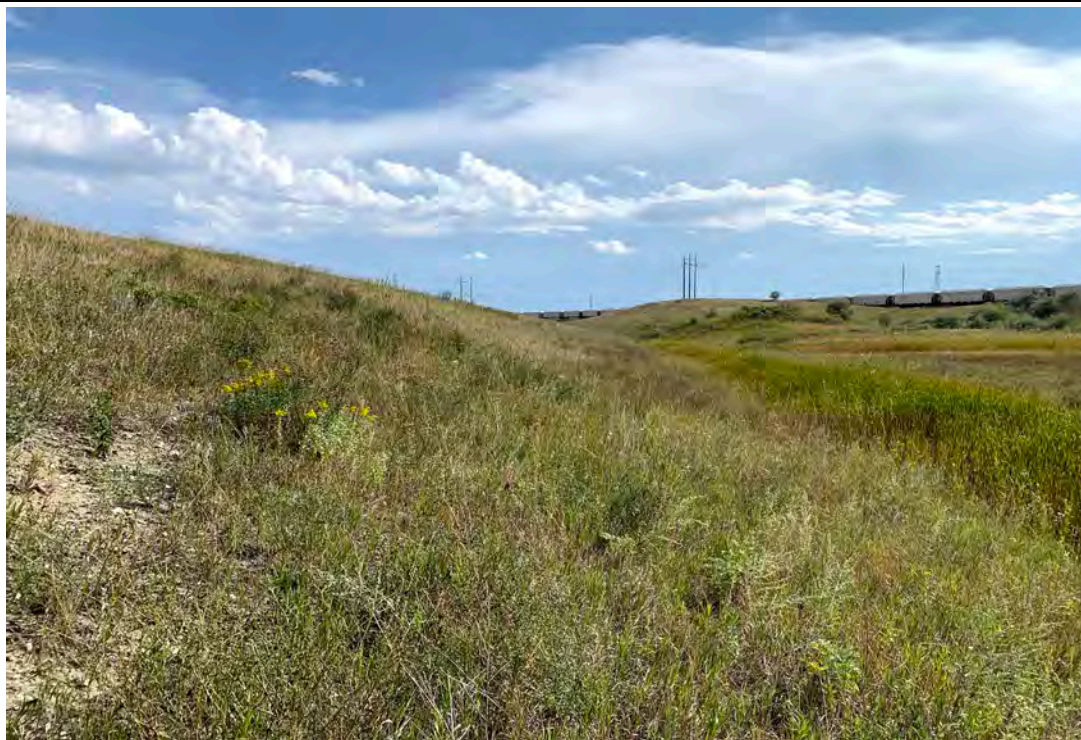
Photograph 17 (West perimeter berm downstream slope)
Well-vegetated downstream slope, good condition. (IMGP2788.JPG)

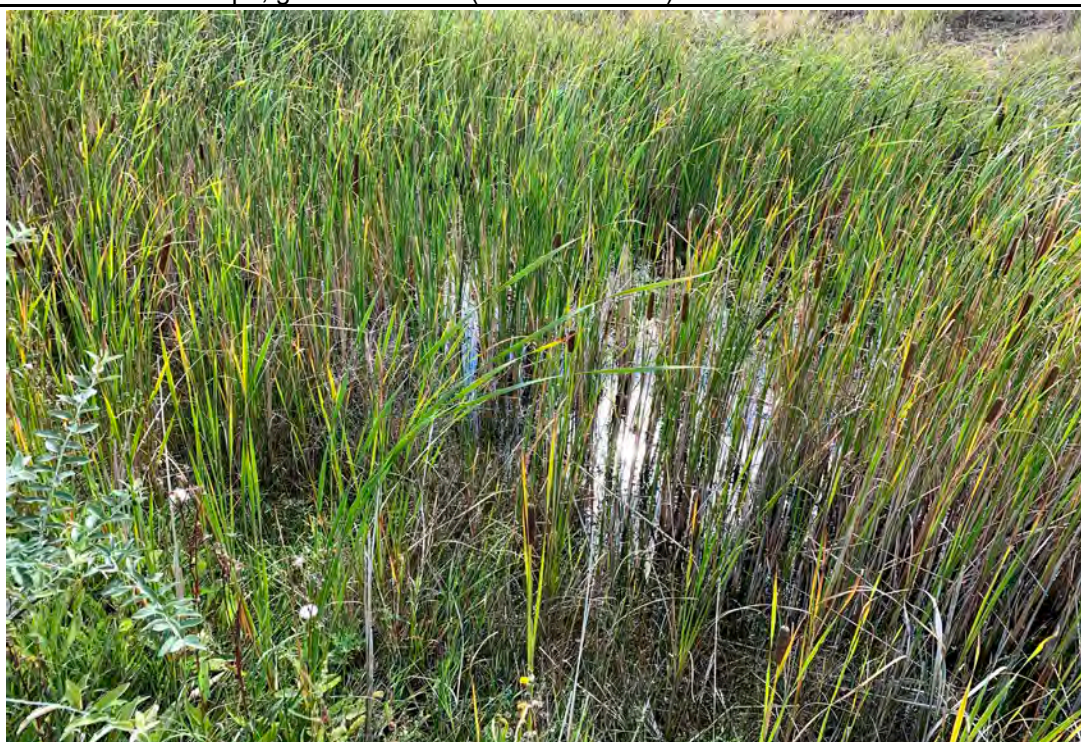
Photograph 18 (West perimeter berm downstream slope and toe)
Standing water and cattails at the toe. (IMGP2789.JPG)

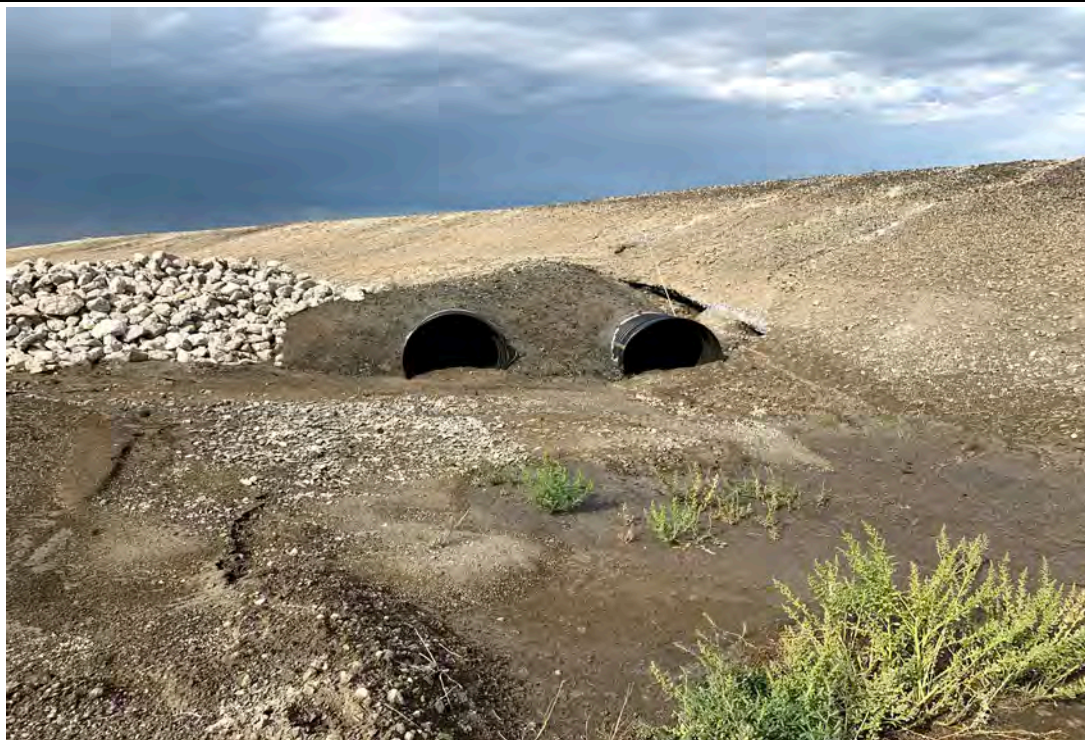
Photograph 19 (West CCR downstream slope)
Perimeter channel culverts partially obstructed by erosion of fly ash and bottom ash. (IMGP2790.JPG)

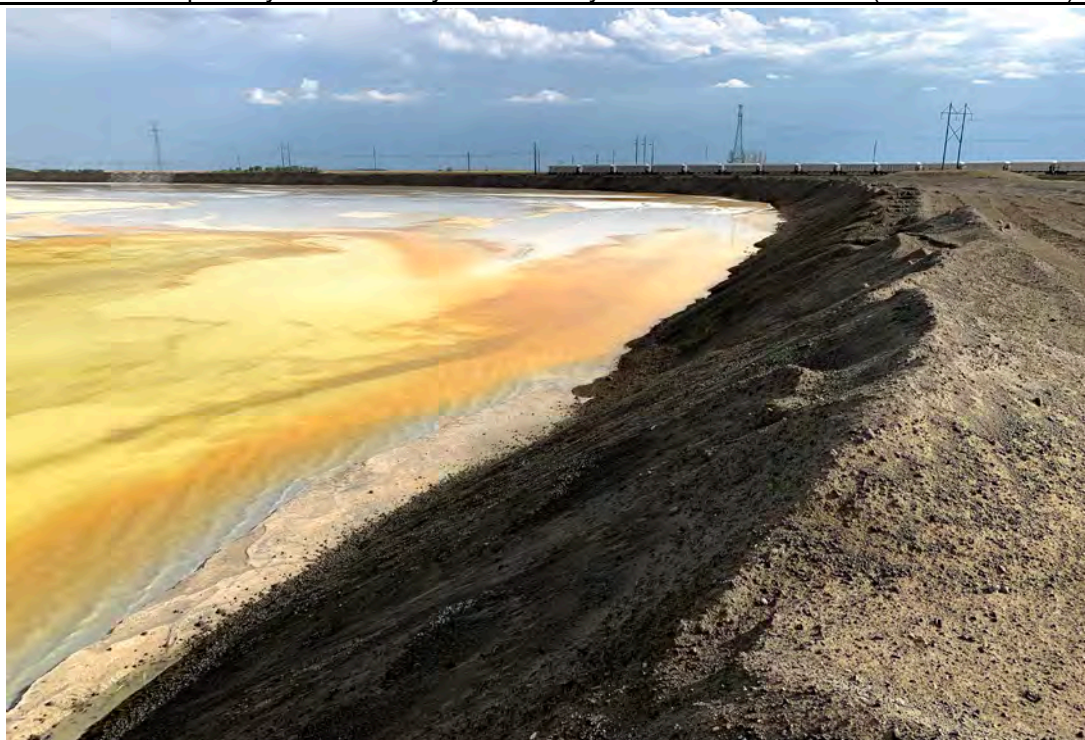
Photograph 20 (West CCR upstream slope)
Upstream bottom ash slope and FGD material pool. (IMGP2793.JPG)

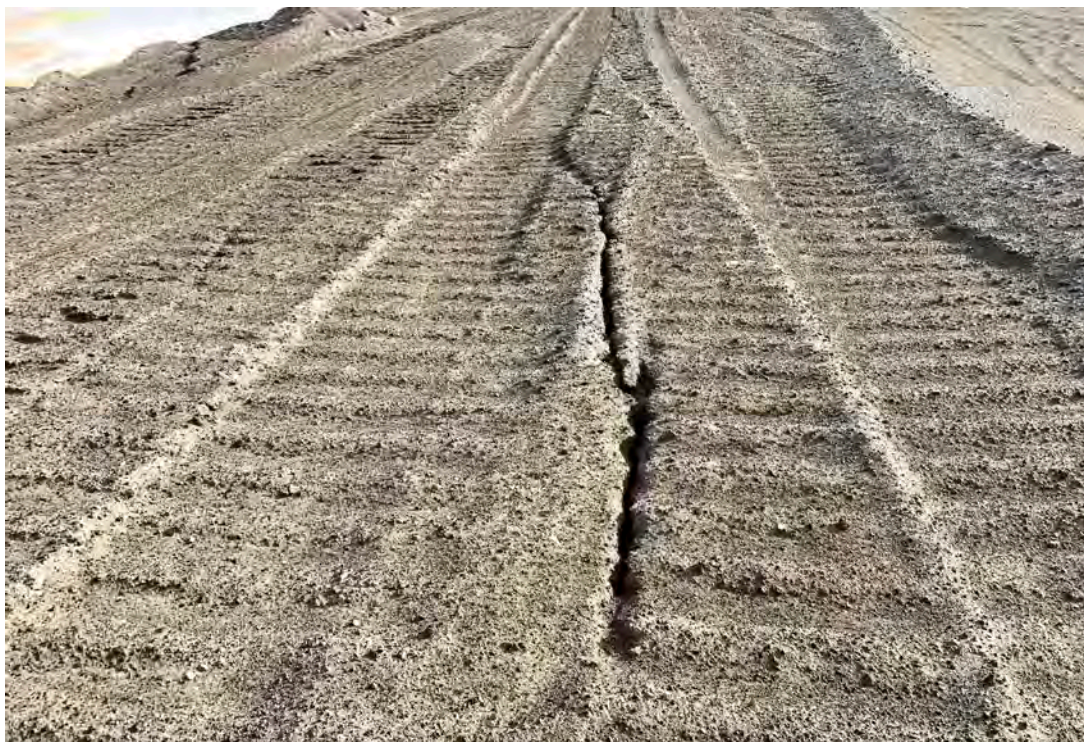
| e. CCR crest cracks/settlement | X | | | Crack in bottom ash noted along west side. |

Photograph 21 (West CCR crest)
Cracks in bottom ash on crest. (IMGP2795.JPG)

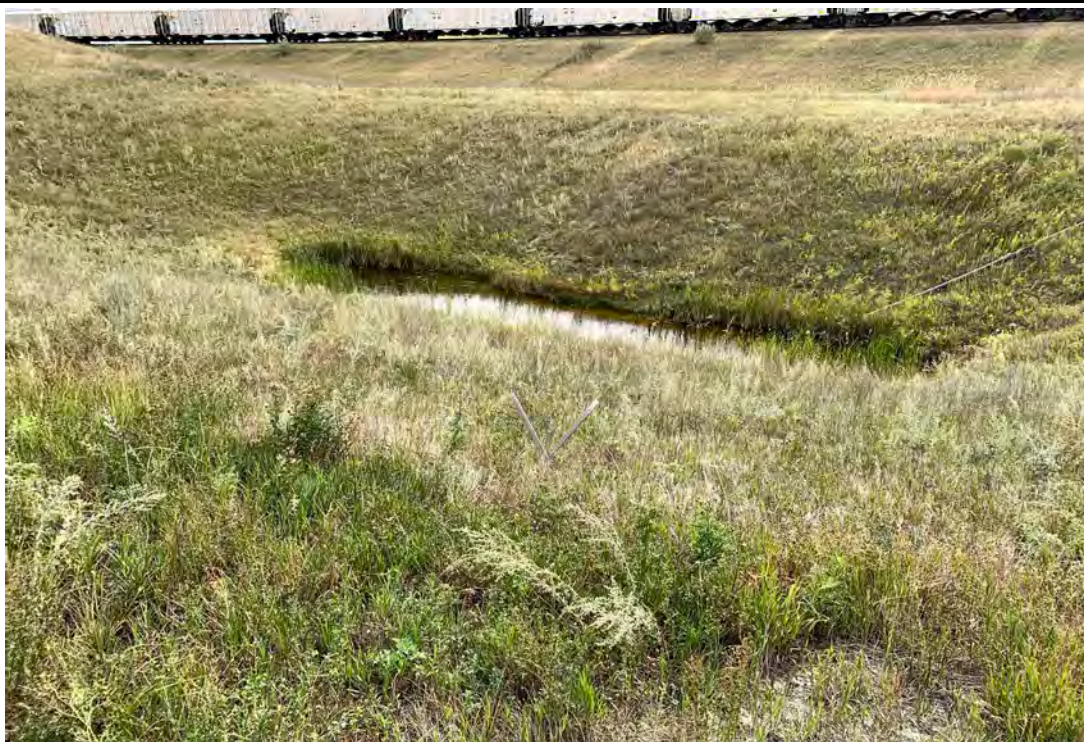
Photograph 22 (Southwest perimeter berm downstream slope)
Standing water in perimeter ditch at toe of slope. (IMGP2798.JPG)

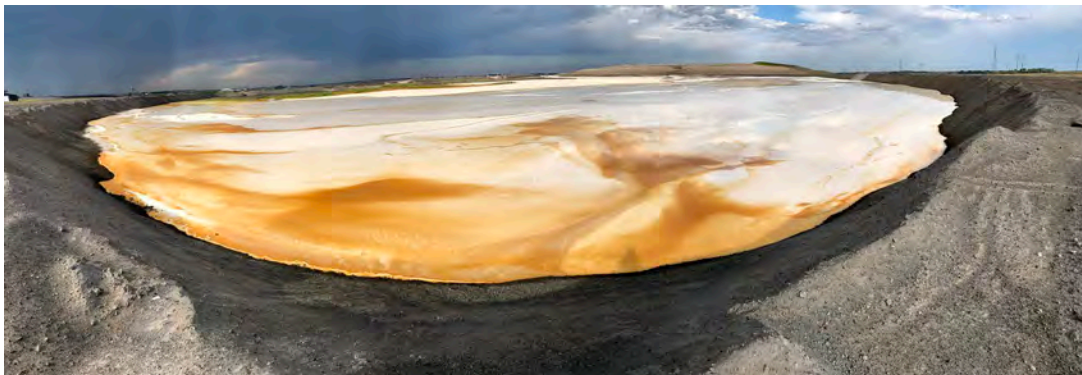
Photograph 23 (Southwest CCR upstream slope)
Panoramic view of Upstream Raise 91 from the southwest corner. (IMGP2801.JPG)

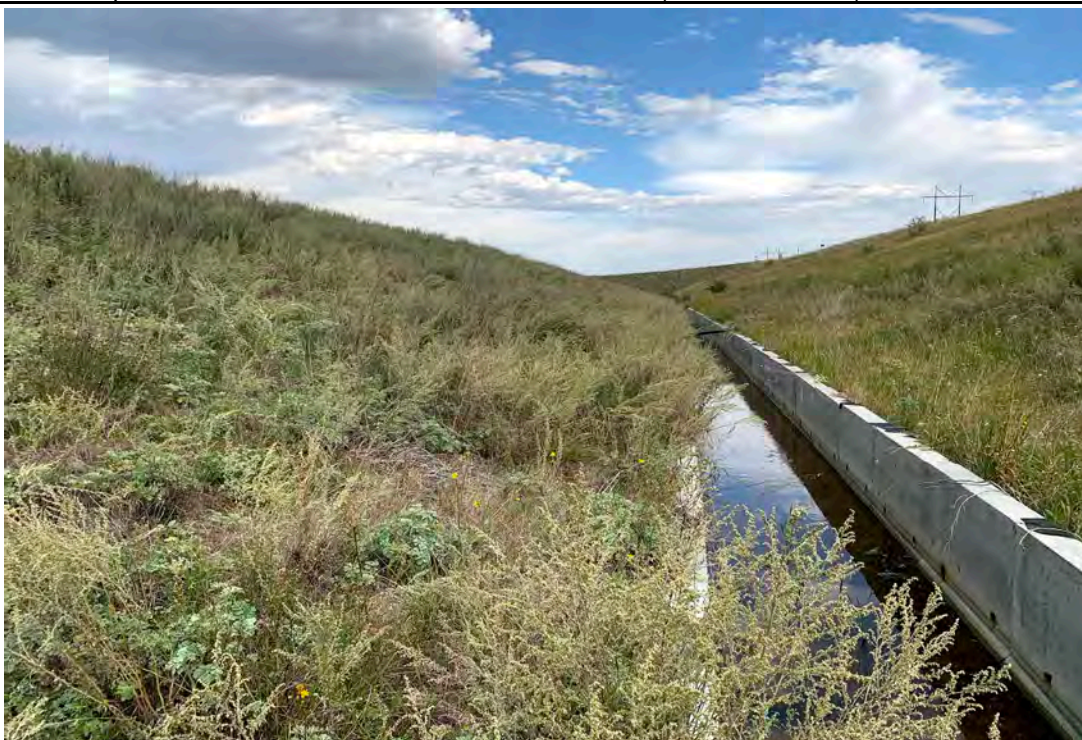
Photograph 24 (Southwest perimeter berm downstream slope and toe)
Well-vegetated downstream slope and perimeter ditch concrete channel. (IMGP2802.JPG)

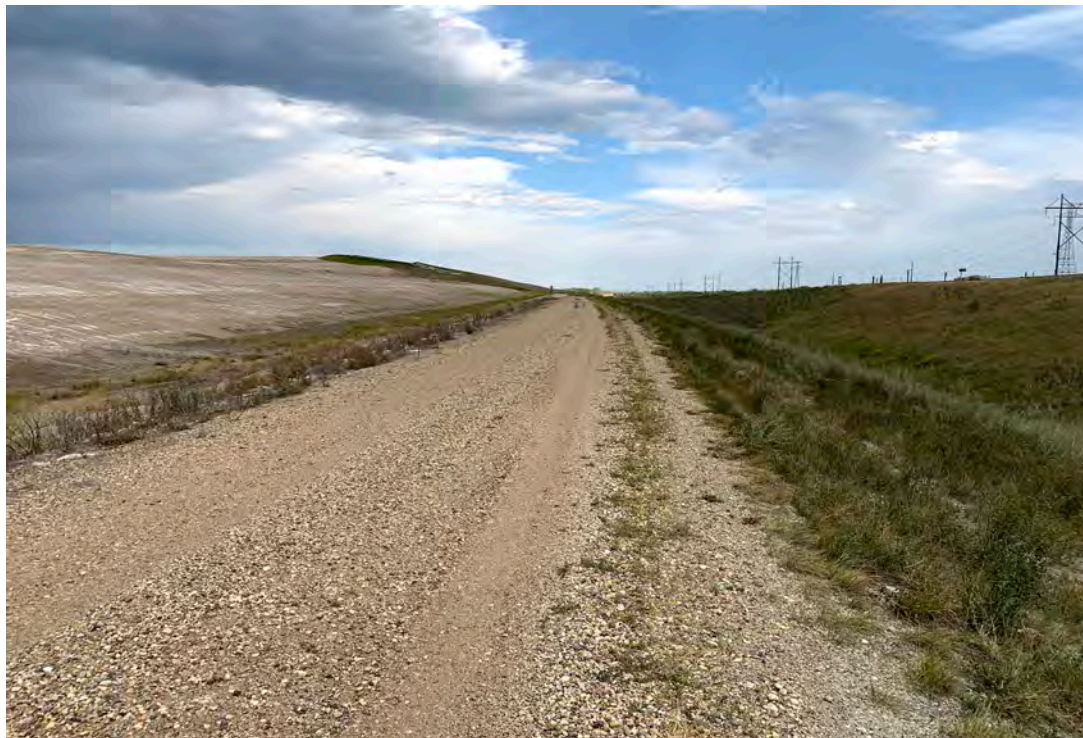
Photograph 25 (South perimeter berm crest)
Perimeter berm crest, gravel road, good condition. (IMGP2803.JPG)

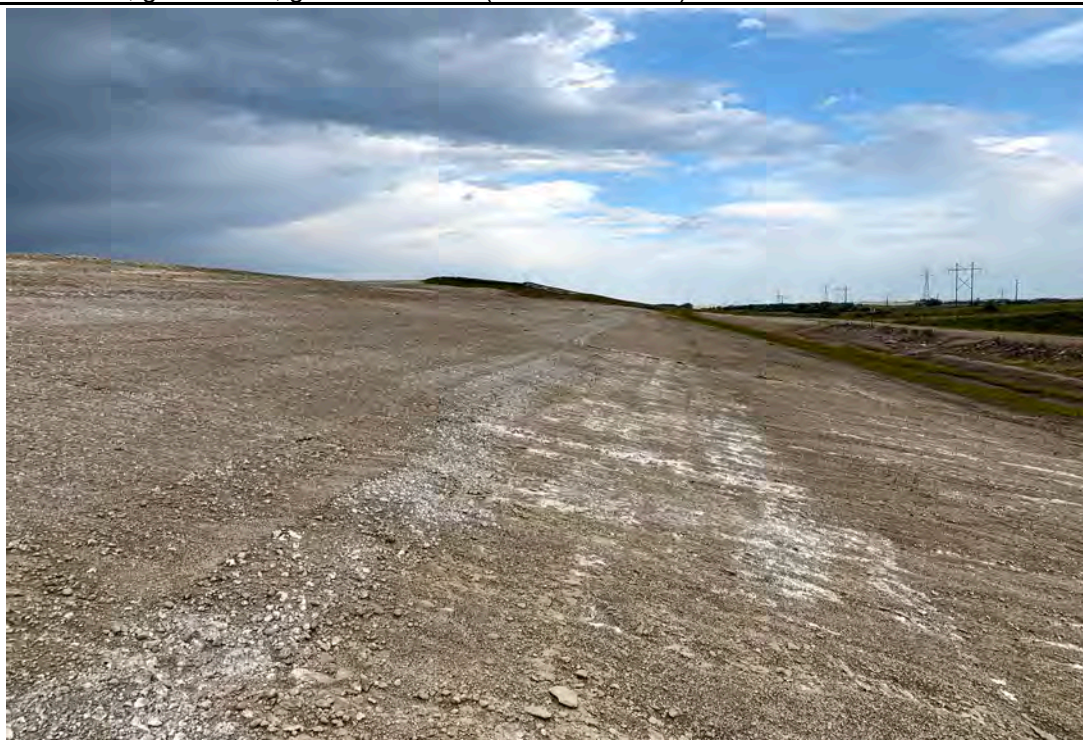
Photograph 26 (South CCR downstream slope)
Fly ash slope, good condition. (IMGP2804.JPG)

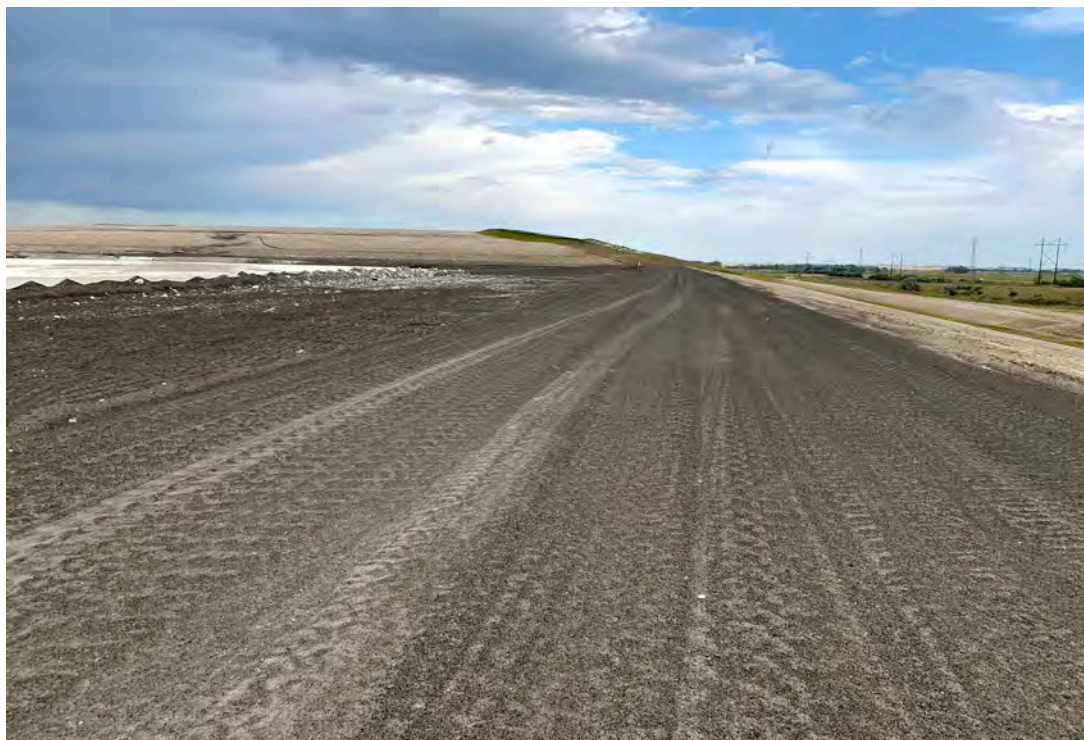
Photograph 27 (South CCR crest)
Bottom ash crest, good condition. (IMG2805.JPG)

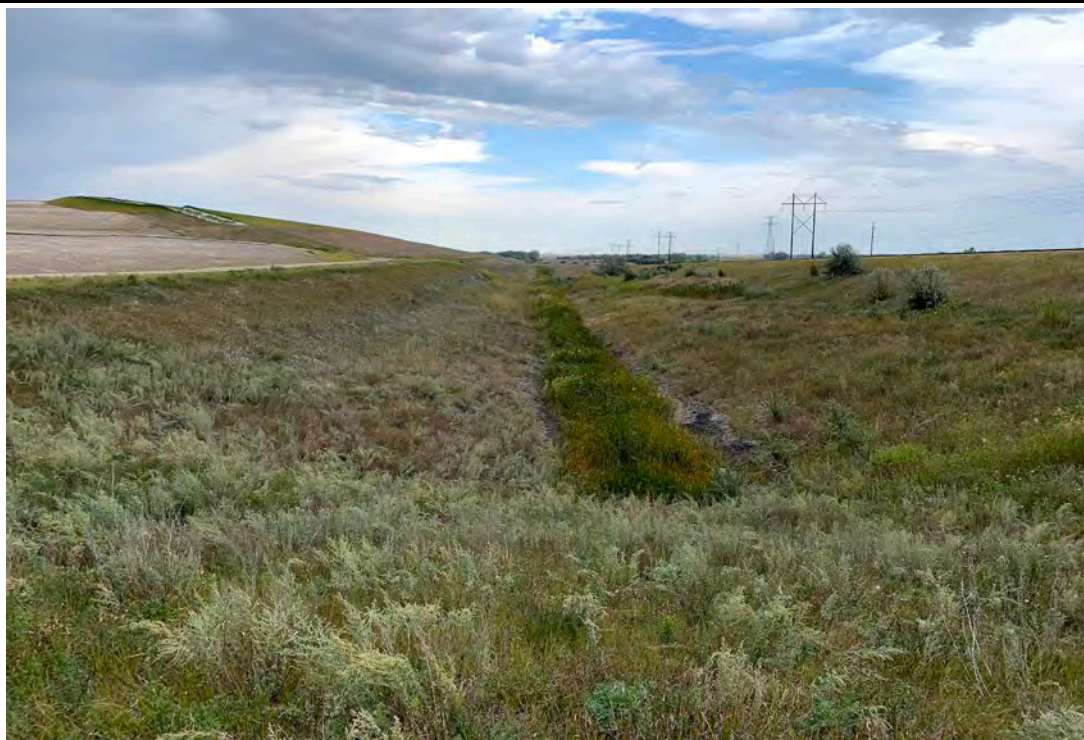
Photograph 28 (Southeast perimeter berm downstream slope and toe)
Well-vegetated downstream slope and toe, good condition. (IMG2807.JPG)

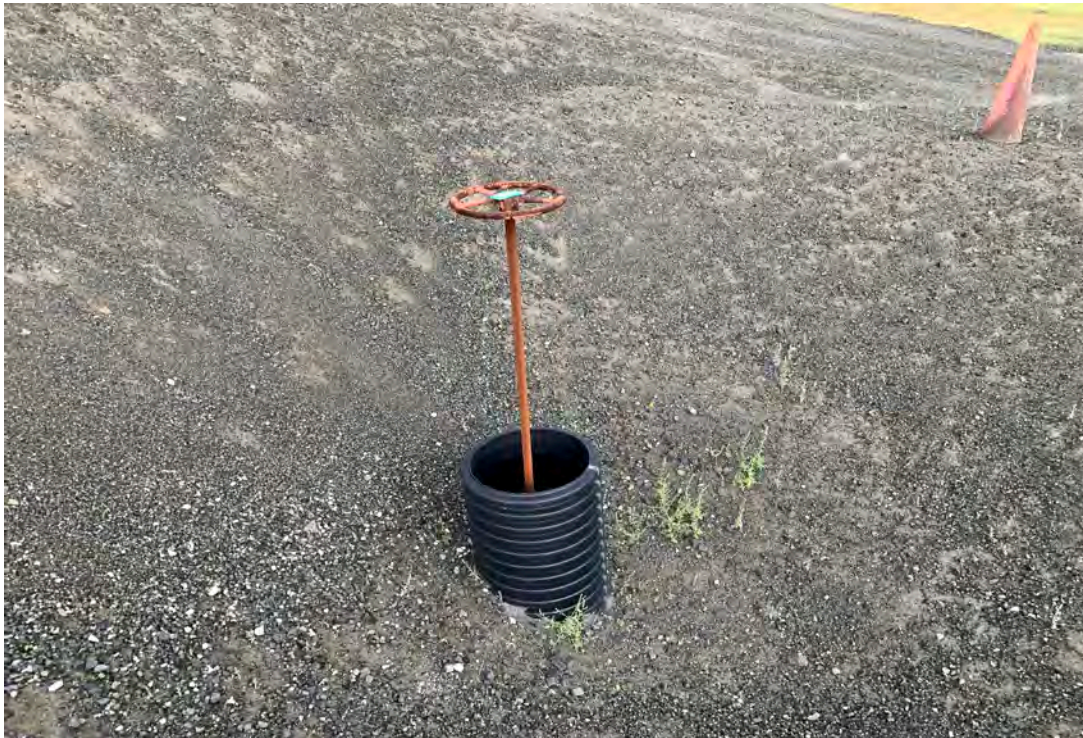
Photograph 29 (East CCR crest)
Seepage piping isolation valve connection to Upstream Raise 92, good access via bottom ash placement.
(IMGP2811.JPG)
