REPORT**2021 Annual Inspection***Coal Creek Station – Upstream Raise 92 CCR Surface Impoundment*

Great River Energy

21451024-20-R-0

January 2022

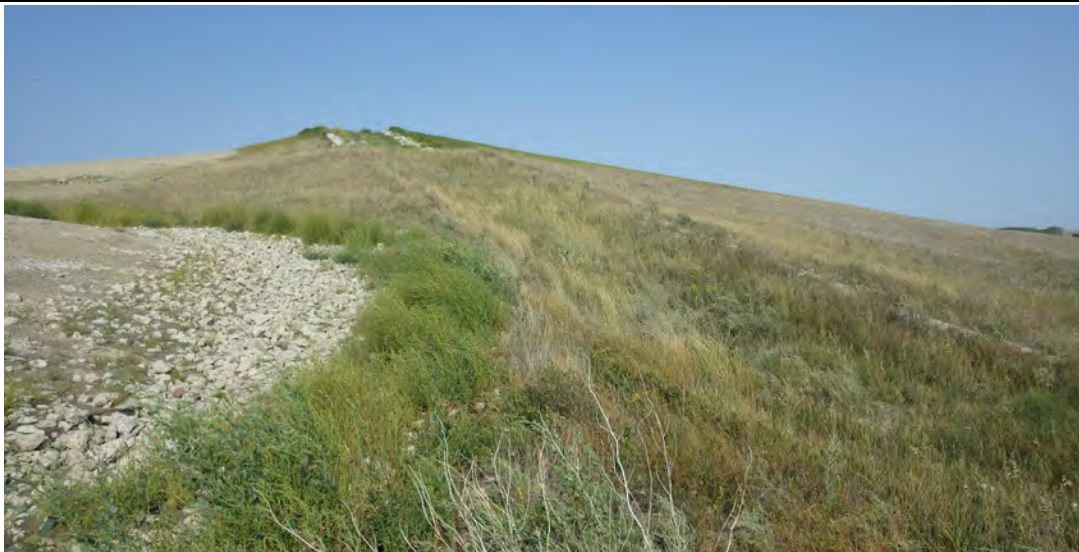
Photograph 1 (Southwest perimeter downchute)
Downchute in good condition and well vegetated. (IMGP7939.JPG)

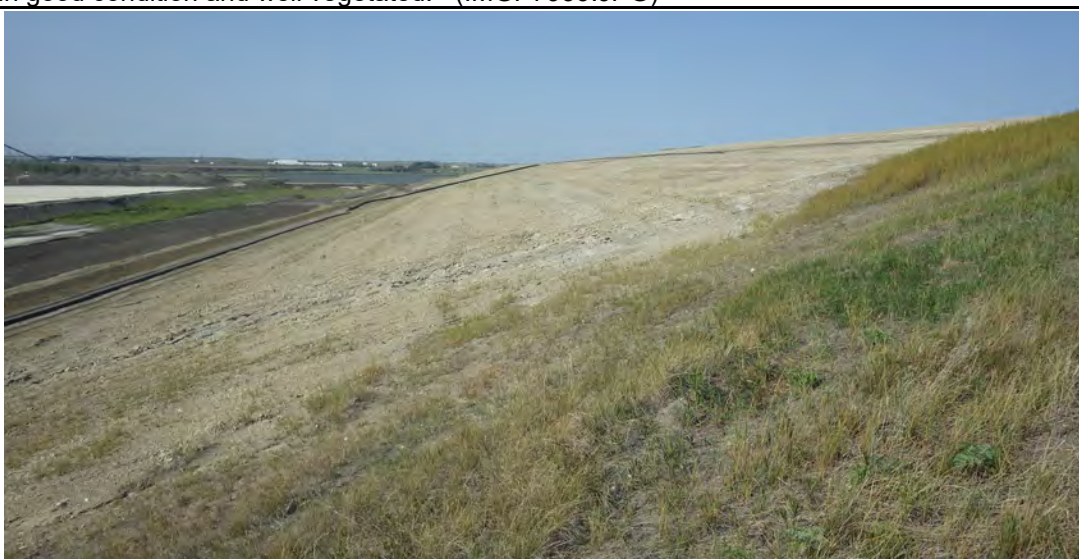
Photograph 2 (West CCR downstream slope)
Minor fly ash erosion. (IMGP7940.JPG)

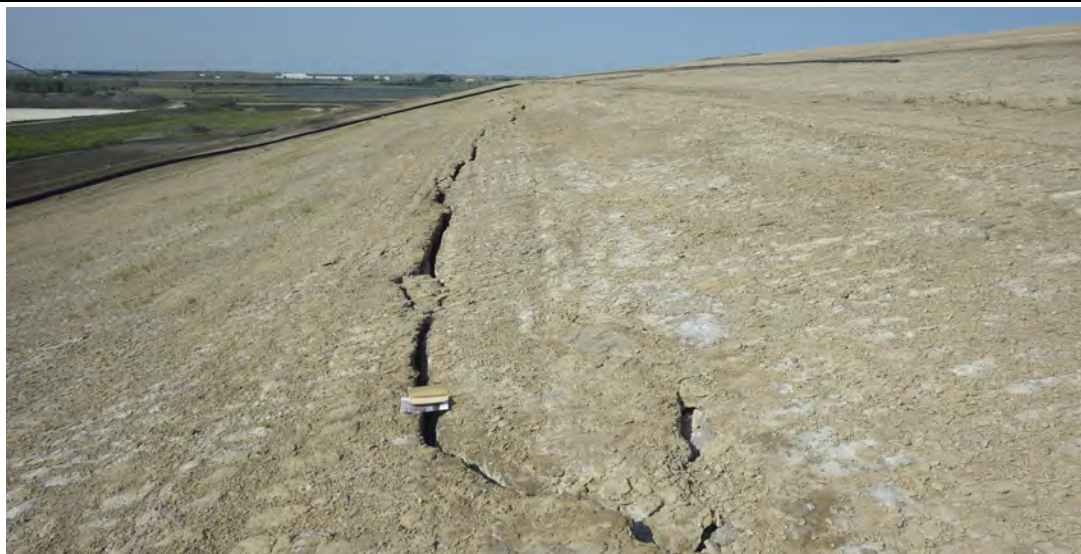
Cracks noted on the surface of the CCR downstream slopes (most prevalent between El. 1,974 ft and 1,998 ft) were between approximately 1 and 12 inches wide, up to 2 feet deep, and up to several hundred feet long. The cracks are expected and can be attributed to consolidation of FGD material on the interior of the facility and the relatively rigid bottom ash and fly ash exterior of the facility. These cracks are continually observed and evaluated by on-site operations personnel for changes to the shape, offset, or length of the features, and the installed instrumentation (inclinometers and piezometers) provides additional information regarding the performance of the facility with respect to the design.

Photograph 3 (West CCR downstream slope)
Crack in fly ash CCR downstream slope below El. 1,974 ft bench (4-6 inches wide inside offset a little lower than outside). (IMGP7941.JPG)

Minor maintenance items that may need to be continually addressed include monitoring the size and shape of cracks in CCR downstream slopes and the CCR crest of the facility, repairing large animal burrows as they appear, monitoring erosion and vegetative success of areas near recently placed articulated concrete block mats and the surface water channel along the south toe of the facility, clean-out of collected material in the perimeter channels and maintaining gravity and culvert piping between Upstream Raise 91 and Upstream Raise 92, reseeded of CCR downstream slopes with final cover, and removal of any woody vegetation growing on the berm downstream slopes. In addition, the outflow piping should be monitored regularly to ensure proper conveyance of water from the facility.

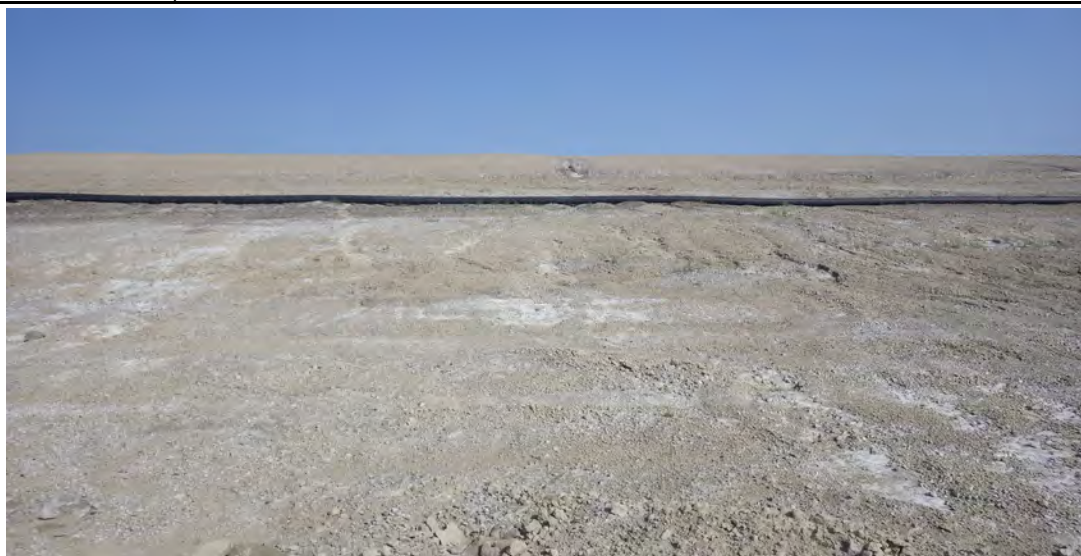
Photograph 4 (West CCR downstream slope)
Minor erosion of fly ash slope above El. 1,974 ft bench. (IMGP7945.JPG)

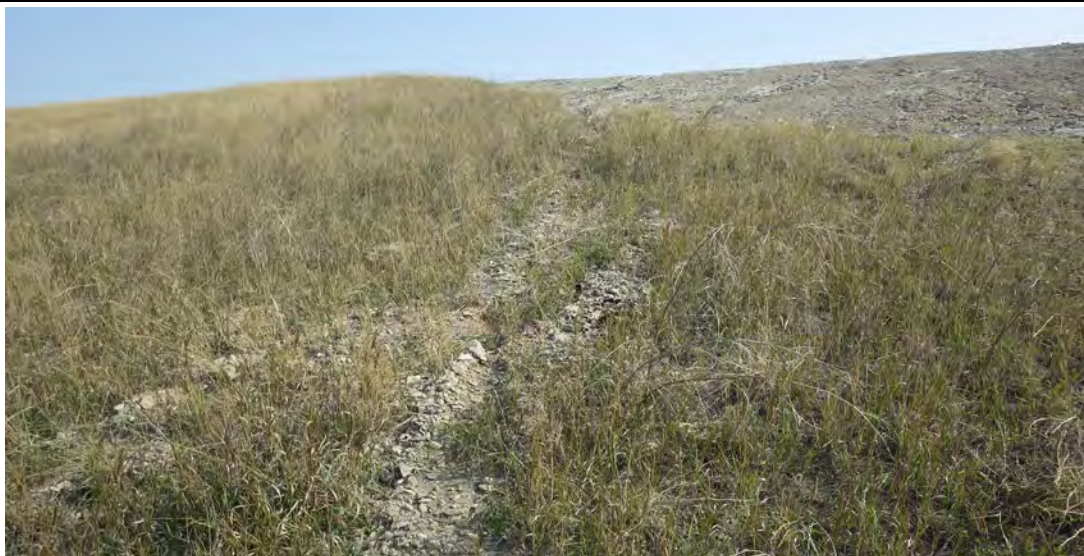
Photograph 5 (North CCR downstream slope (temporary cover))
Minor fly ash erosion onto temporary cover. (IMG7949.JPG)

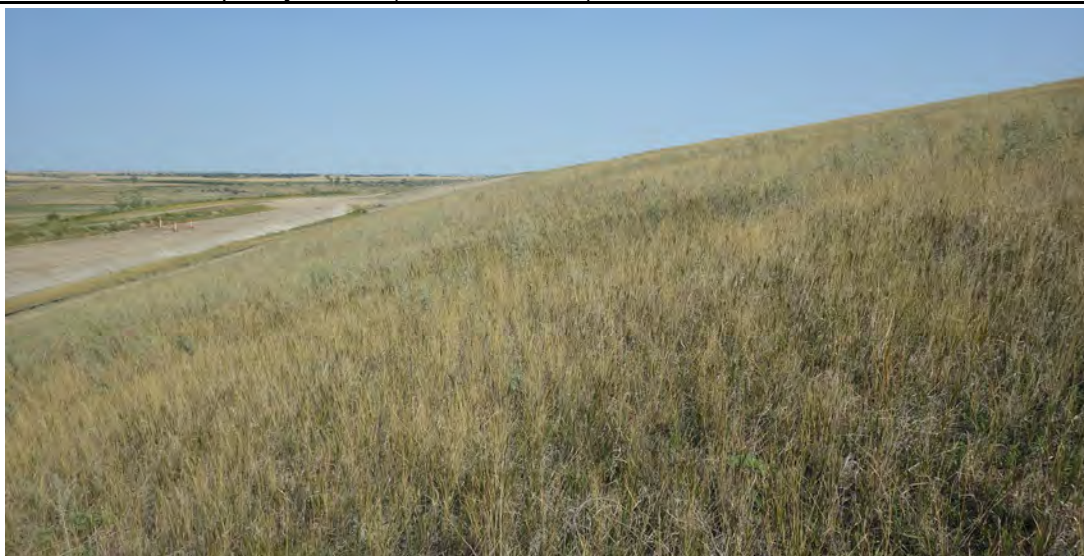
Photograph 6 (North CCR downstream slope (temporary cover))
Temporary cover, well vegetated. (IMG7950.JPG)

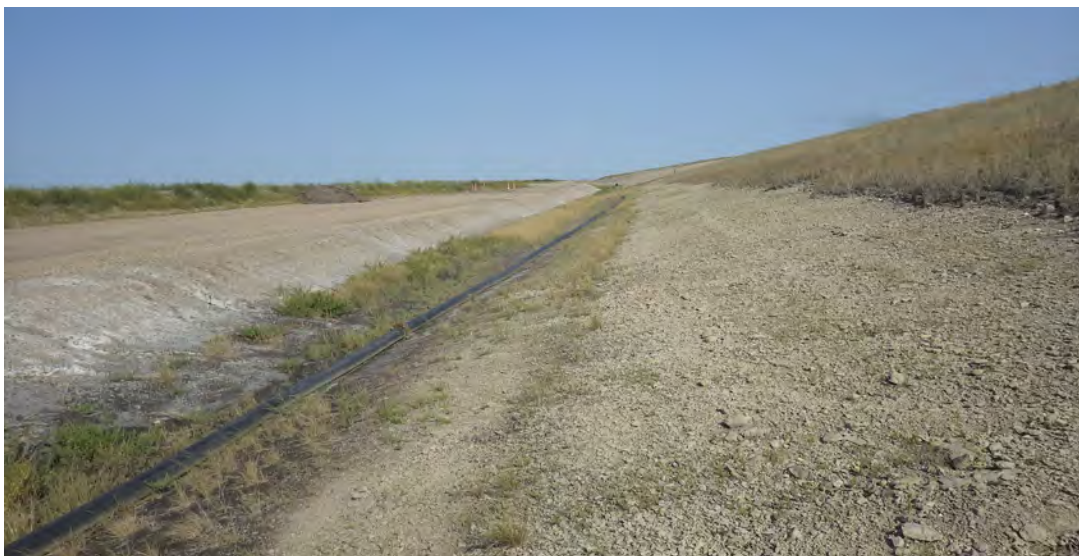
Photograph 7 (North CCR downstream slope (temporary cover) and perimeter berm upstream slope)
Perimeter ditch and culvert to UR91, good condition. (IMG7951.JPG)

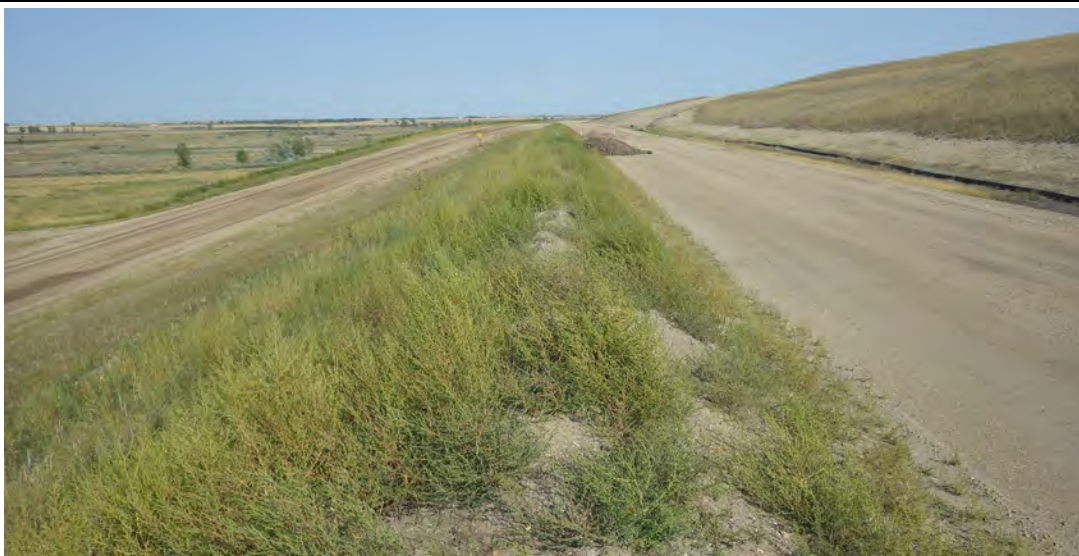
Photograph 8 (North perimeter berm crest and downstream slope)
North haul road safety berm, good condition with weedy vegetation. (IMG7953.JPG)

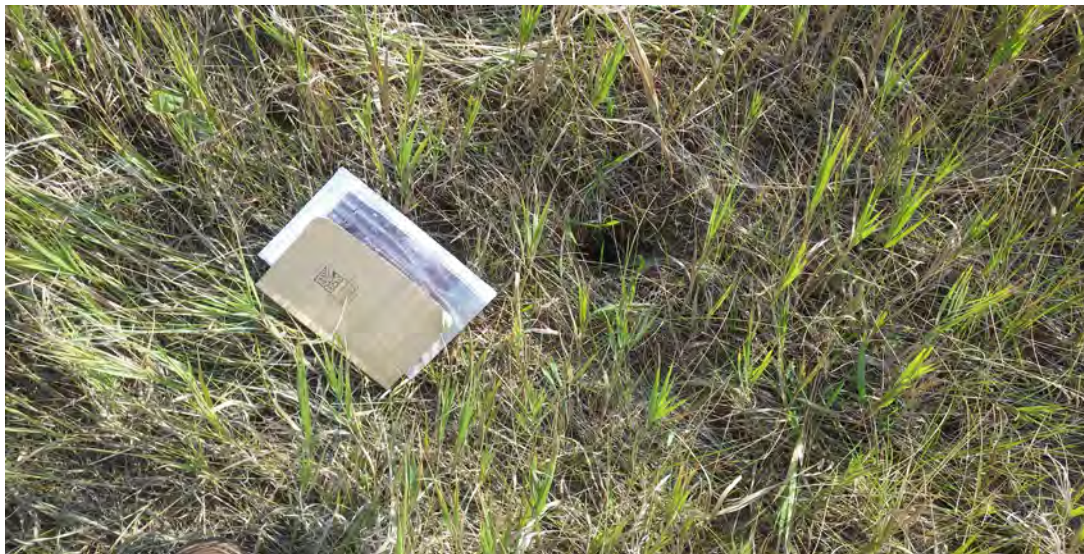
Photograph 9 (North perimeter berm downstream slope)
Small animal burrow (typical). (IMGP7954.JPG)

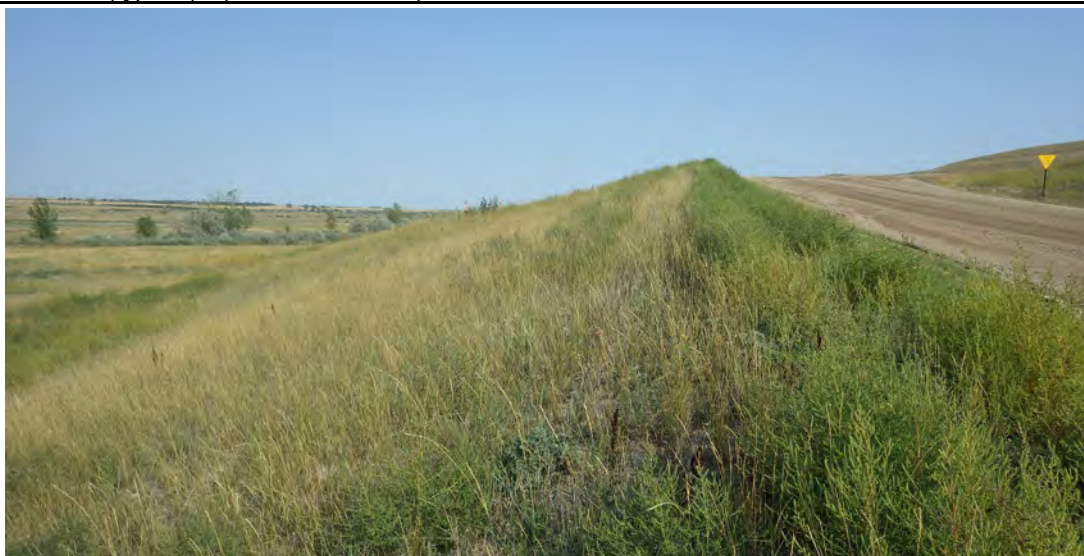
Photograph 10 (North perimeter berm downstream slope)
Good grass vegetation on outer berm. (IMGP7957.JPG)

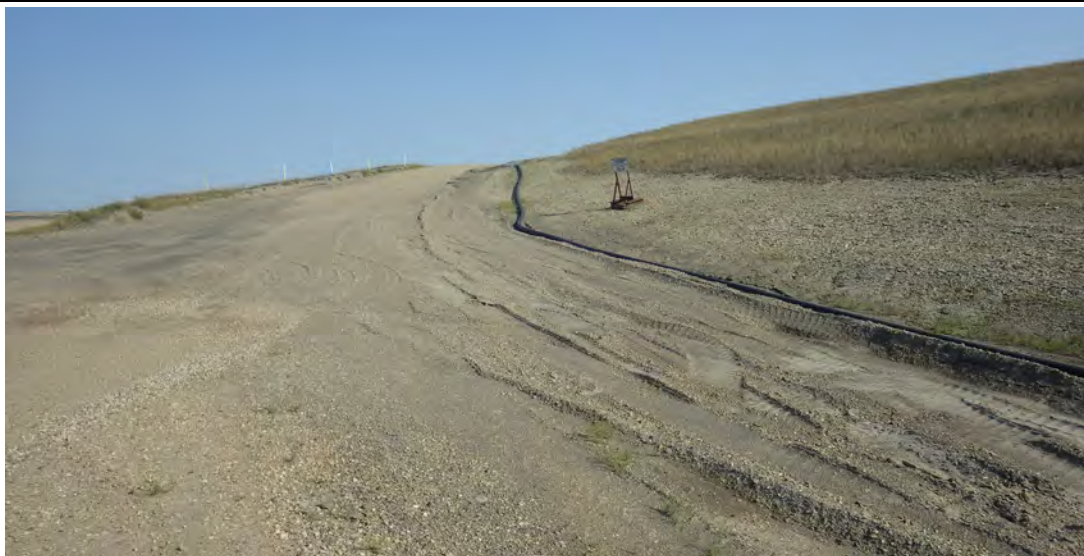
Photograph 11 (North haul ramp)
Recent erosion repairs on inside of ramp (fly ash erosion), Upstream Raise 92 signage. (IMGP7960.JPG)

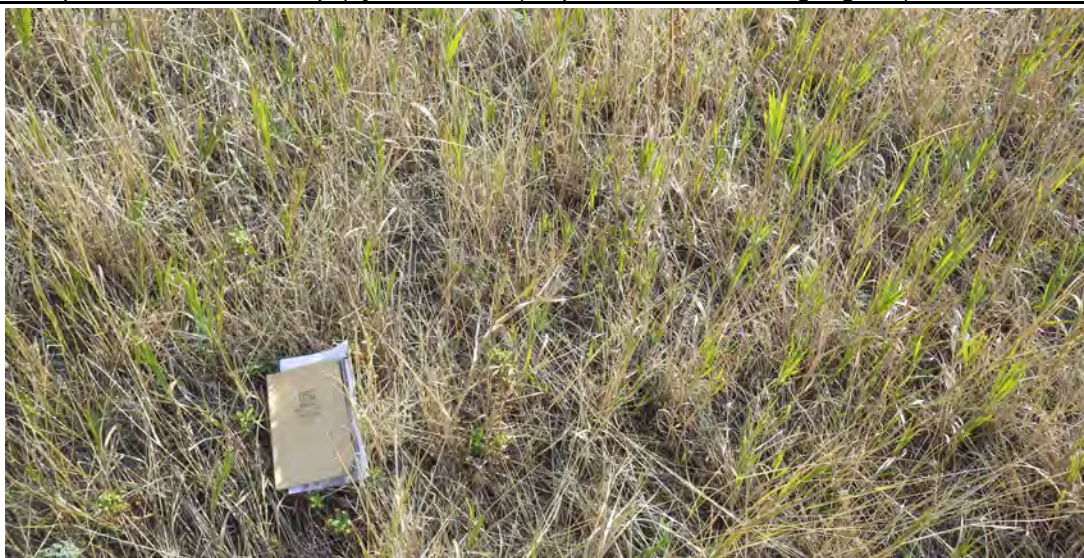
Photograph 12 (North CCR downstream slope (temporary cover))
Temporary cover in good condition. (IMGP7961.JPG)

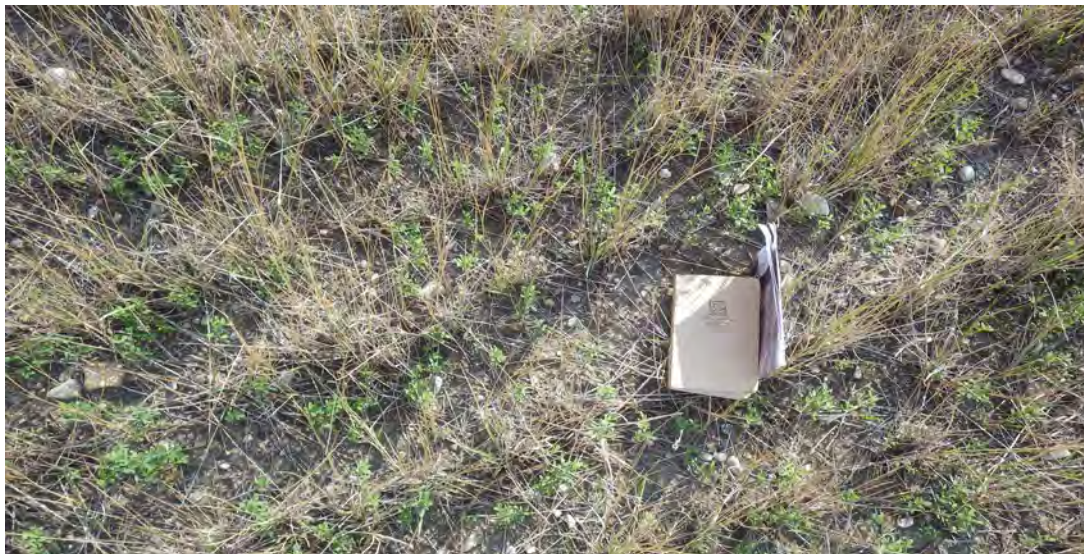
Photograph 13 (North CCR downstream slope (temporary cover))
Temporary cover in fair condition. (IMGP7962.JPG)

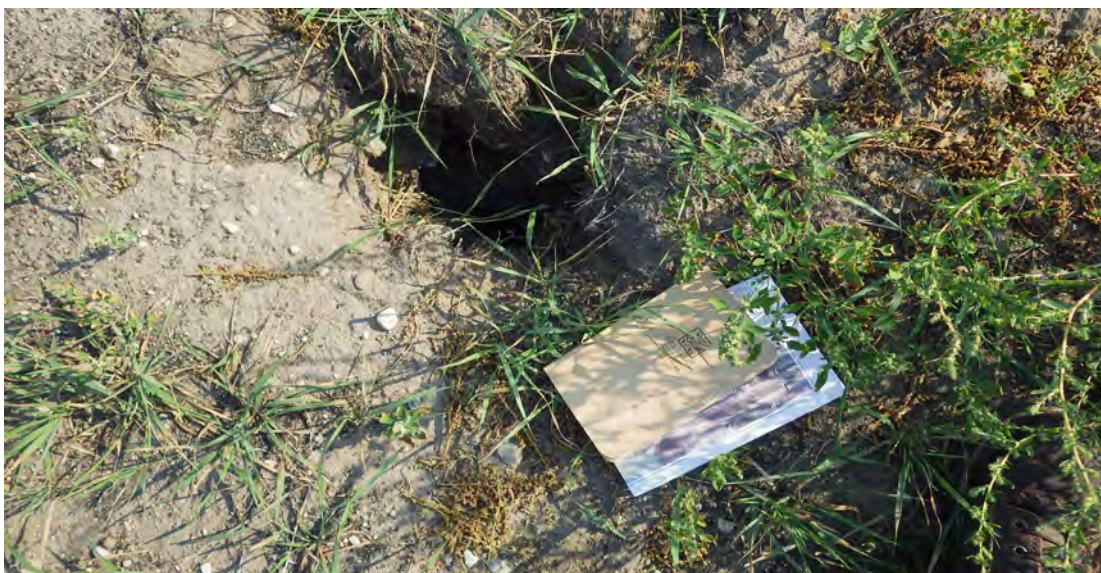
Portions of CCR downstream slopes on the north side of Upstream Raise 92 have temporary cover. These areas were well vegetated with grass and weeds but had experienced some minor erosion. The CCR downstream slopes with temporary cover appeared to be in generally good condition to aid in controlling erosion of the outer fly ash “shell” and limit wind-blown fugitive dust.

Photograph 14 (North CCR downstream slope (temporary cover))
Erosion of temporary cover, 1-2 feet deep. (IMGP7966.JPG)

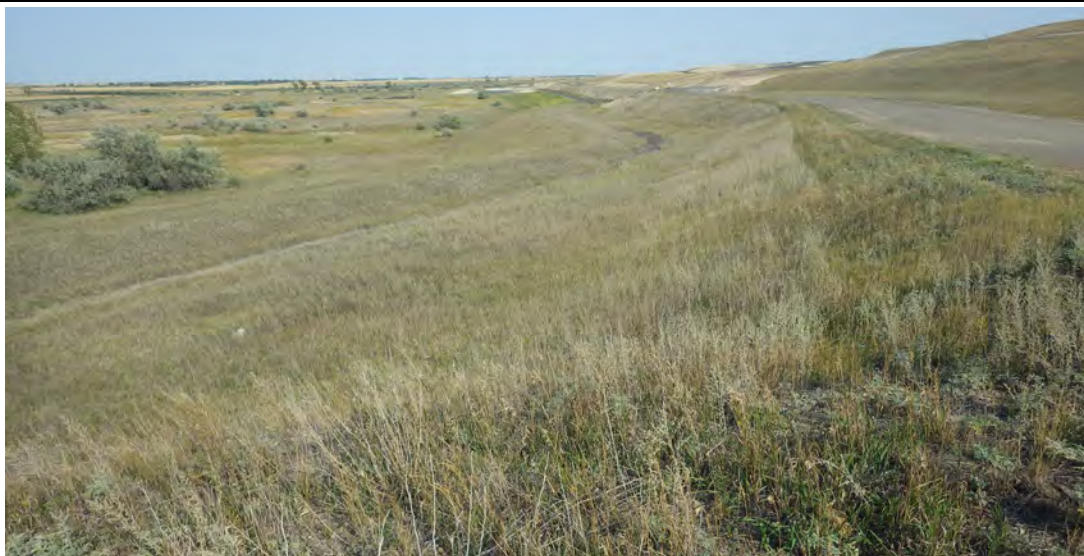
Photograph 15 (North CCR downstream slope (temporary cover))
North contact water ditch and perimeter berm. (IMGP7971.JPG)

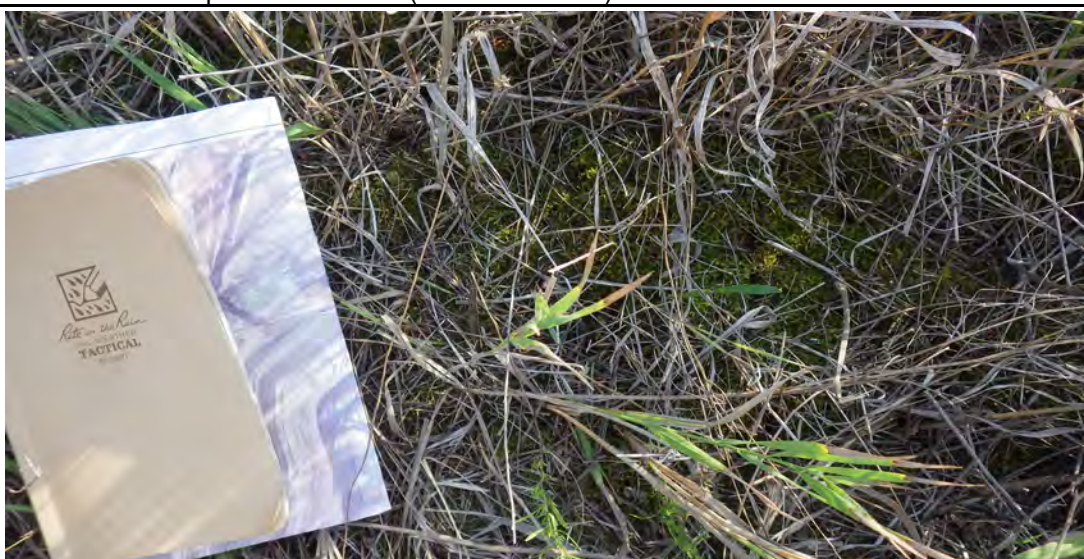
Photograph 16 (North perimeter berm downstream slope)
Mossy area on north perimeter berm slope (slope is shaded most of the year) (IMGP7974.JPG)

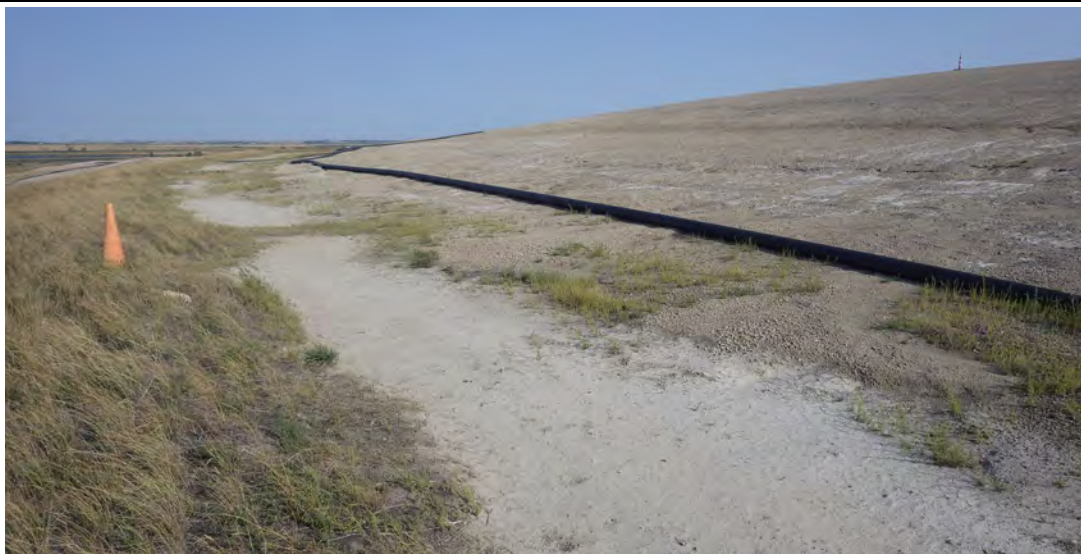
Photograph 17 (North CCR downstream slope)
El. 1,974 ft bench and fly ash slopes above, minimal erosion. (IMG7976.JPG)

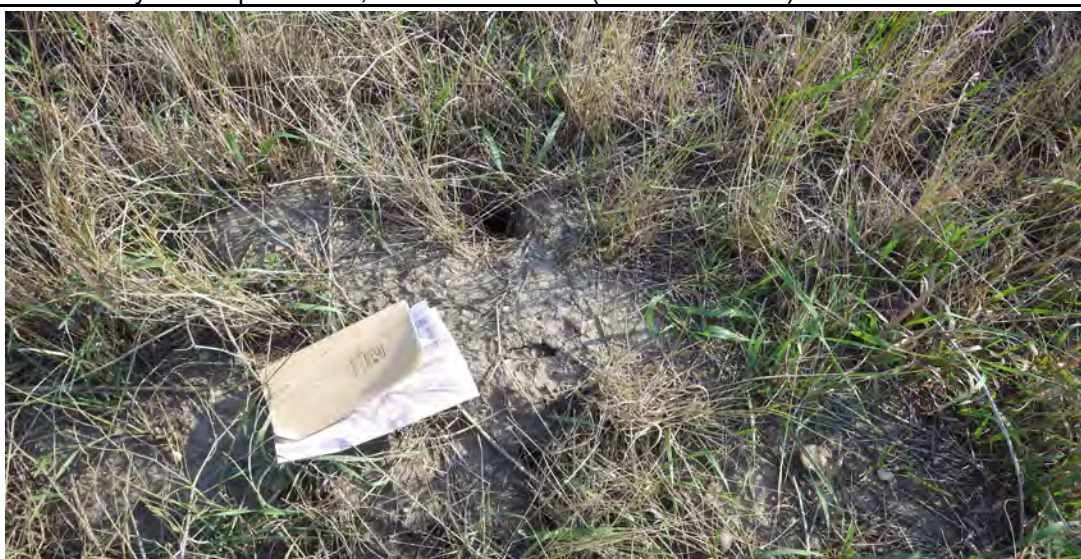
Photograph 18 (North CCR downstream slope (temporary cover))
Small animal burrow in temporary cover. (IMG7978.JPG)

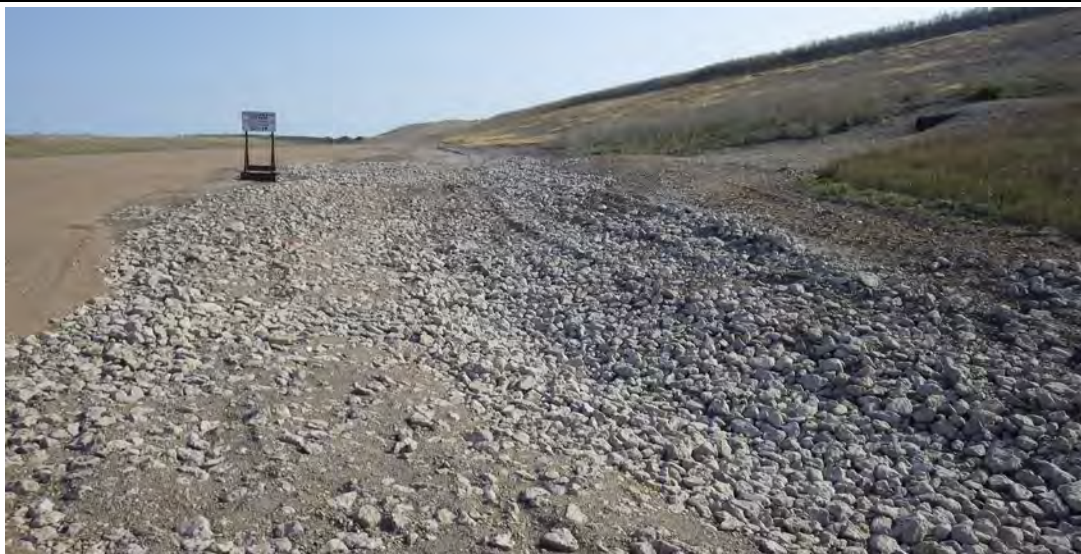
Photograph 19 (East CCR downstream slope)
Concrete rubble erosion protection in good condition at bottom of east haul ramp. (IMGP7982.JPG)

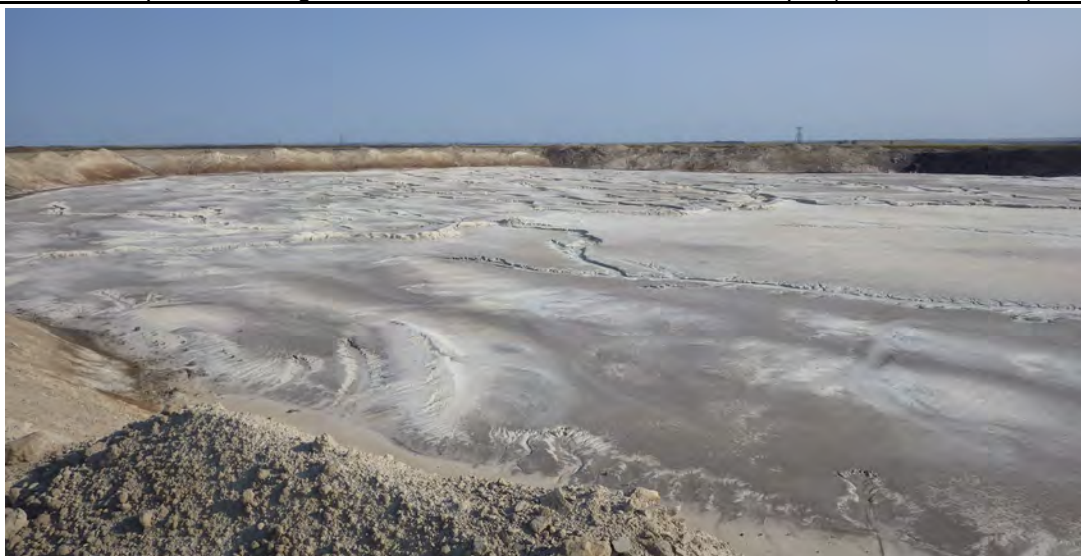
Photograph 20 (CCR upstream slopes)
Remaining exposed FGD material and placement of crown CCR material. (IMGP7984.JPG)

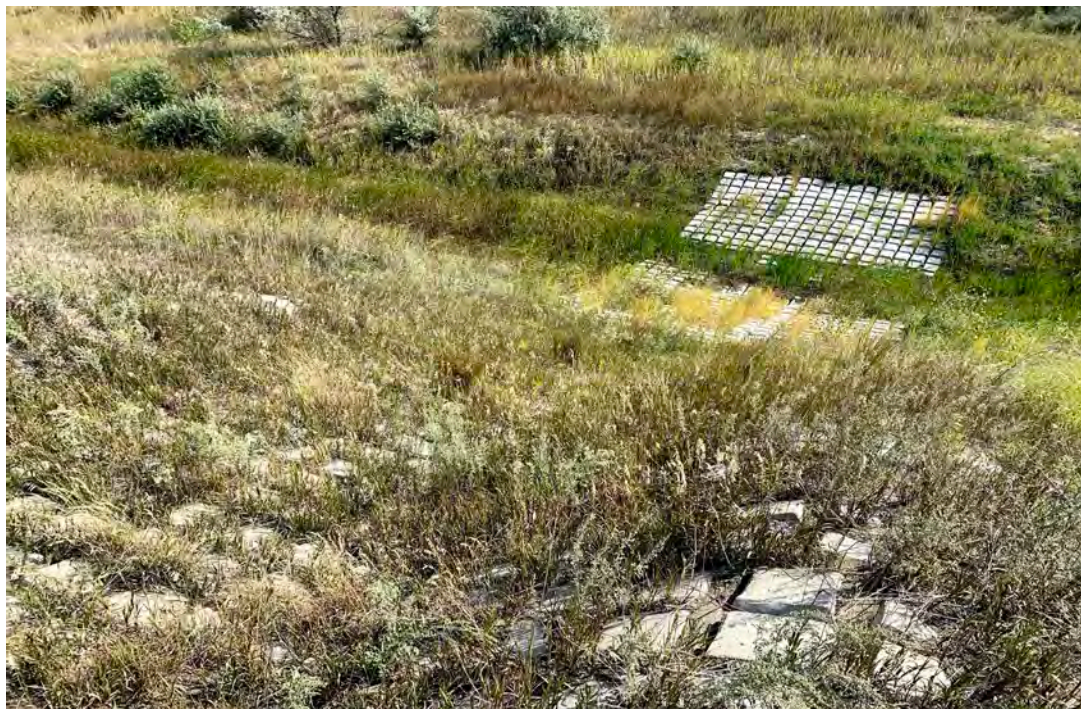
Photograph 21 (Southwest downchute and hydraulic jump basin)
Articulated concrete block in good condition. (IMG2823.JPG)

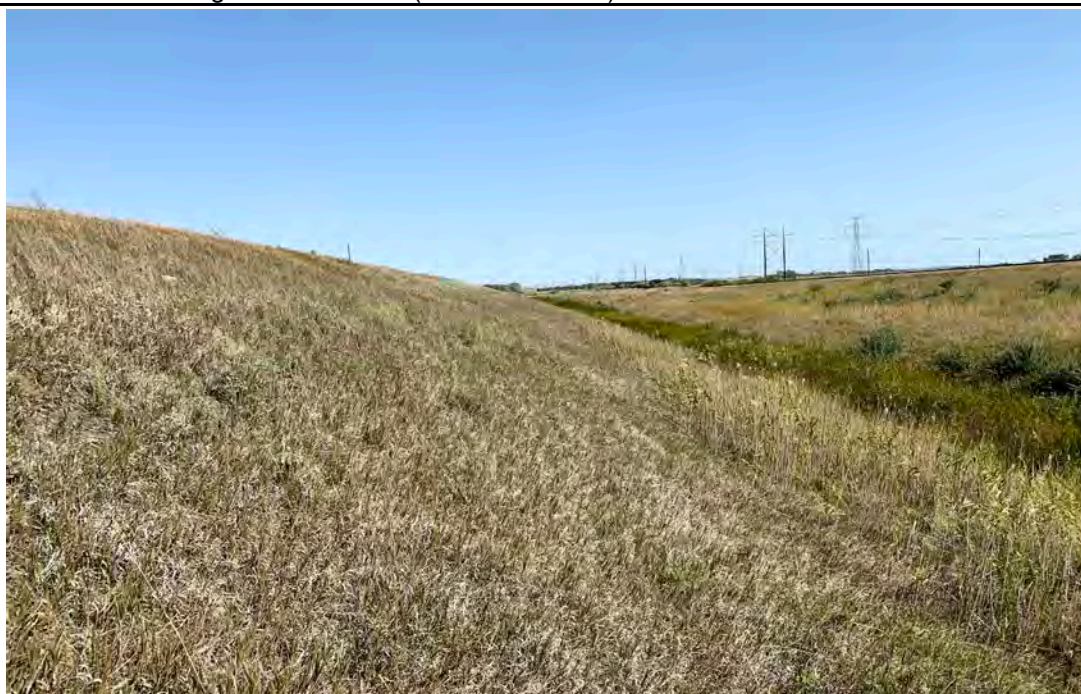
Photograph 22 (South perimeter berm downstream slope)
Perimeter berm downstream slope and toe, good condition and well vegetated. (IMG2824.JPG)

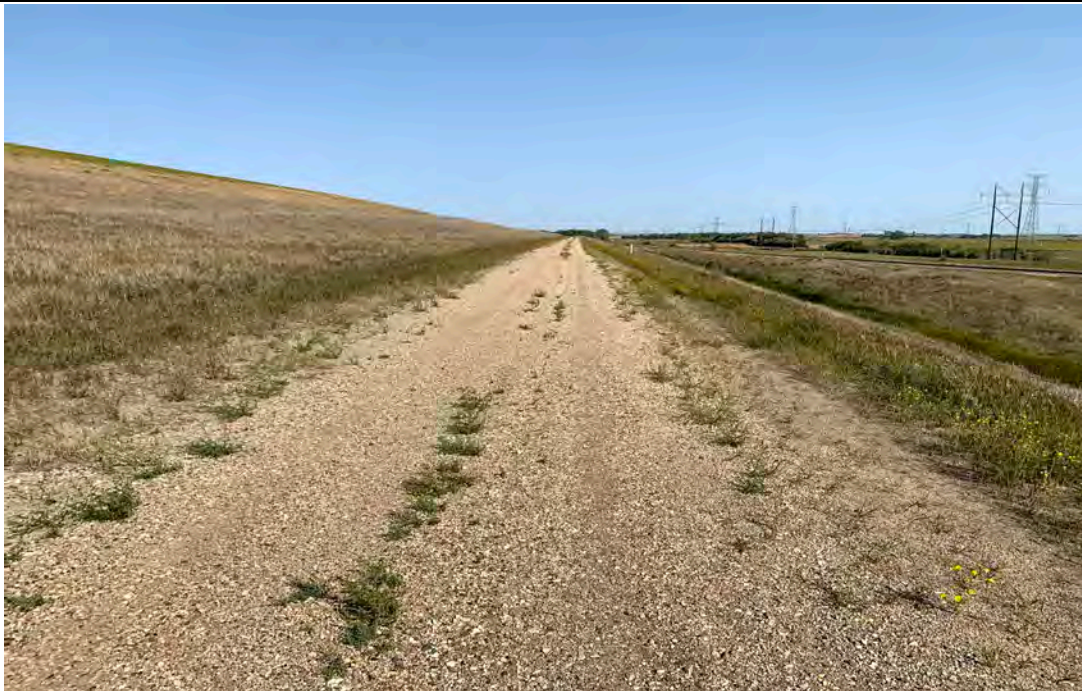
Photograph 23 (South perimeter berm crest)
Perimeter berm gravel road. (IMGP2825.JPG)

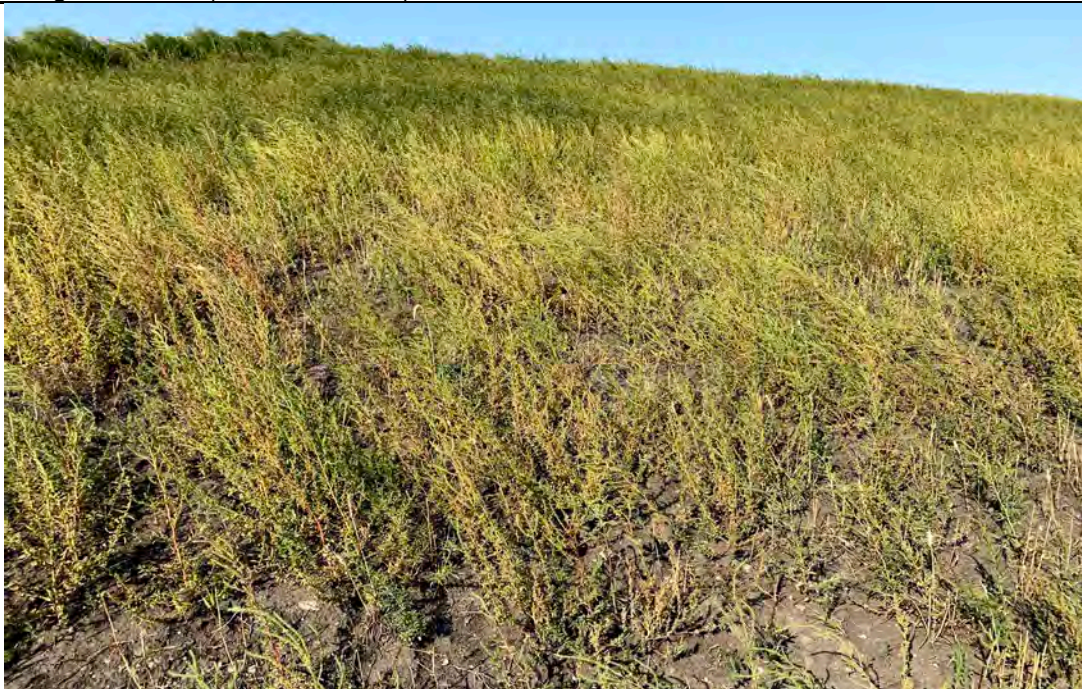
c. Downstream Slope vegetation	X			Weedy vegetation of south final covered slope between El. 1,974 ft and El. 1,998 ft benches
d. Downstream Slope seepage/sloughs/cracks/settlement	X			Cracks due to settlement of fly ash over FGD material at and above El. 1,974 ft

Photograph 24 (South CCR downstream slope (final cover))
Predominately weeds in final cover placed in 2020 (El. 1,974 ft to El. 1,998 ft). (IMGP2827.JPG)

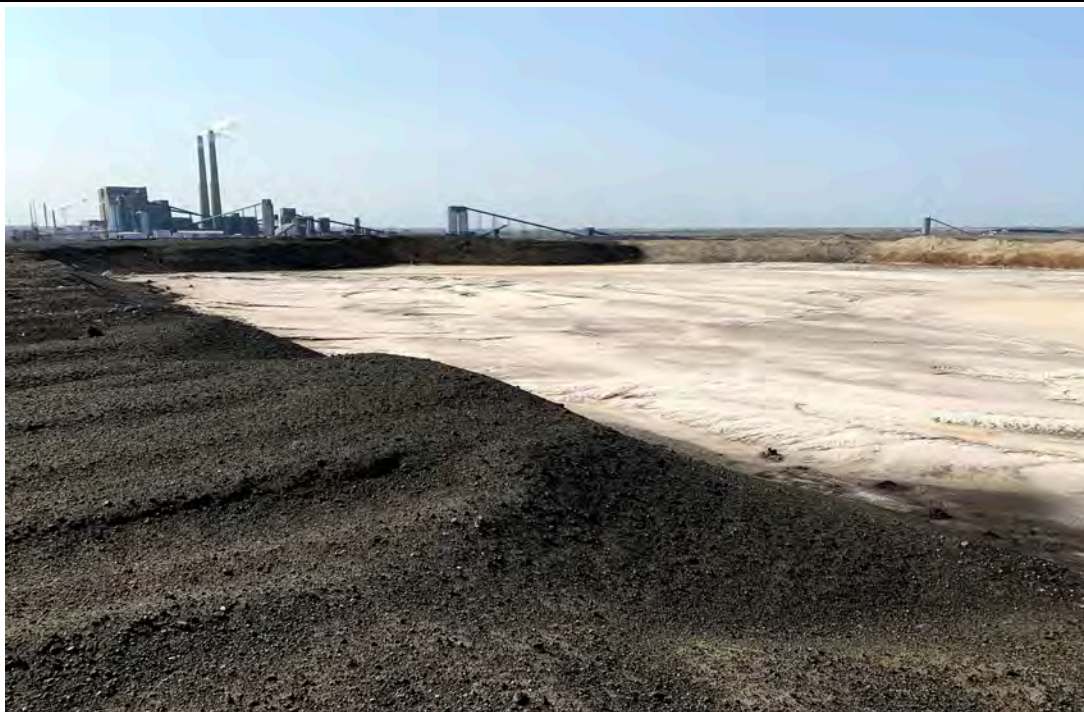
Photograph 25 (CCR upstream slopes)
Remaining exposed FGD material and placement of crown CCR material. (IMGP2832.JPG)

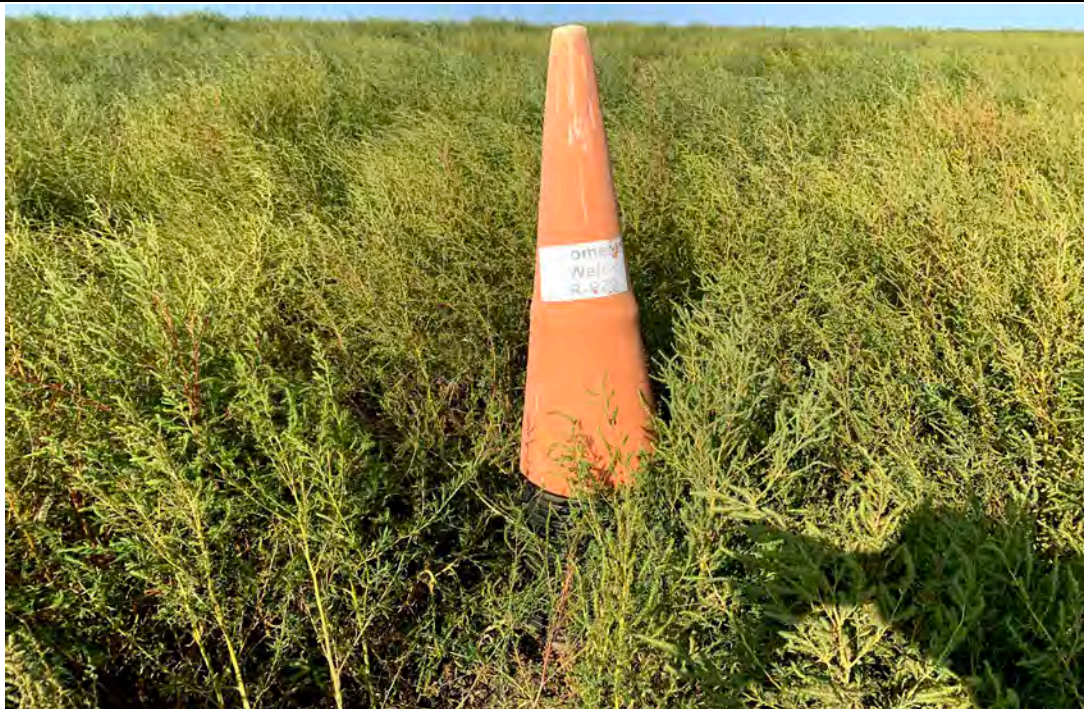
Photograph 26 (South CCR downstream slope (final cover))
Standpipe piezometer marked by cone and weedy final cover placed in 2020. (IMGP2833.JPG)

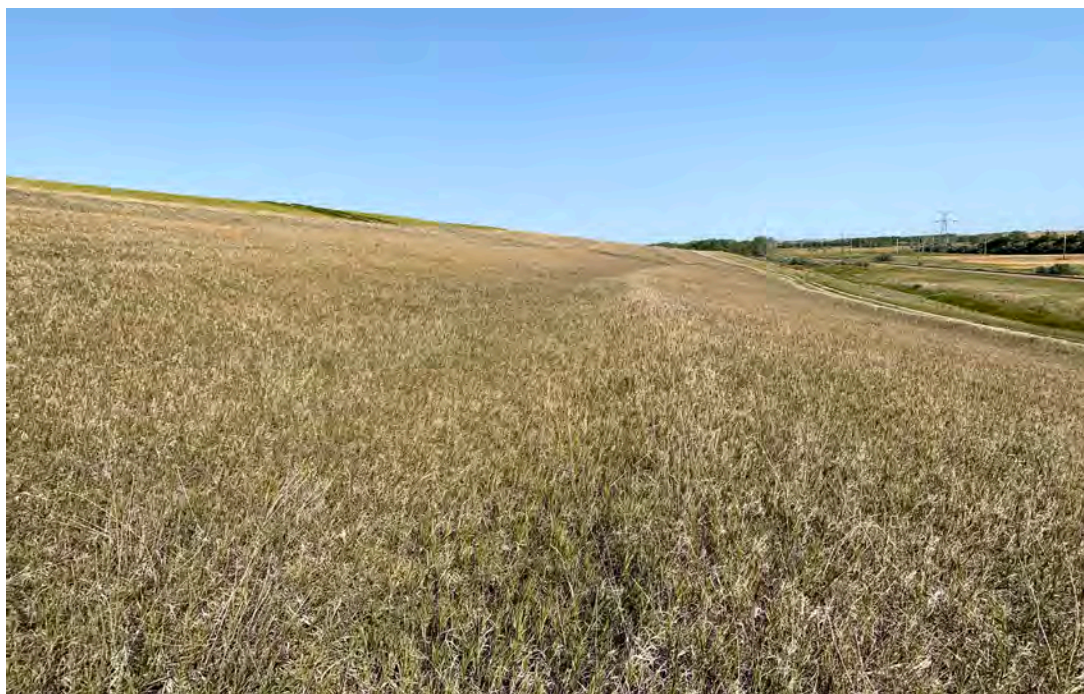
Photograph 27 (South CCR downstream slope (final cover))
Terrace channel and final cover, well vegetated and in good condition. (IMGP2834.JPG)

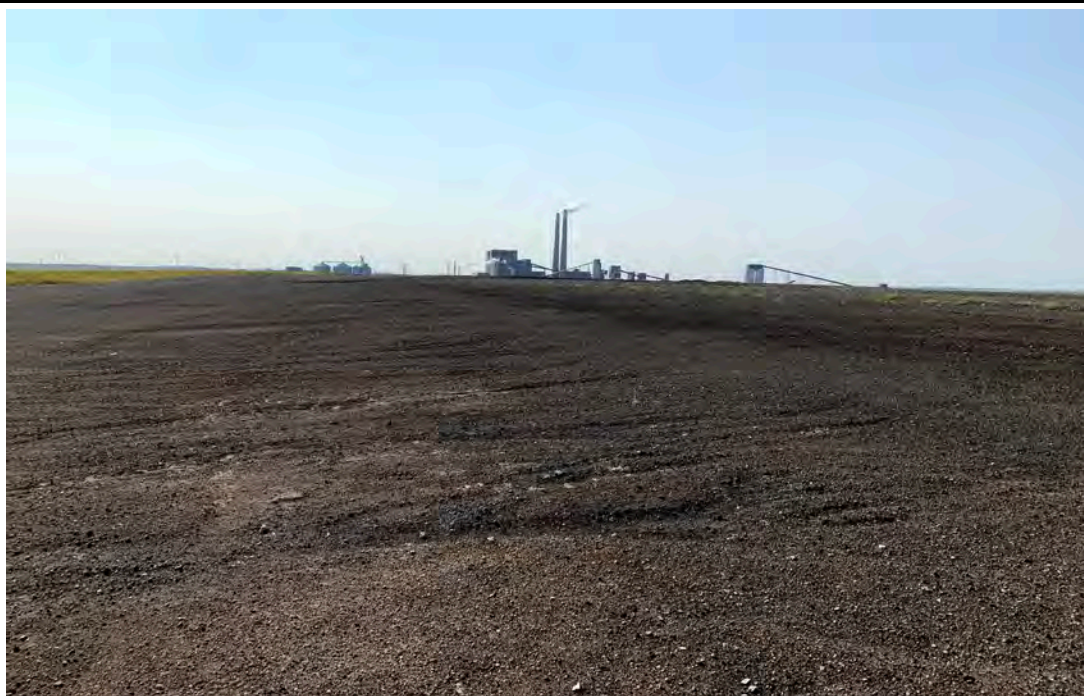
Photograph 28 (South CCR downstream slope)
CCR and non-CCR waste placed as part of crown/cap above El. 1,998 ft. (IMGP2836.JPG)

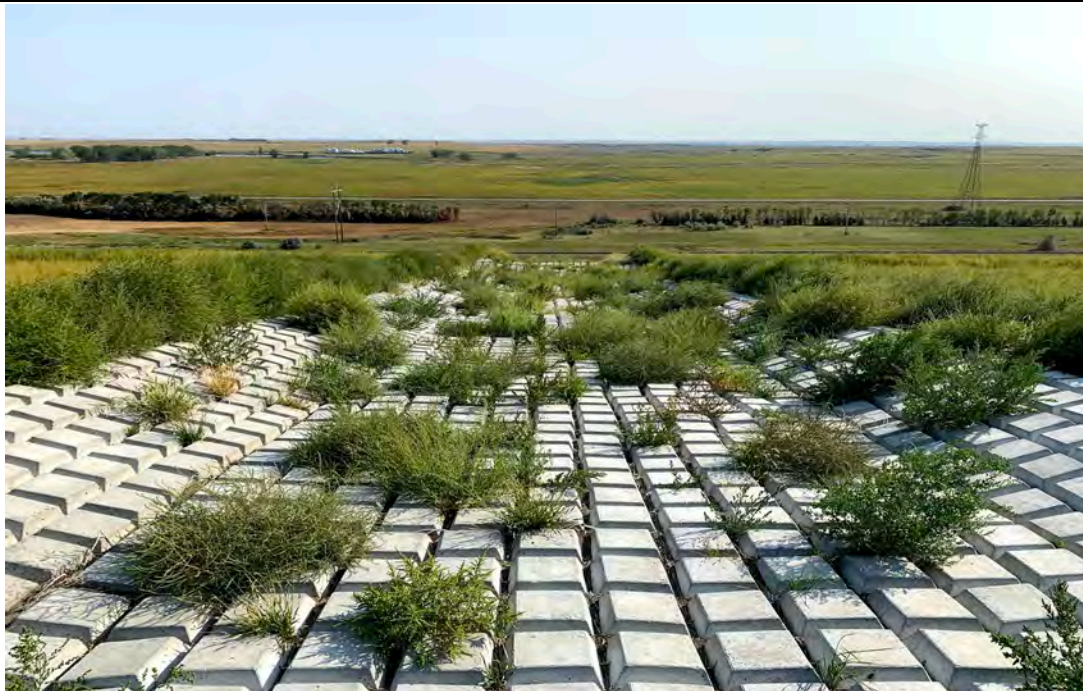
Photograph 29 (South CCR downstream slope (final cover))
Southeast downchute channel, good condition. (IMG2838.JPG)

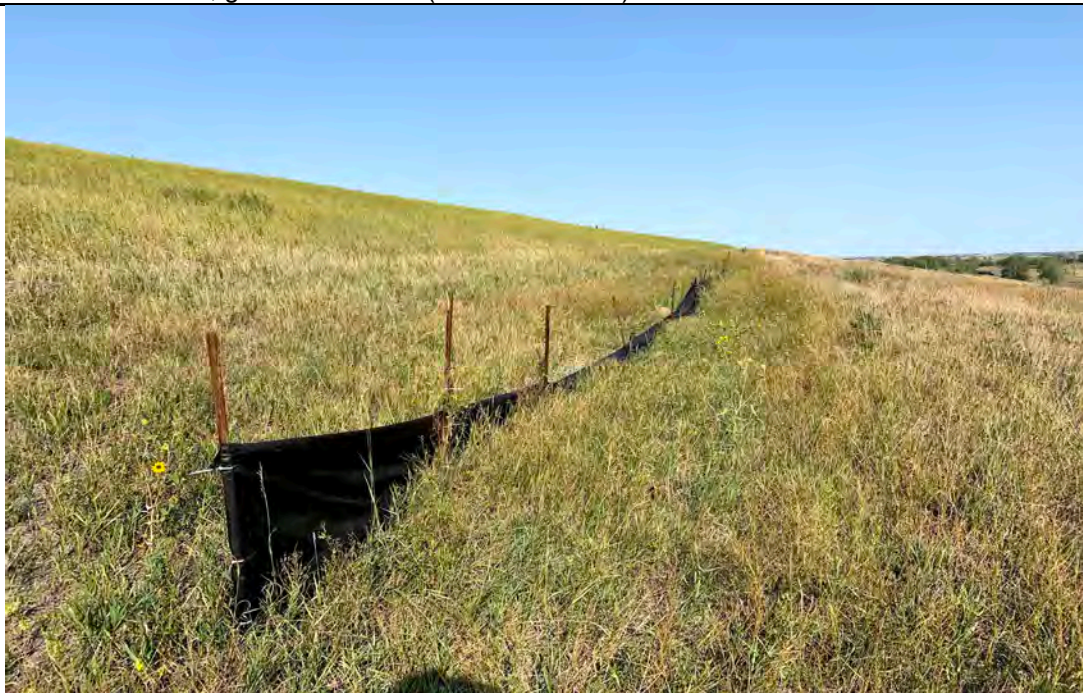
Photograph 30 (South CCR downstream slope)
Silt fence downgradient of final cover installed in 2020, fair condition. (IMG2840.JPG)

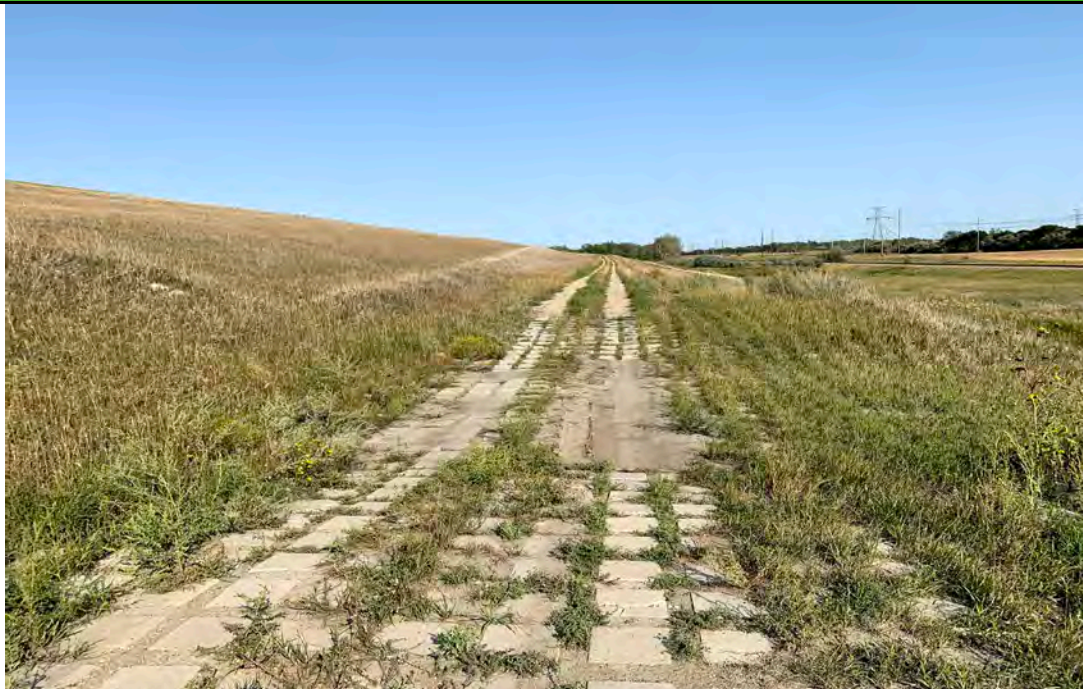
Photograph 31 (South perimeter berm crest)
Downchute crossing the perimeter gravel access road. (IMGP2842.JPG)

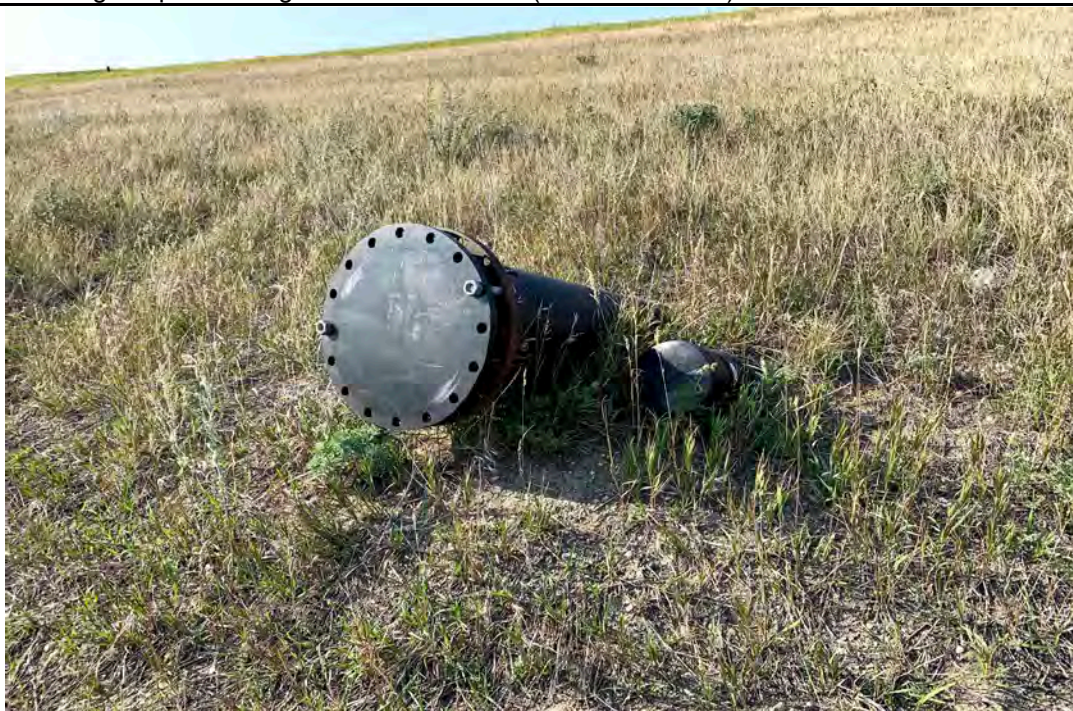
Photograph 32 (South CCR downstream slope (final cover))
Sump riser and cleanout piping. (IMGP2843.JPG)
