Corrective Measures Report

Stanton Station - Bottom Ash Impoundment

Great River Energy

GL21509219.000

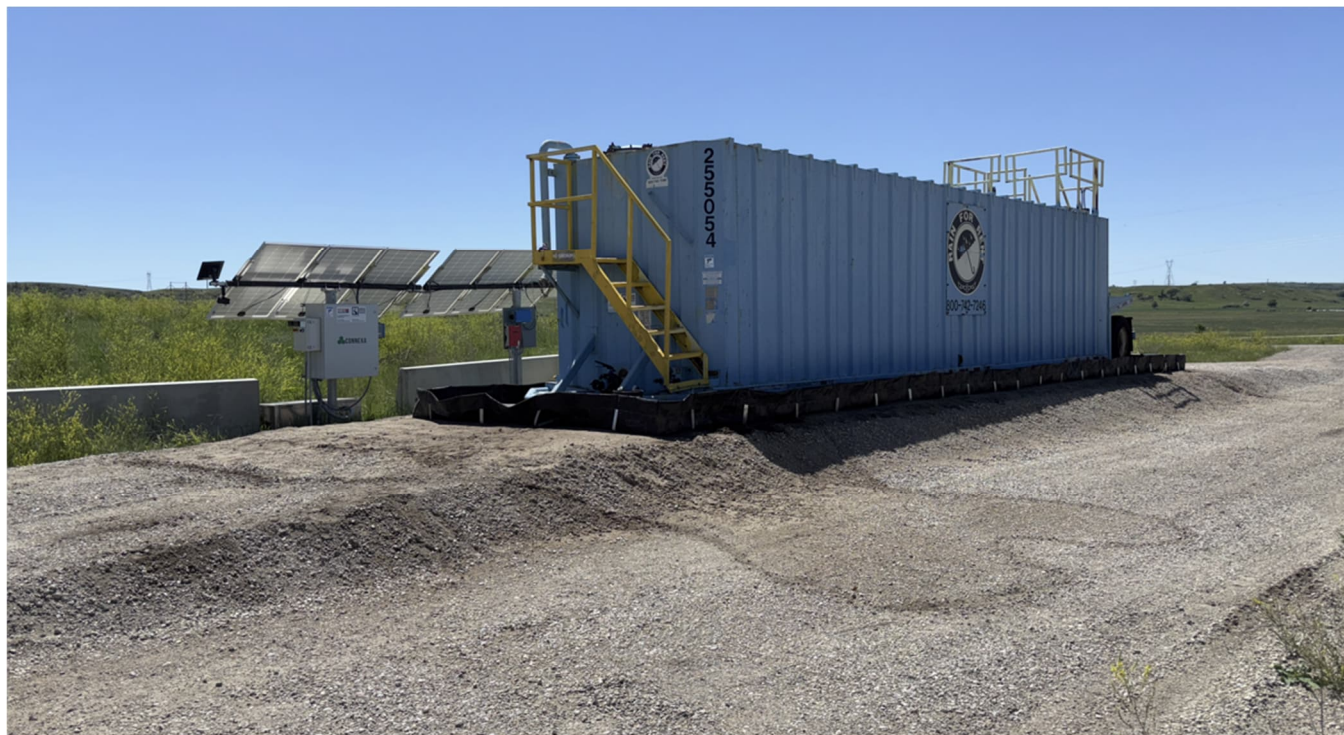
The leachate spill was immediately identified by the onsite dewatering contractor and was contained to the uppermost zone of the gravel pad and roadway constructed on the crown of the Bottom Ash Impoundment and the perimeter berm crest. The leachate evaporated or infiltrated into the near-surface gravel pad materials near the tank, with no evidence that the leachate traveled beyond the immediate area of the spill. Figure 2 and Figure 3 document the identified area where the spill occurred. The spill was reported to the NDDEQ in accordance with required reporting procedures.

Figure 2: Area of identified spill, north and east of the Bottom Ash Impoundment tank (looking southwest). For reference, the tank is approximately 9.5 feet tall.

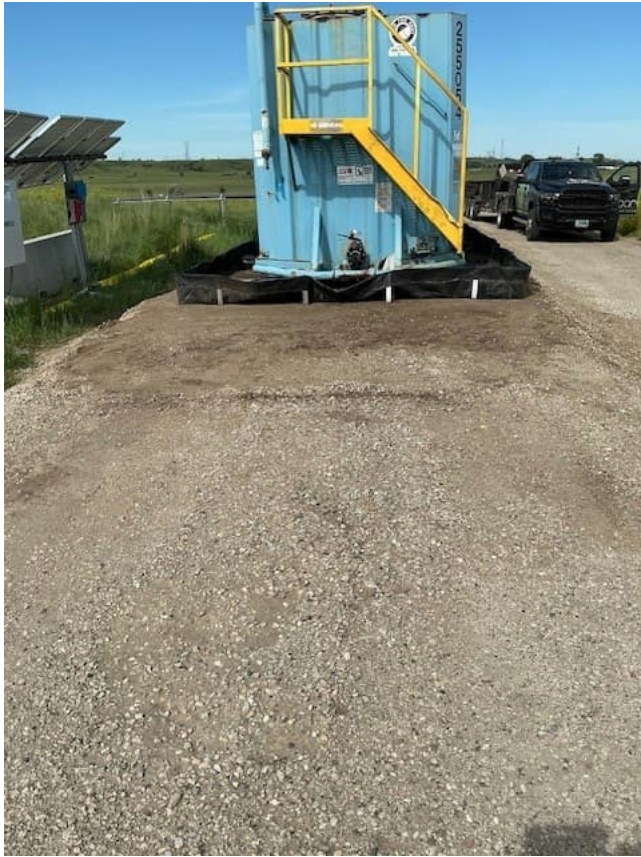
Figure 3: Area of identified spill east of the Bottom Ash Impoundment Tank looking west towards the tank unloading valve/spigot near the bottom of the tank and gravel tank pad.

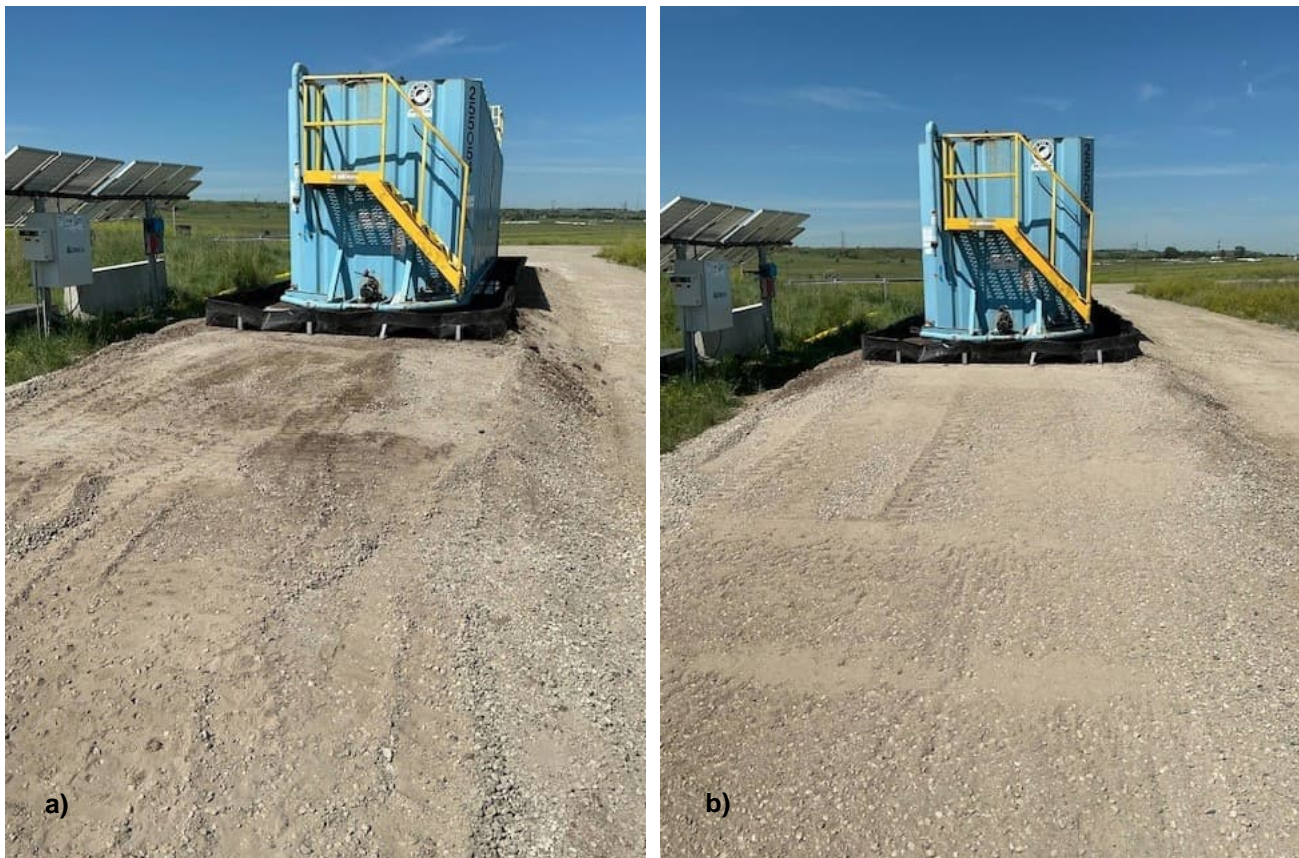
Figure 4: Impacted area east of the Bottom Ash Impoundment tank looking west a) after excavation of impacted tank pad earth materials and b) after backfilling and regrading activities.

Following the spill, the onsite earthworks contractor (Baranko Companies) excavated soils visually impacted by the spill on July 3, 2025. Material was excavated from the gravel pad and adjacent roadway northeast of the tank, including underneath the tertiary spill containment barrier installed around the Bottom Ash Impoundment tank. Approximately 4 cubic yards of impacted earthen material were removed. Figure 4a, 5a, and 6a show the area following excavation of the impacted materials and Figure 4b, 5b, and 6b show the area after backfilling to original grades and regrading the impacted area to maintain site access and allow surface water drainage

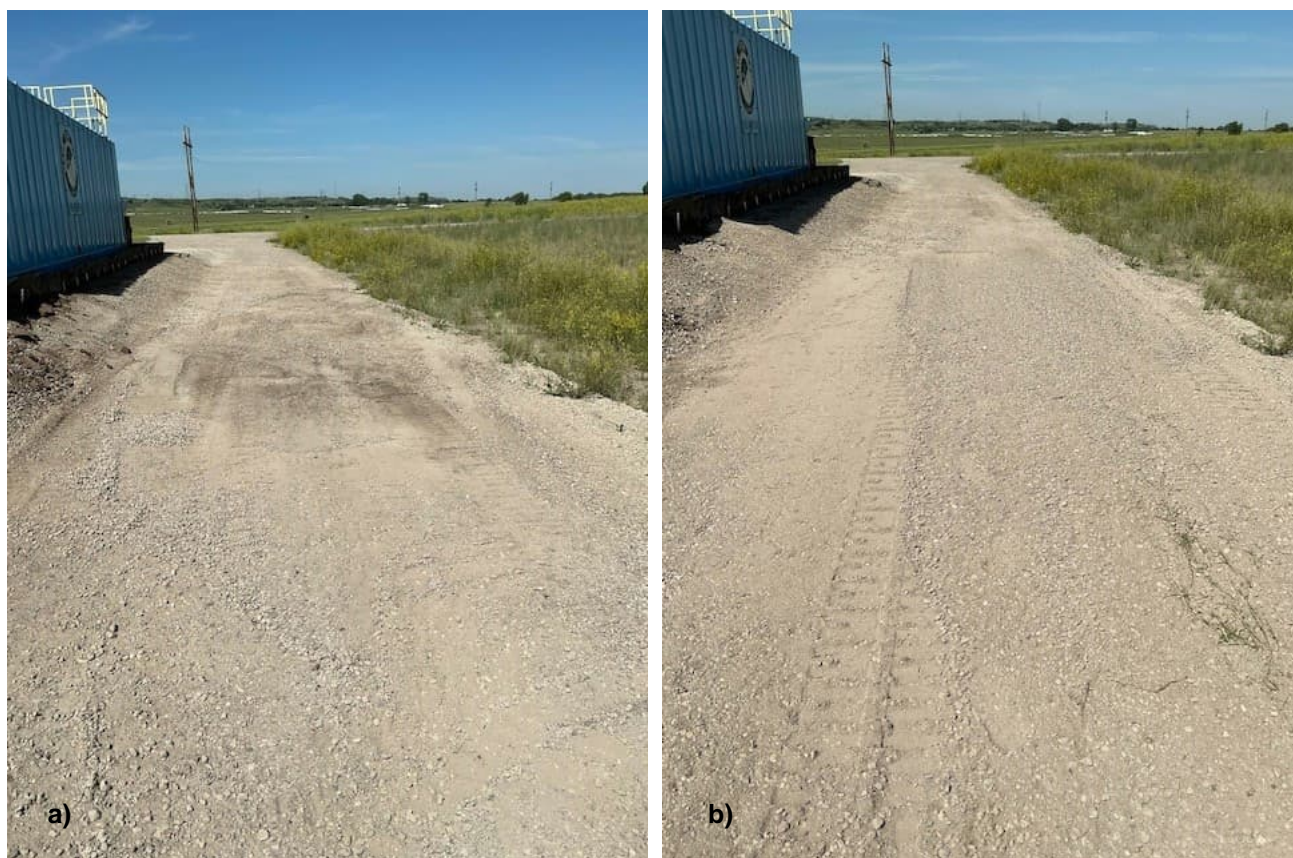
Figure 5: Impacted roadway area north of the Bottom Ash Impoundment tank looking west a) after excavation of impacted roadway earthen materials and b) after backfilling and regrading activities.

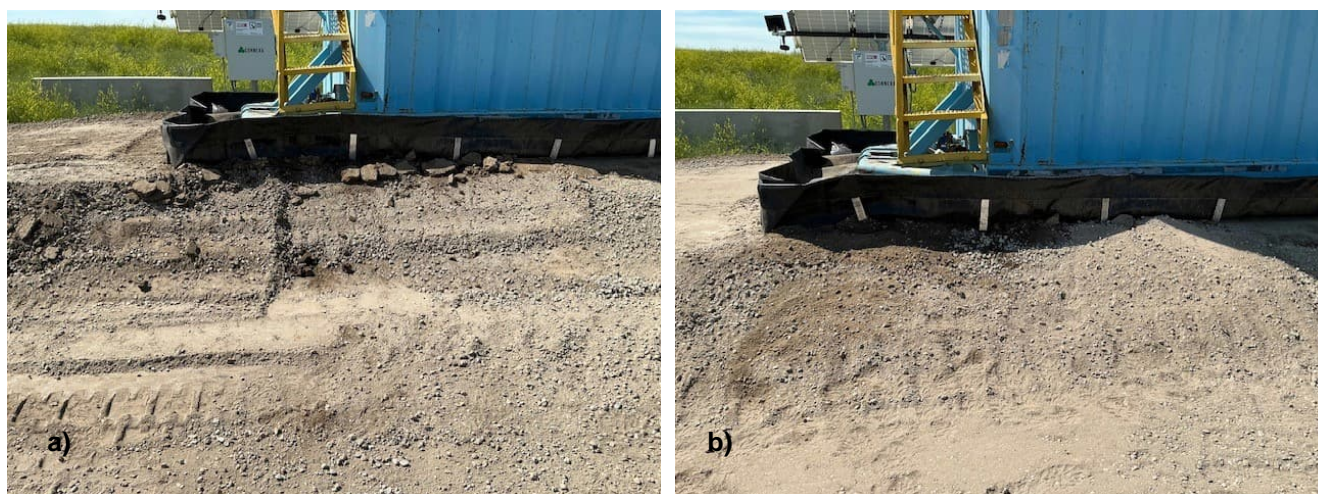
Figure 6: Impacted tank pad earth materials excavated northeast and beneath the tertiary spill containment barrier a) after excavation of earthen materials and b) after backfilling and regrading activities.
