# Post-Closure Care Plan

*Permit Number 0043*

*Great River Energy – Stanton Station*

**Golder Associates USA Inc.**

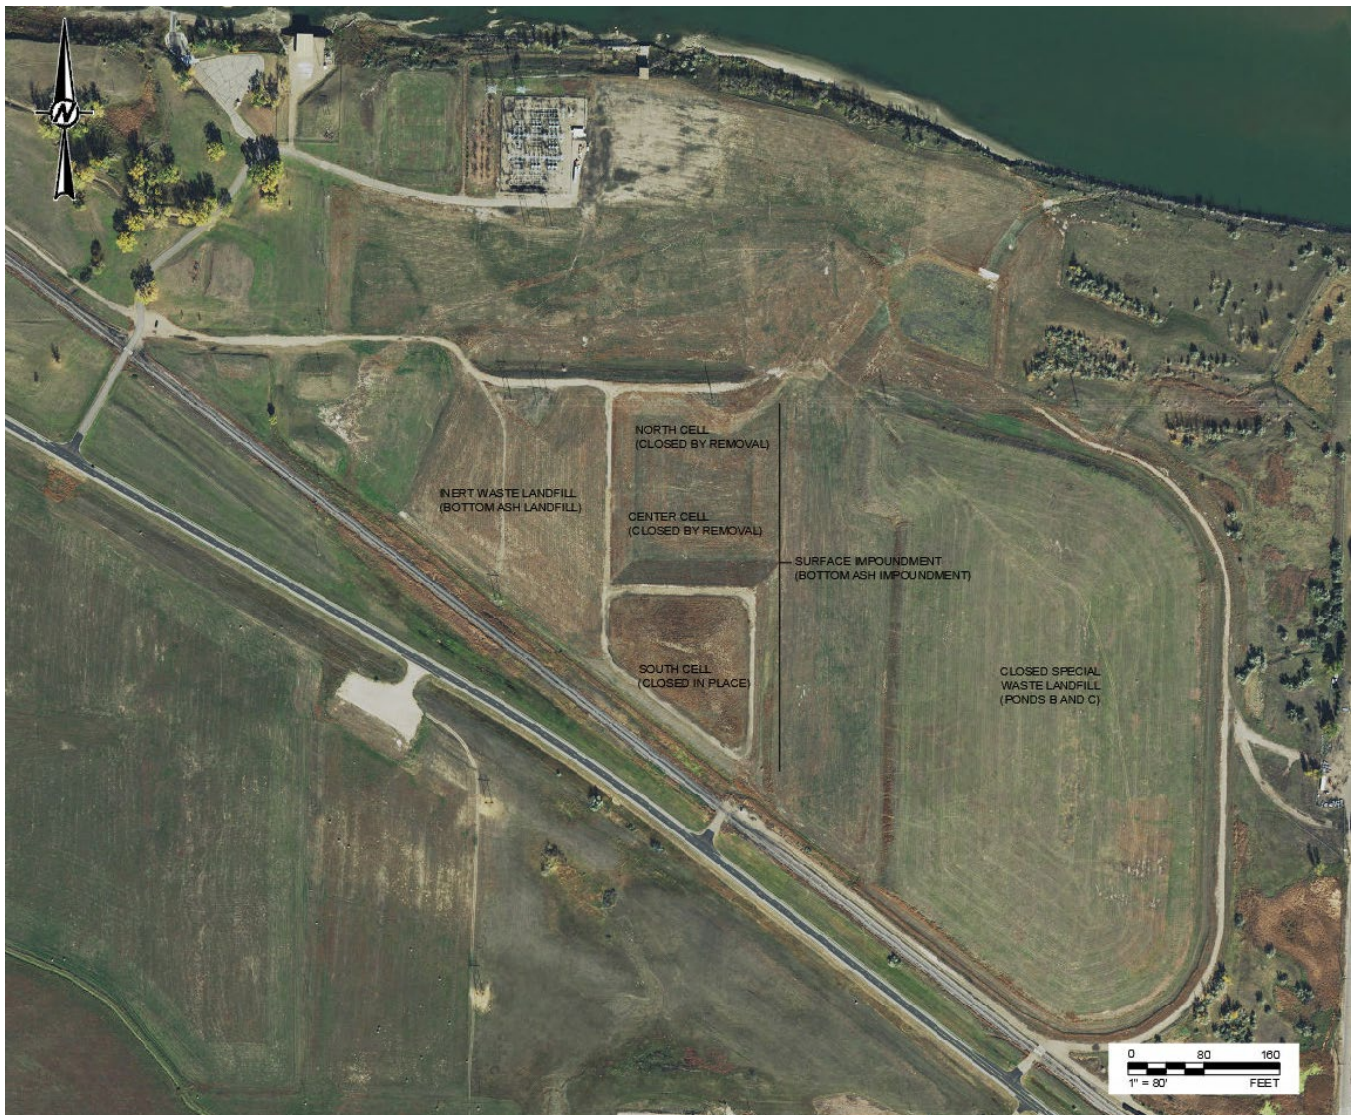
Figure 1 shows the locations of the Bottom Ash Impoundment, Bottom Ash Landfill, and closed special waste landfill at the Stanton Station site.

**Figure 1: Solid Waste Management Units under Permit Number 0043 at Stanton Station (Aerial Image: NAIP 2021).**
