Annual Inspection

Coal Creek Station – Upstream Raise 92 CCR Surface Impoundment

Great River Energy

January 2019

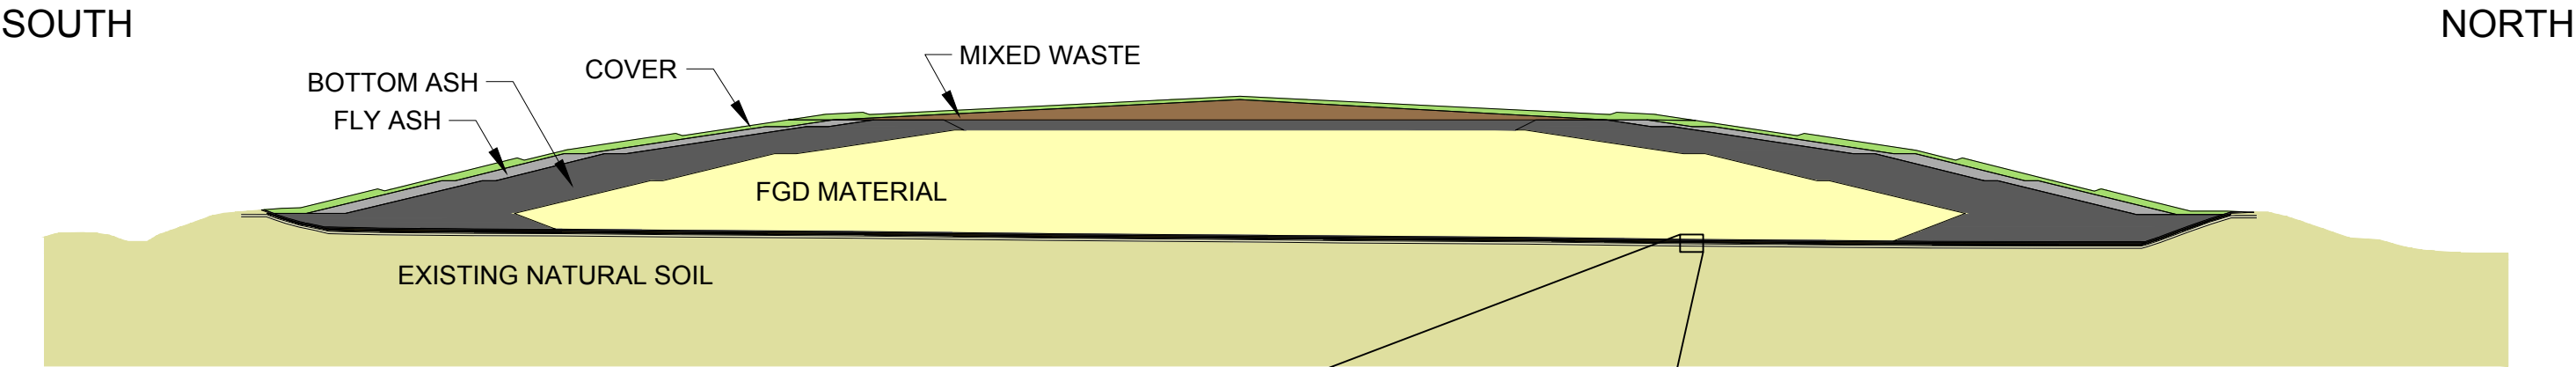
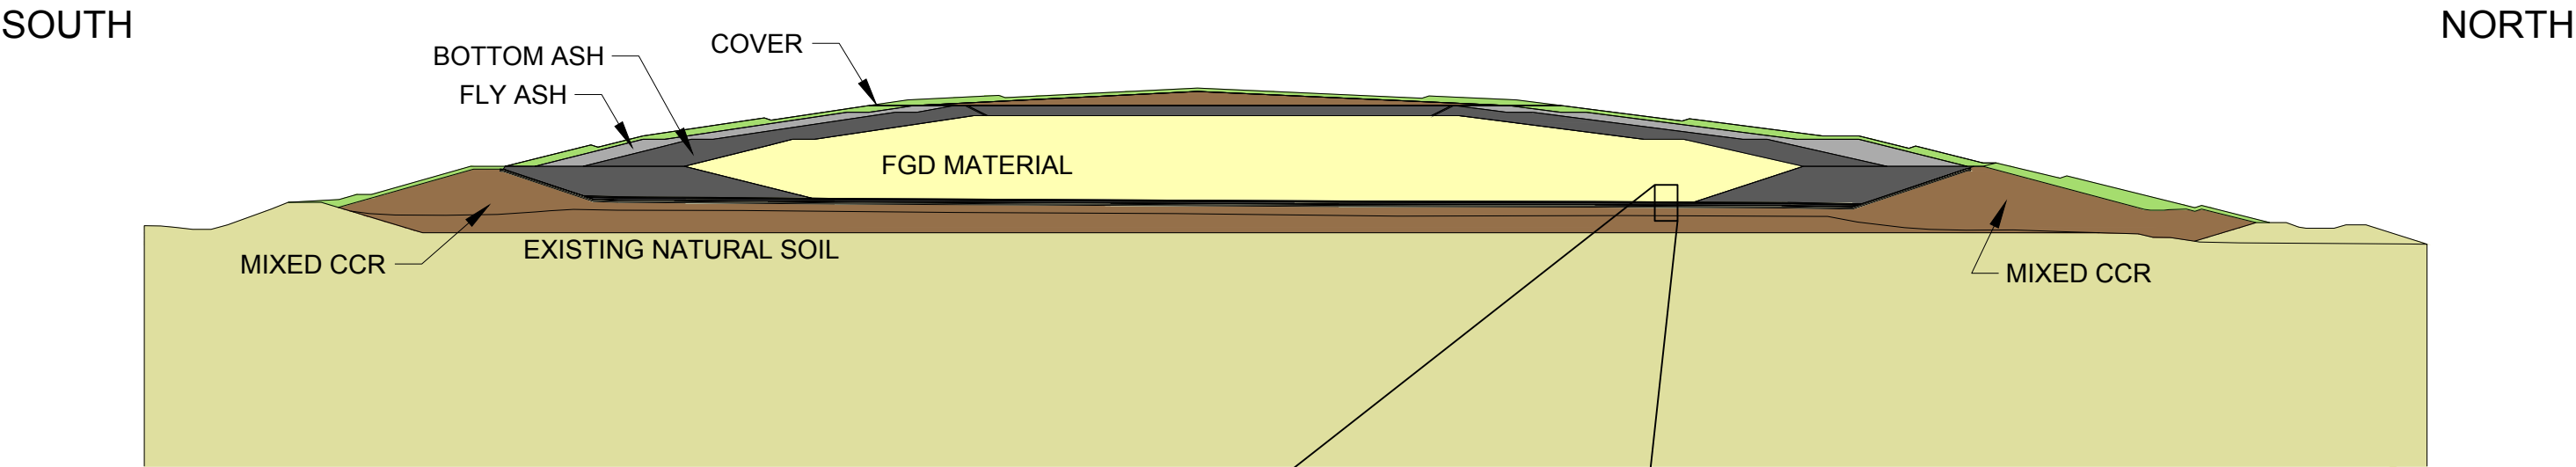
CLIENT GREAT RIVER ENERGY COAL CREEK STATION UNDERWOOD, NORTH DAKOTA			PROJECT 2018 ANNUAL CCR FACILITY INSPECTION REPORT		
CONSULTANT			TITLE UPSTREAM RAISE 92 CROSS SECTIONS		
	YYYY-MM-DD	2018-12-27	PROJECT NO. 1893823		
	DESIGNED	CCS	REV. A		
	PREPARED	CCS	FIGURE 3		
	REVIEWED	TJS			
	APPROVED	TJS
