# Annual Inspection

## *Stanton Station - Bottom Ash CCR Landfill*

### **Great River Energy**

January 2020

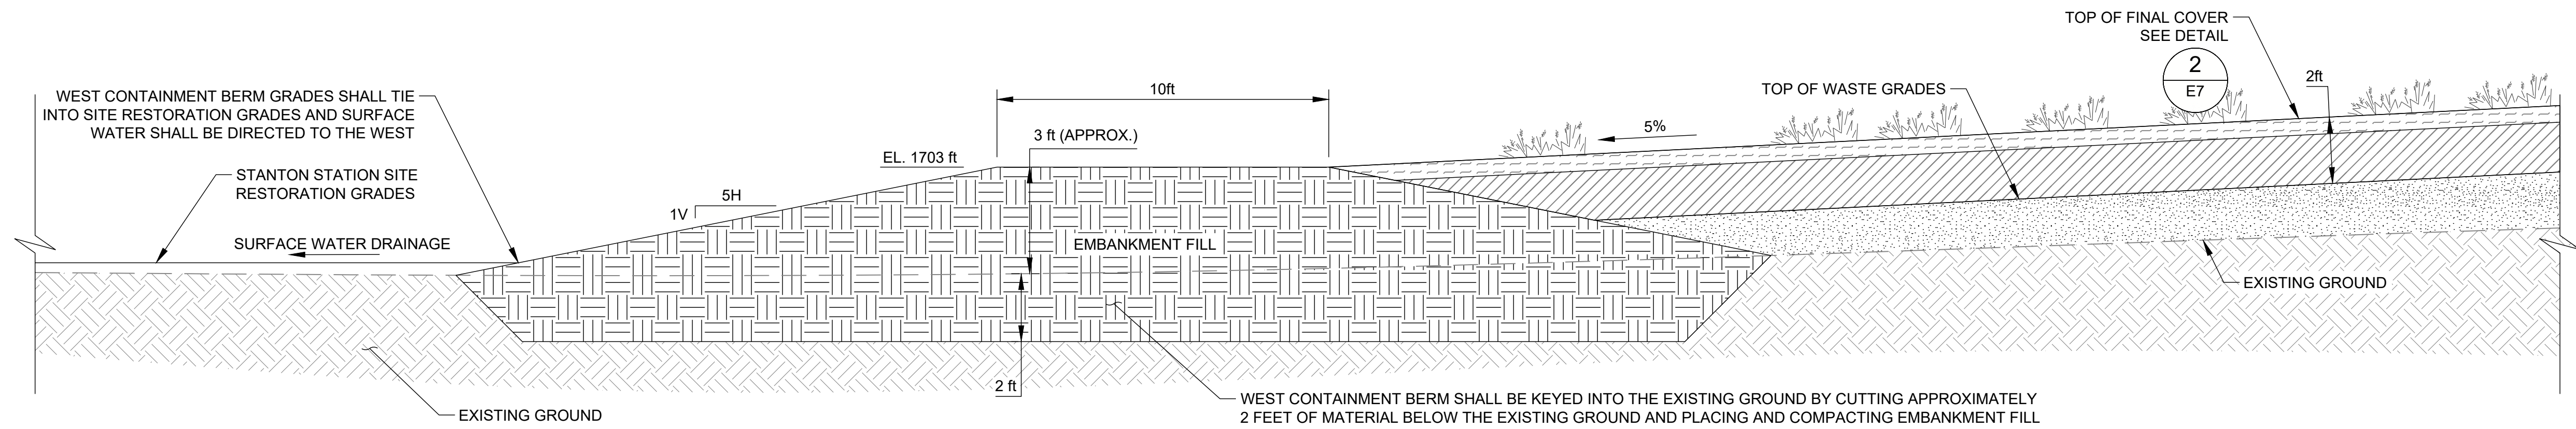
NTS **1**  
E7 WEST CONTAINMENT BERM DETAIL

Where visible, the berm upstream slopes appeared to match the design slopes of 3:1 with no observed section of significant slope movement. The west berm upstream slopes are generally bare soil since they are in the process of being removed as a part of site restoration re-grading. Contact water continues to be directed toward the west side of the facility and will be managed as a part of site restoration activities. The berm upstream slopes of the landfill appear to be in good condition. A new west berm of the Bottom Ash Landfill will be constructed to contain a smaller, consolidated quantity of bottom ash and other permitted materials. This berm was not yet constructed at the time of the inspection.

b. Sump & pump in good condition			X	
c. Containment controls working		X		West containment berm of BAL not yet constructed (part of site restoration activities)
