# Annual Inspection

## *Stanton Station - Bottom Ash CCR Surface Impoundment*

**Great River Energy**

January 2021

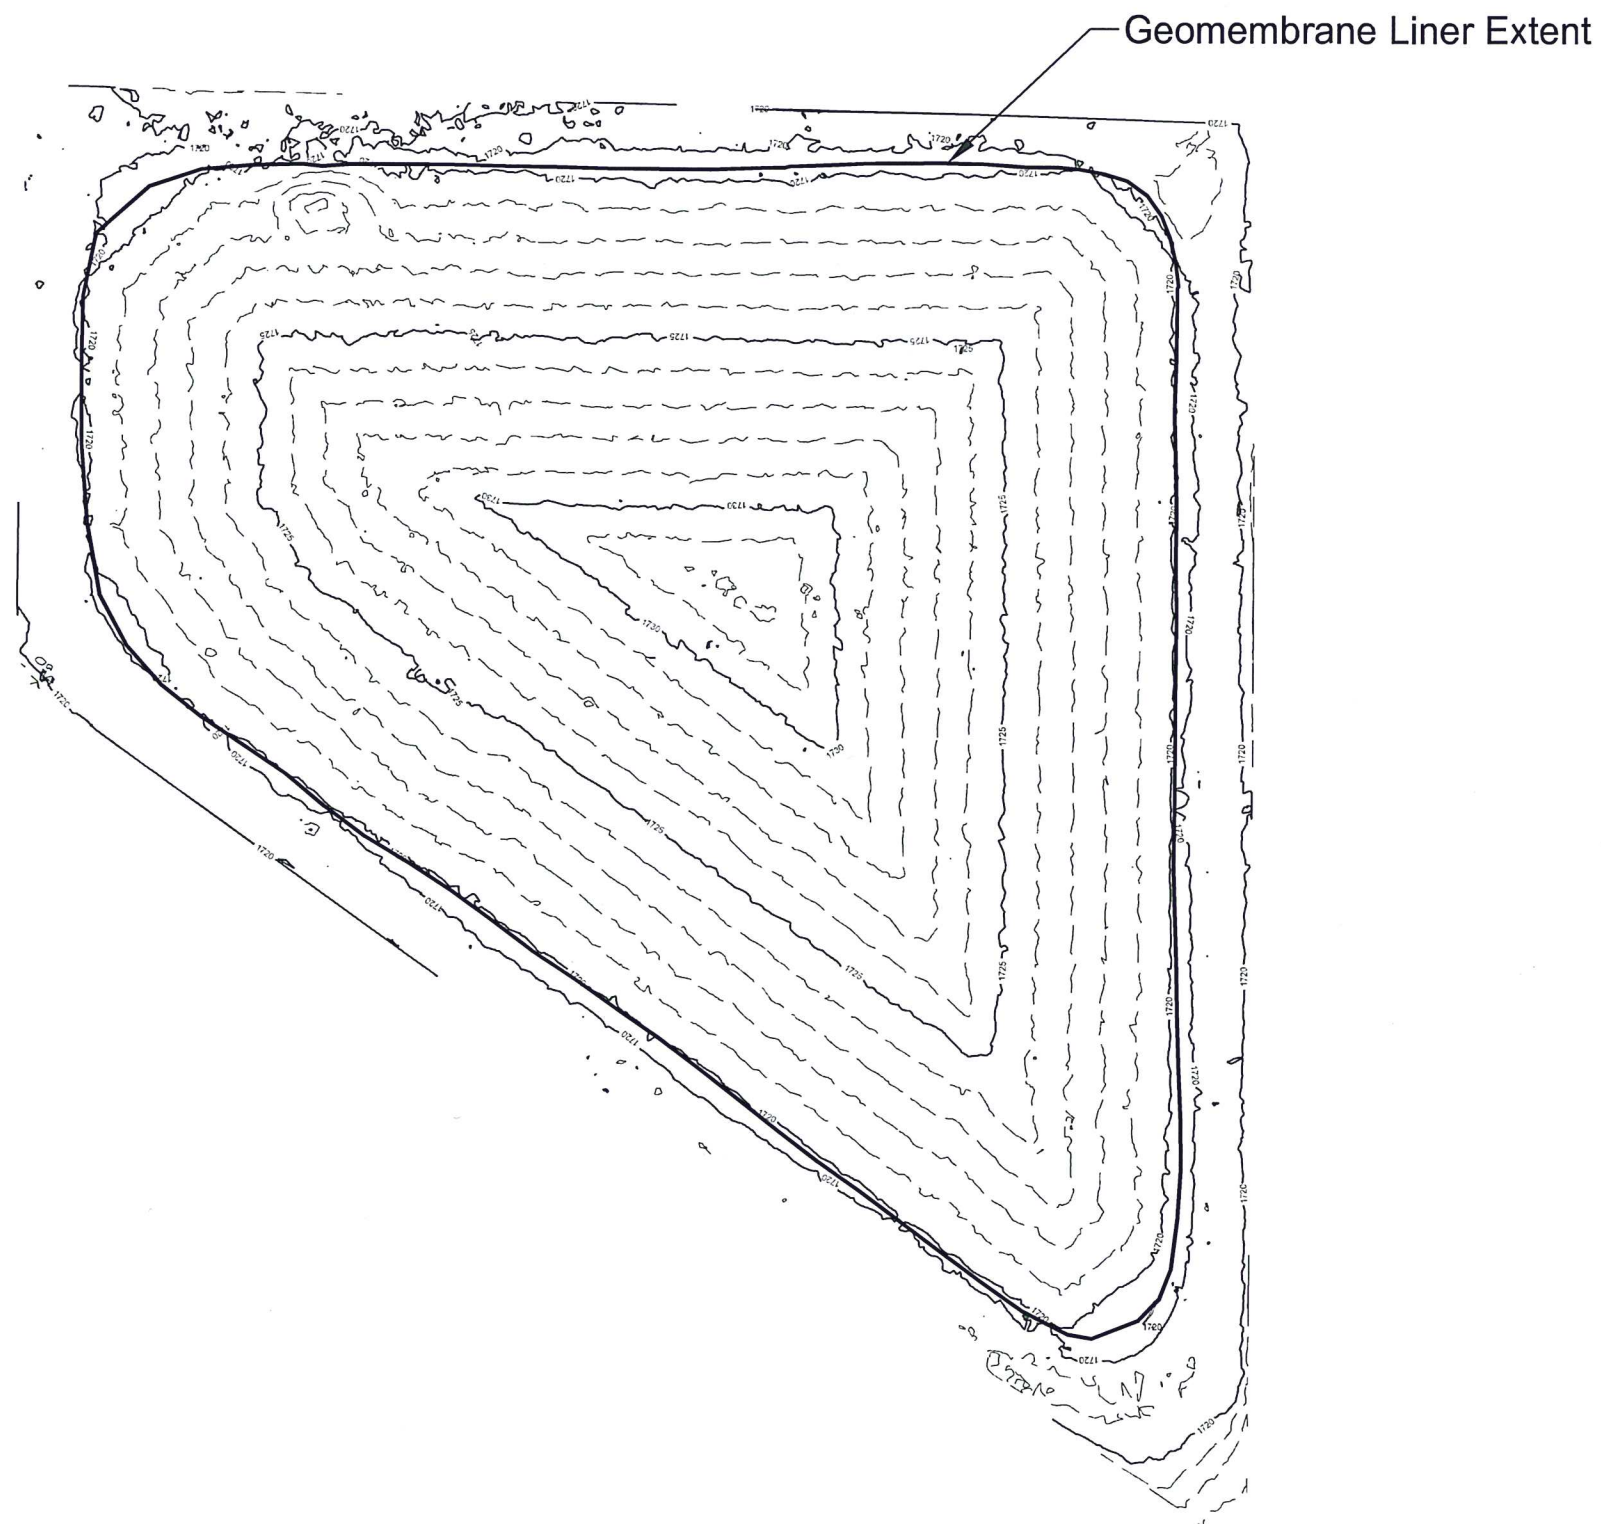
Total cover thickness (growth medium and topsoil) above geomembrane/GCL liner system was verified to be a minimum of 36 inches.

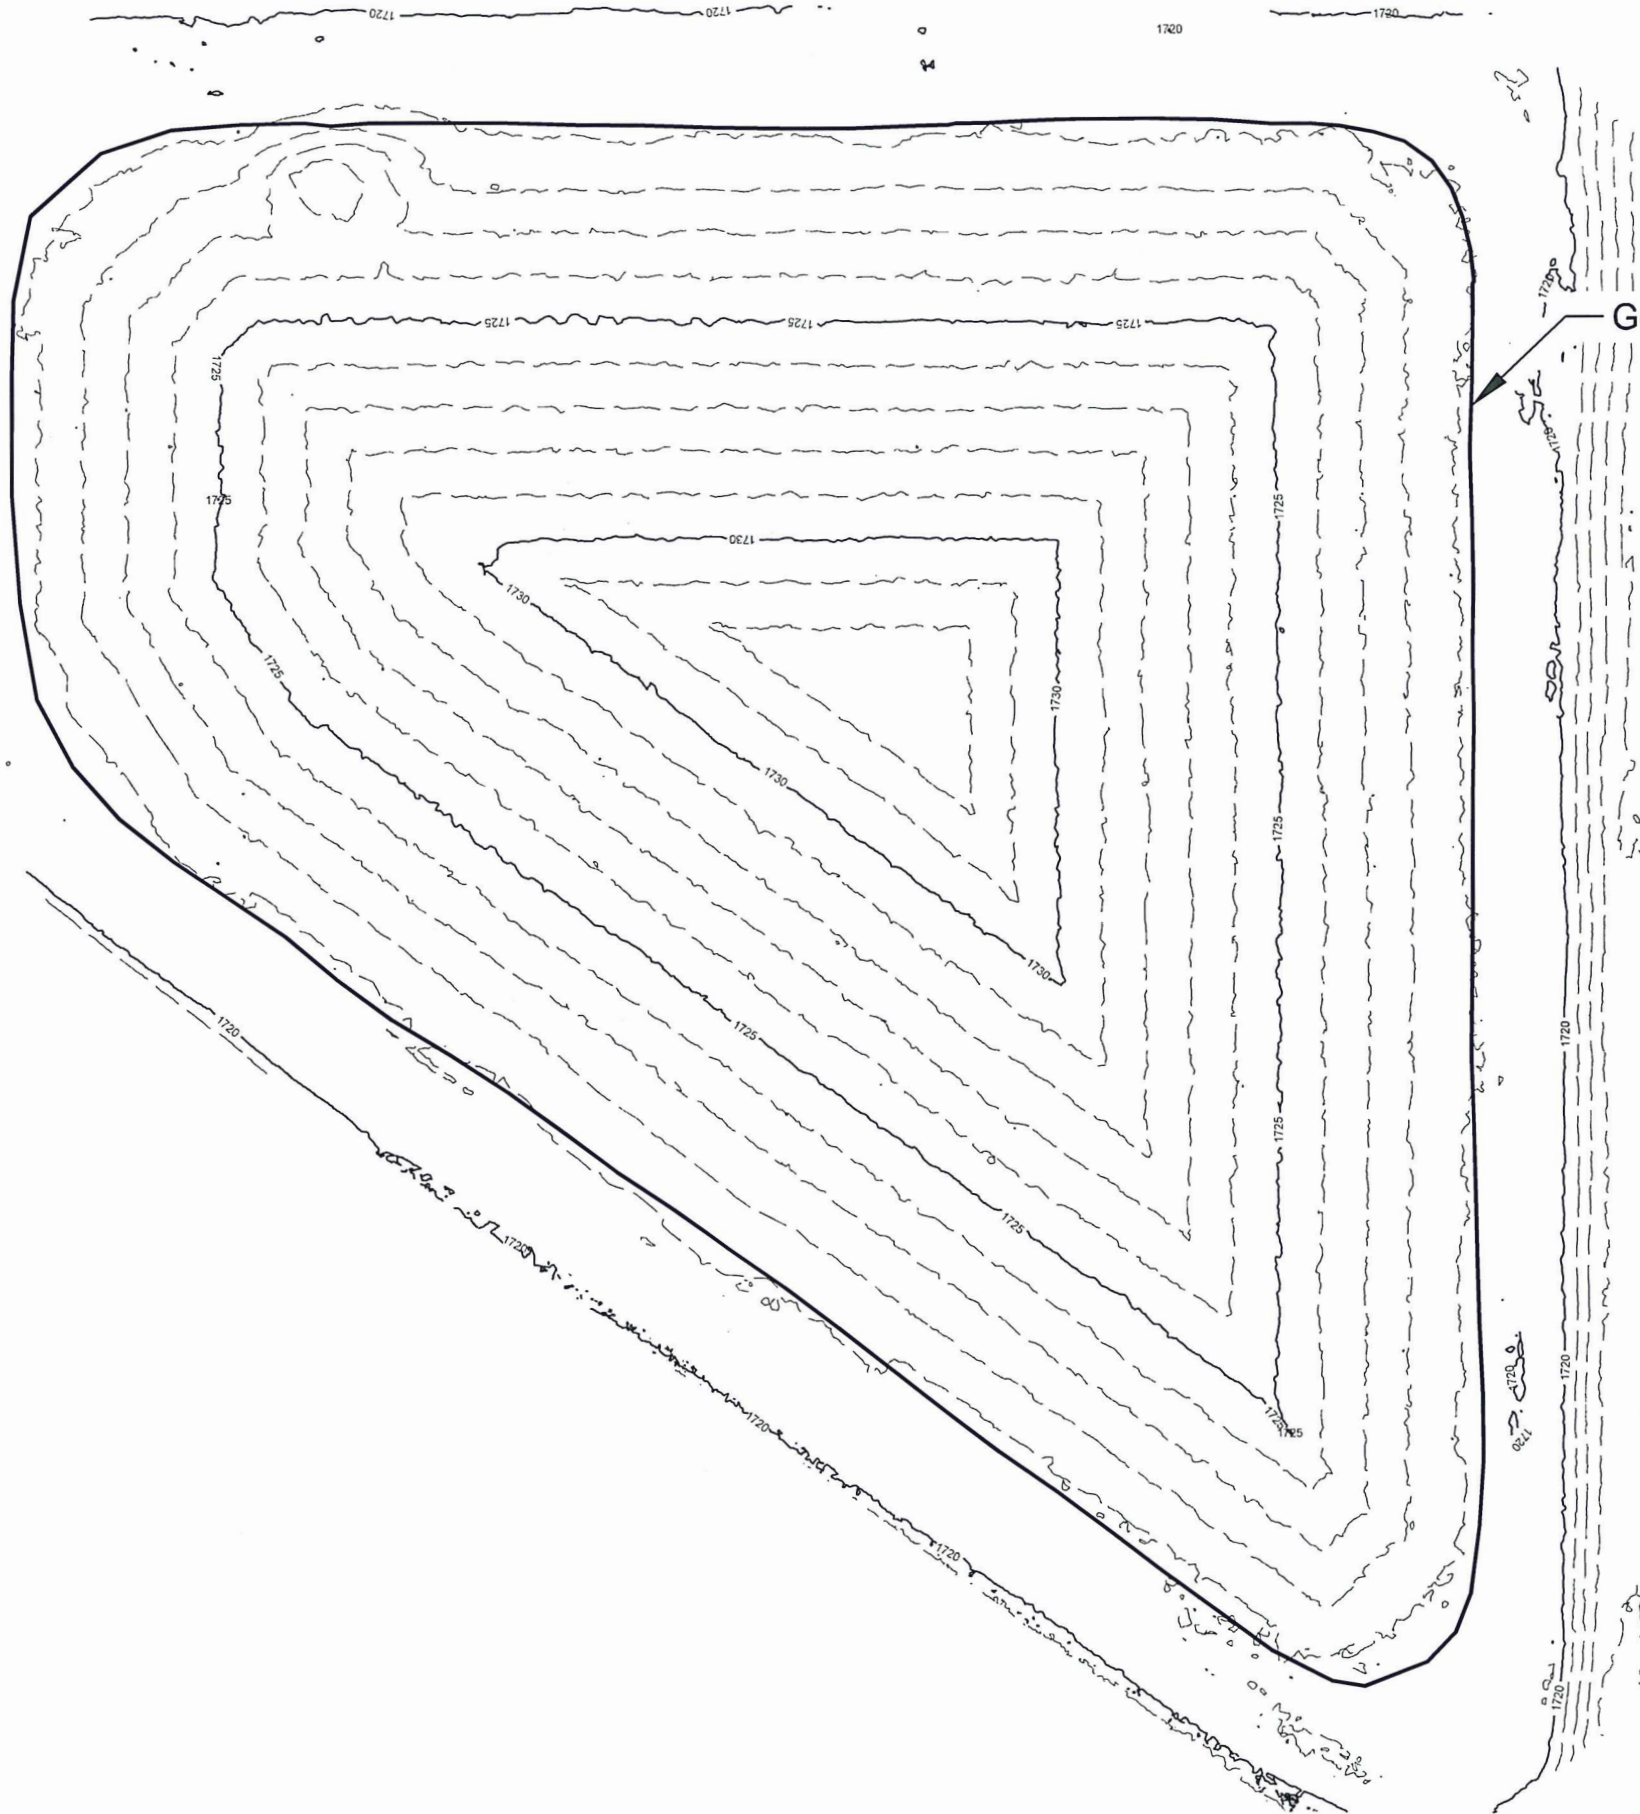
Total cover thickness (growth medium and topsoil) above geomembrane/GCL liner system was verified to be a minimum of 36 inches.
